Report on the investigation of the collision between
the bulk carrier
Alam Pintar
and the fishing vessel
Etoile des Ondes
15 miles north of the Cherbourg peninsula
on 20 December 2009
resulting in one fatality
and the loss of the fishing vessel

Marine Accident Investigation Branch
Mountbatten House
Grosvenor Square
Southampton
United Kingdom
SO15 2JU

Report No 11/2010
September 2010

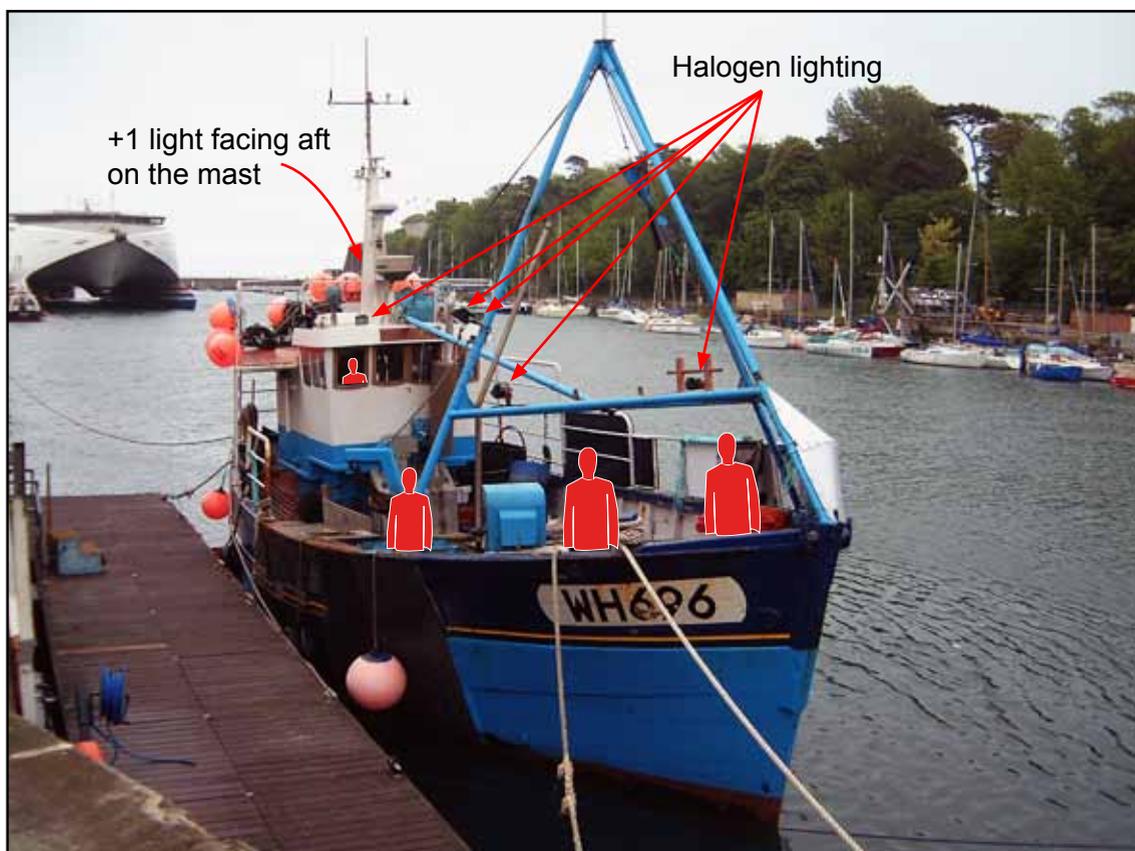
Etoile des Ondes - with halogen lighting and crew positions indicated
(whaleback omitted for clarity)

Initially, the alteration did seem to be effective, but it was subsequently counteracted by (from the perspective of the OOW) random changes of course by *Etoile des Ondes*. The OOW also found it difficult to identify the fishing vessel's navigation lights against the high powered halogen deck lights.

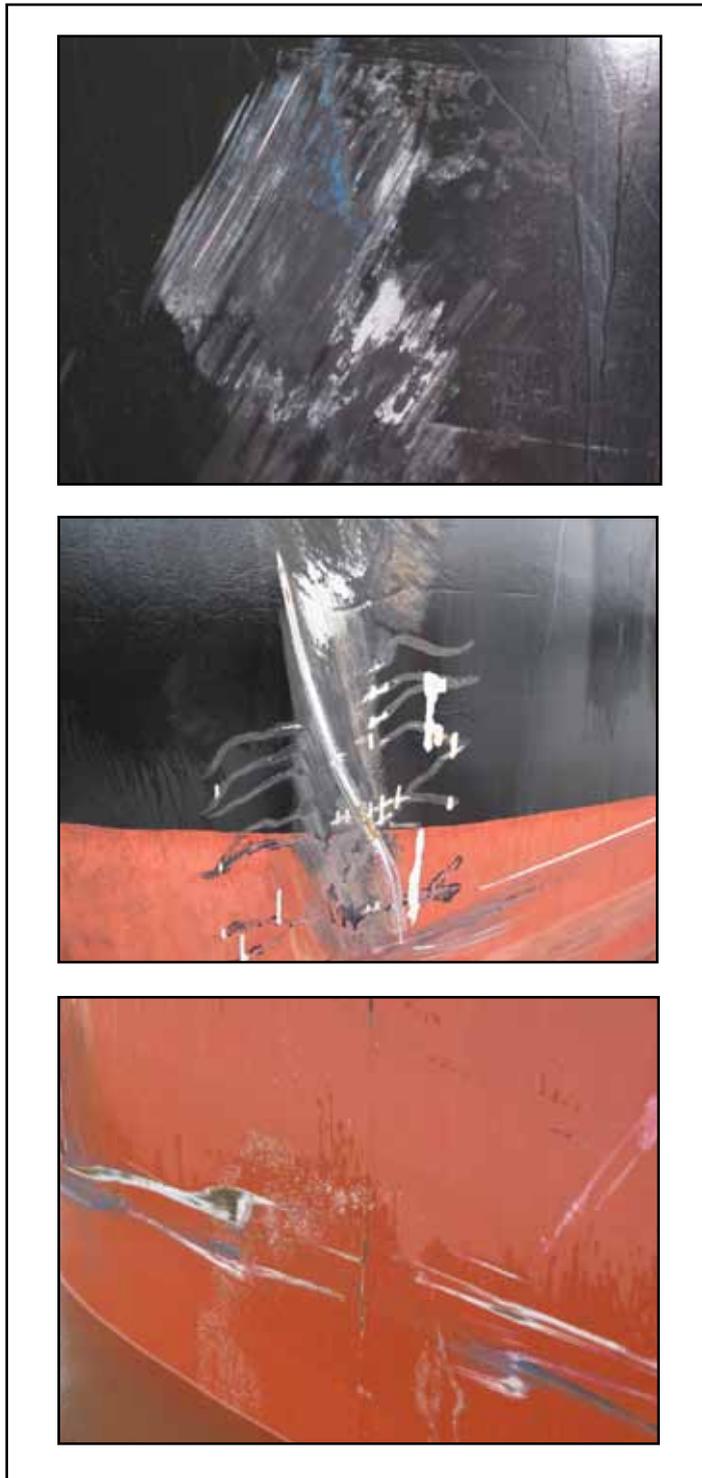
Figure 15

While alongside in Hamburg, *Alam Pintar*'s hull was inspected at close range from a mooring boat, for signs of contact. Cosmetic damage and traces of blue paint were found on the bow (**Figure 15**) and on the port quarter (**Figure 16**). As her hull was black, these blue paint traces were a strong indication of contact with another vessel.

Photographs of *Alam Pintar's* bow indicating contact and showing traces of blue paint
