Report on the investigation of the injury
to a fisherman on board
the fishing vessel

Olivia Jean TN 35

on 10 October 2009

Report No 10/2010
August 2010

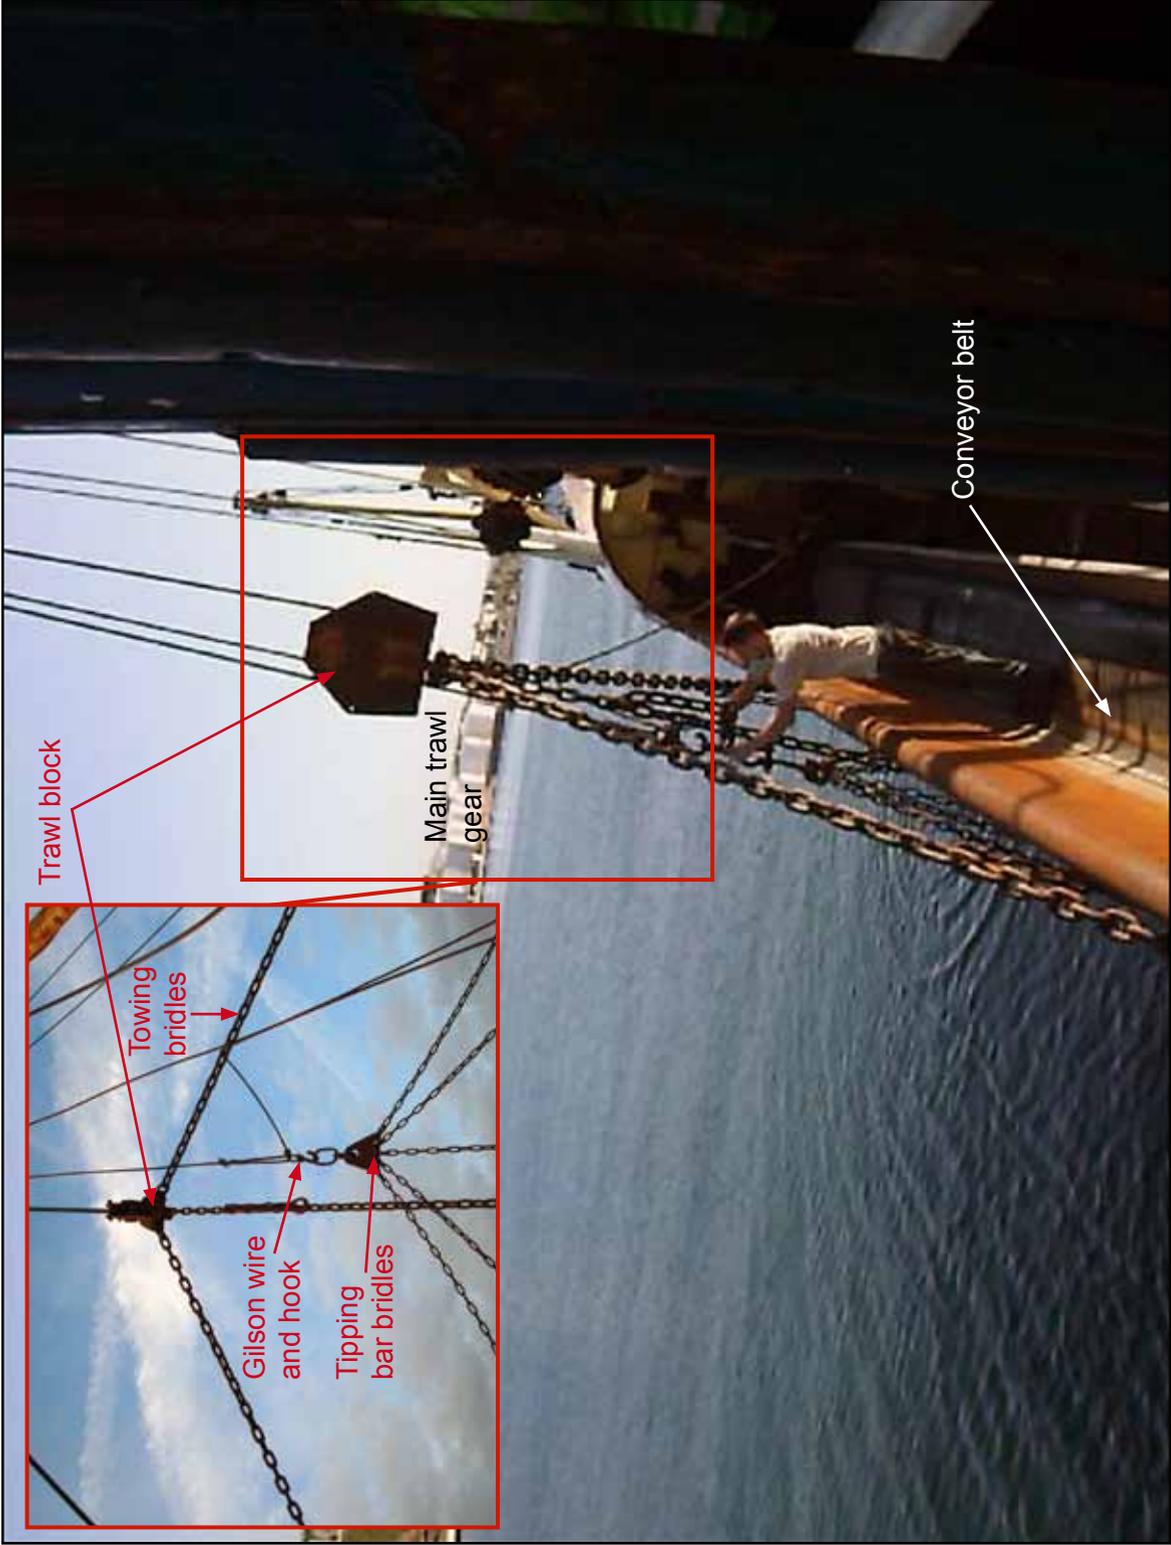
Figure 2

Location of accident

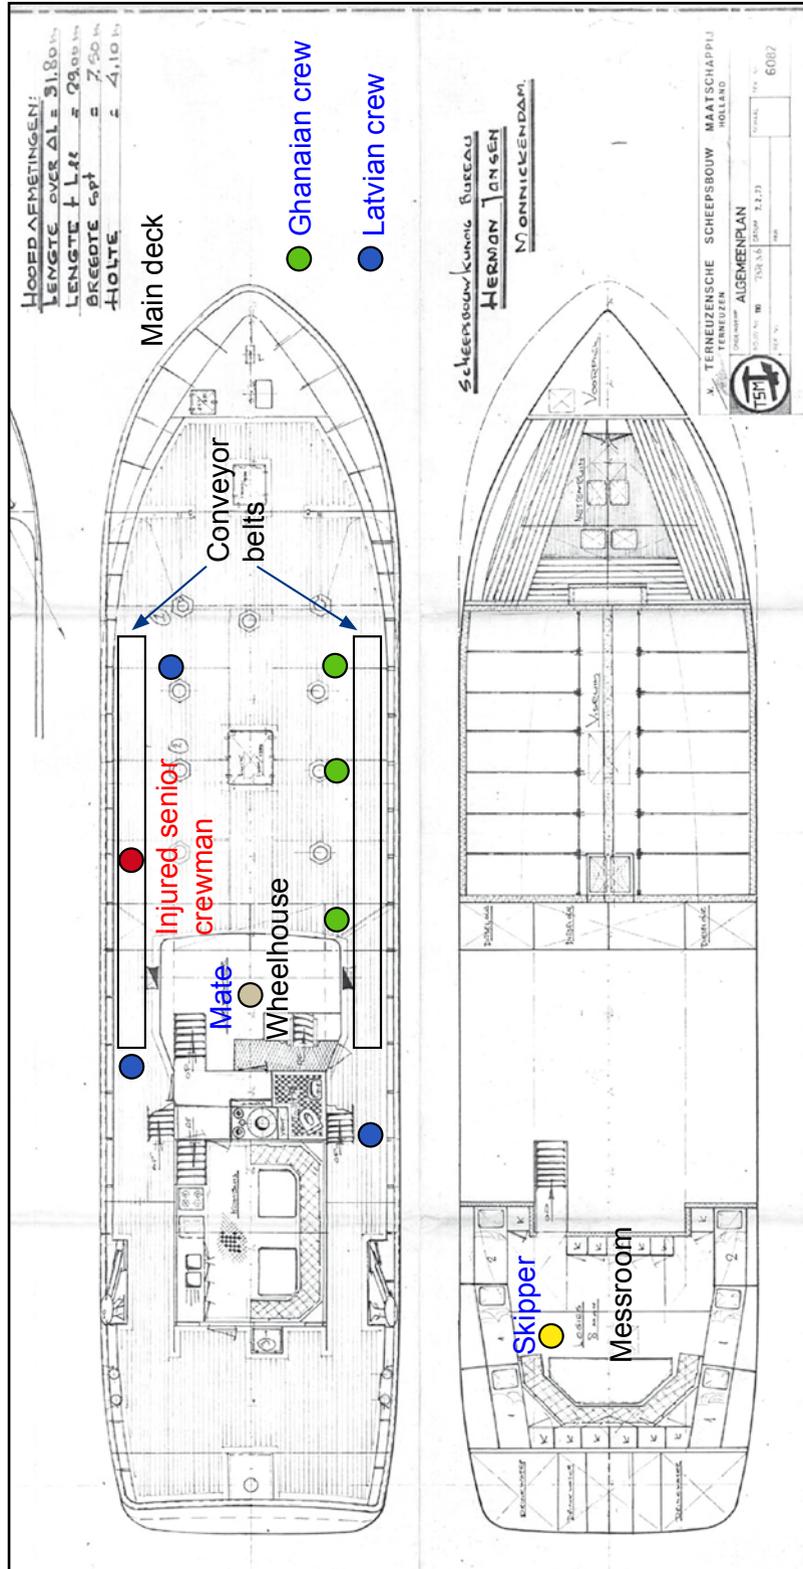
Figure 3

At about 1020, the senior crewman climbed on to the conveyor belt, aft of the main trawl wire, to check the port gear before the catch was tipped out (**Figure 3**).

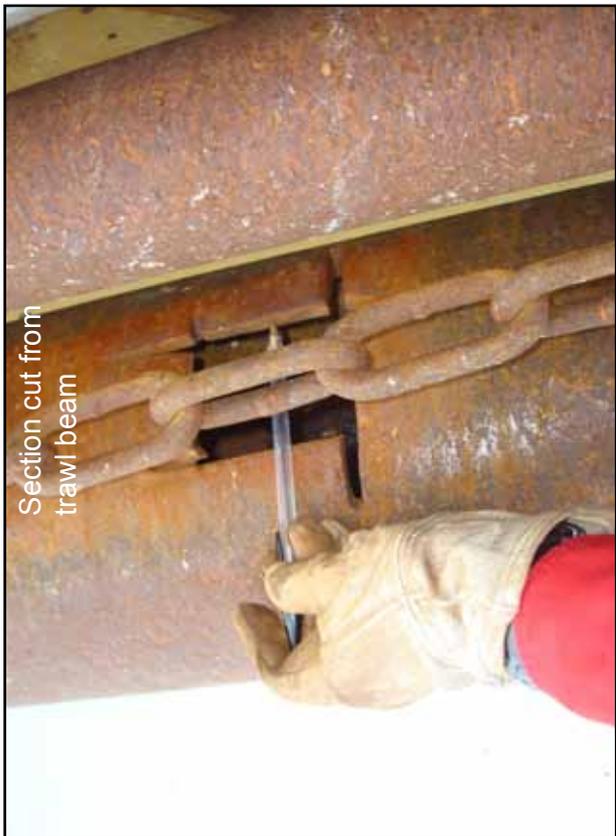
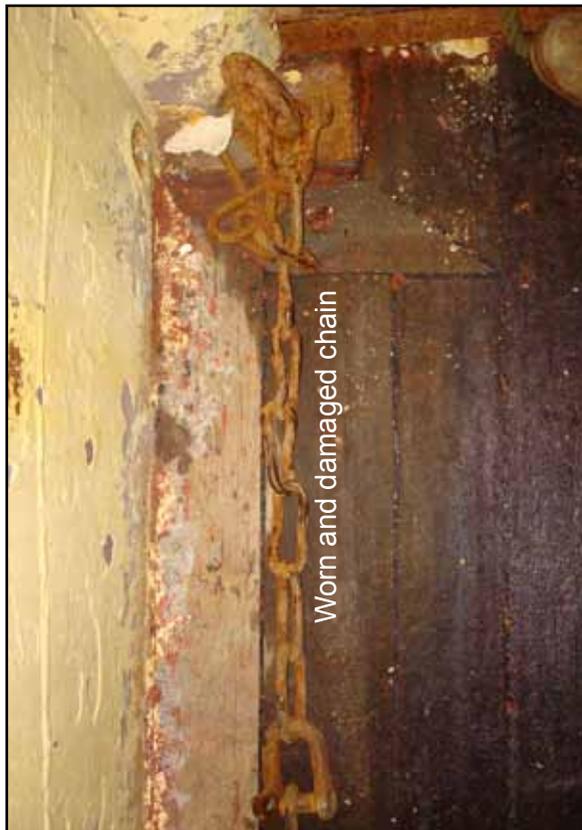
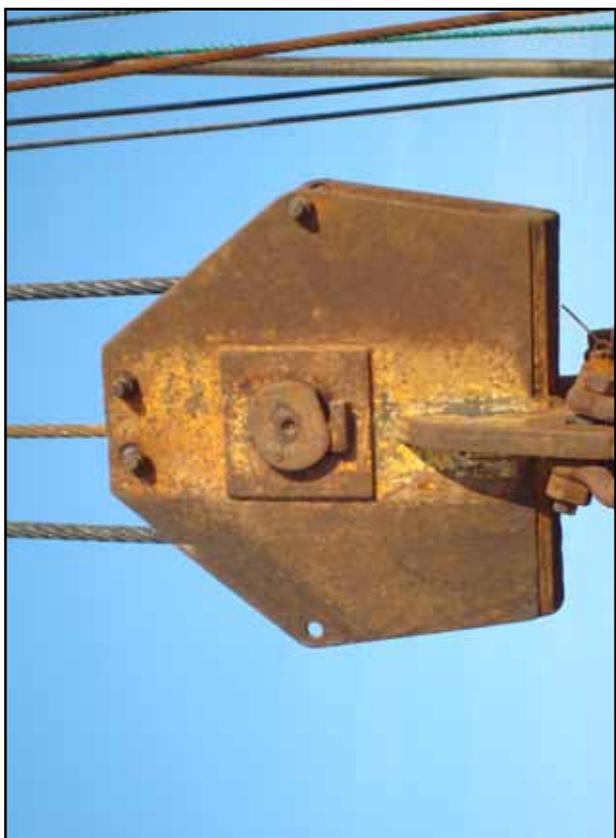
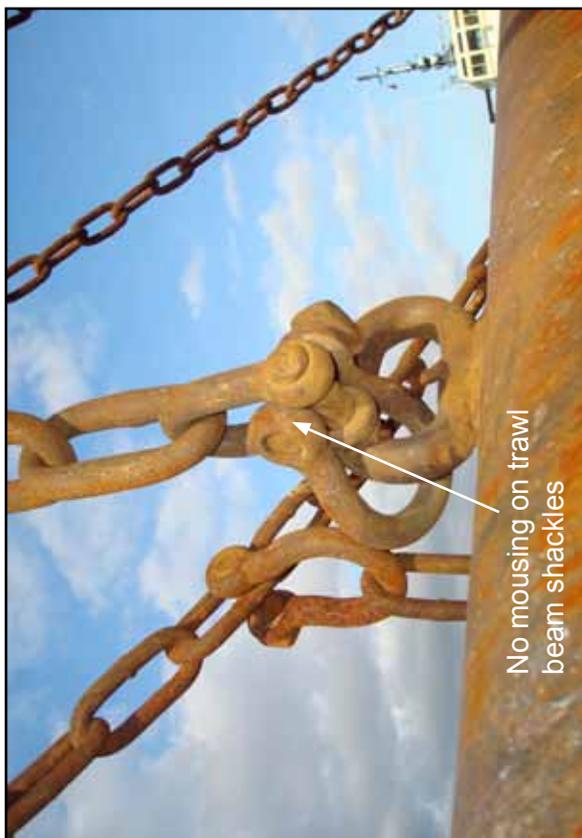
- The trawl beam attachments to the lifting chains were poorly designed and manufactured. These attachments were fabricated using shackles not designed for lifting and cut links of trawl chain. Many shackles and chain links were badly worn (**Figure 8a**).

- Weld repairs to the trawl beams and tipping bars were inadequate. Both beams and bars were cracked in several places (**Figure 8a**).
- The trawl blocks were worn, damaged and with parts found missing (**Figure 8b**).

- The port Gilson wire was damaged, deformed and not lubricated (**Figure 8b**).
- Various parts of the safety chains were worn and distorted by overload; the assembly was made up from a mixture of ill-matched components (**Figure 8a**). The hooks in use consisted of either a proprietary item, or something similar fashioned from a section of shackle (**Figure 8b**). New spare hooks, unused, were found in the deck store.

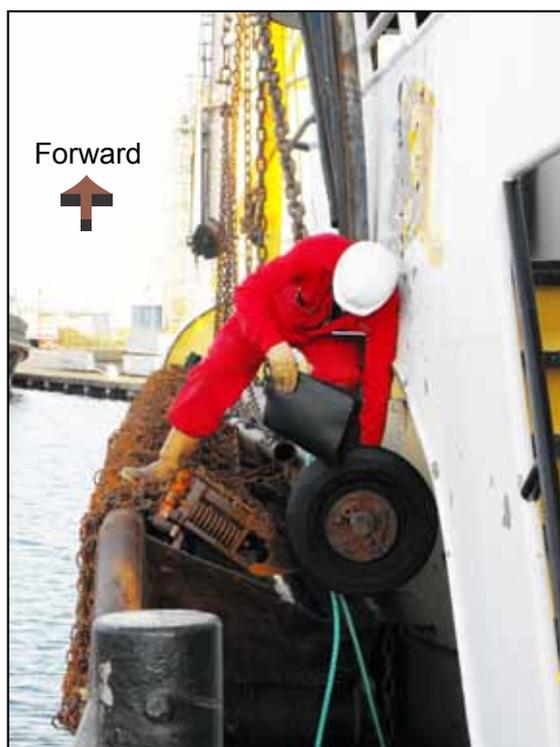
Figure 9

- With the fishing gear “landed on deck”, it was effectively draped over the bulwarks and on top of the conveyor system. This made it impossible to move safely from aft to the main working deck, and the only route was by climbing over the top of the gear and conveyor system (**Figure 9**).

Port side access

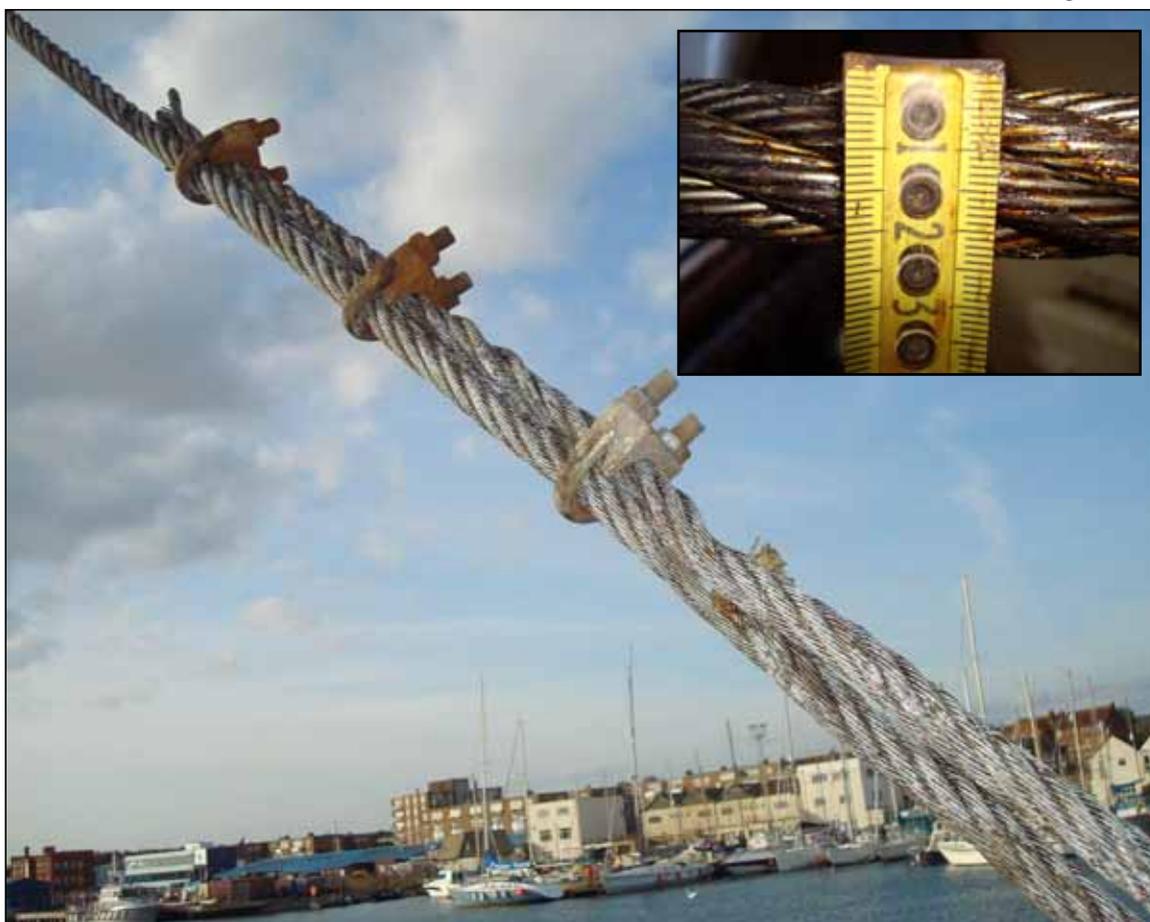
The main trawl wire that parted was supplied as a 700m length of 26mm diameter steel wire rope constructed of 6 strands, with 26 wires per strand wire and a lubricated fibre core (**Figure 10**)¹. The wire had been supplied in November 2008 and was stored at the owner's workshop until it was delivered to the vessel. There were no records of when the wire was supplied to *Olivia Jean*, but it was most likely fitted to the port wire drum at the end of 2008.

Main trawl wire (Bulldog grips incorrectly rigged)

¹ The bulldog grips shown in Figure 10 are incorrectly rigged (see the Code of Safe Working Practices for Merchant Seamen, Annex 20.1)

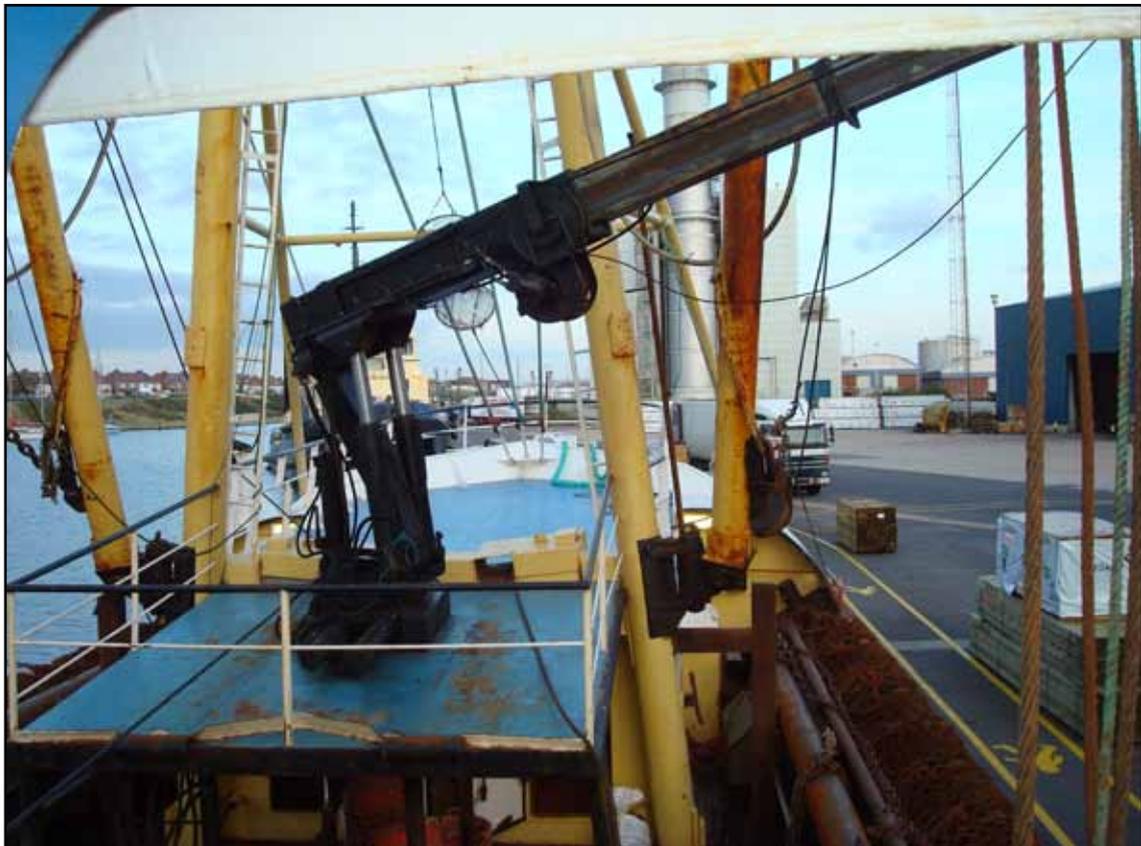
Figure 13

In early 2009, 3000kg of ballast was placed in the vessel in preparation for the fitting of a deck crane; half the ballast was placed in the forward engine compartment and half into the next compartment aft. In July 2009, a HIAB deck crane (**Figure 13**) weighing 750kg was fitted above the main deck, supported by 530kg of additional steelwork. Around the same time, the conveyor belt system on each side of the vessel was replaced.

Additional HIAB crane fitted in 2009
