Report on the investigation of
the uncontrolled descent of an
accommodation ladder from the container ship

Ever Elite

10 September 2009

Report No 8/2010
July 2010

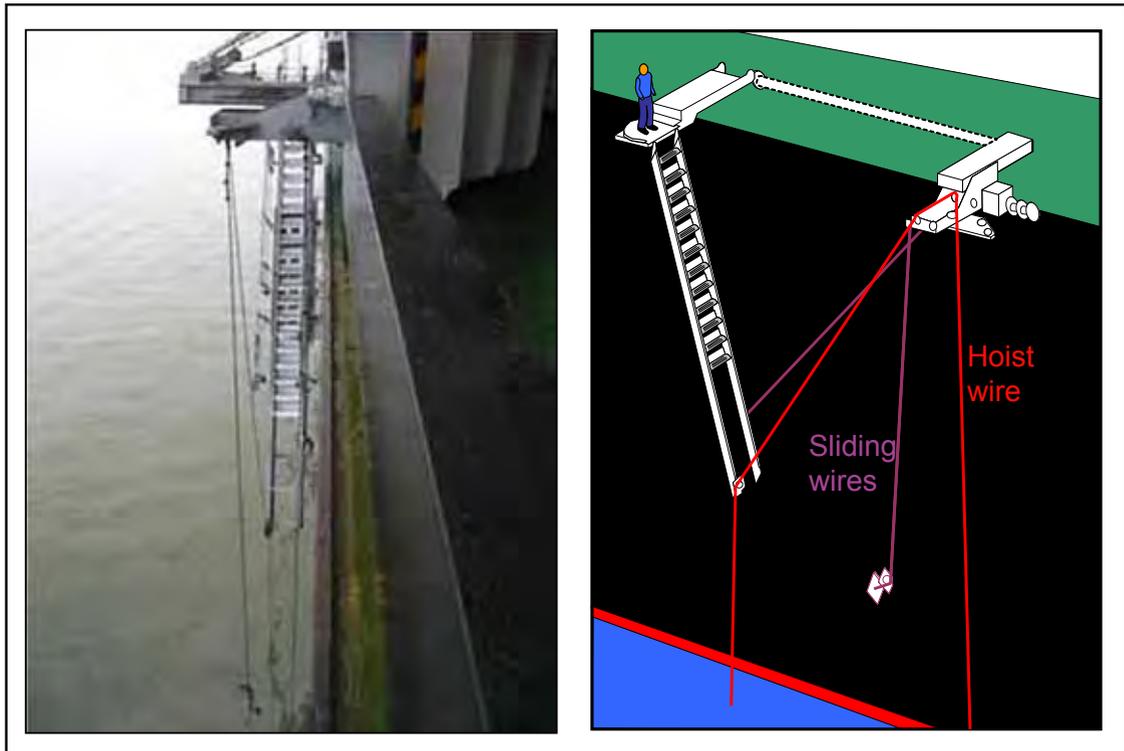
Figure 6

At approximately 0505, AB2 heard a loud bang followed by a whirring sound as the ladder fell rapidly towards the sea. The lower ladder broke away and entered the water, taking AB Huang with it. The upper section of the ladder was left hanging vertically down from its upper platform hinges and the hoist wire was dangling from the davit (**Figure 6**).

Damaged ladder

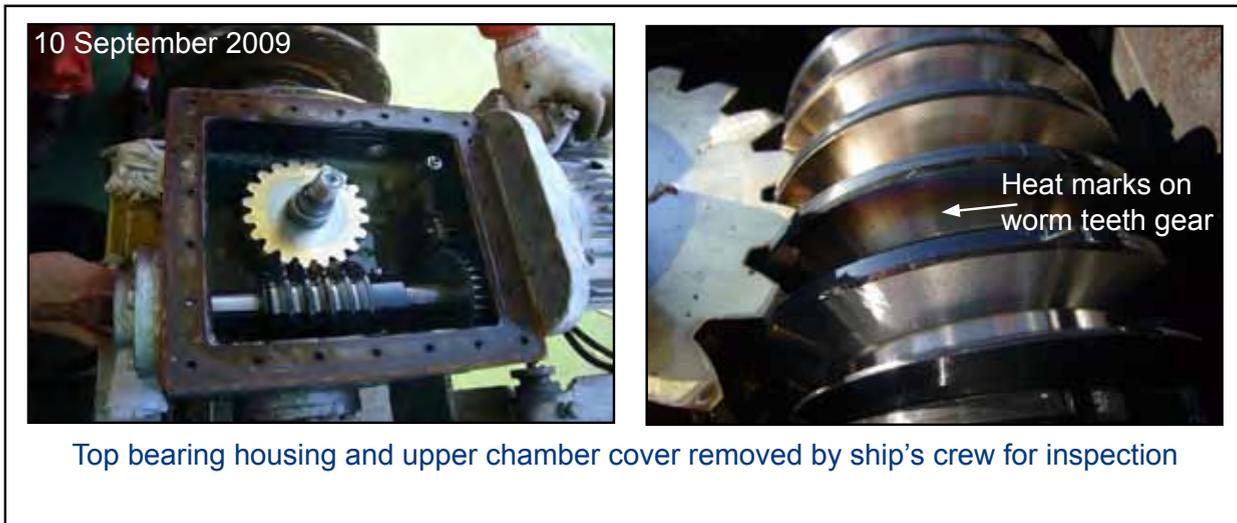
Figure 15

On the day of the accident, the hoist wire was recovered from the davit by the ship's crew and the upper chamber of the gearbox was inspected by the chief engineer in the presence of two Protection & Indemnity (P&I) club surveyors. The self-locking worm and wheel gear arrangement was found to be intact but evidence of heat damage was found on the steel worm (Figure 15).

Initial inspection of the gearbox upper chamber

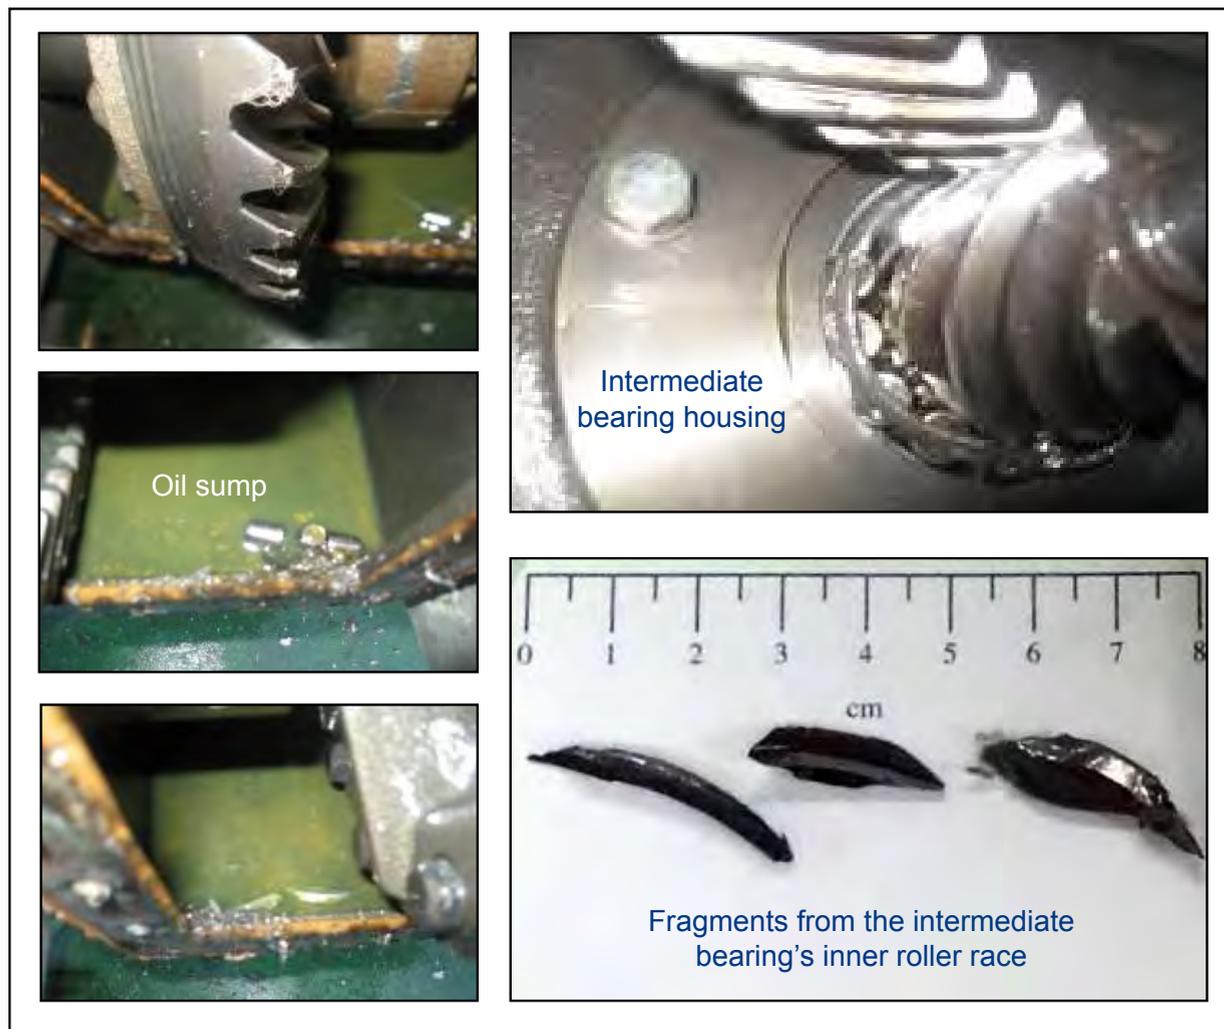
On 14 September 2009, the gearbox was taken to the engine room for overhaul. When the gearbox was stripped down, damage to the intermediate bearing and the spiral bevel gear teeth was exposed. The chief engineer then inspected the starboard accommodation ladder hoist winch gearbox. He found damage to the outer edges of the differential gear unit's spiral bevel gear teeth. As a precaution, he replaced the unit.

Debris and damage found when the lower chamber of the gearbox was opened up and inspected

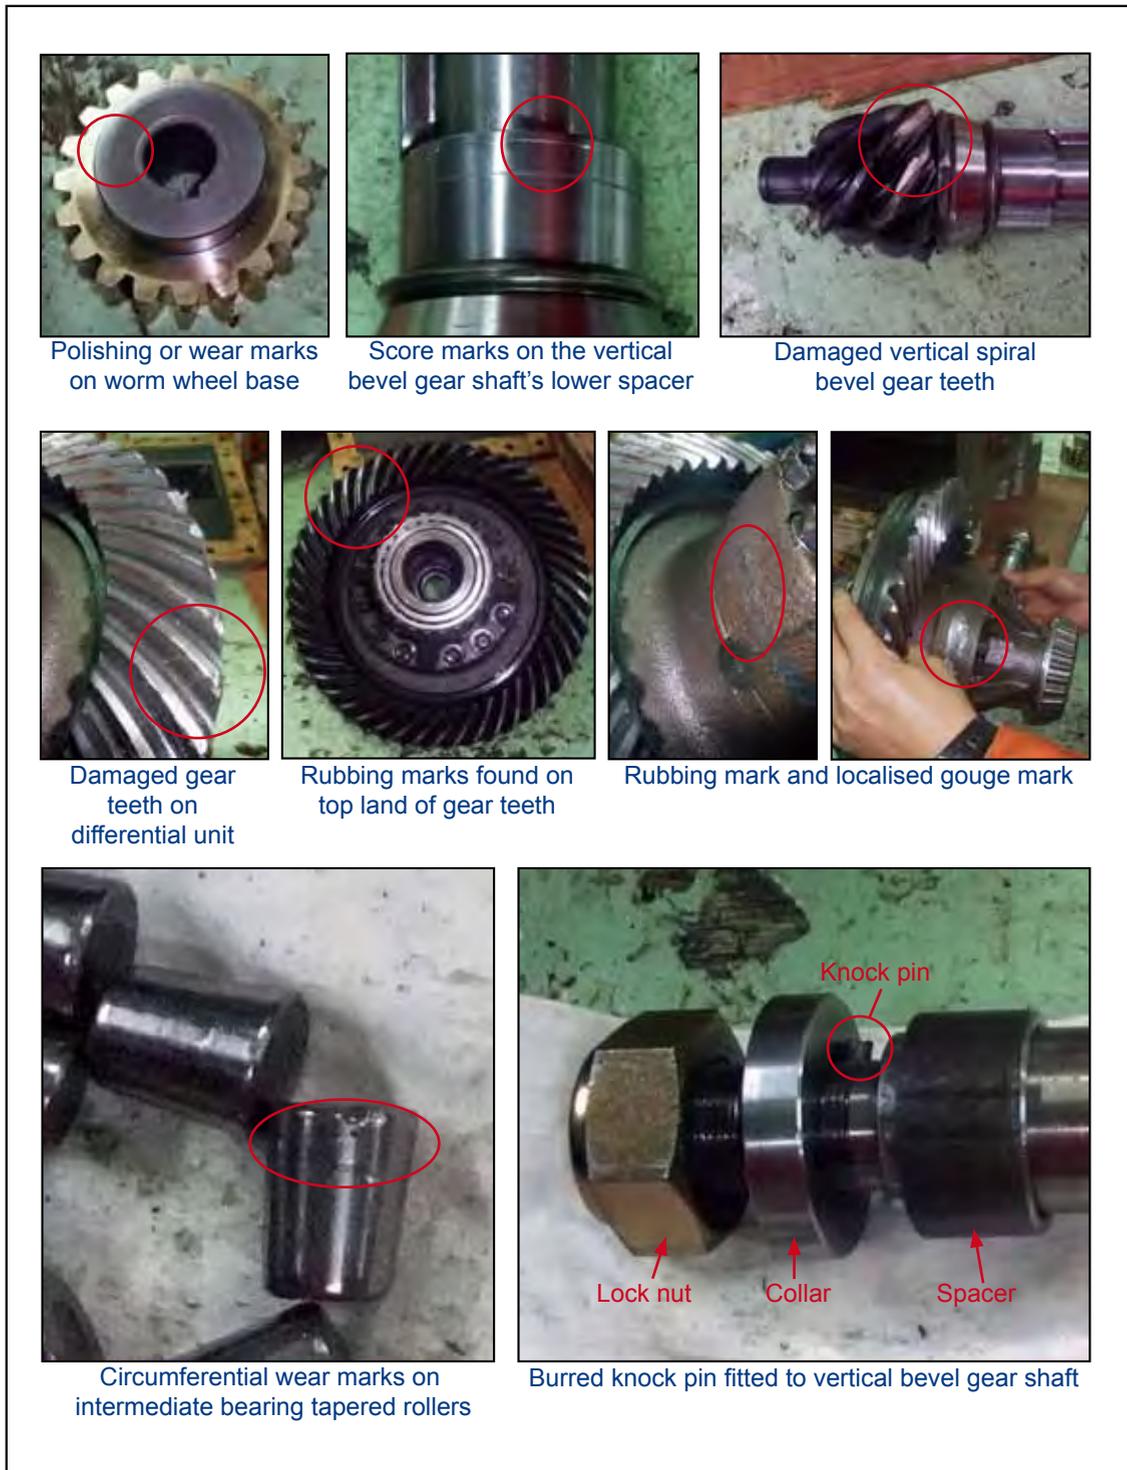
Figure 17

- Polishing or wear marks were evident on the upper edge of the faces of the worm wheel gear teeth and the underside of worm wheel body.
- Two score marks, one of which appeared to be recent, were found on the lower spacer of the vertical bevel gear shaft.
- The spiral bevel gear teeth on both the vertical bevel gear shaft and the differential gear unit were damaged.
- Rubbing marks were found on the top land of the spiral bevel gear teeth on the differential gear unit.
- A rubbing mark on the outer circumference of the differential gear unit body, directly below the vertical bevel gear shaft, was found in line with a deeper localised gouge mark.

- Distinct circumferential wear marks were evident on the faces of the intermediate bearing's tapered rollers.
- The knock pin fitted to the vertical bevel gear shaft was burred.

MAIB observations during inspection of damaged gearbox components

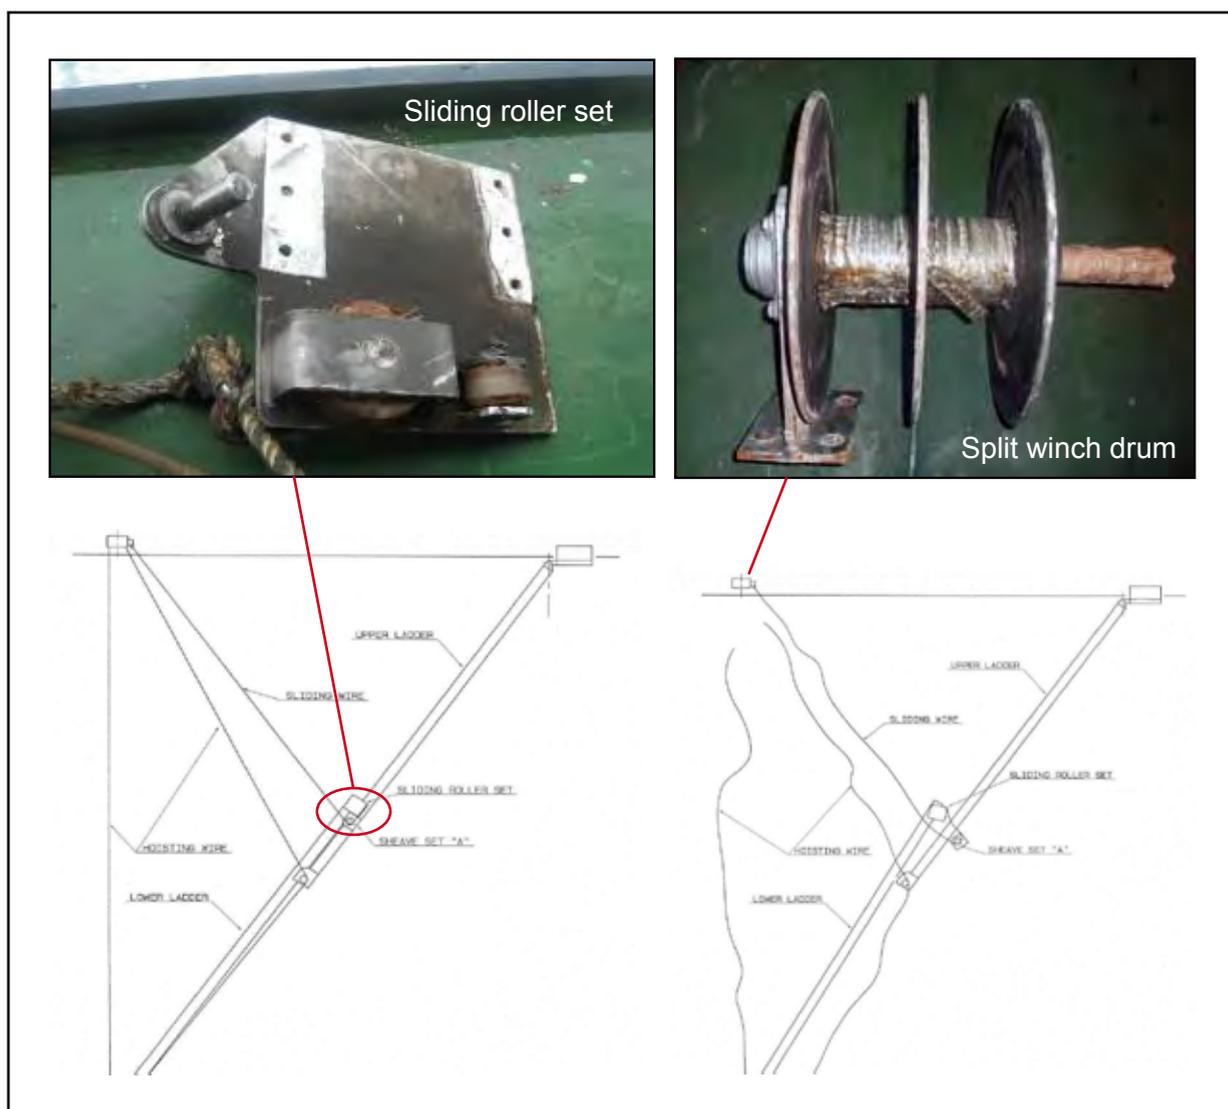
Figure 18

Once this had occurred, the sliding wires accelerated the lower ladder outwards until the base plates of its sliding roller sets impacted with those of the upper ladder sheave blocks (**Figure 18**). The force of the impact caused the 16mm base plate securing bolts to shear, releasing the lower ladder from the upper ladder. The ends of the hoist wire were torn from the drum and the lower ladder was lost overboard.

Detachment of lower ladder

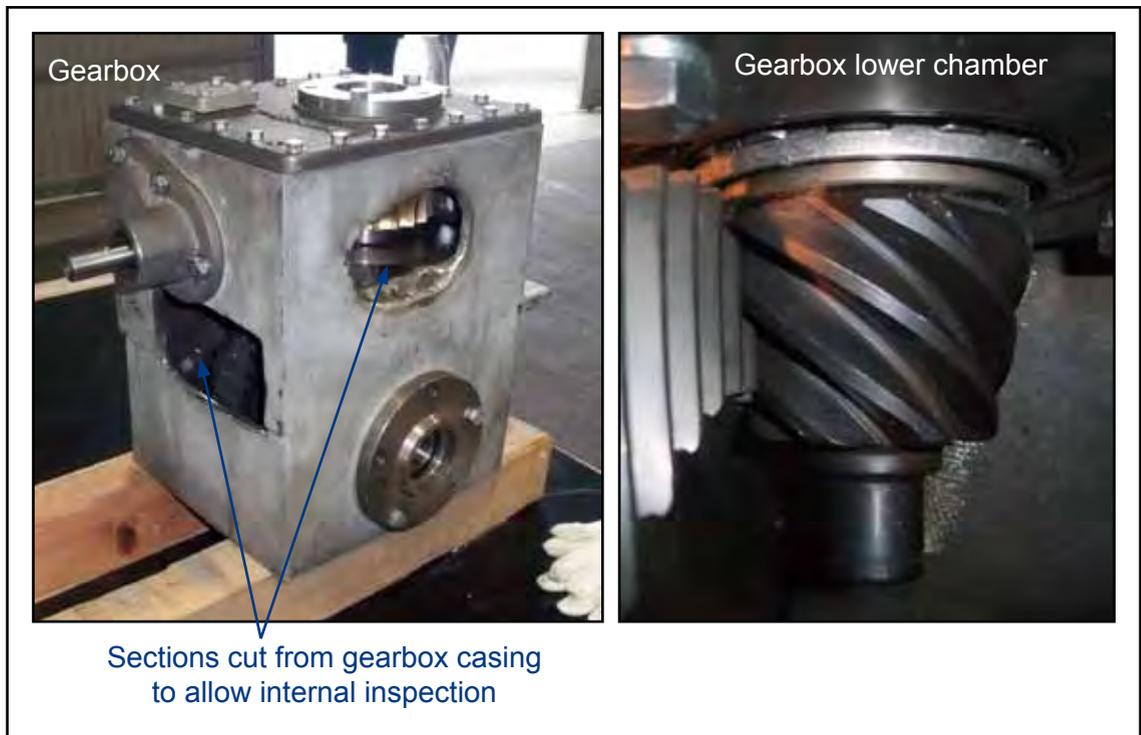
Figure 19

At the request of the MAIB, Nakano made a new gearbox available for inspection (**Figure 19**) at its factory near Imabari, Japan, on 17 December 2009. The manufacturer recreated the circumstances that would have led to the failure mode described in its report, and several potential reasons for the displacement of the vertical bevel gear shaft were explored. It was noted during the reconstruction that the outer tips of the spiral bevel gear teeth on the differential gear unit made contact with the inner race of the intermediate bearing. This caused the vertical shaft to move up and down during winch operation.

Failure mode reconstruction

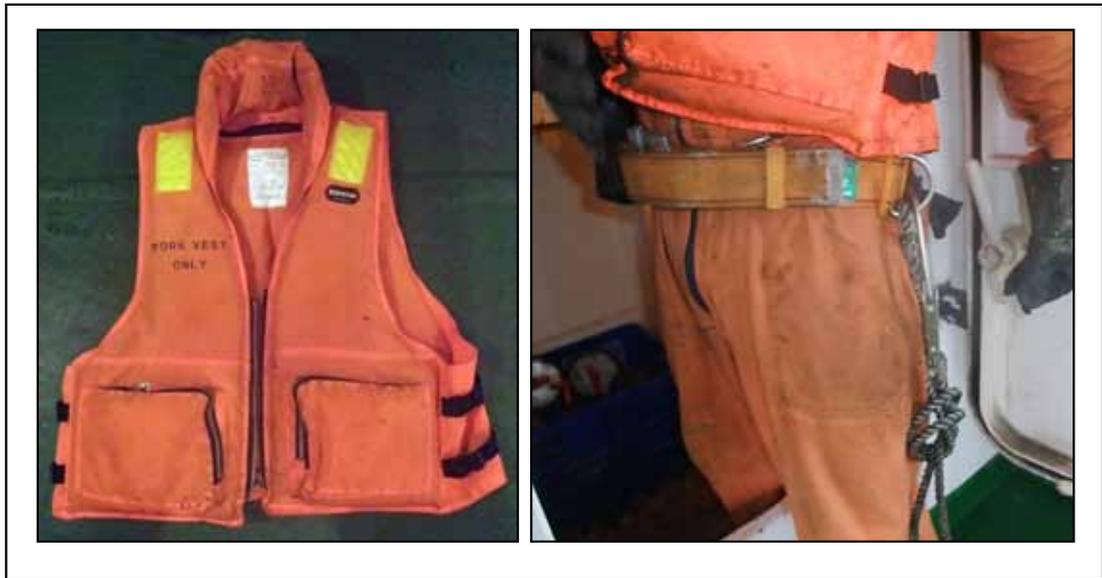
The life vests provided for use while working over the ship's side on board *Ever Elite*, and other EMU vessels, were manufactured in China and had 7.5kg (74N) of buoyancy (**Figure 22**). They were not fitted with lights or whistles.

Working life vests and safety belts provided on board *Ever Elite*

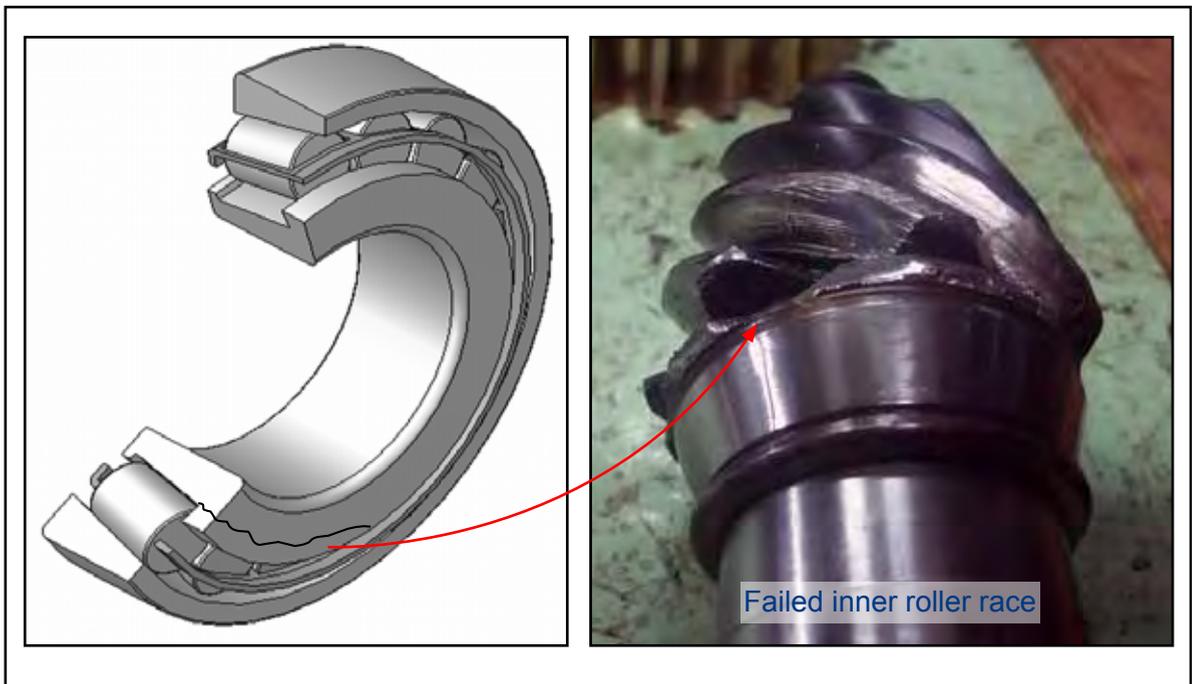
Figure 24

The marks found on the top land of the spiral gear teeth of the differential gear unit and the damaged teeth of the vertical bevel gear shaft, resulted from contact between the two components as the winch drum rotated rapidly when the ladder fell (**Figure 26**). This is consistent with the whirring sound heard by AB2 directly after the initial loud bang.

Intermediate bearing failure

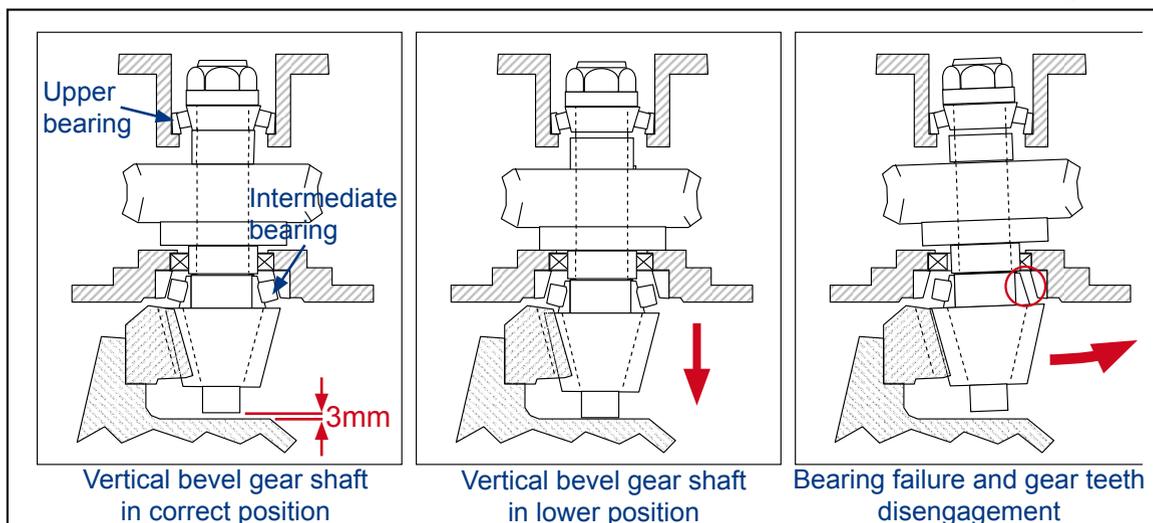
Figure 25

Spiral bevel gear teeth disengagement

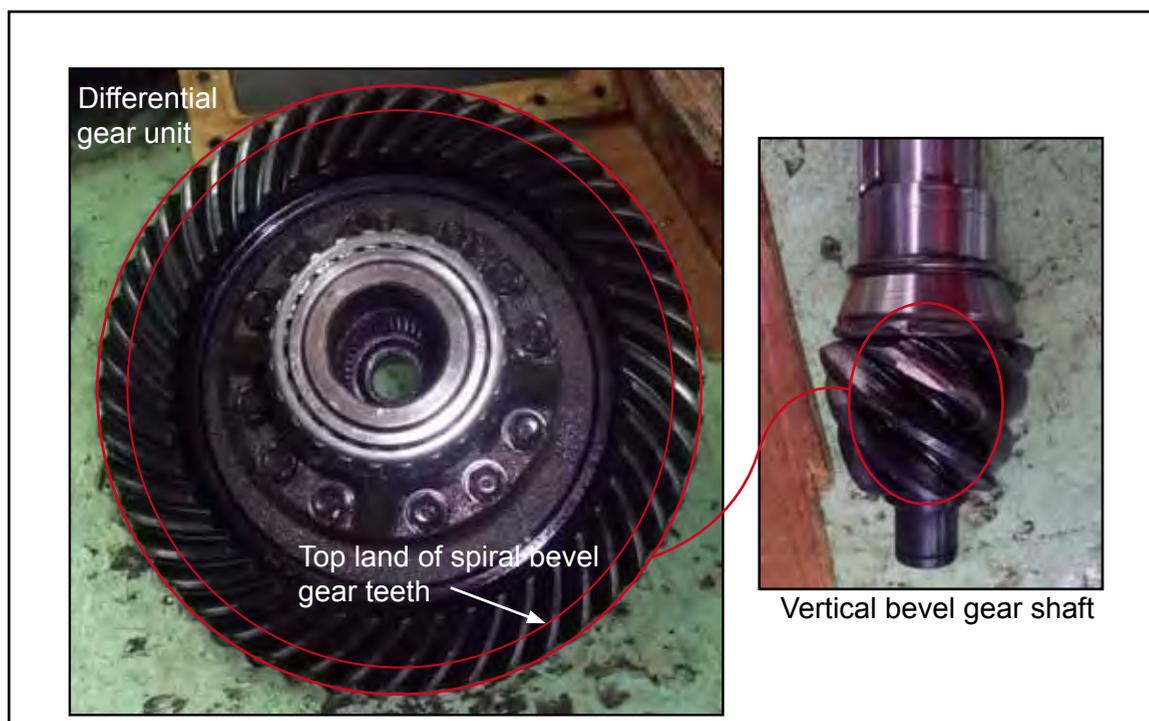
Figure 26

Marks found on the top land of the differential gear unit's spiral bevel gear teeth

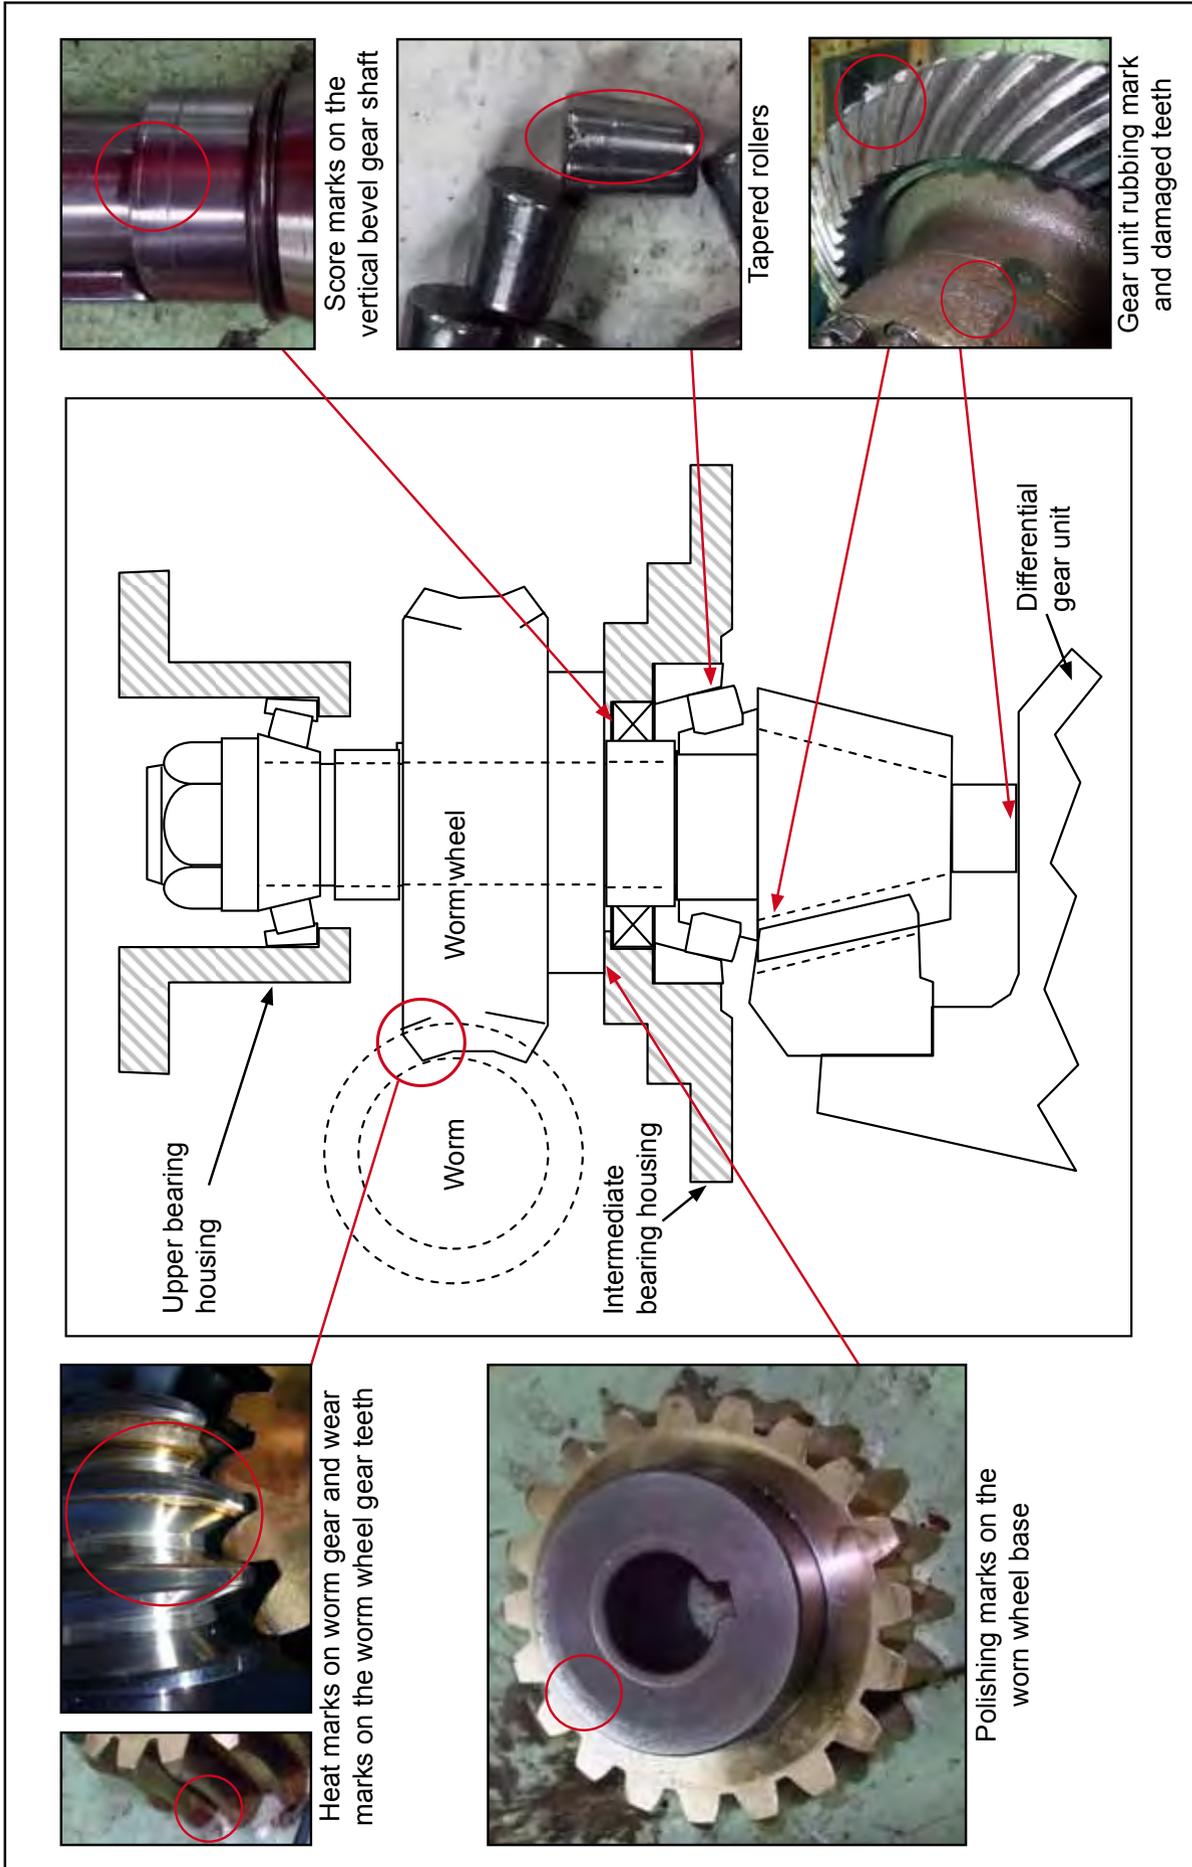
Other damage to the gearbox components noted in **paragraph 1.8** and shown at **Figure 27** indicates that the vertical bevel gear shaft had dropped by at least 3mm prior to the ladder being set free. In particular:

- The heat marks on the worm in the upper chamber would have resulted from contact with the upper edges of teeth on the worm wheel.
- The polishing marks on the underside of the worm wheel body indicate it had been rubbing against the top of the intermediate bearing housing.

Evidence to support the lower position of the vertical bevel gear shaft

- The score marks on the vertical bevel gear shaft appear to have been caused by the shaft rubbing against its oil seal. As the upper mark was more recent than the lower score mark, it is highly likely that the shaft had been turning in the lower of two positions at the time of the failure.
- The marks on the tapered rollers show that the inner roller race had dropped sufficiently to contact and damage the outer tips of the gear teeth of the differential gear unit.
- The marks on the body of the differential gear unit indicate it had been in contact with the vertical gear shaft.

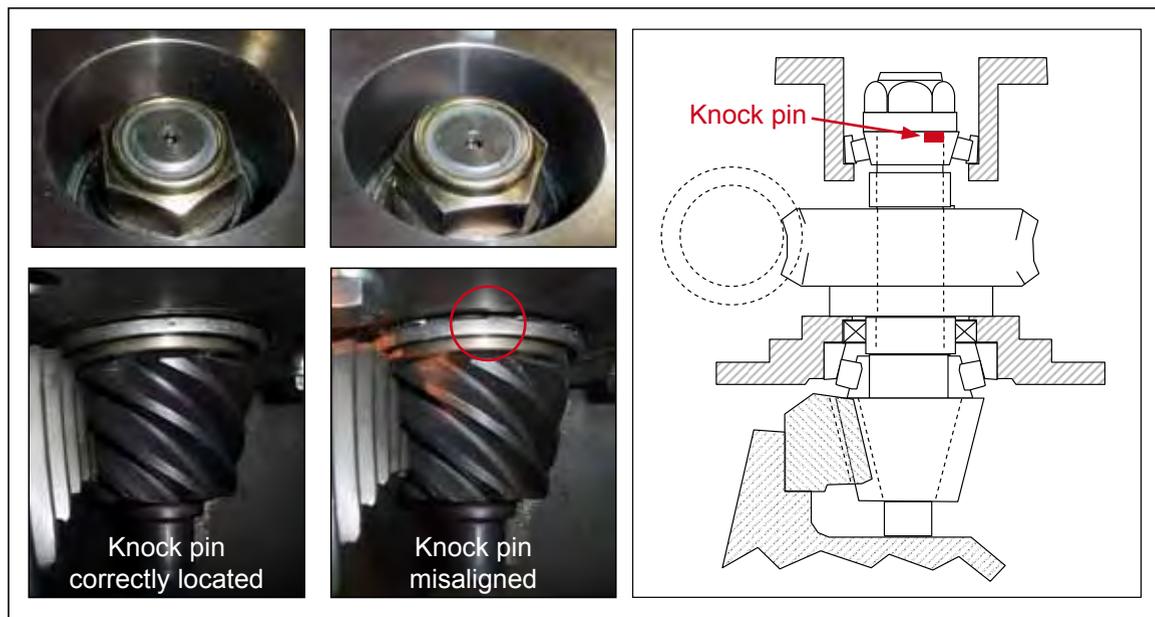
Figure 28

The rotational, polishing and heating nature of much of the damage highlighted also indicates the shaft had been out of position for some time prior to the accident. Furthermore, the burring on the knock pin indicates that the shaft was lower than designed due to the misalignment of, or interference between, the shaft's lock nut collar and the pin (**Figure 28**). This is most likely to have occurred through the incorrect re-assembly of the gearbox following maintenance, and would have been extremely difficult to identify by external visual inspection.

Vertical bevel gear shaft knock pin misalignment

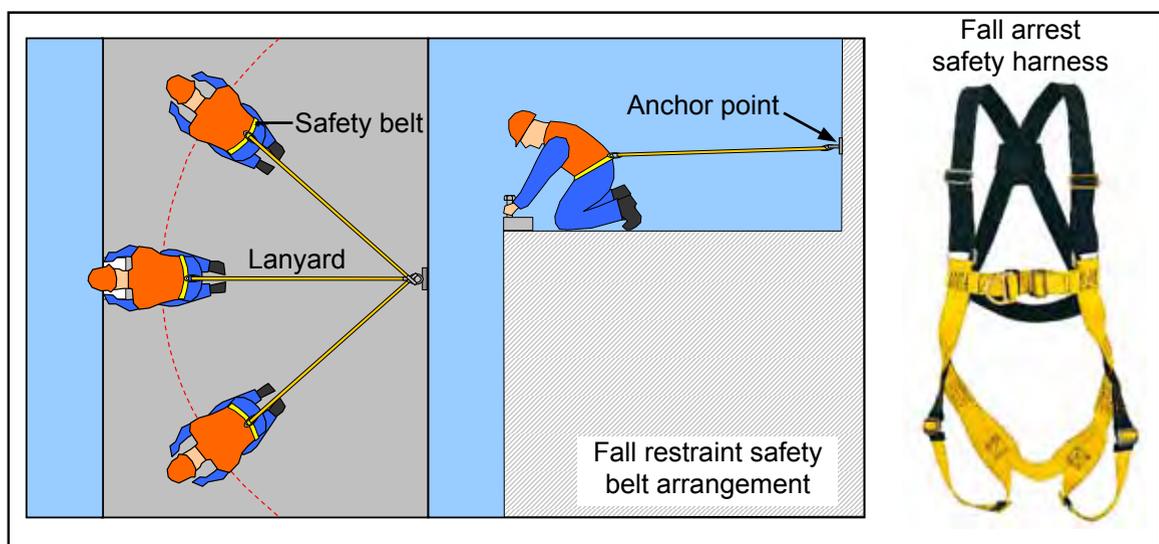
Figure 29

The safety belts provided on board *Ever Elite* were fall restraint, not fall arrest devices. These belts enable people to work up to the edge of a fall hazard, but prevent them from reaching the point from which they can fall (**Figure 29**). In this case, where there was a possibility of AB Huang falling into the water from the accommodation ladder while rigging its handrails, the use of fall arrest equipment was appropriate.

Fall restraint and fall arrest PPE and associated equipment
