Report on the investigation of

the collision between

## mt Saetta and mt Conger

> Report No 3/2010 March 2010

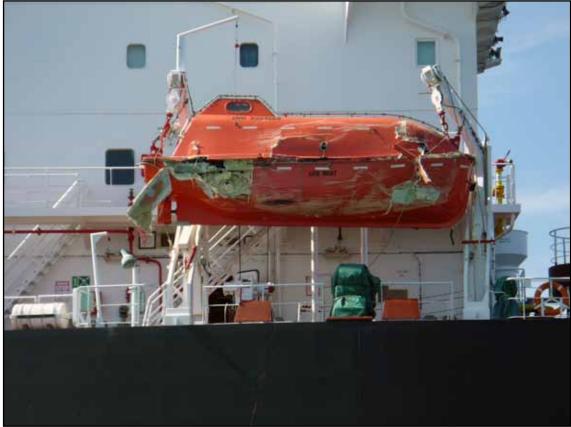
*Saetta* suffered structural damage to her starboard lifeboat (**Figure 5**) and the lifeboat davit arm (**Figure 6**). *Conger* suffered only scratches to her paintwork (**Figure 7**).

Damage to Saetta's starboard lifeboat

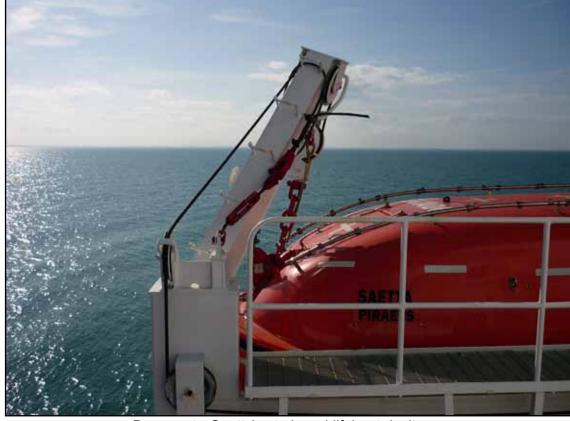
Figure 6

Damage to Saetta's starboard lifeboat davit arm

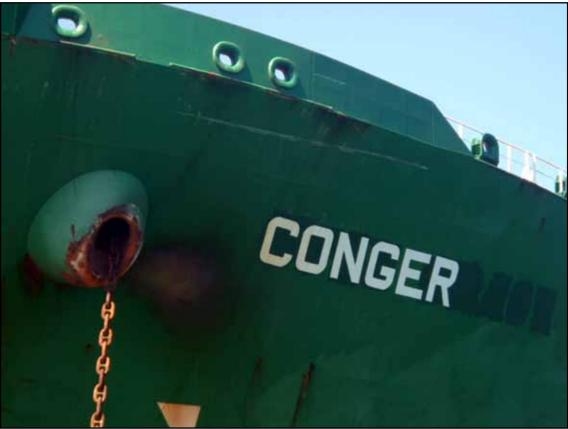
Scratches to Conger's paintwork
