Report on the investigation of  
the capsizing of the fishing vessel

***Aquila***

with the loss of three lives  
Bo Faskadale Reef, Ardnamurchan  
on 20 July 2009

**Report No 5/2010**  
**April 2010**

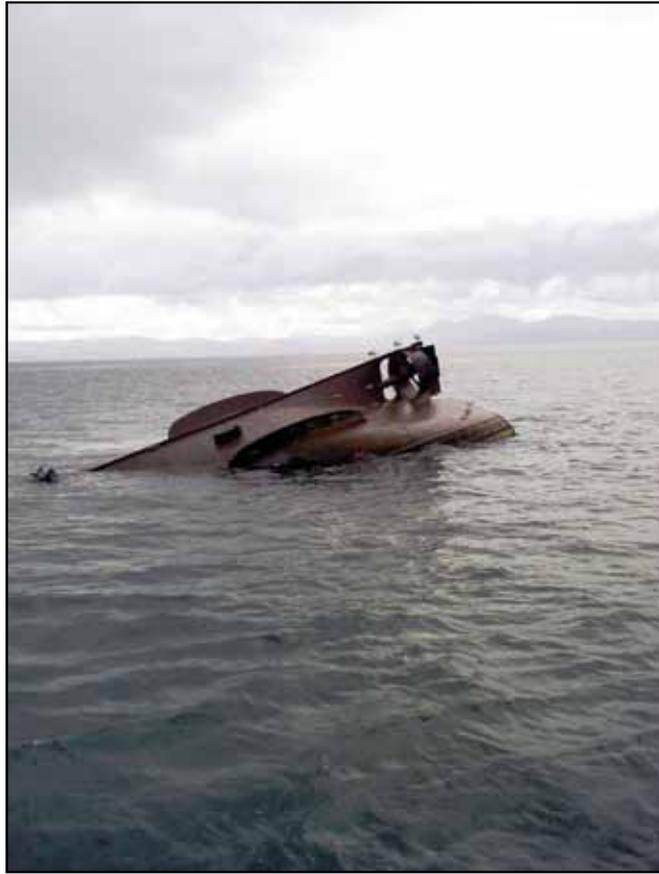
Figure 4

Upturned hull of *Aquila* in the capsized location

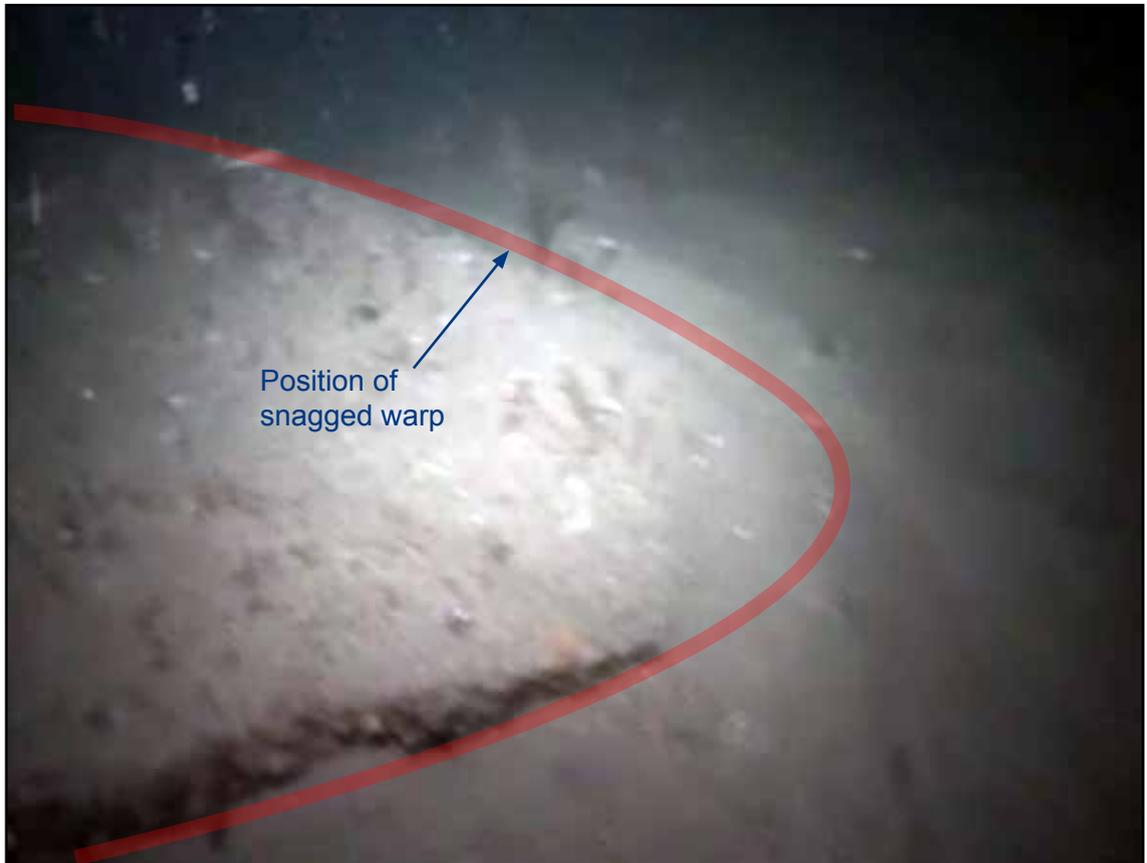
Figure 5

Starboard warp snagged on rock

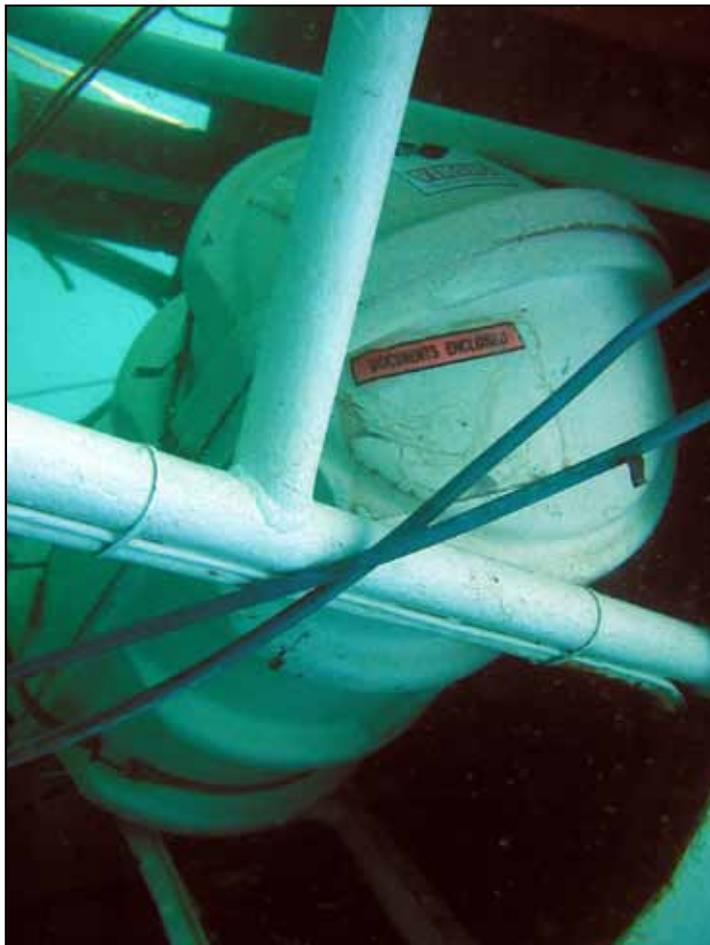
Figure 6

During this inspection it was observed that the Hydrostatic Release Units (HRUs) of the vessel’s liferaft and EPIRB had both activated correctly. However, both the liferaft and the EPIRB had become fouled on parts of the vessel’s superstructure (**Figures 6 & 7**), and had not floated free.

Liferaft fouled in *Aquila's* superstructure

Although not a statutory carriage requirement, *Aquila* had been fitted with an EPIRB as well as a requisite liferaft. HRUs were fitted to both, and it was found that these had activated as designed and allowed both the liferaft and EPIRB to be released from their housings. However, after release, they had both become trapped in the vessel's superstructure.

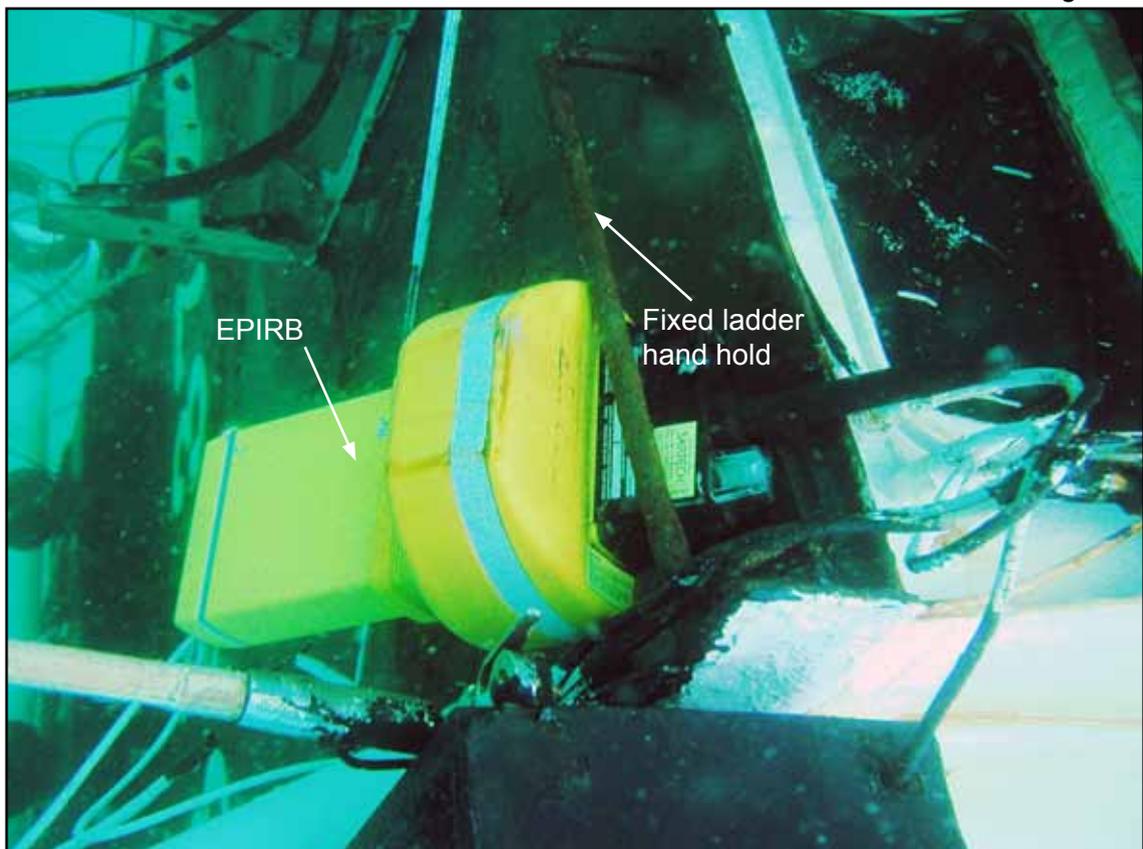
Figure 7

EPIRB fouled in hand hold of fixed wheelhouse external ladder

The EPIRB was examined after the accident, and it was found that it had last been serviced in 2002 and that its battery had been due for replacement in 2005. Once the prudent decision to carry an EPIRB had been made, it should have been serviced annually in accordance with the manufacturer's recommendations. Notwithstanding this, no evidence was found to suggest that the unit would not have operated had it floated free of the vessel.

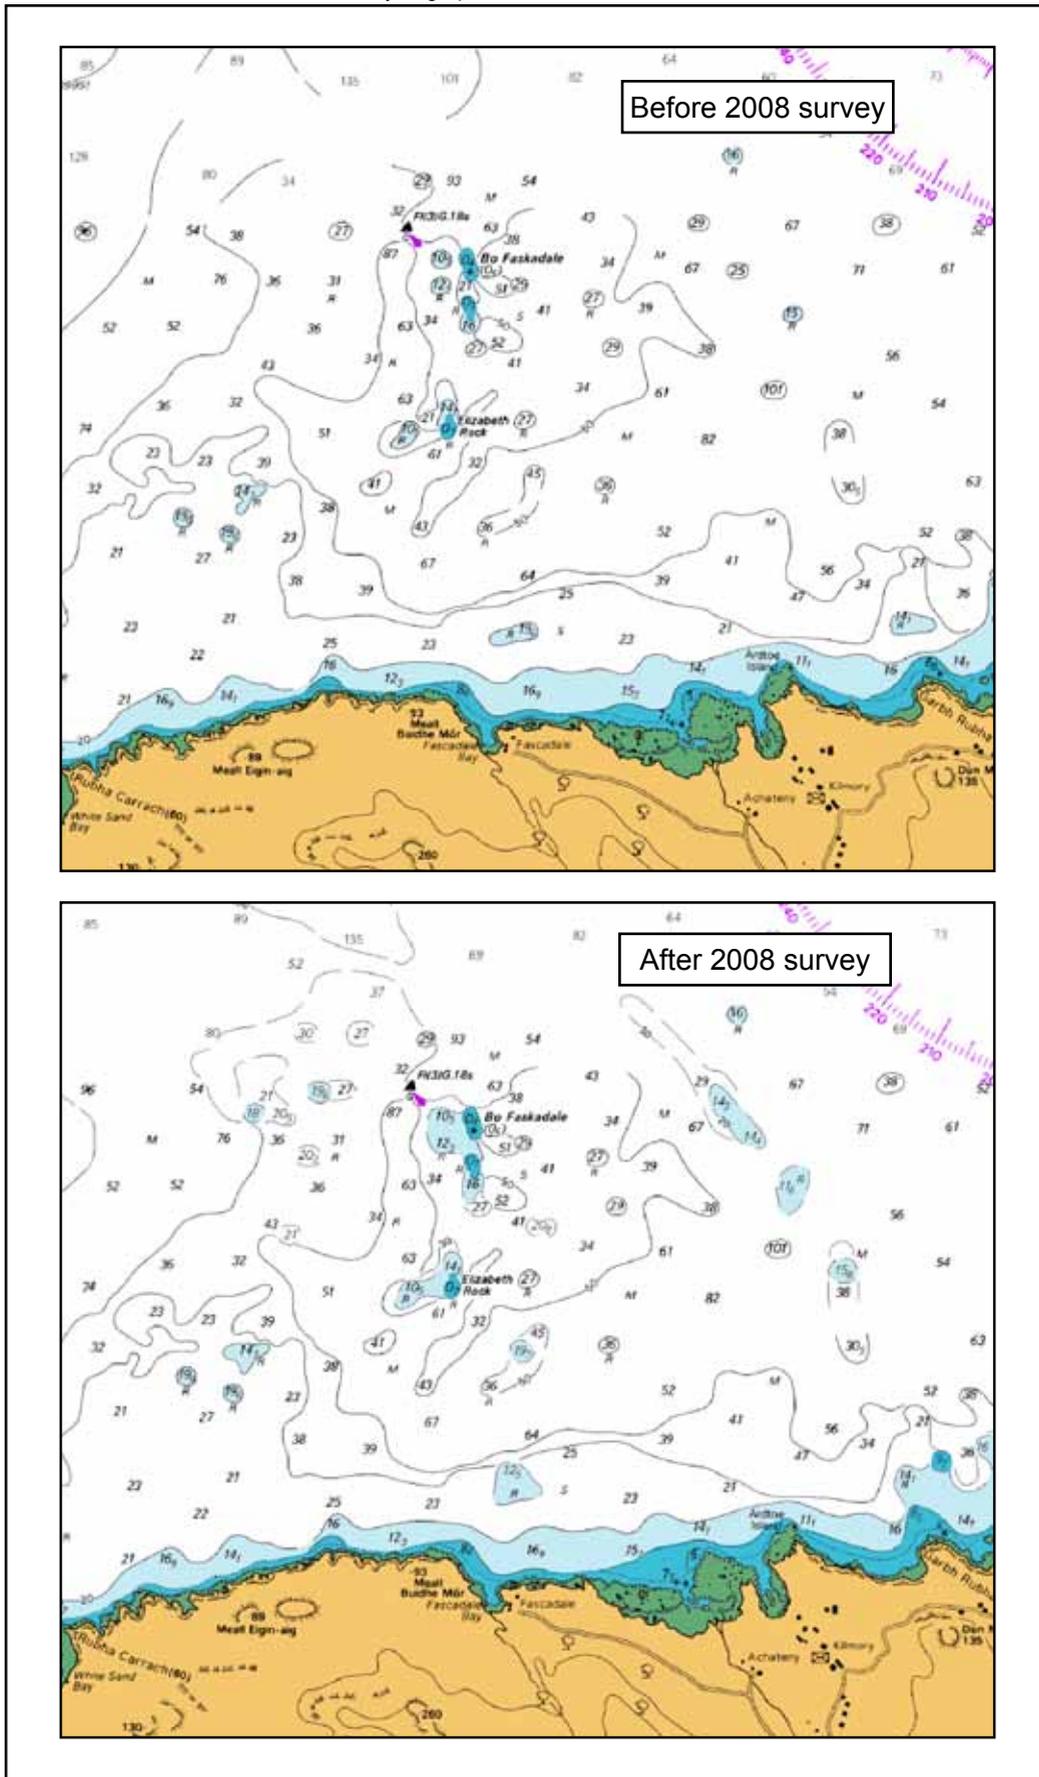
A hydrographic survey of the reef and surrounding area, using modern technology, was undertaken by the MCA in December 2008. The previous survey of this area had been undertaken in 1862 using a hand leadline only. As a result of the significant differences discovered in depths between the two surveys, a new edition of the chart of the area was published, as a matter of urgency, by the UK Hydrographic Office (UKHO) in January 2009 (**Figure 11**).

The electronic chart system in use on *Aquila* at the time of the accident had not been updated with the latest chart edition.

BA chart 2207 (showing depths before and after the MCA's survey, December 2008)

However, the vessel's fishing gear snagged in an area where the depths shown on the old and new chart editions were similar, and it is not considered that failure to carry the latest edition of the chart contributed to this particular accident.

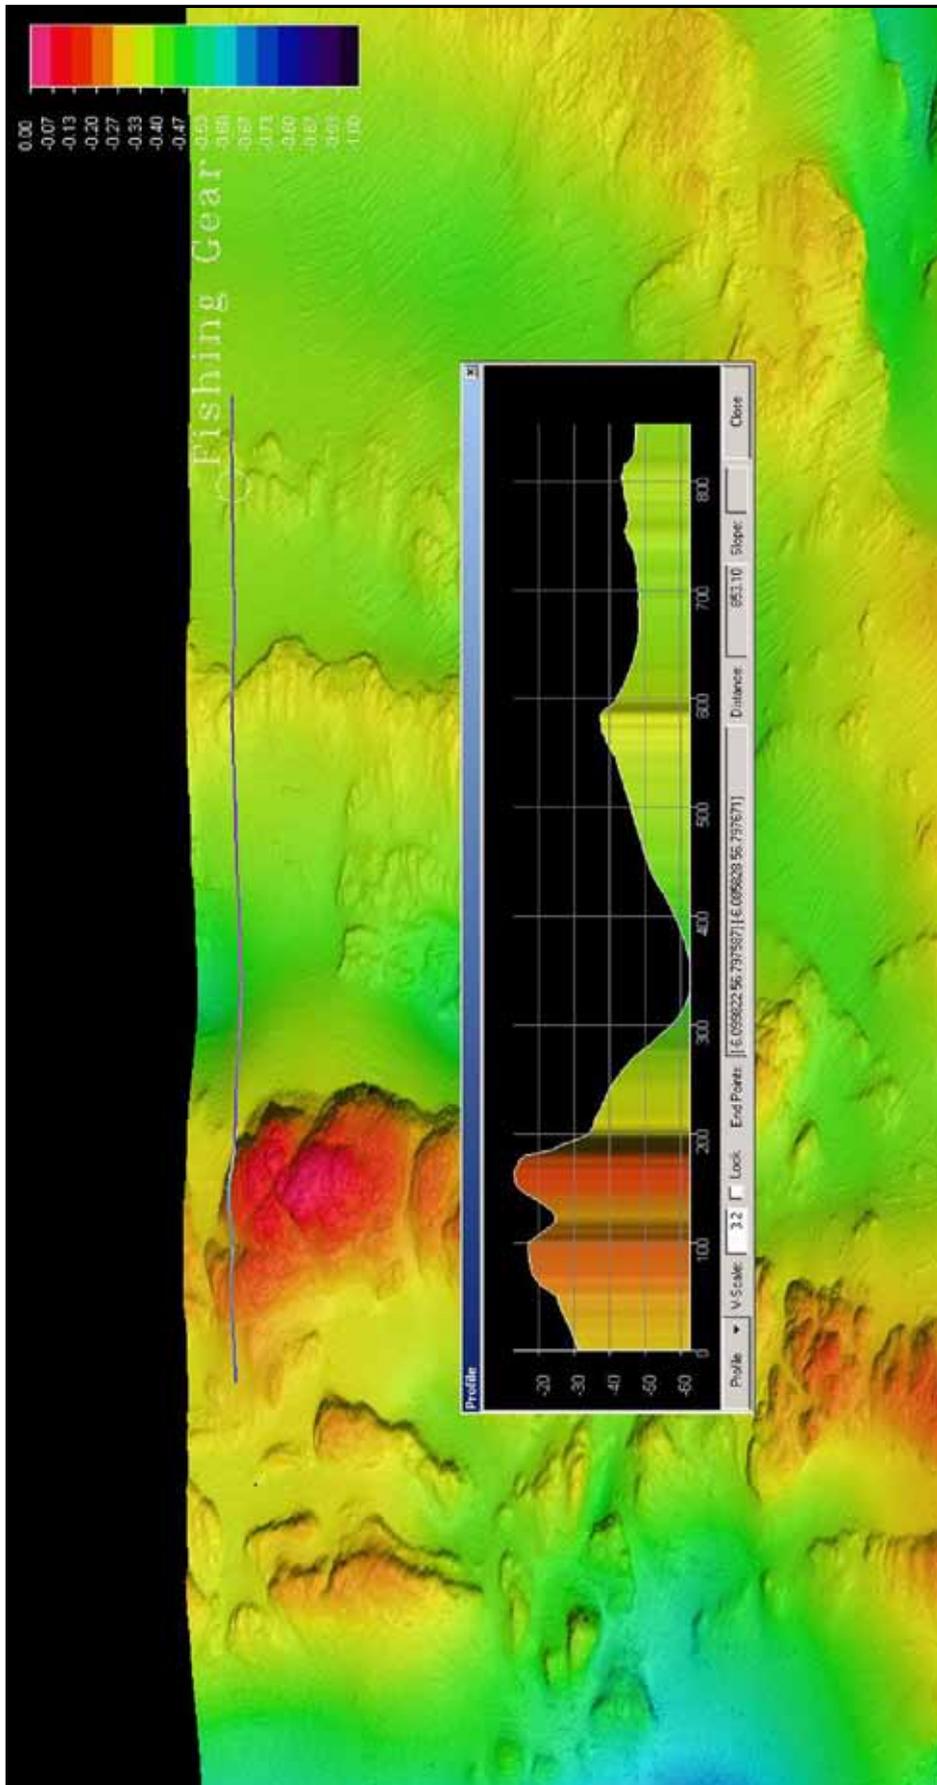
The position of the accident, and *Aquila*’s probable course at the time of the accident, were superimposed onto the latest seabed survey information obtained from the MCA (**Figure 12**). Analysis of this information showed that, while dredging, several metres of the trawl warp would have been in contact with the seabed before it became snagged.

Seabed profile showing track of fishing gear

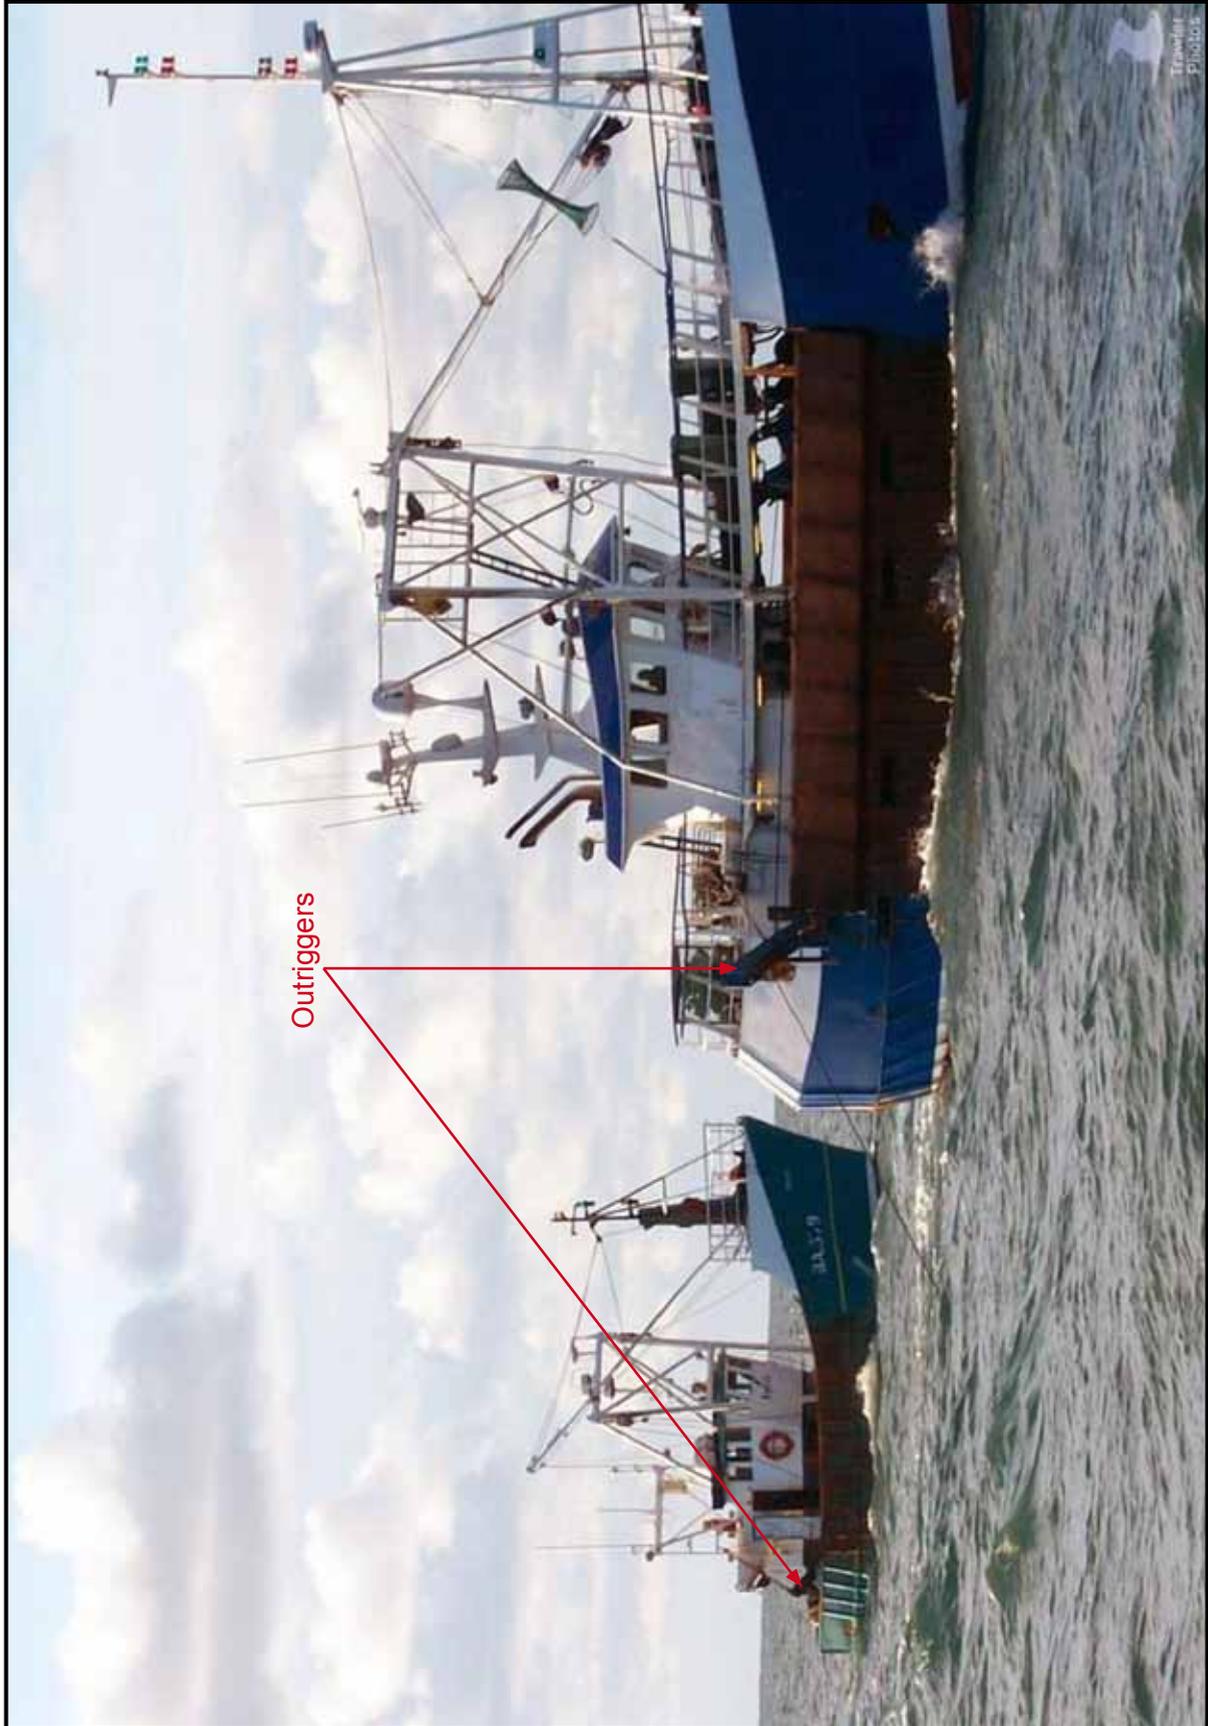
When her gear snagged, the vessel would have rotated about the starboard outrigger (**Figure 13**) and the large waves would have lifted her hull causing a further reduction in her stability. Fishermen should be reminded of the adverse impact on stability when trawling downwind in heavy seas.

*Aquila, and another vessel, showing position of the outrigger*

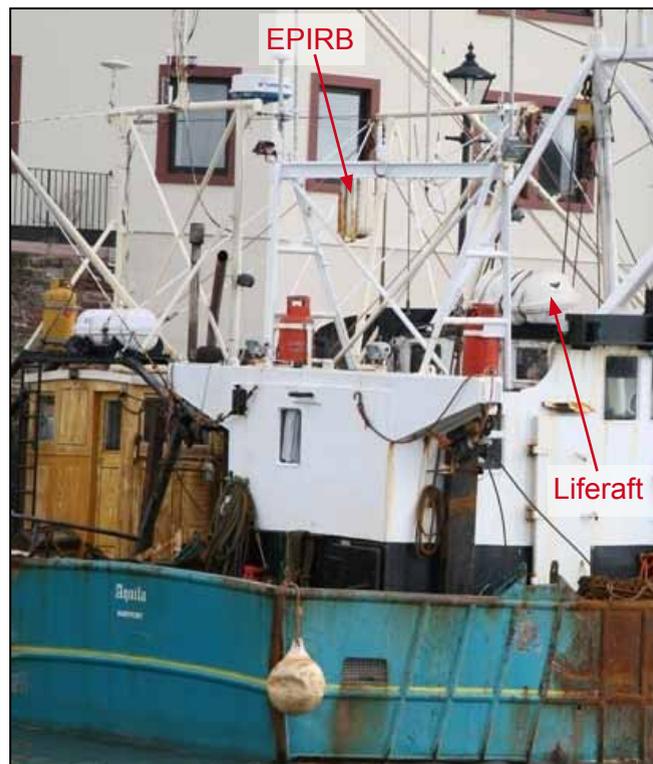
Figure 14

EPIRB and liferaft stowage positions  
on *Aquila*

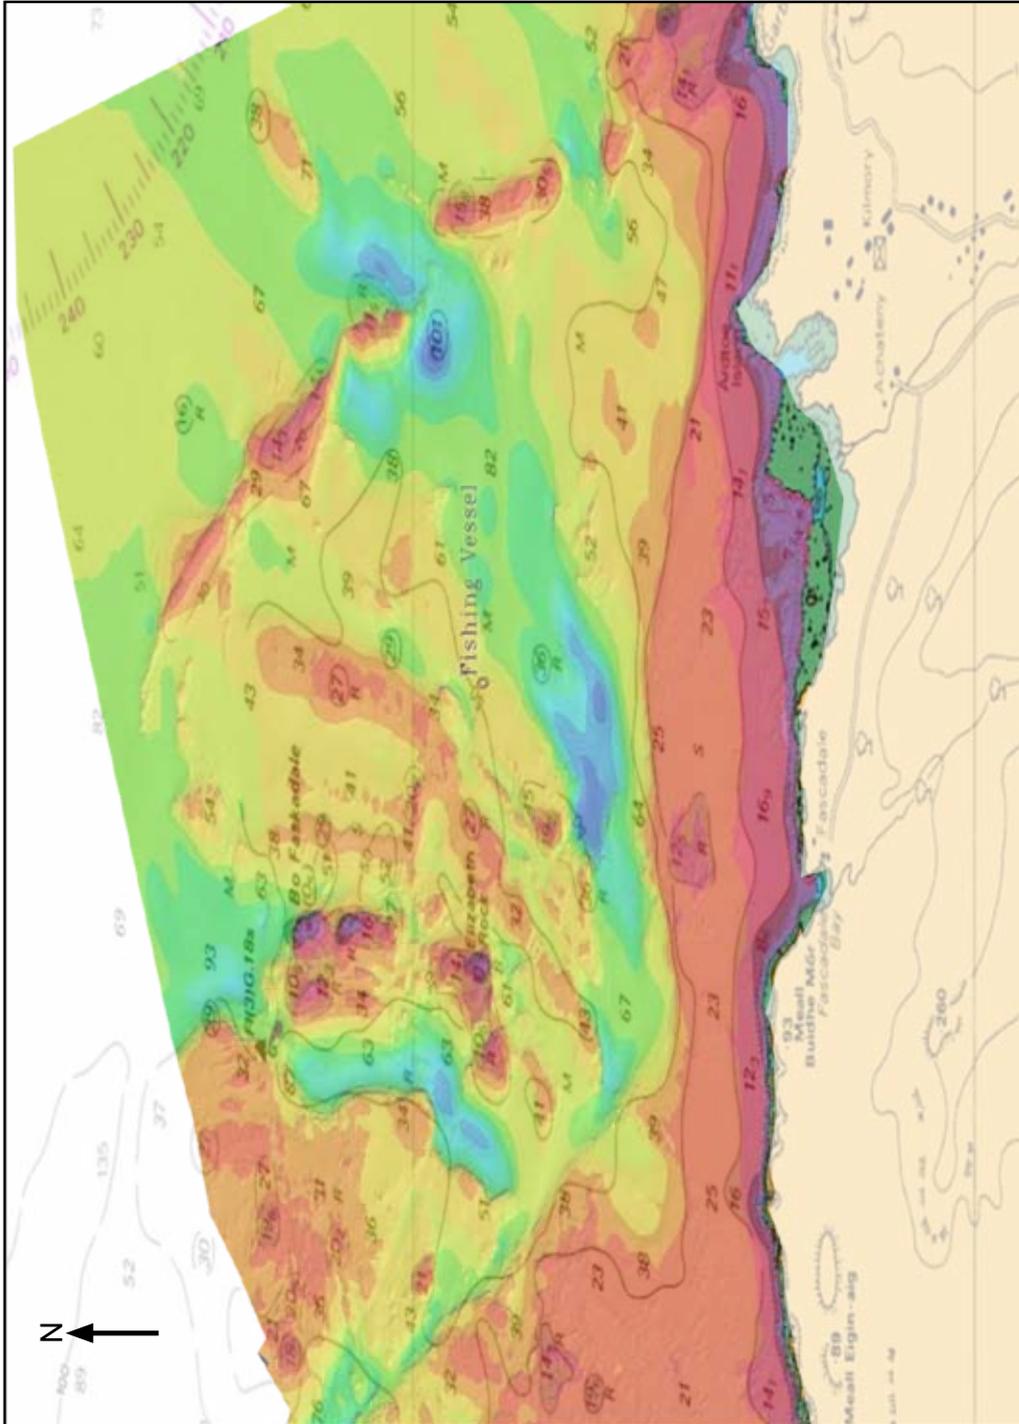
Figure 15

Seabed survey of west side of Bo Faskadale reef

At the time of the accident the tide was flooding, and in a strong south-westerly wind there was a 2m ground swell with wind waves in the area. In these conditions it is probable that standing waves were generated on the west side of the reef. The vessel probably encountered these larger than average waves when she yawed after her gear had snagged.

No warning of this standing wave phenomenon exists on the chart or in the Admiralty Sailing Directions. This information has now been added to both publications by the UKHO, to inform mariners navigating in the area, of the hazard.
