Report on the investigation of
the grounding at high speed of the RIB

Sooty

Calve Island, Isle of Mull

**Report No 22/2009
October 2009**

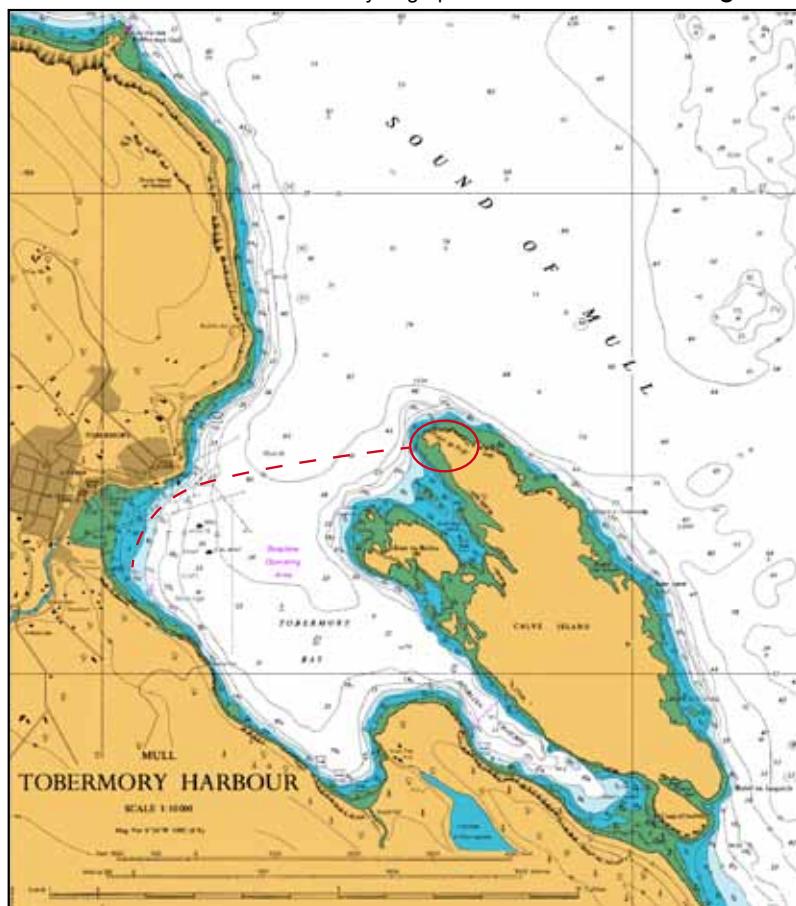
Figure 5

When clear of the fairway the coxswain increased power to get *Sooty* onto the plane². About 1 to 2 minutes later there was a very loud bang, and the craft hit the rocks and stopped on the shore at Rubh' an Righ on the northern tip of Calve Island (**Figures 5 and 6**).

The probable route taken by *Sooty*

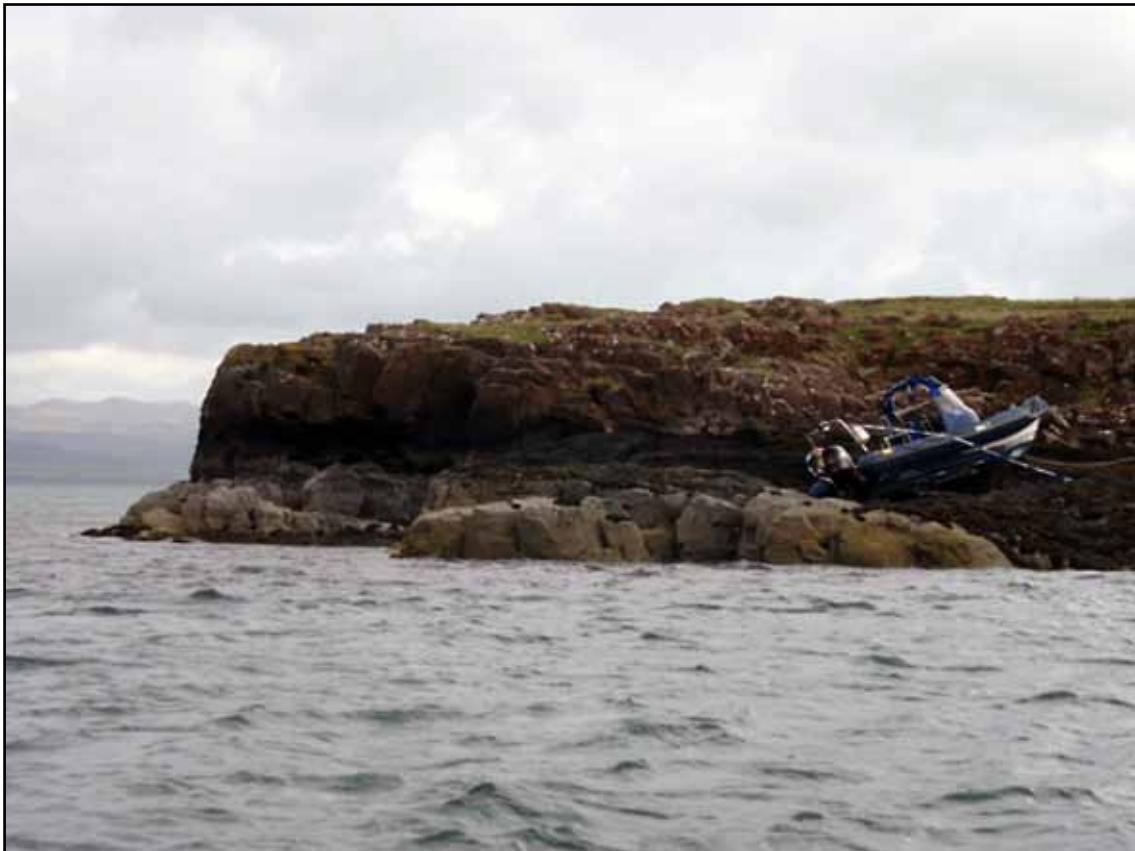
Figure 6

Resting place after the grounding

Note: The height of tide shown is 1.3m less than that at the time of the grounding

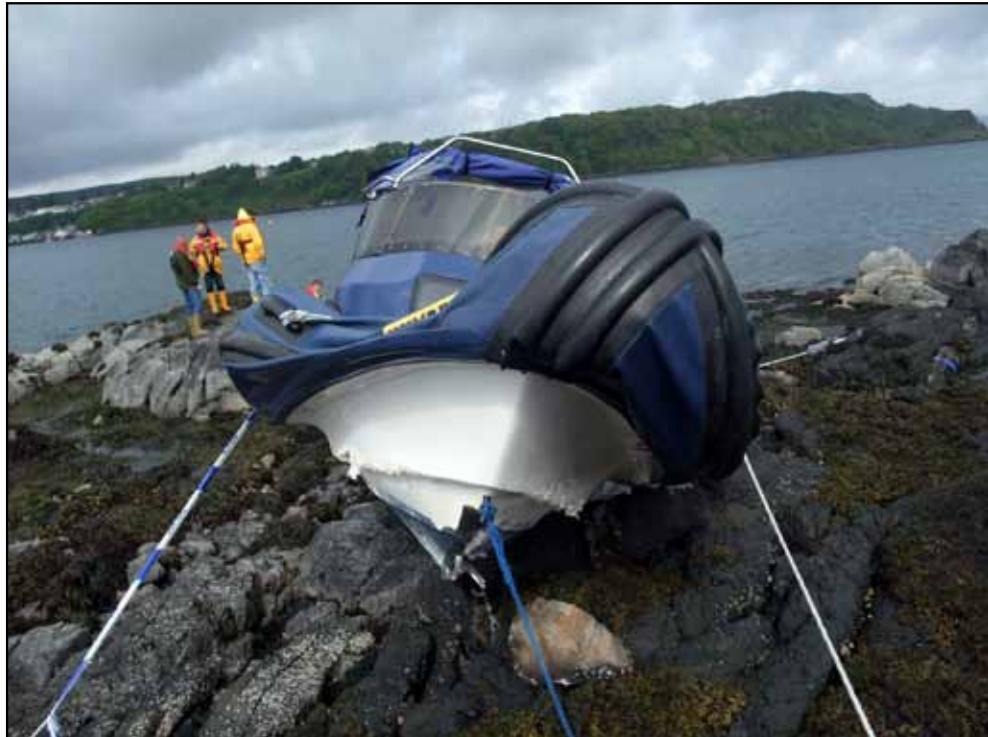
Figure 9

- The port and starboard bow section showed signs of impact damage. Sections of gel coating had been removed, and loose strands of grp matting were visible (**Figure 9**). Superficial damage to the gel coating was observed along the lines of the hull from forward to aft.
- The forward buoyancy tube, incorporating port and starboard bow sections, was deflated.
- All three propeller blades had been damaged (**Figure 10**).

Damage to hull and forward buoyancy tube

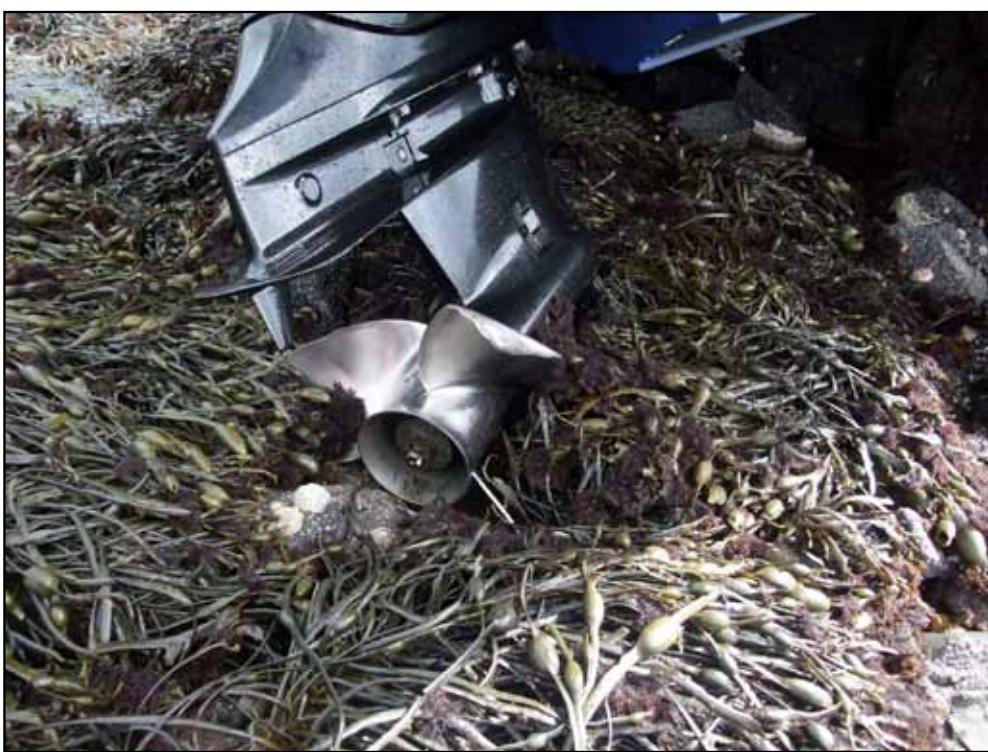
Figure 10

Damage to propeller blades

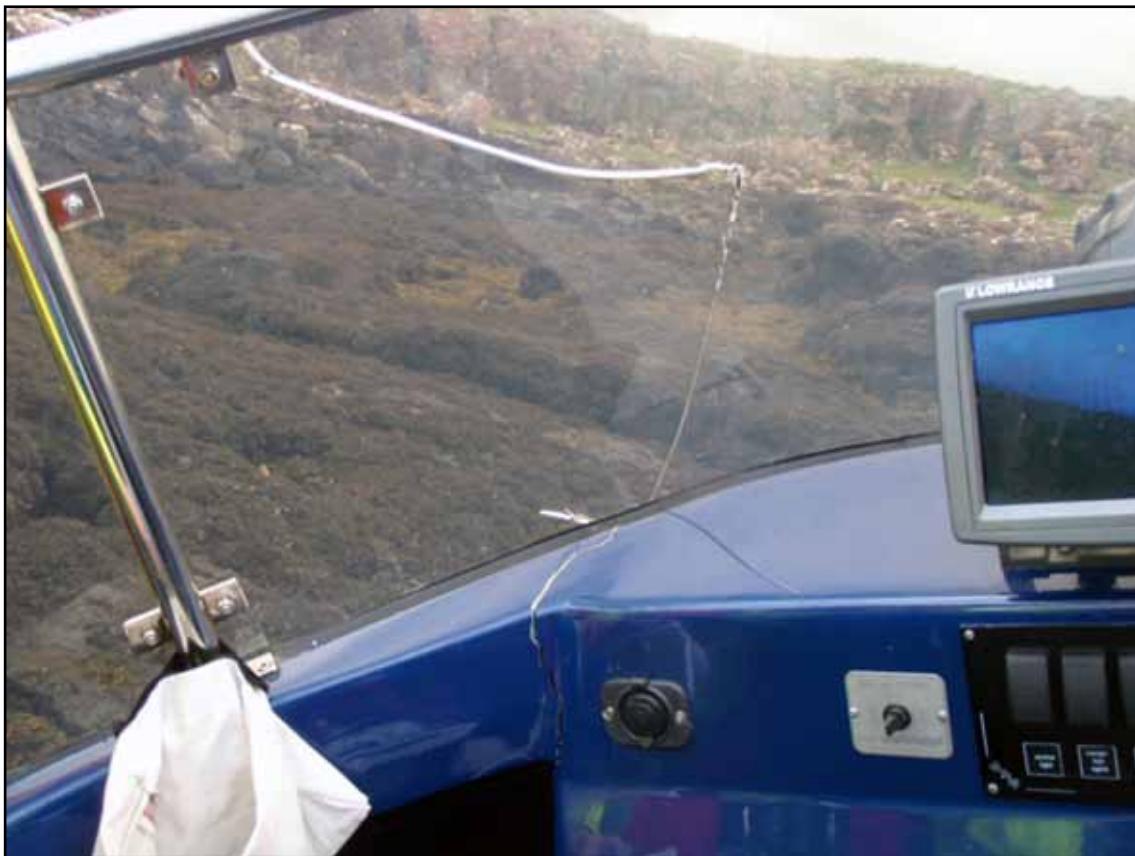
Figure 11

- A 20cm crack was identified inside the anchor chain locker.
- The tinted visor was cracked, the line of the crack continued into the main grp console (**Figure 11**).
- The magnetic compass on the top right hand side of the instrument panel had been dislodged.

Damage to tinted visor and the console

Gary Henaghan was ejected from the boat onto the rocks with sufficient force to inflict fatal head injuries. The seated occupants were thrown into the RIB's visor and console, sustaining injuries consistent with the damage later identified.

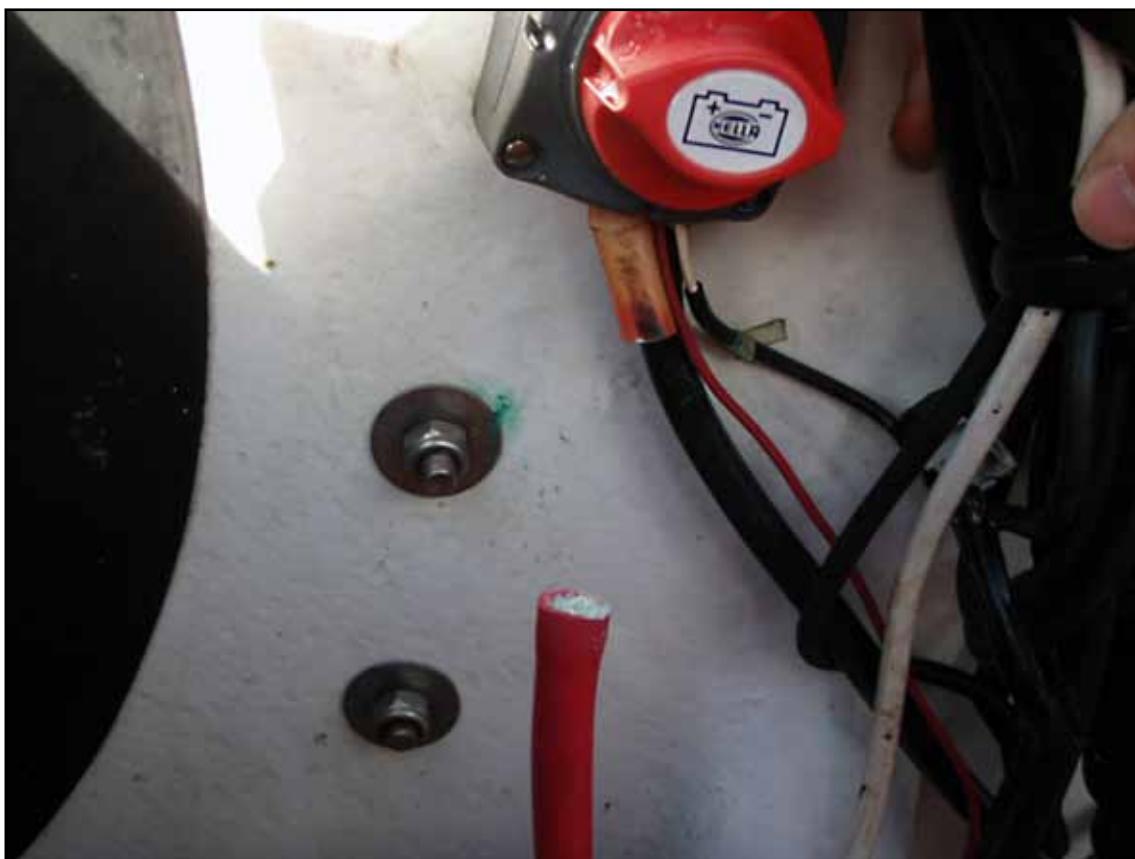
Figure 12

- The battery, housed in an unsecured plastic container, had both positive and negative leads attached. The positive lead had been pulled from the battery isolation switch which was secured to the transom. The crimped connection was corroded (**Figure 12**).

Positive battery lead pulled from the isolation switch

The total loss of electrical power, which resulted in the crew being unable to use the VHF radio after the grounding, was attributable to the battery not being properly secured. This allowed it to be thrown forward on impact, causing the corroded positive terminal to be ripped from the main power supply switch. The position in which the rocker switches were later found must be treated with caution, given that three of the crew were thrown into the instrument panel, and that the coxswain might have disturbed the rocker switches when attempting to use the VHF radio to alert the coastguard.

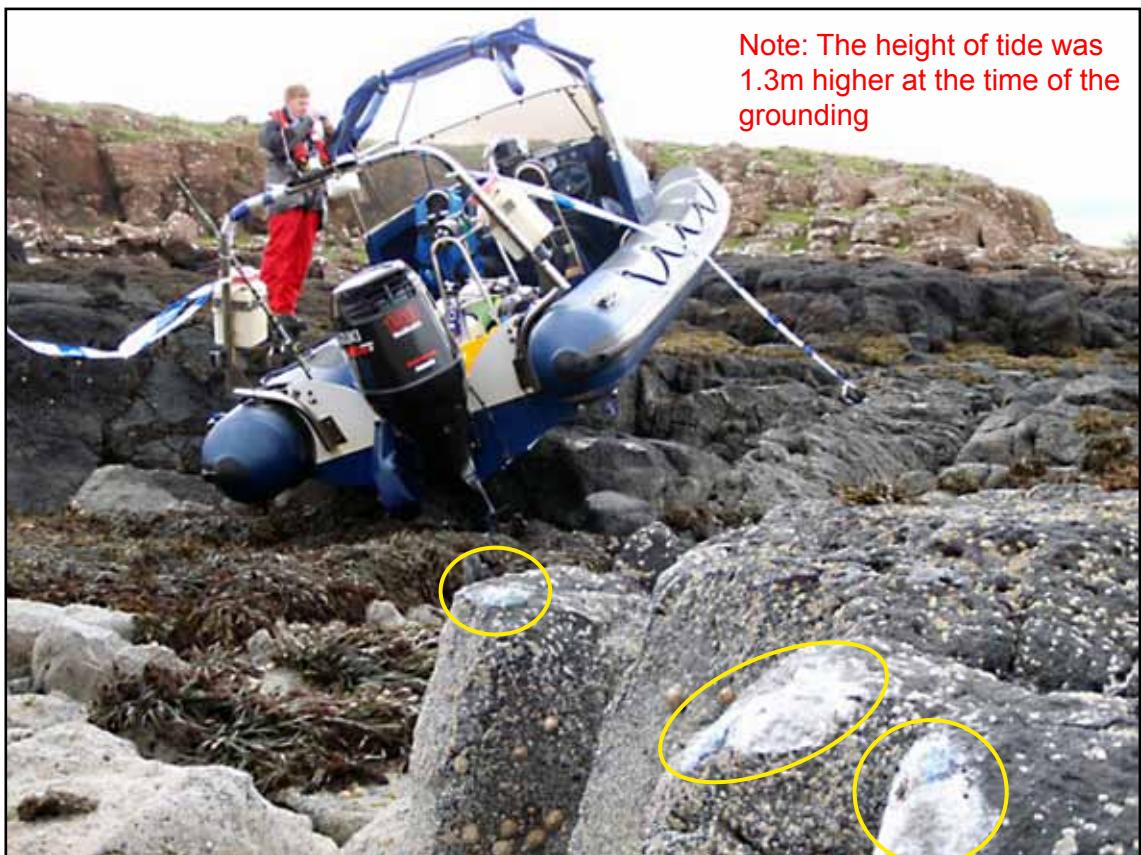
Figure 13

- White gel coat was observed on a rock face to starboard (**Figure 13**).
- Blue anti-foul paint from the underwater section of the hull was observed on several rock faces; directly on the line of approach.
- An underwater scar on a flat rock face, directly on the line of approach (**Figure 14**).

Evidence of gel coat to starboard

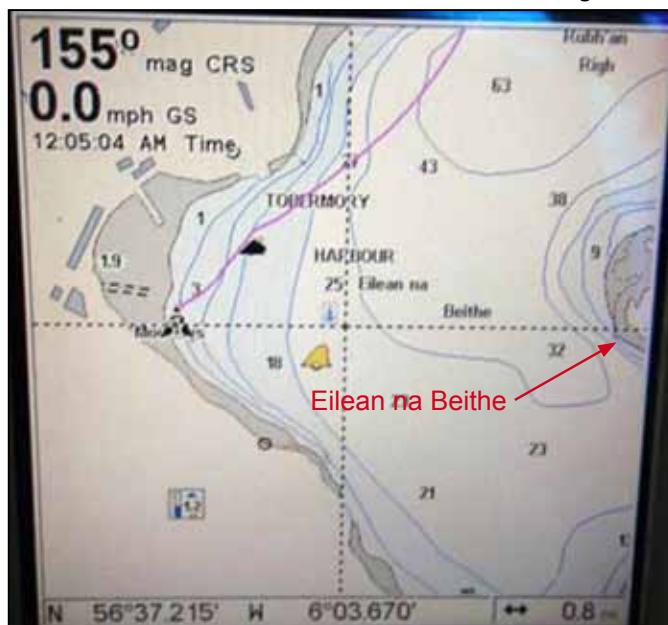
Figure 17

Assuming the GPS mapper was switched on, a map of the area would have been displayed. Positional awareness can be significantly influenced by the range scale of electronic chart displays. Depending on the range scale to which the unit defaulted, it is possible that when the coxswain glanced at the GPS display, he assumed the western tip of Eilean na Beithe, an island lying 2 cables south east of the accident site to be the western extremity of Calve Island (**Figures 5, 17 and 18**). This might have caused him to believe that *Sooty* was heading safely into the Sound of Mull when the RIB was actually heading directly towards the island.

Simulated picture (off centre) showing nearest headland

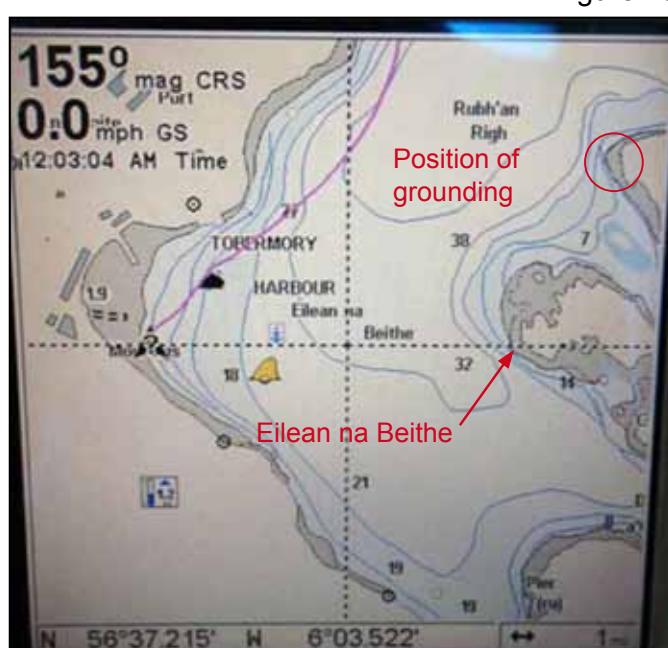
Figure 18

Simulated picture showing Calve Island just behind
