Report on the investigation of the release of cargo vapours
resulting in two casualties on board the chemical tanker

Jo Eik

6 May 2009

**Report No 24/2009
November 2009**

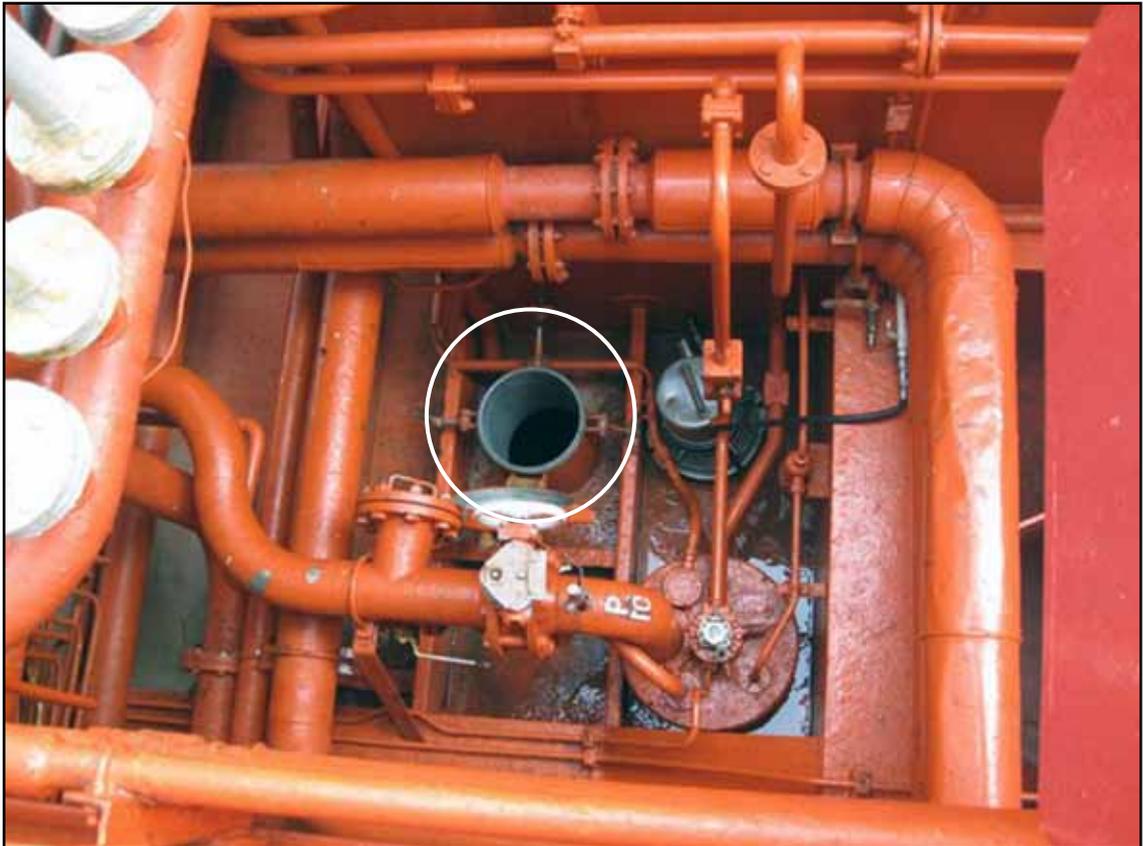
Figure 4

In the meantime, two portable washers were rigged with salt water supplies to clean P10 cargo tank through the tank's two Butterworth hatches¹. The hoses were passed through the hatches and the outboard hatch cover was then dropped onto the hose. The inboard hatch cover was left in the fully open position (**Figure 4**).

Cargo tank P10 open inboard Butterworth hatch

Throughout the washing procedure the inboard Butterworth hatch was left open with the portable washing equipment water supply hose passing through it. As the washer agitated the atmosphere in the tank, sufficient heavier than air cargo vapours were driven out of the open Butterworth hatch with the water mist to create a hazardous environment in the vicinity of the hatch.

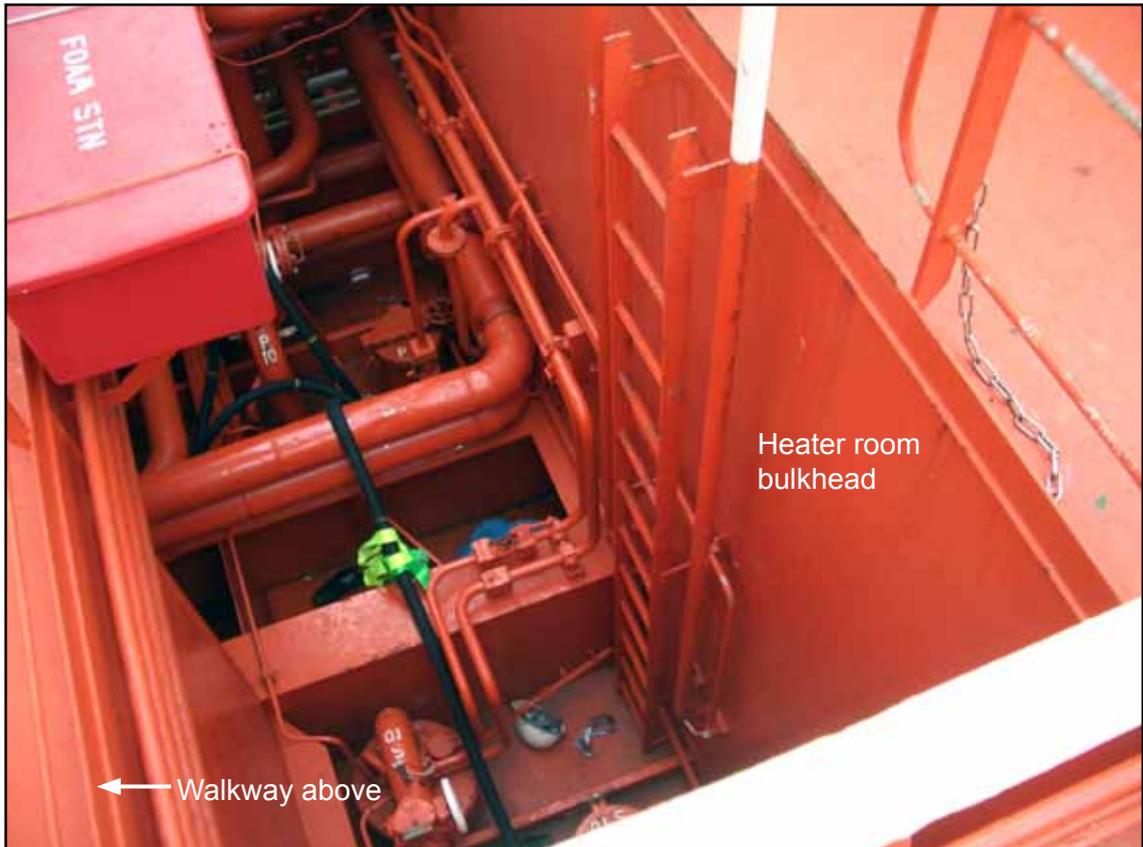
Figure 5

The on watch AB went up to the walkway immediately aft of P10 inboard Butterworth hatch (**Figure 5**) and noted that the pungent smell was stronger than he had previously noticed. A vertical plume of water mist came up from the Butterworth hatch and extended above his head height. To avoid getting wet he moved to the port side of the walkway.

Walkway aft of P10 inboard Butterworth hatch

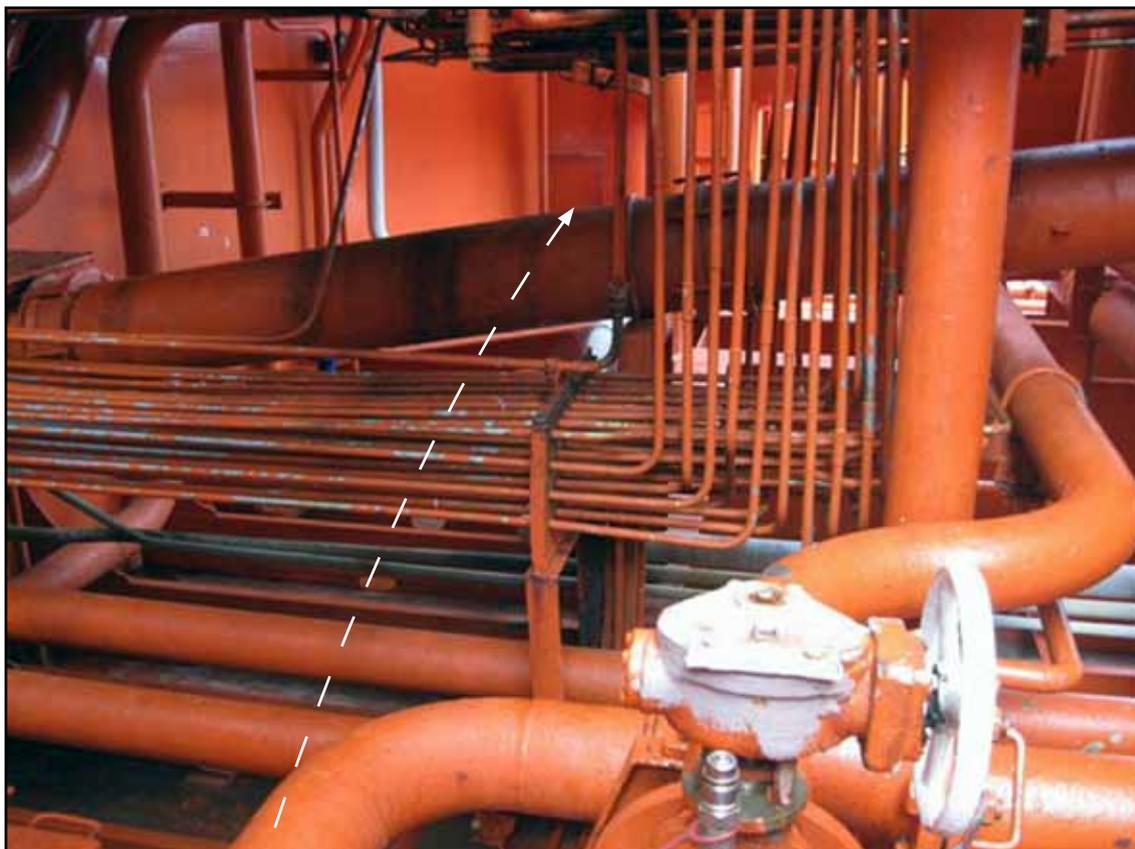
The chief officer noticed the strong smell. He decided that it would be unwise to go down the ladder near to the casualty because he did not know why the AB had collapsed. The chief officer decided to approach the unconscious AB from the port side of the main deck (**Figure 6**). He was not wearing a BA. He struggled to get through the pipework which blocked his way, but managed to get close to the AB. He noticed the crew assembling on the walkway above him and called for help to recover the AB. As he got closer to the AB, the chief officer suddenly lost his motor ability. He could not move from his kneeling position, he lost his sense of smell and was unable to speak. In the meantime one of the ABs from the forenoon watch took a number of large gulps of fresh air, held his breath and went down the ladder to try to move the AB, but without success. Having inhaled the atmosphere in the vicinity of the collapsed AB, he managed to get back to the walkway, where he felt sick and stumbled badly.

Route taken by the chief officer

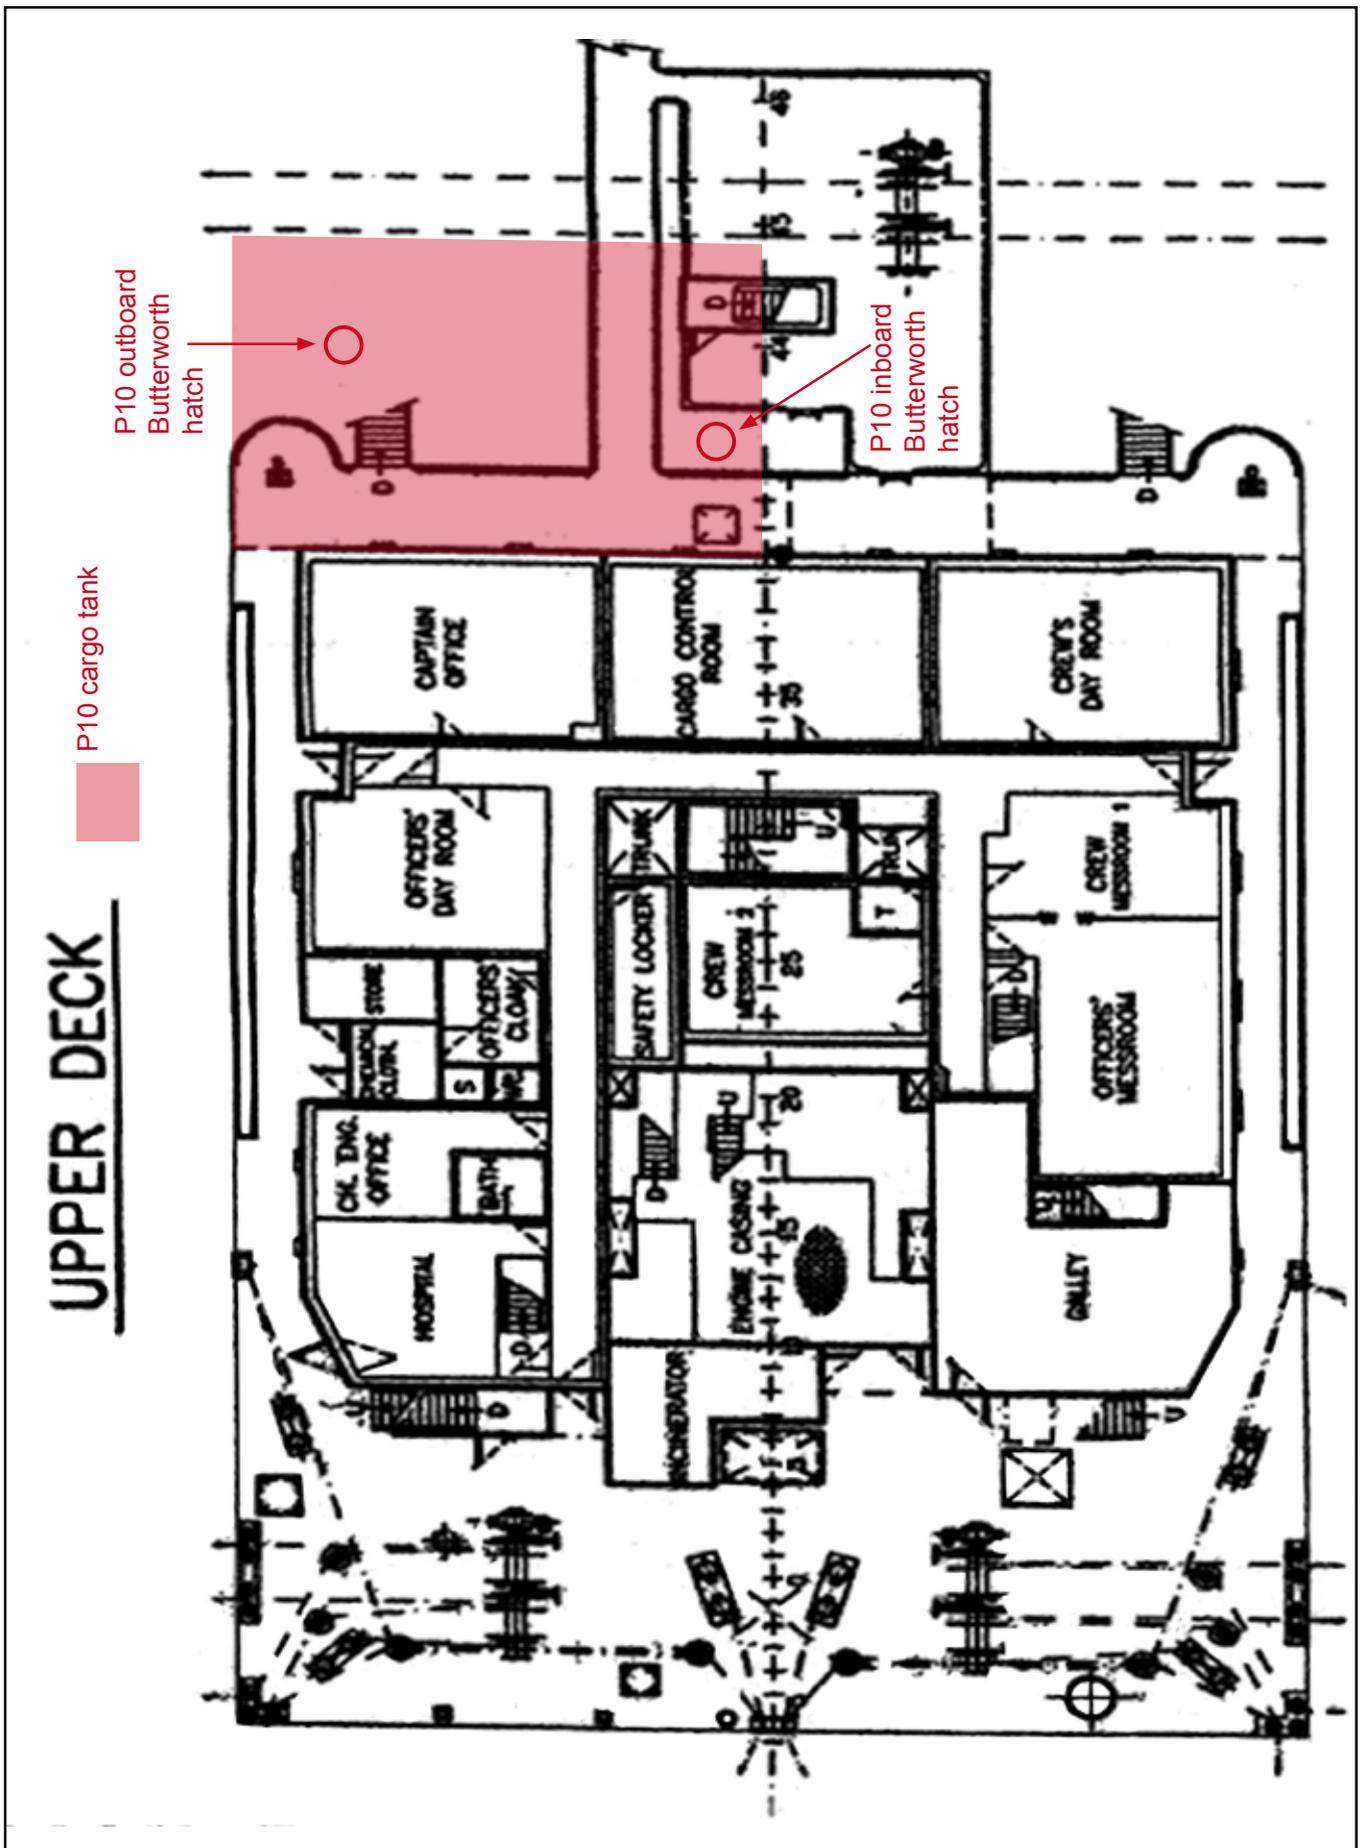
Positions of P10 cargo tank and the inboard and outboard Butterworth hatches

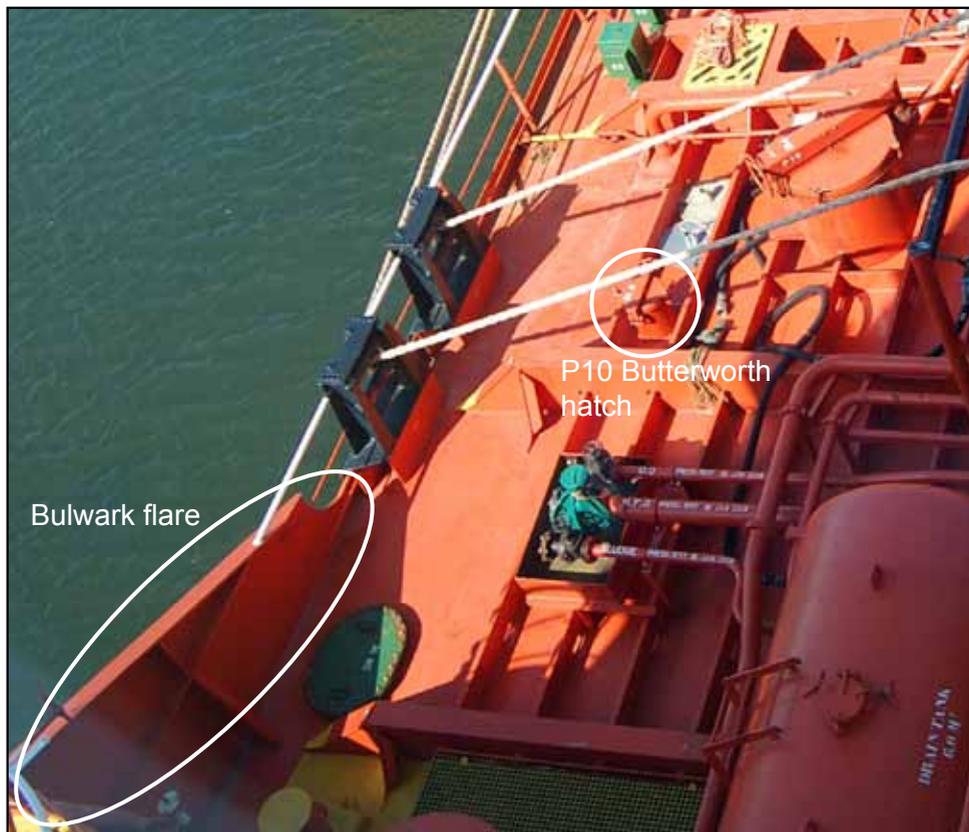
The outboard Butterworth hatch area was reasonably well exposed to airflows across deck, with the exception that it was partially shielded by the port bulwark flare adjacent to the ladder giving access to the upper deck from the main deck (**Figure 17**).

P10 outboard Butterworth hatch and port bulwark flare

It is reported that the outboard P10 Butterworth hatch cover had been dropped onto the washer hose, but the hatch cover could not possibly have formed a seal with the washer hose passing through the opening. However, unlike the inboard hatch, the area around the outboard hatch was more exposed to the environmental airflows and, therefore, the vapour would have dissipated more readily.

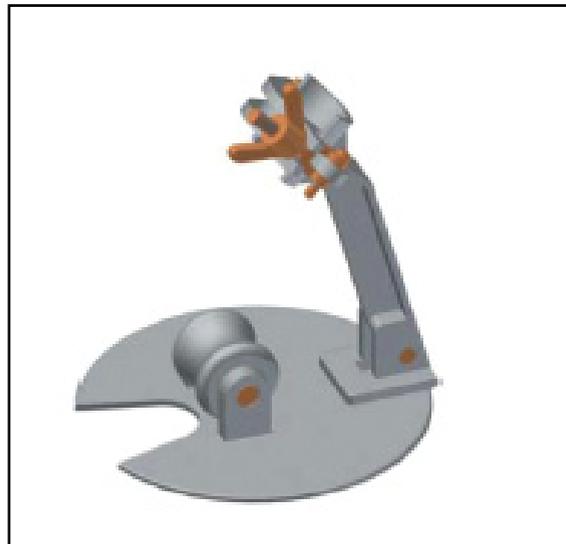
Figure 22

The inboard Butterworth hatch was left open, and as there was no hose guide or blank fitted to reduce the release of the cargo vapours, these eventually accumulated in the vicinity of P10 inboard Butterworth hatch. Portable hose saddle and guide systems are readily available to give the hose a good tank entry line and to reduce any vapour release (**Figure 22**).

Typical portable hose saddle and Butterworth hatch closing plate
