Report on the investigation of
the grounding of the sail training vessel

TS Royalist

near Chapman's Pool
off the south coast of the United Kingdom

Report No 26/2009
December 2009

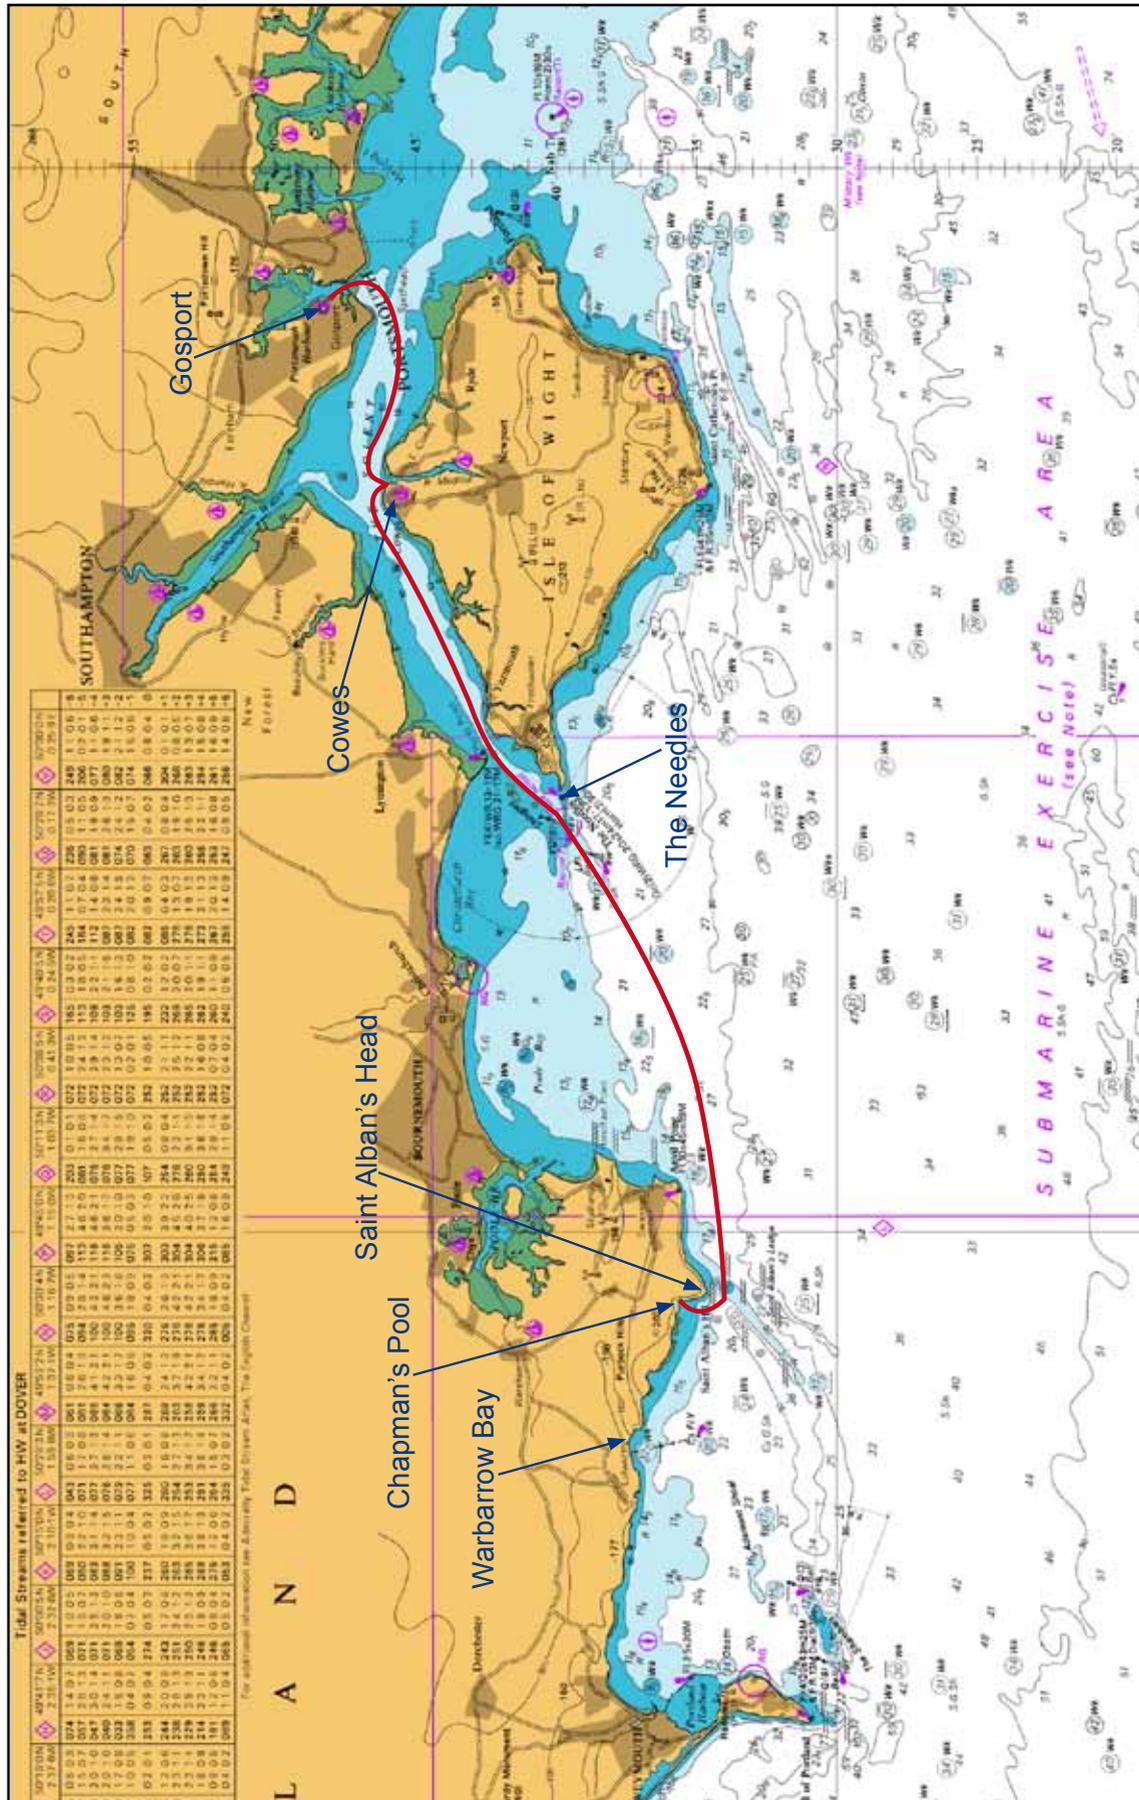
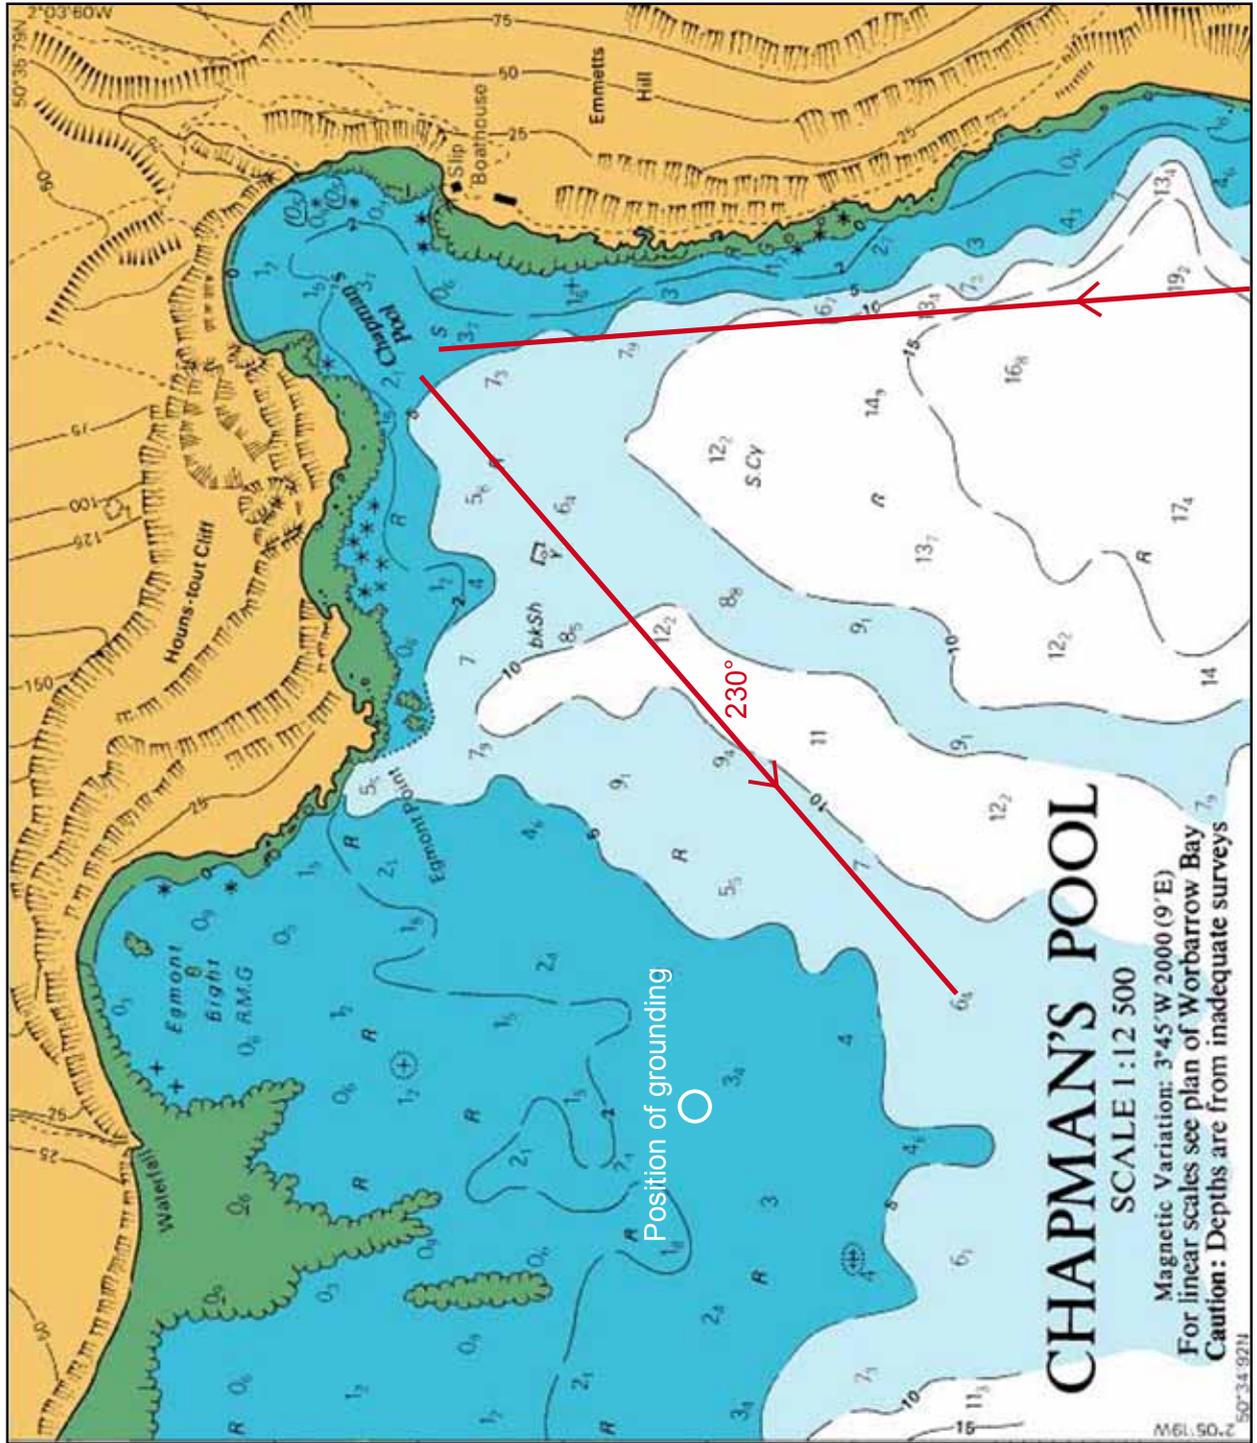
Figure 2

Basic interpretation of intended track to and from Chapman's pool and position of grounding

At 1120, the vessel grounded in a position approximately 2 cables to the north-west of the master's intended track. The master ordered the engines to be stopped and the sails to be furled.

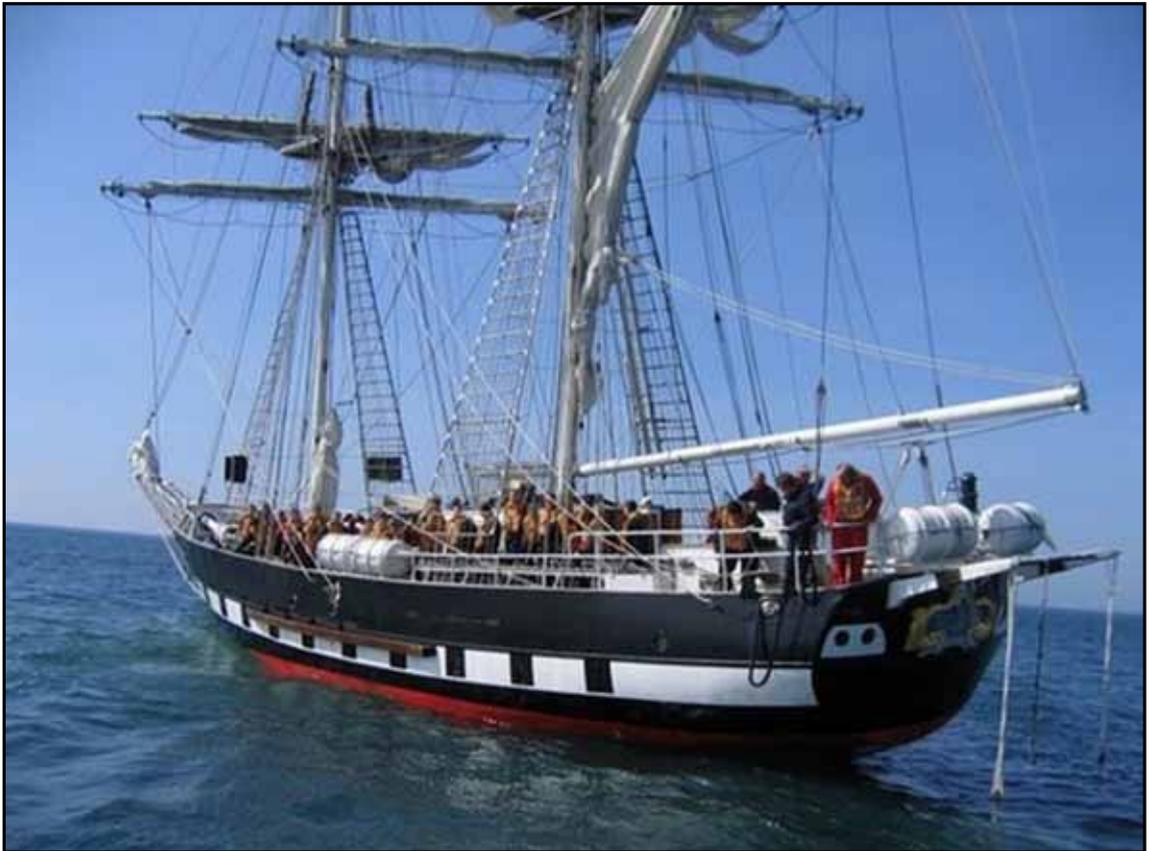
The emergency signal was sounded and the permanent staff instructed the cadets to don their lifejackets and to muster on the port side of the deck (**Figure 4**). They closed the vessel's watertight doors and checked all internal compartments for any ingress of water; none was found.

TS *Royalist* aground off Chapman's Pool

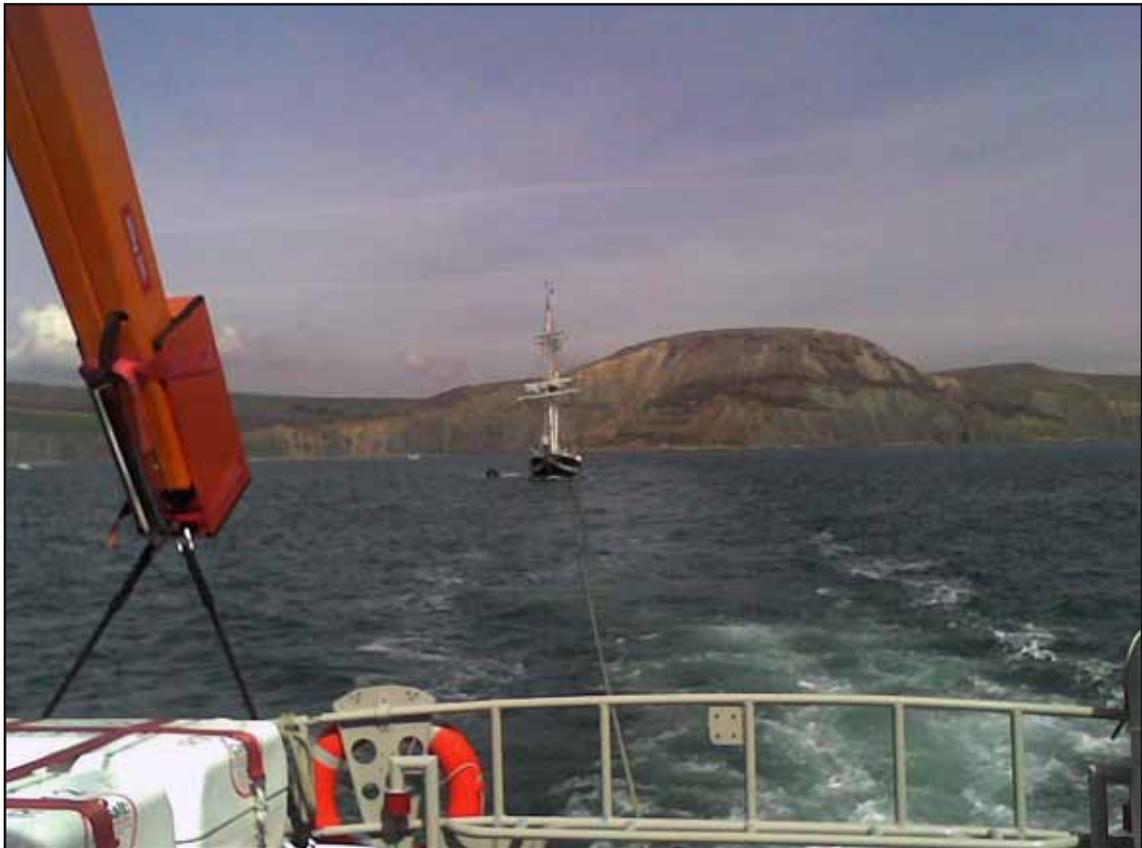
The lifeboat arrived on scene at about 1220 and, having assessed the situation with the master, the lifeboat coxswain decided that he would make an attempt to tow the vessel into deeper water.

TS *Royalist* being towed by Weymouth RNLI lifeboat

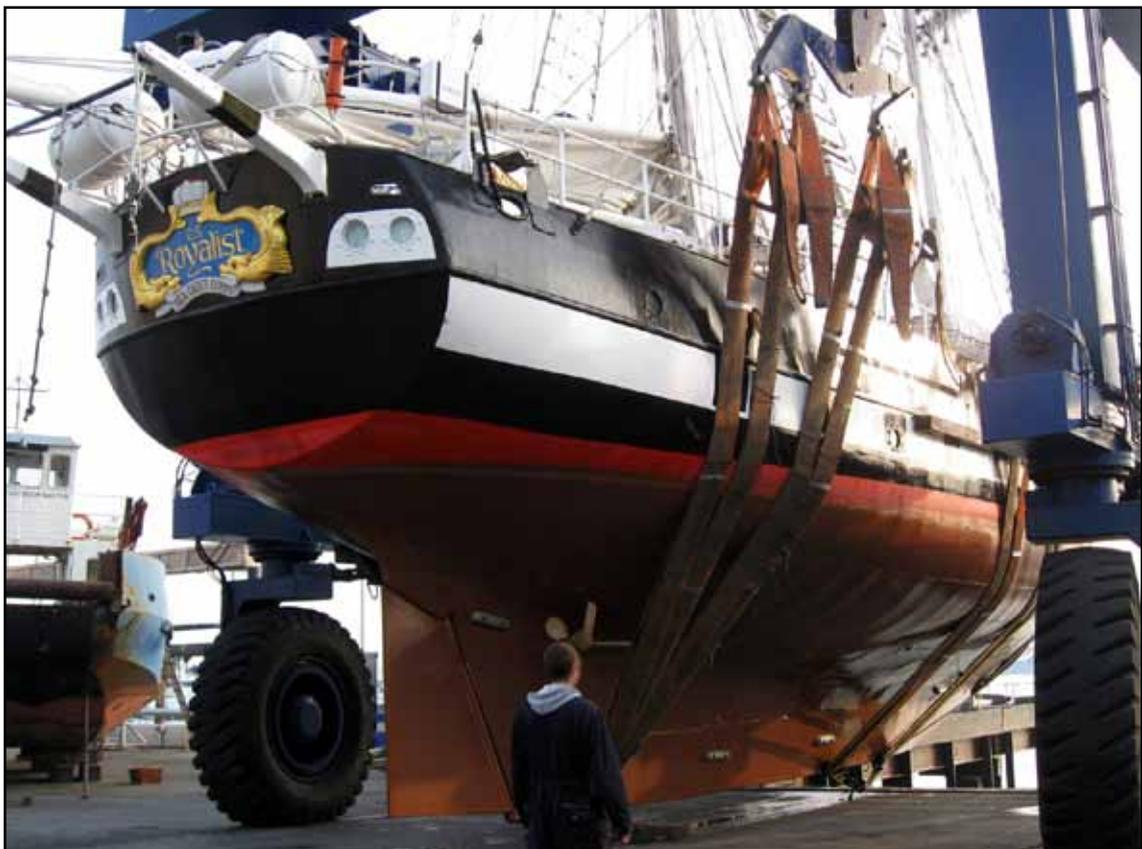
TS *Royalist* arrived at Gosport at 1915. She was lifted out of the water and, on inspection, no grounding damage, except some minor scrapes to the vessel's anti-fouling, was found (**Figures 6 and 7**). The vessel resumed her schedule the following morning.

TS *Royalist* in the lifting cradle for hull inspection after the grounding

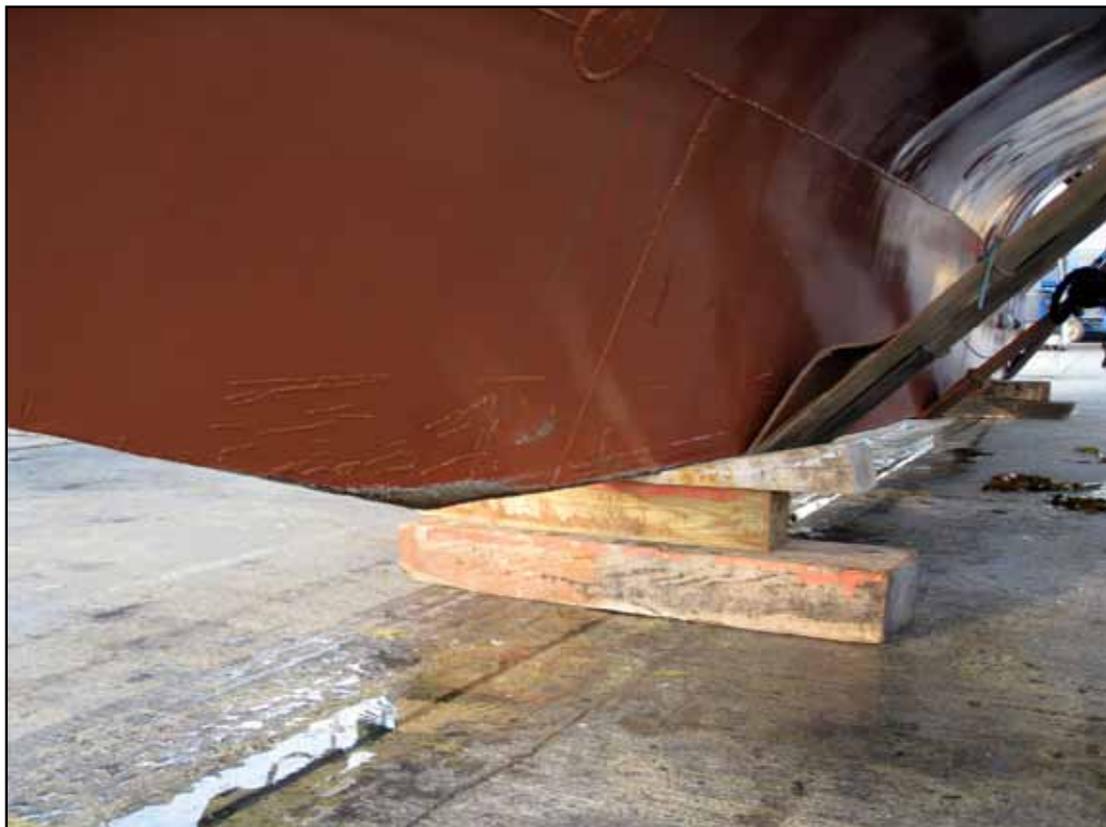
Minor scrapes to the anti-fouling of TS *Royalist*

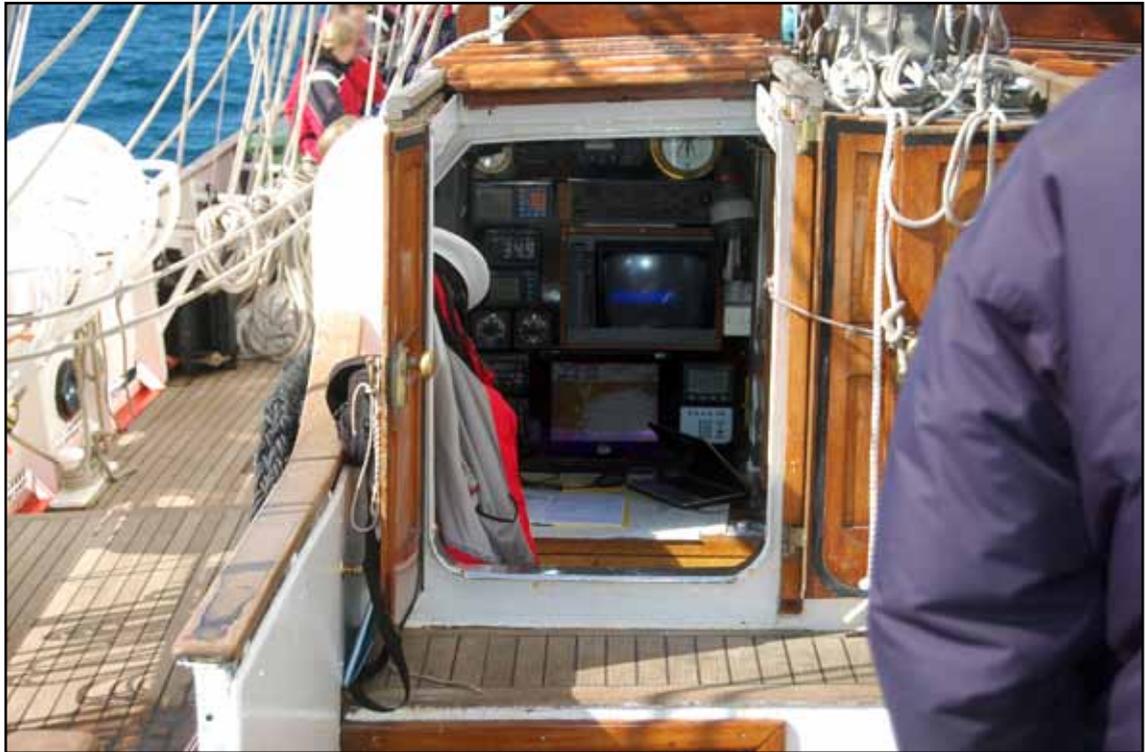
The deck layout was traditional in that she had a deckhouse and an enclosed open-topped cockpit. There were two companionways leading from the cockpit into the deckhouse; the starboard companionway led forward past the galley and down into the accommodation below; the port companionway accessed the small chart room in which all the navigational aids and radio equipment were situated. The wheel, standard magnetic compass, and engine controls were located in the enclosed cockpit and a relative wind direction indicator was sited in front of the helm position (Figures 8 and 9).

View of chart room from the helm position
