Report on the investigation of
a fatal accident on
Wellservicer
3 miles SE of Aberdeen, Scotland
1 April 2009

Report No 1/2010
January 2010

Wellservicer

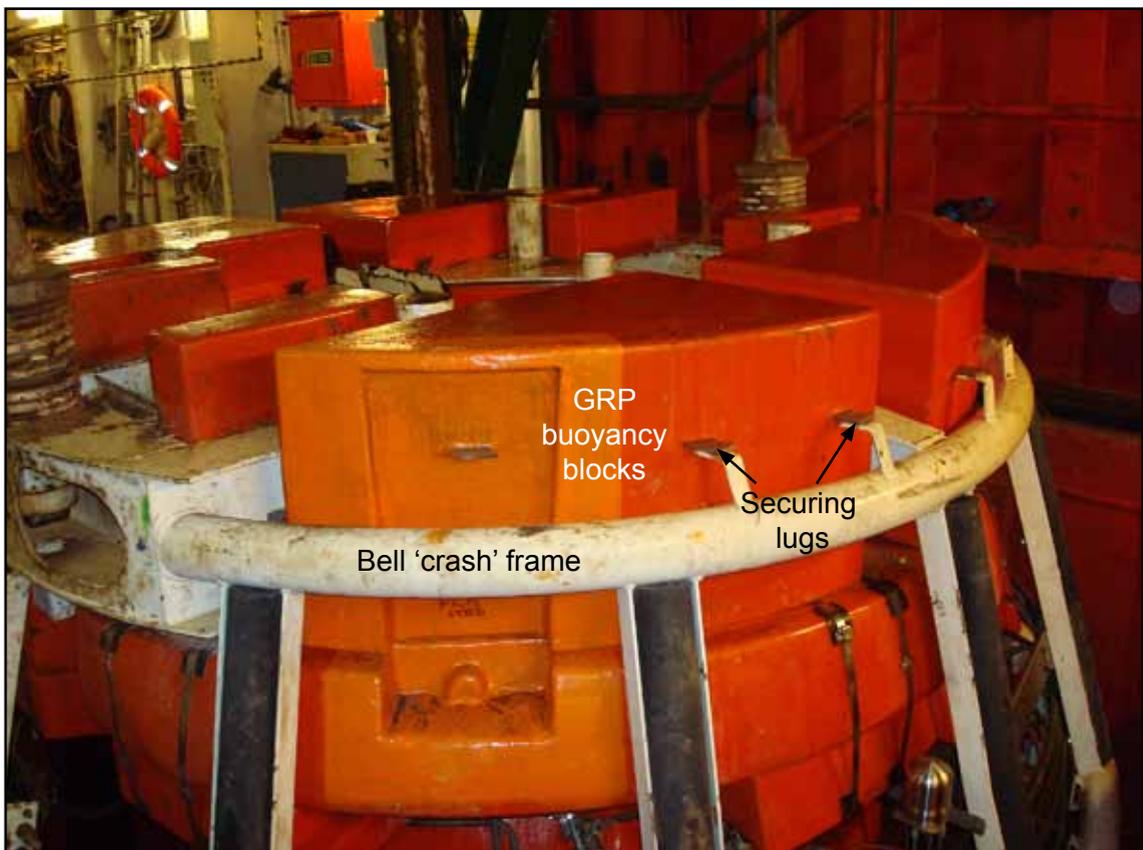
Figure 7

Glass reinforced plastic (GRP) buoyancy blocks attached to the bell (**Figure 7**) needed to be removed for alterations. This was a difficult task due to the close proximity of the cursor and the cumbersome shape of the blocks. It was decided to move the bell and cursor from the TUP trunking to the moonpool, to hang the cursor off from the trolley by means of strops, and to lower the bell to a satisfactory height in the moonpool, thus allowing the blocks to be removed more easily. The bell top also created a convenient working platform to allow work to progress on the cursor suspended several feet above it.

Bell top showing GRP buoyancy blocks

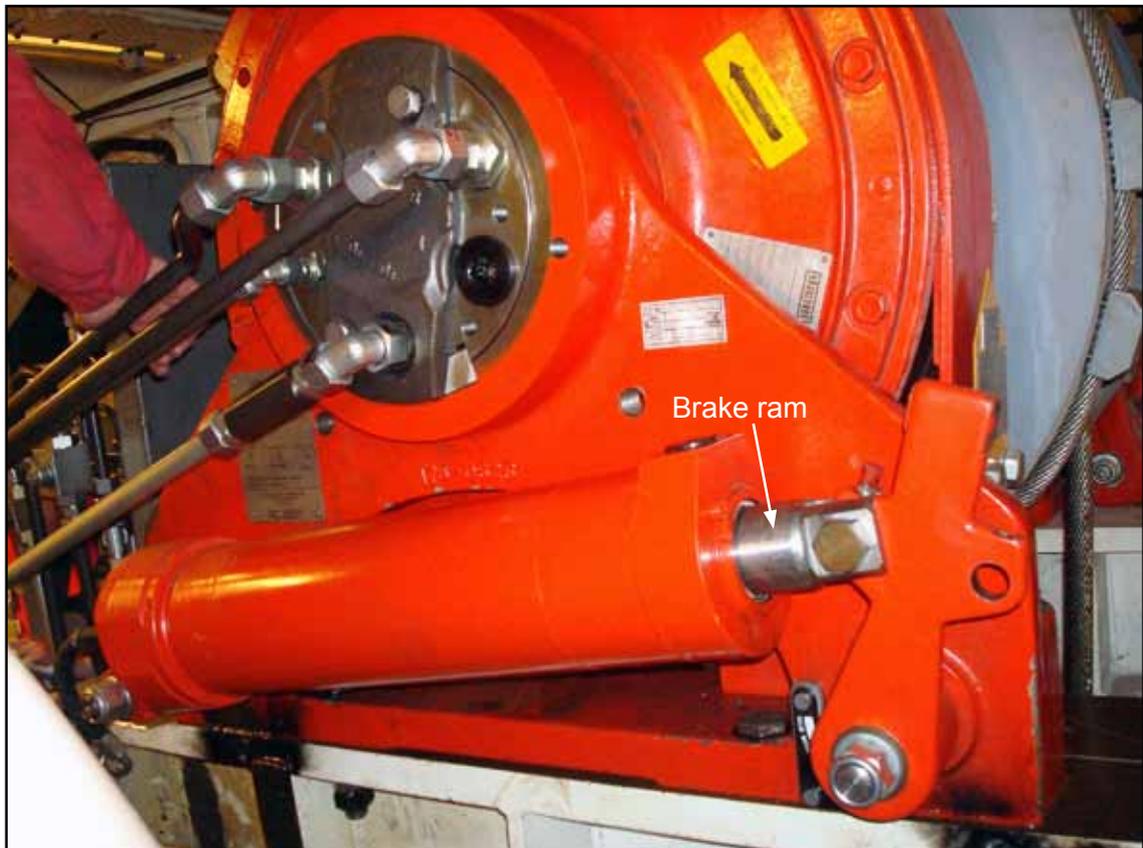
On 31 March, with the bell in the moonpool suspended from its normal winch wires and the cursor suspended by strops from the trolley, modification work continued, including the spooling of wire onto the new cursor winch sited on top of the bell trolley. The wire was then attached to the 4t cursor, enabling it to be independently supported by its own dedicated winch and wire. During the spooling of the winch wire, one of the Modification installation team noticed that, on one occasion, the winch brake ram (**Figure 8**) did not properly apply when

Cursor winch forward brake ram

the local winch control handle was released (**Figure 9**). This was remedied by the winch operator wiggling the control lever, and highlighted to him that the brakes would need some adjustment as part of the system's commissioning.

At one point during installation, a member of the installation team observed that the brakes did not fully apply. This was corrected by wiggling the control handle, and a mental note was made at the time to adjust the brakes later on. This was, in all probability, an early indication that the pilot valve was faulty and the “wiggle” was simply enough to release pressure from the system allowing the brakes to apply.

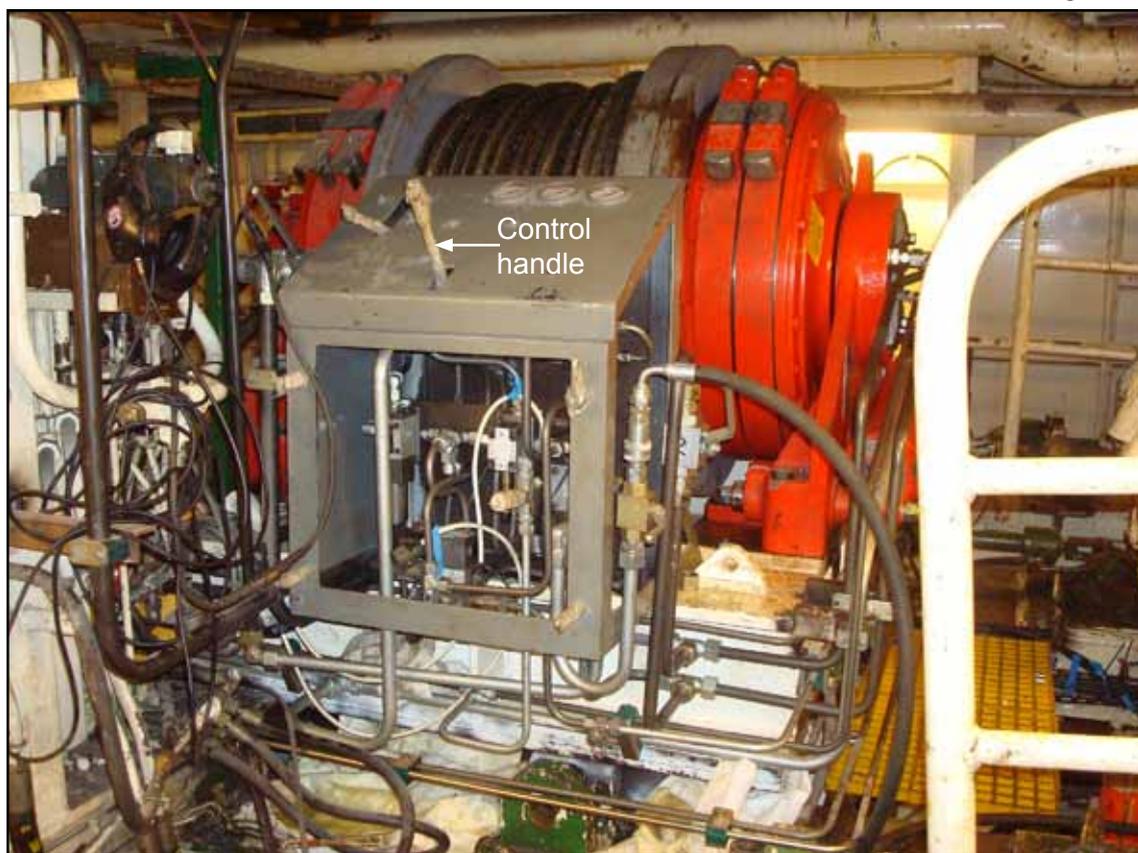
Figure 9

Cursor winch local control panel

Similarly, Technip commissioned an independent external expert, Thomson Engineering Consultants, to carry out an intrusive investigation into the hydraulic circuit. This investigation, observed by Aberdeen Hydraulics on behalf of the MAIB, identified a malfunction within the local control panel for the winch.

power to the winch switched off, neither brake applied as hydraulic pressure was retained in circuits to both the brakes by the defective valve. The weight of the suspended cursor then caused the winch drum to creep back and go into freefall.

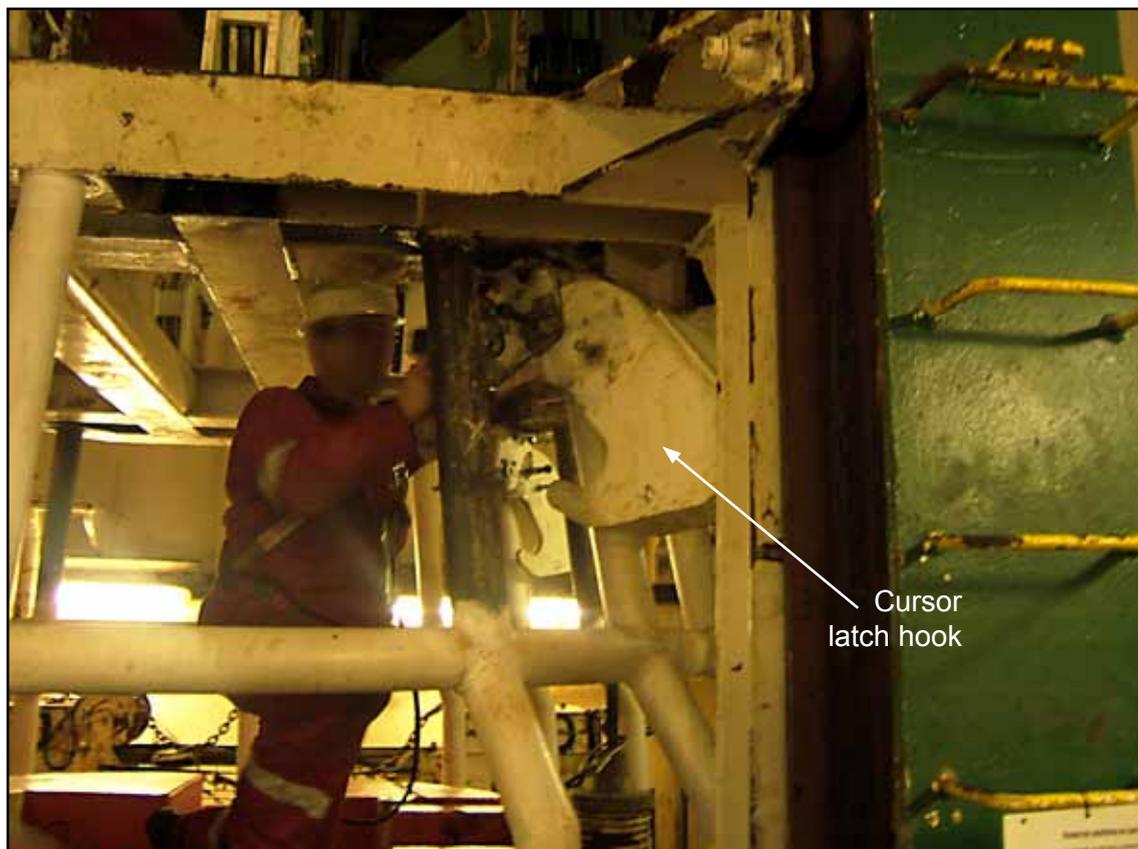
Figure 10

Rigger working on cursor latch hooks under suspended cursor

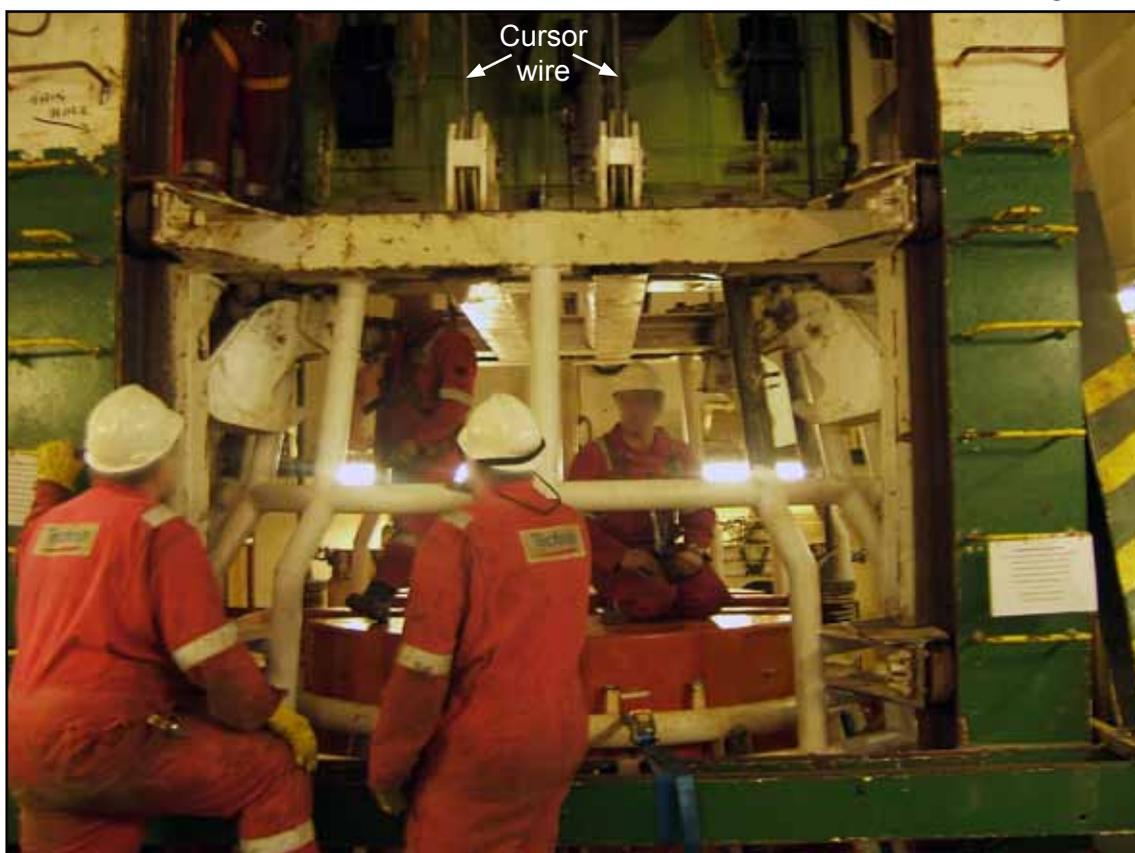
Figure 11

Riggers on top of the bell, under suspended cursor

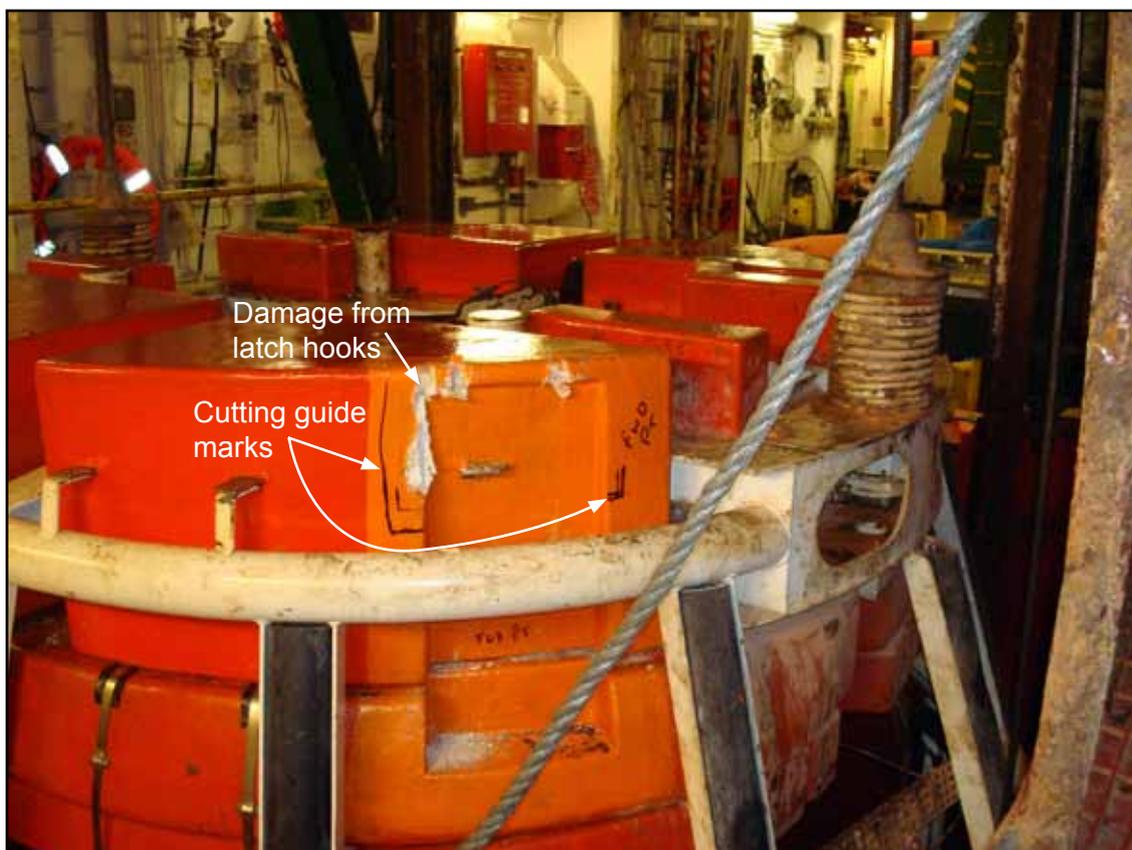
Figure 12

Damaged buoyancy blocks

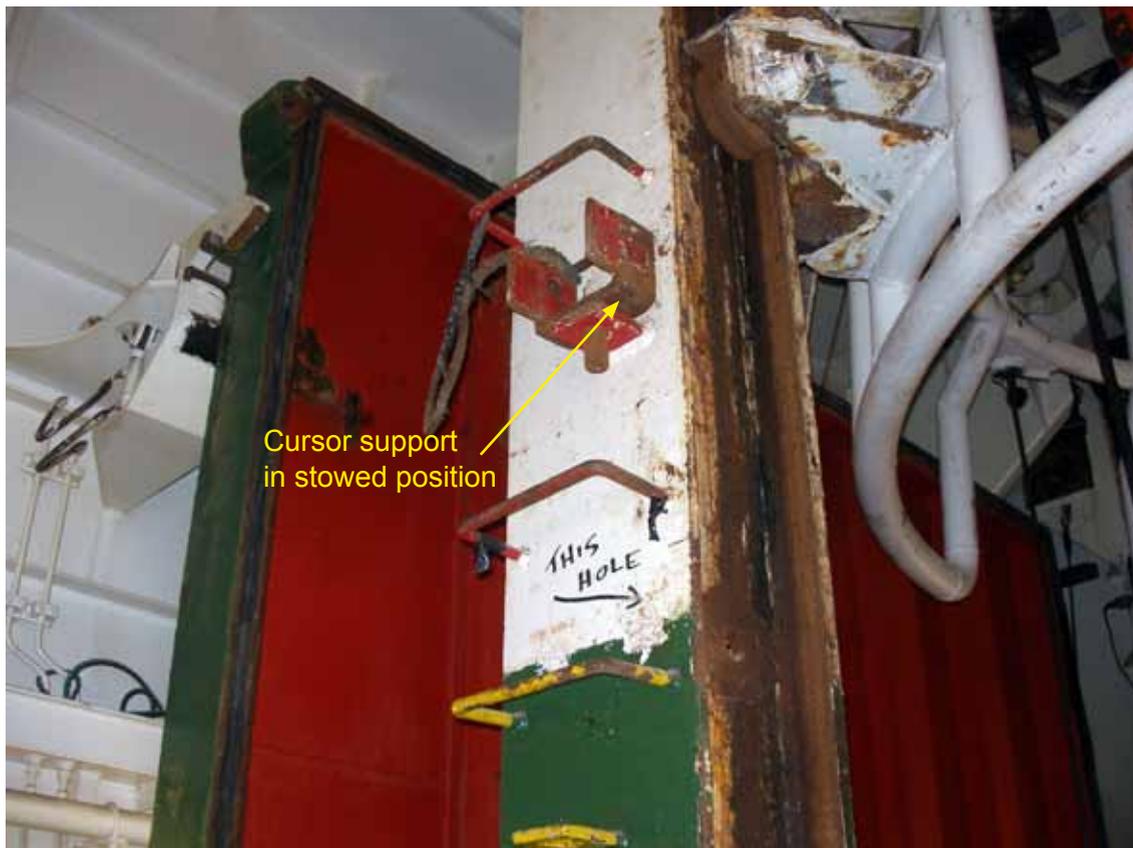
The dive technician supervisor left the control room to go down to the hanger deck after shutting down hydraulic power, and the hydraulic engineer left the local winch control to return to his cabin. A rigger, David Stephenson, better known as "Luey", was already on top of the bell, with his inertia reel fall arrester attached to his safety harness preparing for buoyancy block removal as the cursor was raised. A few seconds later the winch rendered and the cursor fell uncontrollably. This was seen and heard by colleagues, who shouted to Luey to get off the bell. He attempted to get clear of the falling cursor but, as he did so, his inertia reel fall arrester locked in place, preventing any chance of escape. The cursor continued to fall, trapping Luey between it and the diving bell.

Cursor support position at the time of accident

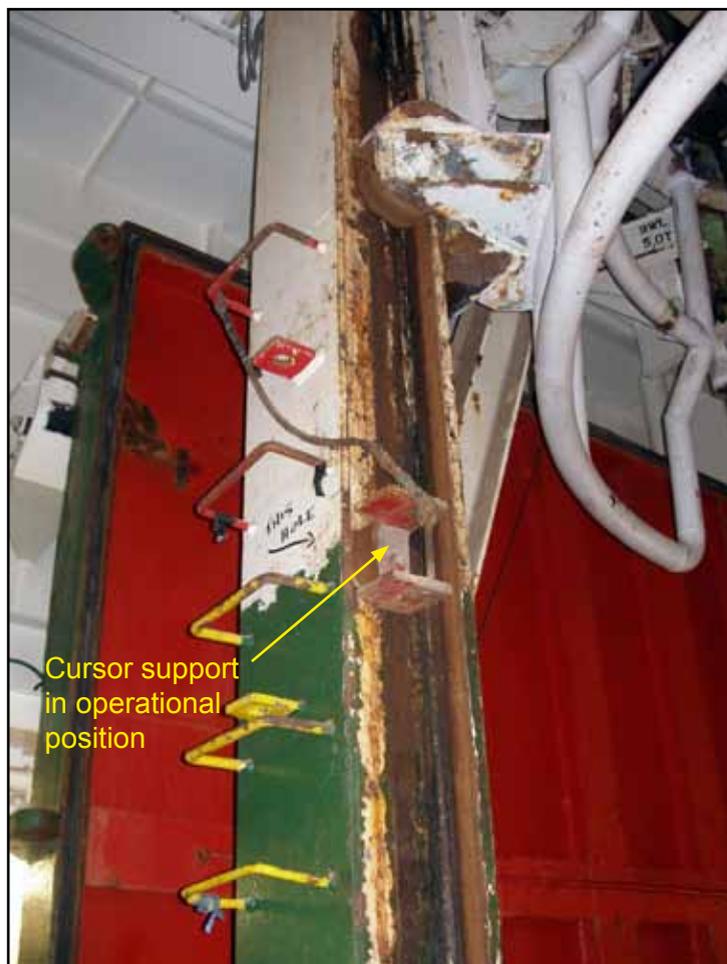
Figure 15b

Cursor support shown in operational position
