Report on the investigation of a
manoverboard accident

FV Maggie Ann

on 12 February 2009

Report No 19/2009
September 2009

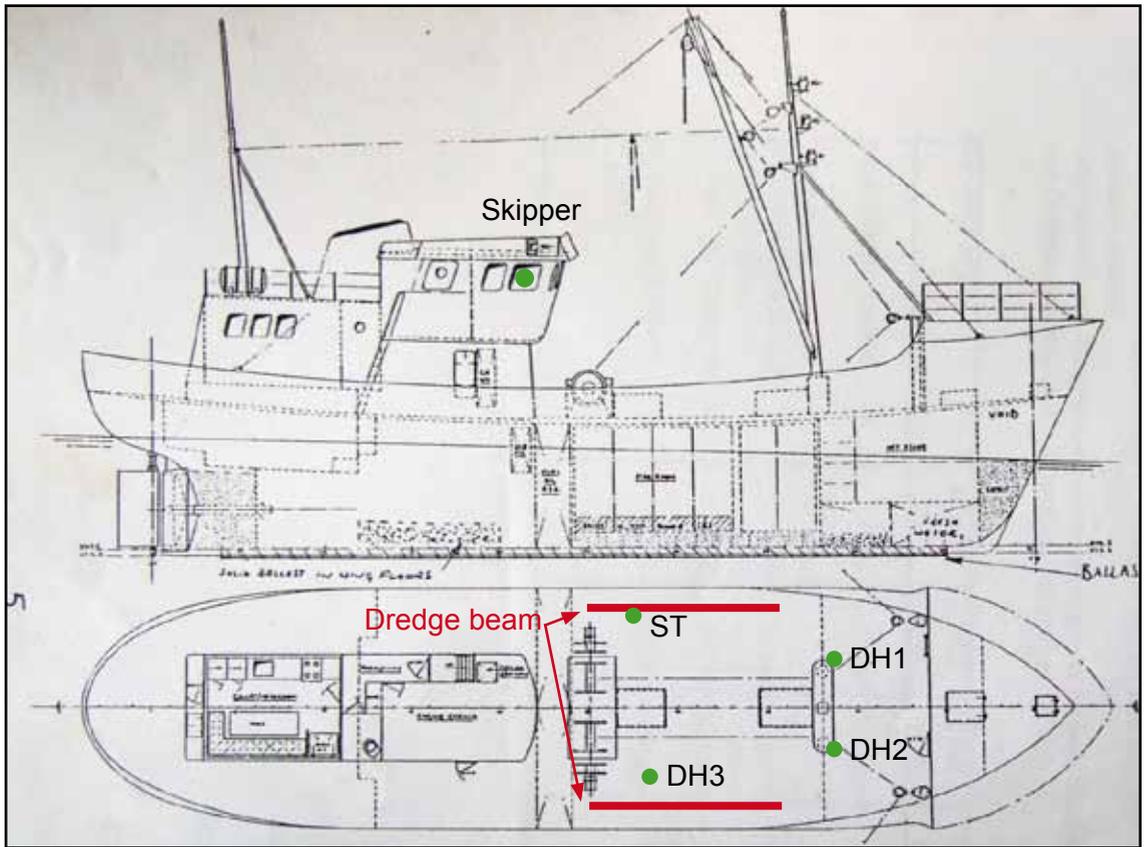
Figure 2

Position of the crew at the time of the accident (1300)

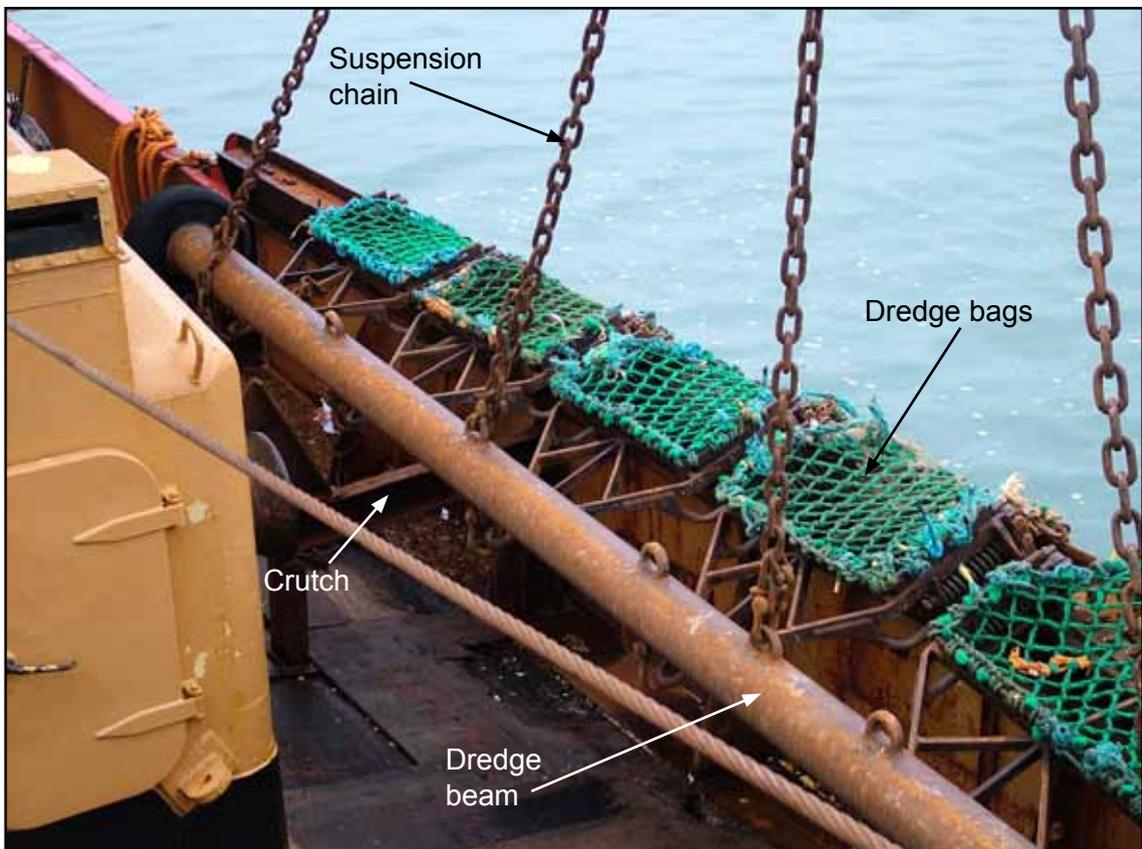
Figure 3

Dredge beam and attached dredge bags

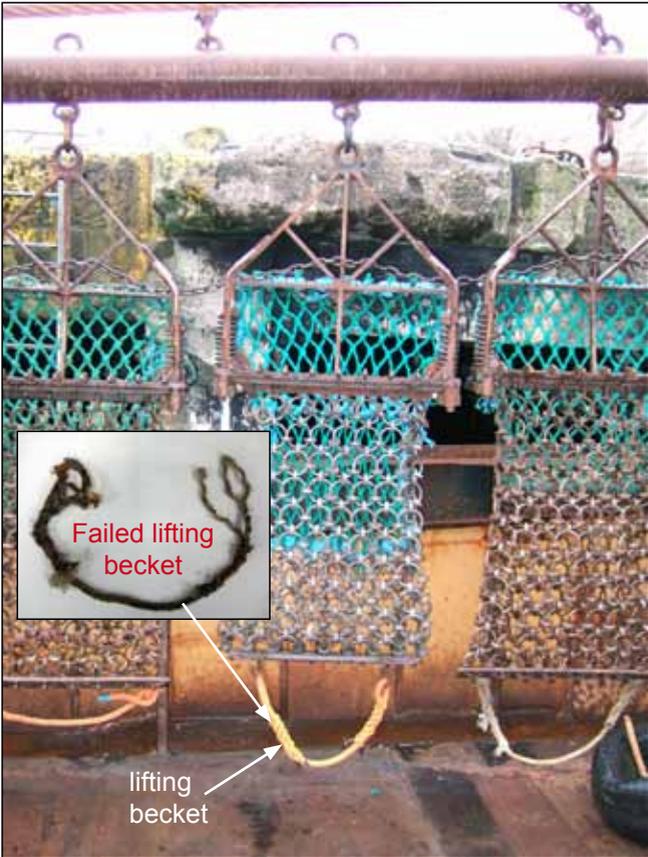
Figure 4

Dredge bags and the parted lifting becket

The lifting becket was made of polypropylene rope and was attached to two metal rings on the scallop dredge by means of an informal splice. The area of attachment was prone to particular wear and degradation. The lifting becket (**Figure 4**) recovered on board *Maggie Ann* after the accident indicates this to be the point at which the rope parted.

If the lifting becket on the dredge bag had not failed, the accident would not have happened. The failure was due to the wear at the point of attachment to a metal ring on the dredge. Such wear is inevitable given that rope (rather

It is possible, but not certain, that the wear might have been detectable on the previous haul or on inspection before sailing. Inadequate maintenance was, therefore, a possible contributory factor. The accident provides an object lesson in the need for a robust inspection and maintenance regime of working gear.

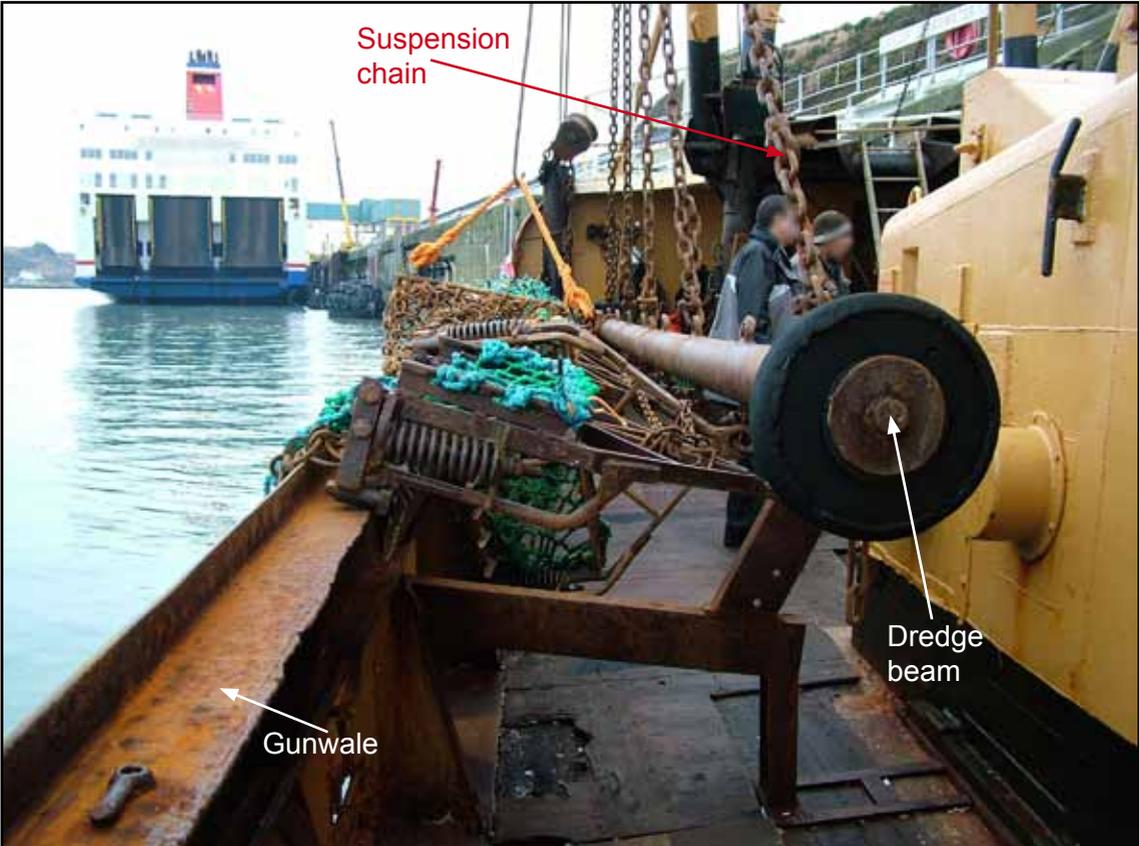
Figure 5

Simulated position of dredge beam at time of accident

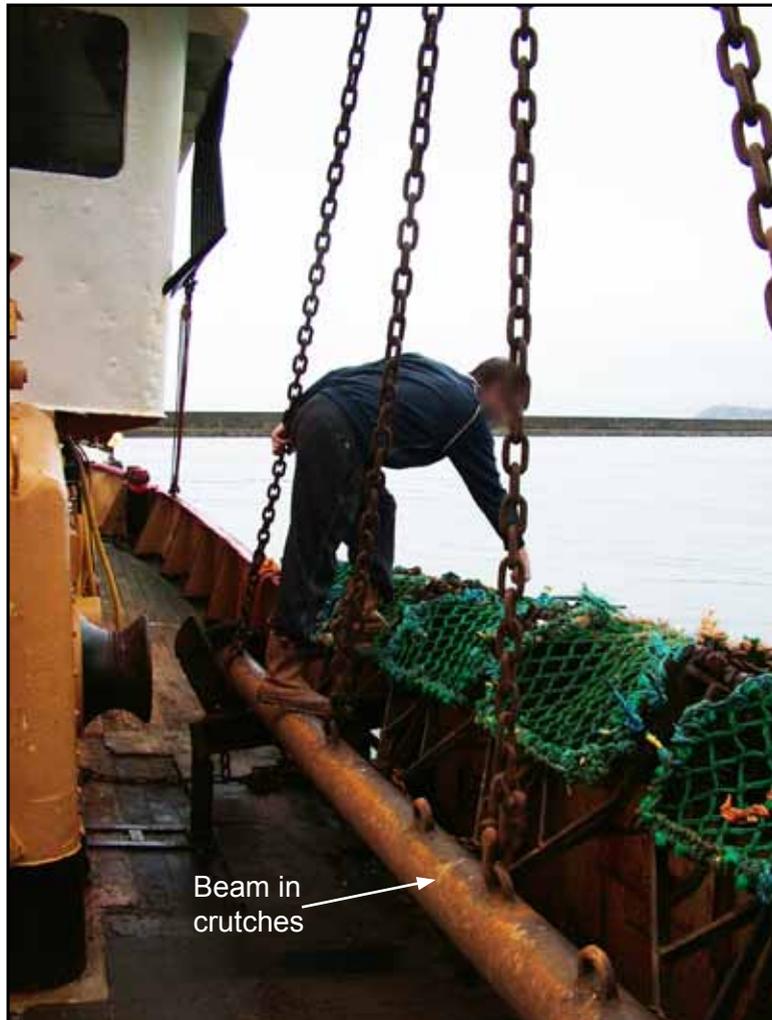
Figure 6

Stefan Tamas, who was working with another deckhand (DH1), started emptying each of the dredge bags in turn, working from aft towards the forward end of the dredge array, with DH1 operating the port tipping winch. To do this, he stood on the elevated beam, holding a suspension chain with one hand and using his other hand (**Figure 6**) to snare the dredge bag lifting becket (**Figure 4**) with the tipping hook. This was made fast to a line leading to the tipping winch. He was not wearing a personal flotation device, such as a lifejacket, or a safety harness. DH1 then heaved the line until the dredge bag inverted, allowing its contents to fall onto the deck.

Simulation by deckhand - snaring the lifting becket

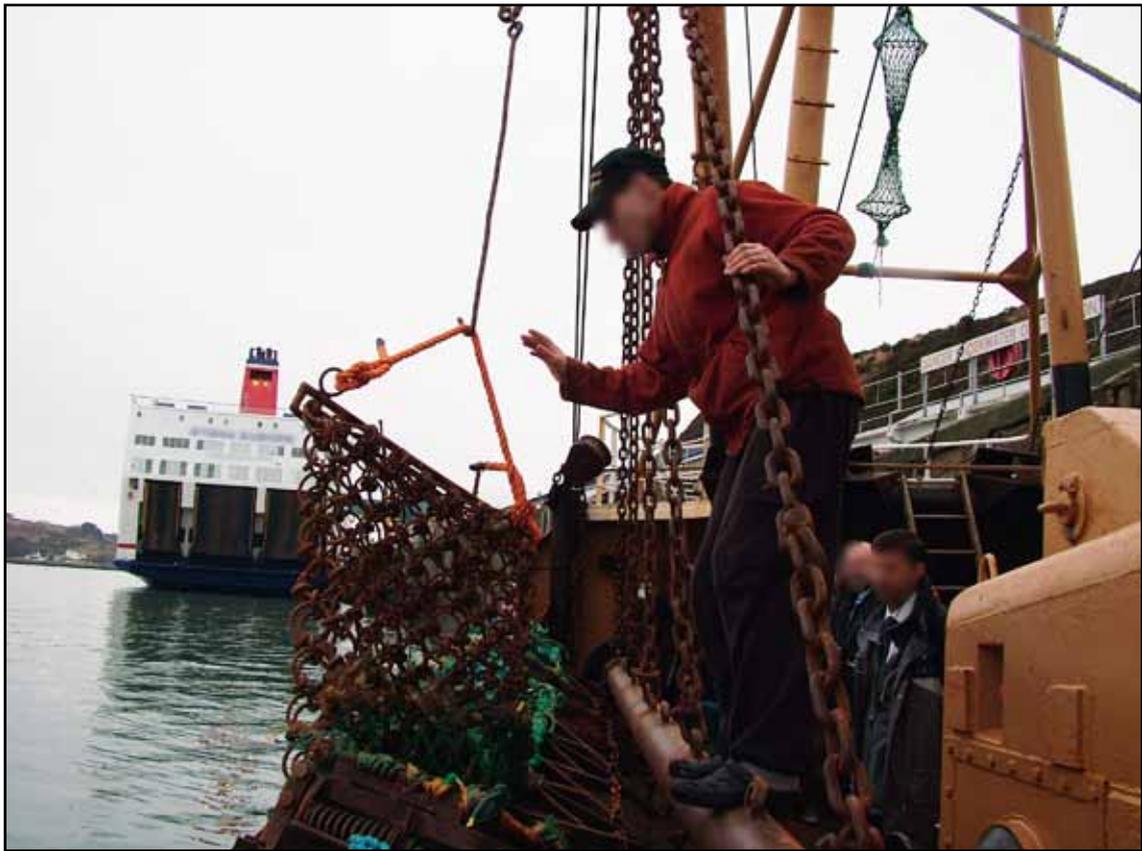
To assist the process of emptying the second dredge bag, Stefan let go of the chain and used both hands to shake the bag (**Figure 7**). As he did so, the lifting becket parted, causing him to fall overboard. DH1, who witnessed the event, immediately raised the alarm and threw a lifebuoy in his direction.

Simulation by deckhand - shaking the dredge bag

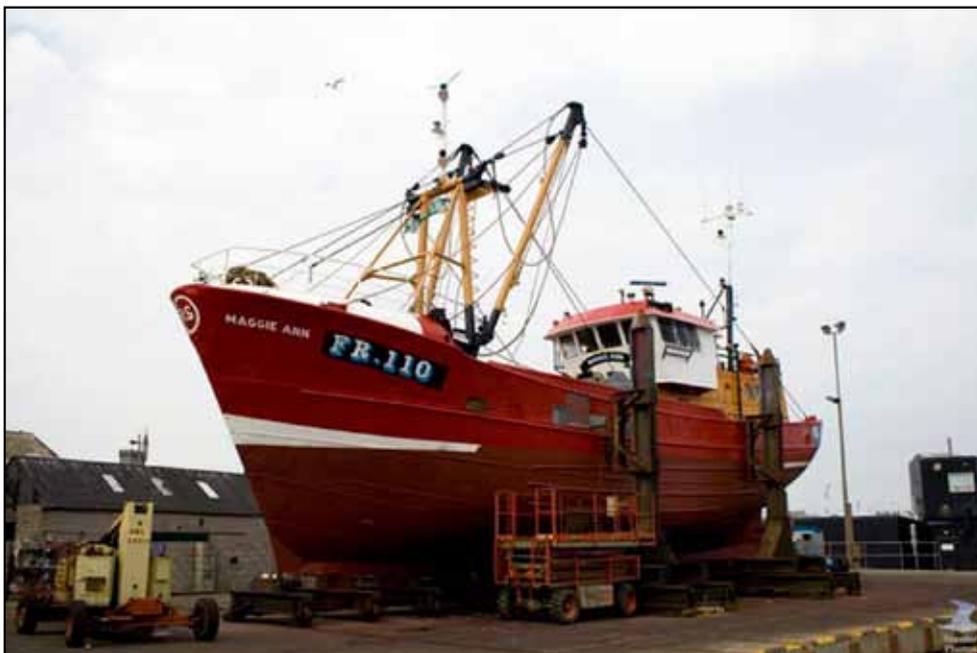
Figure 9

In July 2006, the previous owner levelled the gunwale on either side of the vessel and fitted a 9 metre length channel section on top of it. The modification effectively increased the height of the bulwark by up to about 250mm (**Figure 9**). This allowed the scallop dredges to be taken on board in a more controlled manner; the level gunwale enabled the teeth of all of the dredges to be engaged in the channel section simultaneously, and thereby allowed the dredge bags to be emptied in turn without any further adjustment.

Maggie Ann - showing modification to the bulwark

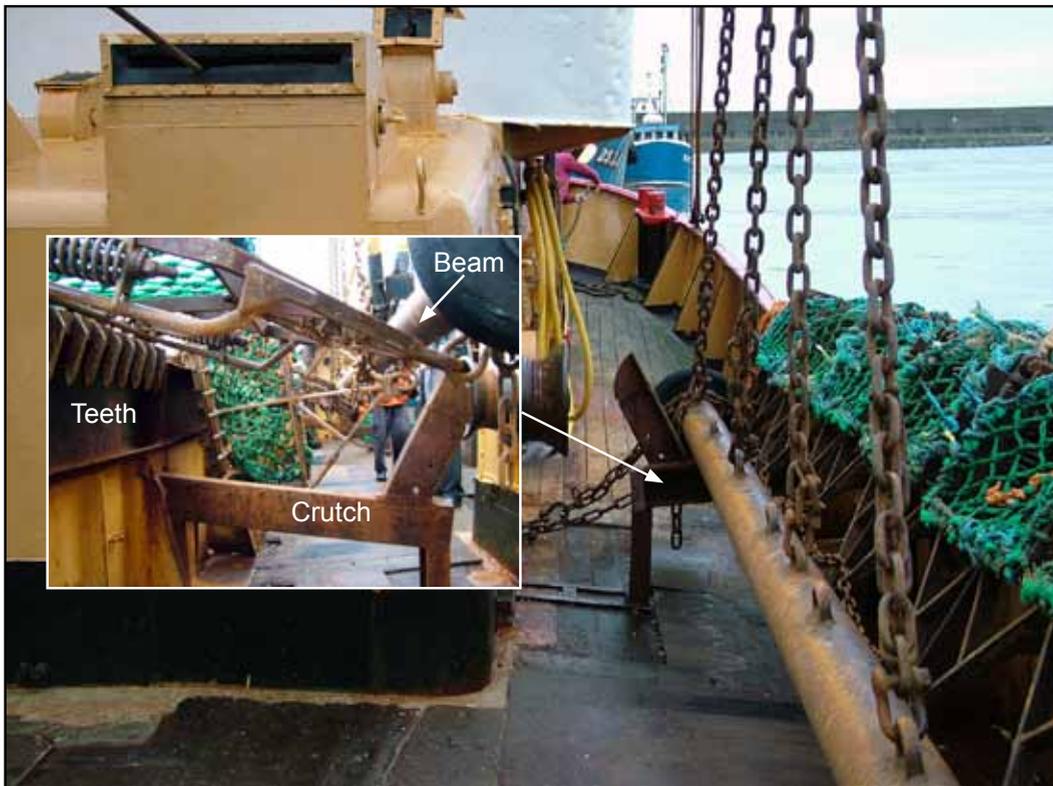
Figure 10

The increased bulwark height improved crew safety, but the dredge beam could no longer be lowered onto the deck. To allow the dredge beam to rest in a secure position while the dredge bags were being emptied, the owner fitted a pair of crutches to the deck (**Figure 10**) into which the dredge beam was lowered. When the dredge bags were full, the dredge beam had to be pulled inboard and down, by means of a separate line that led to a whipping drum on deck (**Figure 11**), to enable it to be landed in the crutches. This resulted in the scallop dredge teeth (**Figure 10**) passing inboard of the bulwark with the dredge bags resting on top of the gunwale. The current skipper did not usually make use of the additional line to land the beams onto the crutches, resulting in the dredge beam remaining suspended and almost level with the gunwale when the dredge bags were full and about to be emptied.

Position of dredge beam when resting on crutches

Following the modifications, the increased height of the bulwark, together with the added protection against movement of the dredge beam provided by the crutches, improved the crew's safety. However, the new arrangement resulted in exposing the crew to new hazards because they were required to stand on an elevated beam to snare the lifting becket and empty the dredge bags. The risks of falling off the beam and of falling overboard also increased significantly when the beam was not lowered into the crutches and instead remained suspended, almost level with the gunwale.

These risks could have been mitigated by pulling the beam down into the crutches, a practice discontinued by the current skipper, or by wearing a safety harness, as recommended by MGN 311 (F). Alternatively, a 'tipping' bar, commonly used on scallop dredgers (**Figure 12**), could have been fitted. This would have enabled all the dredge bags to be inverted at the same time and have avoided the need for deckhands to step onto the dredge beam or to lean over the gunwale.

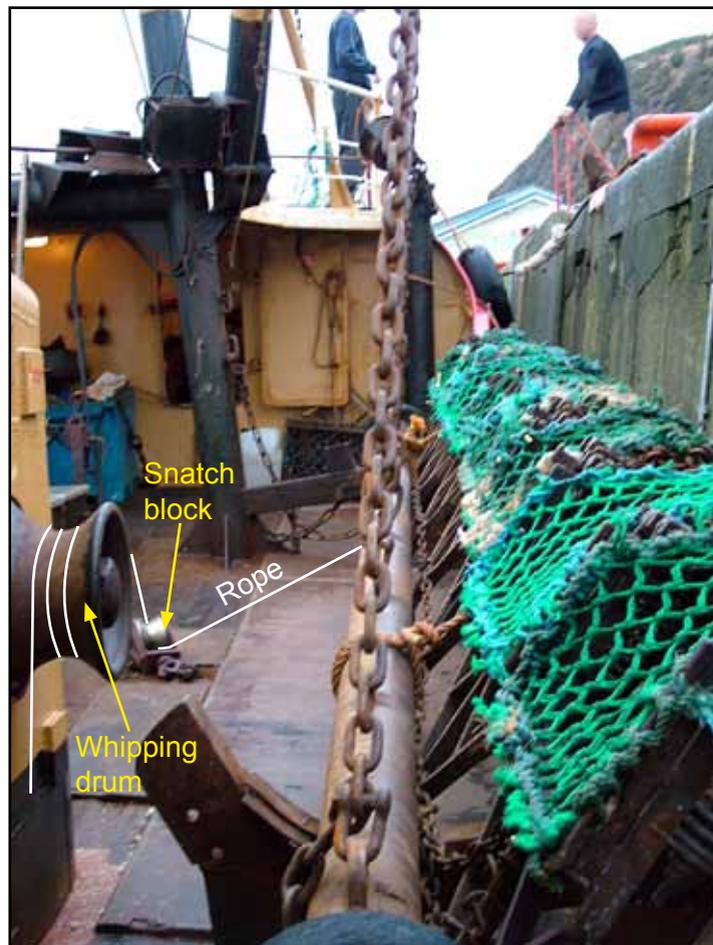
Figure 11

Bowsing in arrangement

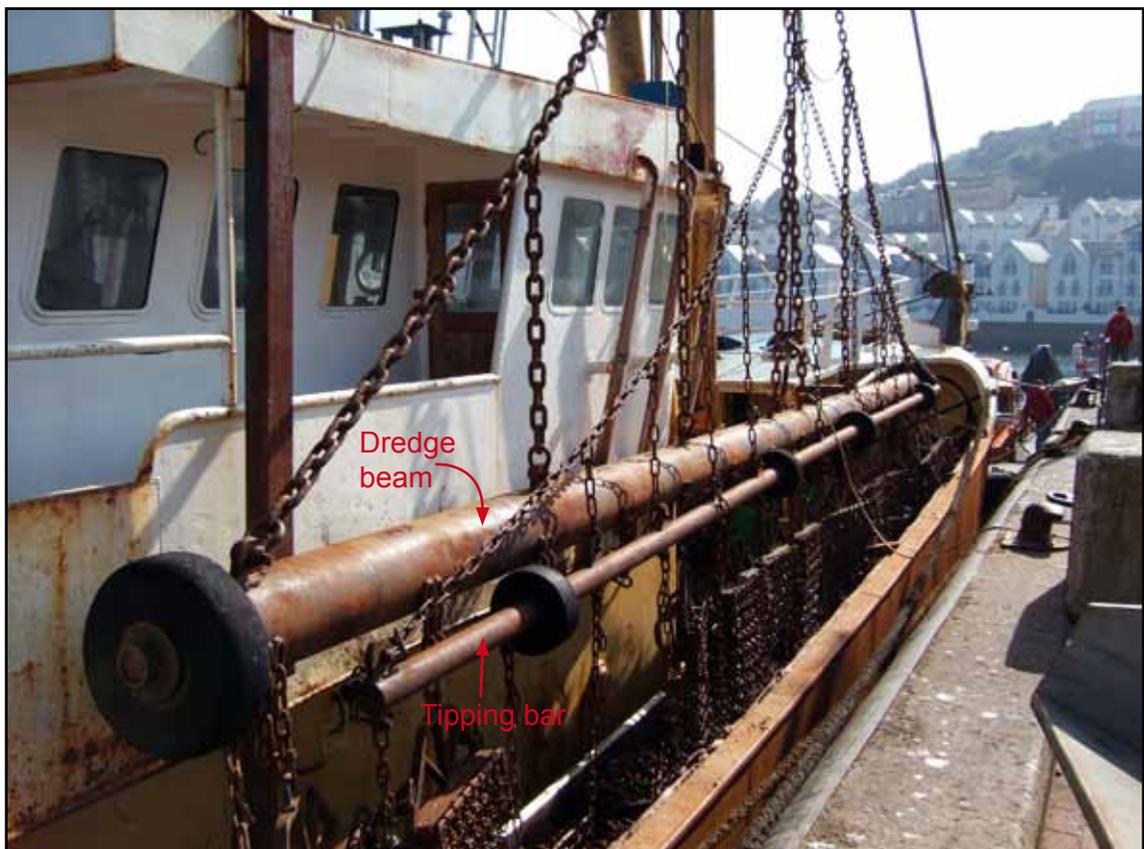
Figure 12

Fitted 'tipping bar' arrangement
