Report on the investigation of
the shift of an articulated road tanker on board the
roll-on roll-off high-speed sea service cargo ferry

Stena Voyager

in Loch Ryan

Report No 21/2009
October 2009

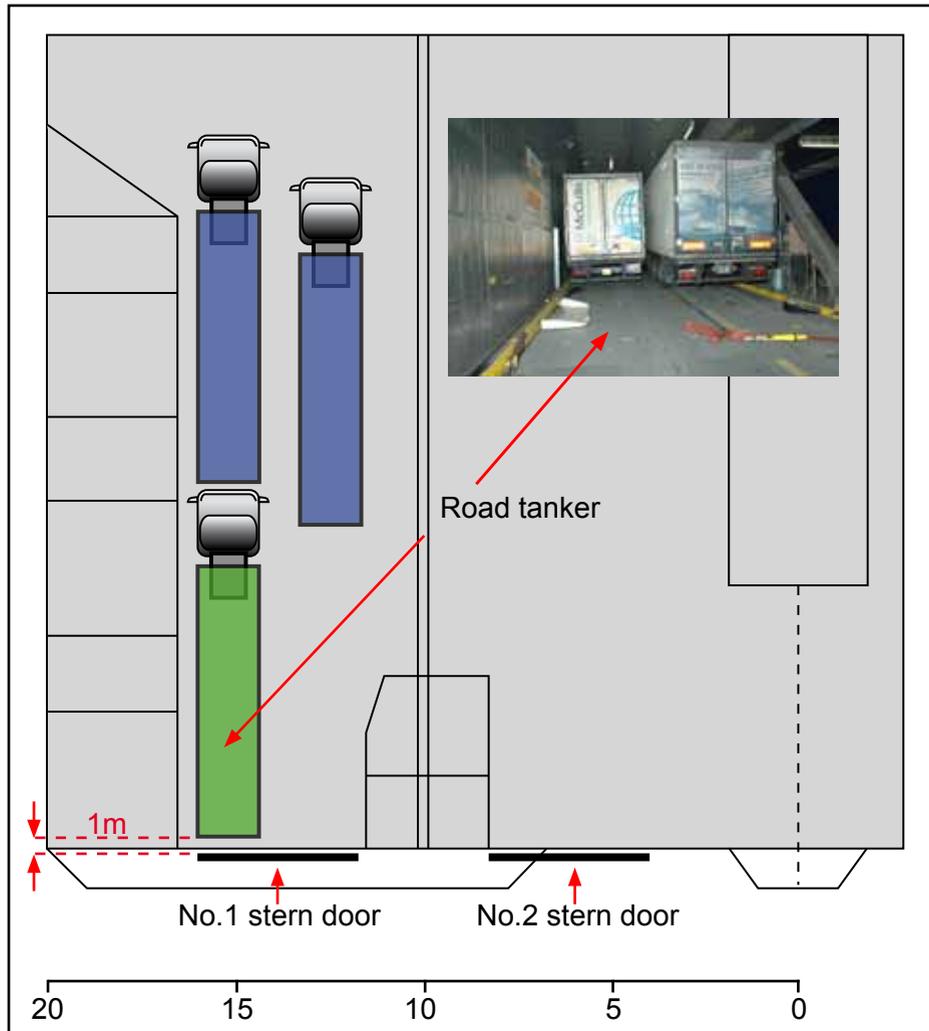
Figure 2

At approximately 2005, the road tanker was marshalled back on board *Stena Voyager* and parked at the aft end of lane number one. The rear end of its semi-trailer¹ was approximately 1m from number one stern door (**Figure 2**). The vessel was now trimmed 20cm by the stern, with a slight port list and a mean draught of 4.8m.

The position of the road tanker at the time of departure

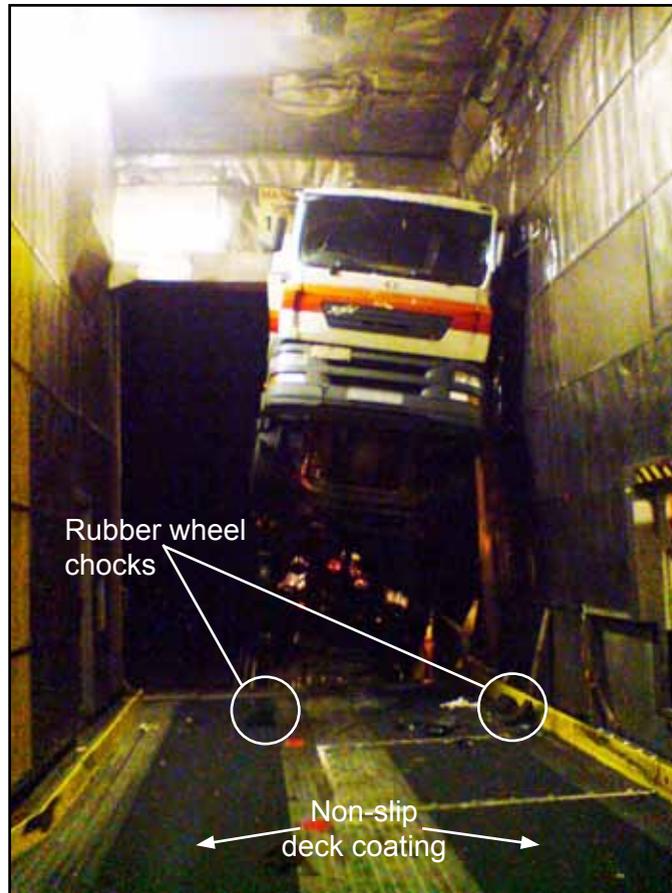
Figure 4

The senior deck assistant and deck assistant immediately went to the aft end of lane number one, where they saw the road tanker's tractor unit raised off the deck and wedged into the top outboard corner of the stern door opening (**Figure 4**). The aluminium door had been lost overboard and the vehicle's semi-trailer was hanging off the back of the ferry directly above the two port water jets. The senior deck assistant used his hand-held VHF radio to alert the bridge of the situation, and the chief engineer confirmed that a 'doors open at sea' alarm had activated. The master immediately stopped the vessel.

Photograph of road tanker tractor unit taken immediately after the accident

One rubber chock was placed on each side of the two wheels on the semi-trailer's rear axle. Four rubber chocks were photographed close to number one stern door shortly after the accident (**Figure 4**).

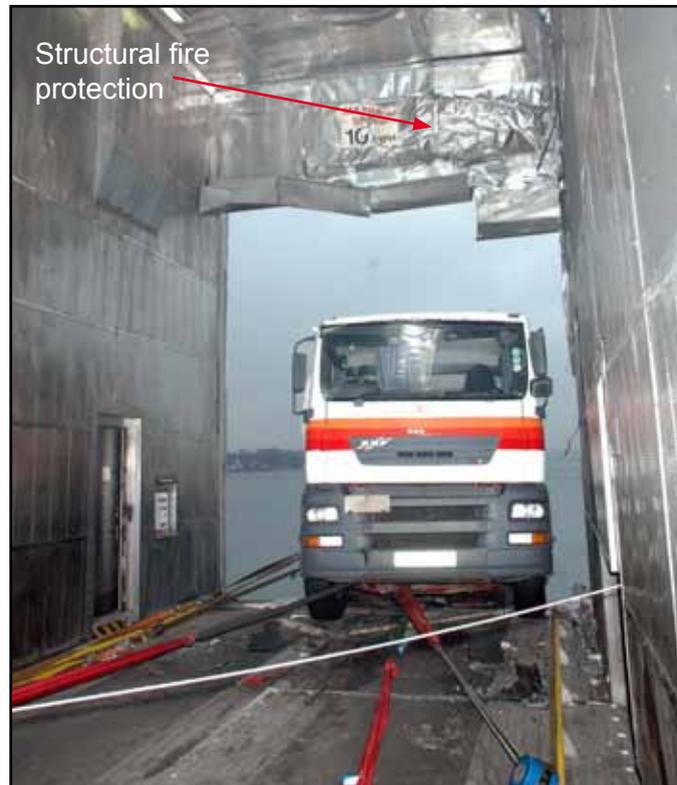
Figure 5

Prompted by the first officer, the deck crew confirmed they could not see anyone in the vehicle's cab and also advised that it was too dangerous to attempt to make it secure. At 2105, *Stena Voyager* was stopped off Leffnol Point (**Figure 3**) to allow the master an opportunity to fully assess the situation and for the vehicle to be stabilised. At 2107, the tractor unit dropped steadily to the deck and the semi-trailer rested on top of number two water jet. The deck crew immediately lashed the cab to the deck (**Figure 5**).

Road tanker tractor unit secured to the deck

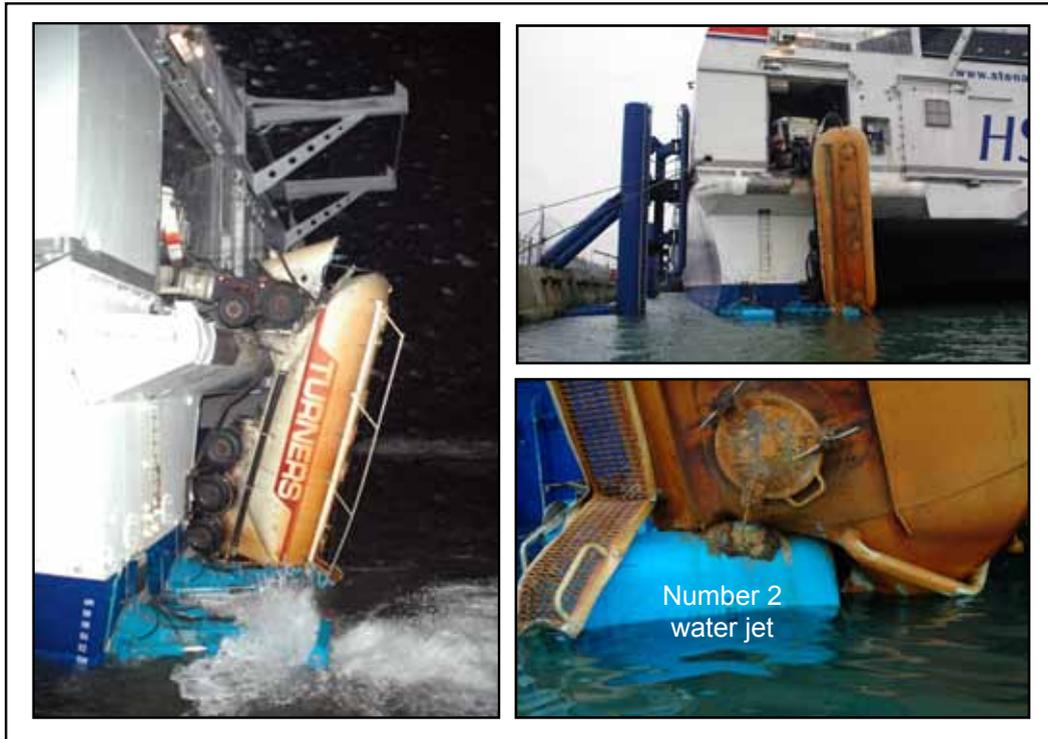
Because the semi-trailer was hanging over the stern of the vessel (**Figure 6**), it was not possible to use the linkspan, so at 2241 the vessel berthed alongside the quay, port side to. It was only then that the master realised the stern door had been lost overboard and alerted the coastguard, which immediately issued a navigation warning.

Road tanker semi-trailer resting on top of number two water jet

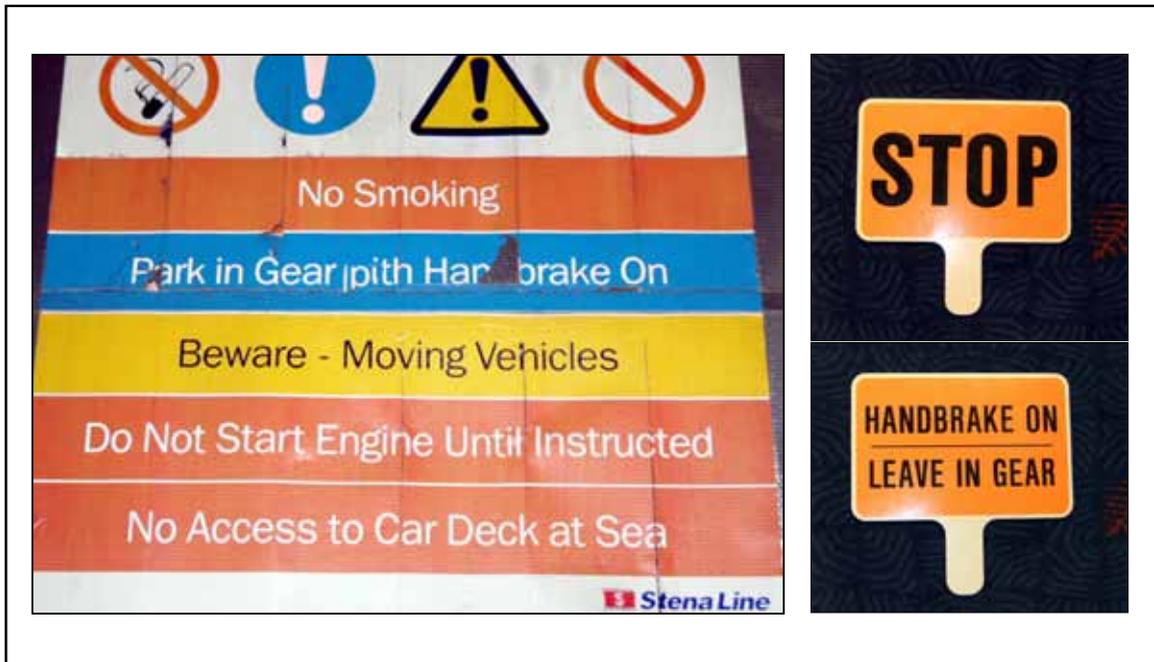
The crew did not verbally instruct drivers to apply parking brakes or seek confirmation that they had done so during the loading operations, but warning posters on the vehicle decks provided a visual prompt for drivers. Hand-held instruction boards were held on board, but were not used (**Figure 13**).

Vehicle deck warning signs and hand-held instruction boards

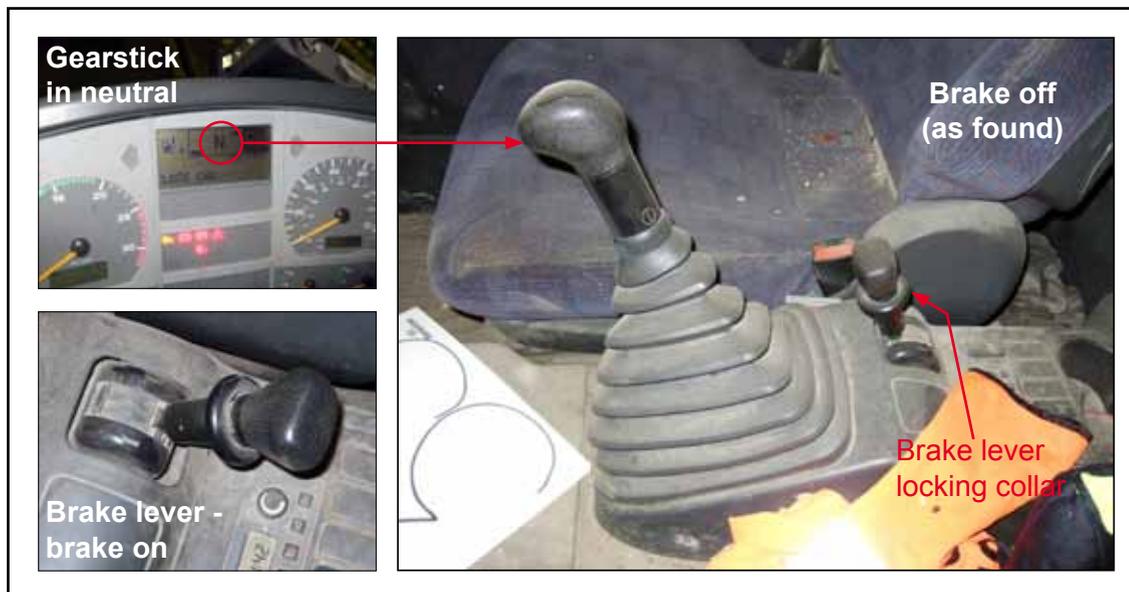
Figure 16

Road tanker tractor unit brake and gearstick

When the road tanker was inspected after the accident its parking brakes were found to be off and its gearstick was in the neutral position (**Figure 16**). The hand brake safety catch mechanism functioned correctly and no faults were found with the braking systems.

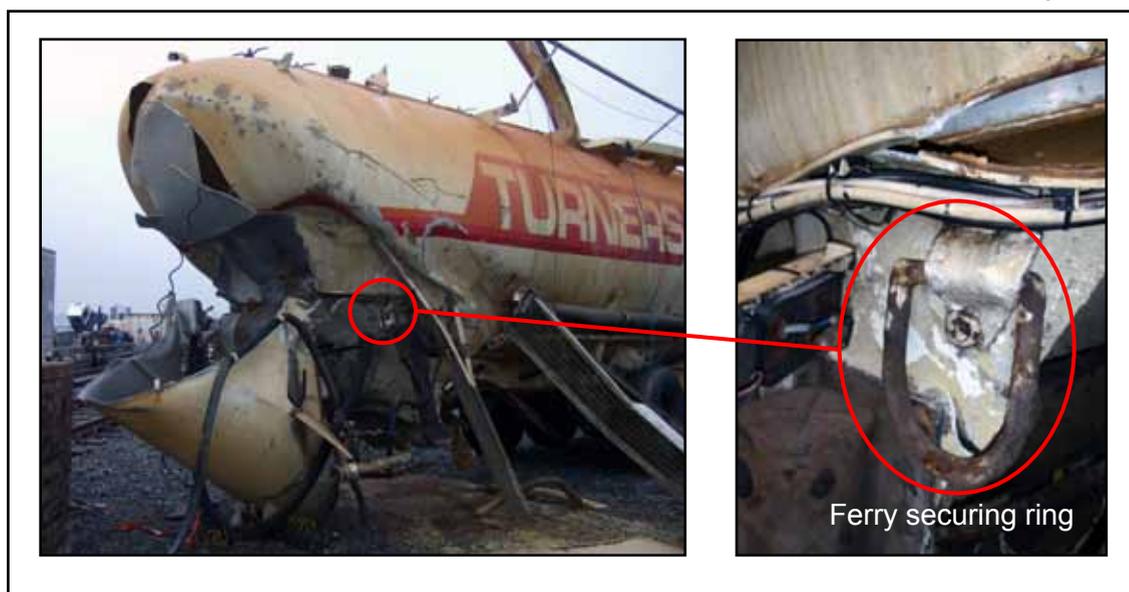
Figure 17

The semi-trailer had two ferry securing rings fitted at its forward end, one on each side (**Figure 17**). The tractor unit had no ferry securing rings. This was the standard configuration on all of Turners' road tankers which were intended to travel by ferry.

Road tanker ferry securing rings

To comply with the guidance provided in IMO resolution A.581(14), the CSS and MCA codes of practice, and the ISO standards, the semi-trailer of the Turner's road tanker should have been fitted with four ferry securing rings on each side. However, it was only fitted with one pair at its forward end. The findings highlighted in paragraph 1.11.1 indicate that the majority of freight vehicles arriving for embarkation on ferries in UK and other European ports do not have the recommended number of ferry securing rings fitted. Moreover, a significant percentage has none at all.

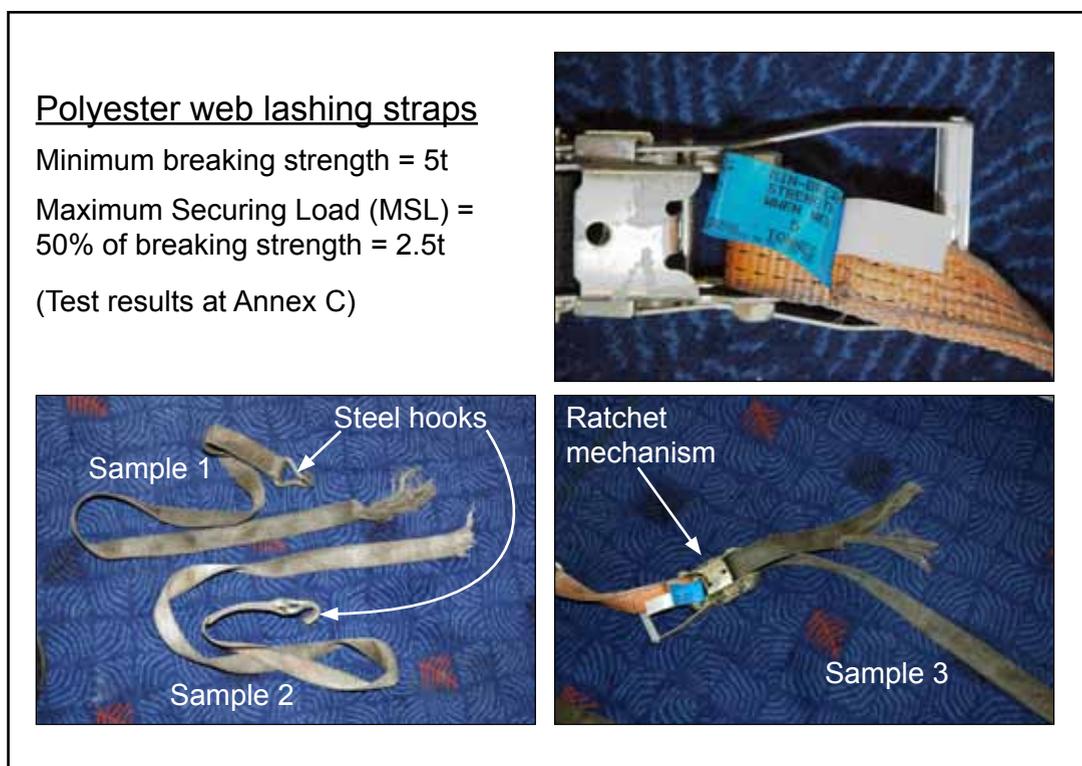
The crew recovered three lengths of failed web lashing after the accident (**Figure 19**). Subsequent analysis (**Annex C**) concluded that two of the failed samples were from the same lashing. One of the lashings had lost 43% of its original strength and the second had lost 65%; the residual breaking strengths were 2.85t and 1.76t. Visually, the lashings appeared as though they had been in service for some time.

Failed lashing straps recovered from the accident scene

Analysis of the failed lashings recovered from the scene of the accident identified that the residual strength of the web lashings used to secure the road tanker was as low as 35% of their design strength. Therefore, the maximum restraining force achievable from the two forward lashings was only 3.5t. Although it was still possible for the lashings to have prevented the vehicle from moving, it would only have required the road tanker to build up momentum over a few centimetres to induce a sufficient shock loading to cause the lashings to fail.

The degree to which the lashings had degraded was attributed mainly to their age, and wear and tear, and was not easily identifiable by visual inspection alone (**Annex C**). Therefore, the need to introduce procedures enabling web lashings to be identified, and to be renewed after being in service for a maximum specified period, is compelling.

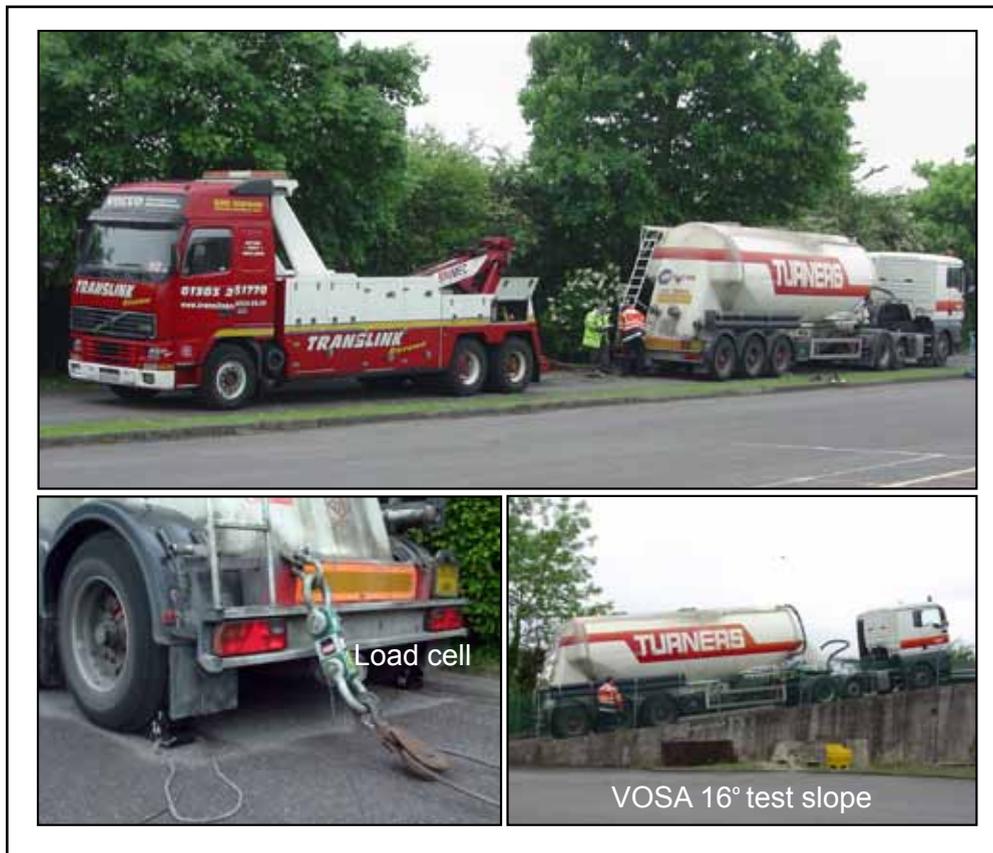
On 13 May 2009, the MAIB, in co-operation with the Vehicle and Operator Services Agency (VOSA) conducted a set of tests to determine the forces required to pull a fully loaded (44t) articulated road tanker, without brakes or lashings, over the three types of rubber chocks most commonly used by Stena Line (**Figure 20**). The results (**Annex D**) found the best performing chock provided an average restraining force equivalent to 4.28t when two were positioned behind the rear wheels of the semi-trailer on level ground; the worst provided a restraining force of 3.5t. The chocking of one wheel effectively halved the restraining forces provided.

Further tests demonstrated that as the gradient of the road was increased, the force required to pull the vehicle over the chocks was reduced. Calculations indicate that the force acting on a 44t road tanker due to its weight alone would cause it to roll over the best performing chock at an angle of 6°. Measurements were also taken on an inclined section of road to establish the magnitude of shock loads applied by a free rolling vehicle to initially slack lashing straps. The maximum theoretical force acting on the road tanker in the aft direction during the trans-critical phase of *Stena Voyager's* passage was calculated to be almost 3t.

Wheel chock performance tests

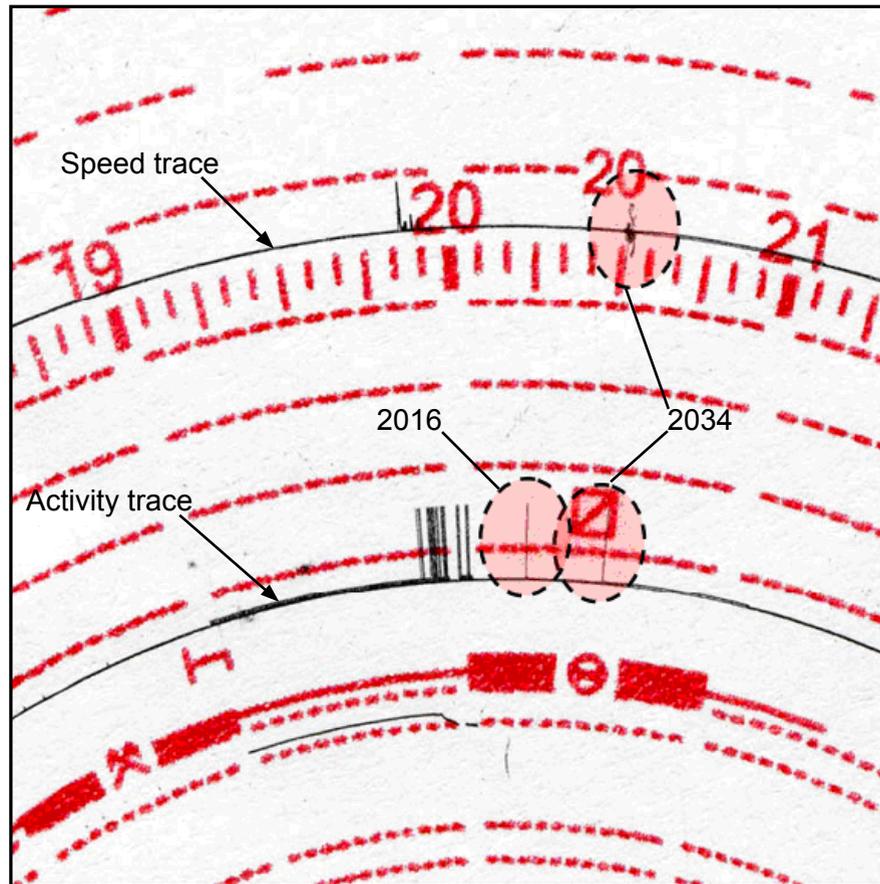
Despite its engine being stopped, the road tanker's movement at the time of the accident was recorded on the disc (**Figure 21**). The violence of the impact on the vehicle as it crashed through the stern door was also sufficient to create marks on the vehicle's speed trace. Careful analysis of the disc indicates the road tanker probably moved aft at 2016, shortly after *Stena Voyager* departed the berth. This was 18 minutes before it passed through the stern door.

Tachograph marks

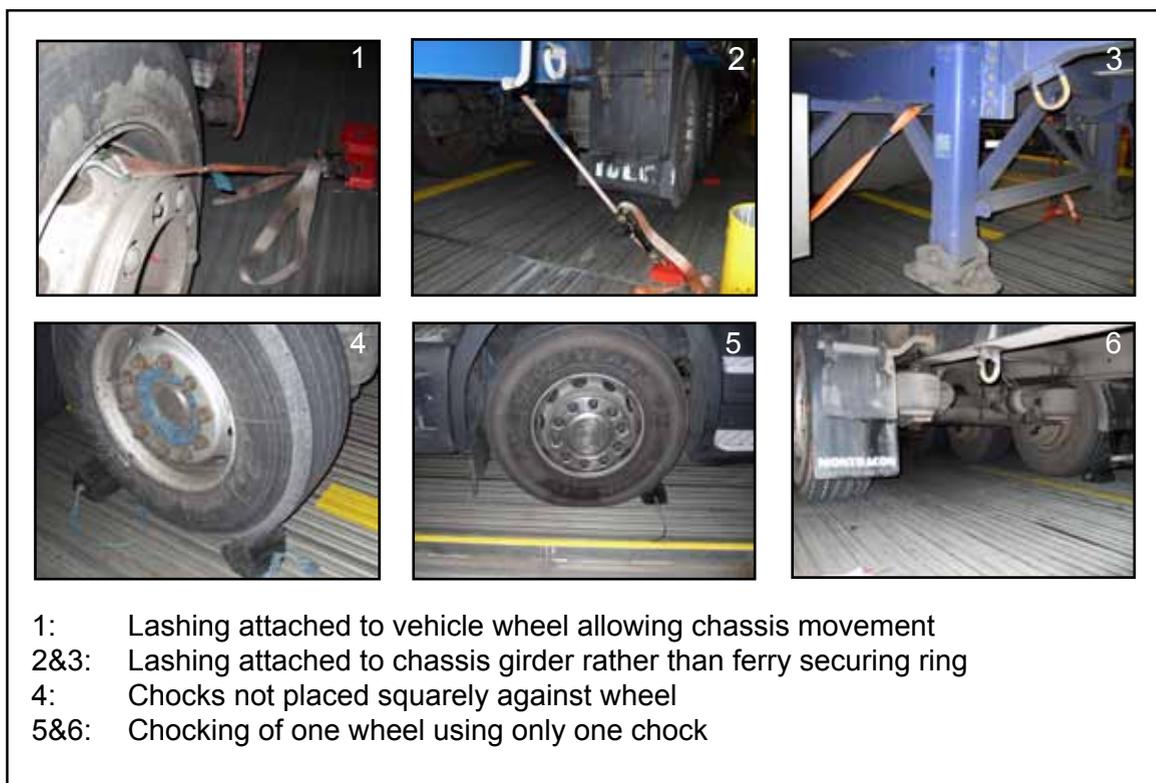
During the visit to *Stena Explorer*, a review of her cargo securing manual found that the cargo securing requirements set out in SMSO number 23 differed from those given in the equivalent document on board *Stena Voyager*, and both contradicted the instructions given in SMSO number 8 (**Annex A**). The crew were observed to chock one wheel on each vehicle, and in some cases chocked only one side of a wheel; not all chocks were placed squarely against the wheels (**Figure 24**). Several vehicles were found to be secured with fewer than four lashings.

The crews of *Stena Voyager* and *Stena Explorer* had adopted different securing practices, and neither was fully compliant with the minimum requirements set out in the cargo securing manuals. This had not been identified by any internal or external audits.

Securing practices on board *Stena Explorer*
