Report on the investigation of
a person overboard during a passenger transfer from

HMS Westminster to Princess Rose

on the River Thames

Report 16/2009
July 2009

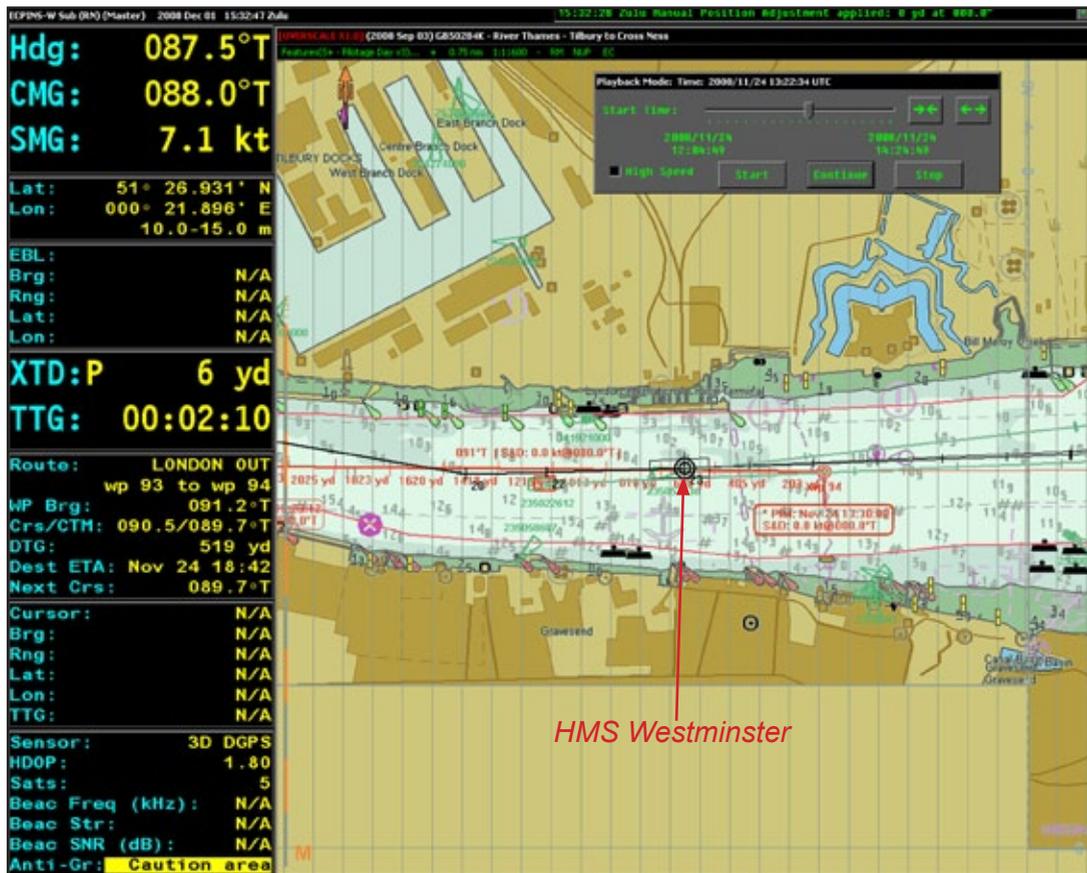
At approximately 1321 (**Figure 3**), HMS Westminster's executive officer and OOW assessed from the starboard bridge wing that the river conditions were 'well within limits for transfer'. With the ship's speed now at 5 knots through the water and with the fenders in position, the executive officer gave approval for the boat transfer to commence. The fenders were not tied to the vessel's guardrails; they were being tended by hand.

WECDIS download - immediately before passenger transfer

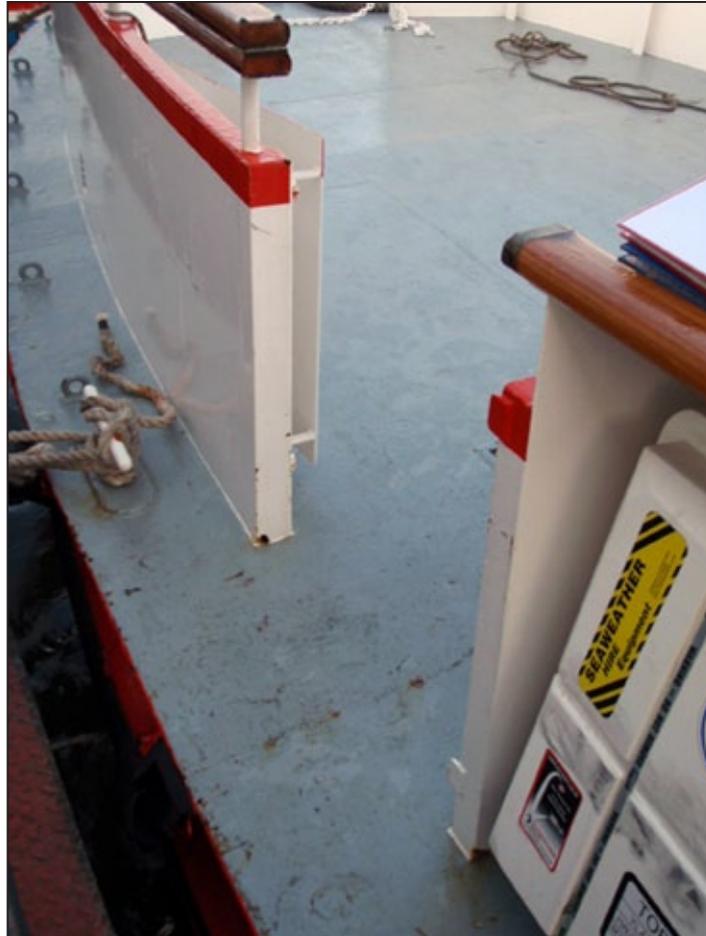
Figure 4

The pilot ladder and manropes were then lowered but, with the bottom rung of the ladder lying just above the water, the CBM and the crew of *Princess Rose* were concerned that its lower wooden steps might be crushed between the two vessels. *Princess Rose's* helmsman placed the rudder amidships, engaged neutral and put the throttle to idle. He then left the wheelhouse to help bring the bottom four steps of the pilot ladder and its lower spreader² inboard through the boarding gate (Figure 4). The ladder was then flaked across the deck and the crew of *Princess Rose* signalled to the deck of *HMS Westminster* that they were happy for the passenger transfer to commence.

Princess Rose boarding gate

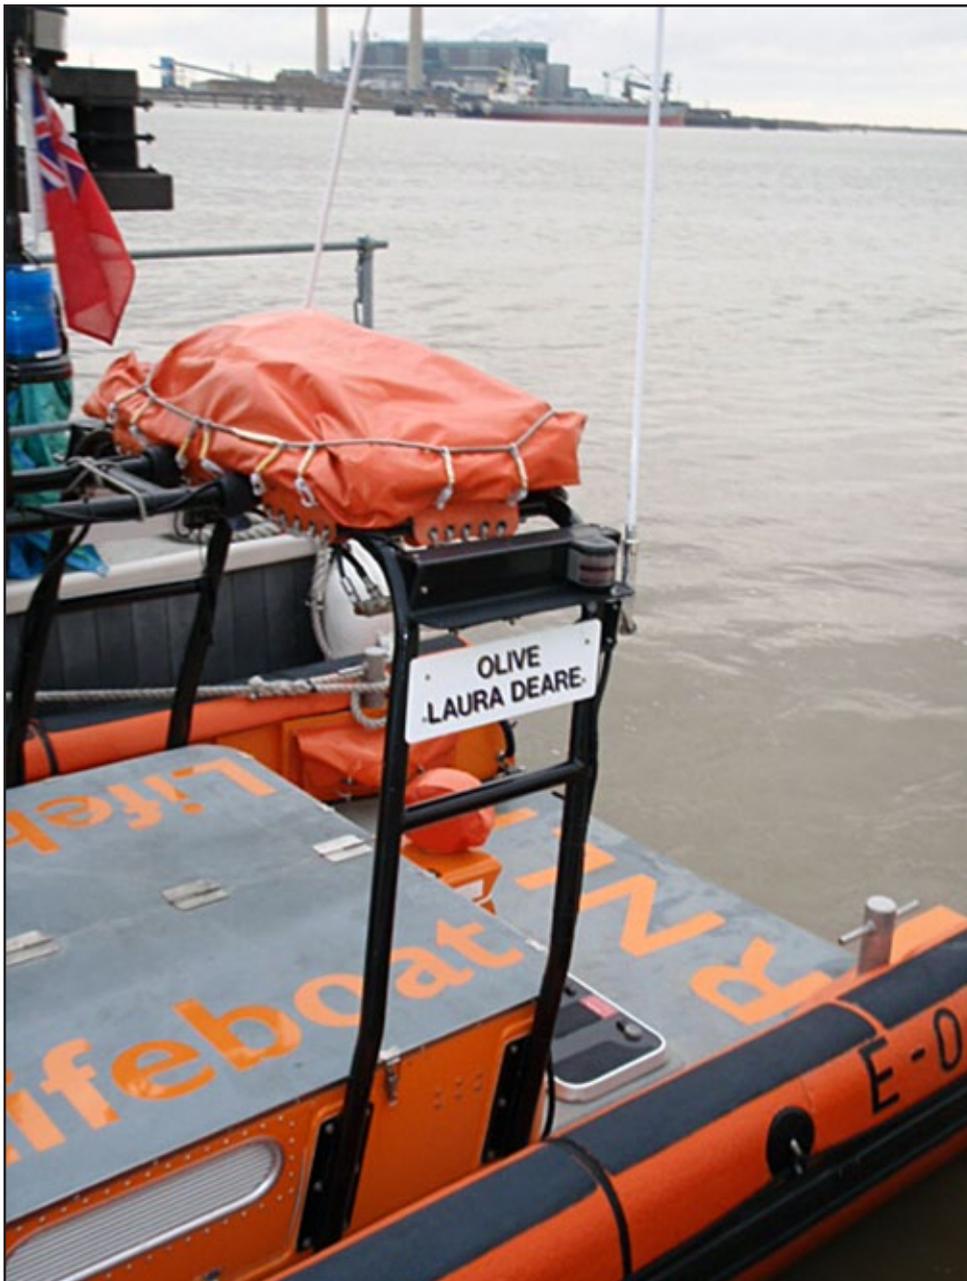
Figure 5

Manoverboard recovery procedures were immediately initiated by both vessels, and the coxswain of the lifeboat astern saw the accident and stopped his vessel adjacent to the DRNLO. The lifeboat crew were unable to lift her over the inflatable tube on the port bow and had to move her to the vessel's low stern transom (**Figure 5**), where they pulled her on board. The lifeboat took the DRNLO to the Royal Terrace Pier, where she was collected by an ambulance alerted by the Thames Vessel Traffic Service (VTS). She was then taken to the Gravesend lifeboat station where paramedics attended to her. The DRNLO was not required to be taken to hospital.

Low transom of RNLI lifeboat used to recover the casualty from the water

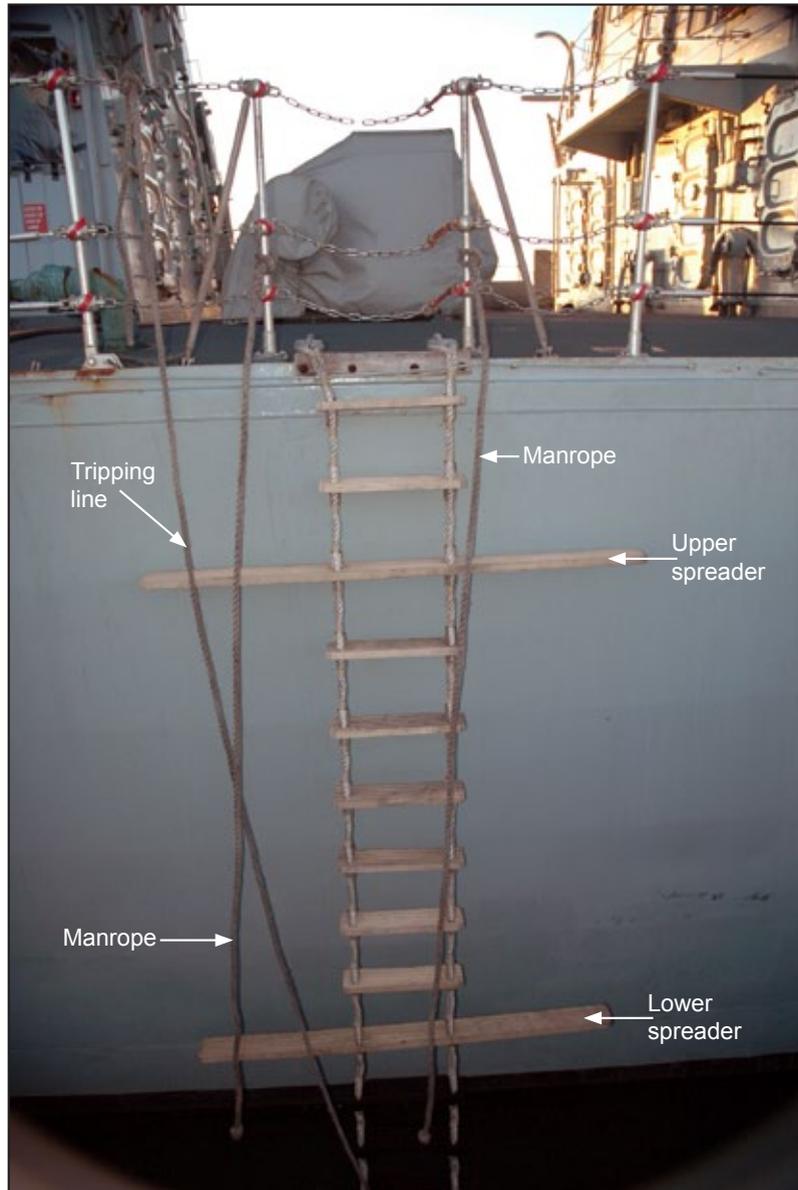
Figure 7

The equipment comprised a pilot ladder secured to deck eye pads using spring hooks, two 24mm polypropylene manropes, and a hook line. The pilot ladder was fitted with two anti-twist spreader bars and its bottom four steps were made of moulded rubber. A tripping line was attached to the bottom rung of the ladder to assist with its deployment and recovery (**Figure 7**). There was no rescue strop provided in the area of disembarkation. VHF radio communication was available between the deck and the bridge.

Pilot ladder as rigged at the time of the accident

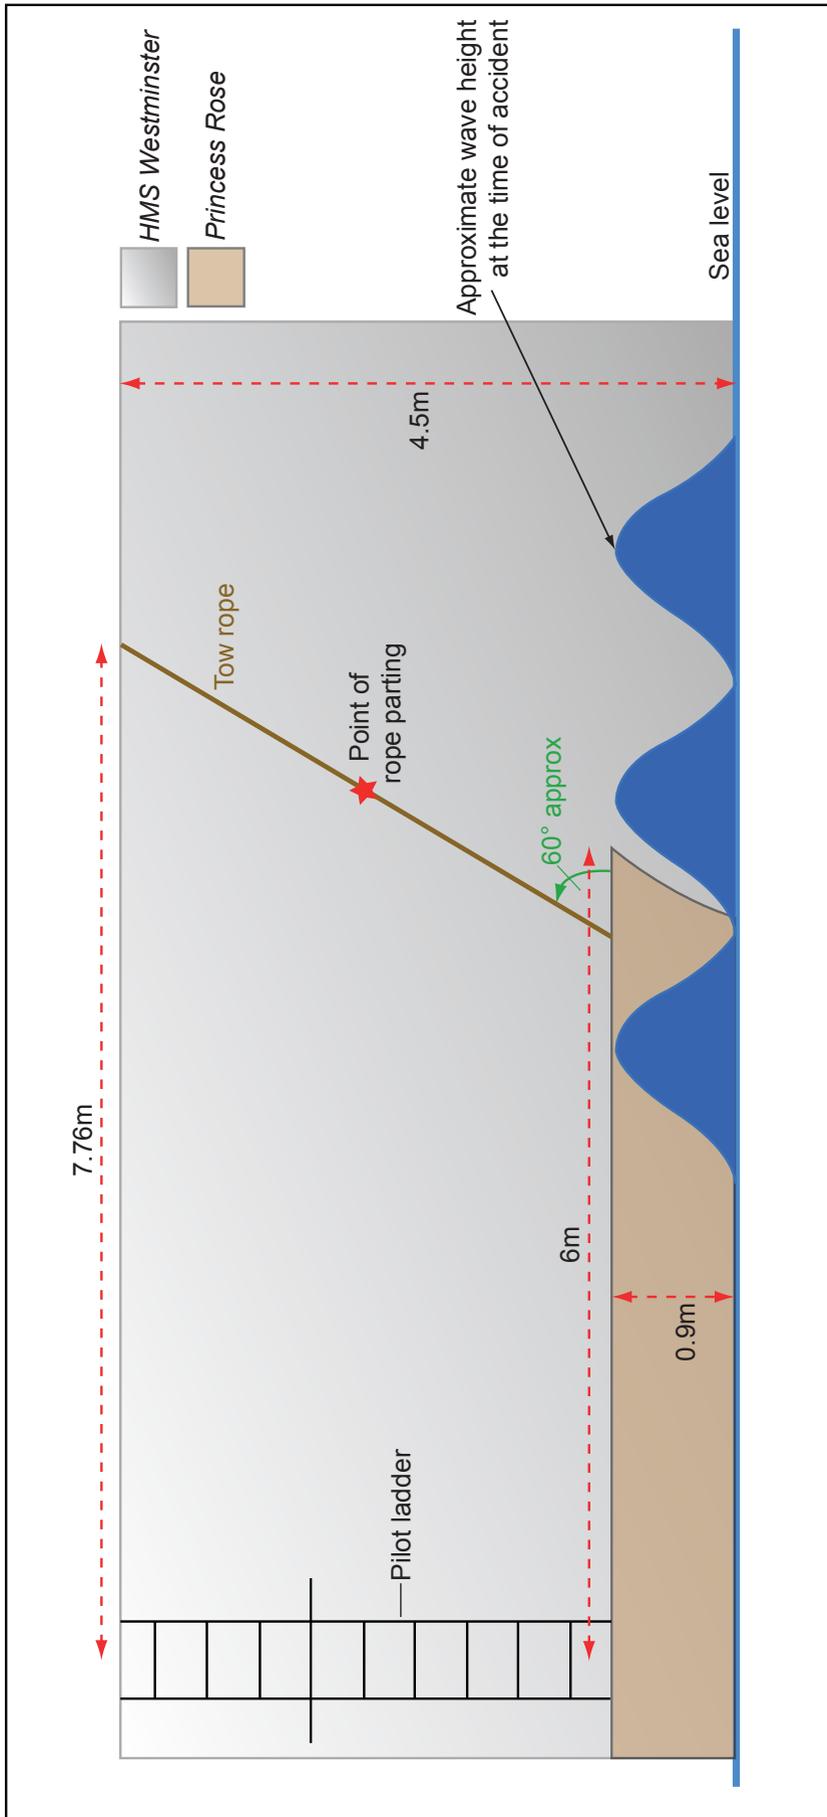
Figure 8

In this case, the angle of the painter was relatively steep (**Figure 8**), and when *Princess Rose* began to pitch as the sea conditions worsened, the resultant vertical movement of the vessel's bow induced a shock loading and caused the polypropylene rope to part. It is likely this could have been avoided had a longer painter been provided and attached further forward on board *HMS Westminster*. It is also likely that the movement of *Princess Rose* in relation to the transfer position following the failure of the painter would have been controlled more quickly if one of the crew had remained in the wheelhouse. Although the use of a painter reduced the need for frequent engine and helm movements, the need to be able to manoeuvre immediately is very important, particularly when transferring people.

Relative position of *Princess Rose* and the pilot ladder while alongside *HMS Westminster*

1. The angle of the painter was relatively steep, and when *Princess Rose* began to pitch as the sea conditions worsened, the resultant vertical movement of the vessel's bow induced a shock loading and caused the polypropylene rope to part. [2.3.1]
