Report on the investigation of  
the entrapment of an engine room fitter  
in a watertight door  
on board the ro-ro passenger ship

***Eurovoyager***

approaching Ramsgate, UK

**Report 17/2009  
July 2009**

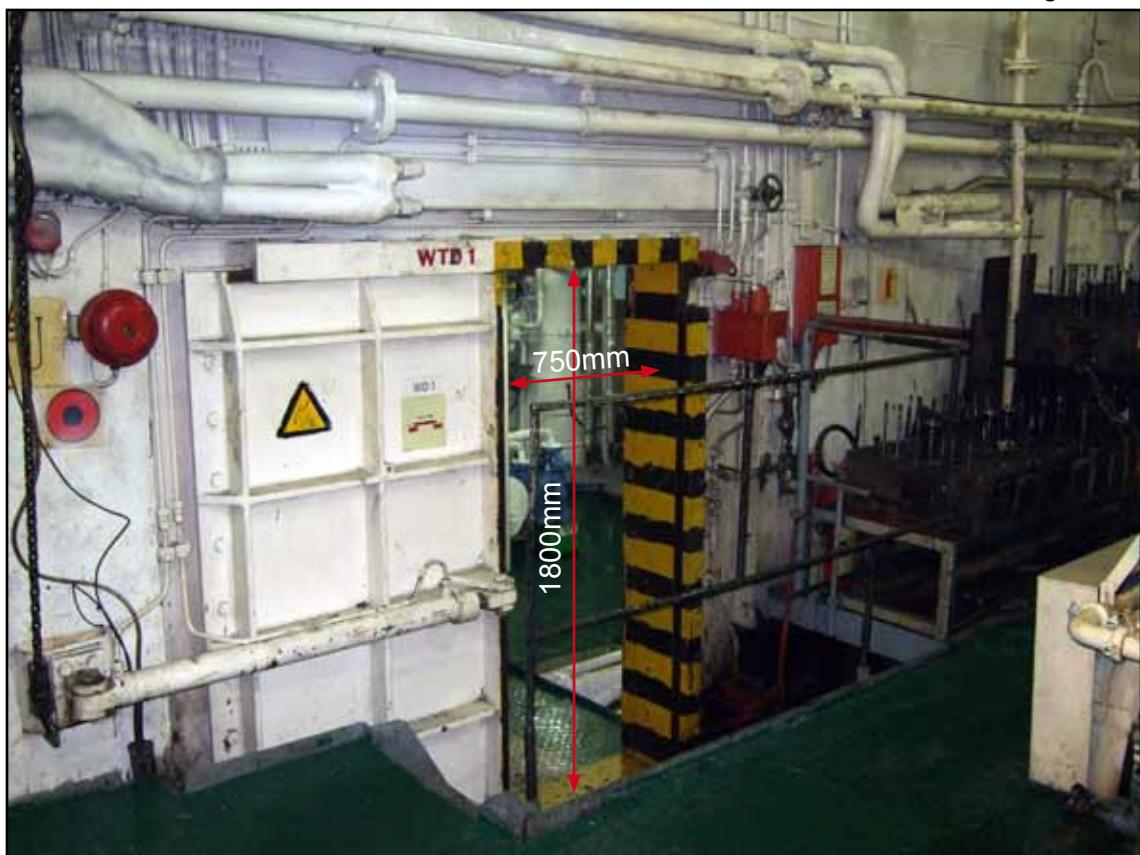
Figure 5a

There were 11 watertight doors, excluding the bow and stern doors and 4 weathertight deck barriers. Four of these doors were located in the machinery space (Deck 1), and the remaining 7 on Deck 2 (**Figure 4**). All of the doors were made of solid steel and were identical in construction except for two in the accommodation, which were narrower. WTD1 measured 1800mm x 750mm (**Figure 5**).

Photograph of watertight door No.1 (open) - view from auxiliary engine room

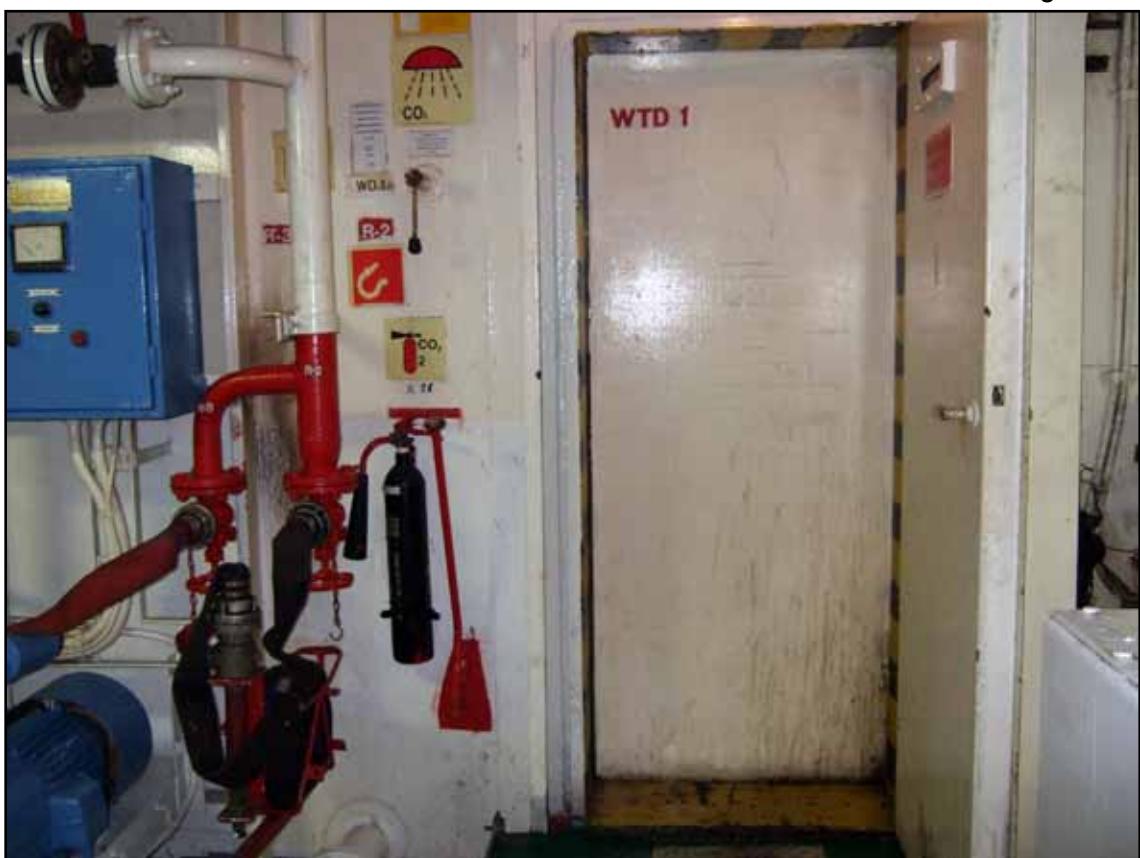
Figure 5b

At around 0750 on 3 November, the fitter went to the engine control room (ECR) and made himself a cup of coffee. At 0759, as the vessel was departing Ostend, the master announced on the public address system that he intended to close the watertight doors. He then switched the doors to remote operation from the bridge. Just after 0800, the second engineer asked the fitter to tidy and clean the workshop. At 1123 the fitter left the workshop located aft of the main engine room for an early lunch. He went to the changing room which was forward of the auxiliary engine room, operating three watertight doors on his way (**Figure 2**). The changing room used by the engine ratings was an adapted machinery compartment. It contained a washing machine and facilities for cleaning hands. At 1126, as the fitter was coming out of the changing room in to the auxiliary engine room, he became trapped between the frame and door of watertight door number 1 (WTD1).

Photograph of watertight door No.1 (closed) - view from changing room

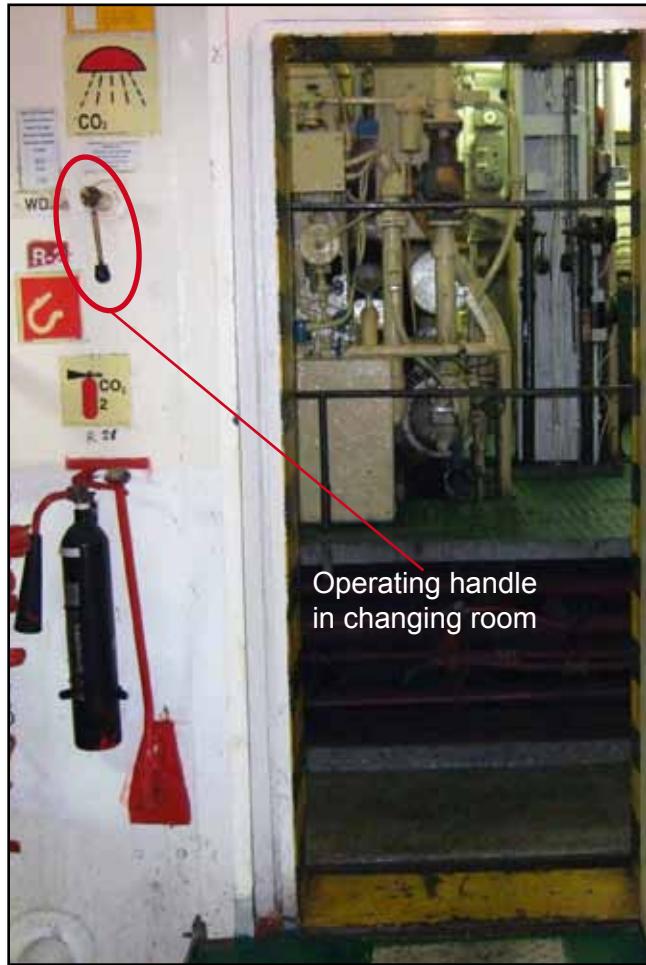
Figure 6a

Photograph showing door operating handle

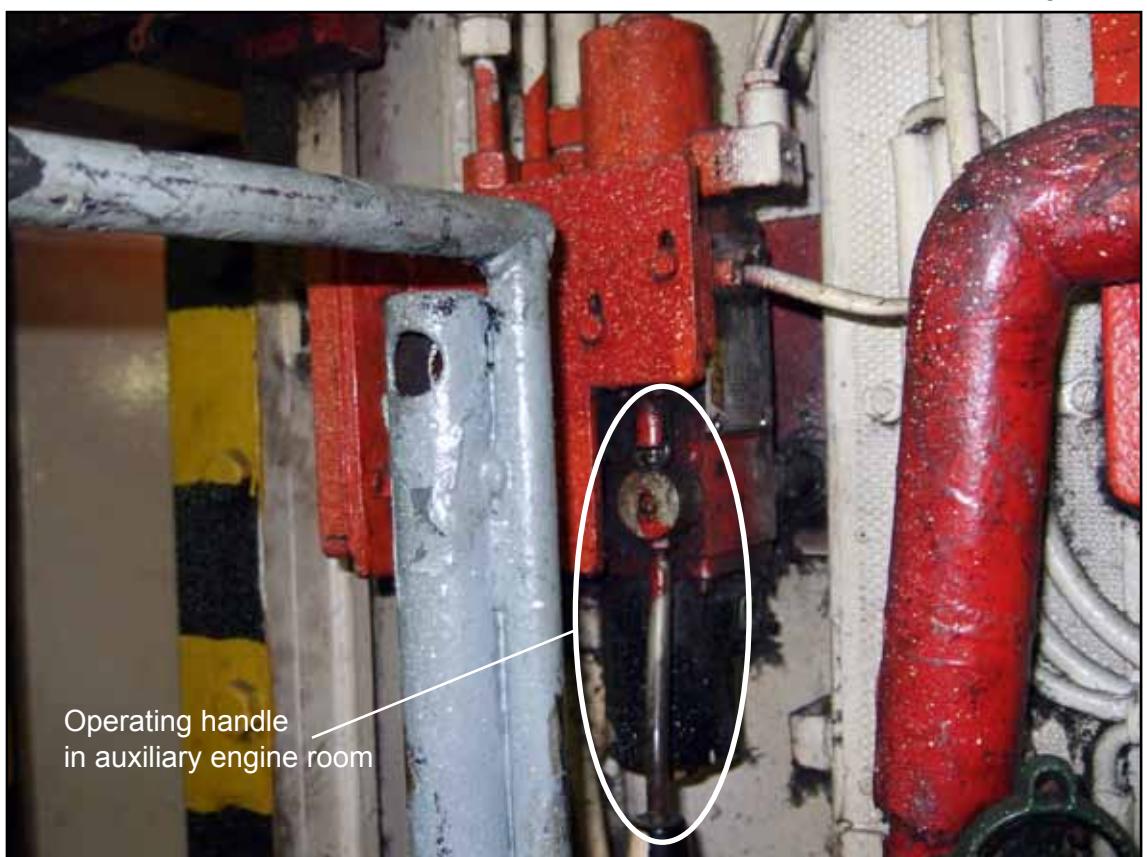
Figure 6b

Operating handle  
in auxiliary engine room

Photograph showing door operating handle

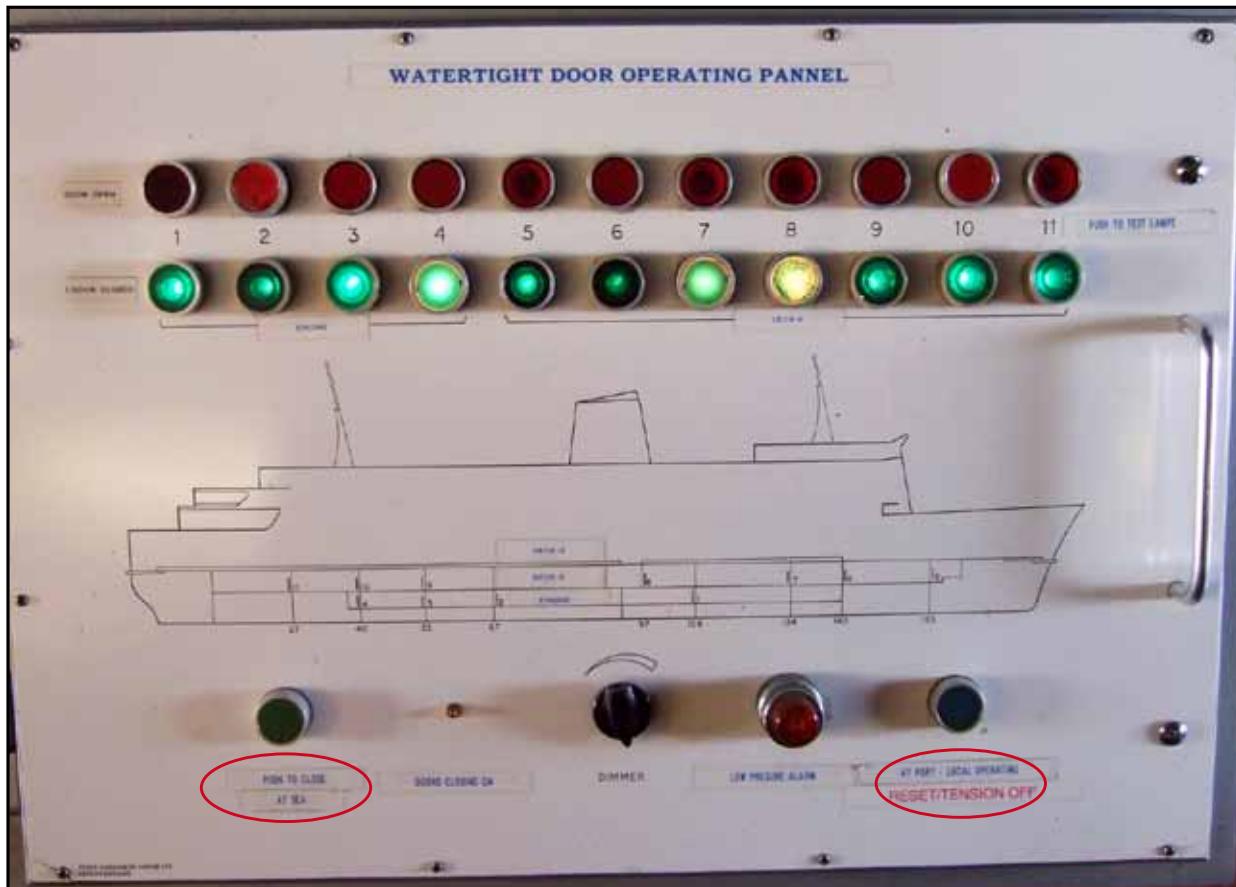
Figure 7

Watertight door operation panel

- The presence of an unapproved damage control information booklet.
- The ambiguous labelling on the operating console.

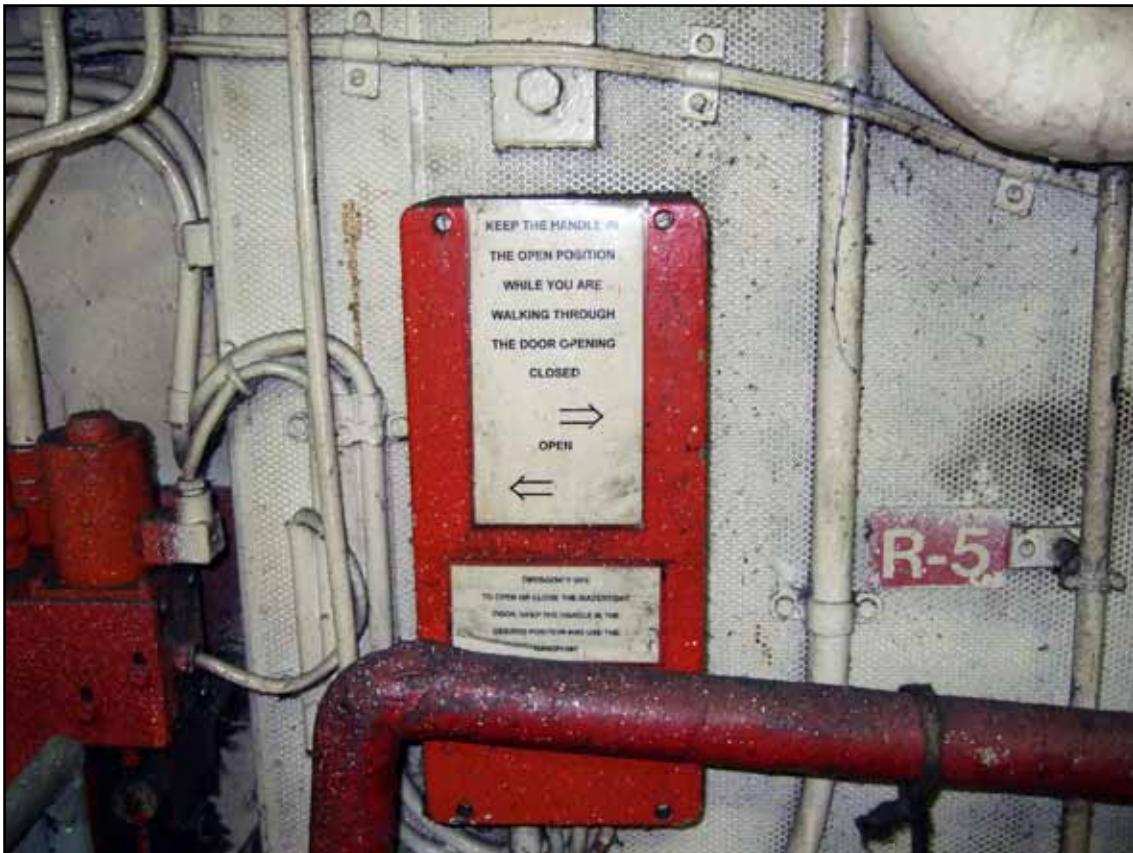
Figure 8

Emergency operating procedures and instructions were available on either side of each watertight door stating that the operating handle was to be kept in the open position while transiting the door (**Figure 8**). There were no instructions to open the door fully before passing through it. Furthermore, there were no posters or notices to indicate the potential dangers of entrapment if the correct transit procedures were not followed.

Instructions for transiting the watertight doors

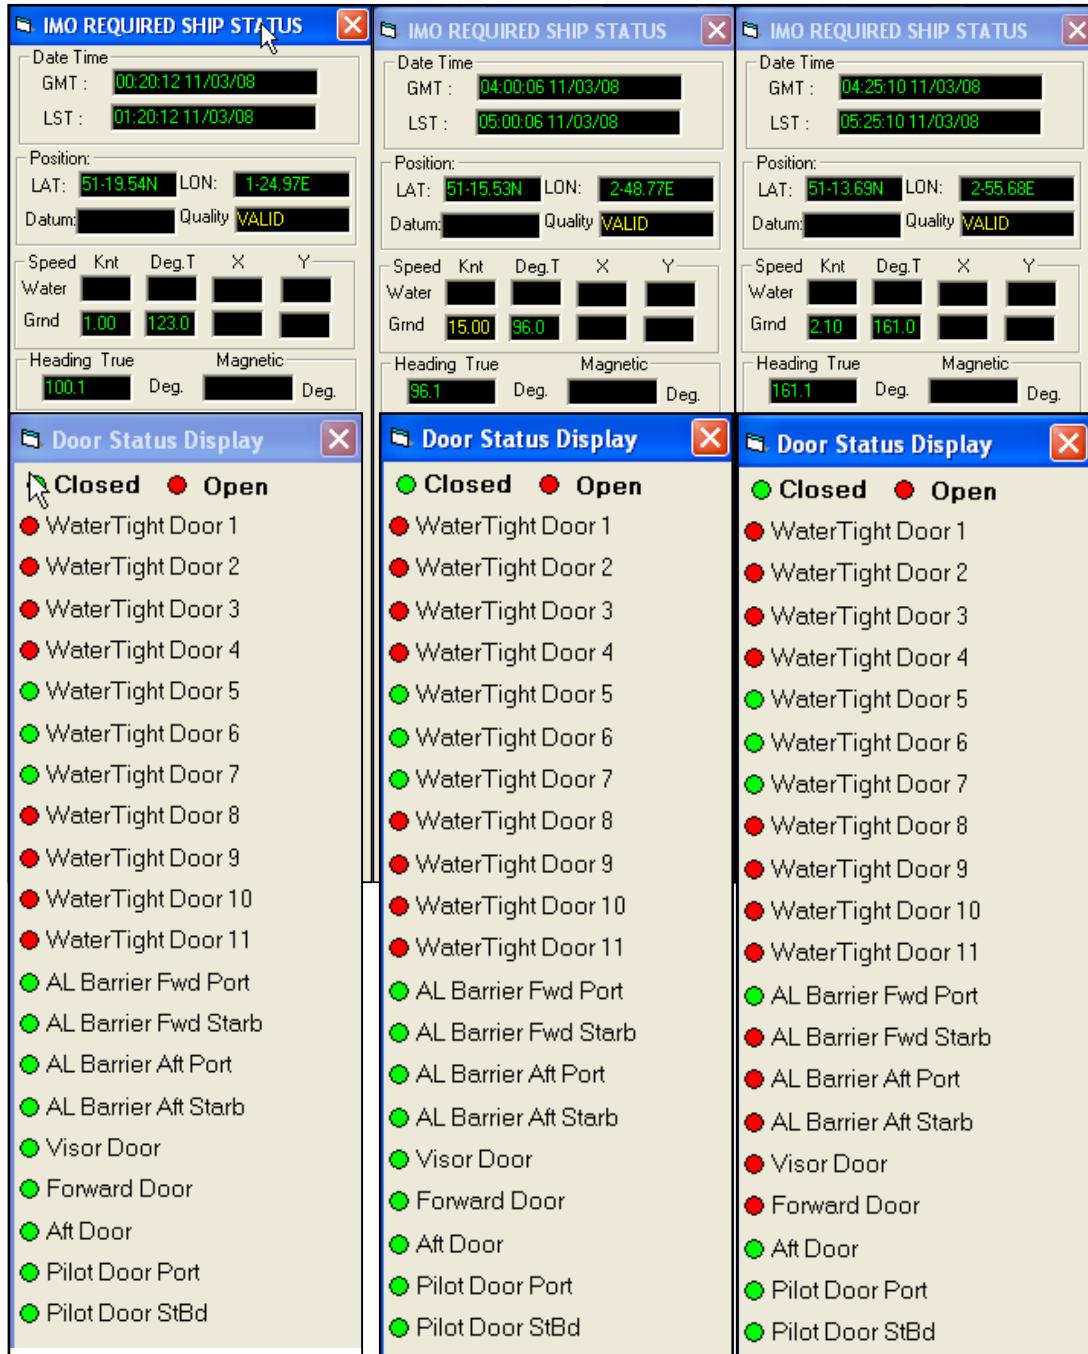
Figure 9

Extract of VDR data showing the status of the watertight doors on the vessel's previous passage

However, all of *Eurovoyager*'s watertight doors were required to be kept closed at sea, and the number left open during her voyage prior to the accident is of concern. Moreover, the similar status of the doors found in the VDR data recovered during the annual performance checks from as early as 2003, indicates that this was a long-standing practice. Not only did the crew fail to close doors after passing through, the indication on the door operating console on the bridge showing that the doors were open was ignored. For a vessel operating in the Dover Strait, which is one of the world's busiest waterways, such practices were potentially very unsafe.

- 2009/151 Adopt measures, including the review of VDR data, to ensure that its procedures for the operation of watertight doors are strictly observed.

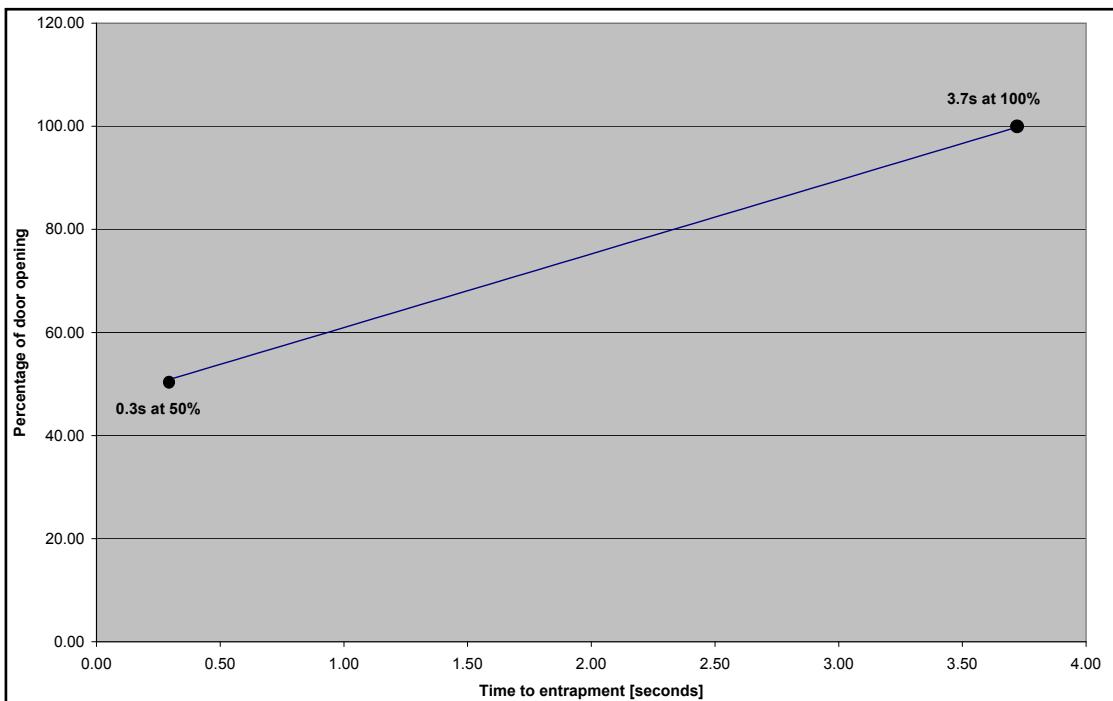
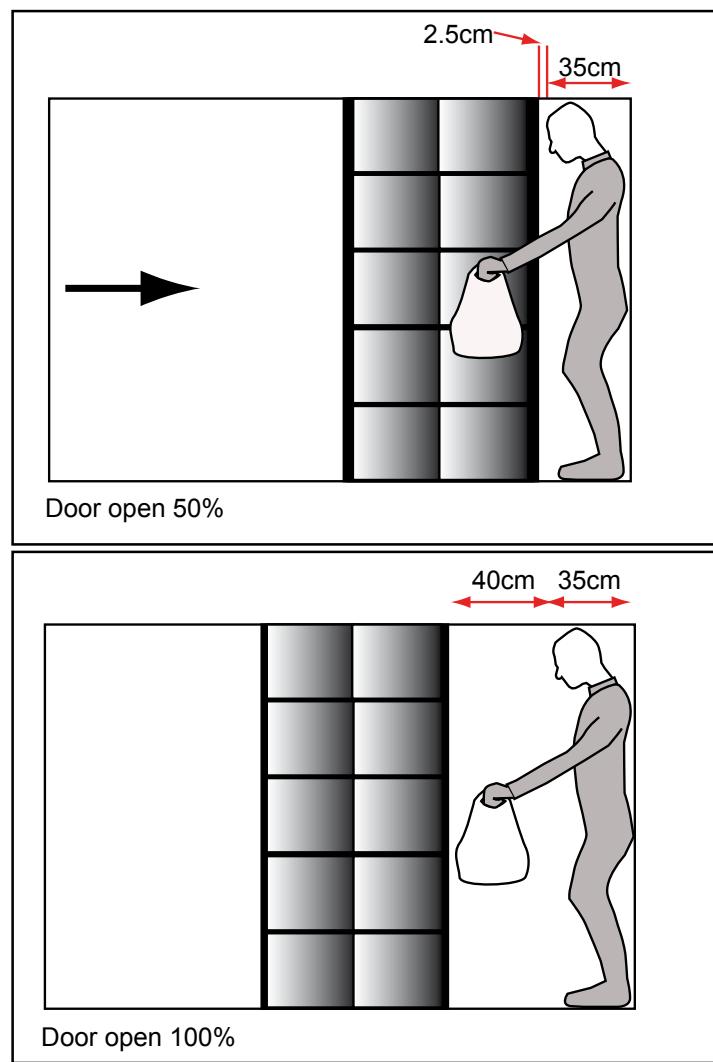
Door transit times and scenarios

The position in which the fitter was found suggests that he only opened the watertight door by an amount which enabled him to pass through side-on, leading with his left shoulder. The door closure rate was almost three times faster than the rate required by ships built after 1992. Therefore, assuming a body depth of 35cm, he would have had 3.7 s to get through the door if fully opened, but only 0.3 seconds (**Figure 10**) if it was opened halfway. As the fitter was 6cm taller than the door opening, he is likely to have bent his knees when passing through, thus further reducing the time available.

Graph illustrating the relationship between transit time and door opening

Diagram of door transit scenario

- Adjusted the closing timing of all doors in keeping with the current SOLAS requirements to be between 20 and 40s.
- Applied for approval from Bureau Veritas for the use of the Damage Control Information Booklet.
- Replaced the onboard training manual with an up to date document in which the procedures for the operation of watertight doors reflected those contained in the Damage Control Information Booklet and the vessel's SMS.
- Confirmed that all watertight doors close within 62s when switched to remote mode of operation.
