Report on the investigation into
the flooding and foundering of the grab hopper dredger

Abigail H

in the Port of Heysham

Report 15/2009
July 2009

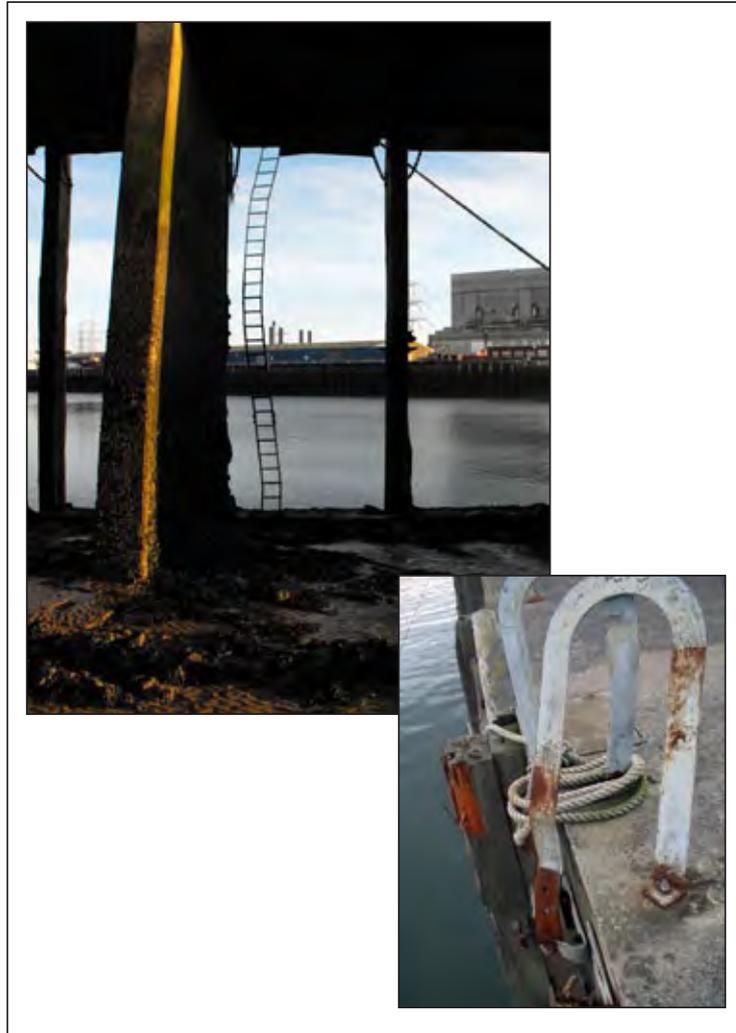
Figure 3

The Fish Quay was not in regular use and it was not maintained to the same standard as other quays in the port (**Figure 3**). The skipper decided to finish dredging earlier than usual to allow plenty of time for manoeuvring and so that mooring lines could be rigged and secured while there was still some daylight. At 1630 the skipper contacted the duty port manager (DPM) on VHF radio and requested permission to move across the harbour to the Fish Quay. The skipper was advised that a ferry was approaching and he waited to allow it to pass. Once clear, *Abigail H*'s inflatable boat was used to rig mooring lines and the vessel was secured alongside the Fish Quay. Long mooring lines, secured to the extreme ends of the quay, were used to allow for the large tidal range in the port, avoiding the need for the crew to get up in the night to adjust them. Although the crew had no intention of going ashore, they were conscious that the ladders attached to the quay were in poor condition and decided to leave their inflatable boat secured on the outboard side of *Abigail H*, ready for immediate use if necessary.

Access ladders at the Fish Quay

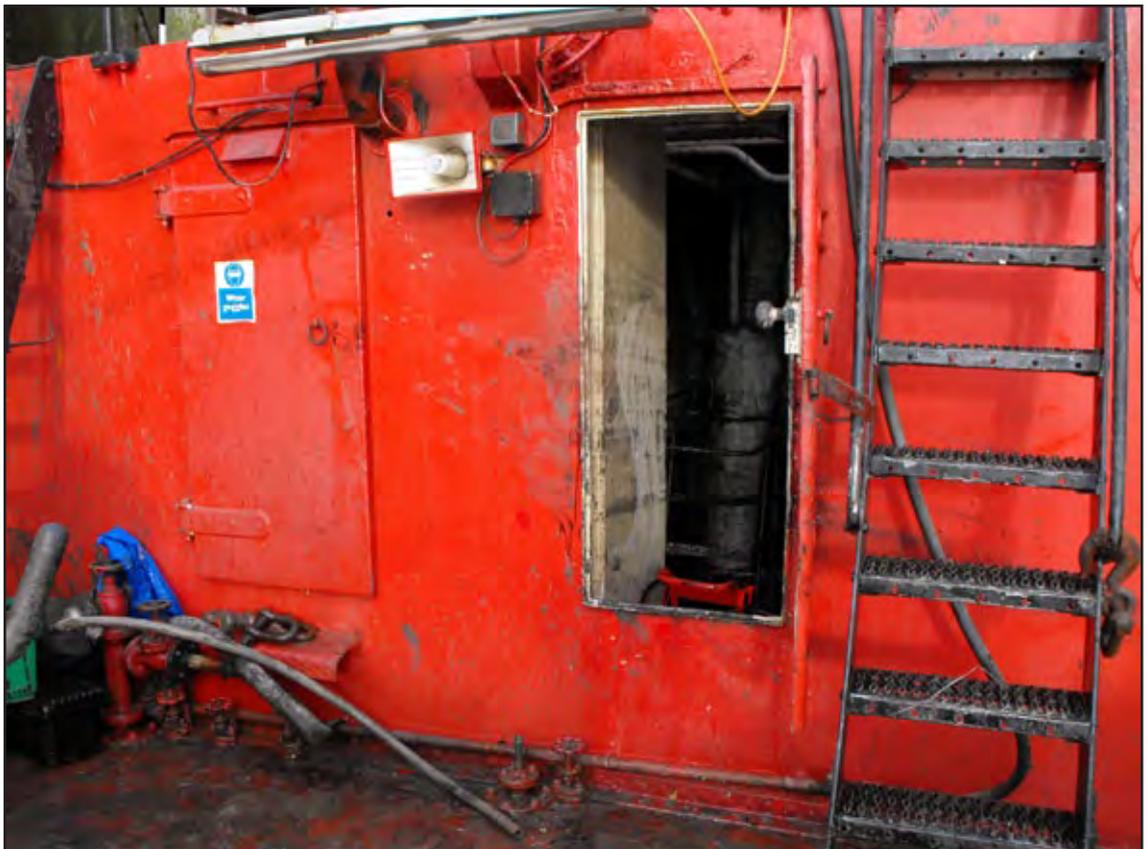
Figure 4

When the dredger operator, deckhand and engine room fitter arrived on the South Quay the owner gave them additional clothing from his kit bag and then they all got back into the inflatable boat to return to *Abigail H*. The stern of the vessel was low in the water, but the forward part was still buoyant and it appeared to be in a stable condition. The four men climbed on board to attempt to find the cause of the problem. Although the aft deck was awash, the water level had not reached above the sill of the door to the engine room. None of the doors to the superstructure were watertight, but all had substantial sills (**Figure 4**). The owner opened the door to the engine room and used the dredger operator's torch to look inside. He saw a significant amount of water in the engine room, which covered the generator on the port side and was at least half way up the main engine. The surface of the water was still and there were no obvious sources of flooding, but he concluded that because water was not yet above the aft door sill, the cause of the flood must be in the engine room.

Aft deck and entrance to the engine room

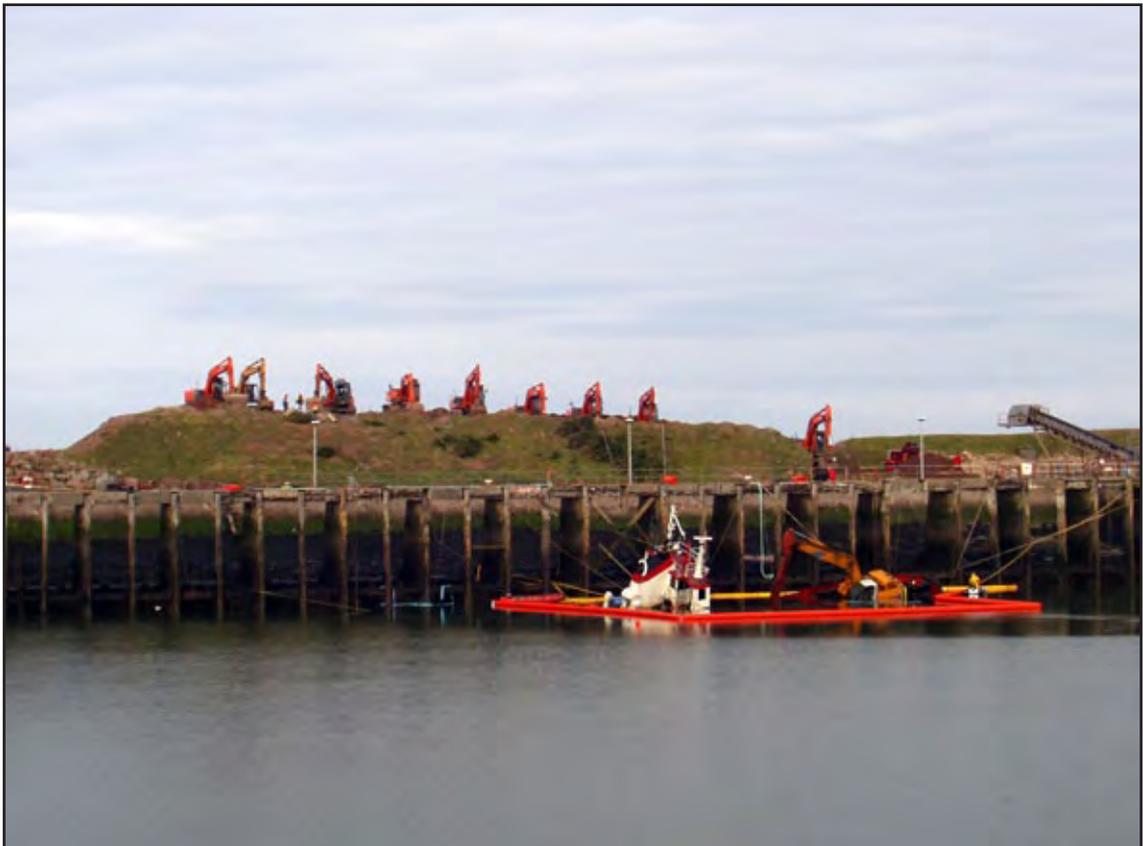
Figure 6

Buoyancy tanks on either side of *Abigail H*'s hopper, and the forward hold underneath the dredging machine, slowly flooded throughout the rest of Sunday 2 November. *Abigail H* became more unstable as the height of tide increased, and the vessel began to roll away from the Fish Quay. The owner was concerned that the vessel would capsize to starboard and the crew, assisted by the port safety manager, rigged mooring ropes around the dredging machine and superstructure. These were led ashore and attached to excavators that were brought to the site and positioned on a hill behind the Fish Quay (**Figure 6**).

Excavators used to stabilise *Abigail H*

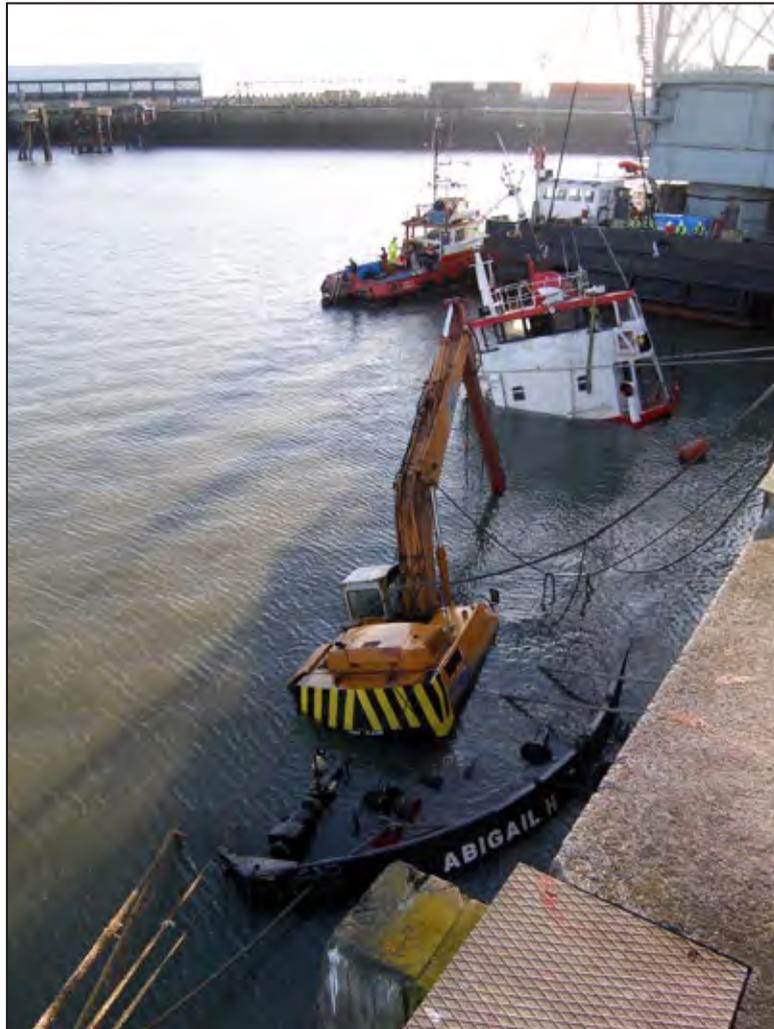
Figure 8

The salvage team was mobilised on 17 November and work on site began the following day. The condition of the vessel had deteriorated; the engine room was free-flooding and water had entered the buoyancy tanks and forward hold. Diving inspections did not find any significant damage or holes in the hull. Land winches were used in an attempt to heave *Abigail H* upright (**Figure 7**) and, on 25 November, the vessel was refloated by removing water from the flooded compartments and by lifting the stern using a floating crane (**Figure 8**).

Salvage arrangements

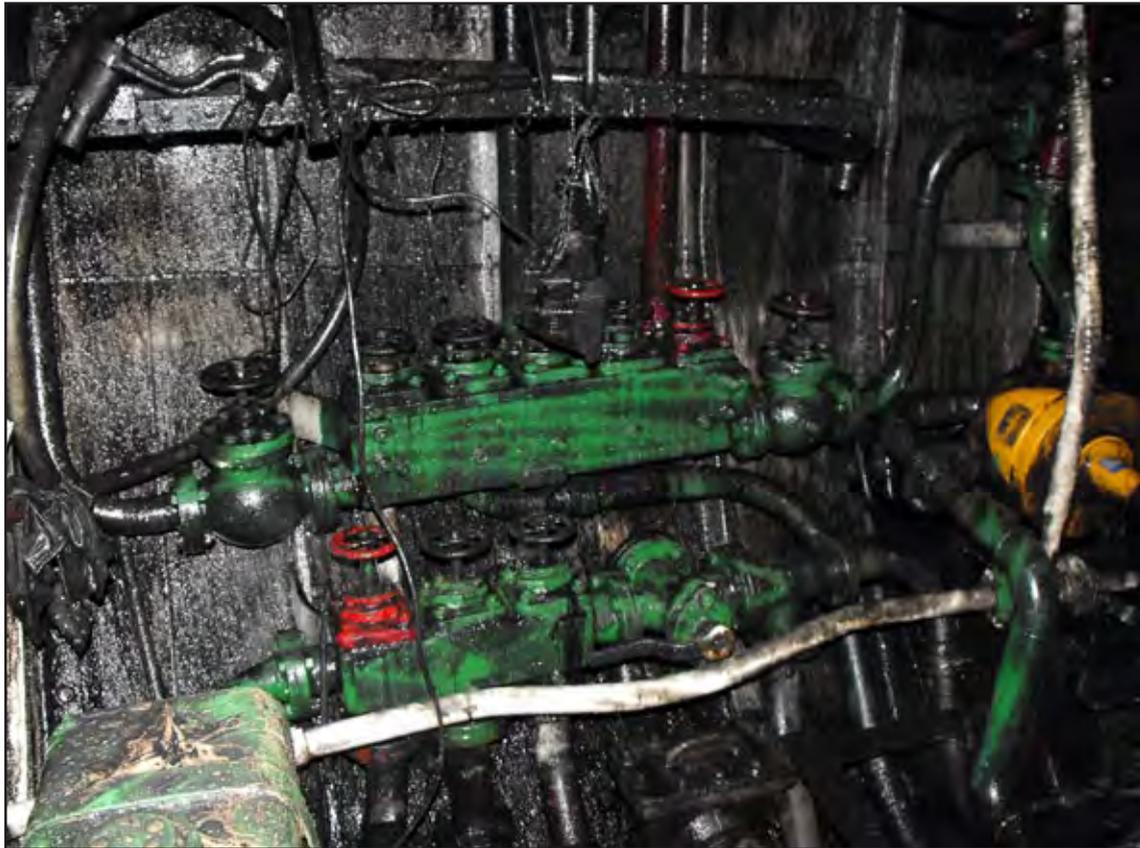
Figure 9

A detailed survey of the engine room found the sea water system valves in the positions described by the engine room fitter. The inlets to the main engine and generator cooling systems were shut, and the valves allowing the fire main to be used were open (**Figure 9**). Closing these valves made no difference to the rate of water ingress or to the level of water in the engine room.

Fire main valves on the aft suction and discharge valve chests

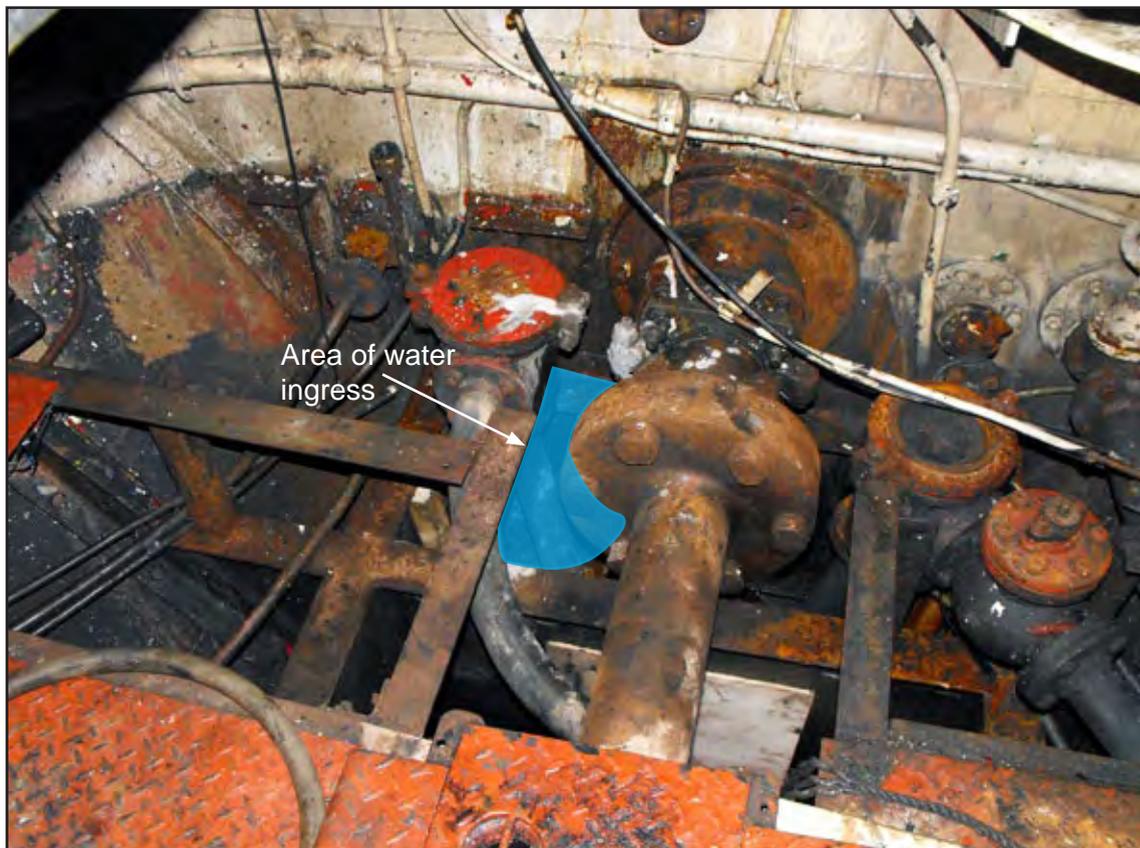
Figure 10

After a considerable time, the level of water and oily waste in the engine room was reduced enough for a disturbance on the otherwise smooth surface to be seen near the stern gland. Closer inspection found evidence of water ingress in an area close to the bilge suction line on the starboard side of the stern gland (**Figure 10**). There was no leakage from the stern gland itself.

Location of the source of the flooding

The leak was found on the starboard side, beneath the stern gland, in the area of the bilge suction line. The bilge could not be fully pumped out and the external hull could not be inspected, so the leak could potentially have been due, either to hull perforation, or water flooding back through the bilge suction pipework through connections with the fire main and main sea inlet.

Localised pitting and wasting of plating beneath bilge and tank suction is not uncommon. It is good practice to keep bilges dry and to inspect these areas regularly to warn of any problems. The crew reported that *Abigail H* grounded occasionally while dredging, and this would have led to some mechanical damage to hull plating. These factors, combined with the age of the vessel and its poor condition in 2005/6 add support to the most likely cause of the flood being due to localised failure of the hull plating.

1. The cause of the vessel flooding was water leaking into the engine room. It is considered most likely that this was due to perforation of the hull plating beneath the bilge suction pipework on the starboard side of the stern gland. [2.2.1]
2. In the absence of the general manager, the Port of Heysham's safety management and emergency response procedures had limited effectiveness. [2.5.1]
3. The limited communication between the port and the emergency services in the early stages of this accident led to confusion and, if circumstances had deteriorated, could have reduced the effectiveness of the response. [2.5.2]

- 2009/143 Improve existing procedures to keep the level of oily waste in the bilges of their vessels to a minimum and introduce routine inspections of pipework and internal surfaces of hull plating to identify vulnerable areas and give the maximum warning of potential failures.

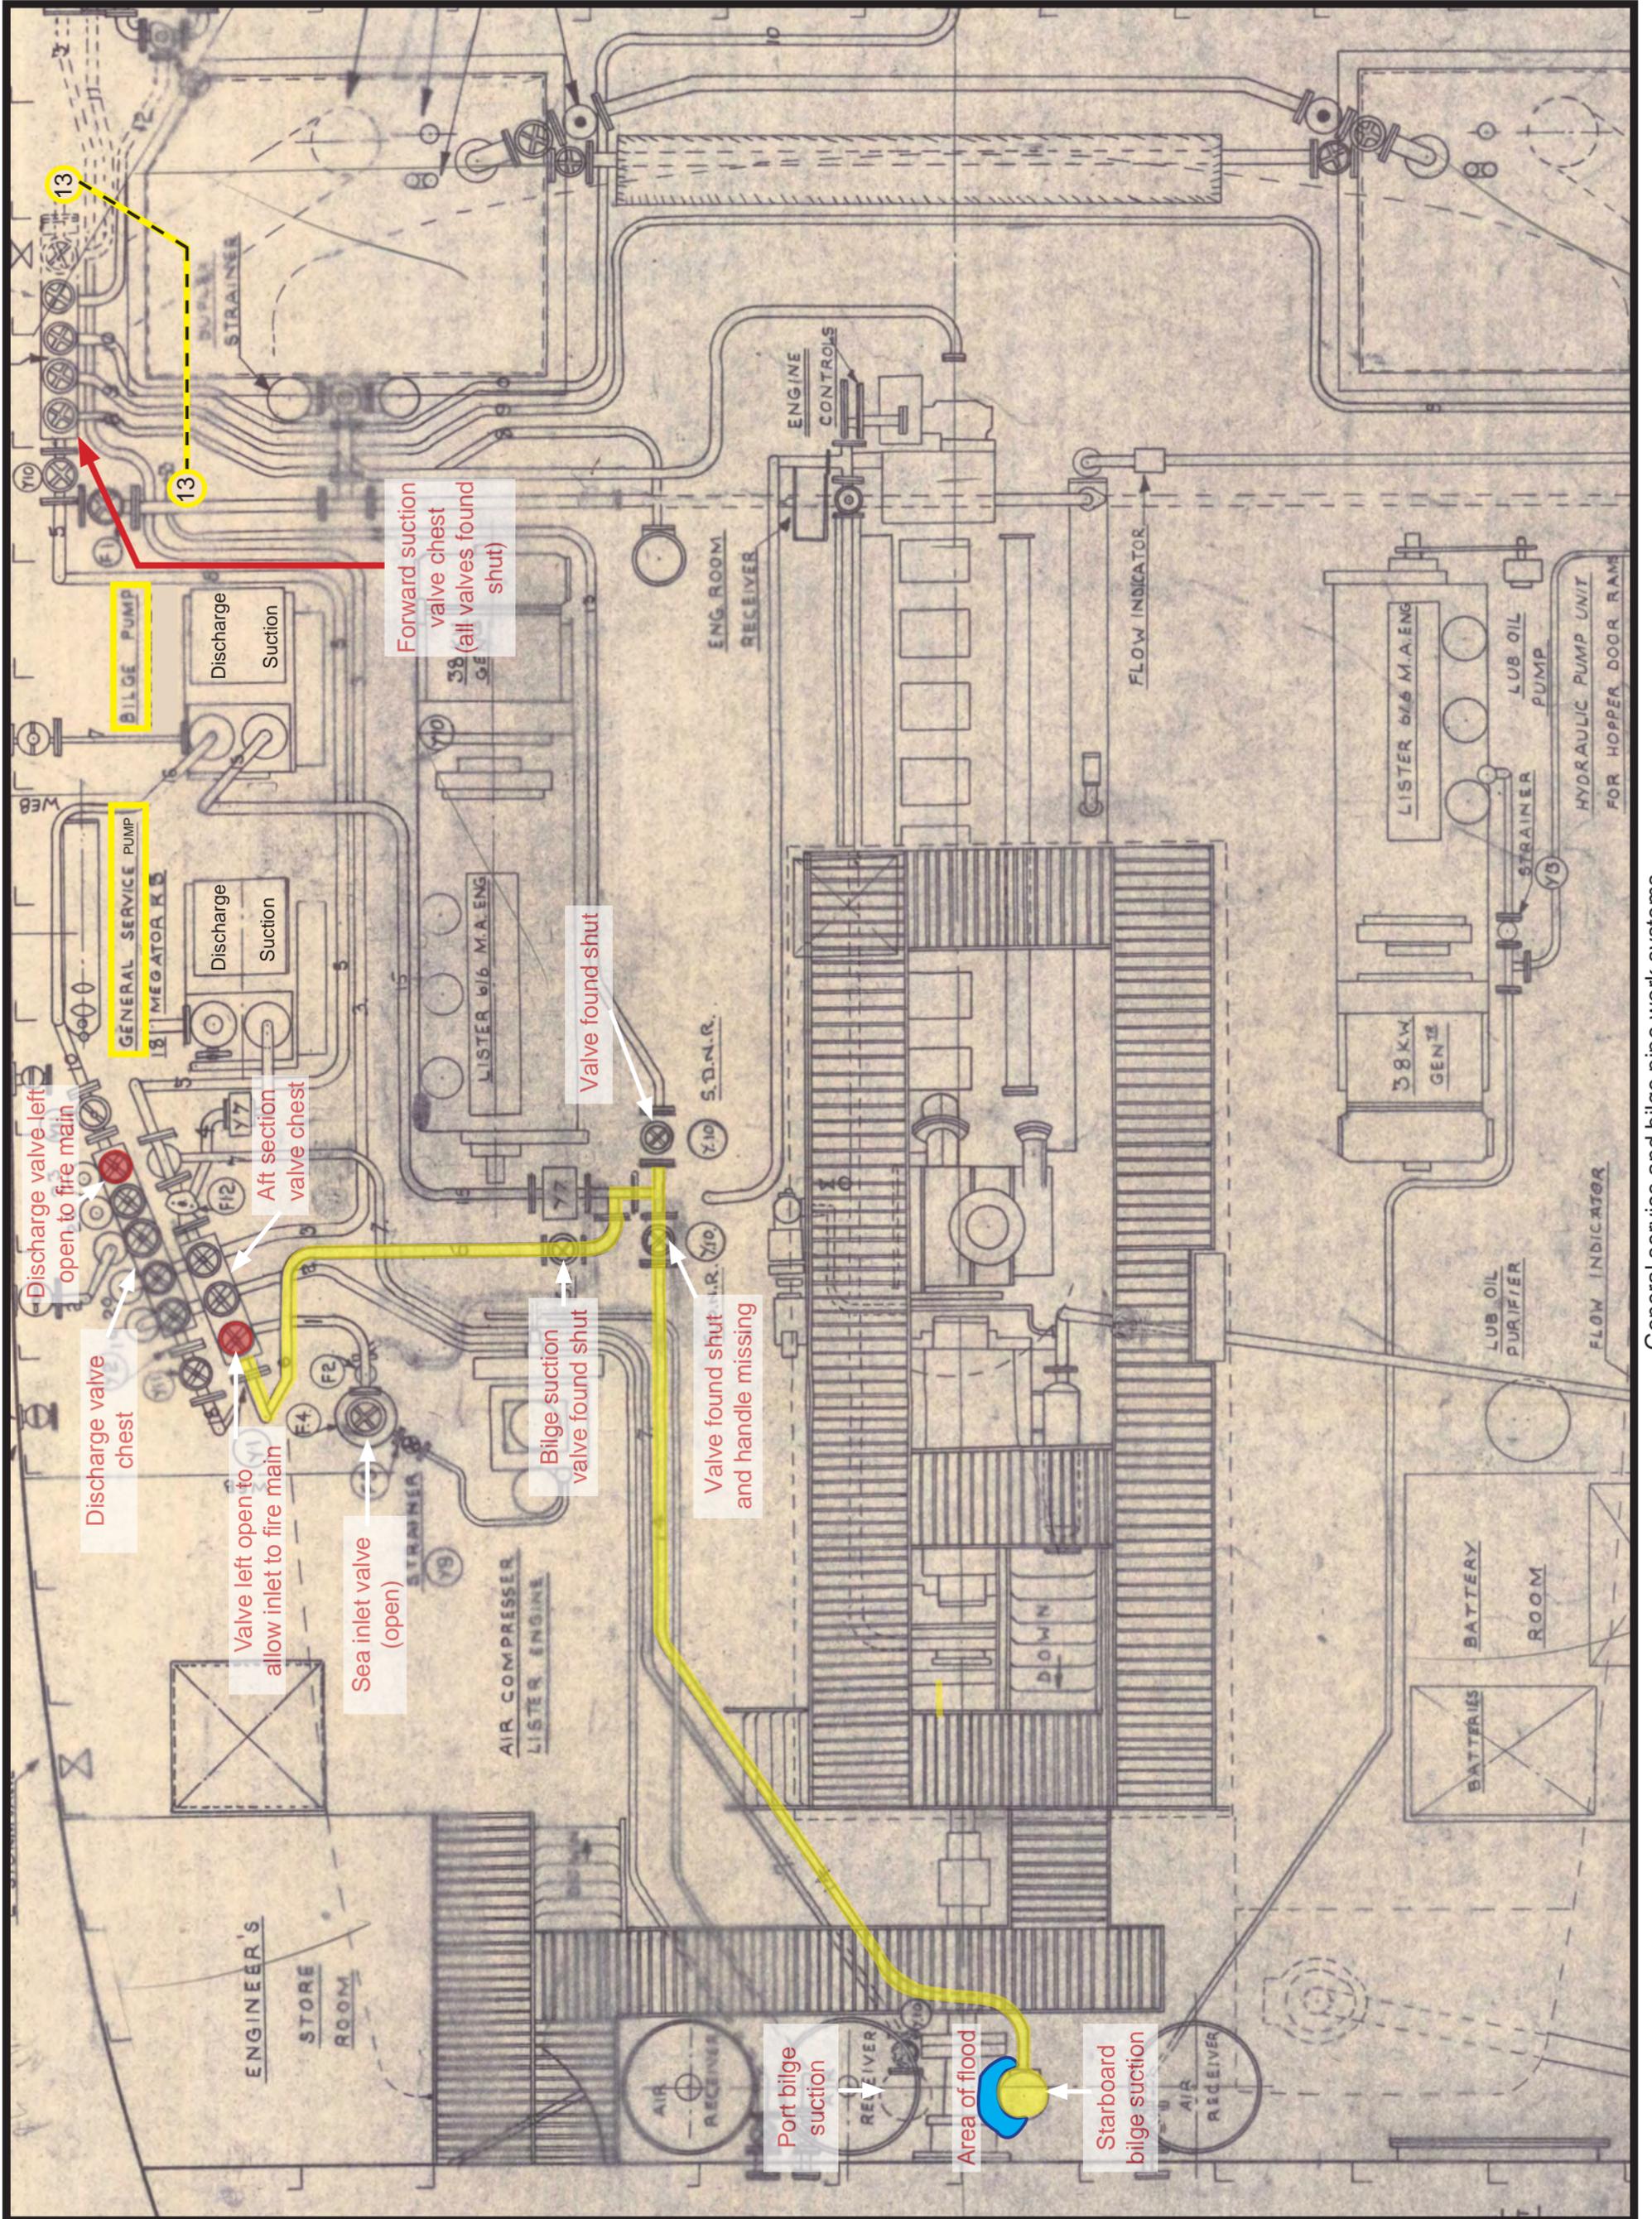
It could not be determined if the water was coming from a penetration in the hull, or by leaking back through the bilge suction pipework via connections linking it to the fire main sea water inlet (**Figure 11**). However, the valve

General service and bilge pipe work systems

connecting the fire main inlet with the bilge suction system was found to be shut, as was a second, screw down non-return valve that isolated the bilge suction line to the starboard side of the stern gland from the rest of the bilge system. This valve was the only one in the system without a handle, and did not appear to have been operated for some time

It was understandable for the crew to leave the sea inlet to the firemain open so that the general service pump could be started easily. However, if the valve connecting the fire main sea water inlet to the bilge suction system was open or leaked, then sea water would have been able to flood into the bilge system. If the valve to the bilge suction on the starboard side of the stern gland was also open or leaked, then these two together could have allowed sea water to back flood into the bilge. However, following good engineering practice, both these valves were found to be shut, and the stern gland suction line valve was of the non-return type to prevent back flooding, even if left open. Shutting the sea inlet during the MAIB's survey of the engine room had made no discernible difference to the rate of flooding, and it is considered most likely that water entered through a perforation in the hull plating in the area near the stern gland bilge suction.
