Report on the investigation of the fire on board the fishing vessel

***Vision II***

Alongside at Fraserburgh

**Report No 8/2009**  
**March 2009**

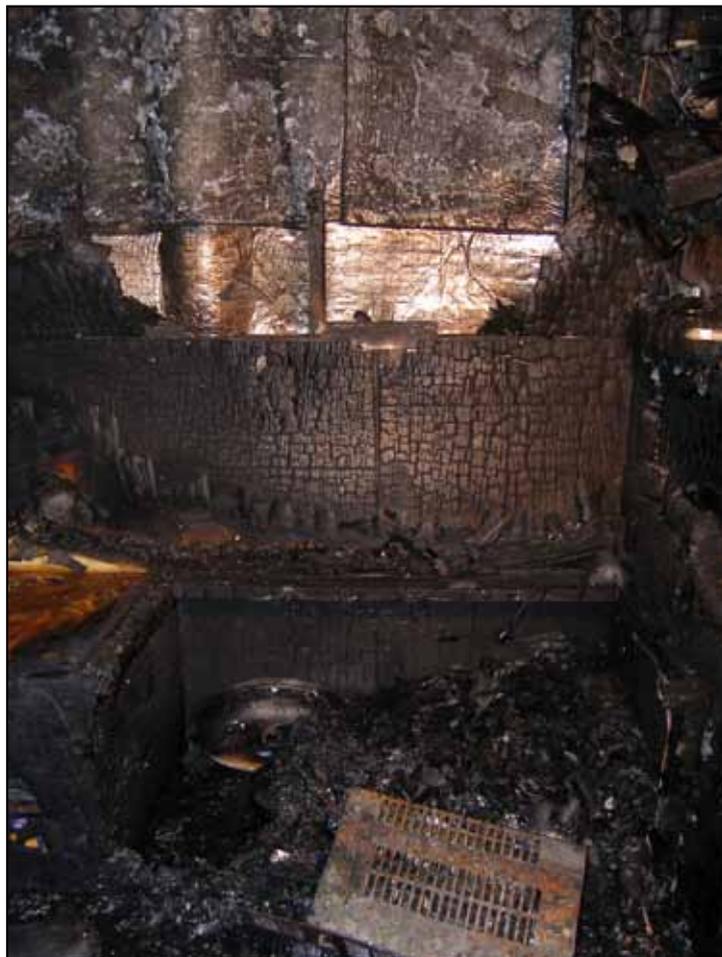
Figure 3

A 'V' shaped burn pattern was observed directly above the seating area where the electric fan heater was fitted. The pattern indicated that the fire originated in this area, started at a low level and spread upwards. Although the heater was severely damaged by the fire, the contents of the locker around it remained semi intact (**Figure 3**). This was the only area of galley seating destroyed in the fire.

Seat of the fire in the vicinity of the electric heater

The pronounced 'V' shaped charring mark in the wooden bulkhead behind the galley heater, the burned out locker under the 'V', and the melted pan on the galley range, were key indicators that the source of the fire was located in or close to the electric fan heater fitted in the locker under the galley bench seat.

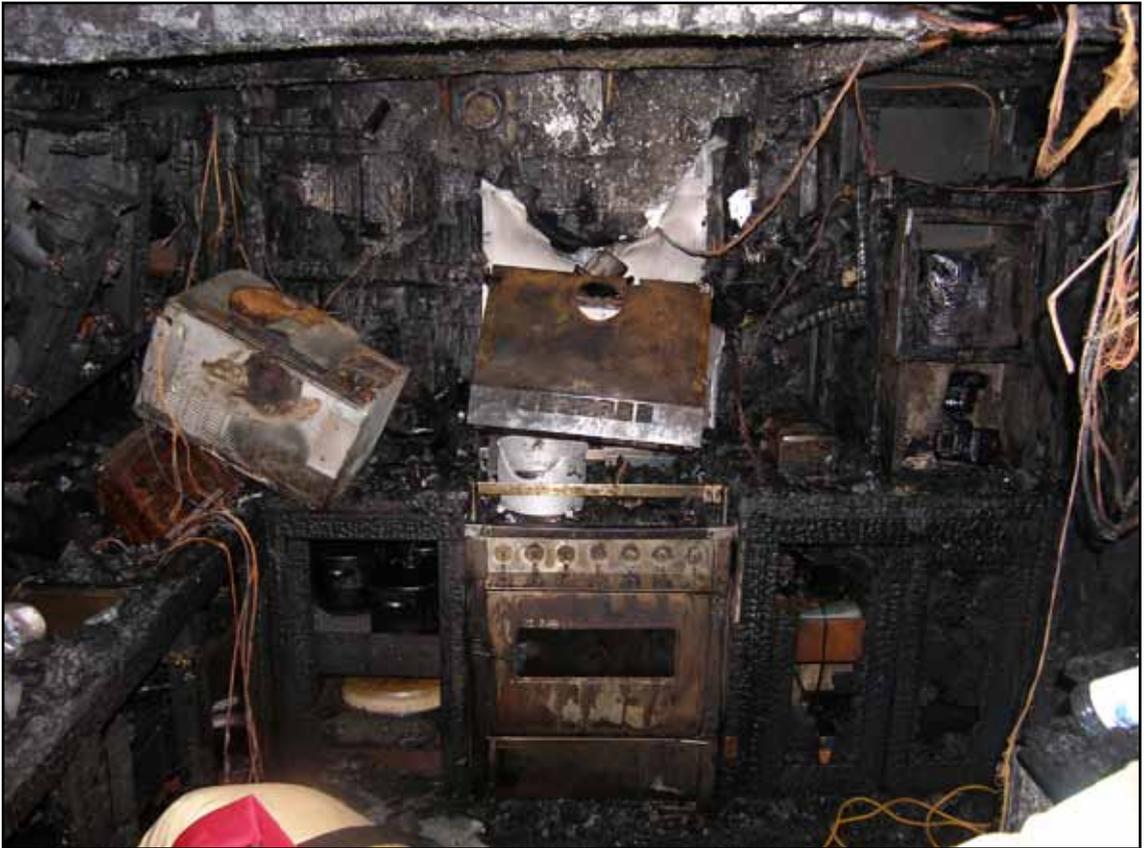
Figure 4

Galley range showing partially melted pan

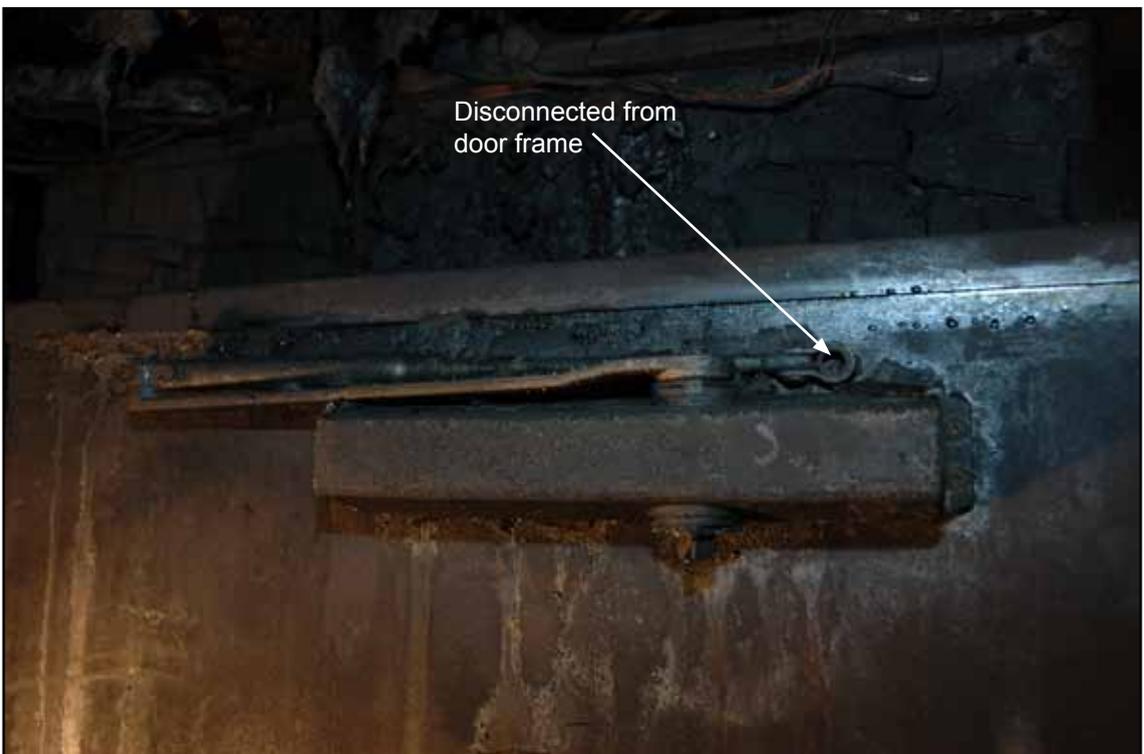
Figure 5

The galley had an A60 rated fire door which was fitted with a self-closing mechanism that had been disconnected (**Figures 5 and 6**). The door was secured in the open position by a permanent hook and eye holdback (**Figure 7**). The burn pattern on the door indicated that the galley door was in the open position during the fire. The open door allowed the fire to spread into the adjacent main passageway.

Galley fire door self-closing mechanism

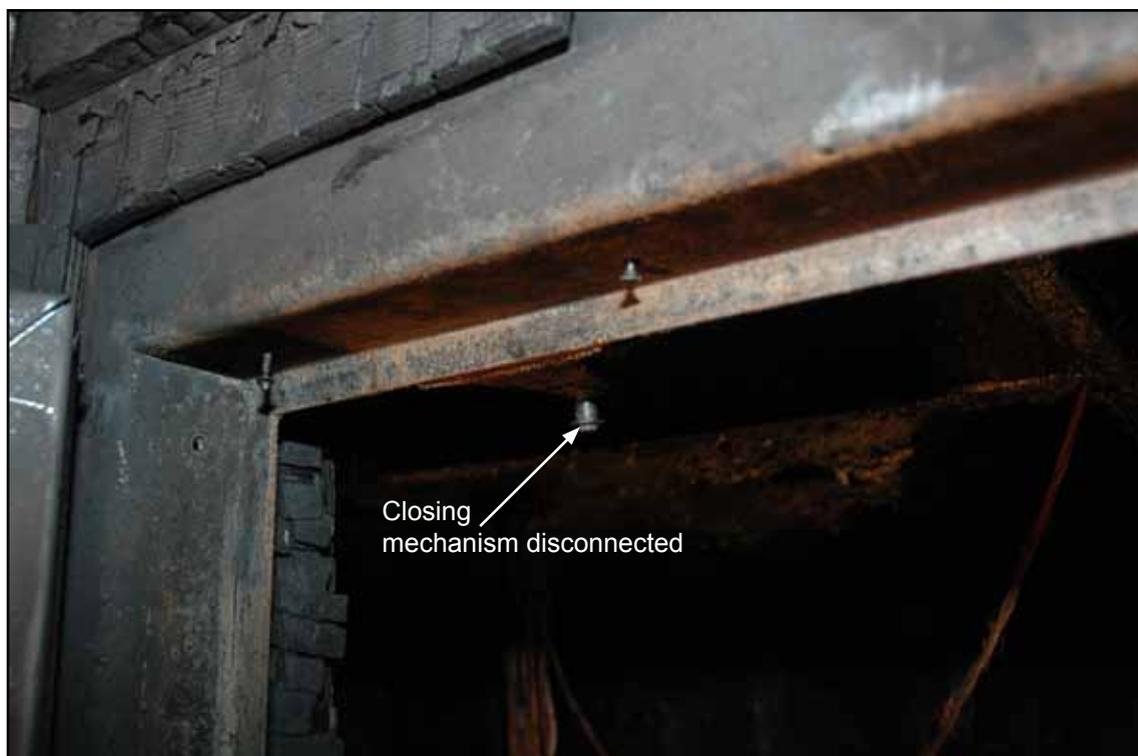
Figure 6

Galley fire door frame

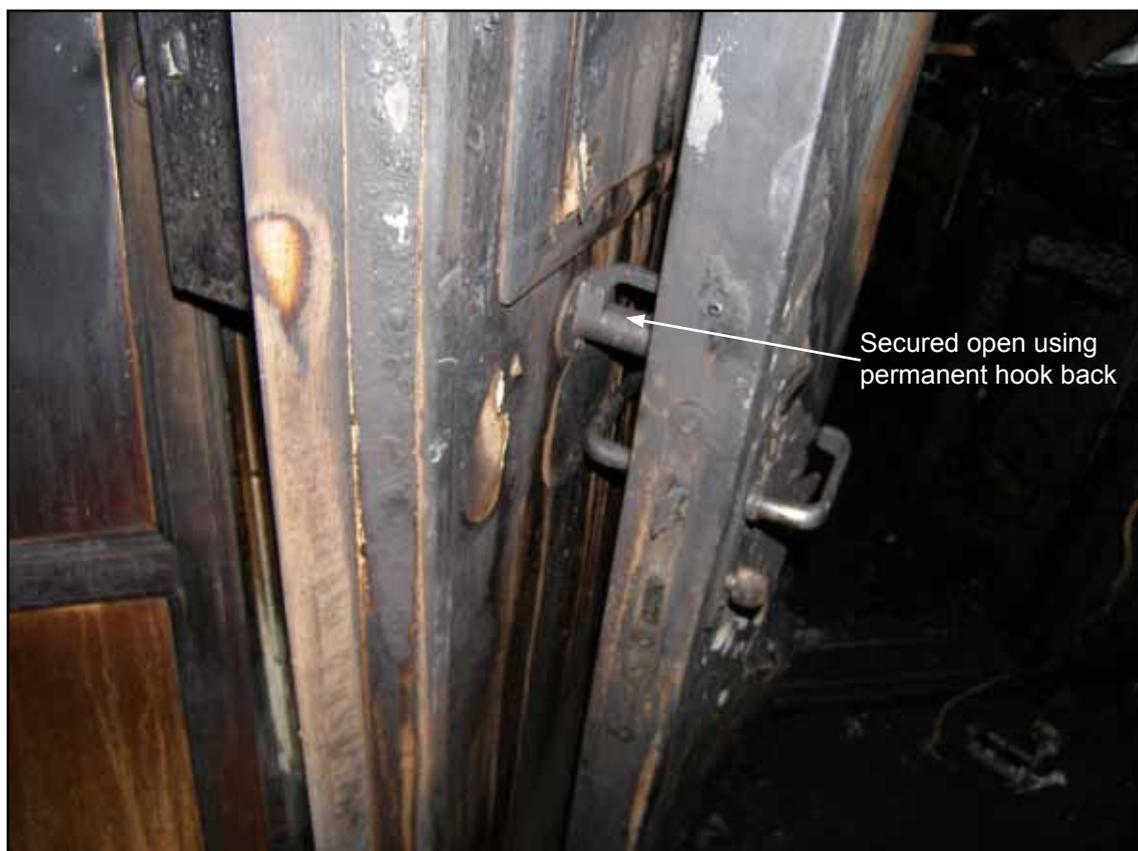
Figure 7

Galley fire door - open position

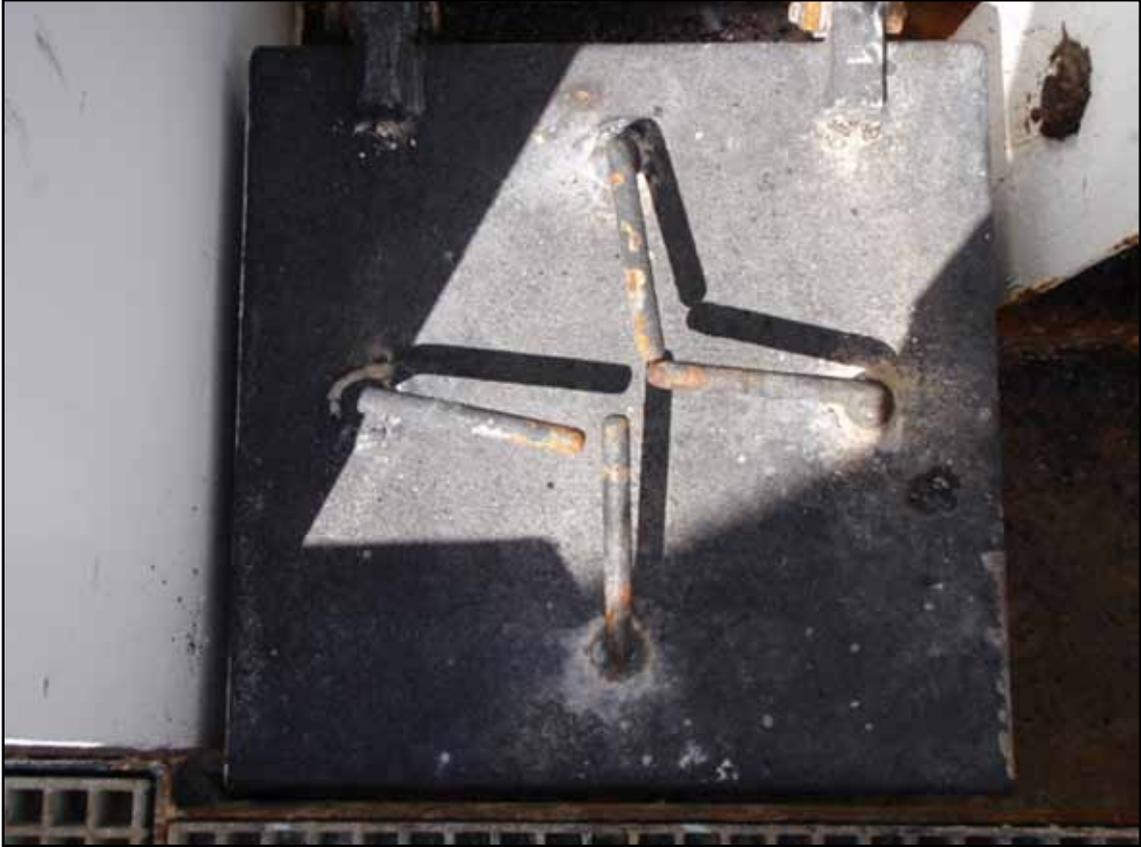
Figure 8

The cabin space, which was protected by an A60 fire door with an operational self-closing mechanism, suffered only minor smoke damage. The side of the door, external to the cabin space, showed significant fire and smoke damage to the upper part. The escape hatch inside the cabin showed that no attempt had been made to use it. Closer inspection of the escape hatch revealed the securing dogs were seized, and several blows from a sledge hammer were required to free them in order to open the hatch (**Figure 8**).

Emergency escape hatch from the main cabin

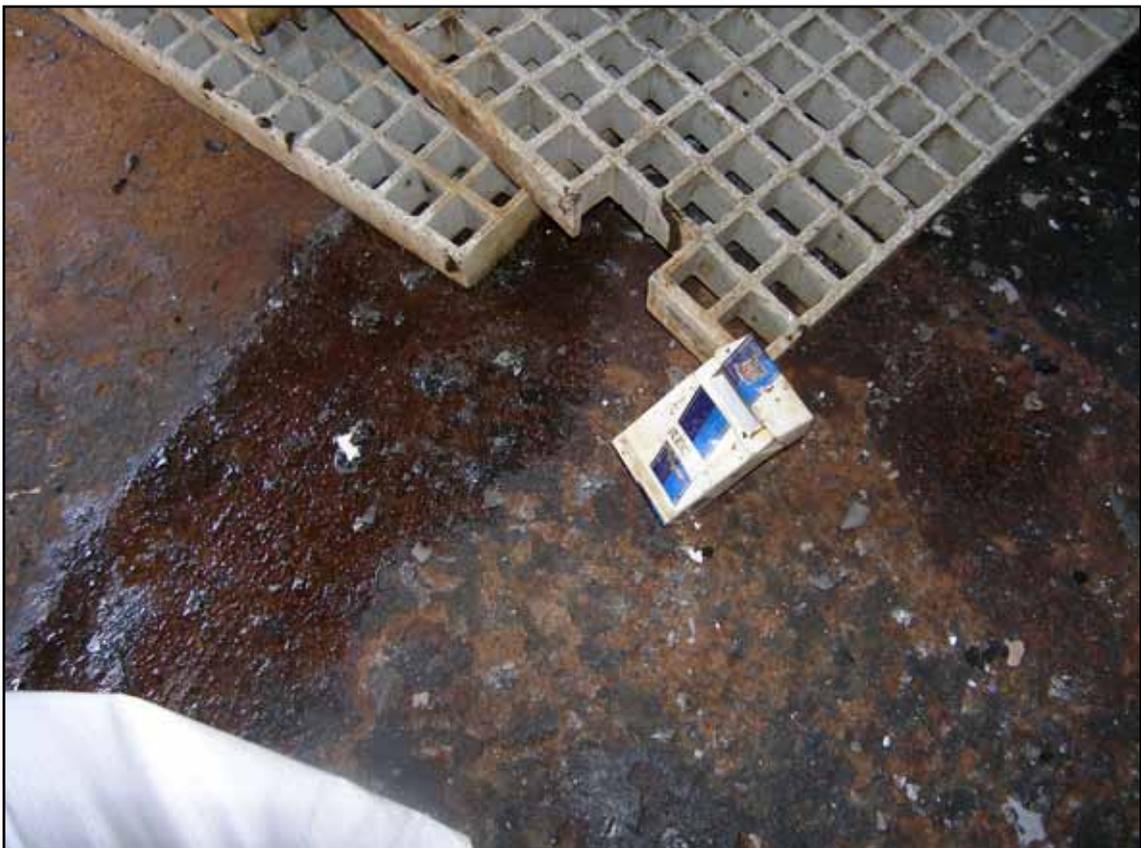
Figure 9

The external watertight storm door from the main passageway on to the net drum deck was partially open and was reported by the firefighters on scene to be '*issuing flames*'. Smoke damage to the upper section of the door supports this theory. An empty cigarette packet was found close to the door on the drum deck (**Figure 9**).

Empty cigarette packet on drum deck

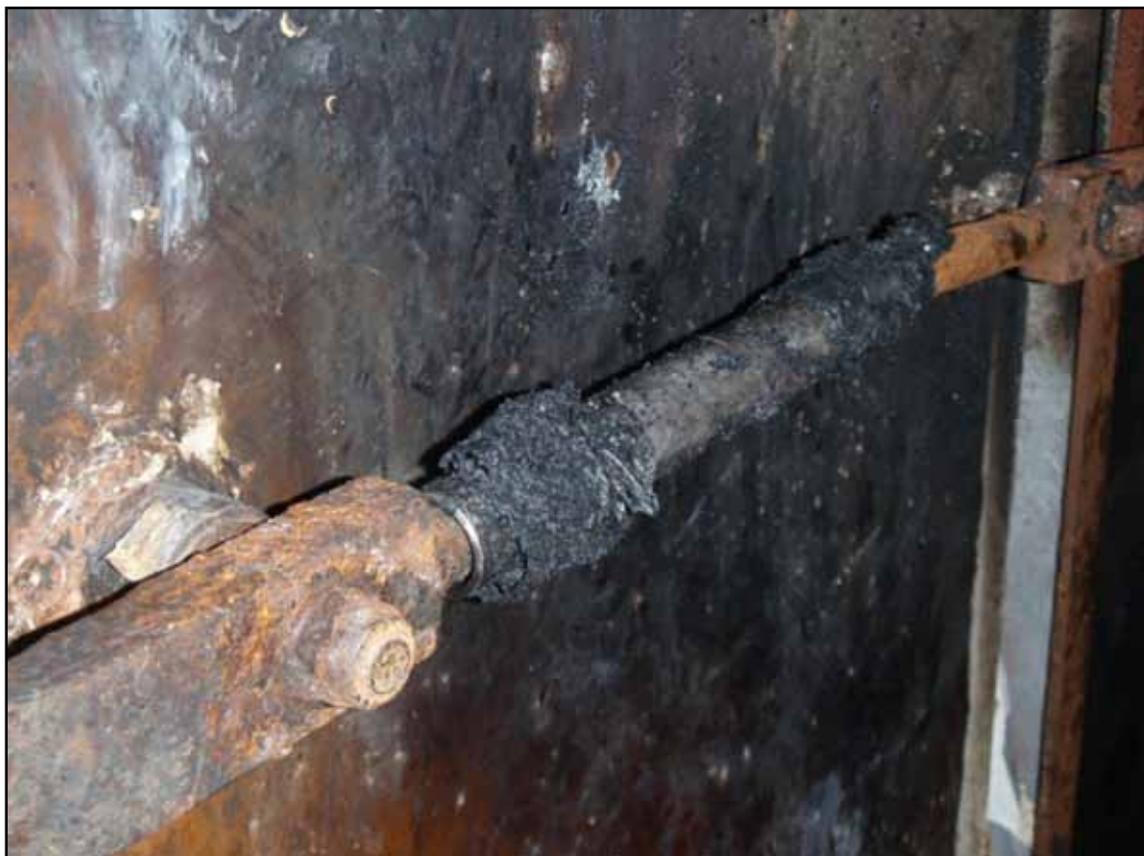
In respect of ship security for those living on board, Rimants Venckus was described as '*paranoid*', and he apparently felt the need - like many other crews living on board fishing vessels - for robust overnight security. The security measures he adopted included locking the wheelhouse door, for which each crew member had a key, and securing two dogs internally on the net deck watertight door with a section of scaffolding tube (**Figure 13**).

Example of the scaffolding tube used to secure two internal dogs

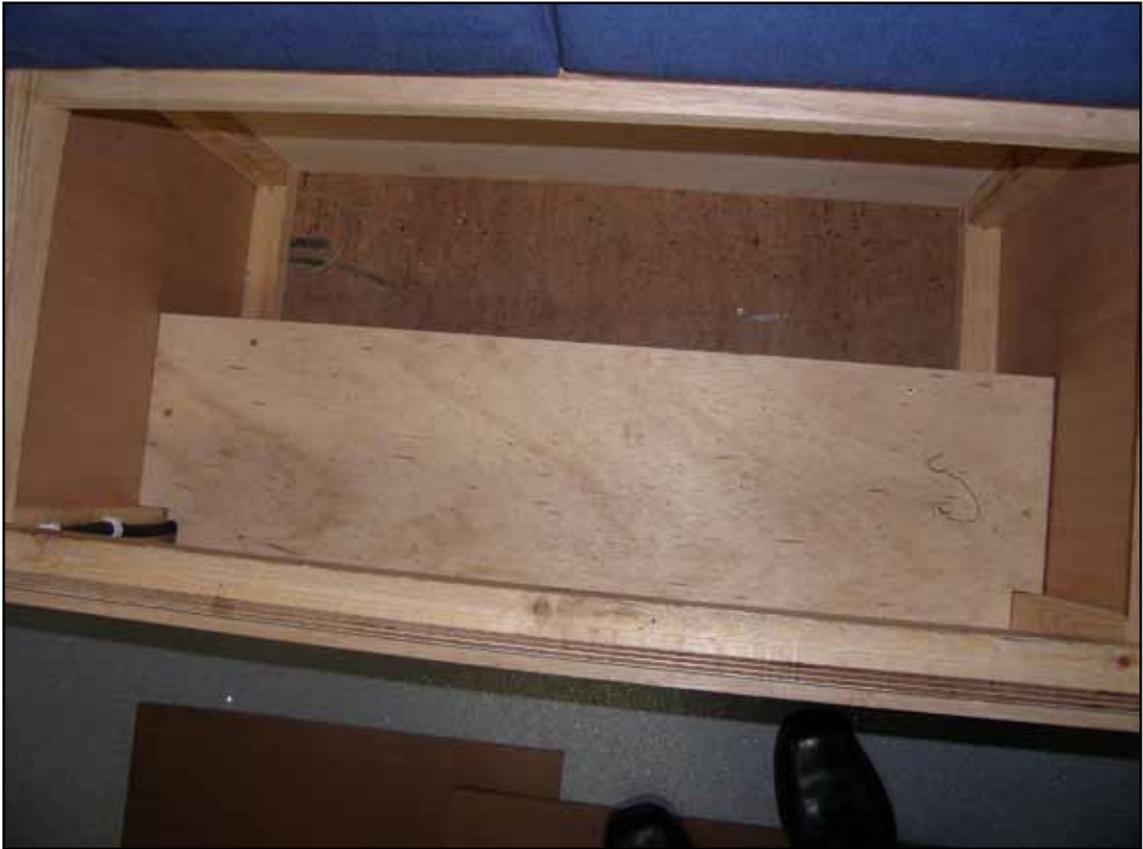
Figure 16a

Example of cabin heaters fitted inside seat lockers and boxed in

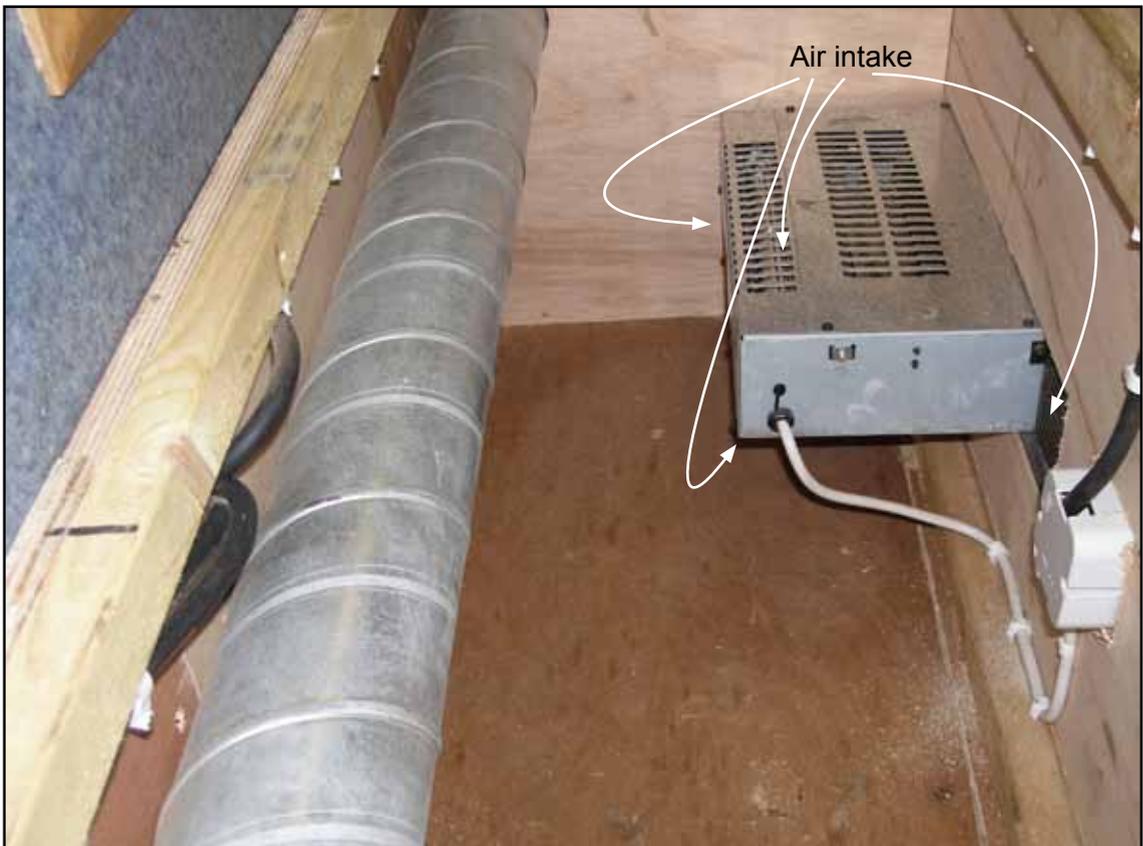
Figure 16b

Example of how the galley heater was fitted inside seat lockers

On *Vision II*, all of the heaters, except the galley heater, were 'boxed in' with plywood. The boxes were designed to prevent combustible material coming into contact with the heaters and ensure the airflow was unrestricted. *Vision II*'s galley heater had no such plywood box, and it was possible to cover the heater casing and restrict the air intake. That the galley heater on *Vision II* was surrounded with combustible material, which possibly also restricted the air intake, was probably a contributory factor to this accident.

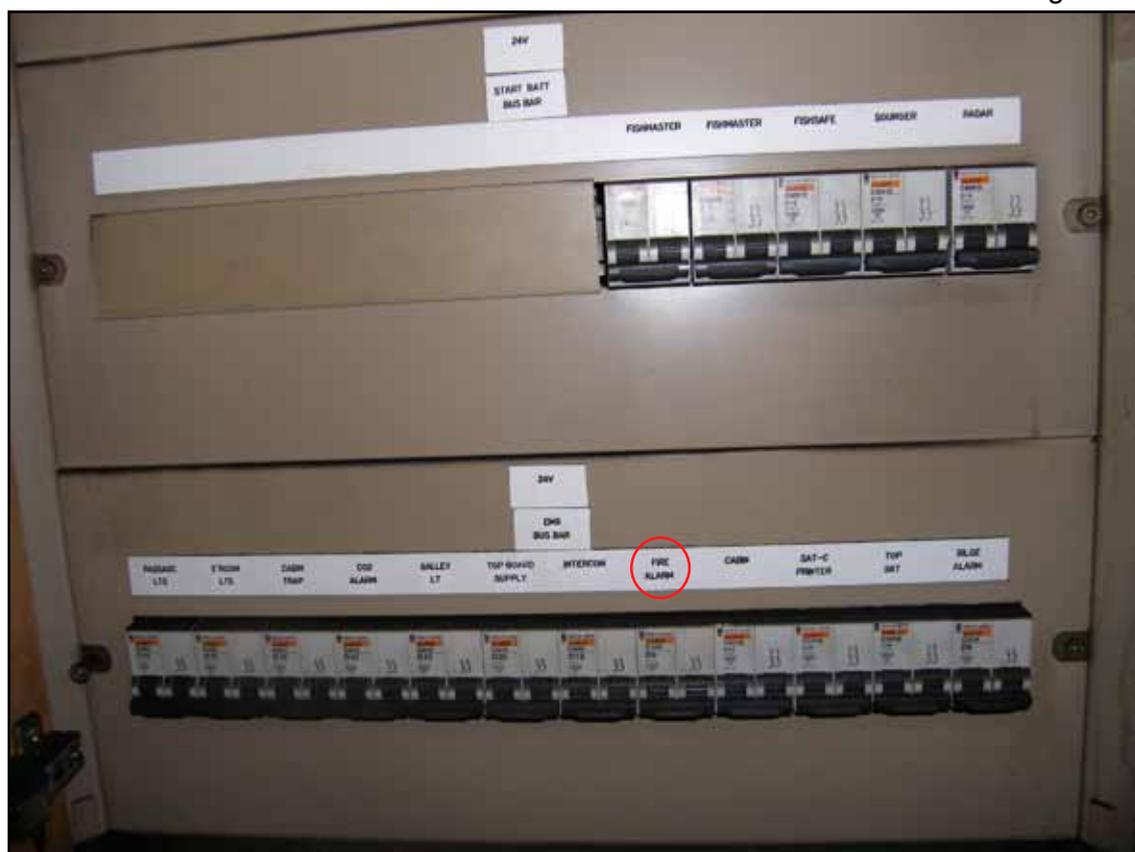
Figure 17

Heat and smoke sensors were fitted to the deck head almost directly above the source of the fire. The sensors were connected to a wheelhouse alarm panel, which was fed from the vessel's 24v battery supply. The alarm detection panel, along with other equipment wired into the 24v emergency switchboard, had been electrically isolated by turning the individual breakers off (**Figure 17**).

All equipment on the emergency bus bar turned off

With the detection system isolated, none of the crew on board could have been alerted to the outbreak of fire.

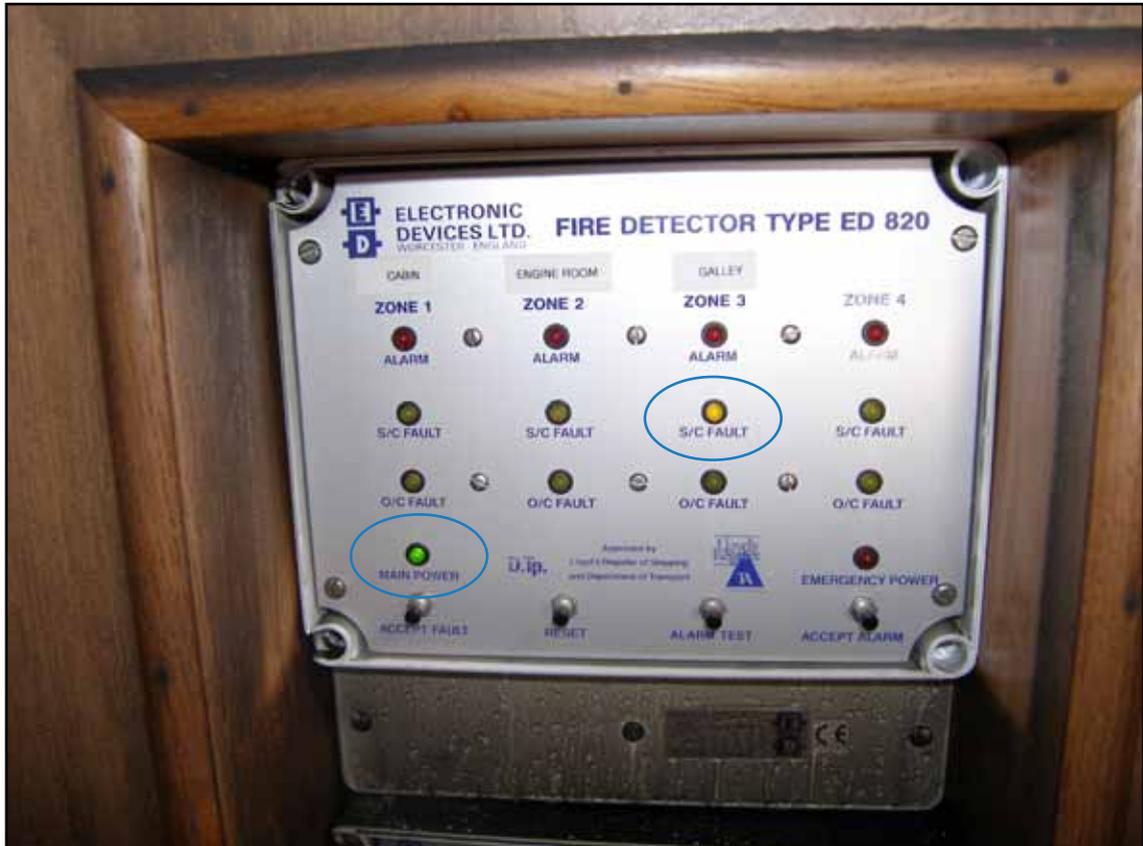
Notwithstanding that the galley sensors were reported not to have activated for some time, the intensity of the fire made it impossible to determine whether or not the sensors had been operational. However, the fire investigation was able to prove that by turning on the appropriate switchboard breaker, the system activated correctly and showed a short circuit, as expected, in the galley (**Figure 18**).

Fire detection panel activated by switching on fire alarm breaker

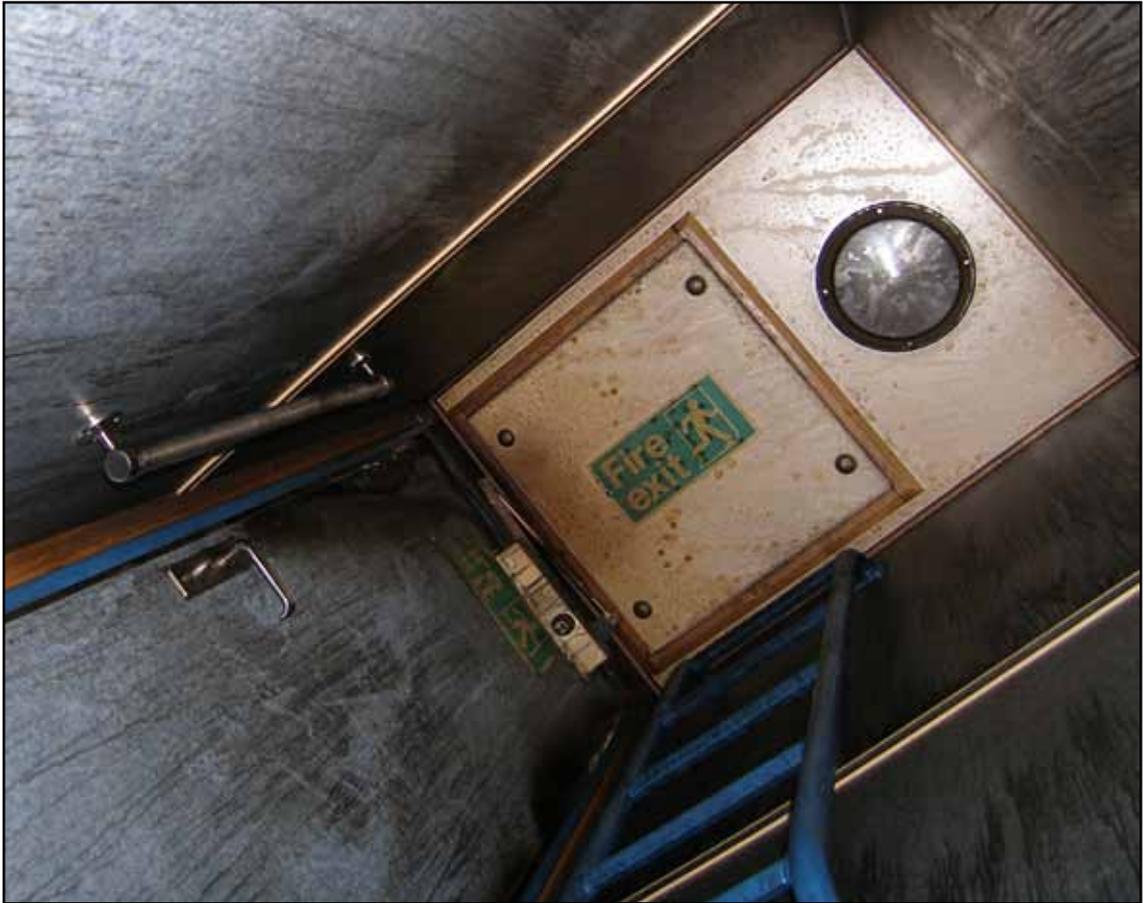
Figure 19

That the deck head panel had not been disturbed indicates that Rimants Venckus did not attempt to escape by this route (**Figure 19**). However, had he chosen to use the dedicated escape route, it would not have been successful as the escape hatch securing dogs were seized in the closed position (**Figure 20**).

Internal deck head panel covering the escape hatch

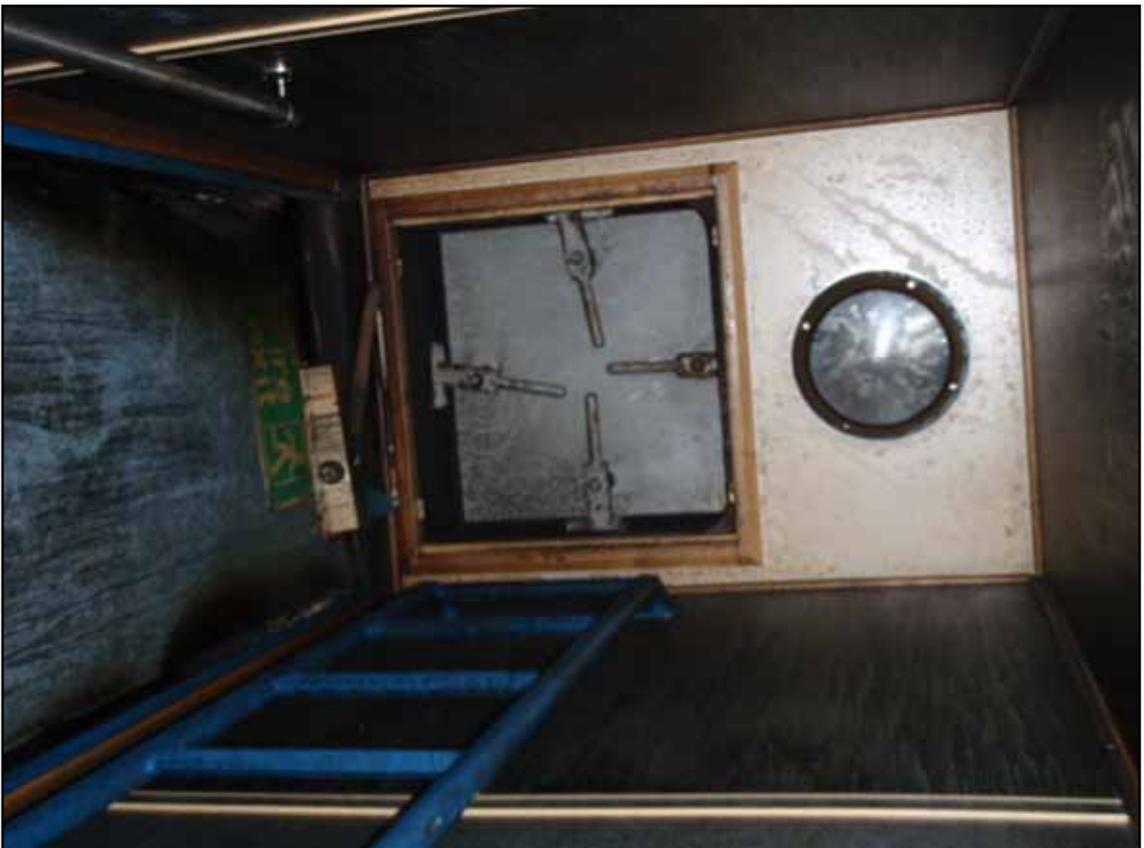
Figure 20

Deck head panelling removed exposing the escape hatch

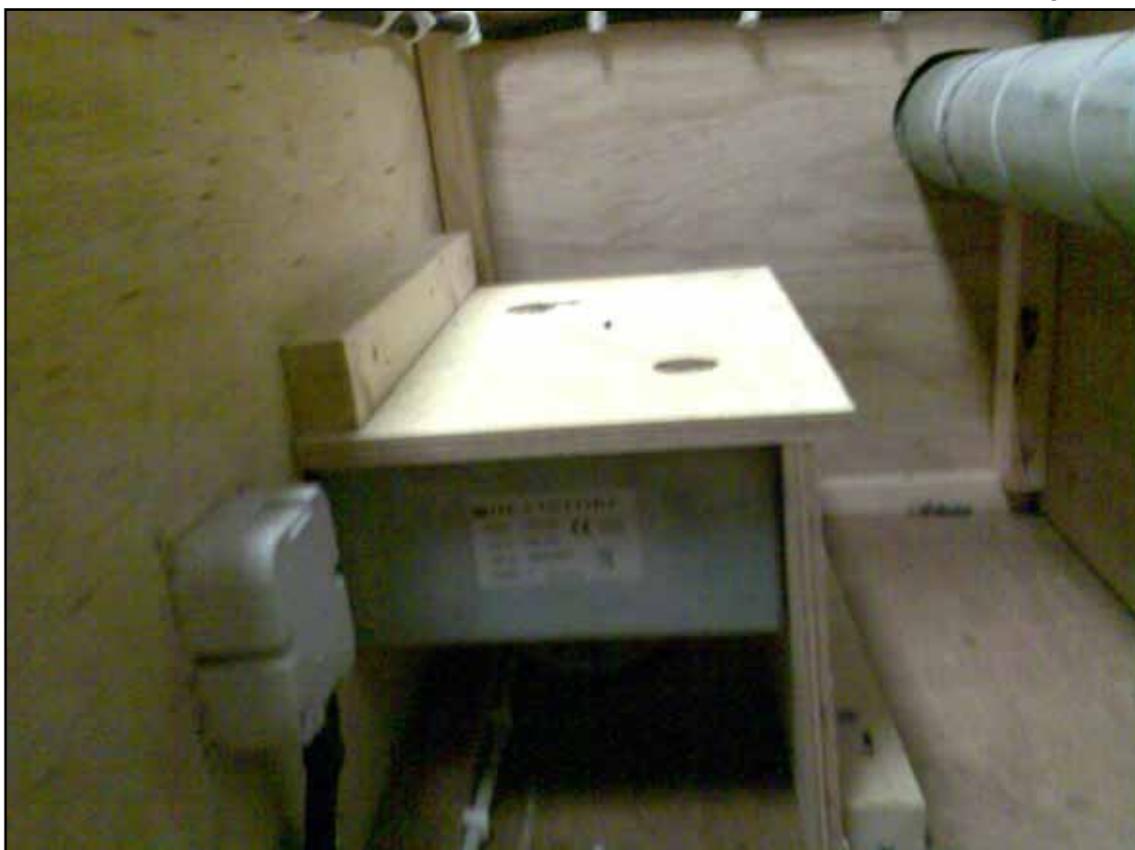
Figure 21

Partial 'boxing in' of heater on new vessel subsequent to this accident

Checks conducted on a fishing vessel being built discovered a galley heater which had been partly 'boxed in' (**Figure 21**), where it was possible to restrict the air intake, indicating a continued lack of clear installation requirements and quality assurance. If similar fan heaters are to be fitted on fishing vessels in the future, both the shipbuilder and the surveyor should determine that the fan heaters are:
