Reports on the investigations of  
the fire on board the fishing vessel

***Shark***

the foundering of the fishing vessel

**Report No 13/2008**  
**August 2008**

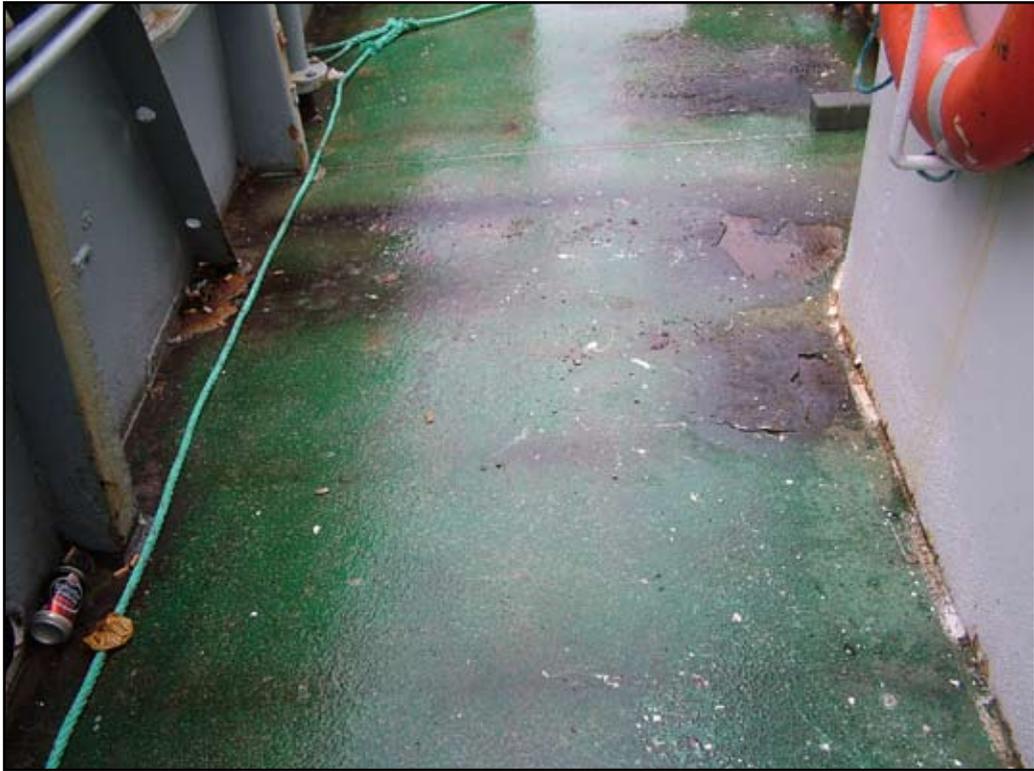
Figure 10

Blistering of the paint on the main deck

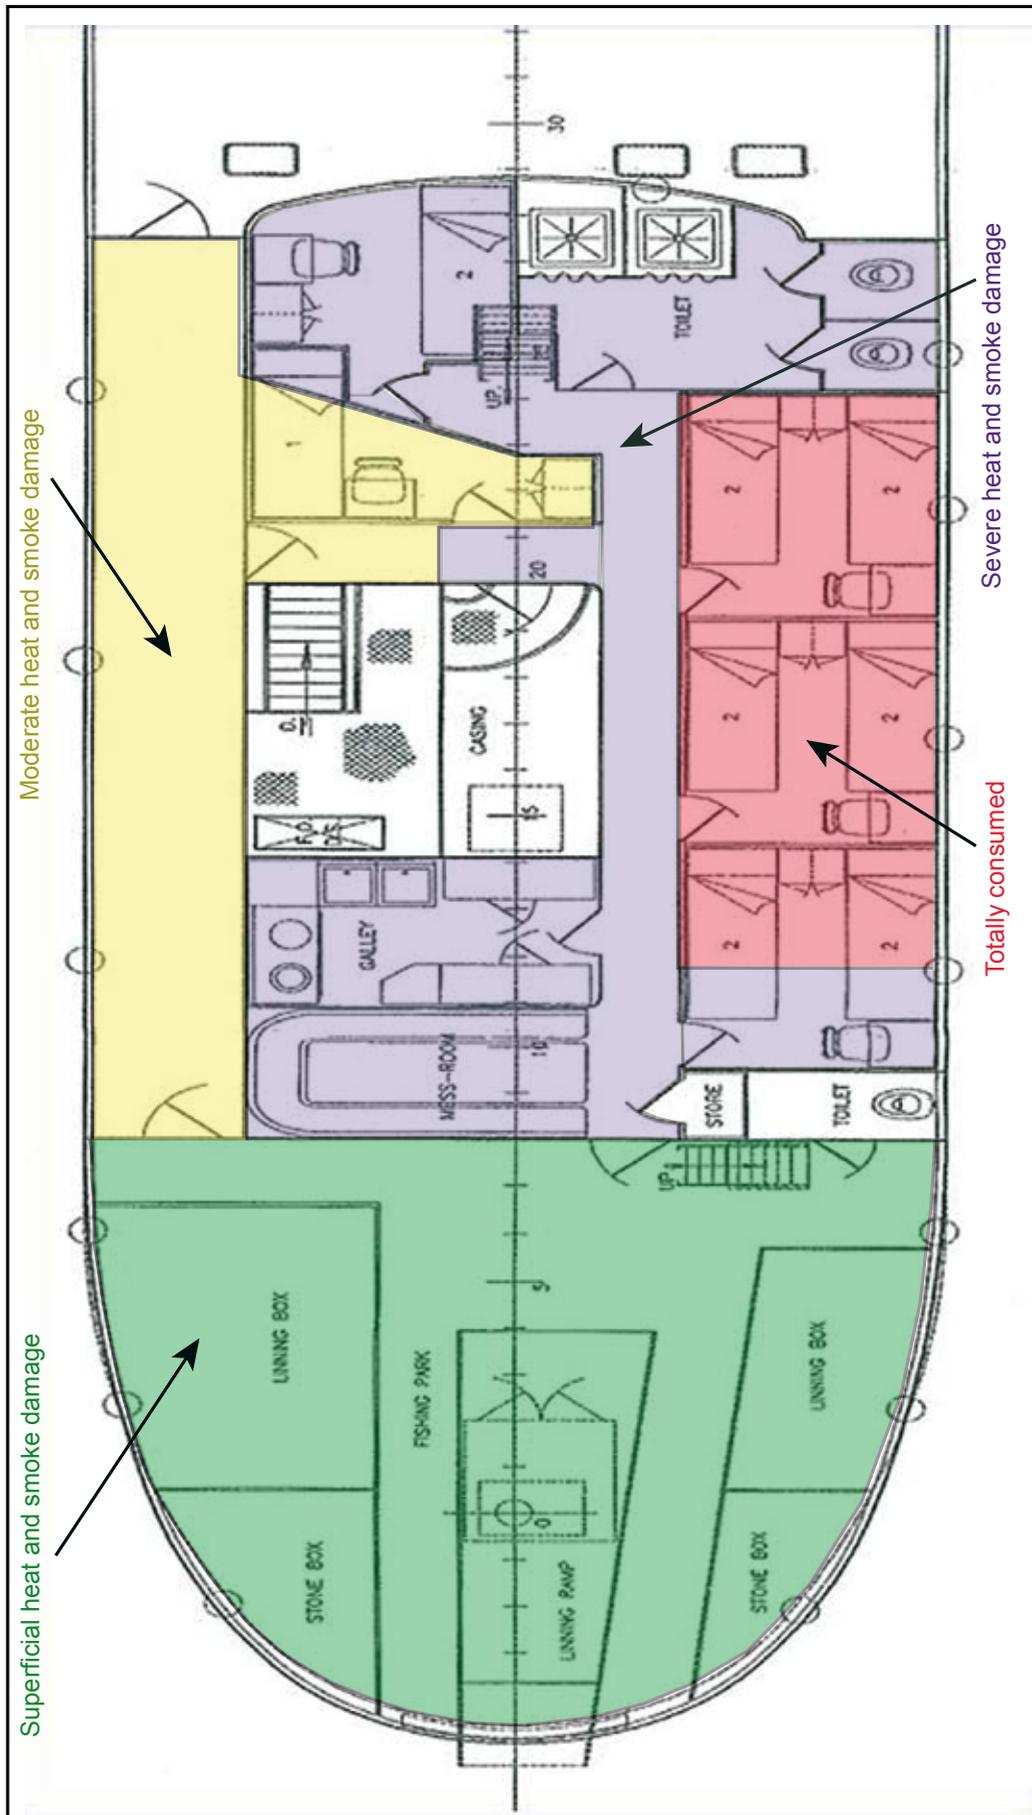
Figure 13

With the exception of the blistering of the main deck, the fire and smoke damage was confined to the compartments and equipment located within the containment area. The extent of the damage varied, as illustrated at **Figure 13**.

The most severe damage was evident in cabins No 1 and 2. In both cases the plywood bunks, bedding, foam mattresses, furnishings, personal belongings, wooden lockers and bulkhead facings had been totally consumed. The deckhead linings had completely collapsed exposing the gap between the top of the non-continuous, twisted bulkheads and the deckhead in cabins No 1, 2 and 3. Some of the deckhead insulation was displaced, exposing the underside of the main deck to the heat of the fire. In No 1 cabin there was a crate of brandy bottles at the forward bulkhead; some of the bottles had broken under the intense heat. No 1 and 2 cabin scuttle glasses were broken, and the deadlights were found to be in the closed position. The ceramic deck tiles were largely intact throughout all the cabins.

The damage to No 3 cabin was slightly less than that in cabins No 1 and 2. The fittings and furnishings at the forward end of the cabin were totally consumed, but the damage was less severe towards the after end of the cabin. The scuttle glass was intact.

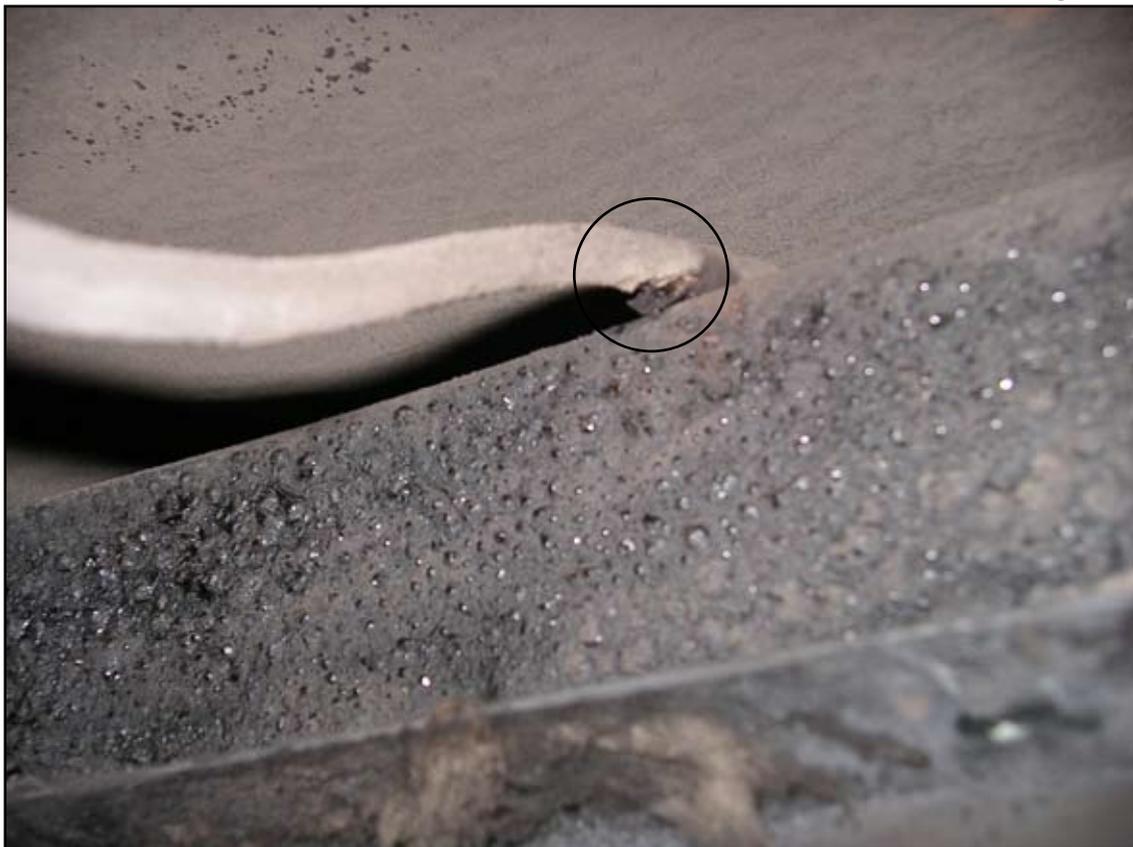
Figure 14

Cable chafing

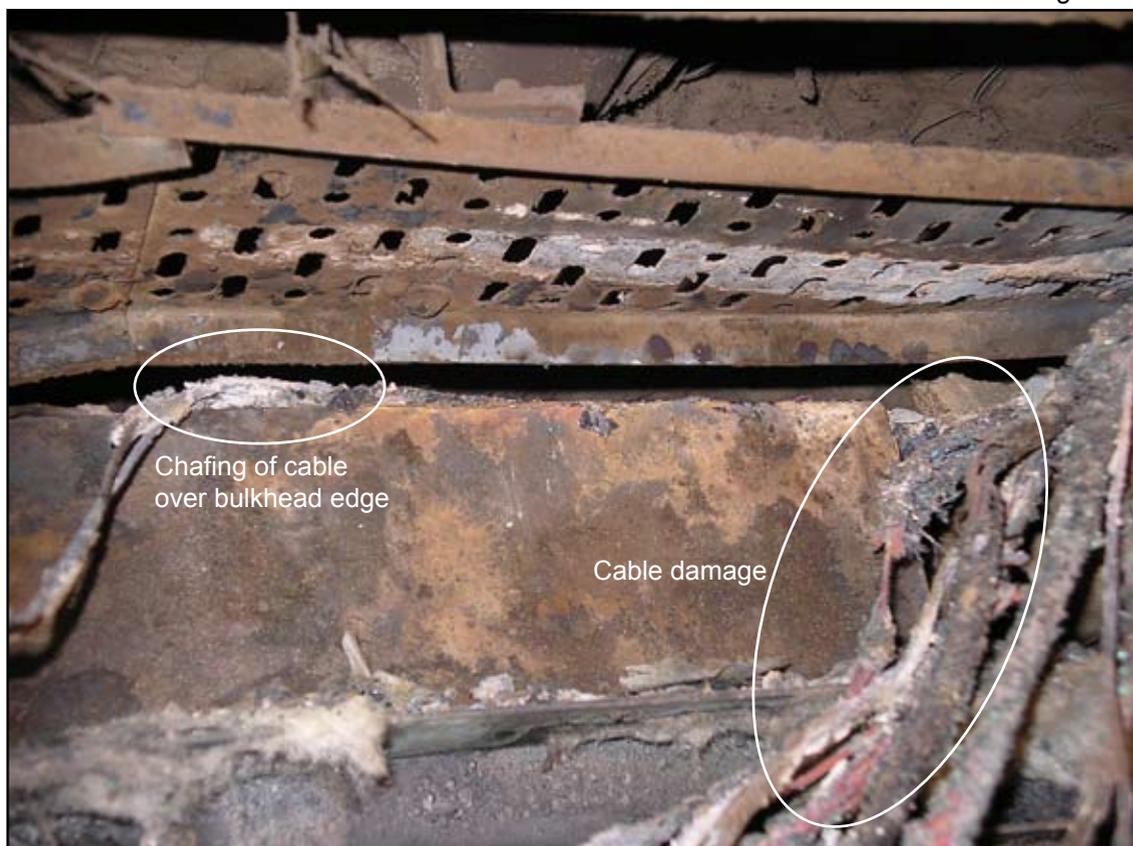
Figure 15

Cable damage and evidence of chafing

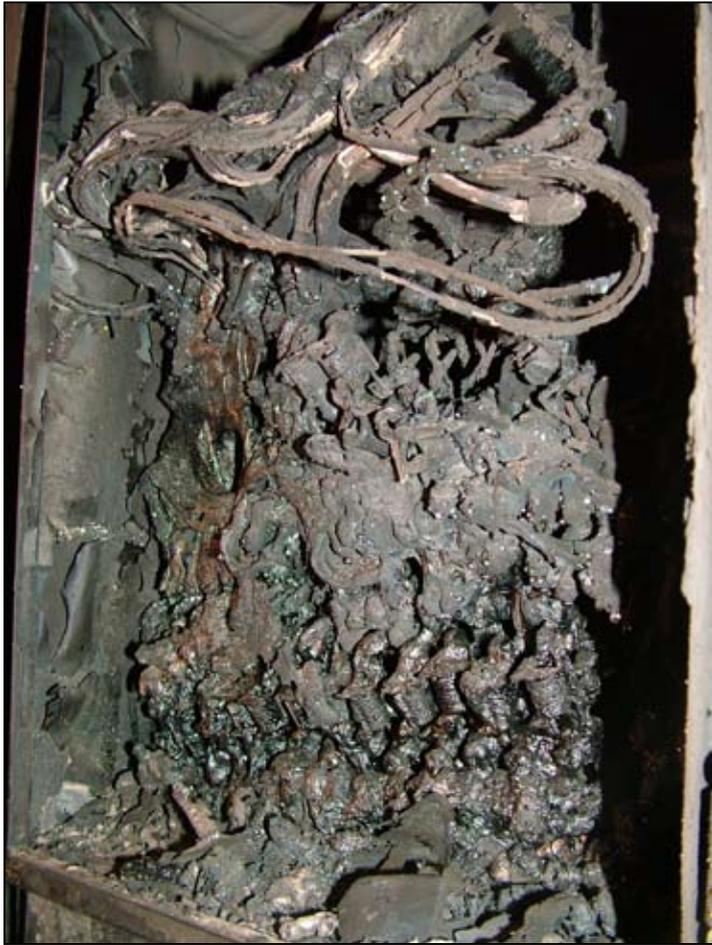
Figure 16  
Damage to the 220v electrical distribution panel

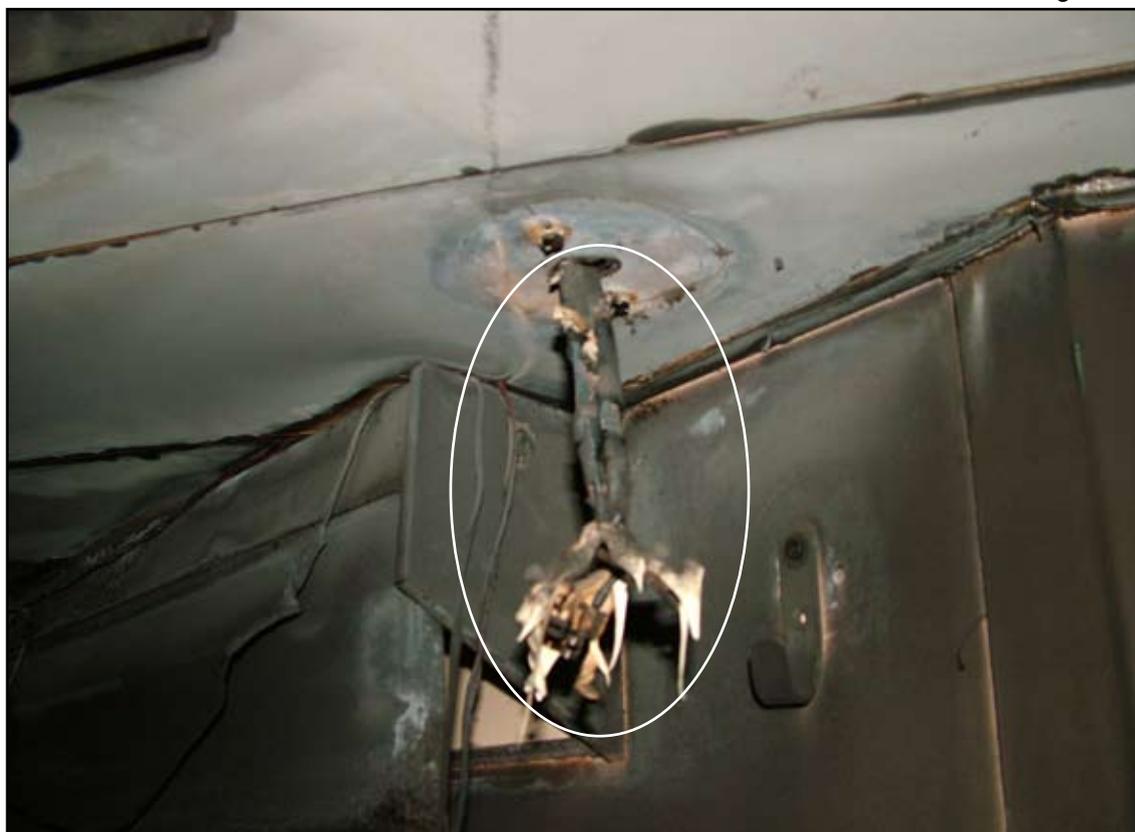
Figure 19

Fire damaged heat/smoke detector head

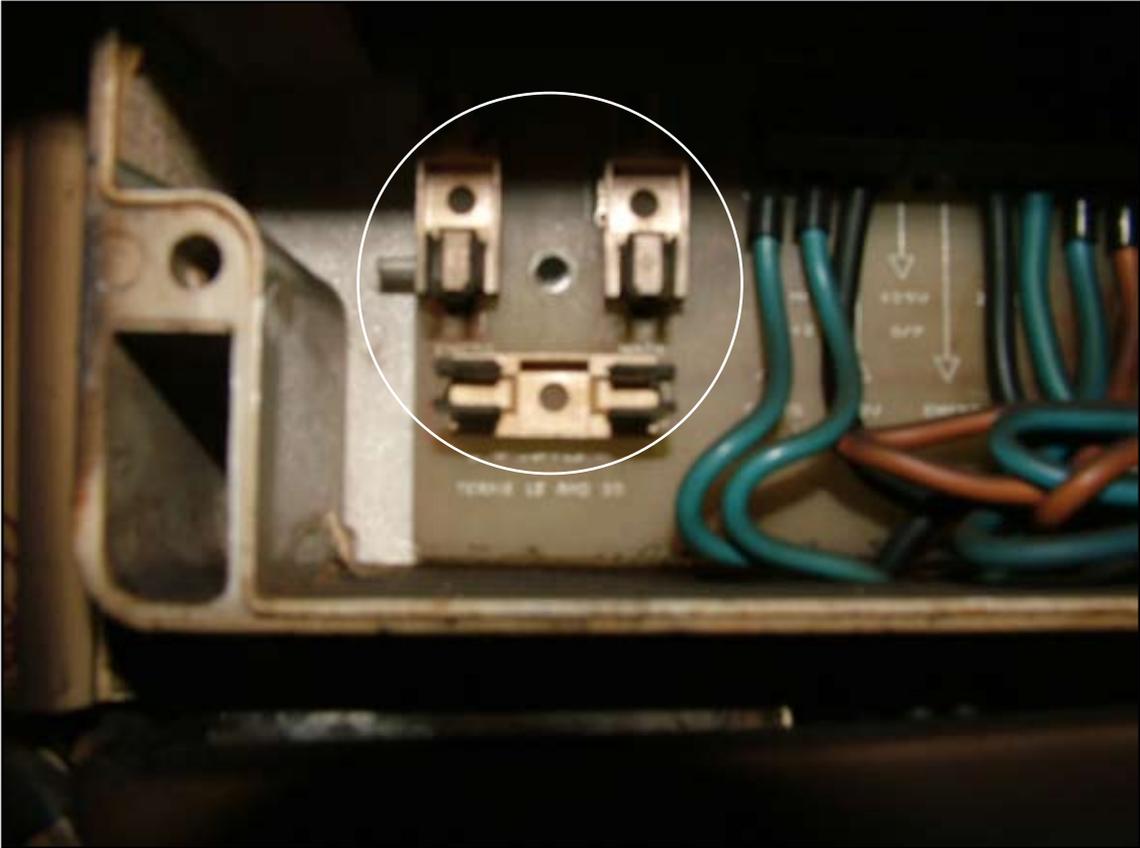
Figure 20

Location of missing fuses in the fire detection control box

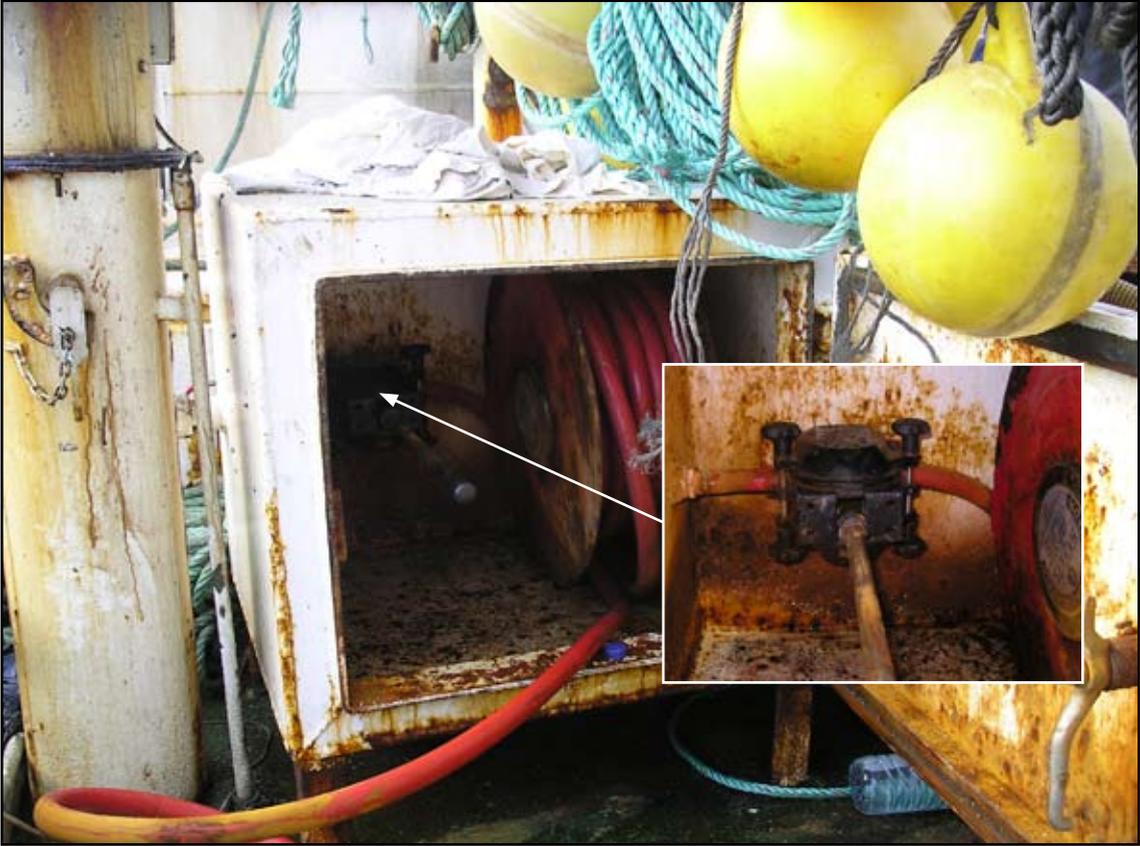
Figure 21

Emergency "Gusher" hand fire pump enclosure

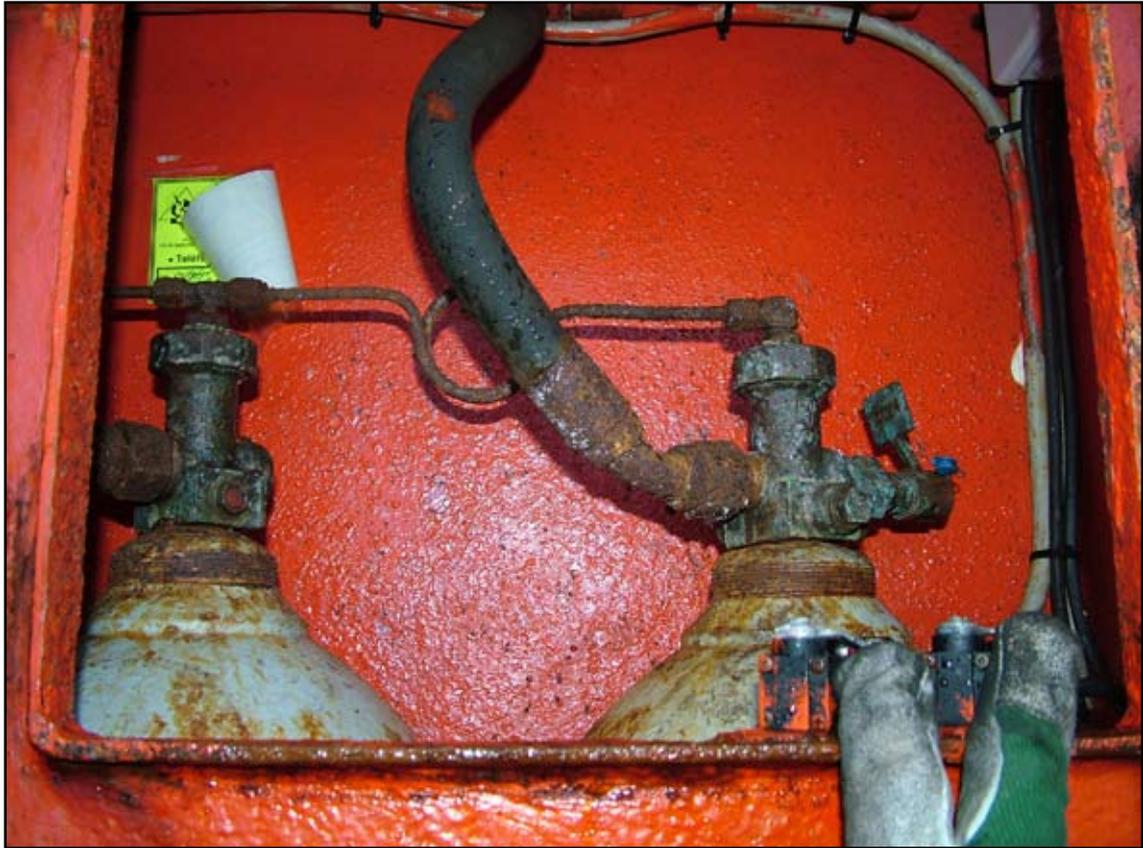
Figure 22

Corroded CO2 bottle pipework

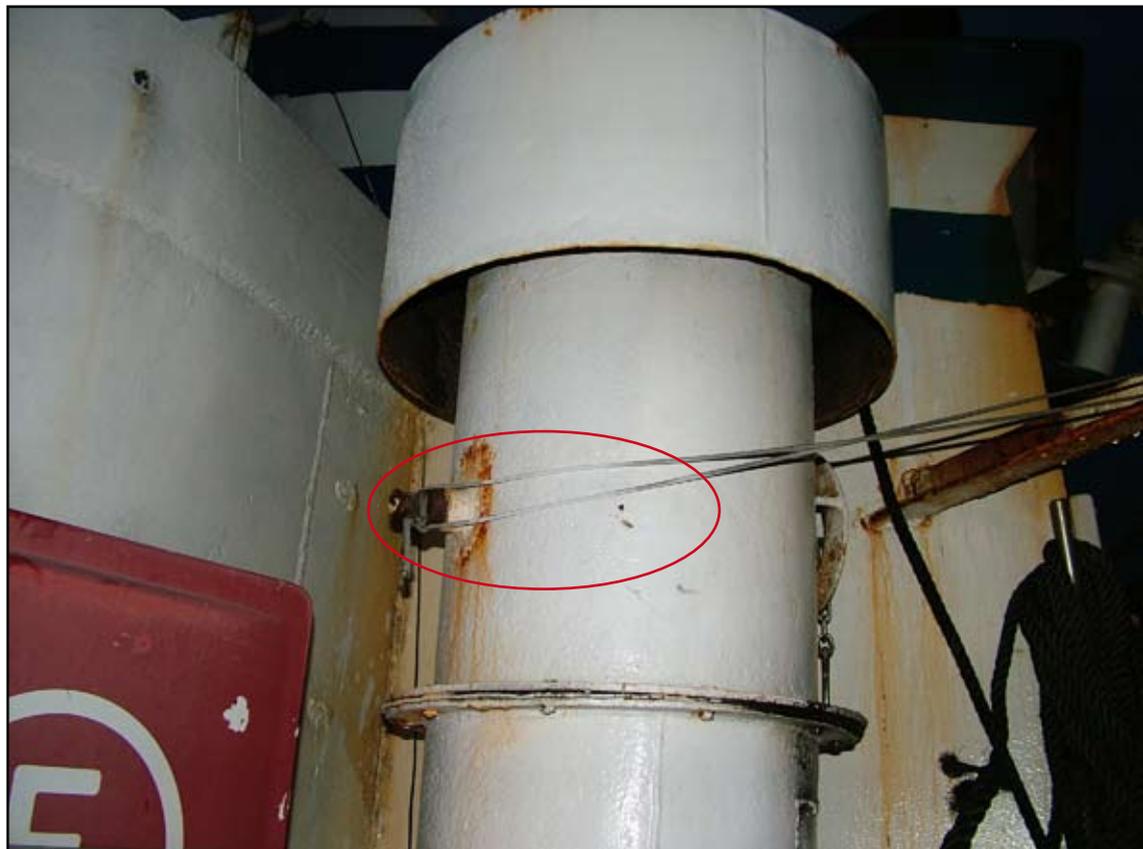
Figure 23

Ventilation shut-off flap valve obstructed by lashings

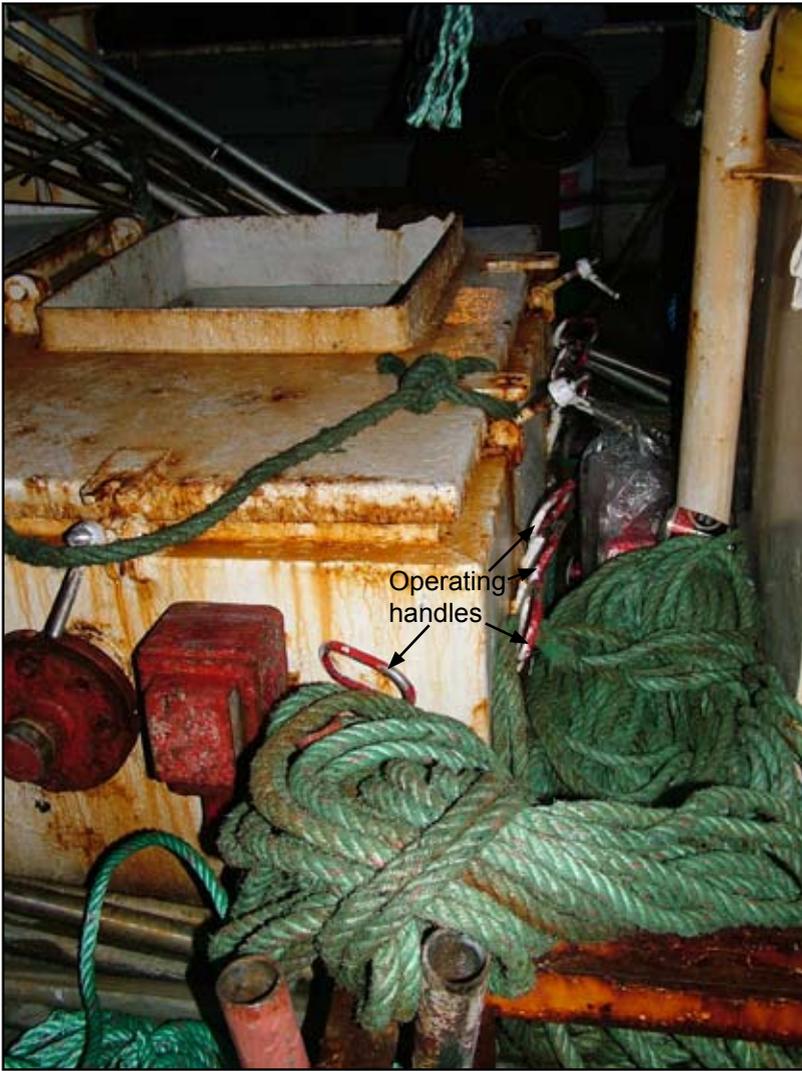
Figure 24  
Quick shut-off valve operating gear  
obstructed by bundles of ropes

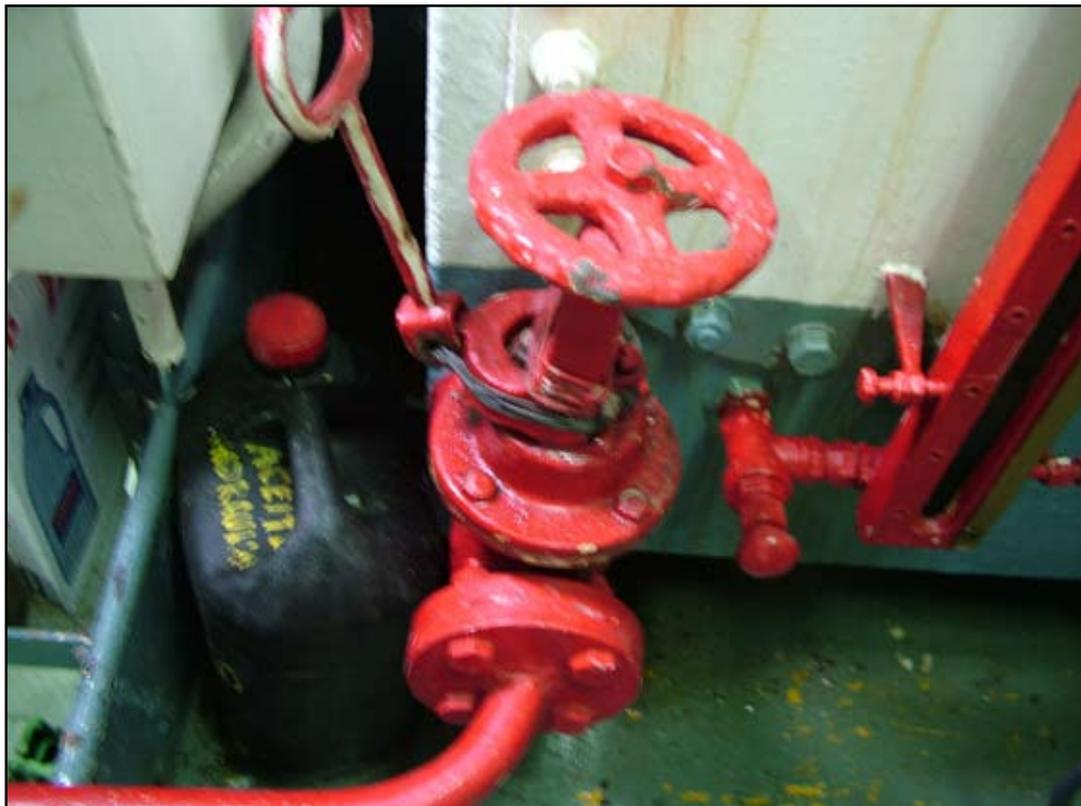
Figure 25

Quick shut-off valve lashed in the "open" position

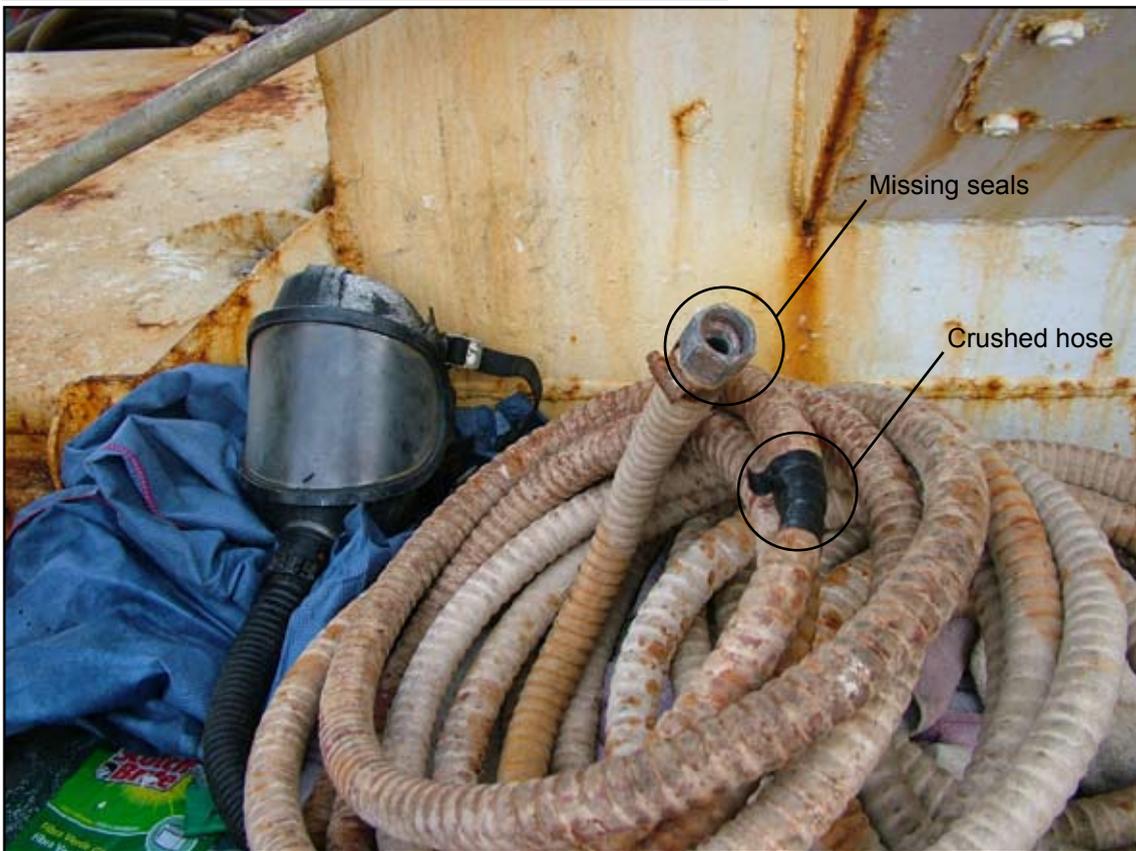
Figure 27

Condition of smoke mask

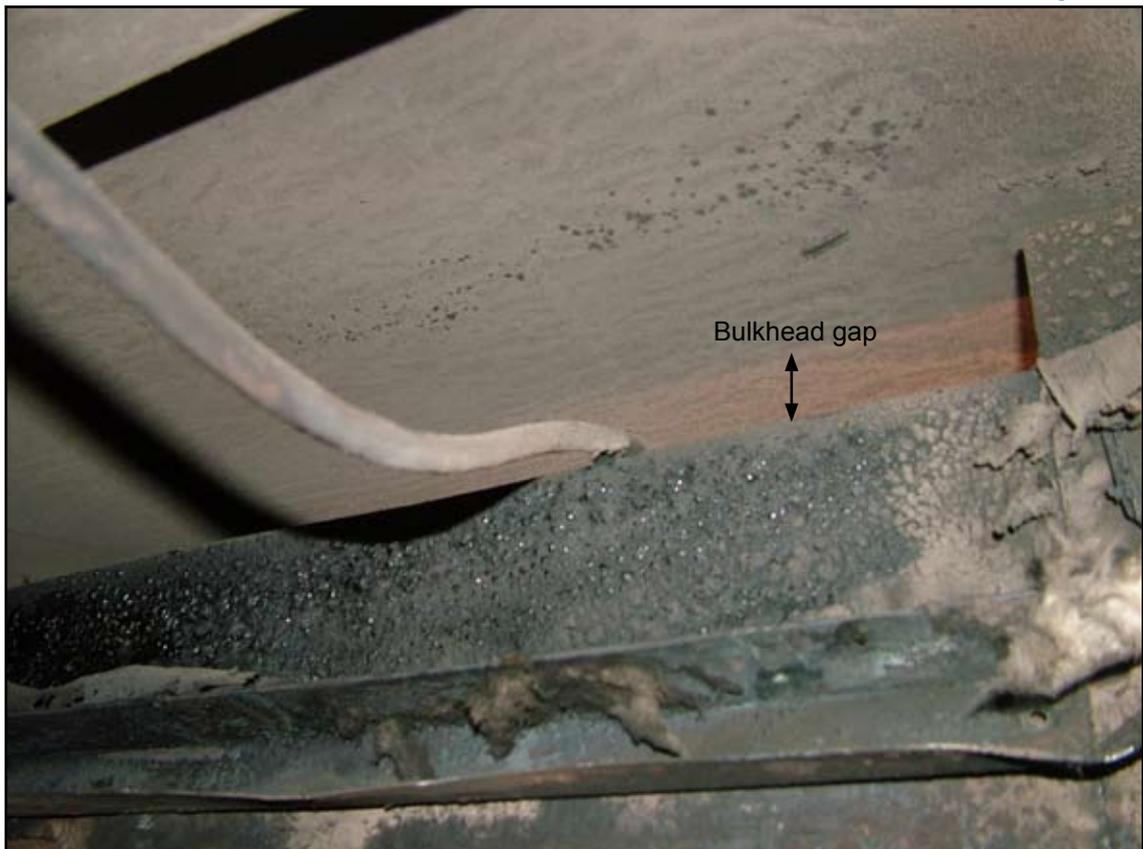
Figure 28

Gap between bulkhead and deckhead

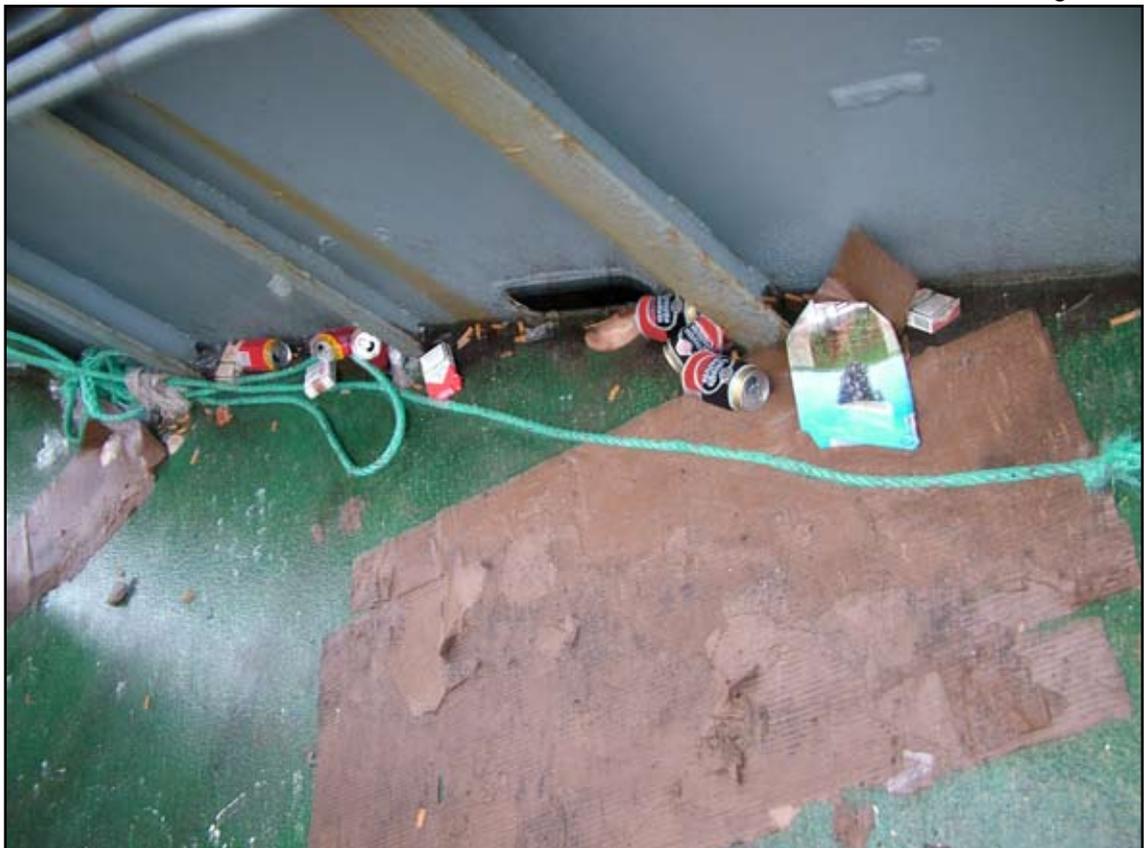
Figure 29

Example of discarded beer cans on the main deck

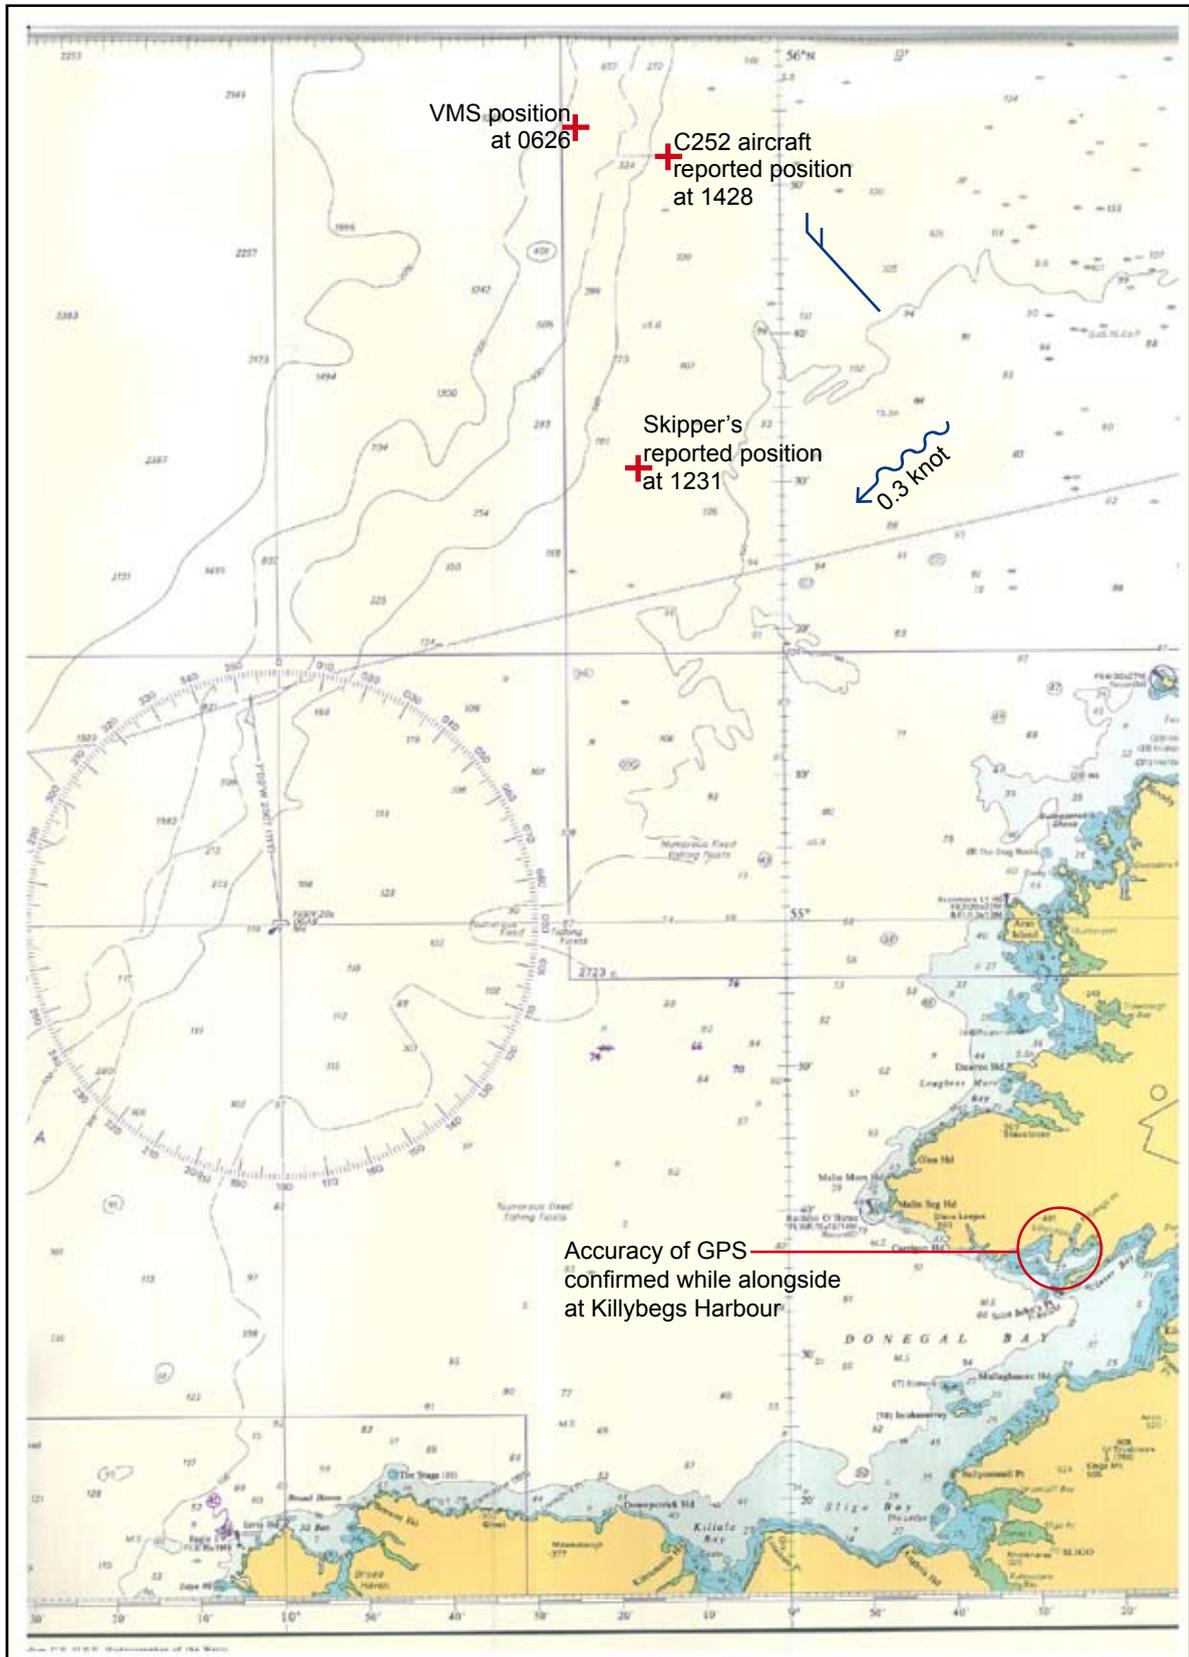
Extract of Admiralty Chart 1127 - showing reported and actual positions of *Shark* on 19 January 2008

At 1231 the skipper gave his position as 55° 31'N 9° 17'W from one of his GPS units. It was on this position that the emergency services calculated their ETAs. However, at 1428 the C252 aircraft spotted *Shark* and corrected the position to 55° 52'N 9° 13'W. This was 21 miles north of the skipper's 1231 position. Checks with MFA showed that the position transmitted at 0626, immediately before the fire was 55° 54'N 9° 24'W, which was about 8 miles north-west of the 1428 position. As the vessel had been stationary for most of the time during the fire, the 0626 and 1428 positions are considered accurate (**Figure 30**).

Checks made on the GPS units while at Killybegs confirmed that both GPS units were accurate. The error in the 1231 position was likely to have been due to the skipper misreading the GPS data, during what was a very stressful time, when the fire re-ignited. The error resulted in revised emergency services ETAs by up to 1 hour 10 minutes. Fortunately, in this case, it did not adversely impact on the efficacy of the rescue effort.

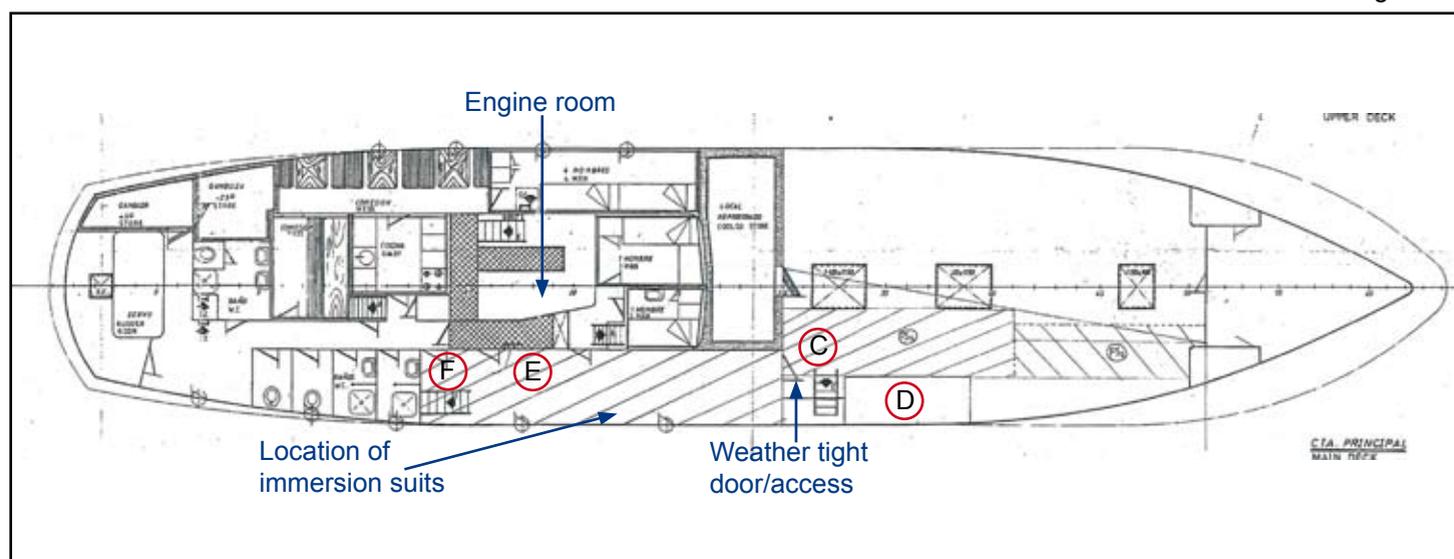
General Arrangement plan of main deck

Water entered the starboard accommodation alleyway with some force through the open weathertight door from the main deck (**Figure 34, C**). The crew standing in this area quickly evacuated via the hatch onto the upper deck (**Figure 33, A**). As they left, they shouted to the skipper in the wheelhouse to warn him of the situation. The ingress of water progressed from the alleyway into the engine room and aft accommodation via other accesses which had also been left open (**Figure 34, E and F**).
