Report on the investigation of the capsizing of
Plas Menai RIB 6
while undertaking unauthorised RIB riding activity
near Caernarfon, Wales, 1 July 2008,
resulting in one injured student

**Report No 6/2009
February 2009**

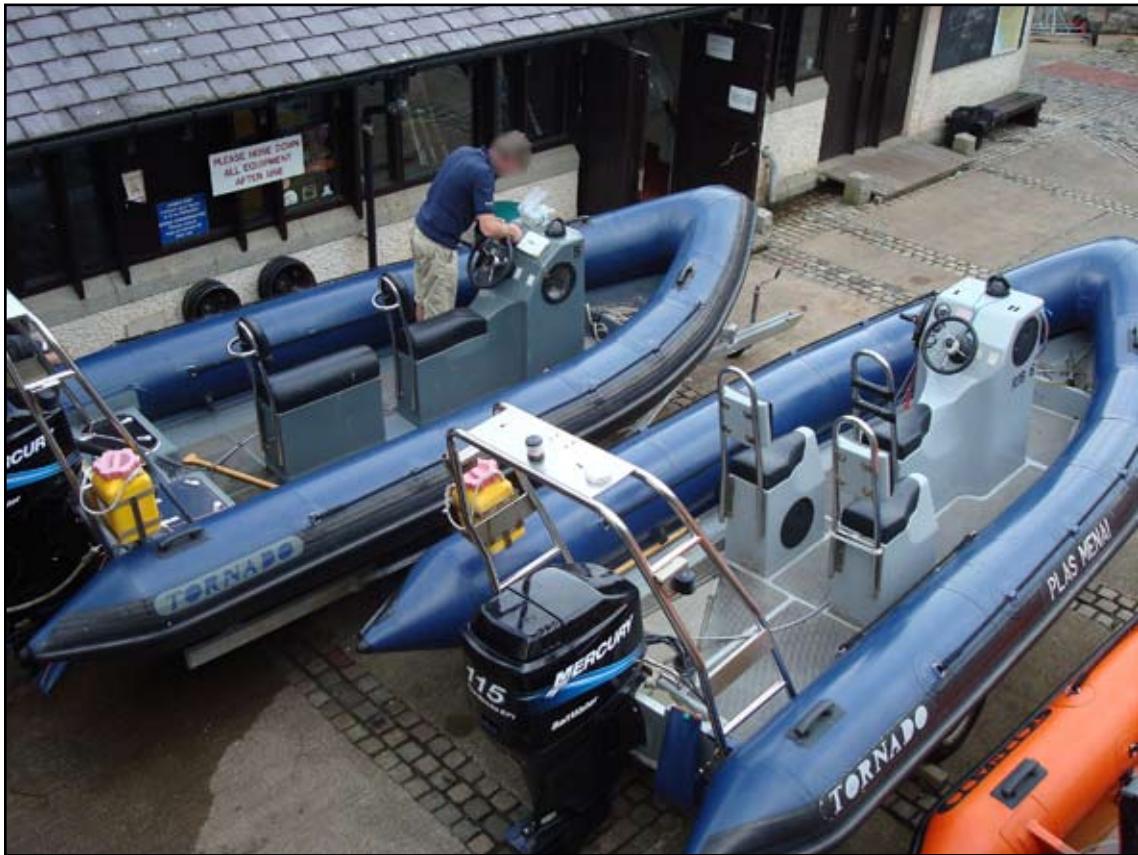
Figure 3

RIB 5 and RIB 6

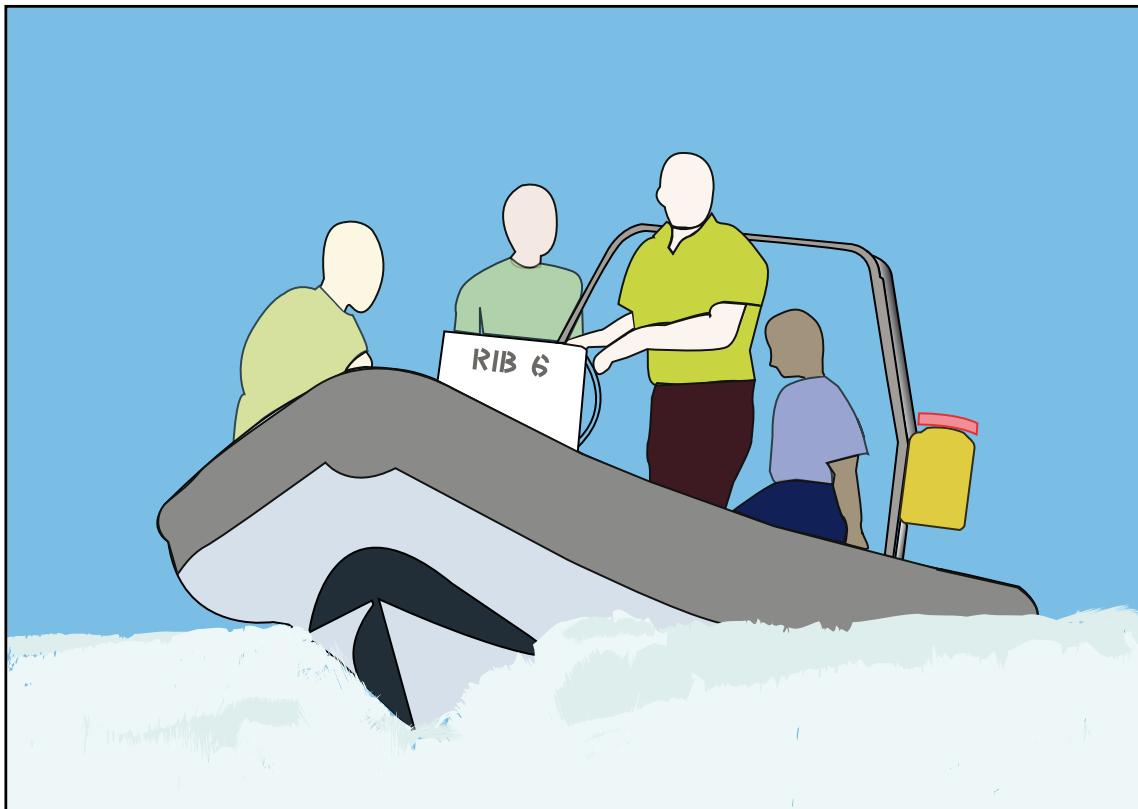
Figure 4

The SLiC and JLiC drove their RIBs from a position sitting on the jockey seat behind the console. The AI preferred to drive from a position standing next to the helm console on the port side, as she found it difficult to stand up in front of the seat, and felt that this position gave her better forward visibility when operating in waves (**Figure 4**).

Illustration showing *RIB 6* with driver standing at side of console

The AI stood at the port side of the console of *RIB 6* so as to get a better view forward. While this is a recognised technique when conducting powerboat training, it was not appropriate under the conditions prevailing at the time of the accident.

Plas Menai should review the qualifications and experience of instructors and, where necessary, provide further training to cover safe and effective powerboat handling under all local conditions.

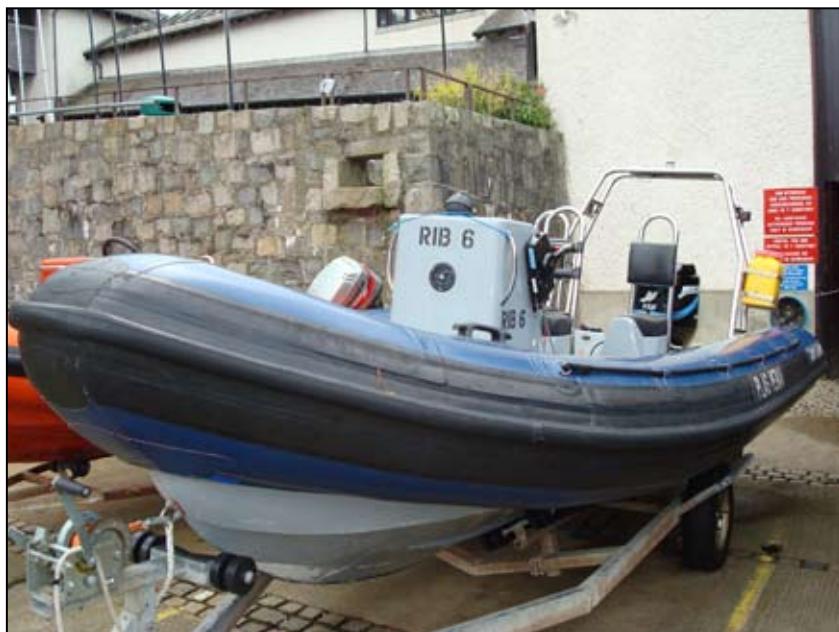
Figure 5

Tornado Boats International Ltd, the manufacturers of this 5.8m RIB, describe the boat as having a pronounced bow sheer and a shape that easily punches through oncoming waves. They also state that the deep Vee-shaped hull allows the craft to operate in the roughest of conditions (**Figure 5**). The RIB was fitted with a CE plate noting it as suitable for use in the Recreational Craft Directive (RCD) category C⁵ "Inshore" area, with a maximum capacity of 10 persons.

RIB 6 seen from bow
