Report on the investigation of the electrical blackout
and subsequent grounding of the ro-ro cargo ship

Moondance

in Warrenpoint Harbour, Northern Ireland

Report No 5/2009
February 2009

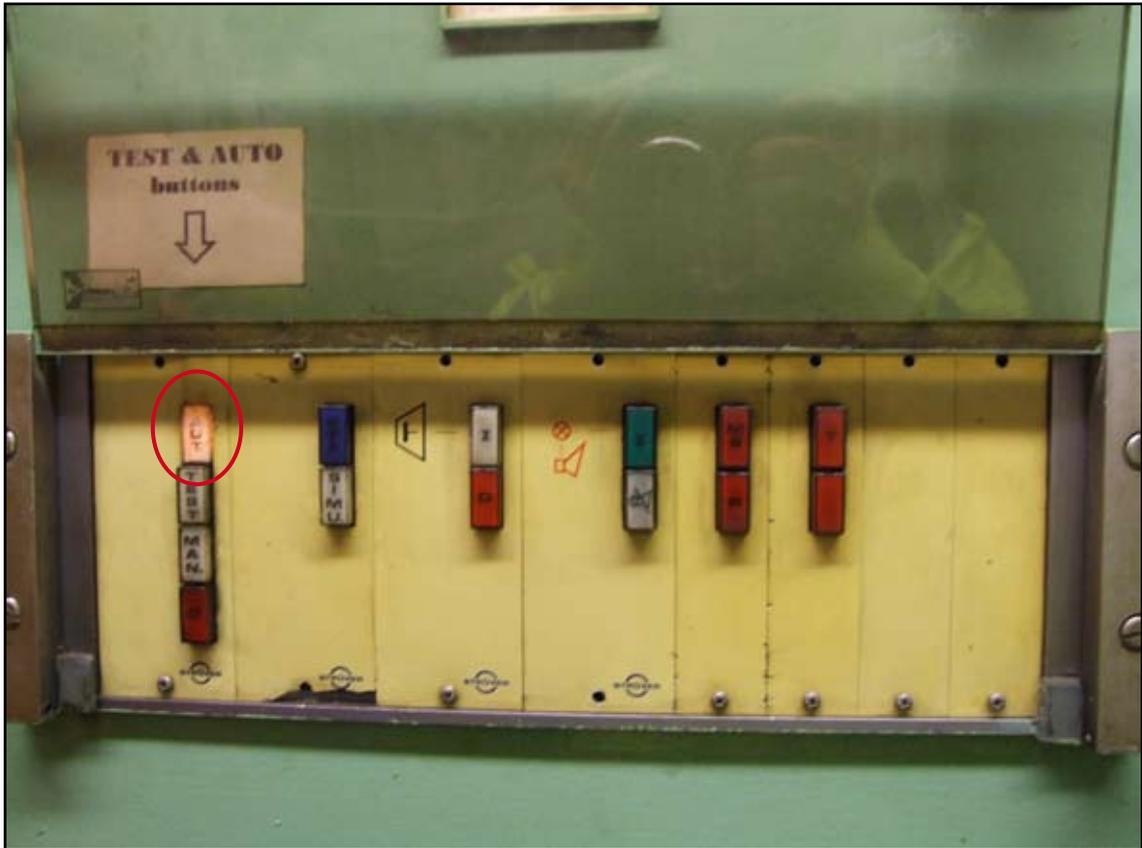
Figure 7

At about 1825 the third engineer went to the emergency generator compartment and found the generator's control panel was set to the "manual start" position instead of the normal "automatic" stand-by position (**Figure 7**). He started the generator in "manual mode", clutched in the emergency fire pump and confirmed that it was pumping correctly (**Figure 8**). He then went to the steering gear compartment and confirmed that the rudder stocks were damaged and that the hydraulic oil header tank had lost its oil charge. He then returned to the engine room and reported his findings to the chief engineer. By now there was limited lighting being supplied from the emergency generator, and the situation in the engine room became calmer.

Emergency generator control panel shown in "auto" start position

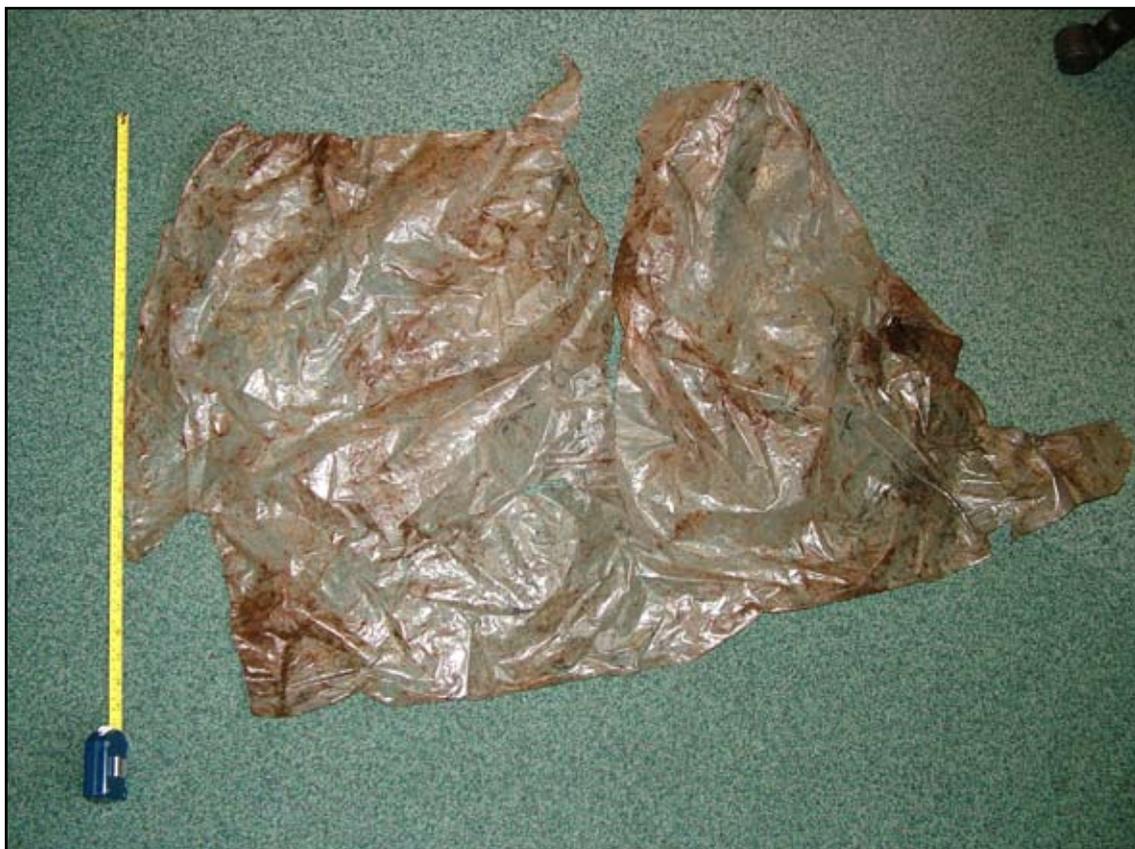
Figure 11

During the morning of 30 June the chief engineer asked what had been found in the strainer. He was presented with the contents of the rubbish bin, which included mussels and a large piece of plastic (**Figure 11**), which he was told was recovered from the strainer.

The chief engineer showed the plastic sheeting to the master and suggested that this was the cause of the sea water cooling supply interruption to the generators. Following discussions with the superintendent, the chief engineer was advised to reconstruct the blockage in the strainer and photograph the evidence (**Figures 12 and 13**). During the reconstruction, none of those present, who had originally cleared out the strainer, advised the chief engineer that the plastic sheet had not come from the strainer.

Plastic sheeting reported to have come from the main service pump strainer

The suggestion that the plastic sheet (**Figure 11**) had come from the main service pump suction strainer, and had reduced the water flow to the main service pump and hence to the generator coolers causing the trip conditions, was a plausible explanation, but one that required further investigation. Had

Inspection of the heavily mussel encrusted, port main service sea chest grating (**Figure 29**) confirmed that the plastic could not have passed into the strainer, so this scenario was dismissed. While inspection showed the mussel growth to be severe, main service and harbour service pump performance trials proved that its impact on pump performance was negligible. In addition, had there been a reduction in flow related to main service pump performance, i.e. through a strainer blockage, or a degraded pump, then the main engine sea water low pressure alarms would have sounded, but this was not the case. It can therefore be concluded that the sea water supplies to the main engines were satisfactory, but those to the generators were not, although these were supplied from the same source.

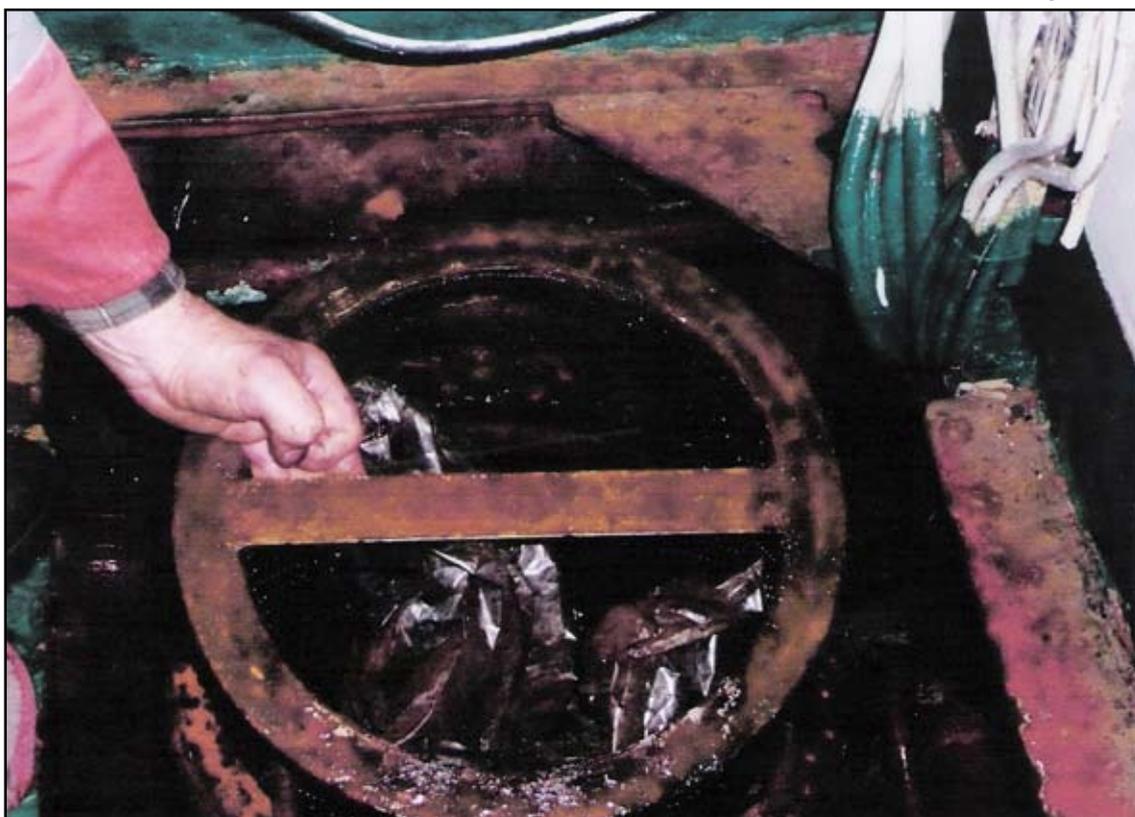
Figure 12

Reconstruction of purported blocked main service pump strainer - top view

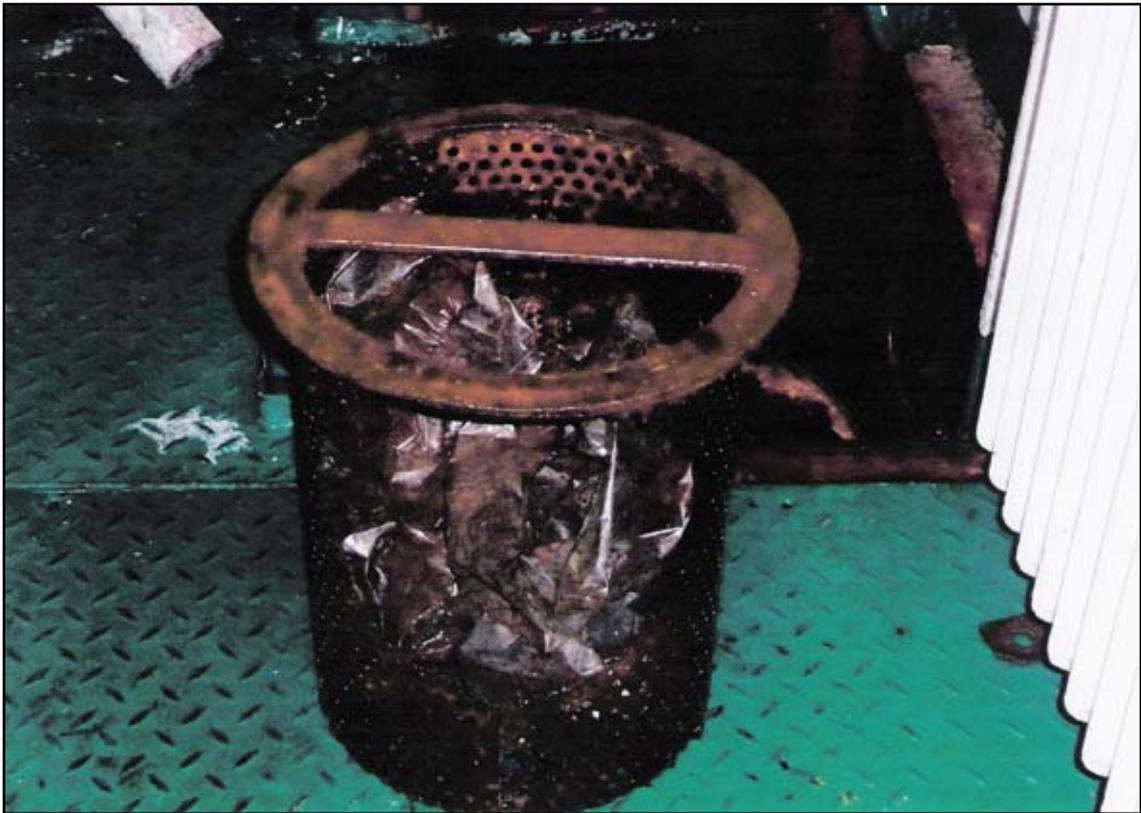
Reconstruction of purported blocked main service pump strainer - side view

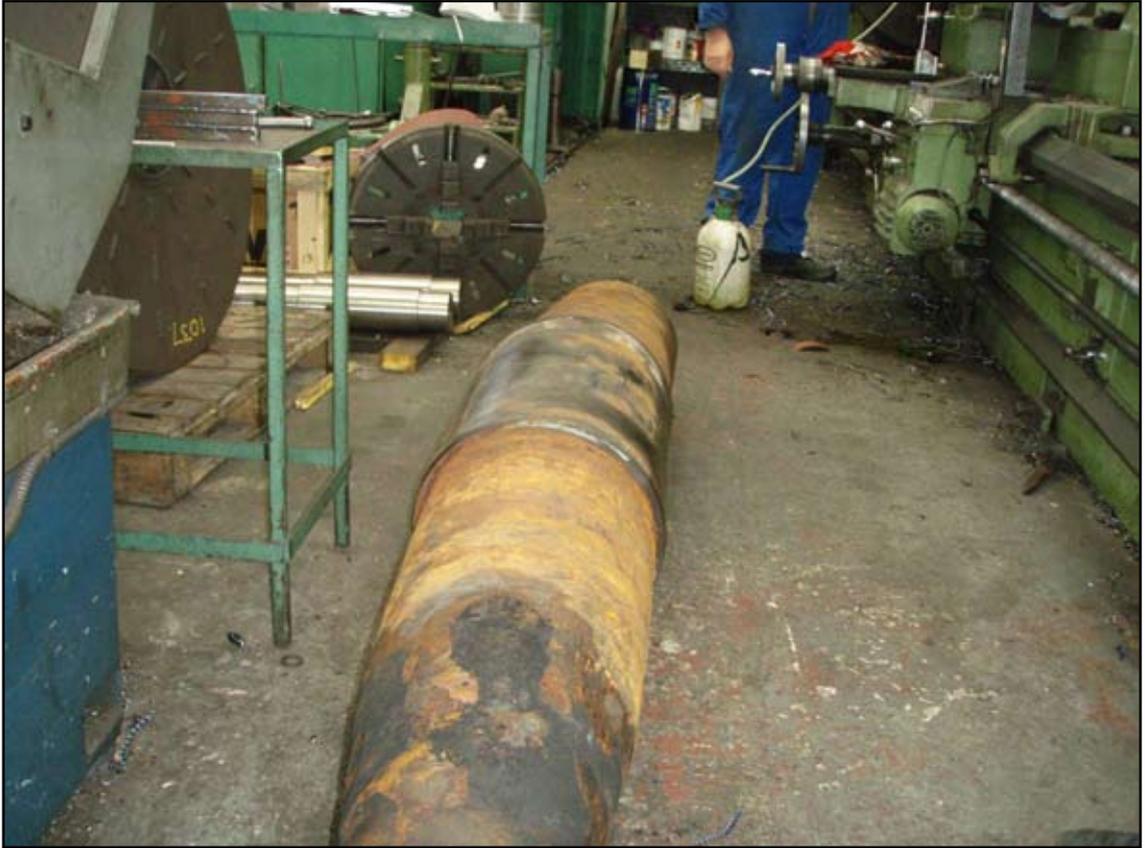
The survey identified no evidence of hull damage. The propellers were also undamaged, but the starboard rudder stock was bent by about 10° (**Figure 14**) and the port rudder stock by about 5° (**Figure 15**).

Starboard rudder stock distortion

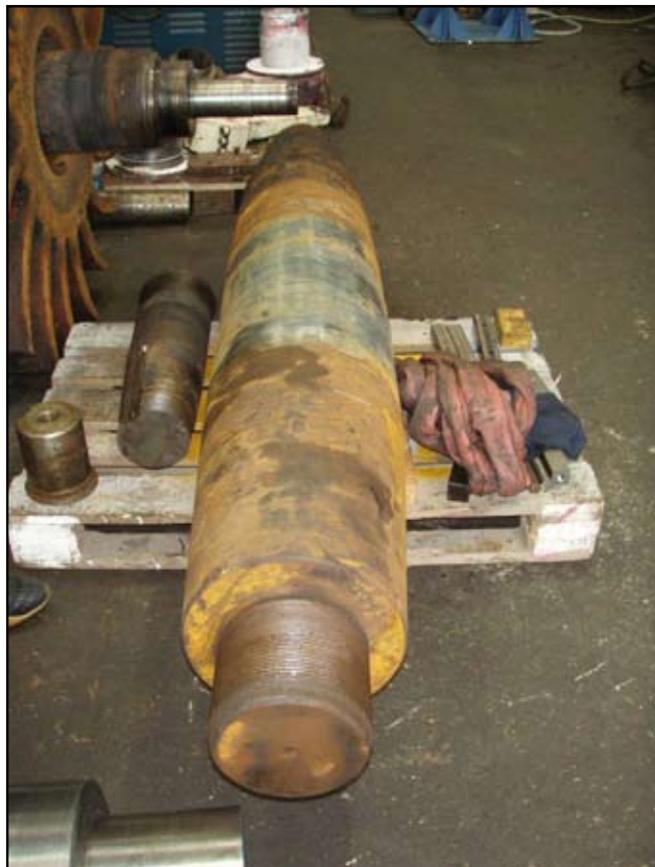
Figure 15

Port rudder stock distortion

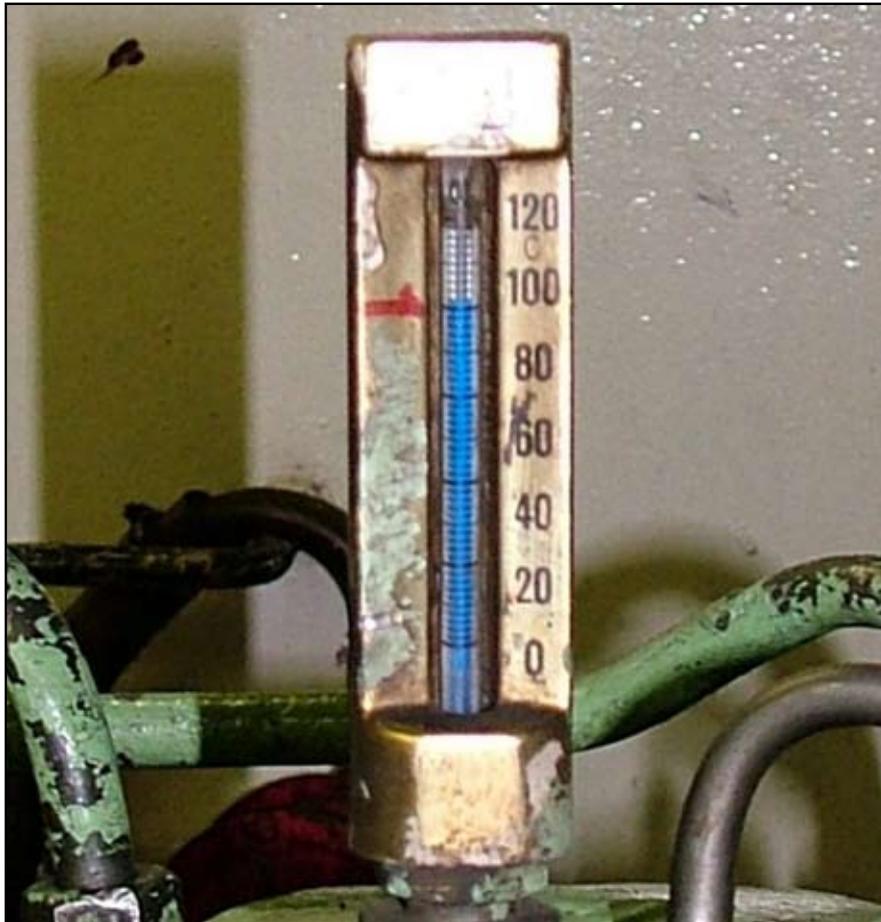
The fresh water temperature was monitored manually using a thermometer fitted to the engine fresh water rail (**Figure 19**). It was noted that the engraved 20°C graduations on the thermometer housing were misaligned to the graduations on the glass alcohol thermometer providing ambiguous temperature readings.

Port generator fresh water system thermometer

It was observed that the fitted thermometers required a correction to be made because of misalignments between the graduations on the housing and the glass alcohol thermometer. This makes temperature reading ambiguous and fault finding more difficult.

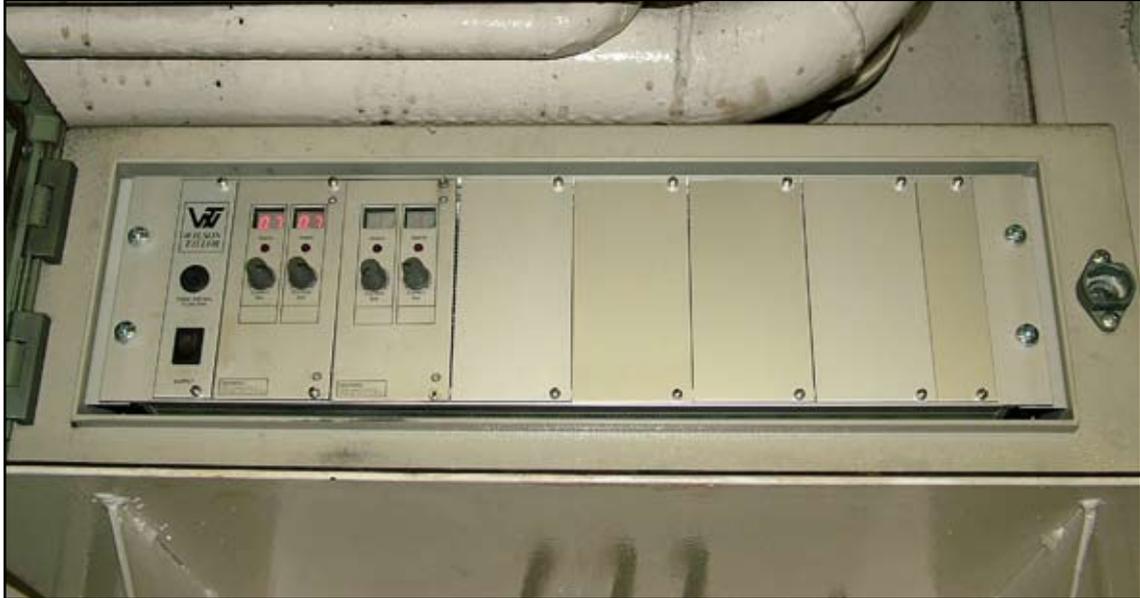
Figure 25

The sea water system was protected from the build up of marine growth, which could cause blockage and affect heat transfer, by an Intakematic Marine Growth Protection System. The port and starboard main service pump suction strainers were fitted with sacrificial anodes (**Figure 24**) fed by a low, direct current (dc), electrical supply provided via a control panel (**Figure 25**). The system operating instructions (**Annex F**) specified a normal current setting of 0.3 amps, but it was noted that the control panel was set to deliver 0.7 amps.

Intakematic Marine Growth Protection System control panel

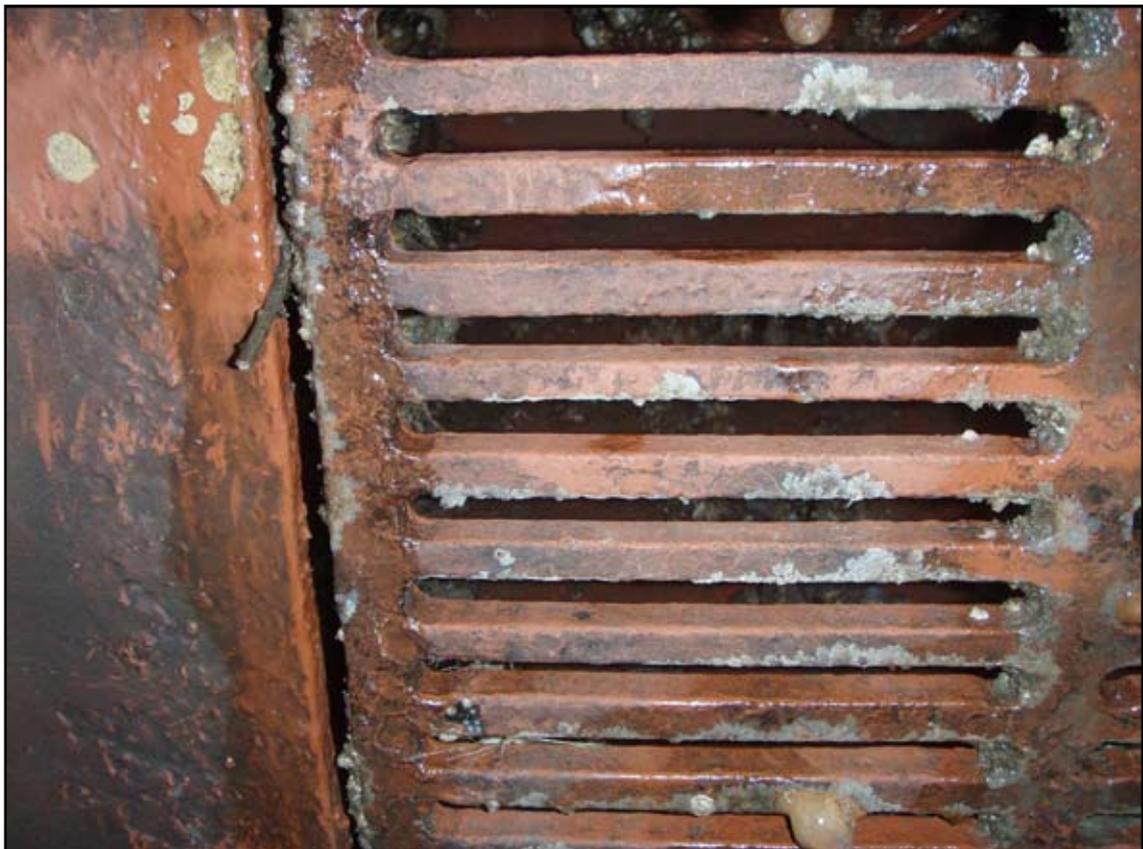
Figure 26

All gratings were found to be correctly secured. The mainly unused starboard, low level suction grating was largely free of marine and crustacean growth (**Figure 26**), although there was a small amount of mussel growth inside the sea chest (**Figure 27**). There was heavy mussel attachment to the outside of the port high level suction gratings for both the harbour service and main service pumps. Mussel attachment on the inside of the gratings was markedly worse. Mussels were also attached to the inside of the sea chest, although the pump suction stub pipes were clear (**Figures 28, 29 and 30**).

Starboard main service pump low level suction grating

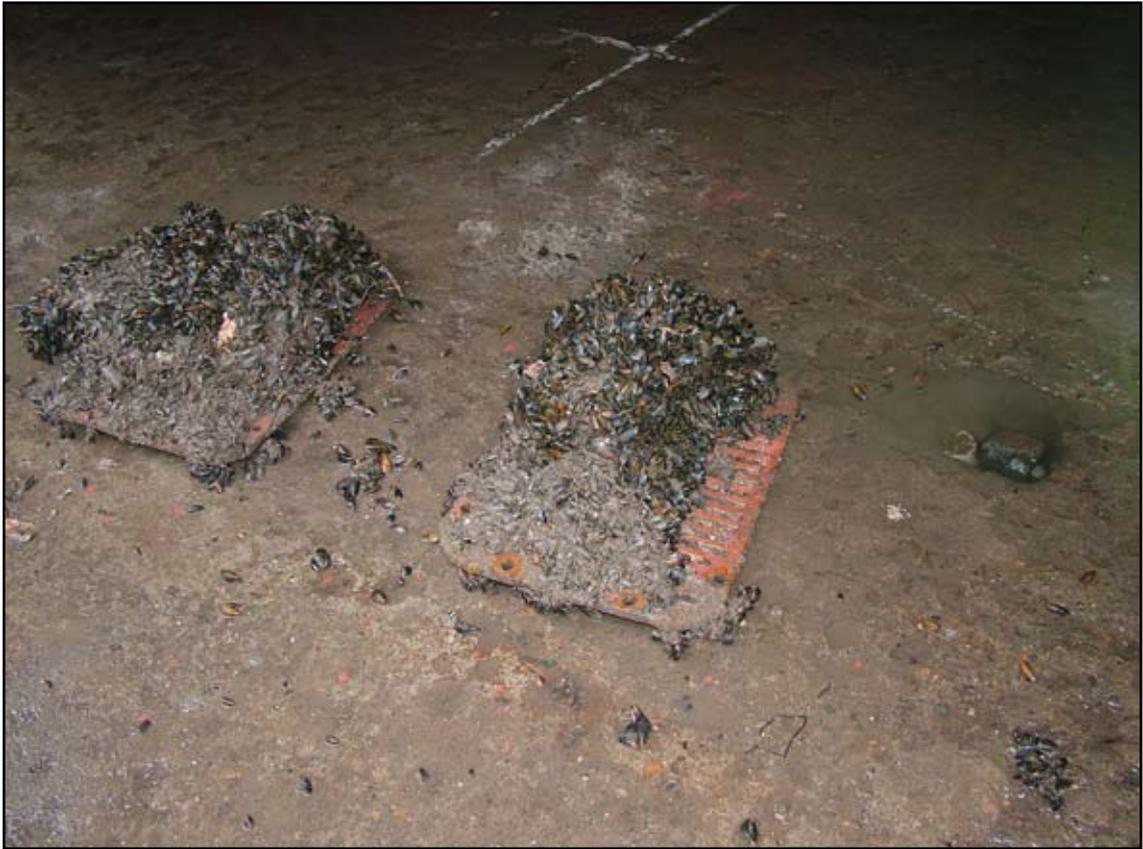
Port main service pump and harbour service pump
high level suction grating - internal view
