Report on the investigation
of a hazardous diving incident
involving

MV Norma

in the Dover Strait

on 21 June 2008

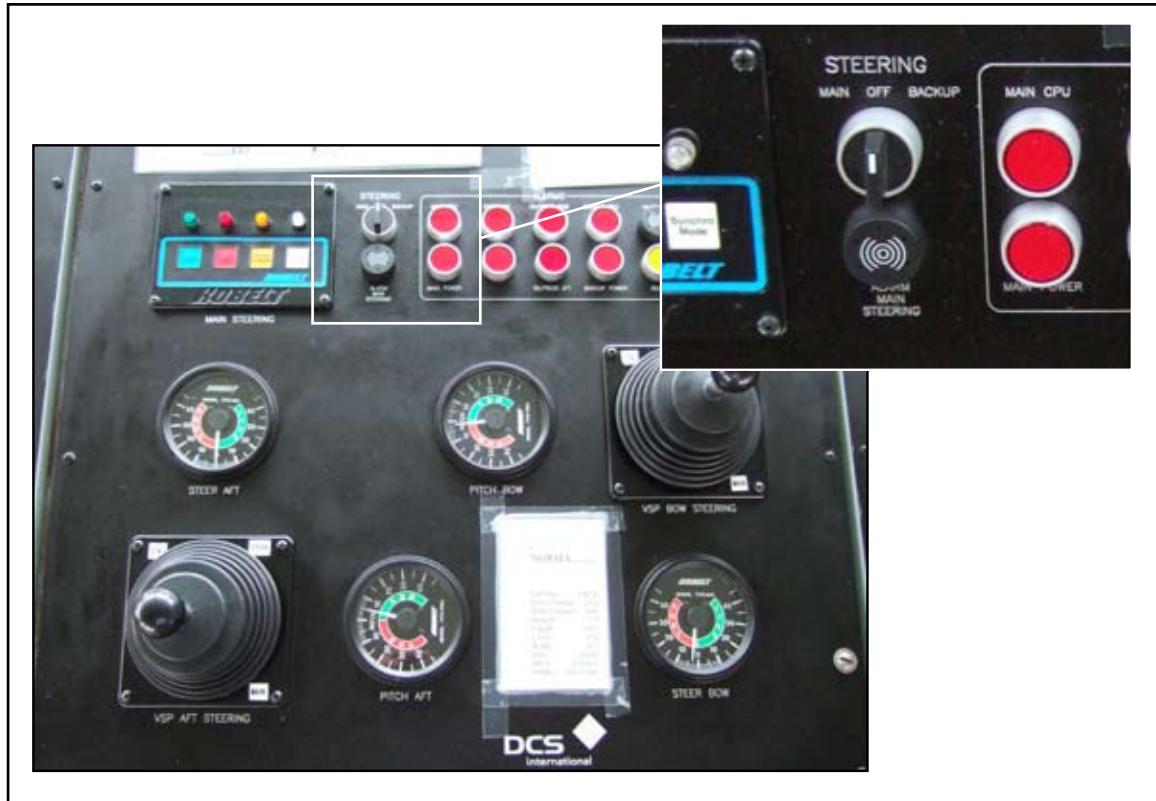
Figure 2

sited on the Voith Schneider propeller (VSP) control panel (**Figure 2**), to the off position. He then called the master using VHF radio and informed him that the motors had been switched off. The second officer did not inform the engine room that the electric motors were no longer required.

Propulsion and steering control panel

The incident would not have occurred if the aft VSP had been stopped as intended. Although the OOW turned the steering control switch to the off position (**Figure 2**), this only disengaged the control of the propeller pitch; the propellers continued to rotate. It is evident that the OOW was unaware that the VSPs

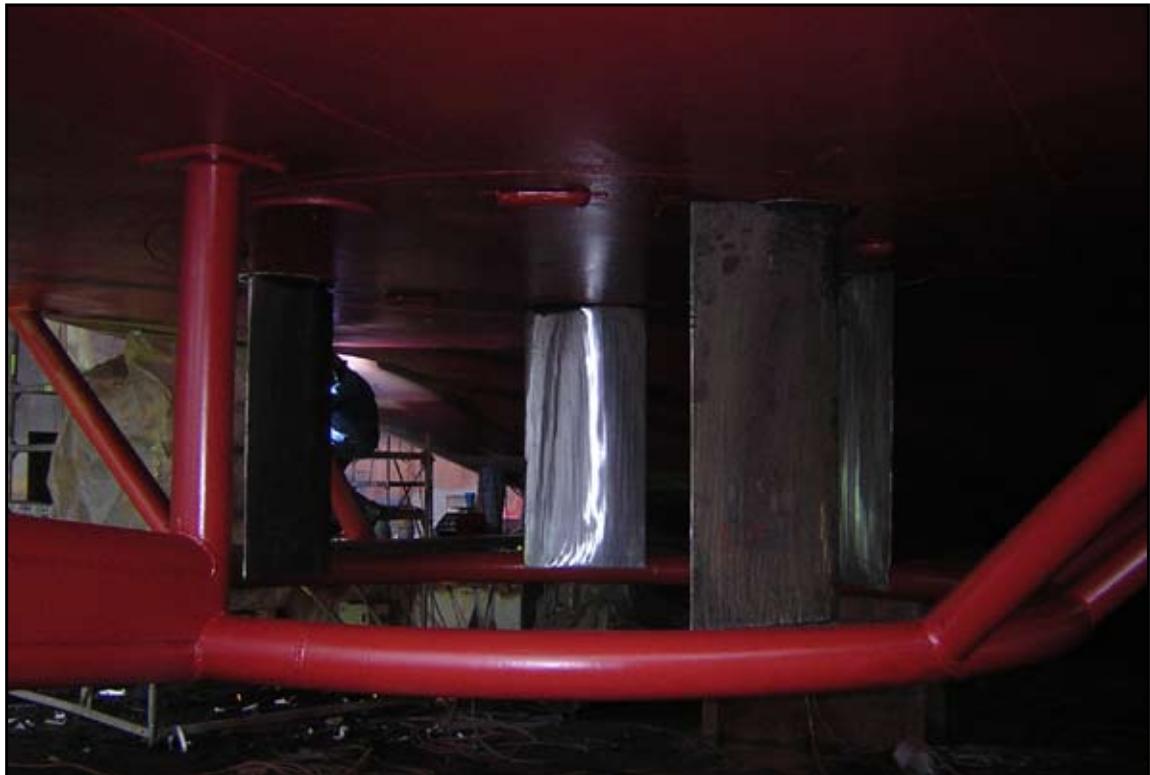
Figure 4

Meanwhile, the diver had been rotating violently and had realised that he was being dragged towards the aft VSP (**Figure 4**). He was unable to cut his umbilical cord but managed to turn on the air supply from his bail out bottle³. When the VSP finally stopped, he was about 3 metres away. He was then able

Voith Schneider propeller

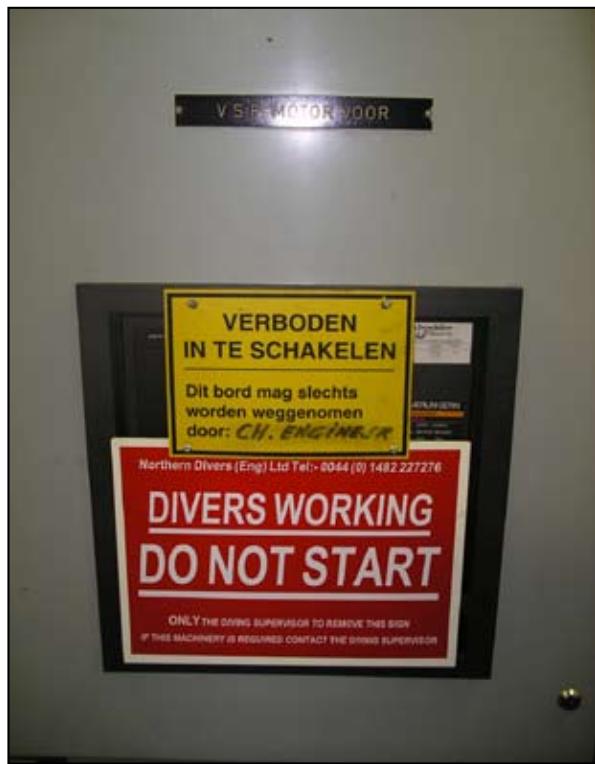
Figure 5

Warning sign on VSP switchboard

The following morning, the project team and the vessel's senior management agreed measures to isolate the vessel's propulsion. These included the placement of warning signs on the VSP switchboard in the engine room (**Figure 5**) and the use of 'emergency stop' switches, which disabled the VSP's starting circuit from the bridge (**Figure 6**). A 'permit to work' system covering diving operations was also implemented (**Annex B**).

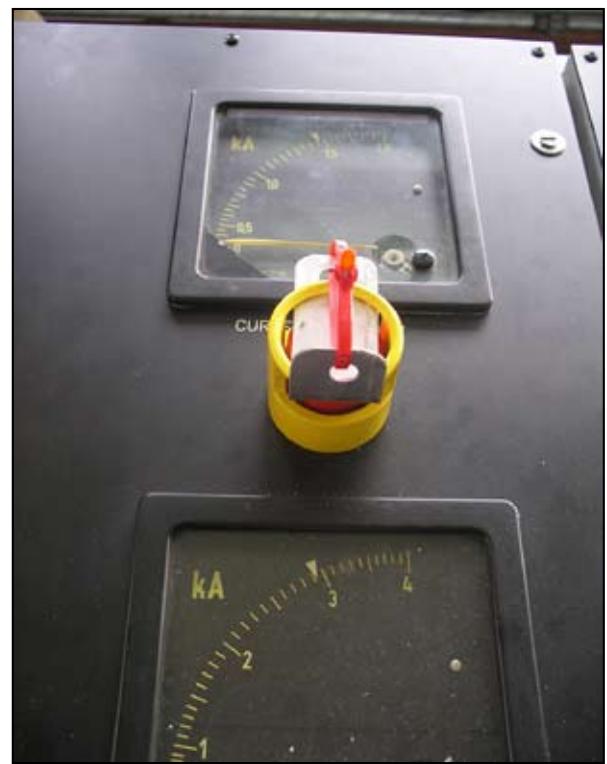
Figure 6

Emergency stops on bridge - measures to isolate motors from activation

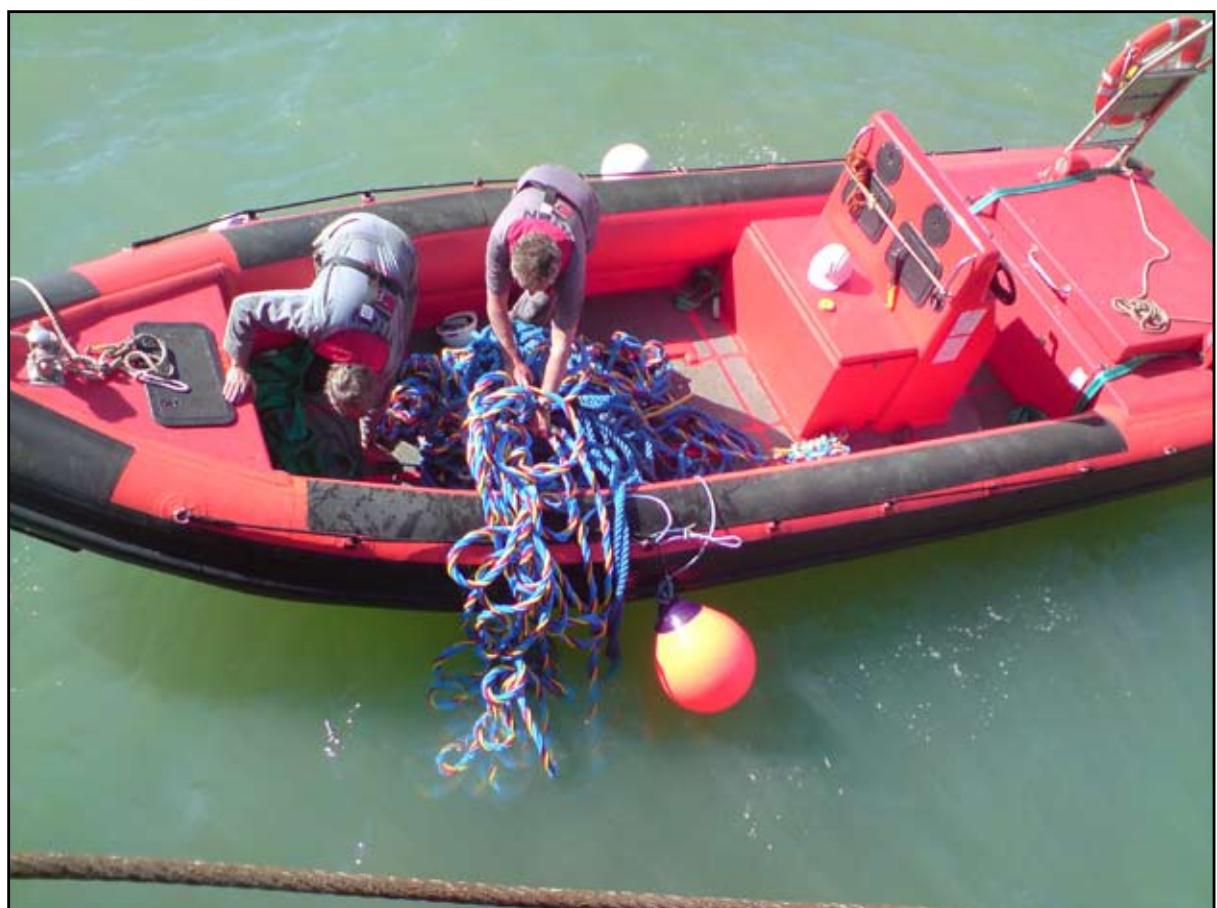
Figure 7

With the aft VSP cleared of the remnants of the umbilical cord and polypropylene rope (**Figure 7**) *Norma* departed Dover at 1545 on 24 June to return to the dive site. The relocation of *UB38* was successfully completed on 14 July despite several delays due to bad weather.

Recovery of umbilical cord and shot line in Dover

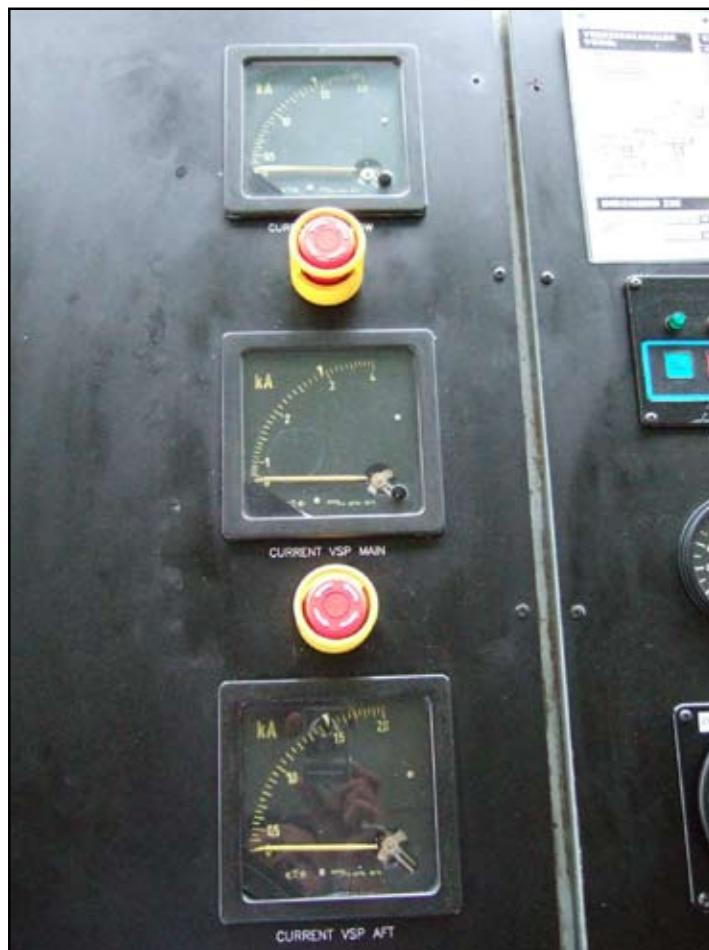
Figure 10

The electric motors were started from the VSP switchboard sited in the engine control room. Once running, the VSP units idled at 650 RPM in neutral pitch and each drew about 500A of electrical current. Control of the pitch was via the steering control system, which was switched on and off at the VSP control panel on the bridge (**Figure 2**). The control panel was also fitted with ammeters to indicate the power drawn by the units (**Figure 10**) along with emergency stops, which had to be depressed in a locked position. When activated, the emergency stops broke an electrical circuit, and the engines could not be restarted unless the bridge stops were reset.

Ammeters on bridge control panel

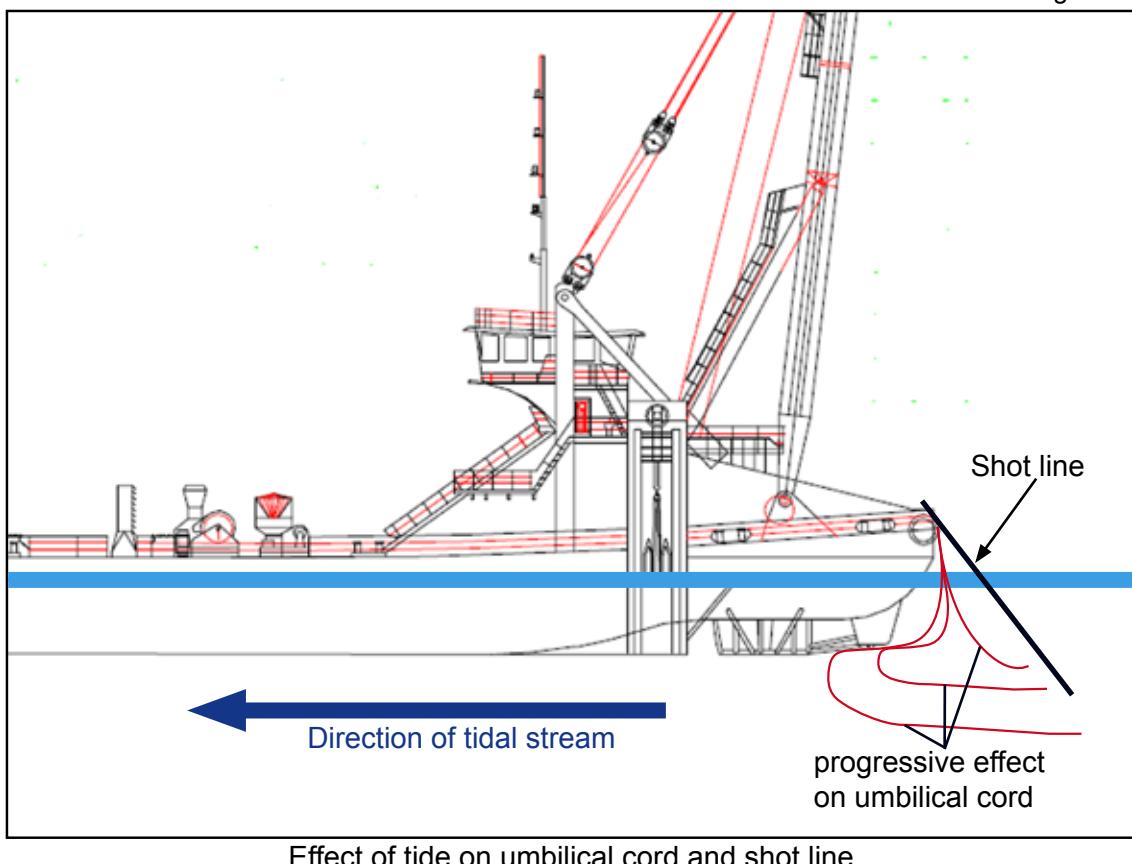
Figure 11

As soon as the diver started his descent, it is evident that his umbilical cord and the polypropylene line he was carrying were swept under the vessel's stern by the prevailing tidal stream (**Figure 11**). The cord and rope then became entangled in the vessel's aft VSP, which was idling on zero pitch, and the diver was reeled in to within 3m of its rotating blades. Loss of life or serious injury was only prevented by the rapid actions taken to stop the propulsion motors and the quick thinking of the diver to switch to his bail out bottle in what must have been an extremely harrowing situation.
