Report on the investigation of
the console detachment of the
rigid inflatable boat

Partner 1

Studland Bay, Poole

Report No 19/2008
October 2008

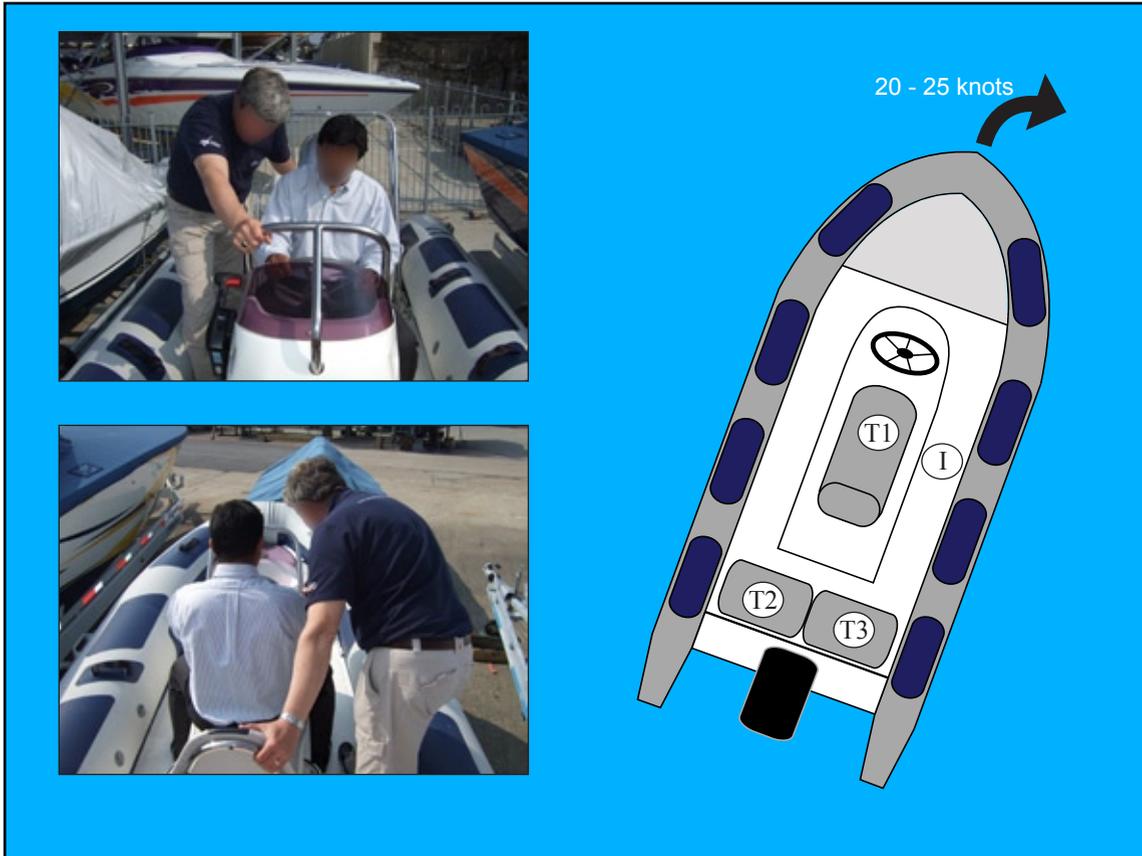
Figure 2

After lunch, the RIBs weighed anchor and the instructor in *Partner 1* demonstrated manoverboard recovery procedures to his students. These were then practised by the trainees, with each taking a turn as helmsman to recover a marker float. On completion, the instructor demonstrated a number of high speed manoeuvres, during which the straight line speed was limited to 25 knots in accordance with the training school's safety procedures. The exercise included a series of S manoeuvres and culminated in a steady U-turn at the end of each run (**Figure 1**). Two trainees each completed four circuits on the helm, without incident. The third successfully completed three circuits and began his final leg at about 1515. He was sitting on the console's double jockey seat with the instructor standing to his right, holding onto the console and seat module's chrome handle bars. The other trainees were sitting next to each other on the double bench seat at the stern of the RIB (**Figure 2**).

Positions of the trainees and instructor at the time of the accident

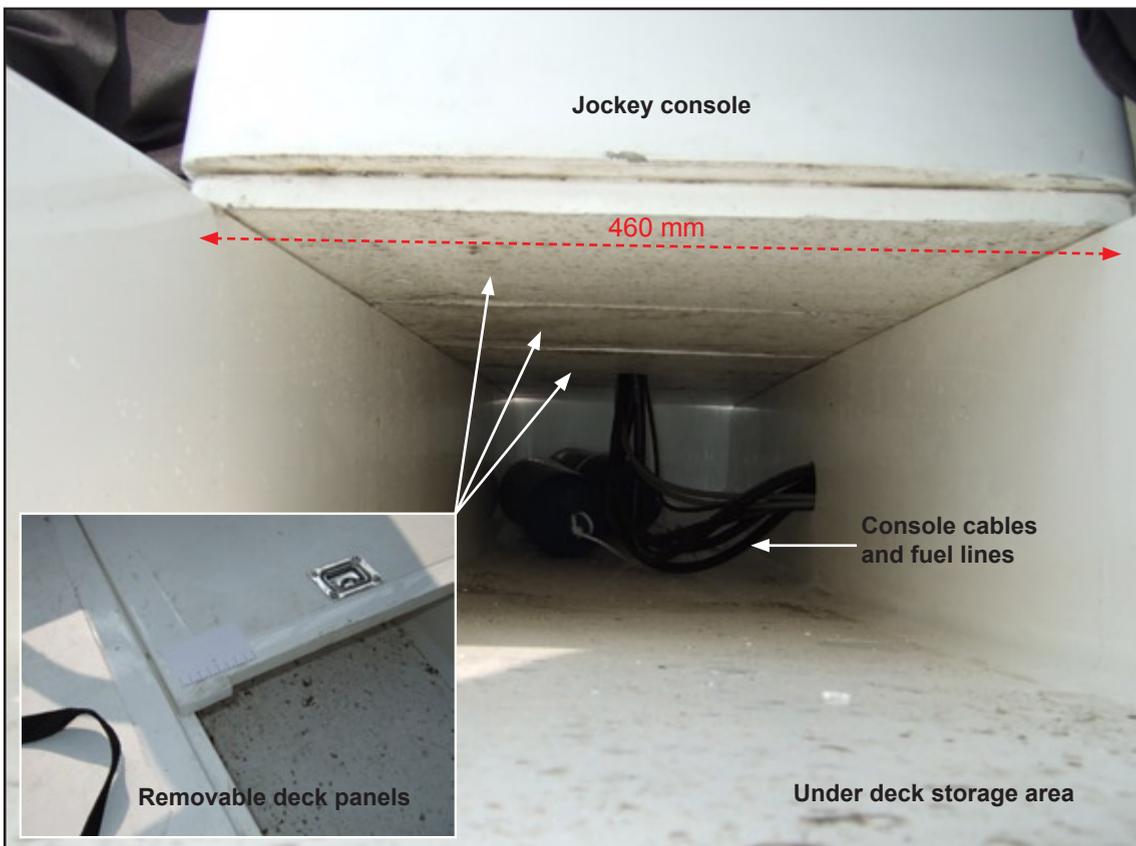
Figure 3

RIB-X XP510 under deck storage channel

The XP510 has a recessed channel which runs the full length of the deck along its centre line. The channel is used for storage and is covered by a row of 20mm thick, 500mm square, removable panels. The double jockey seat and console module sits on top of the deck panels (**Figure 3**). Generic instructions for the securing of consoles and seats to its craft are provided by RIB-X in a commissioning guide (**Annex B**). This stipulates that the modules must be bonded to the deck using a marine grade polyurethane adhesive. The structure is then reinforced by passing a series of M6 (minimum size) stainless steel self tapping screws, or coach bolts, through the module's landing flange and into the deck. The screws are fitted with penny washers and spaced at maximum intervals of 150mm.

However, the XP510 is the only RIB in the Explorer range to be fitted with a full length under deck storage channel, and RIB-X expect the removable deck panels to be supported by lengths of aluminium angle bar, or a suitable alternative, before they are bonded to the deck (**Figure 4**). This requirement is not documented in the RIB-X commissioning guide.

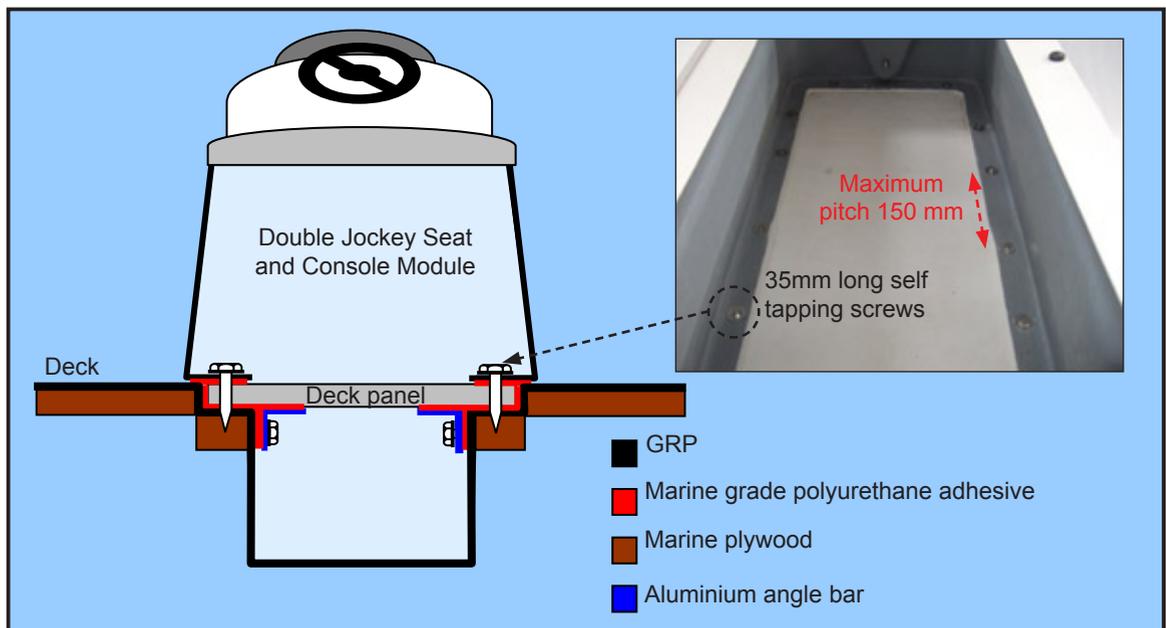
Figure 4

Manufacturer's approved securing arrangement for a combined double jockey seat and console module to the XP510 hull

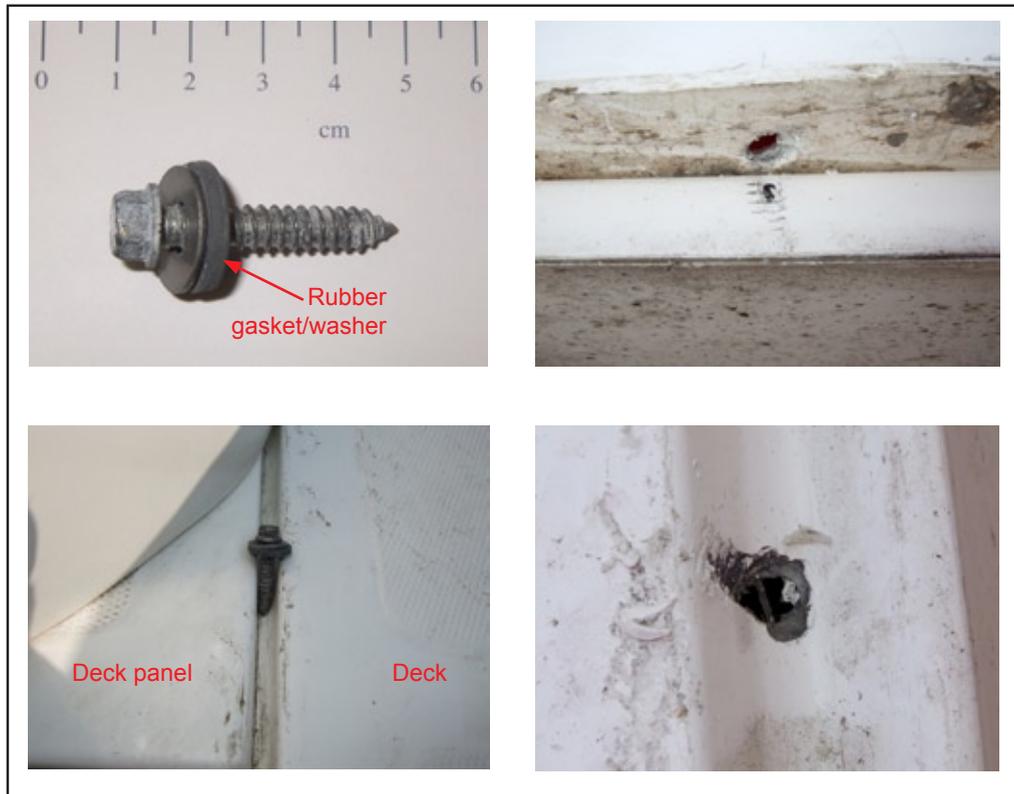
Figure 5

Partner 1 was examined at Cobbs Quay Marina shortly after the accident. The initial inspection identified that the console module had detached from the deck, but was still connected to the hull by its steering and engine control cables. The module had been secured to the deck by 4 x 35mm long M6 stainless steel self tapping screws, each fitted with steel penny washers and rubber gaskets/washers. Only one of the screws (port aft)

had effectively penetrated the deck's 18mm thick plywood base. The others passed through the gaps between the deck edge and the removable panels, merely scoring the glass-reinforced plastic (GRP) coating of the deck and the edge of the panels (**Figure 5**). A layer of silicon-based sealant was found between the console module landing flange and the deck panels (**Figure 6**).

Partner 1 console module securing screws

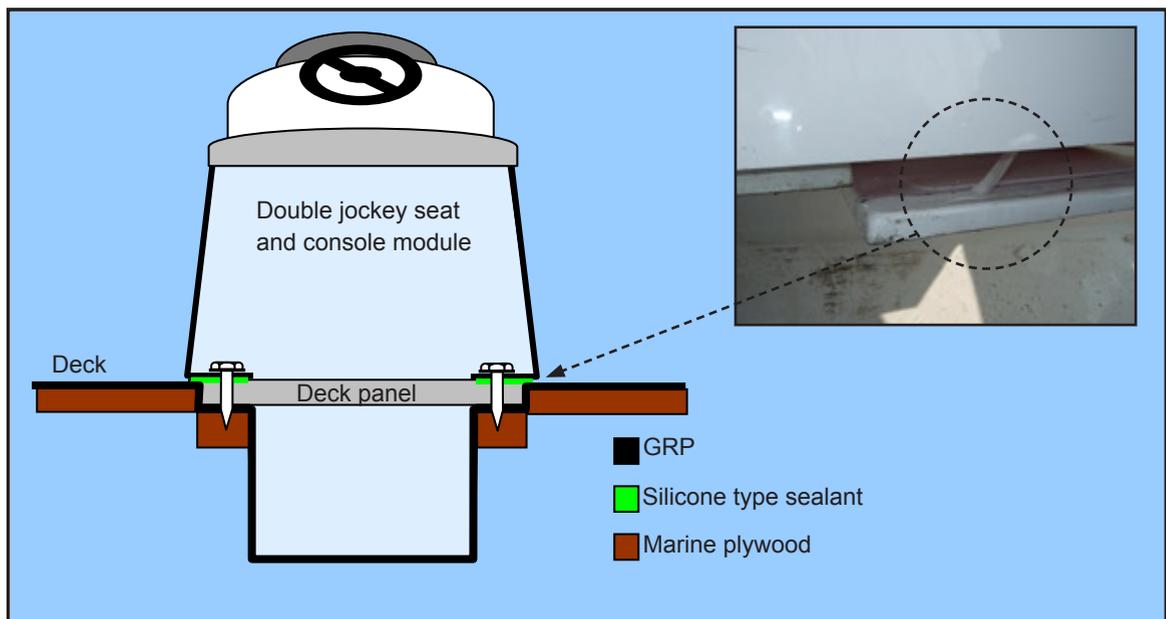
Figure 6

Partner 1 console module securing arrangement

- The seat and console module was secured to the removable deck panels by a silicone type sealant
- The removable deck panels were secured down using only four screws
- Deck panel support brackets/bars had not been fitted.

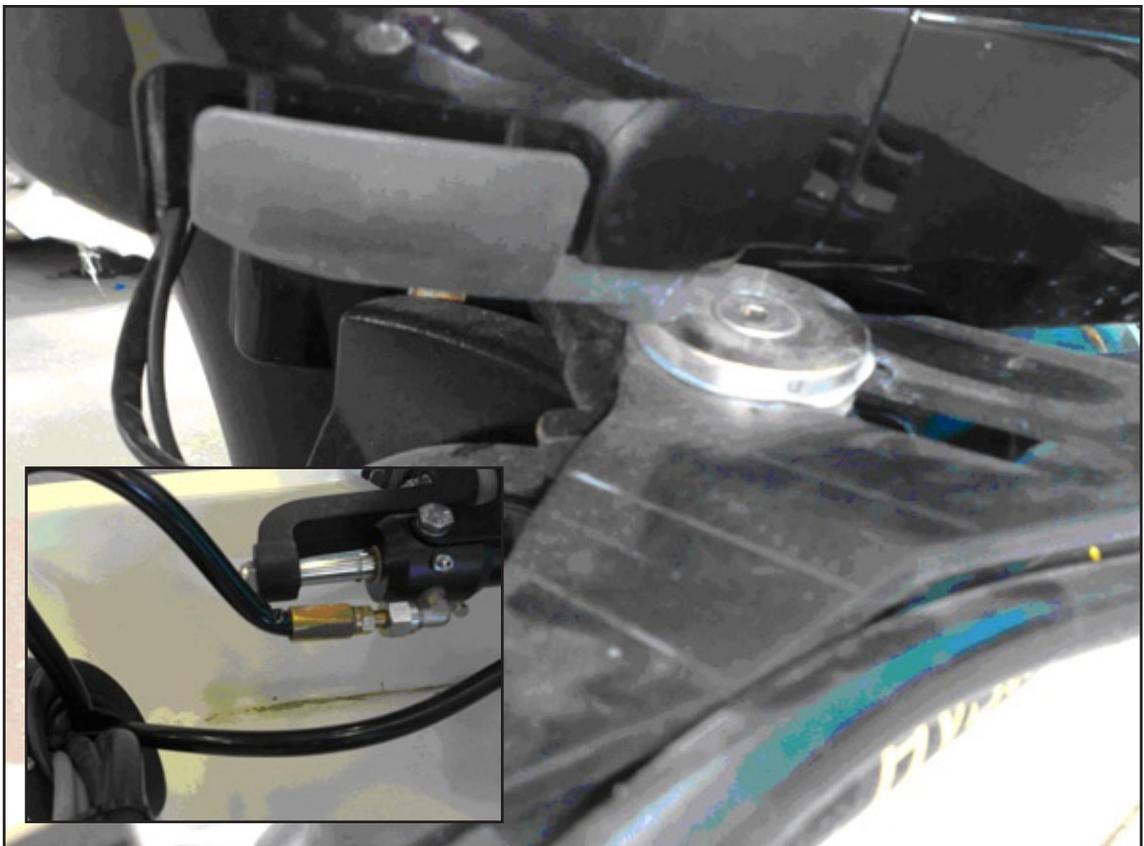
Figure 7

- No sealant had been applied to the top two engine securing bolts, allowing potential water ingress to the bare wood within the transom
- Several screws used to secure the steering mounting plate were missing
- The hydraulic hoses were incorrectly routed, causing kinking when turning to port (**Figure 7**)
- The steering system did not function through the full travel of the steering arm, limiting the movement of the engine to port and starboard
- The helm pump unit was found to be loose
- The engine was fouling on the steering mechanism and damage was evident (**Figure 7**)
- The steering helm unit securing arrangements were found to be loose, and had been fitted without sealant being applied.

Partner 1 Steering mechanism

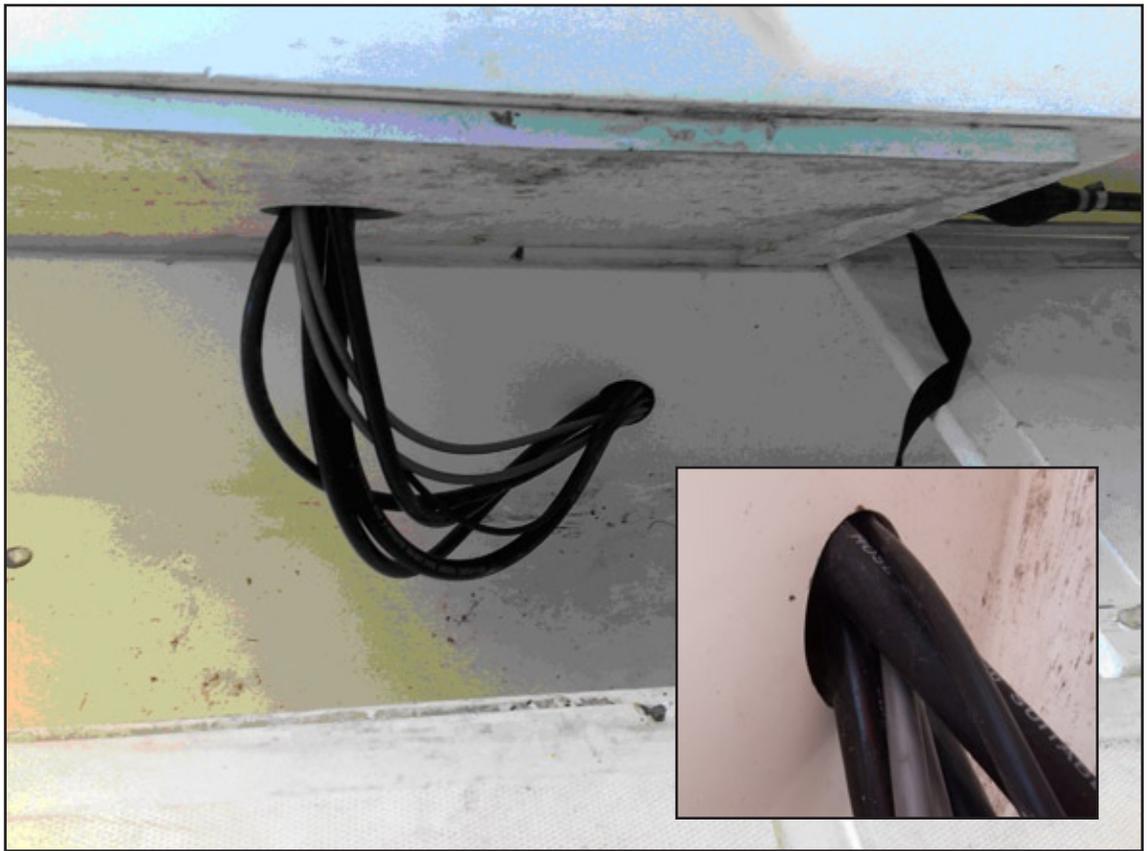
Figure 8

- Cables were unsupported and ducting tubes were not used
- Unprotected cables passed through deck openings, presenting a chaffing hazard (**Figure 8**)

Partner 1 cable runs

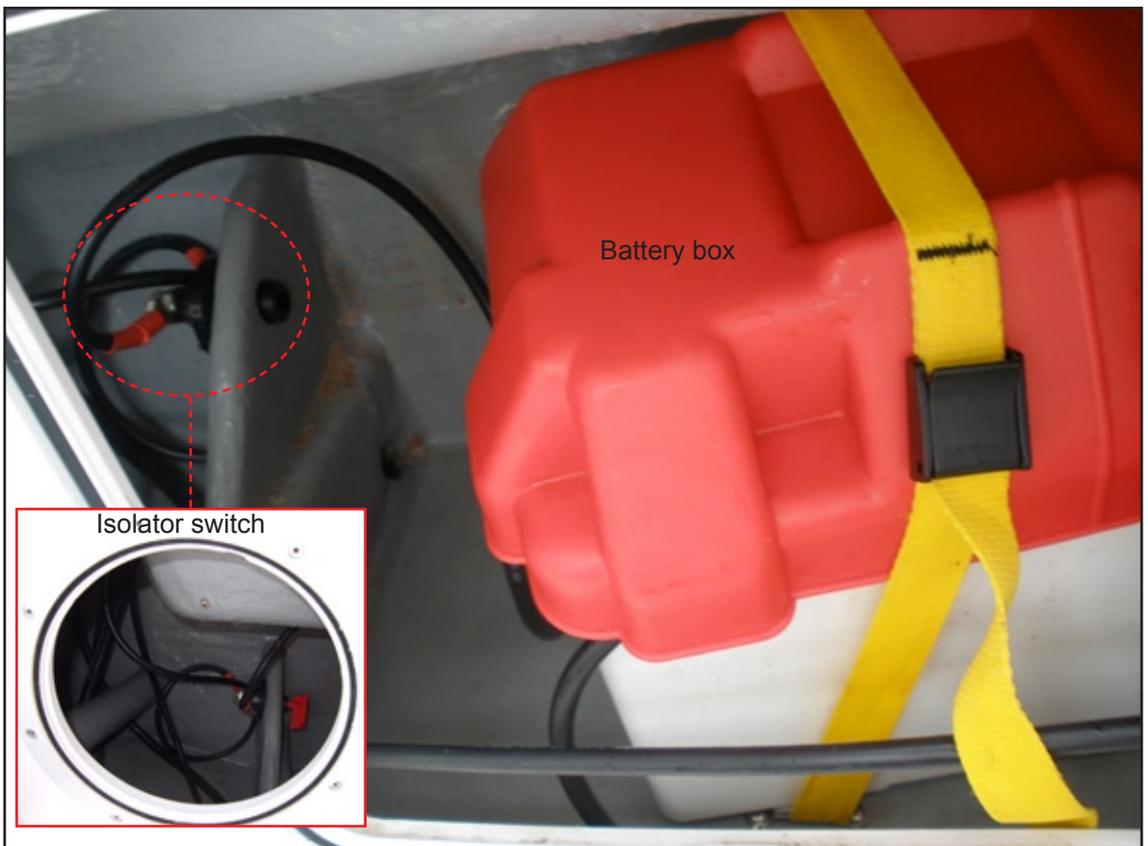
Figure 9

- The electrical isolator switch and battery were located in the bilge area; grease had not been applied to the terminals and corrosion was evident (**Figure 9**)
- The battery box was not adequately secured to the deck.

Partner 1 battery box and electrical isolator switch

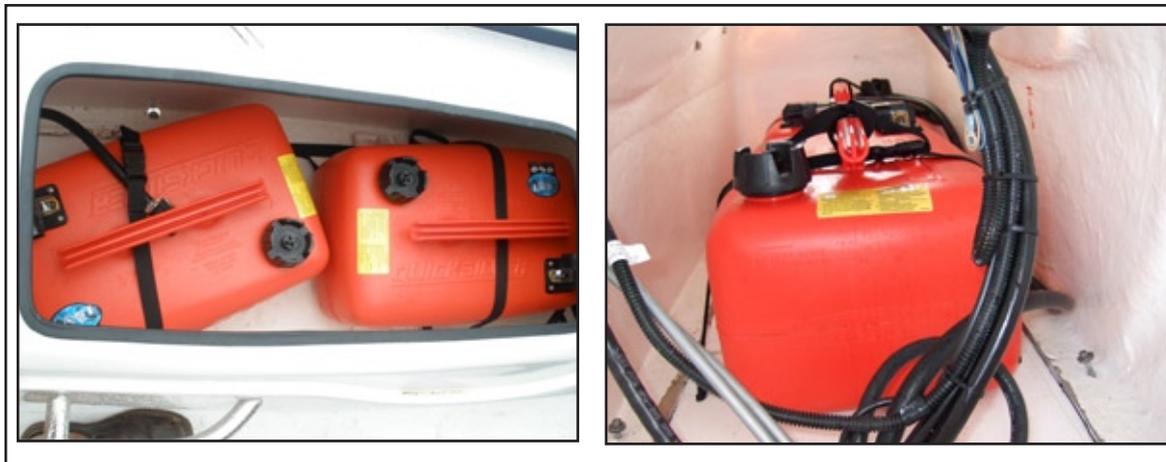
- The fuel lines were run along the same route as the electrical cables and were subject to the same chaffing hazard
- A fuel/water separator had not been fitted
- The fuel tanks were located under the double jockey seat, and no form of ventilation had been provided, allowing a potential for fuel vapour build up (**Figure 10**)
- The fuel tanks were not appropriately mounted or secured, allowing them to move within the confines of the console module.

Partner 1 fuel tanks

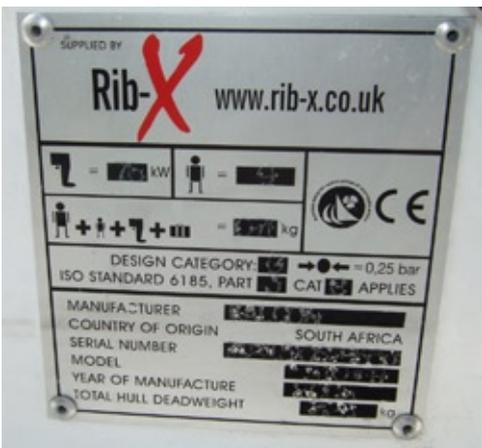
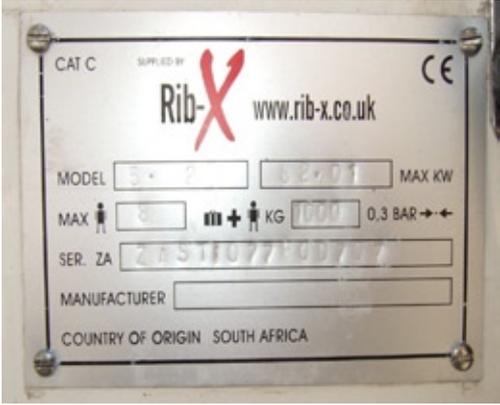
Figure 13

approved by the manufacturer. RIB-X and its dealerships advertise the maximum power rating for the XP510 as 130hp (**Annex A**). However, the craft's builder's plate gives a maximum engine size of 76kW (100hp). *Partner 1* was fitted with an 80hp Mariner outboard motor and a hydraulic steering system.

Builder's plates attached to *Partner 1* and an unnamed RIB-X Expert RIB
