Report on the investigation of
the grounding of

Astral

on Princessa Shoal,
East of Isle of Wight

Report No 4/2009
January 2009

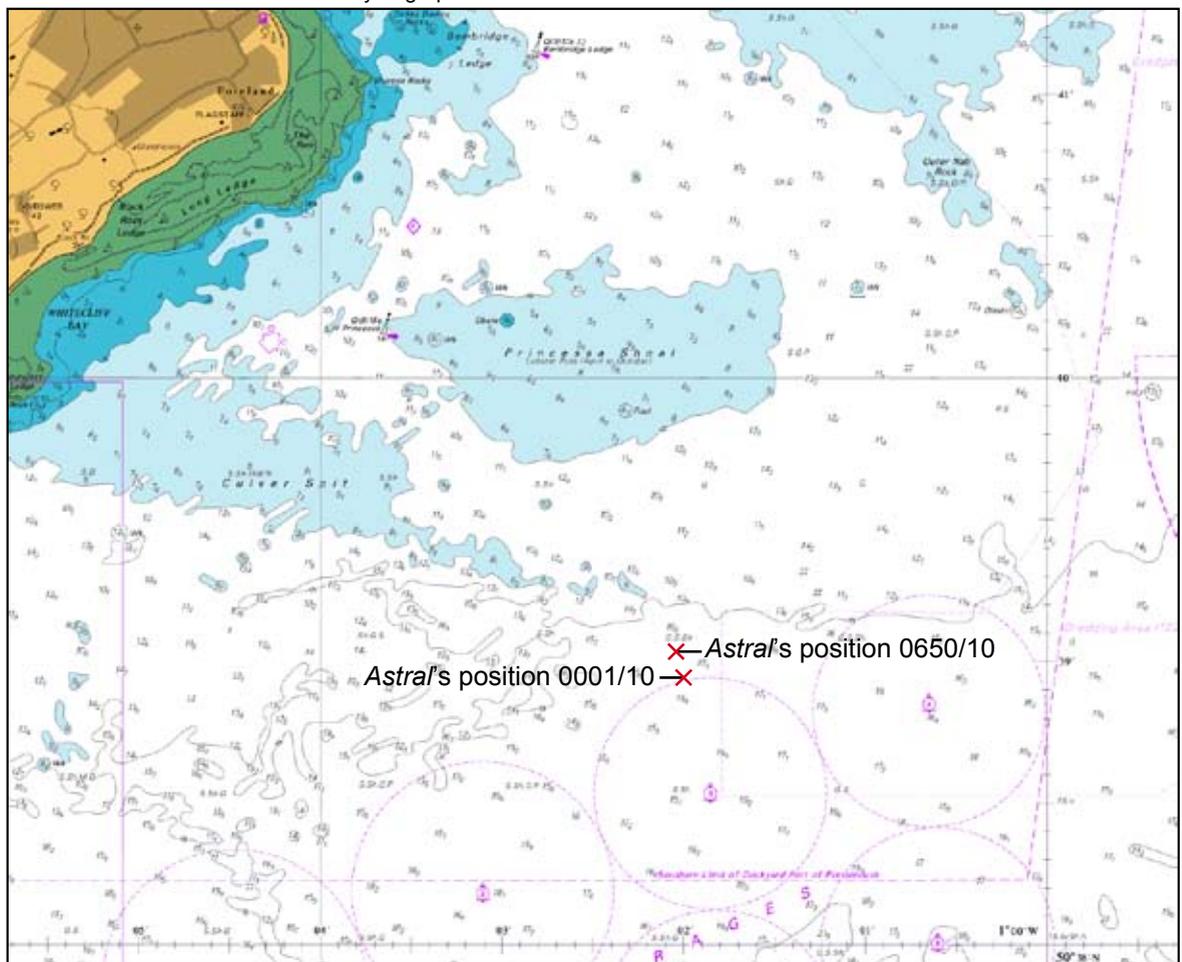
Figure 5

Astral's position at start of dragging anchor

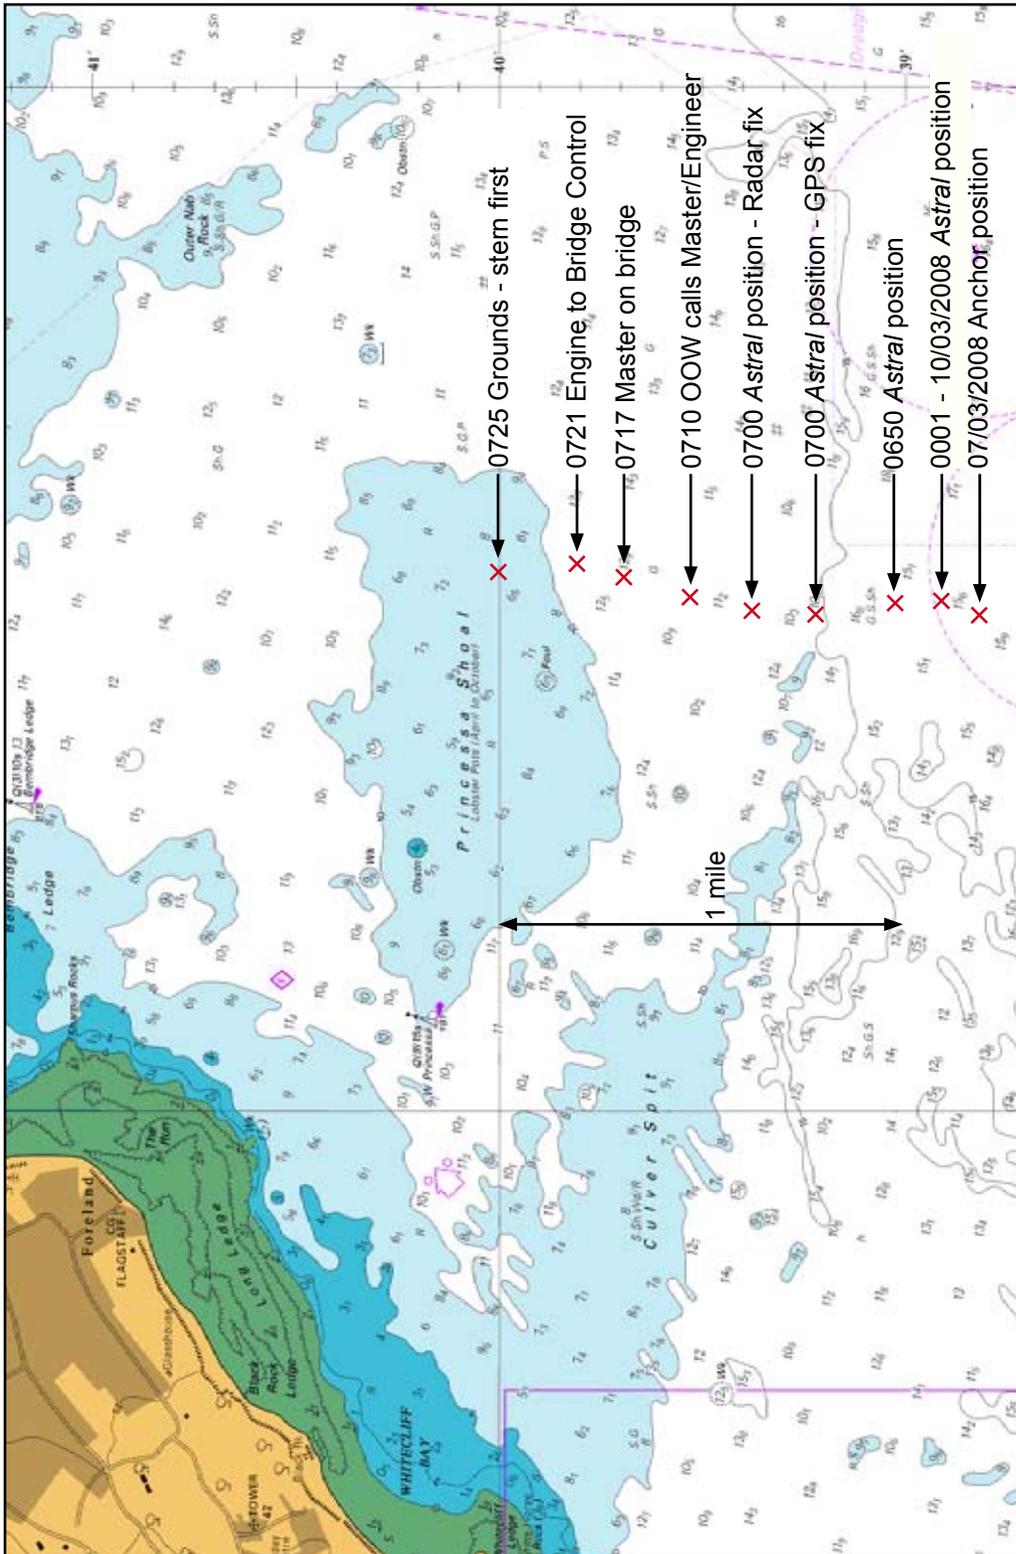
Figure 6

At 0704 the 2/ON observed the range and bearing of the Nab Tower from the radar cursor as 077° x 3.16nm (**Figure 6**), and wrote this in the logbook as the 0700 position, but did not plot this on the chart. The 2/ON believed that the discrepancy between this position and his previous position was due to the cable stretching² in the deteriorating weather, moving the ship's position to the north.

Positions of Astral during dragging

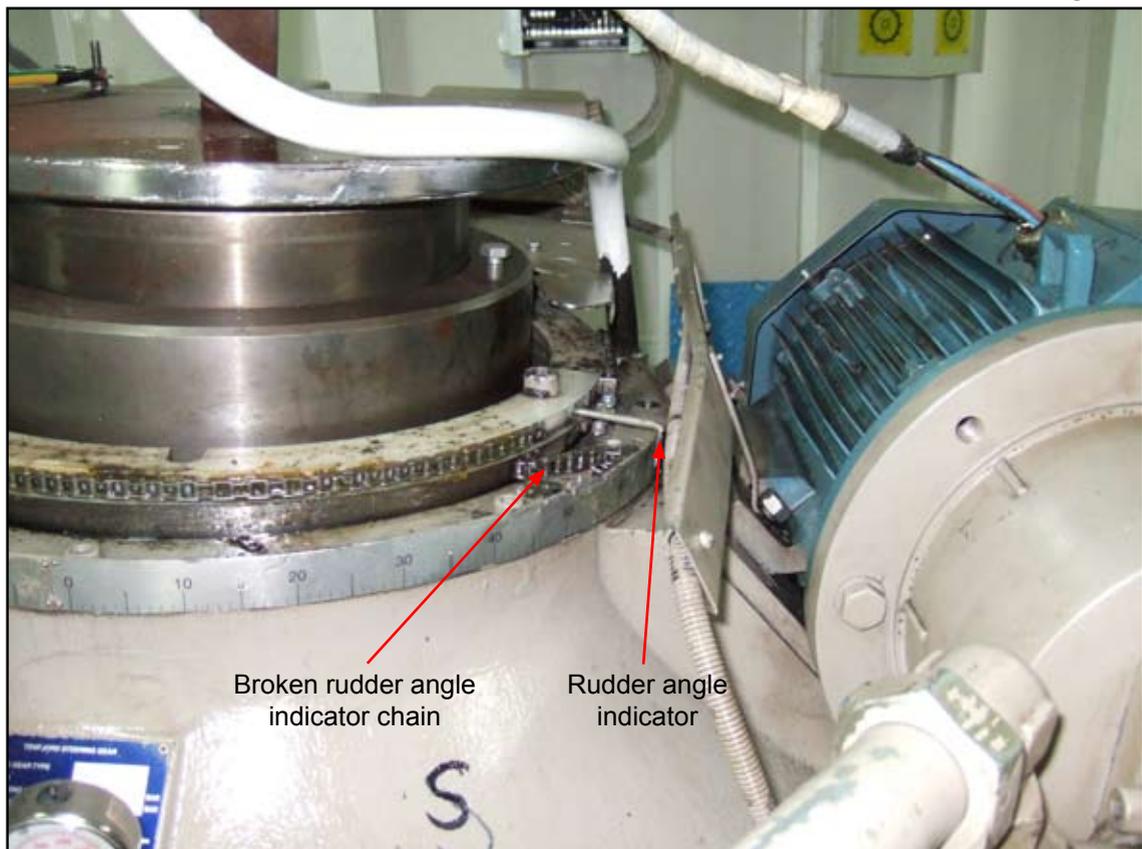
Figure 7

It was immediately apparent to the master that the vessel had lost steering and the rudder indicated hard over to starboard, an angle of 72° (**Figure 7**). An inspection by the chief engineer showed substantial damage to the steering gear, the steering motor and the adjacent hull structure, with no water ingress evident. As the rudder angle indicator chain arrangement had been snapped by the impact it was not possible to identify the actual position of the rudder.

Damaged rudder indicator

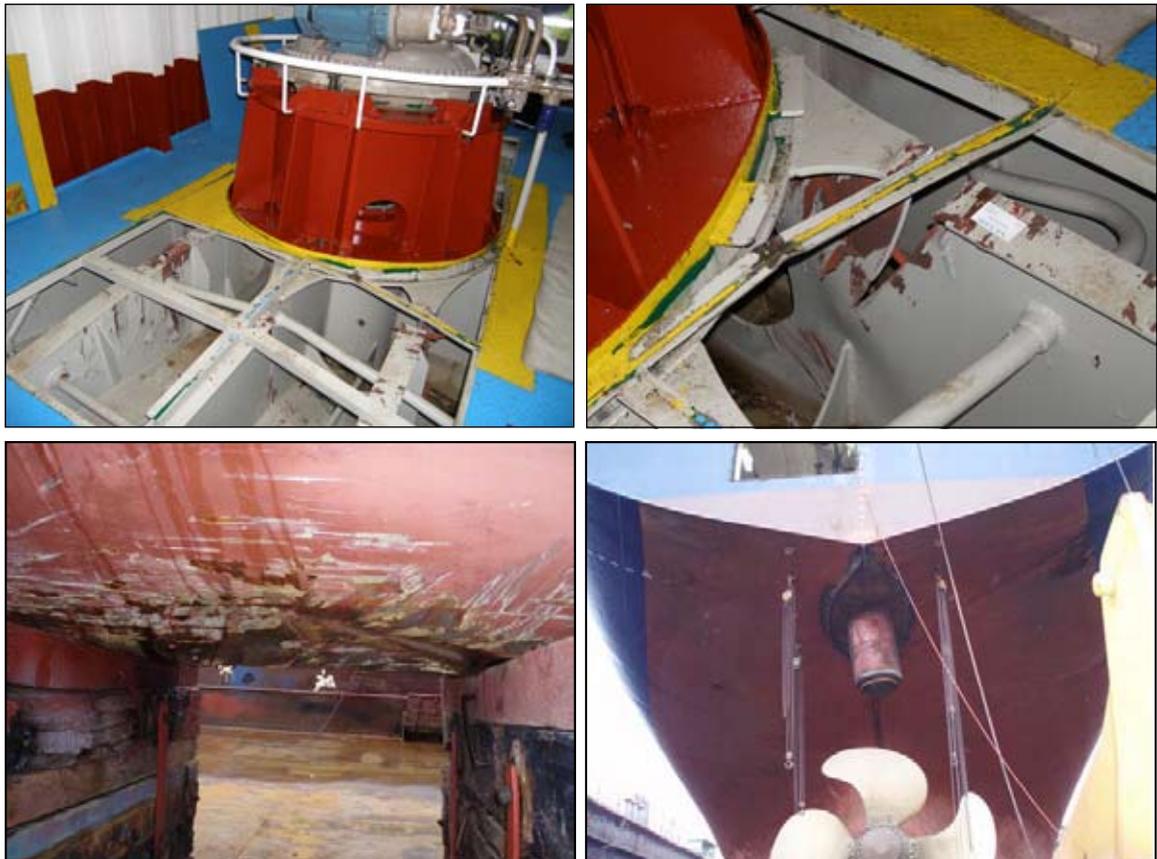
Figure 10

Extensive damage was caused to *Astral's* fish tail rudder, which was cracked on both sides along 80% of its length. Her steering gear had been lifted vertically from its mountings and landed back on the mounting bolts, stripping the threads or shearing all the securing bolts. The steering gear room shell structure, shell

plating and frames were significantly damaged (**Figure 10**) as the rudder was thrust upwards. The rudder was removed and placed on deck before the vessel was towed to Denmark for repairs.

The Bureau Veritas (BV) Survey report in the Fredericia Shipyard in Denmark, between 27 March and 16 April noted that the vessel's bottom plating had severe indents and scratches in several places. Bottom plating, totalling around 84m² and damaged frames were replaced (**Figure 10**).

Damage to *Astral*
