Report on the investigation of
Sichem Melbourne
making heavy contact with mooring structures
at Coryton Oil Refinery Terminal
on 25 February 2008

Report No 18/2008
October 2008

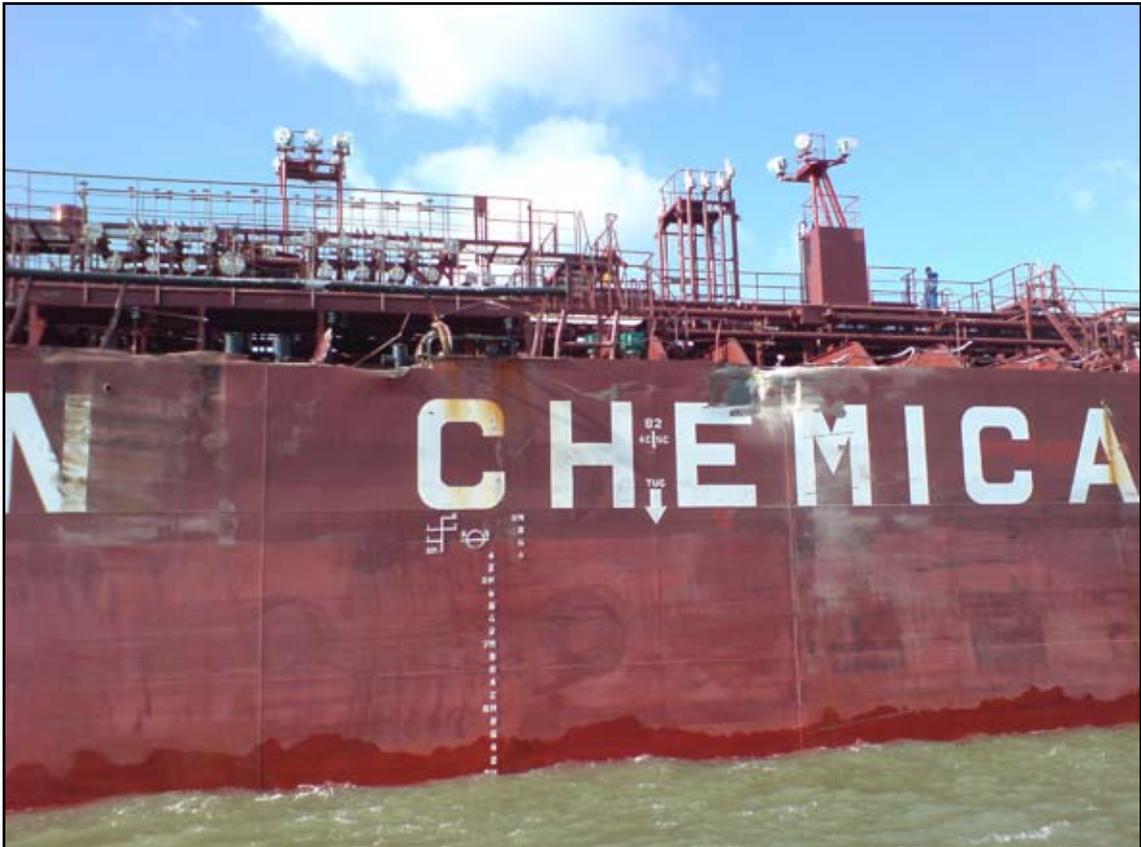
Figure 3a

At daylight the next morning the full extent of the damage to both ship (**Figures 3a, b, c, d**) and mooring structures (**Figures 4a, b, c, d**) was established. The mooring dolphins were inspected by divers for foundation damage, and were deemed secure. Temporary repairs were carried out above water and the dolphins were declared sound enough to attach ropes to, and safe for personnel.

Damage to *Sichem Melbourne*'s sheer strake and deck edge

Following an inspection of *Sichem Melbourne*'s main engine controls and hull damage by a surveyor from the ship's classification society, Det Norske Veritas (DNV), the ship was allowed to sail, in ballast, to a repair yard. Her full term Safety Construction Certificate was withdrawn and a short term certificate, valid for 6 days, was issued in its place. No deficiencies were found with the engine control system and the ship's manager made arrangements for hull repairs to be carried out.

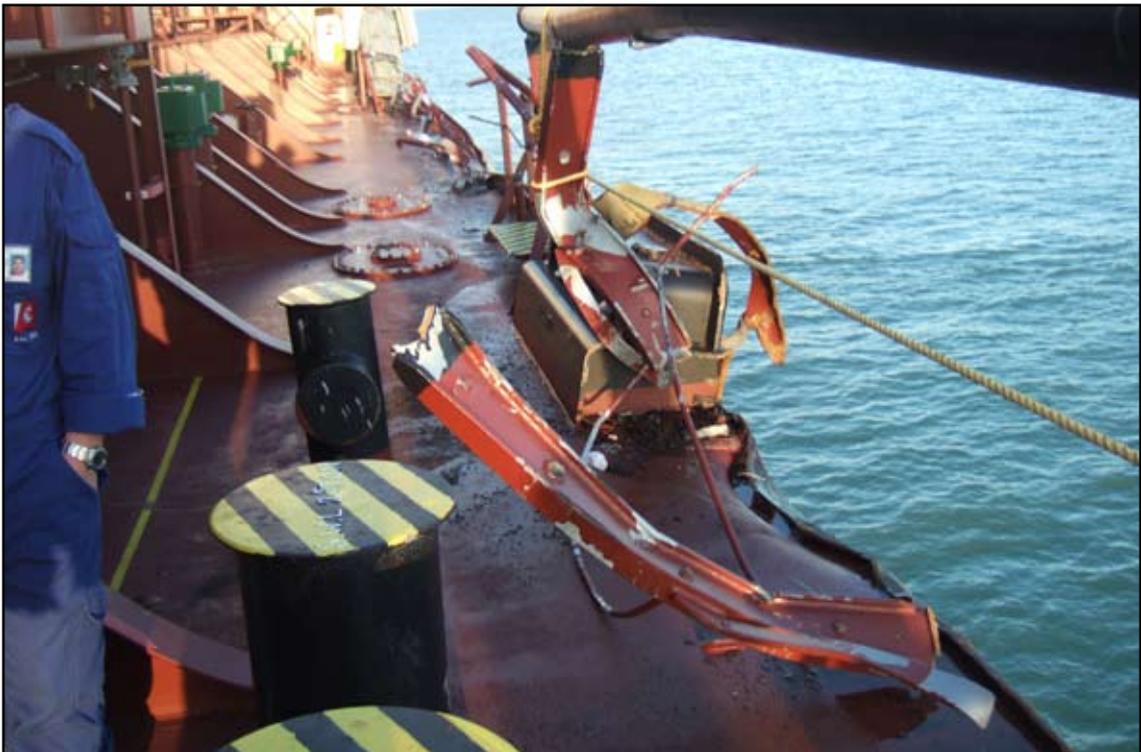
Figure 3b

Deck edge damage

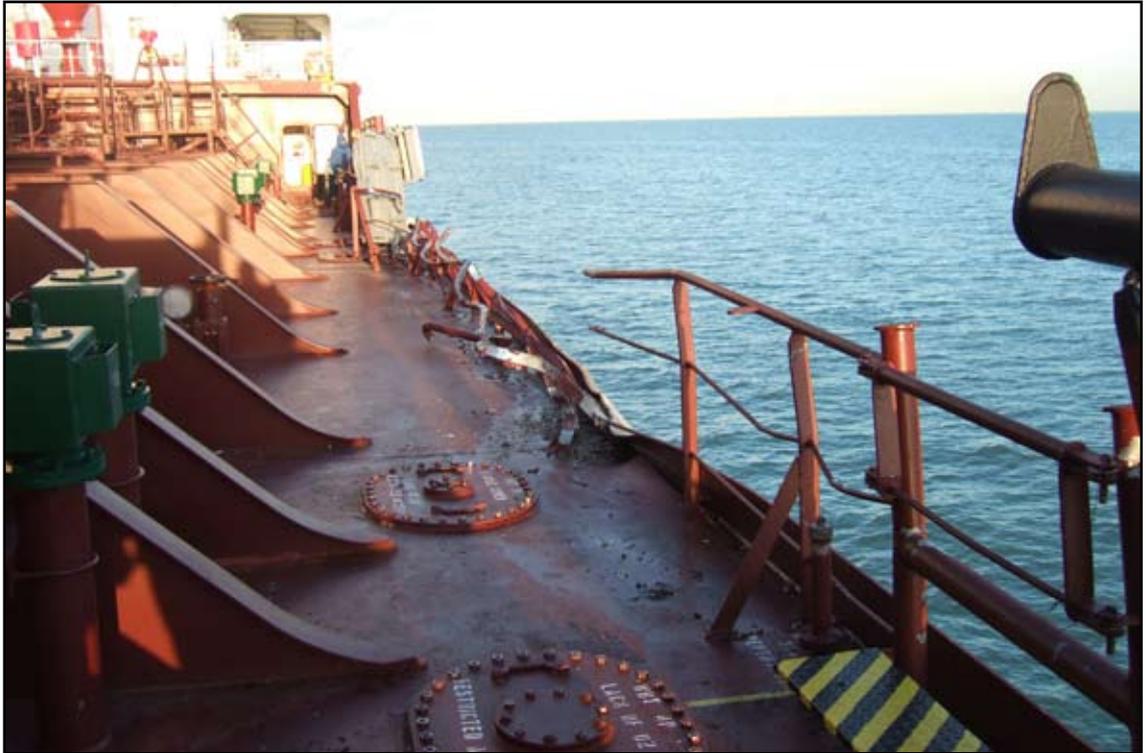
Figure 3c

Rail damage

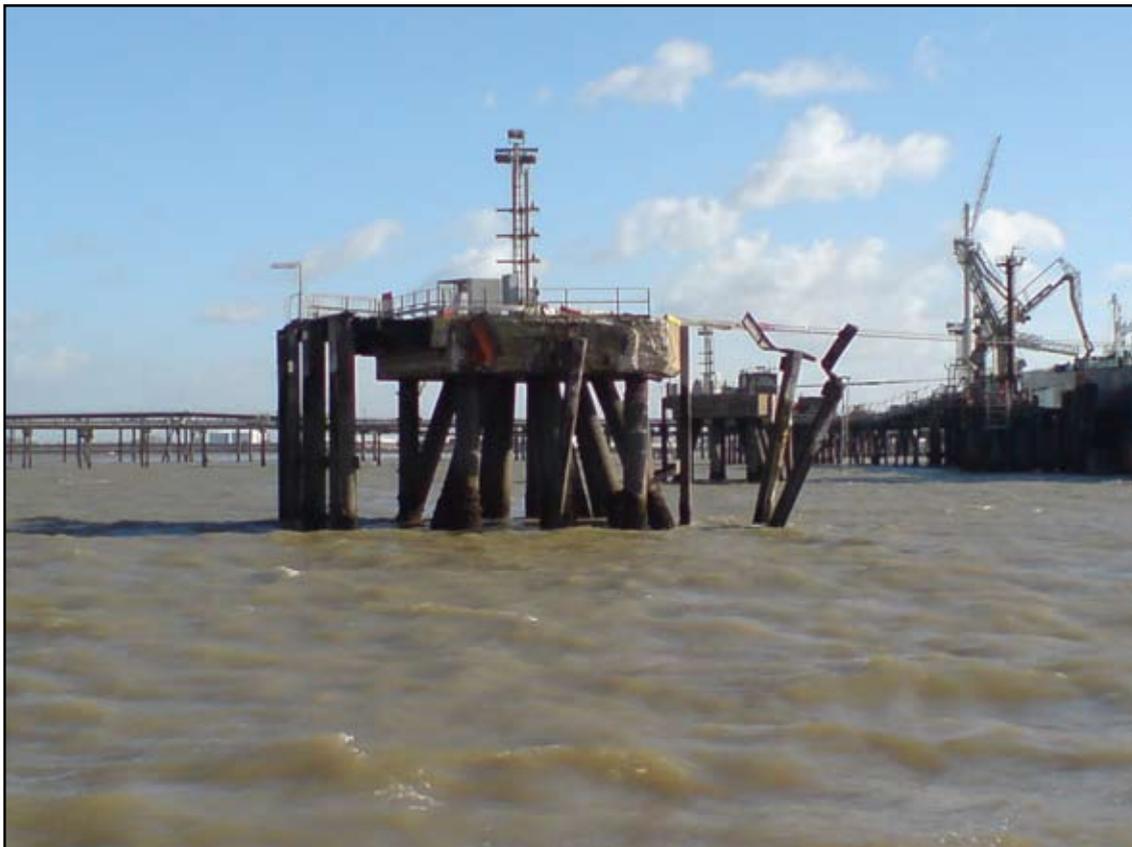
Figure 4a

Damage to MD 41 mooring structure and stern lines leading to *Thornbury*

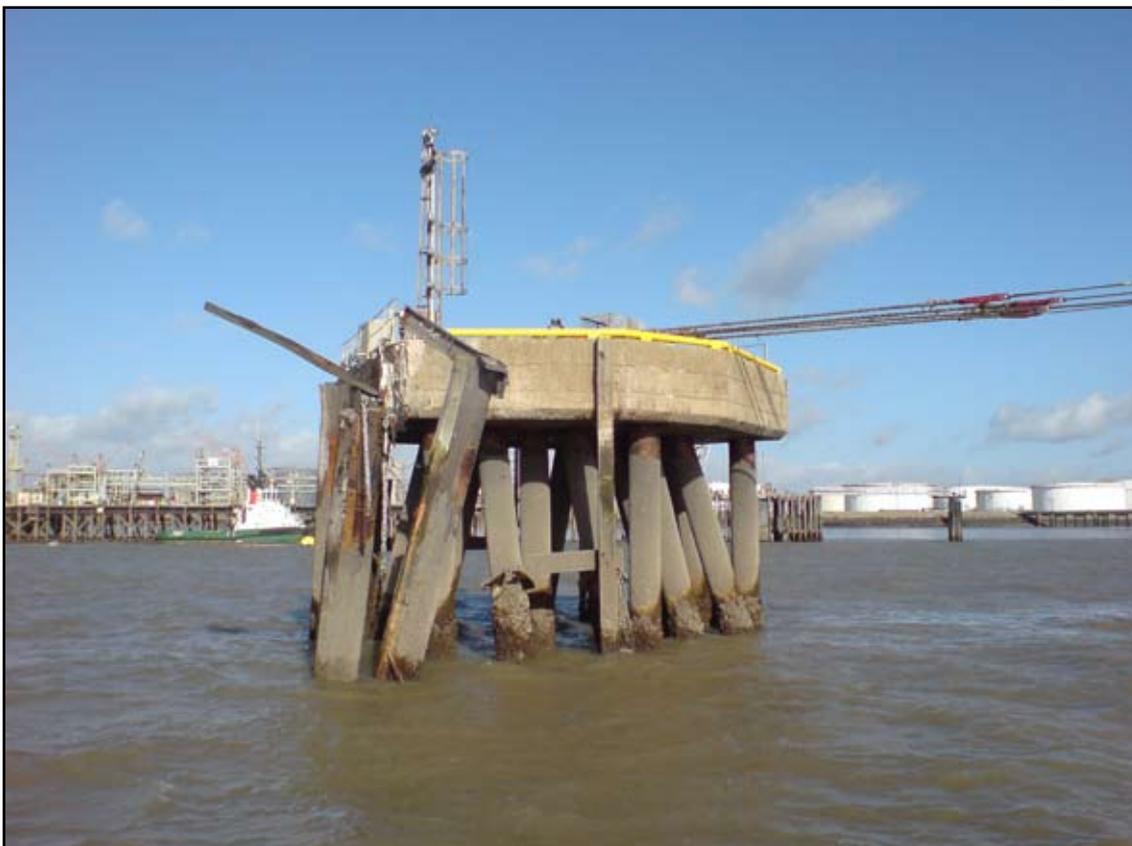
Figure 4b

Damage to MD 41 mooring structure and stern lines leading to *Thornbury*

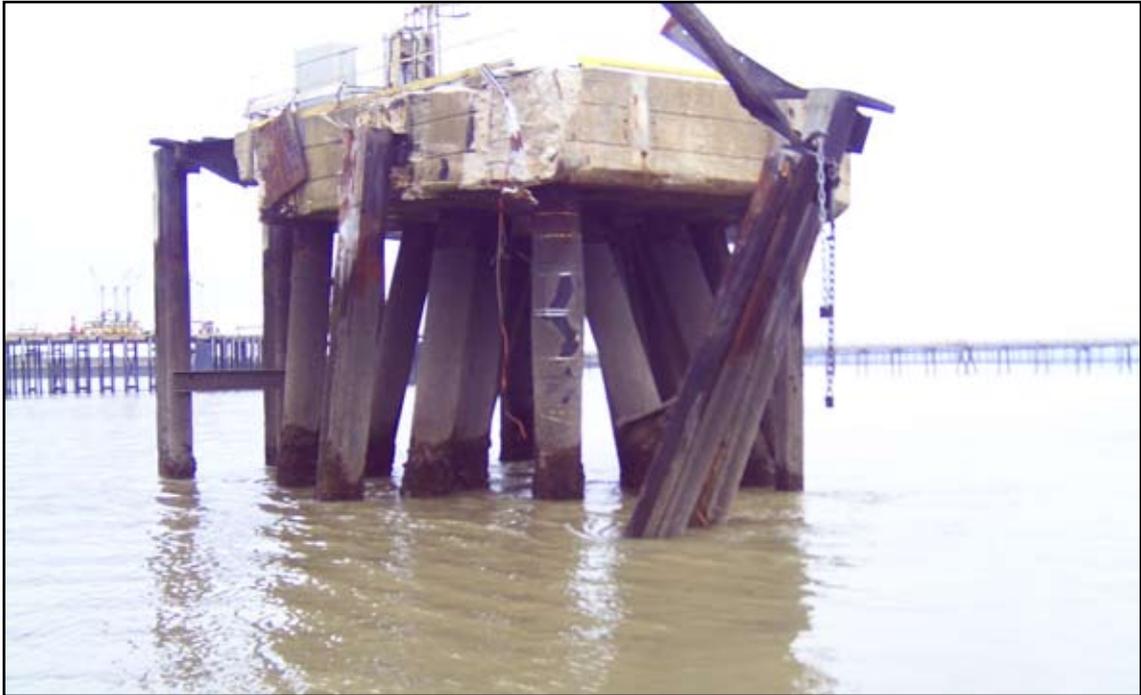
Figure 4c

Damage to MD 41 mooring structure

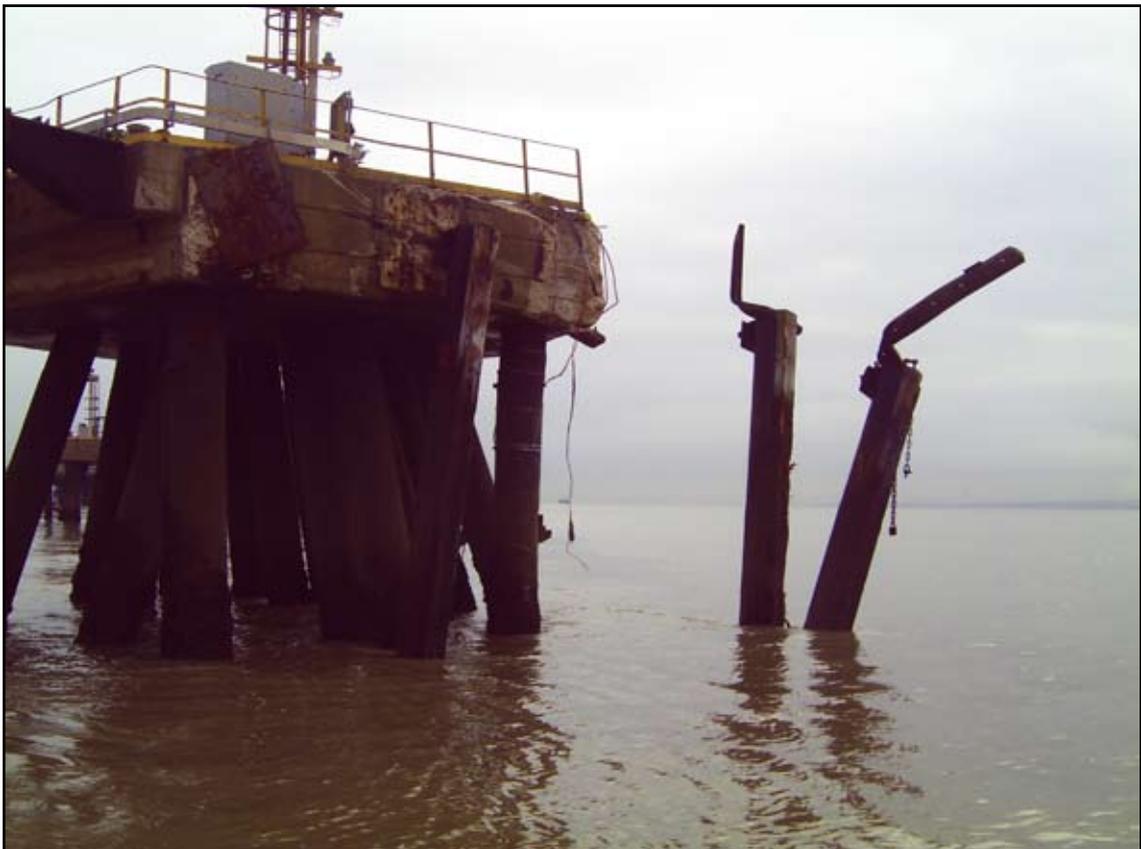
Figure 4d

Damage to MD 41 mooring structure

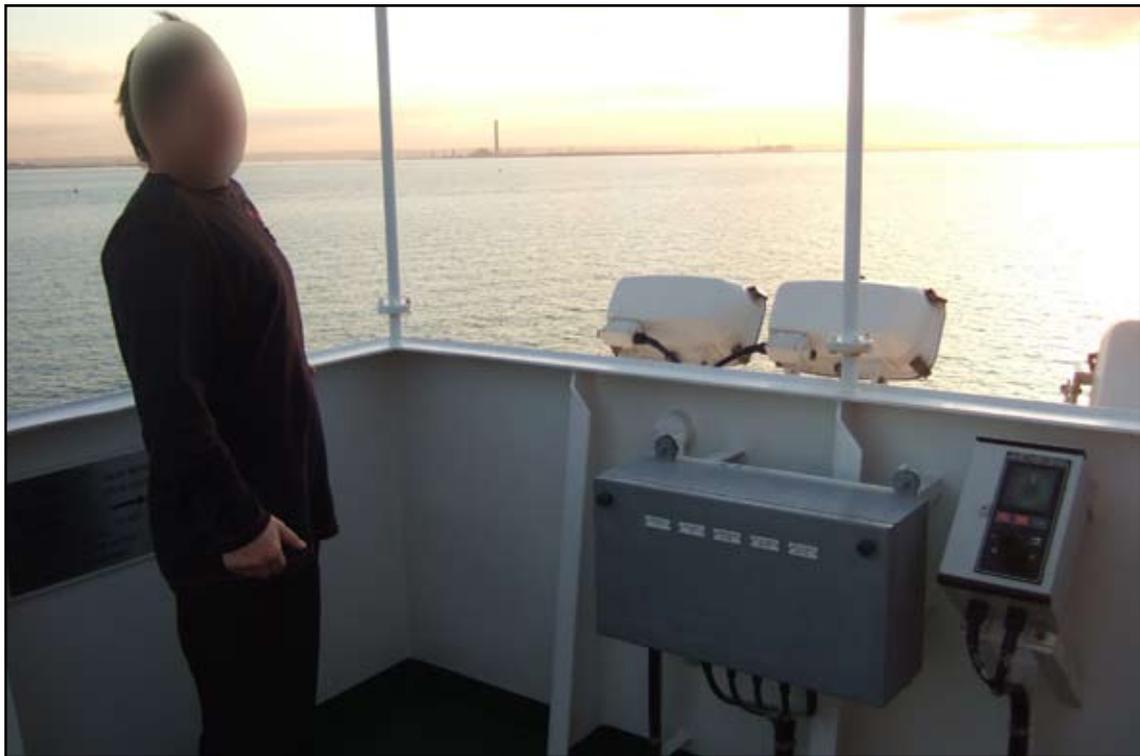
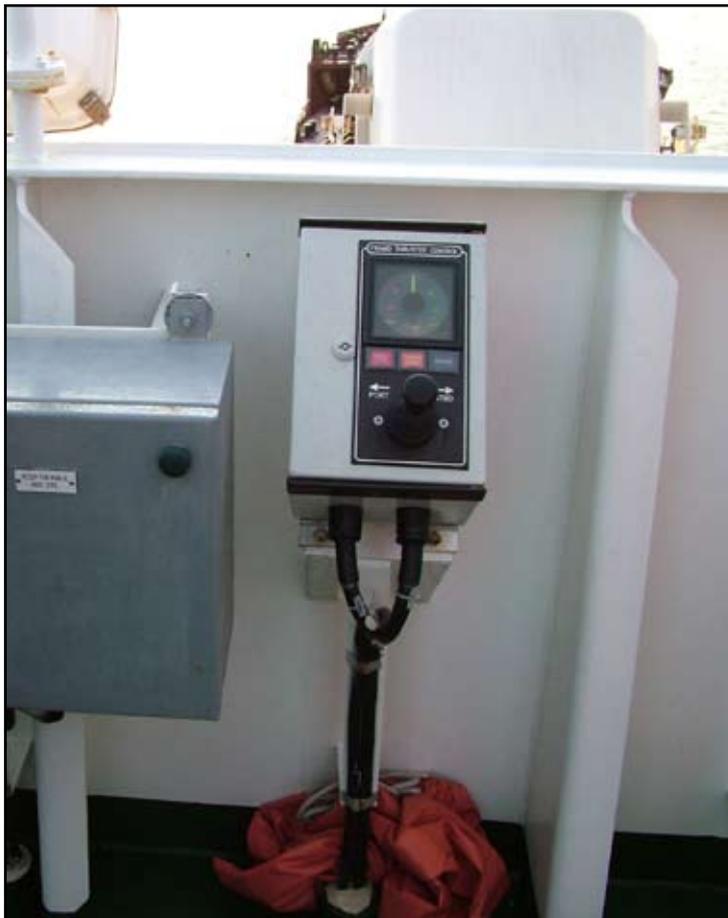
Figure 5a

At the time of the accident, the bridge was manned by the master, pilot, chief officer and a helmsman. The chief officer and helmsman were positioned by the bridge telegraph and helm respectively, while the pilot and master were stationed on the bridge wing with the master in position to control the bow thrusters (**Figures 5a, b**). The bow thruster control was placed in a convenient position for operation on the bridge wing, but the pilot's view of this was obscured by the master's body.

Bridge wing and bow thruster control

Detail of bow thruster control
