QinetiQ report on stability investigation of mv *Riverdance*

# MV RIVERDANCE Stability Investigation for MAIB

August 2009

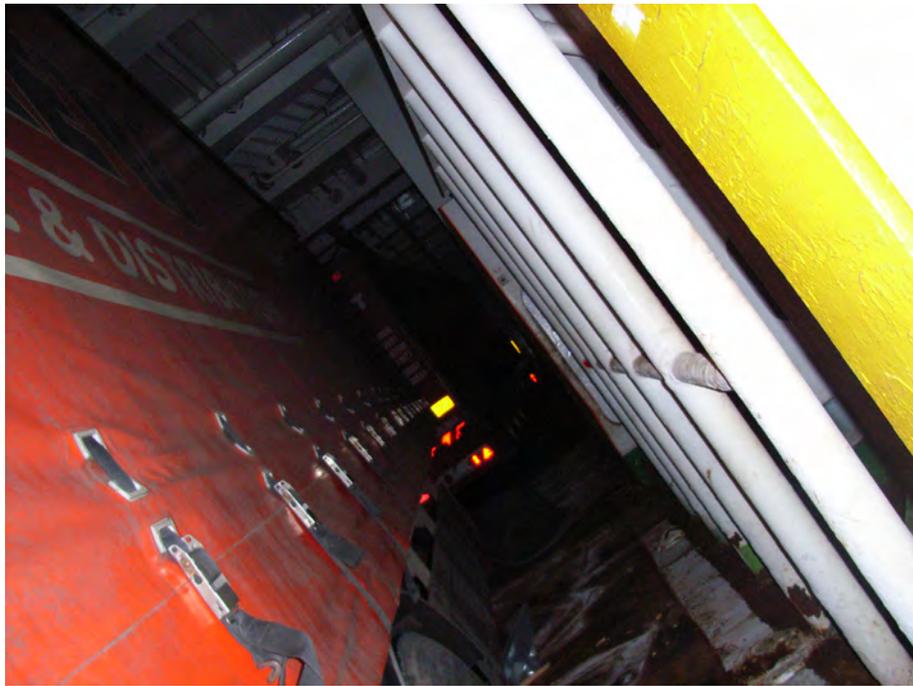
- 3.4.7 Photographic evidence from the salvage operation after the incident clearly shows that many of the trailers on the main cargo deck actually remained secured by their chains or lay securely against other trailers or ship's structure even when the vessel was at 90 degrees to Starboard on the beach. Figure 3-9, 3-10 & 3-11.

*Figure 3-9 - Trailers on the Main Deck still secured by lashing chains*

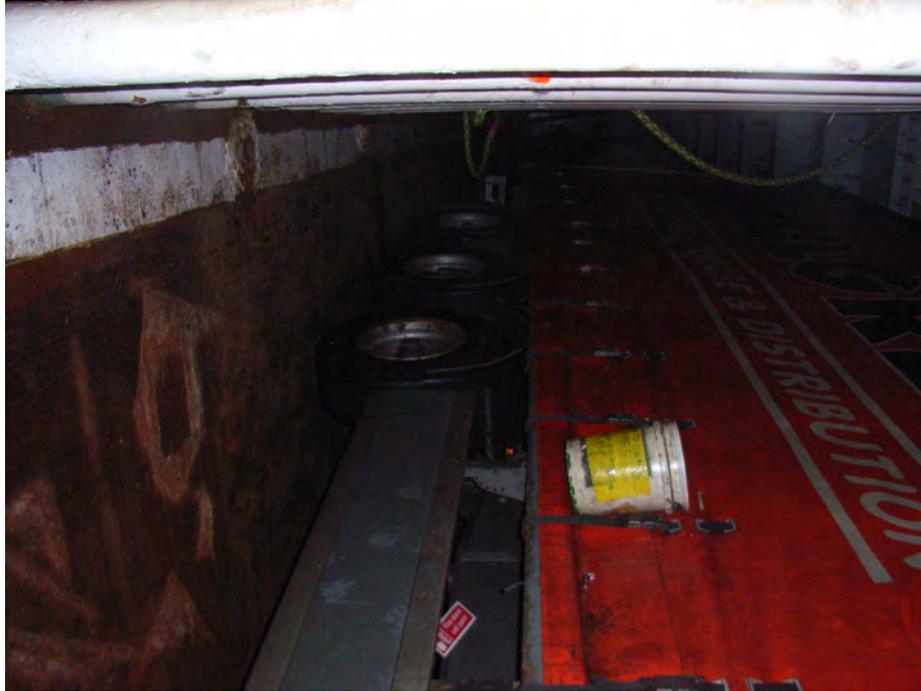
*Figure 3-10 - Trailers on the Main Deck chocked against other trailers or ship's structure*

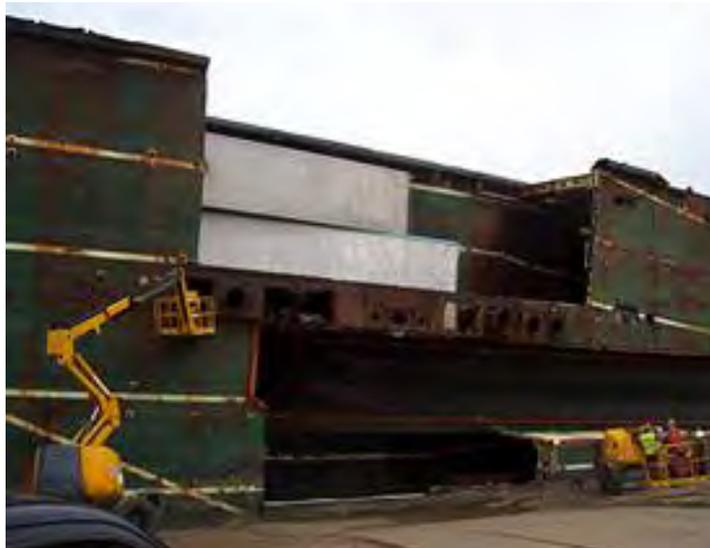
*Figure 3-11 - Intact trailers on the Main Deck during salvage*

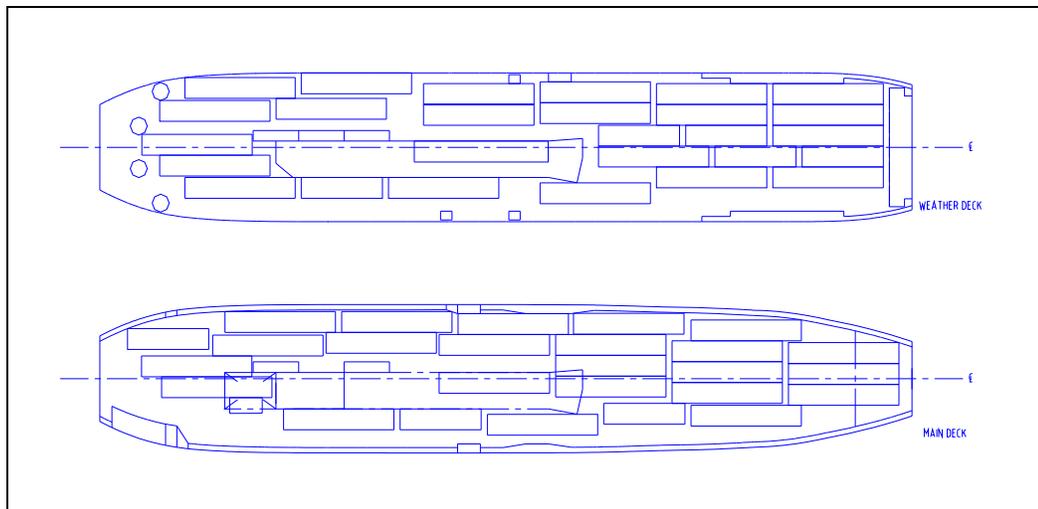
3.4.11 If it was assumed that all of the trailers on both the Main and Upper (Weather) Decks broke their lashings and moved to Port, where possible, then the layout of trailers would likely be as shown Figure 3-14 below. This figure shows all of the trailers stacked next to each other, shifted as far to Port as possible, on both Main and Upper (Weather) Decks. This also takes accounts of the internal arrangements of the vessel that restricts the movement of the trailers. This most extreme cargo shift case, with all of the cargo shifted results in a maximum list of 25.4 degrees and hence the observed mean combined list and heel angle of 35 degrees could not have been caused by cargo shift alone. Although in combination with beam wind effects the vessel could reach 34 degrees combined list and heel. However, based on the evidence from the RAF video and salvage photographs, including those shown in Figures 3-10 and 3-11, this extreme case did not occur prior to or after the turn.

*Figure 3-12 - CAD Sketch of Trailer layout with the most extreme cargo shift case with all cargo on Main Deck and Upper (Weather) Deck shifted to Port where possible*

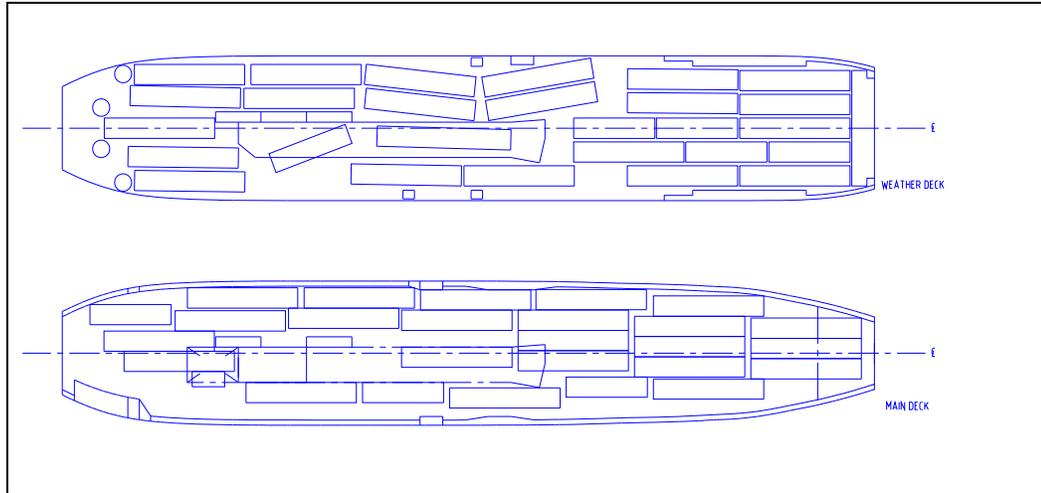
3.4.12 On examination of the RAF video following the turn, an updated detailed CAD sketch of the shift of the trailers on the Upper (Weather) Deck was created and analysed. With the cargo shift seen in the RAF video after the turn and without any loss of cargo taken into account, Figure 3-13 shows the most likely layout of the Main and Upper (Weather) Decks. The Main Deck is shown still with all the trailers shifted to Port where possible (taking into account the restrictions of ships structure and other trailers), which is know to be a worst case cargo shift for this deck, as photographs clearly show trailers still in position hanging in their restraints. The resulting list angle for this case is 8.9 degrees to Port.

Figure 3-13 - CAD Sketch of trailer layout with Upper (Weather) Deck cargo shift as per RAF video and with all cargo on Main Deck shifted to Port where possible

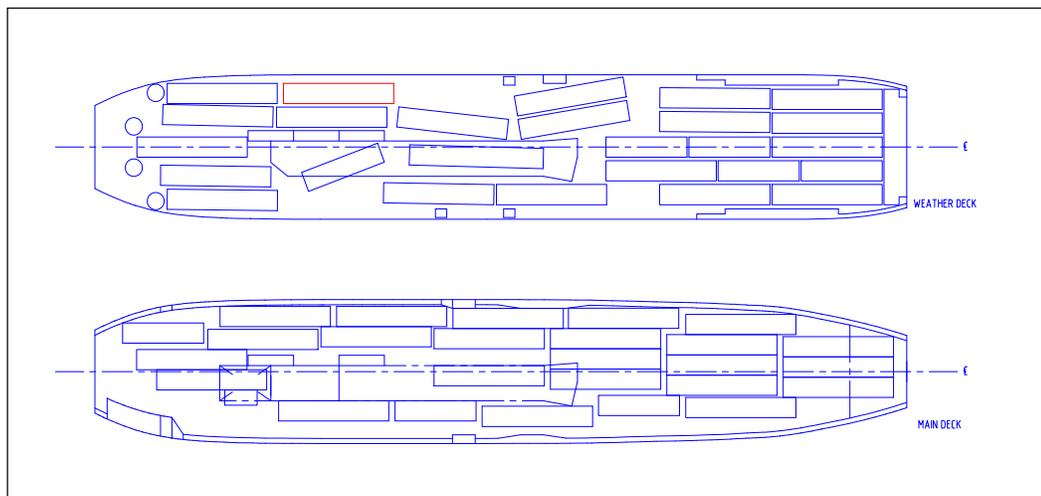
From the RAF Video it is clear that the contents of some of the trailers have been washed away by the waves. Two trailers located on the Port side of the vessel lose their cargo (The trailer shown in red in Figure 3-14 plus the one immediately forward of it), and the trailers at the aft of the vessel suffer severe damage which is likely to have resulted in cargo loss. Hence it is approximated that 44te of cargo in total is lost. The third trailer from the stern on the Port side was lost overboard (a loss of an additional 6 te, 50 te lost in total). The loss of cargo on the Port side Upper (Weather) Deck results in a decrease of the list angle to 4.5 degrees to Port. The video picture of the upper deck is shown in Figure 3-15 and 3-16. Figure 3-16 shows the skirt side of the trailer flapping and the severe damage to the trailers at the aft of the vessel.

Figure 3-14 - CAD Sketch of trailer layout with Upper (Weather) Deck cargo shift and loses as per RAF video and with all cargo on main deck shifted to Port where possible

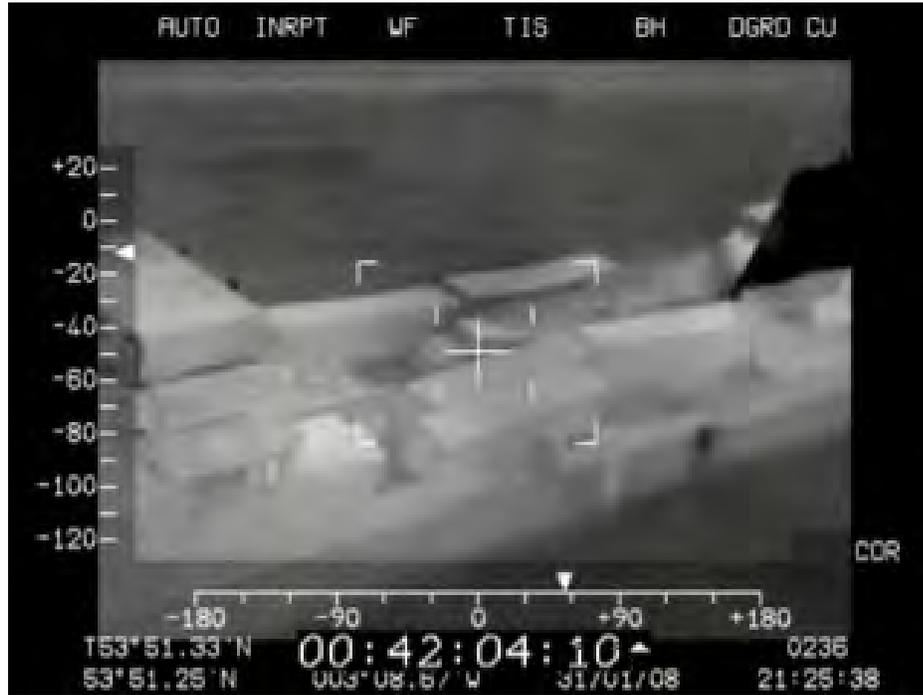
3.4.14 In order to consider the most likely case for cargo shift contribution to the incident, for the remainder of the analysis the contribution by cargo shift is considered as 4.5 degrees, which with the wind effects (45kts) would produce a combined list and heel angle of approximately 10 degrees.

*Figure 3-15 - Video of Upper (Weather) Deck trailer layout after the turn*

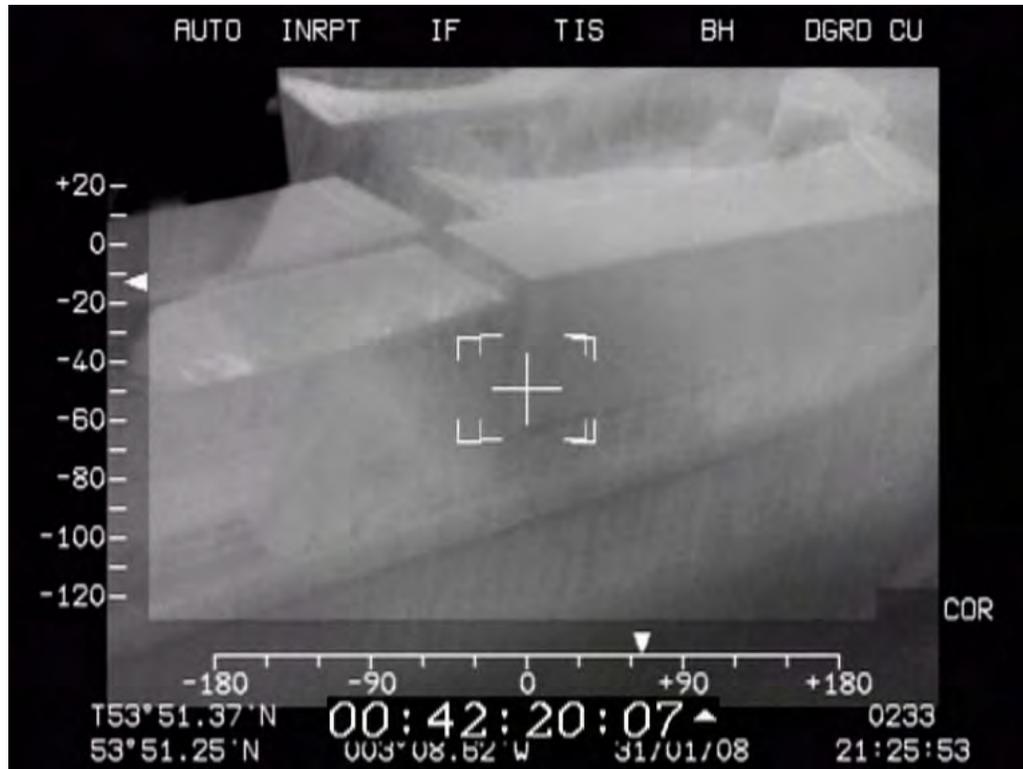
Figure 3-16 – Video of Weather Deck trailers showing damage to trailers

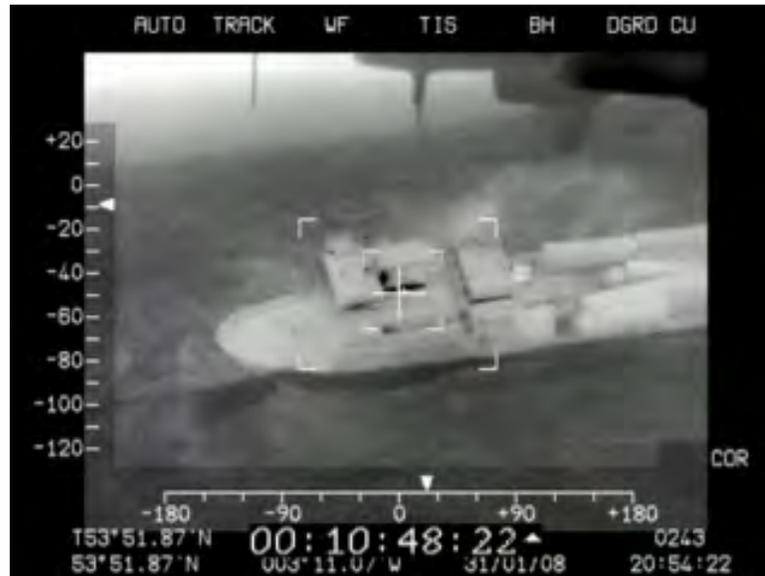
severe roll and rapid turn to Starboard. This indicates that significant amounts of water had flowed rapidly along the Upper (Weather) Deck during the turn. The video footage also shows that while the vessel was initially over at approximately 35 degrees to Port (at 2100) this angle can be seen to have slowly reduced to approximately 20 degrees by 2135, Figure 3-18 & 3-19.

Figure 3-18 - Vessel at 35 degrees in waves at 20:54

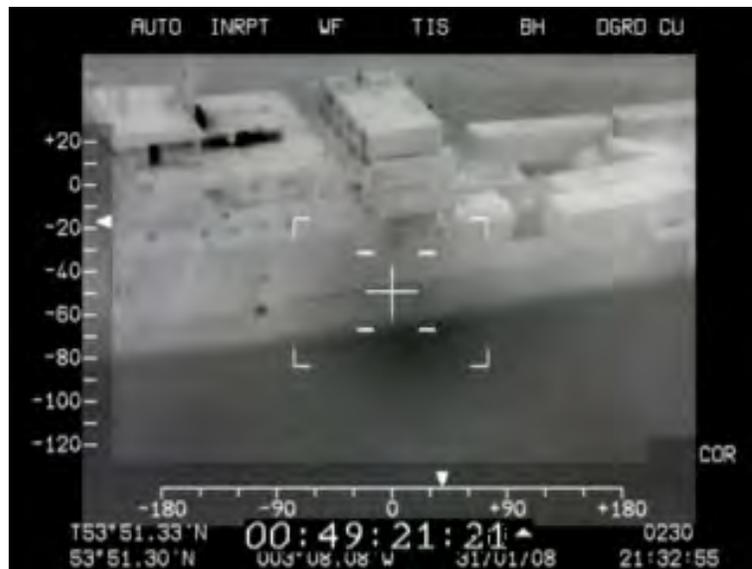
Figure 3-19 - Vessel at 20 degrees in waves at 21:32

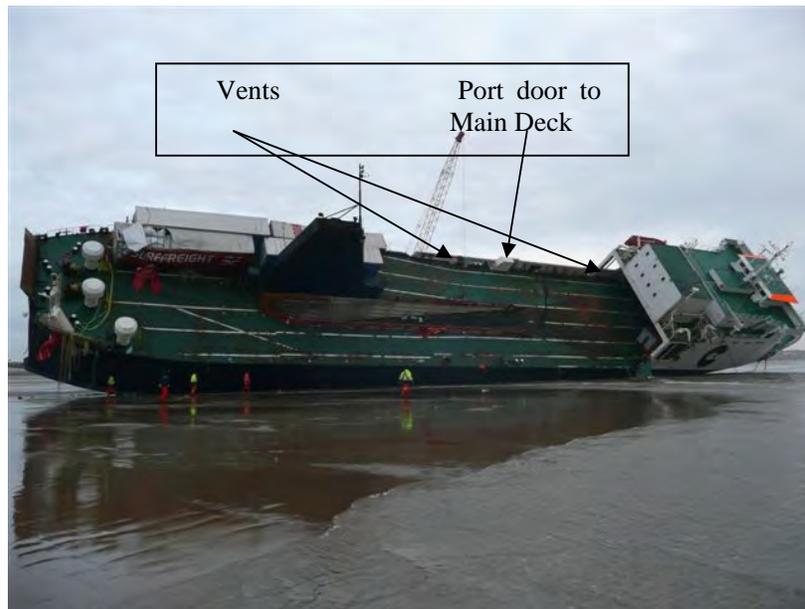
These main down flood points are shown pictorially with those most likely to down flood due to their position are marked in red in Figure 3-21 and on photograph Figure 3-22.

Figure 3-22 - Picture of upper (weather) deck showing potential downflooding points

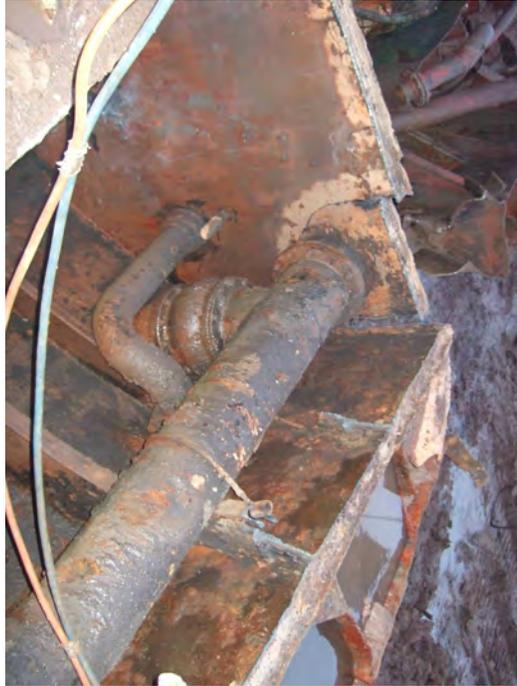
- 3.8.3 A crew member reported that the valve on the main cross connect between the main heeling tanks 13 Port and Starboard, was opened at some time shortly after 1 hours notice at 1830, approximately 50 minutes prior to the turn to Starboard. If this valve is opened, the pump would not restrict fluid transfer and would spin freely with any movement of fluid in the pipe. The possibility of transfer of fluid between these tanks hydrostatically is investigated. As can be seen in Figure 3-28, once the main cross connection valve between the two tanks is opened there are the sprung non return valves on the pipe inlets and the height of the discharge pipe exits stopping the flow between the tanks. The valve is shown in Figure 3-29 below. The render at Figure 3-30 is shown to further indicate the pipe and valve arrangement in the vessel.

*Figure 3-29 - Picture of Starboard tank suction non return valve*

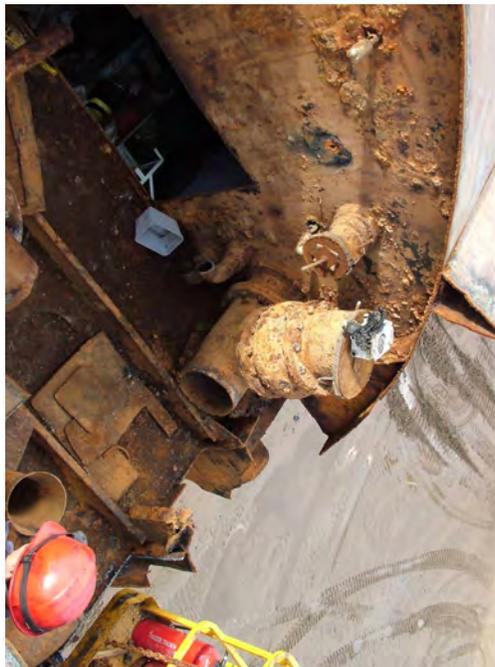
3.8.10 Detailed drawings of the valve arrangement were not available, so only photographs taken by the MAIB during the demolition phase were available to undertake an approximate calculation on the force of the spring on the inlet valve. The valves from the salvage process are shown in photographs in Figure 3-34, 3-33 & 3-34.

*Figure 3-34 - Picture of Port heeling tank during demolition*

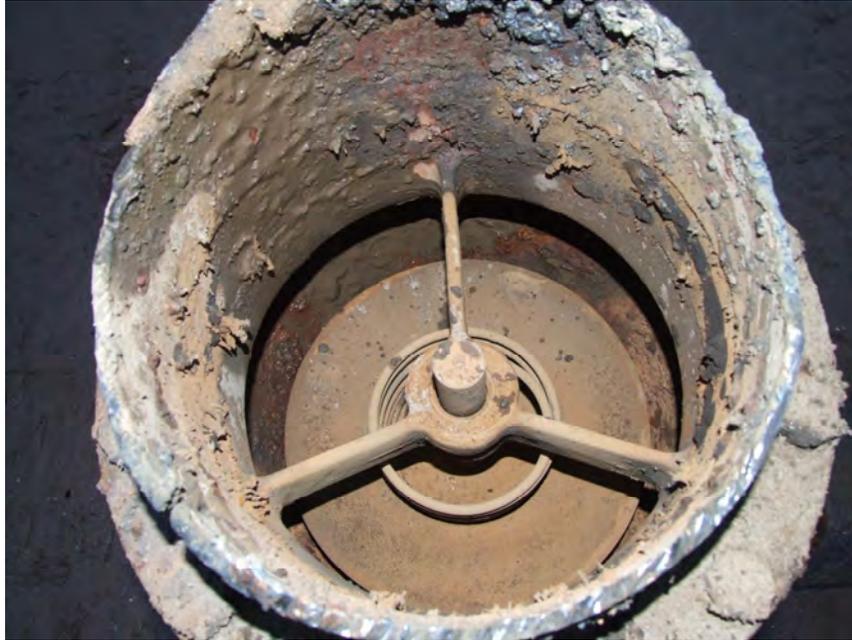
*Figure 3-35 - Picture of Starboard discharge valve in the open position – note extended centre shaft*

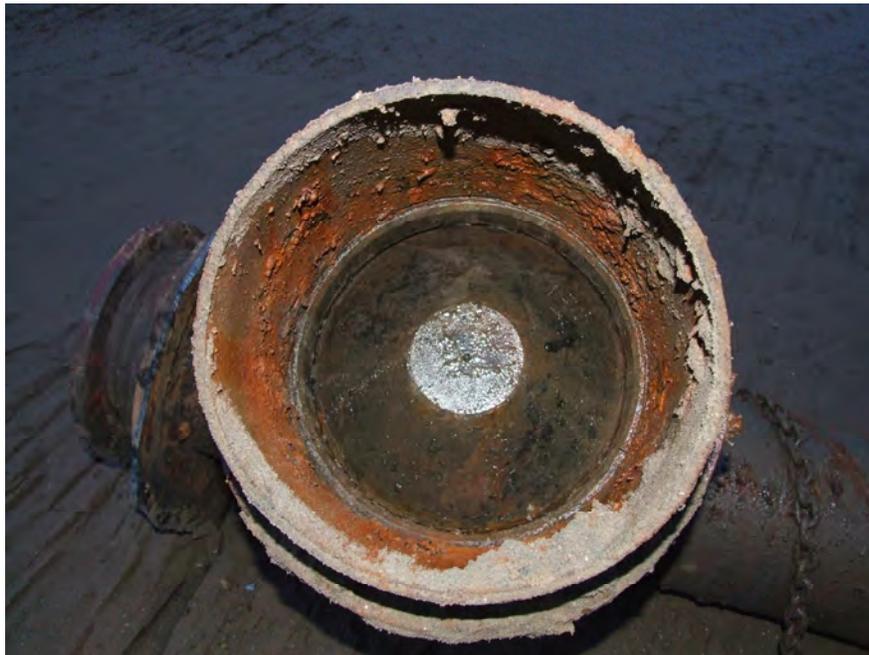
*Figure 3-36 - Picture of Starboard suction valve*
