Report on the investigation of the death by asphyxiation of

two crewmen on board

Sava Lake

**Report No 15/2008
September 2008**

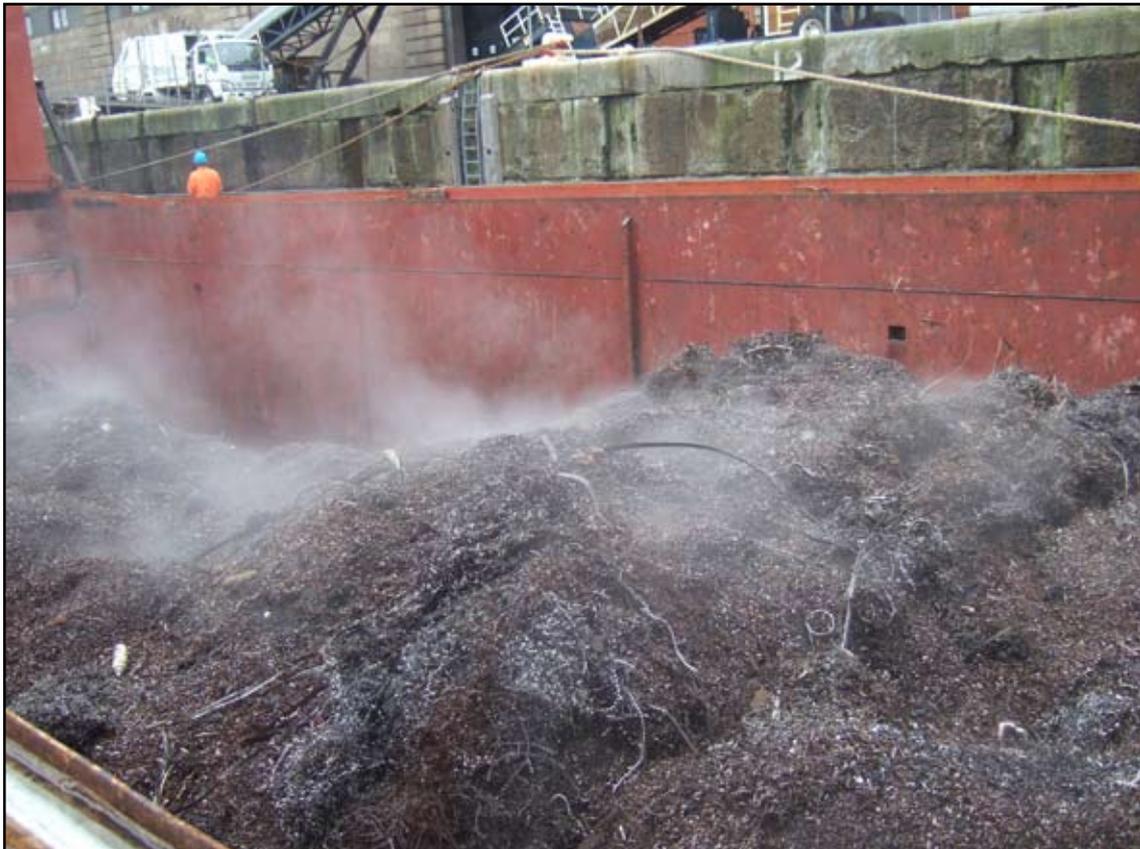
Steel turnings on board *Sava Lake*
(as photographed in Dover on 19 January 2008)

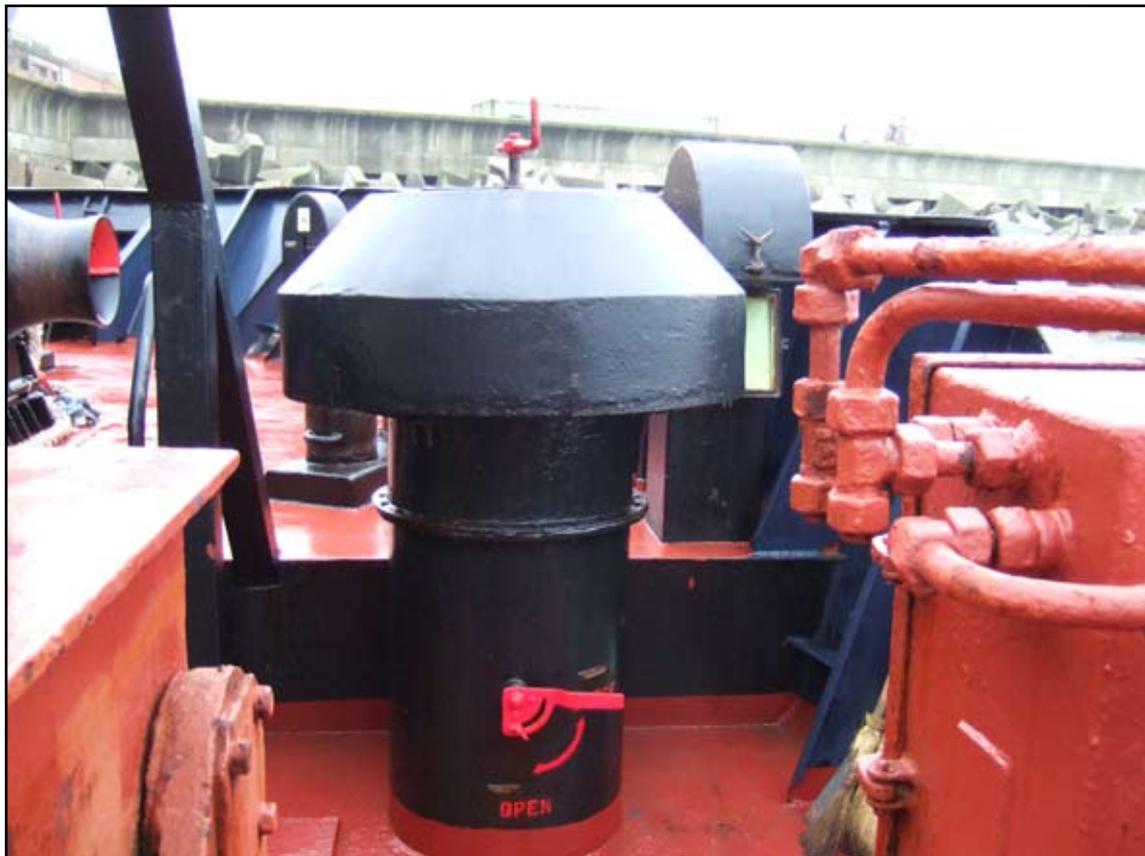
Figure 8

Starboard forward cargo mushroom ventilator and fire damper

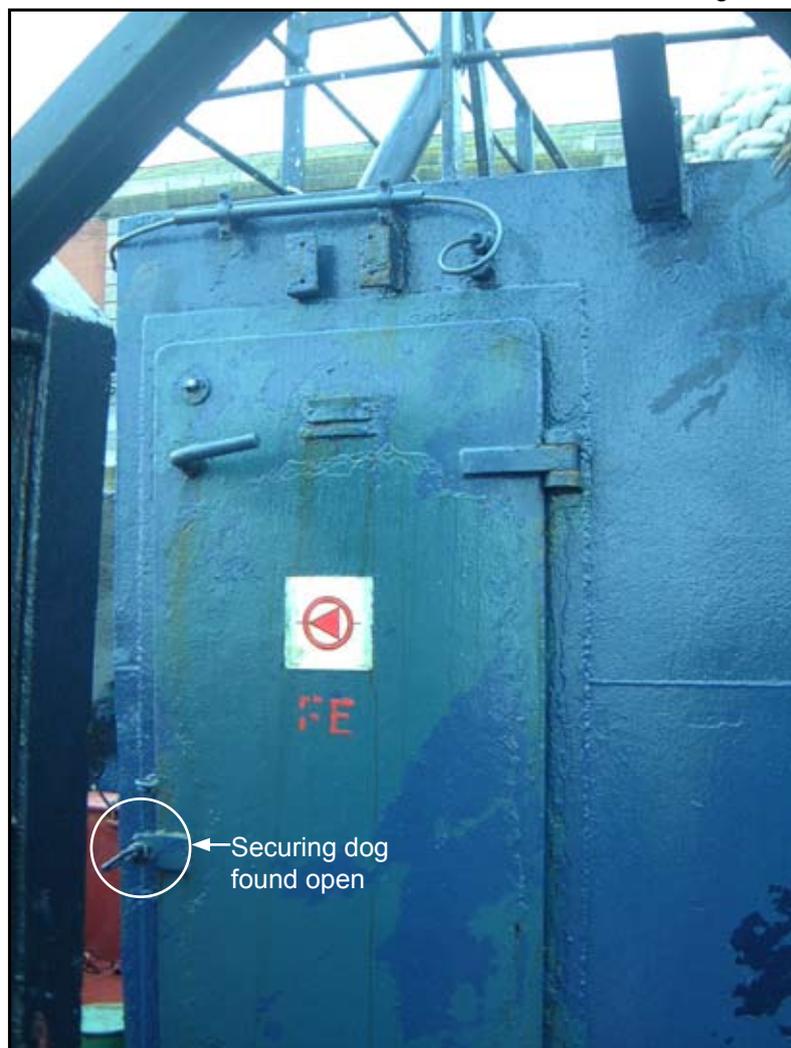
Figure 10

The chief officer noticed that the weather tight door to the forward store was closed, but that the locking securing arrangement was not closed as he would have expected (**Figure 10**). The chief officer opened the door to the forward store and saw the two missing men lying motionless at the bottom of the ladder.

Weather tight door to forward store

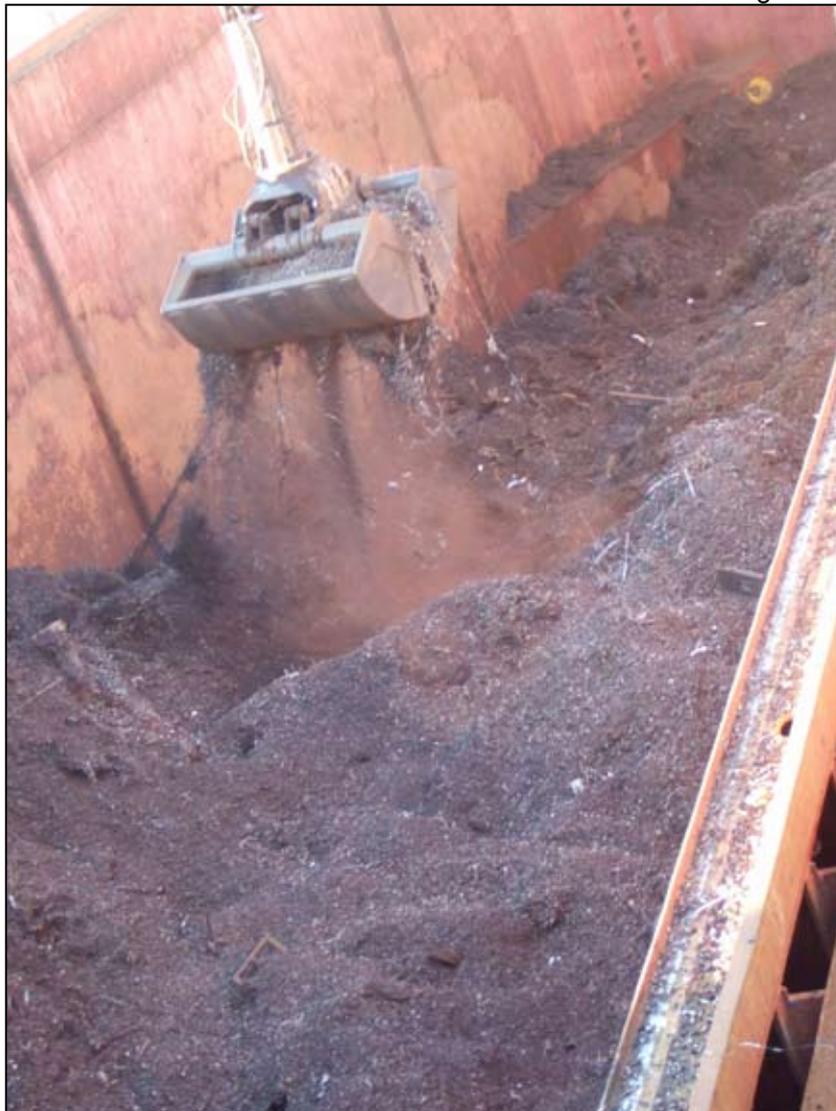
Figure 12

The cargo was unloaded in Newhaven on 6 February (**Figure 12**) when it was noted to be heavily oxidised.

Cargo unloaded in Newhaven

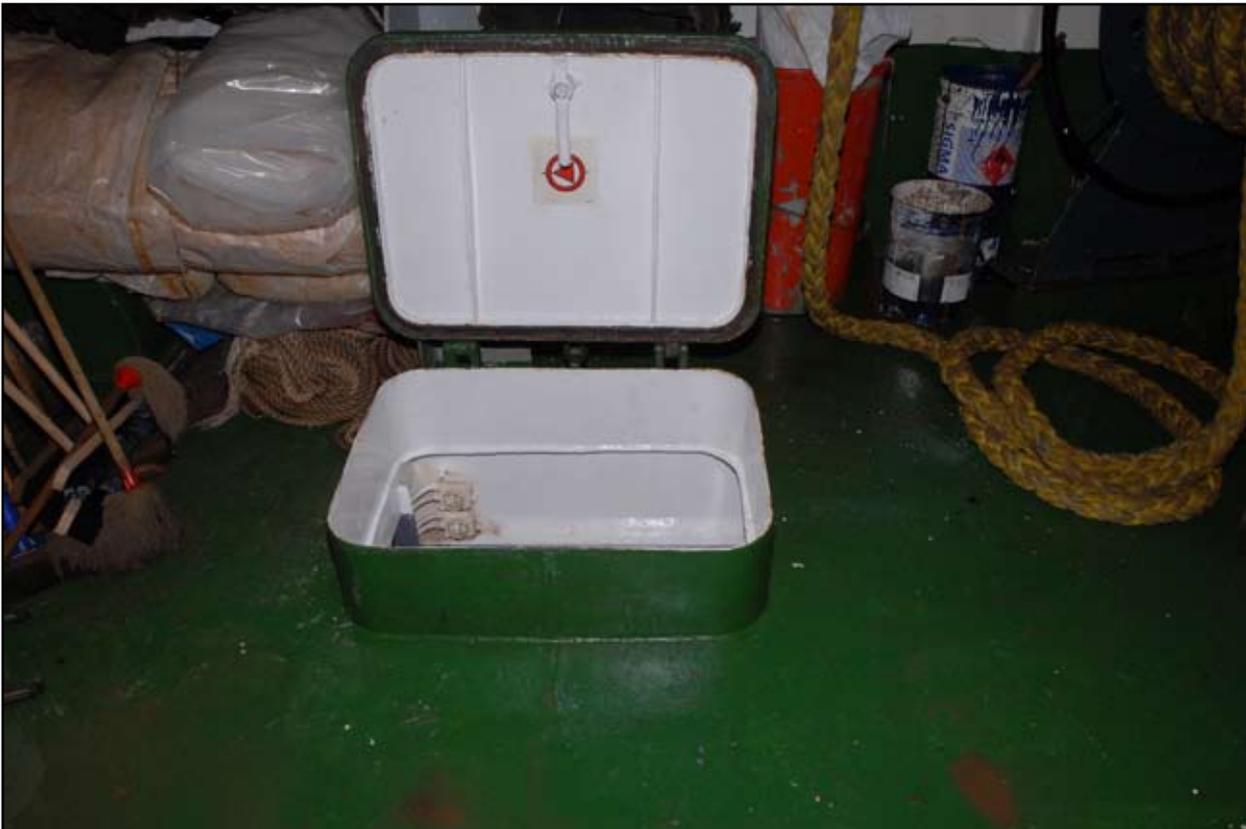
The forward store was accessed through a weather tight door on the starboard side of the deck house and down a single steep ladder. The store contained the vertical access ladder down to the bow thrust room. The two compartments were separated by a hatch (**Figure 16**). The hatch was routinely left open on passage and the two spaces were effectively common.

Hatch from forward store to bow thrust room

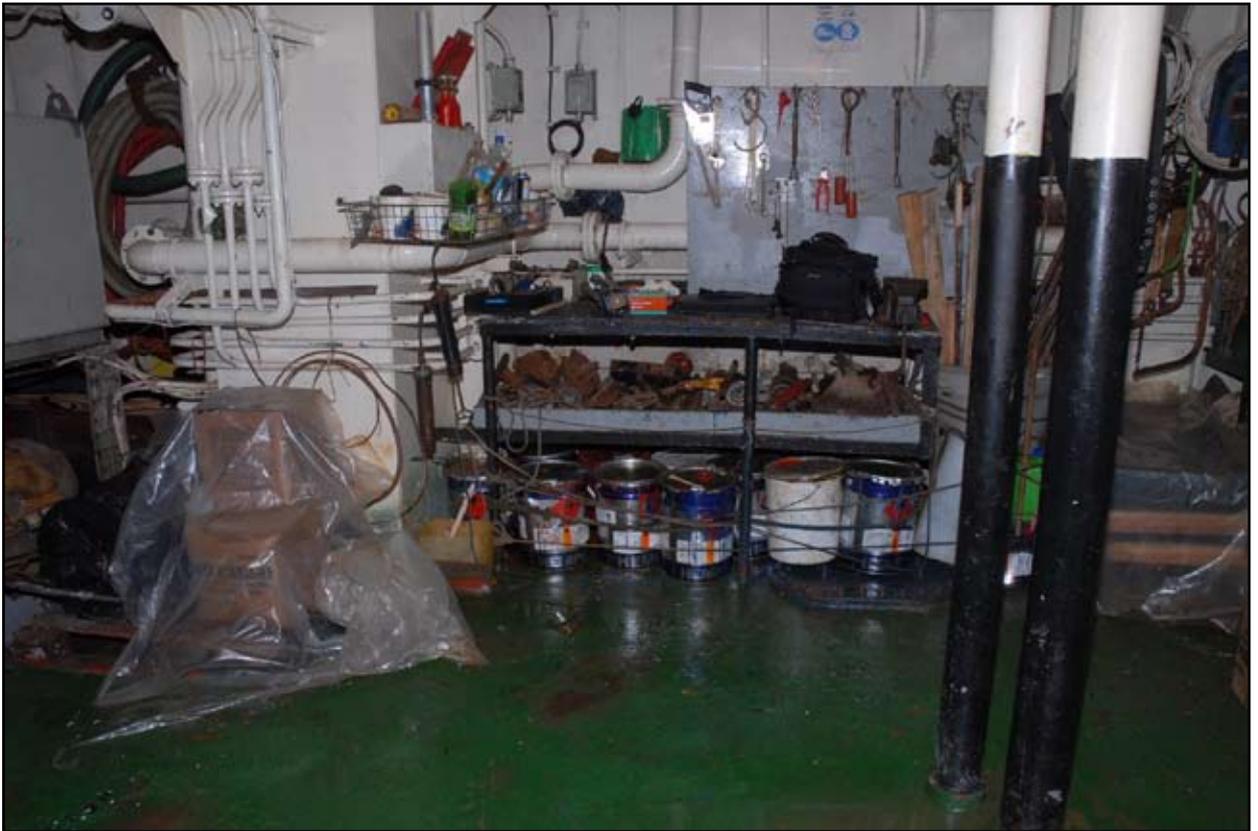
Figure 17

The forward store was used as an AB's workshop and store, and contained the usual deck workshop tools and small quantities of paint and chemicals (**Figures 17**). The space also contained electrical switchboards for deck machinery, hydraulic oil tanks and provided storage for *Sava Lake's* forward mooring ropes when these were not required on the fore deck.

Forward store

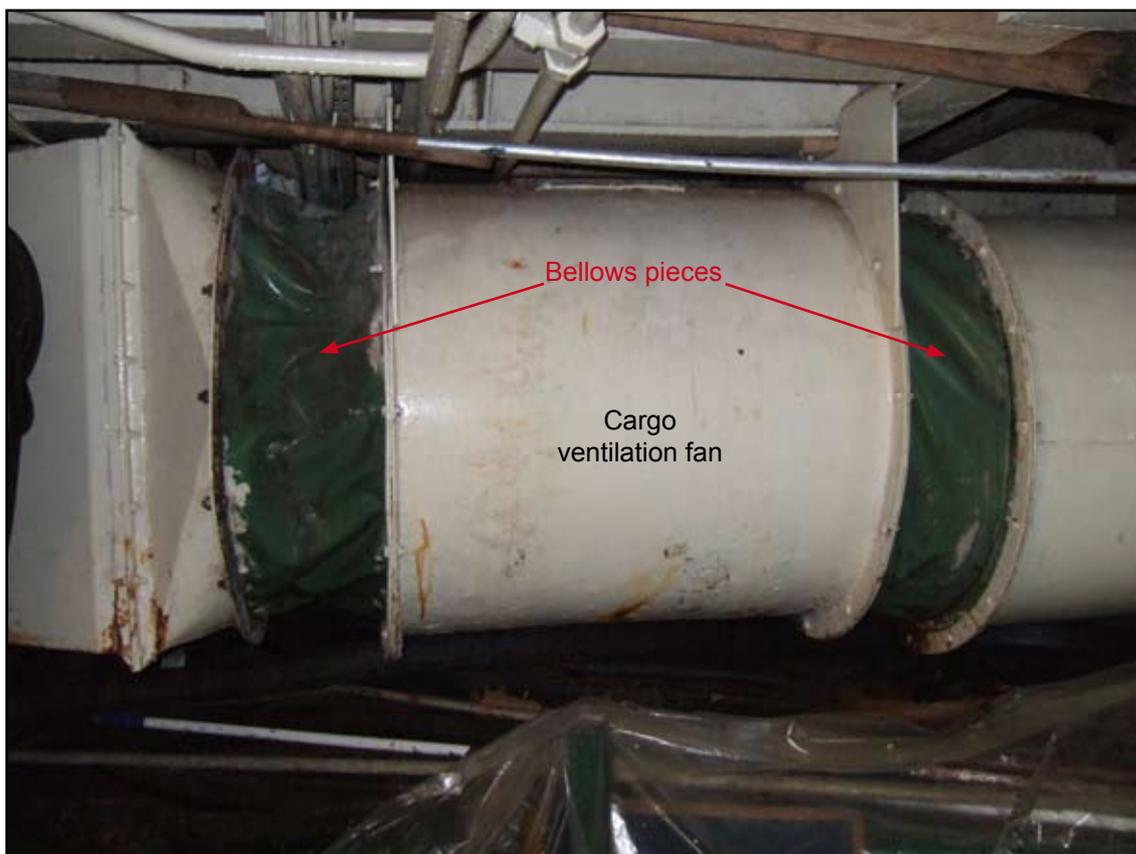
Figure 24

Three of the four bellows pieces were found to have been cut to create openings of up to 30 cm at the bottom of the ducts. The cuts had allegedly been made by an earlier crew of *Sava Lake* to allow for the drainage of sea water during heavy weather and to facilitate the removal of cargo residue that had been drawn in from the adjacent hold (**Figure 25**).

Cargo ventilation fan and bellows pieces

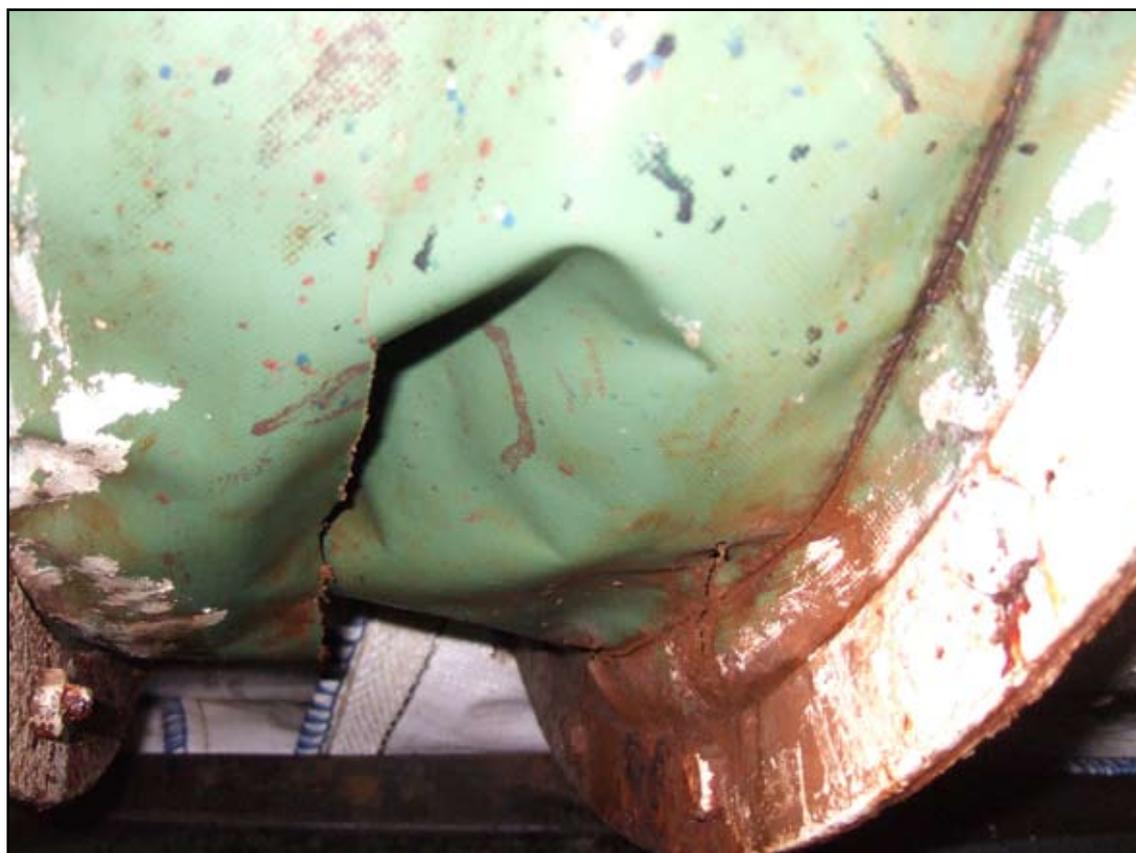
Figure 25

Cut bellows piece

The cuts in the flexible bellows pieces fitted to the ventilation ducts that ran through the forward store created an air path between the store and the adjacent cargo hold. This created an “unsafe condition” that, with the right combination of cargo and circumstances allowed a noxious atmosphere to develop within the forward store.
