Report on the investigation of the
inadvertent release of carbon dioxide and disabling of

Figaro

off Wolf Rock

Report No 14/2008
August 2008

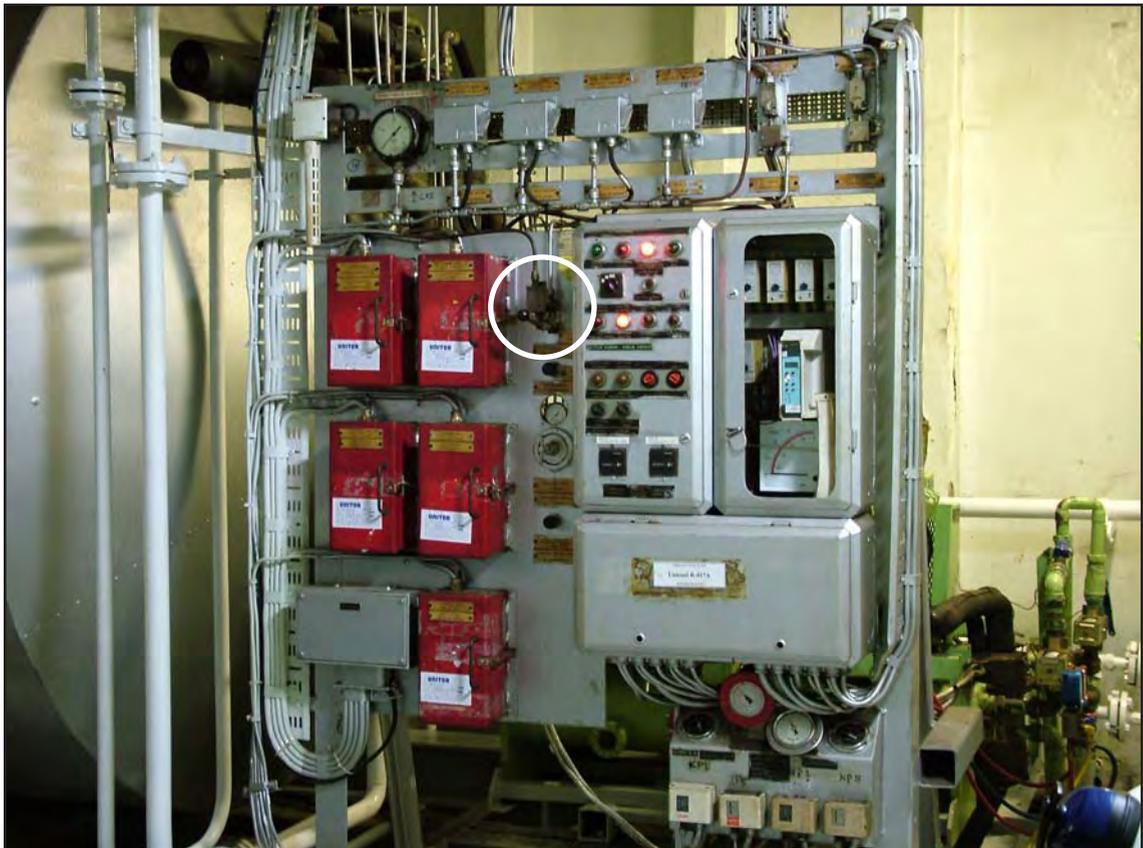
Figure 3

The EE opened all five of the cabinets in sequence and operated the main and distribution valve remote controls. The 3E, stationed in the CO₂ compartment on deck 5, reported via radio that he could not see any of the corresponding valves in the system operating. The CE, EE and 2E went to the CO₂ compartment on deck 5 and attempted to move the valves manually. The distribution valves moved freely, but the main valve was stuck in the closed position. The CE, EE, 2E and 3E inspected the position of the local control levers. These were arranged differently to the remote controls, and only the distribution valve controls were housed inside cabinets. There was a single control lever to operate the main pilot release valve and this was mounted on the panel with no form of enclosure (**Figure 3**). On inspection, the distribution valve controls were all found in the 'down' position. The main release valve control lever was found in the 'up' position.

Main release valve in the CO₂ room on Deck 5

There were no markings on the operating levers to indicate what the different positions signified, and there was little guidance in the manufacturer's manual to assist in diagnosing the problem. The CE concluded that the remote system had malfunctioned, but considered that in the event of a fire he could still release the CO₂ by opening the main and distribution valves manually. He was not sure what position the levers should be in and decided to leave them as they were found. The main stop valves on the CO₂ storage tanks were re-opened so that gas was immediately available in an emergency.

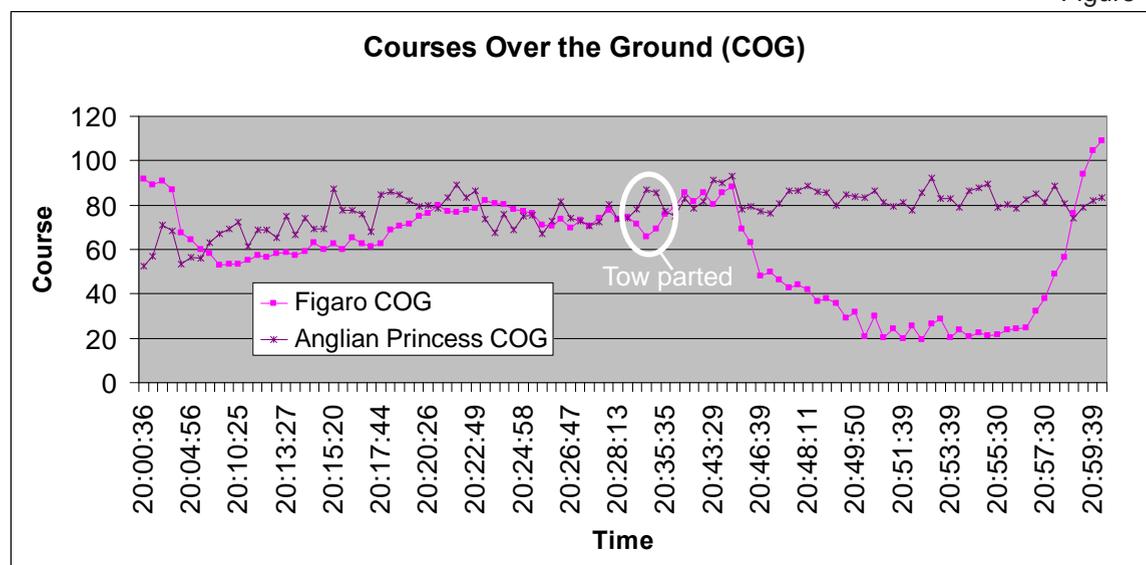
Figure 6

Study of AIS data shows *Anglian Princess* making good a course to the east at about 3.5 kts. At 2026 *Figaro's* heading begins to alter to starboard, turning through north and reaching 007° at 2029. The courses over the ground (COG) for *Anglian Princess* and *Figaro* begin to converge at around 074°. The next AIS data sample for *Figaro*, 3 minutes later at 2032, shows that the heading has altered, through 29° to port, to 338°. *Anglian Princess's* speed drops sharply from 3.7 to 1.4 kts and the courses over the ground diverge, *Figaro* altering to port to make good 065° and *Anglian Princess* to starboard to make good 085° (**Figure 6**).

Graph of *Figaro* and the ETV's courses over the ground

The tow line failed at a critical point in the recovery operation, just as *Anglian Princess* was beginning to gain control of *Figaro* and turn it to starboard, towards an easterly heading. *Figaro* had been drifting with a heading of 330° (+/- 15°) for several hours, and it is possible that wind forces acting on the ship could have caused the 29° yaw from 007° back round to 338° that was seen between 2029 and 2032. This yaw coincided with a sharp reduction in *Anglian Princess*'s speed from 3.7 to 1.4 kts and it is likely that the tow line came under considerable load during this time. Communications between *Anglian Princess* and Sennen Cove ALB at 2034 reported that the tow line had parted.

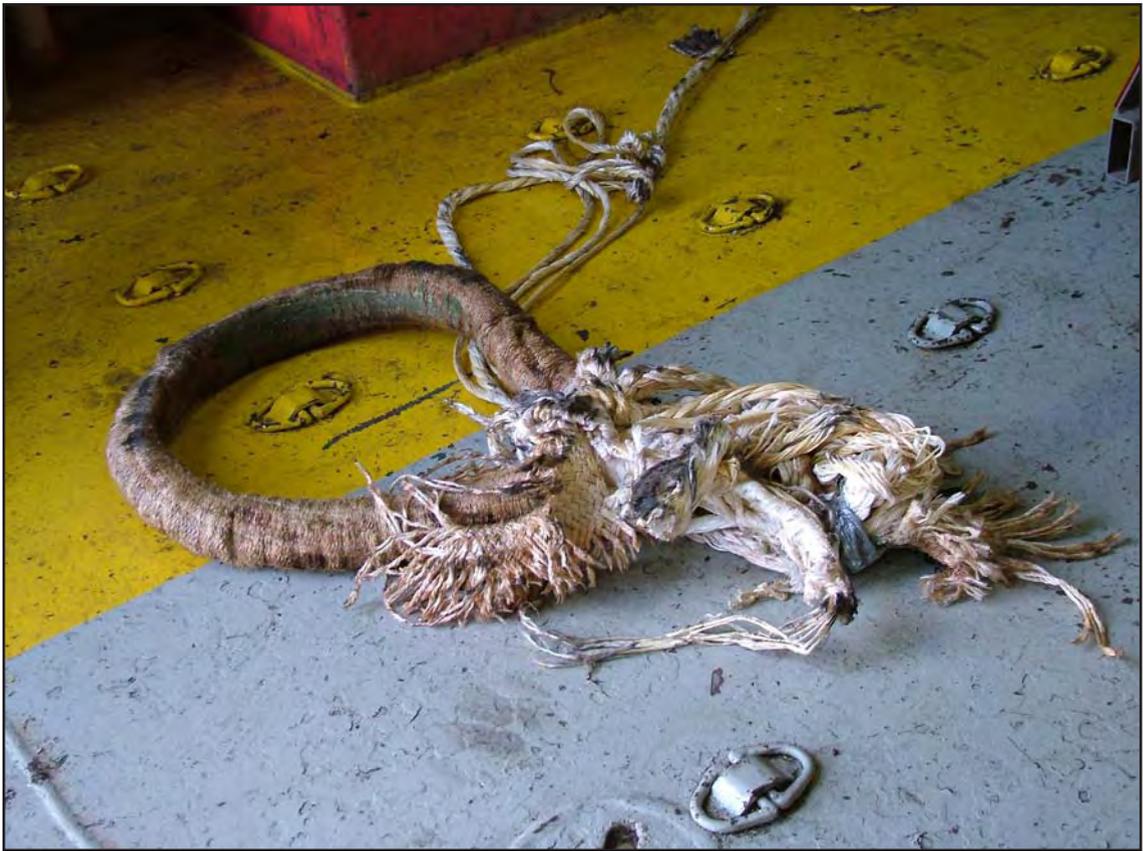
Remains of the soft eye of the tow line attached to *Figaro*

The soft eye was sent for detailed inspection and dissection by a specialist company, Tension Technology International (TTI) to determine why it had failed. TTI noted that the soft eye had become very stiff and, by comparing the rope core with the protective jacket, that it had contracted to approximately half its original length. This was caused by a combination of the rope cores pulling through the splices under extreme tension and compaction of the rope under recoil after it parted. The rope cores had failed at the splice, in two principal methods; four of the ten individual splices had slipped, causing the remaining strands to be overloaded. There was evidence of overheating with rope cores becoming fused together and further damage consistent with violent recoil. TTI concluded that the rope “*had been subjected to a severe load that had occurred quite quickly*” [sic].

Further work was done to establish the strength of the tow line and the suitability of the splicing method. The line was manufactured out of HMPE¹, which has a low friction coefficient. Although the splice had been done in accordance with the manufacturer’s instructions, TTI reported that they and another major manufacturer recommended using 24 to 26 splices in this material to prevent the strands from slipping.

Undamaged rope yarns were taken from the sample and subjected to tensile testing. An analytical method was then used to estimate that the rope’s residual strength after it had parted was in the order of 230 tonnes. It was also estimated from the general condition of the rope, that its minimum breaking load before the accident would have been about 75% of its value when new, giving 270 tonnes. The effect of the four slipped splices was considered to have reduced the actual breaking load by 25% and so it was concluded that the tow line would have parted at a load of about 200 tonnes.

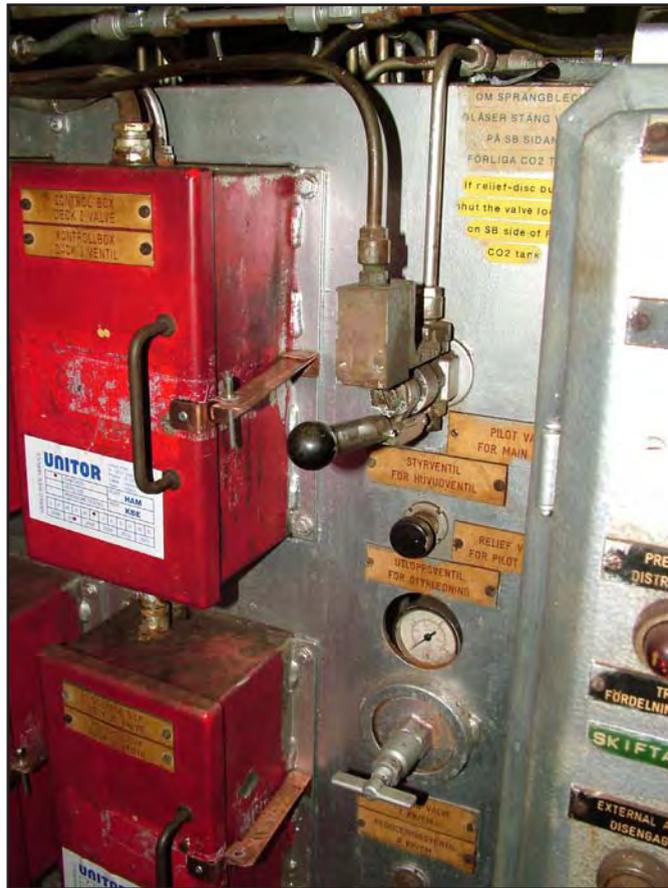
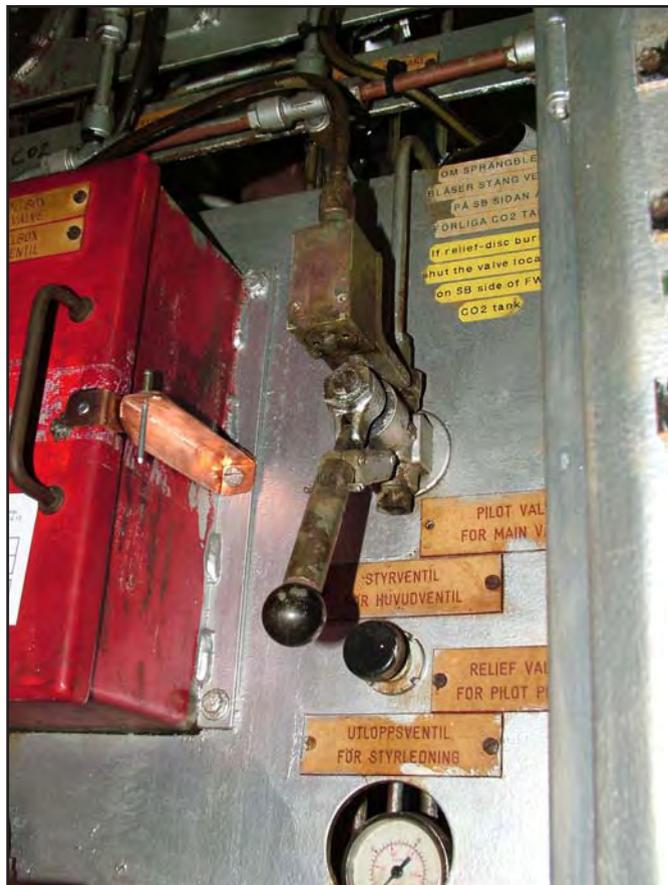
Figure 11

Main pilot release control valve on the CO₂ room control panel

The main pilot valve (16A) was mounted so that its operating handle was horizontal when the valve was closed. In normal circumstances, it only needed to be moved a short distance (around 20mm) downwards, before the mechanism released and the valve handle fell to the vertical position under gravity. The valve handle should have been opened by the MCU remote piston during the earlier test, but there were two leaks and the piston was partially fouled, preventing it from moving throughout its full range of travel.

It is most likely, that during the routine test on 22 November, the remote piston moved a short distance, pressing up on the main pilot valve (16A) operating handle, before a combination of the leaks and fouled piston stopped it from pushing the handle fully downwards as intended. The lever would then have stayed in this position, with tension in the mechanism until 6 December.

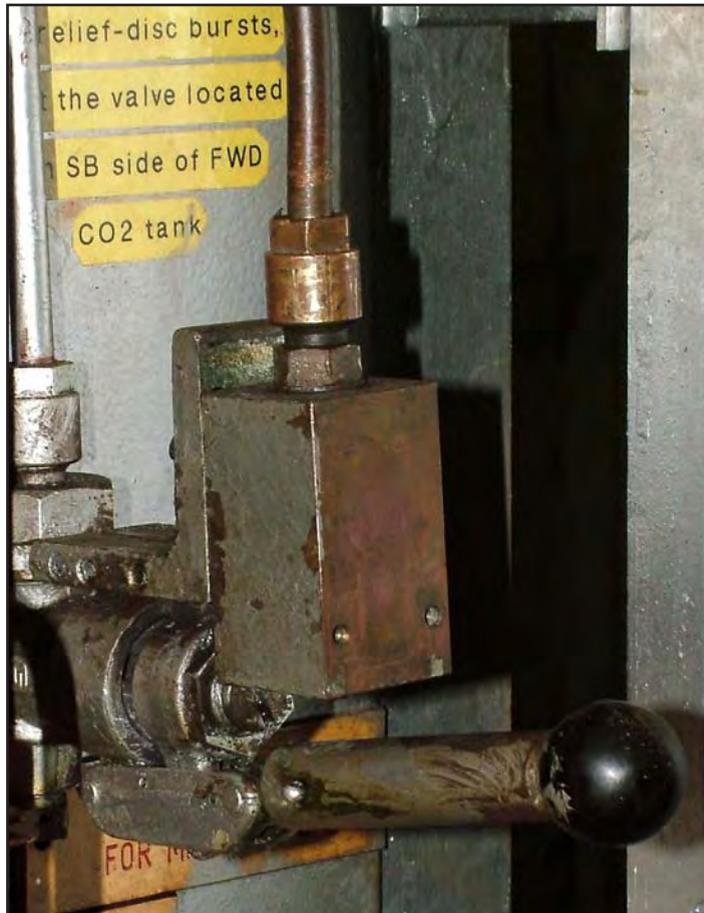
Figure 12

Main pilot release control valve arrangement

It is not possible to be absolutely sure why the CO₂ system operated on 6 December, but there was no evidence to suspect that the controls were operated in error or maliciously. The release of CO₂ was coincident with the vessel shuddering as it reached the bottom of a wave trough, and it is most likely that the motion caused the main pilot valve (16A) to open.

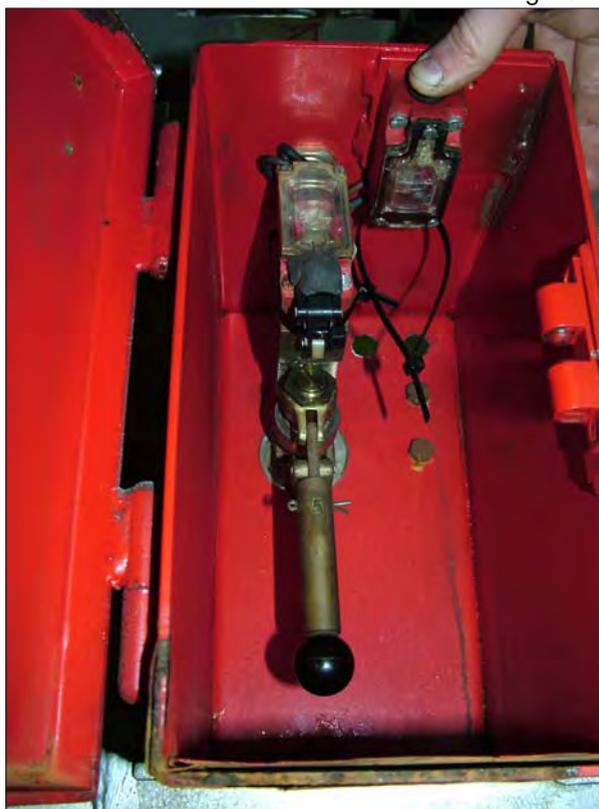
Figure 13

During the routine test on 22 November 2007, all of the operating levers in the Master Control Unit were pulled down from the vertical to the horizontal position, releasing CO₂ gas to extend each of the five pistons on the CO₂ room control panel. The cabinets on the CO₂ room control panel were kept closed and the 3E, witnessing the test, expected to see the large distribution valves operate. When there was no movement of the valves, the cabinets were opened and all five distribution pilot valve levers (16B to 16F) were found in the down (open) position (**Figure 13**). The main pilot valve lever (16A) was found in the horizontal (closed) position. However, there were no markings to describe what the positions meant. The CE was able to operate the distribution valves (4B to 4F) by hand, but could not open the main valve (4A).

Distribution valve pilot release control lever
