Report on the investigation into the foundering of the motor cruiser

Last Call

at Whitby

Report No 11/2008
June 2008

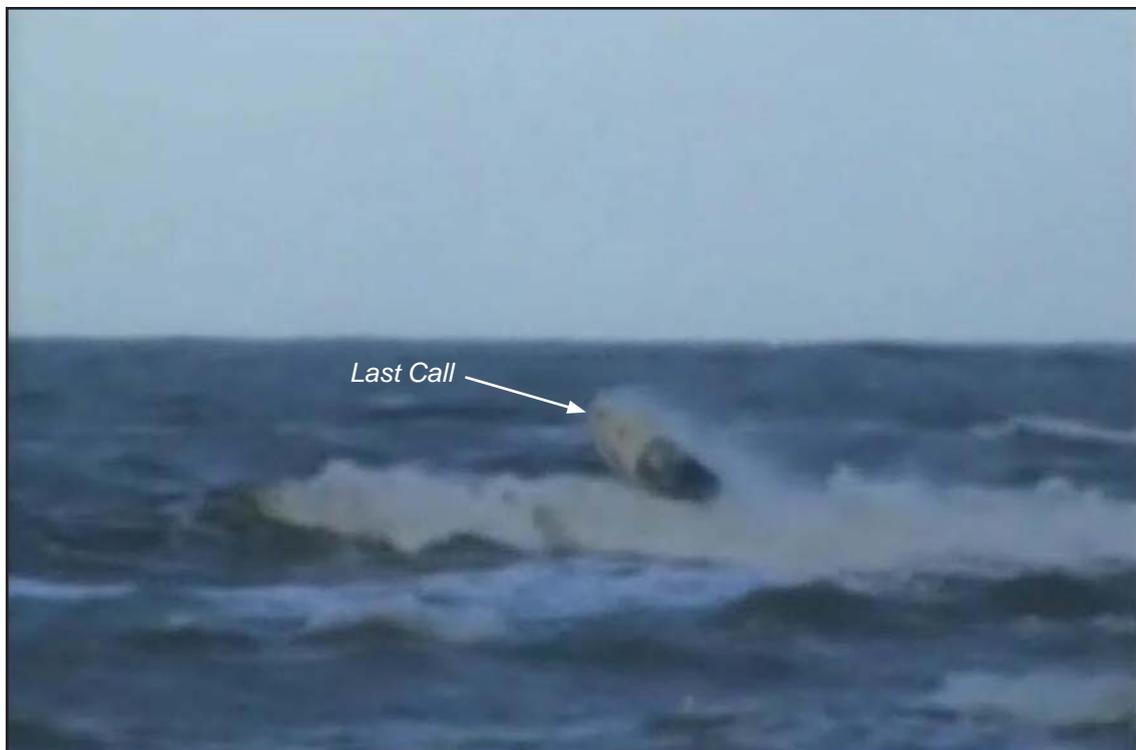
Figure 6

As *Last Call* approached the harbour entrance, it was set toward the east breakwater and encountered a steep breaking wave. The craft rose up almost vertically and one person was observed falling into the aft part of the cockpit. *Last Call* landed on its keel in a deep trough. It continued outbound, and rose up again vertically onto the crest of a second breaking wave, described by witnesses as higher than the boat itself. As the craft passed over the crest, control was lost, and it landed on its stern and took a sharp 270° turn to port (**Figure 6**). During the turn, two of the crew fell overboard, one wearing a lifejacket and one in dark clothing without. *Last Call's* engine then either stalled or the gear change engaged neutral, and the boat was swept by the wind and tide along the seaward side of the east breakwater extension (**Figure 7**).

Last Call as control was lost, turning 270° to port
(image captured from video)

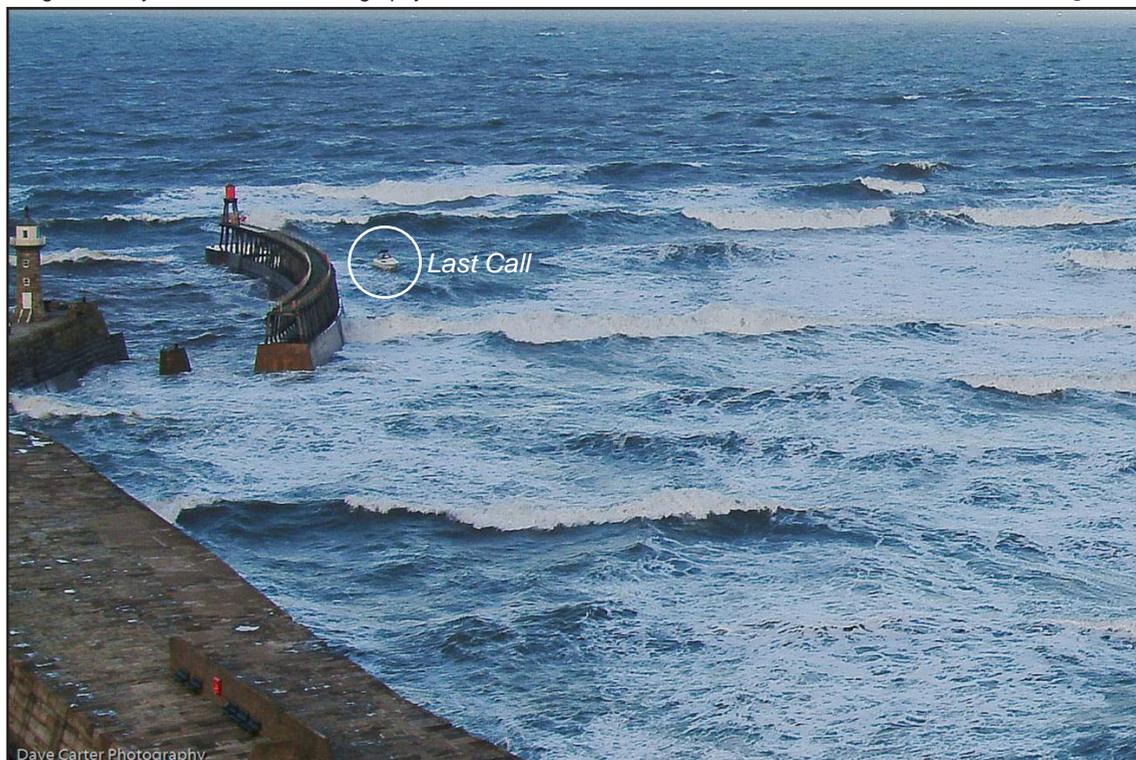
Figure 7

Last Call drifting along the east breakwater extension

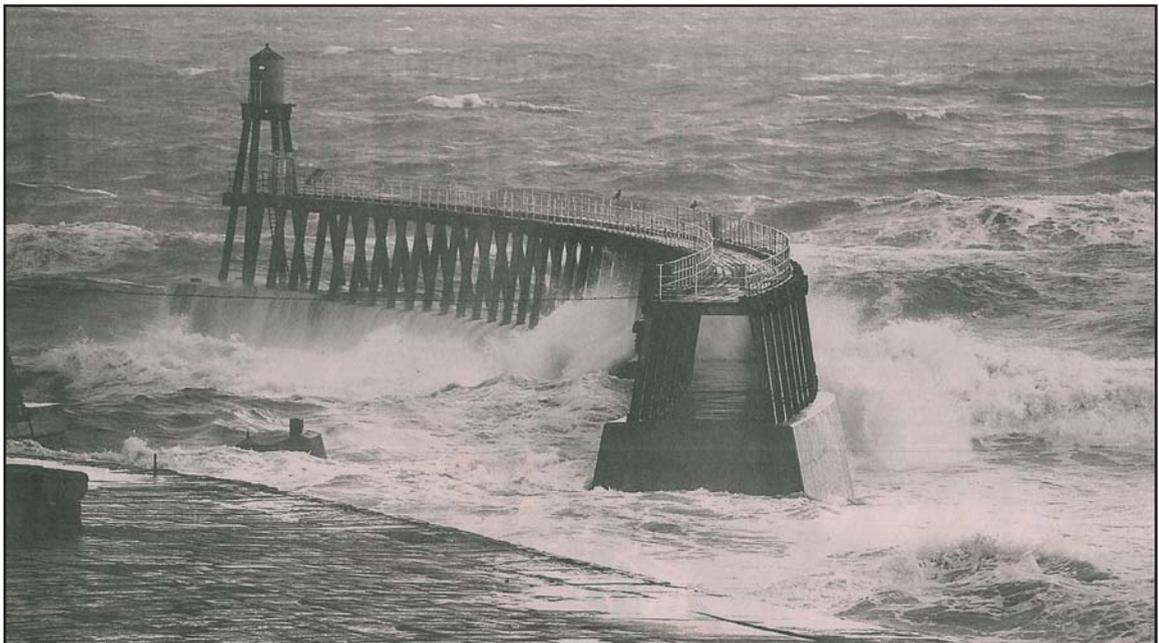
Figure 9

The conditions near the east breakwater extension at the time of the accident can be seen in **Figure 9**.

Weather conditions at the time of the accident - East Breakwater

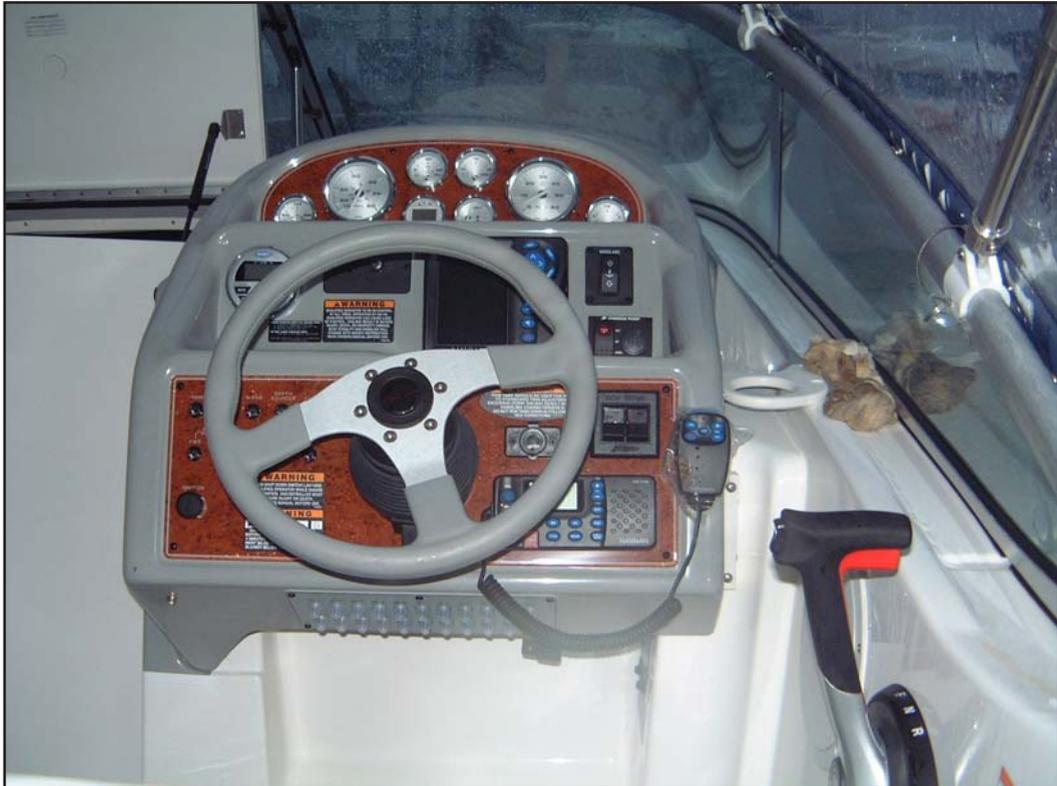
Figure 10

The helmsman's seat was positioned close to a 'tilt adjustable' steering wheel. The space available for the helmsman to stand behind the wheel was minimal. From the information available, there was no additional equipment fitted to *Last Call* over and above the manufacturer's initial specification.

245 SB - helmsman's position (similar craft)

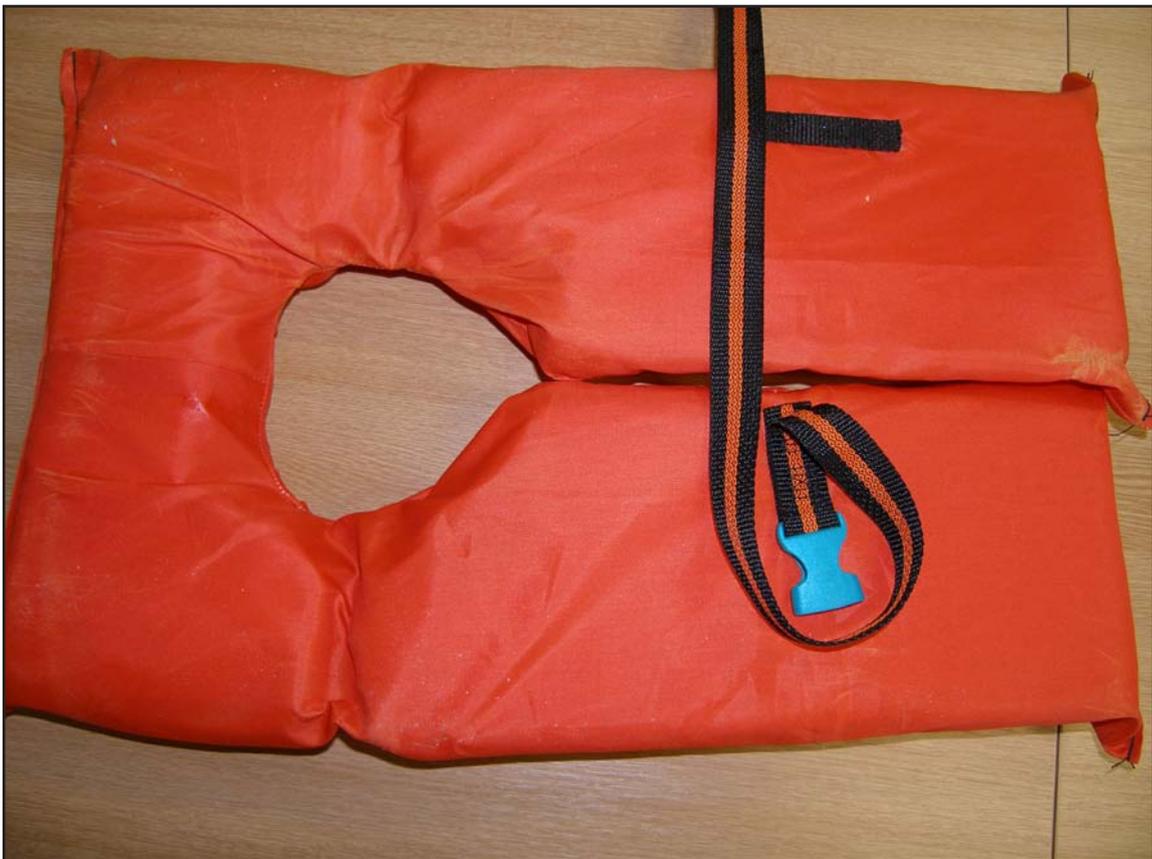
Figure 16

US Type II PFD

The lot number showed that the vests were manufactured in the fourth quarter of 2003. They were designed for a person weighing 90lbs (40.8kgs) or more and provided a minimum buoyancy of 15.5lbs (77N). It is a USCG requirement that all recreational boats must carry one wearable PFD (Type I, II, III or V) per person on board. In Europe, a Bayliner 245SB is certified to carry 8 passengers and luggage up to a maximum of 758kg.

The Type II PFDs had other shortcomings that made them unsuitable for coastal use in rough conditions.

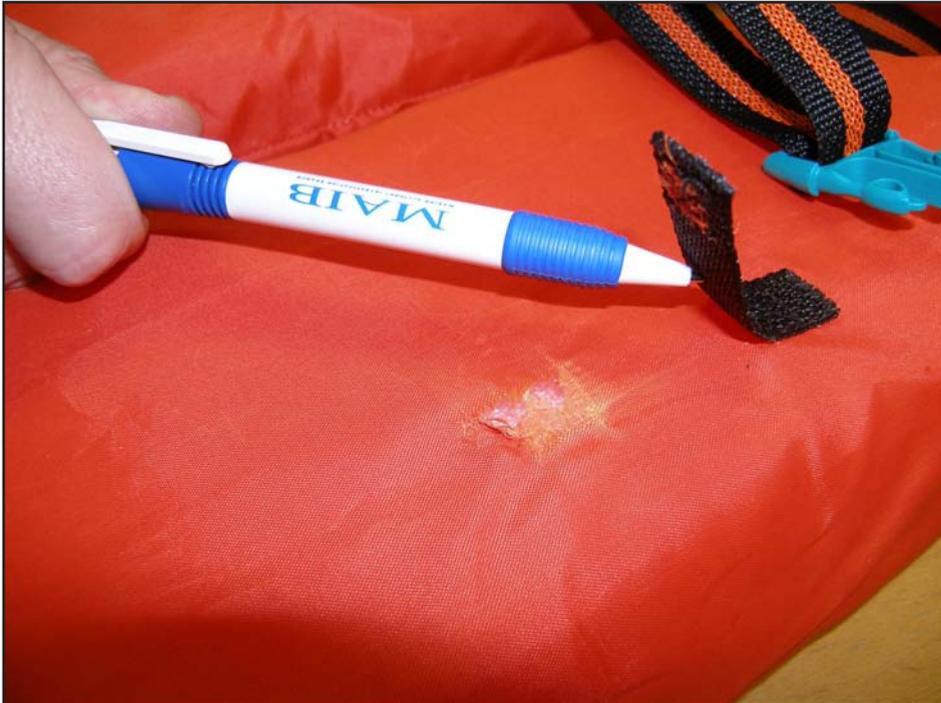
Figure 17

Inspection of the buoyant vests recovered from and worn by Andrew Carrick and Jill Russell, showed that their structure had remained intact, but the web securing strap had become detached from the front of the buoyancy chamber cover (**Figure 17**).

Detachment of web securing strap

Strength. On Andrew Carrick's Type II PFD, the straps, which held the foam collar in place, became detached when the fabric surrounding the collar ripped in the area of the strap stitching. This allowed one side of the foam buoyancy section to float free, and significantly reduced the Type II PFD's ability to hold its wearer's head above water. A flotation device similar to a Type II PFD, manufactured by a reputable UK company, incorporates double thickness material at webbing securing points to guard against the webbing becoming detached from the material during use.

Had the crew been wearing adult lifejackets, properly fitted and designed to the appropriate EU ISO 12402 requirements, their chance of survival would probably have been significantly increased, especially given the extremely fast lifeboat response time.
