Report on the investigation of

Ursine

Pride of Bruges

Report No 10/2008
May 2008

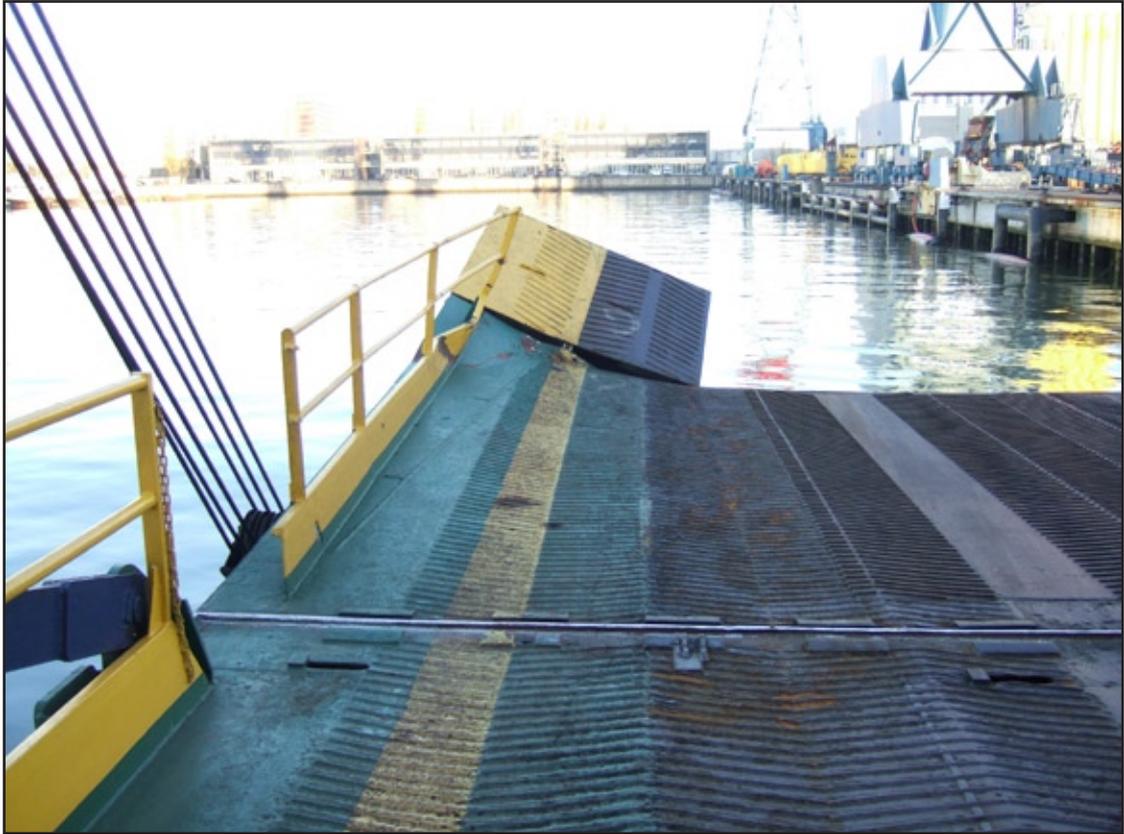
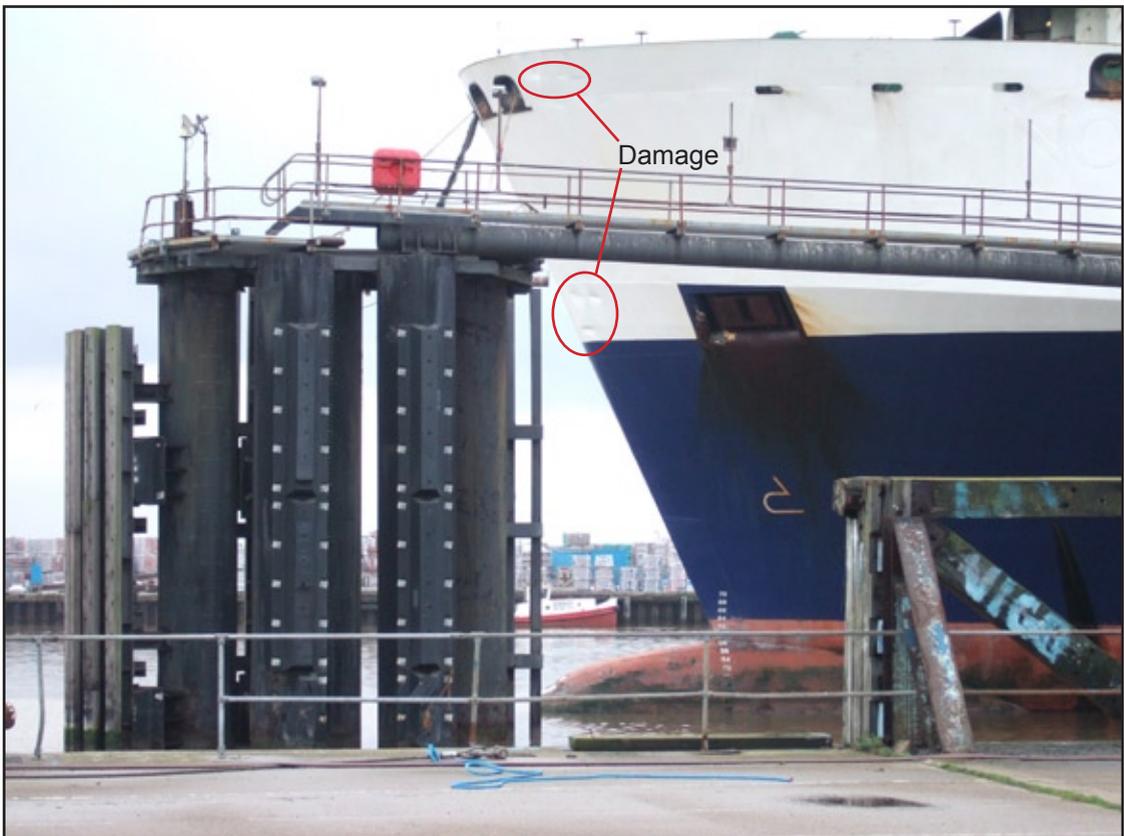
Figure 4

Pride of Bruges, which was not embarking passengers at the time of the contact with *Ursine*, was pushed astern by some two metres, causing three mooring lines to part and resulting in minor damage to the steelwork of her bow and stern ramp. The force of the impact was sufficient for the master to sound the general alarm. After an inspection, the vessel was determined to be safe to remain in service, with repairs being scheduled for her next refit.

Ursine’s stern ramp was damaged as a result of the impact, which required her to be taken out of service to allow the ramp to be repaired to the satisfaction of her classification society. A condition of class was subsequently issued to enable the vessel to undertake a single voyage to a repair port. The vessel’s stern light and associated supporting steelwork were also damaged by the contact (**Figure 4**).

Damage to *Ursine* (top) and *Pride of Bruges* (bottom)
