Report on the investigation of  
the collision between  
***Lady Hamilton of Helford***  
**and**  
***Blithe Spirit***

Falmouth Bay, Cornwall, England

3 October 2007

**Report No 8/2008**  
**April 2008**

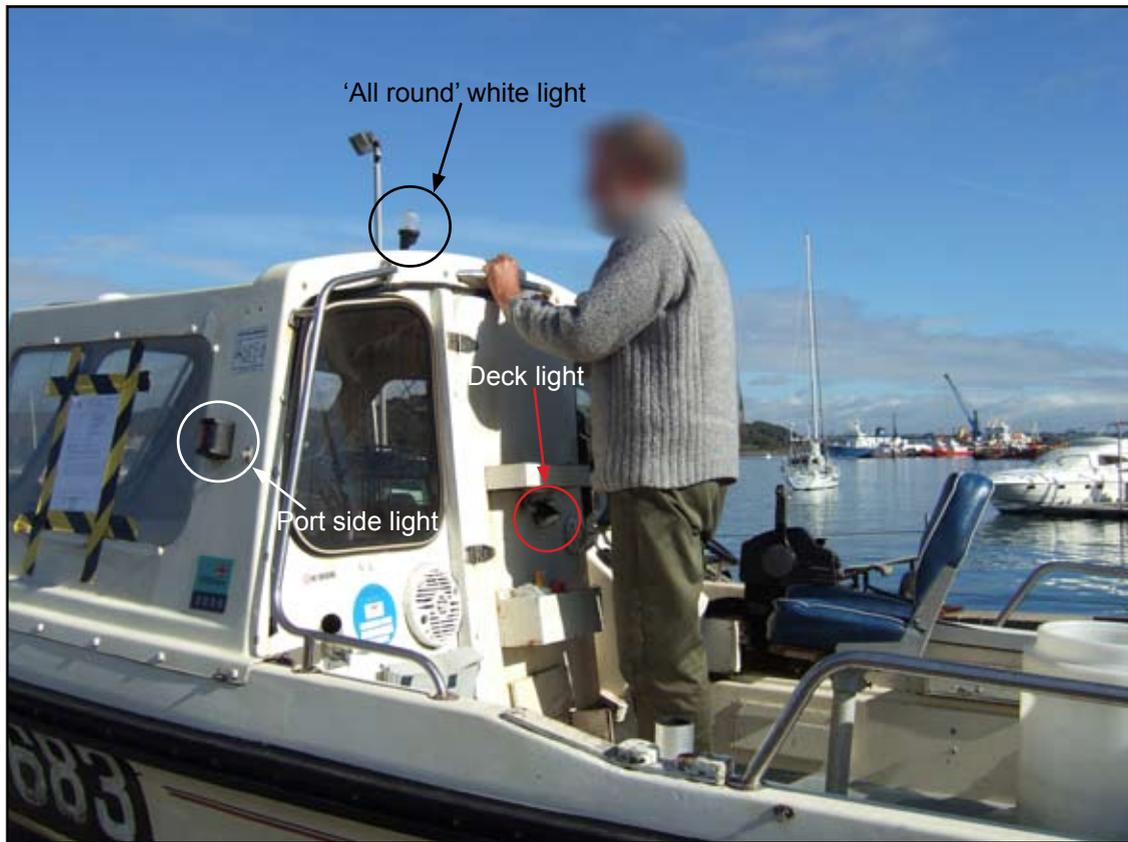
Figure 3

*Blithe Spirit* navigation and deck lights

The day after the accident, the white navigation light switch was found to be in the off position, and its bulb had failed. The starboard sidelight also failed to illuminate when the power was switched on. Both sidelights were dismantled and inspected (**Figure 10**). The port sidelight bulb was in very poor condition, but was the appropriate type for the fitting and functioned correctly. The starboard sidelight bulb was canted over to one side, which caused its end caps to short out the electric circuit. When the bulb was squared up in its housing it illuminated correctly. The bulb was not designed for the housing, it was too long and it did not have conical end caps with locating nipples to hold it in place. The flares and smoke floats carried on board were out of date and in very poor condition.

As the bulb of *Blithe Spirit's* all round white light was subsequently found to have failed, and the bulb in the starboard sidelight, which was an auto bulb and not the correct type for its housing, had been dislodged, it is also possible that one or both of these lights were not illuminated. However, it is equally possible that the sidelight bulb was dislodged and the all round light bulb failed when the vessels collided.

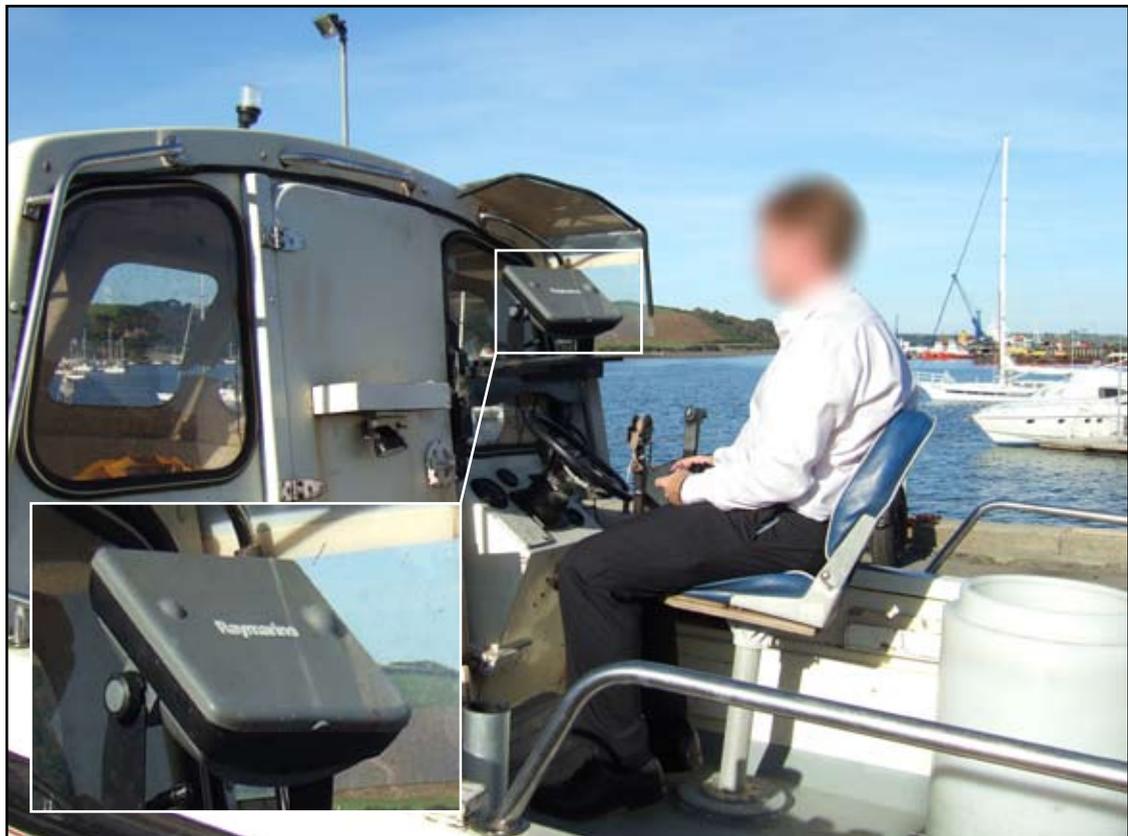
Figure 4

View from the seated position on board *Blithe Spirit*

The actions of *Blithe Spirit's* skipper also indicate a complacent approach to the operation of his craft. He habitually transited the bay at speed during darkness and was fully aware that he was unable to see ahead when seated. However, he made no attempt to monitor the effectiveness of his alteration to port. The skipper's lack of action in this respect not only indicates an acceptance or disregard of the risks involved, but it also demonstrates a lack of awareness of the pace at which situations change when travelling at speed. The poor condition of the pyrotechnics on board *Blithe Spirit*, and her skipper's decision not to wear a lifejacket or kill-cord are further examples of the skipper's casual attitude to safety. On this occasion, he was extremely fortunate. Had he been thrown into the water rather than into the boat on impact, it is almost certain that, unconscious and without a lifejacket, he would have drowned.

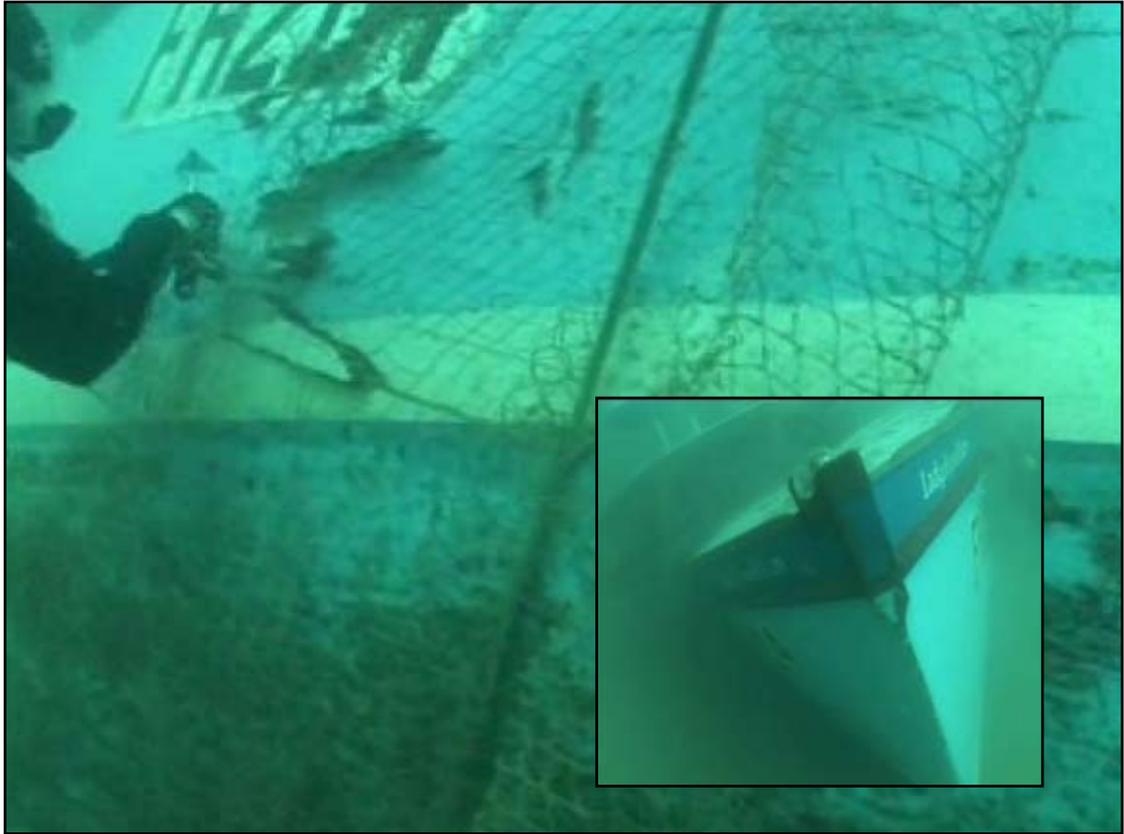
Figure 5

Following the foundering of *Lady Hamilton of Helford*, several dive surveys were conducted to assess her suitability for recovery. During a dive survey conducted on 5 October 2007, video footage indicated that the vessel had been struck above the waterline on her port side, adjacent to the wheelhouse (**Figure 5**). This damage was confirmed when the vessel was later recovered (**Figure 6**). The impact had caused a number of wooden planks on and above the waterline to split. A number of additional planks below the waterline had also cracked and sprung. The extent to which the wheelhouse structure had been dislodged to starboard is shown at **Figure 7**.

Damage observed by diving team

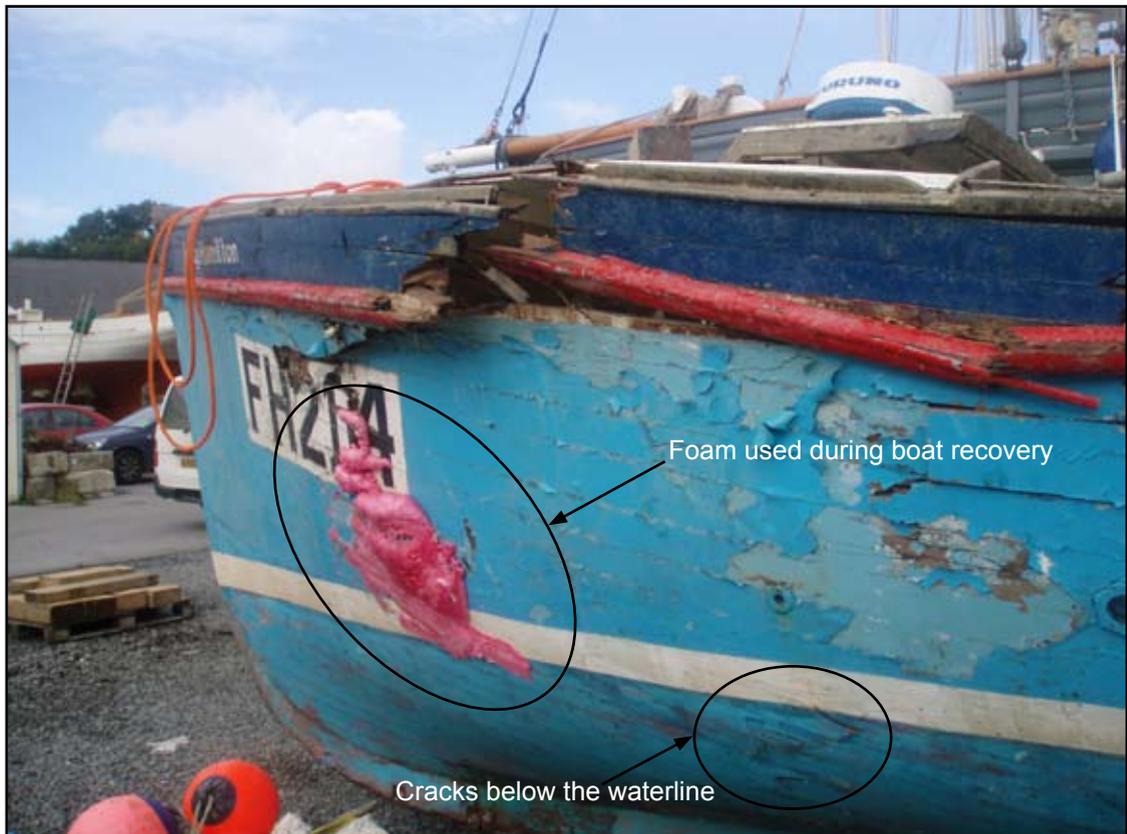
Figure 6

Damage to the hull of *Lady Hamilton of Helford*

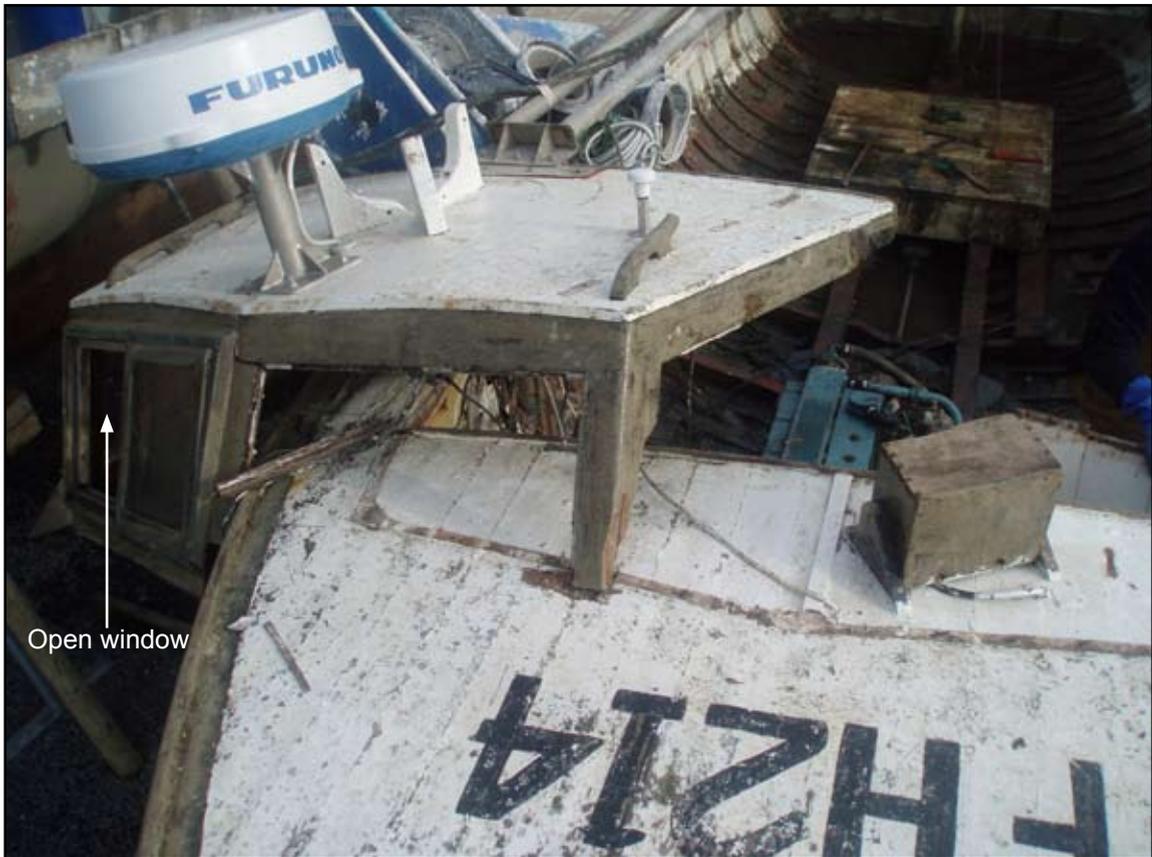
Figure 7

Damage to the wheelhouse of *Lady Hamilton of Helford*

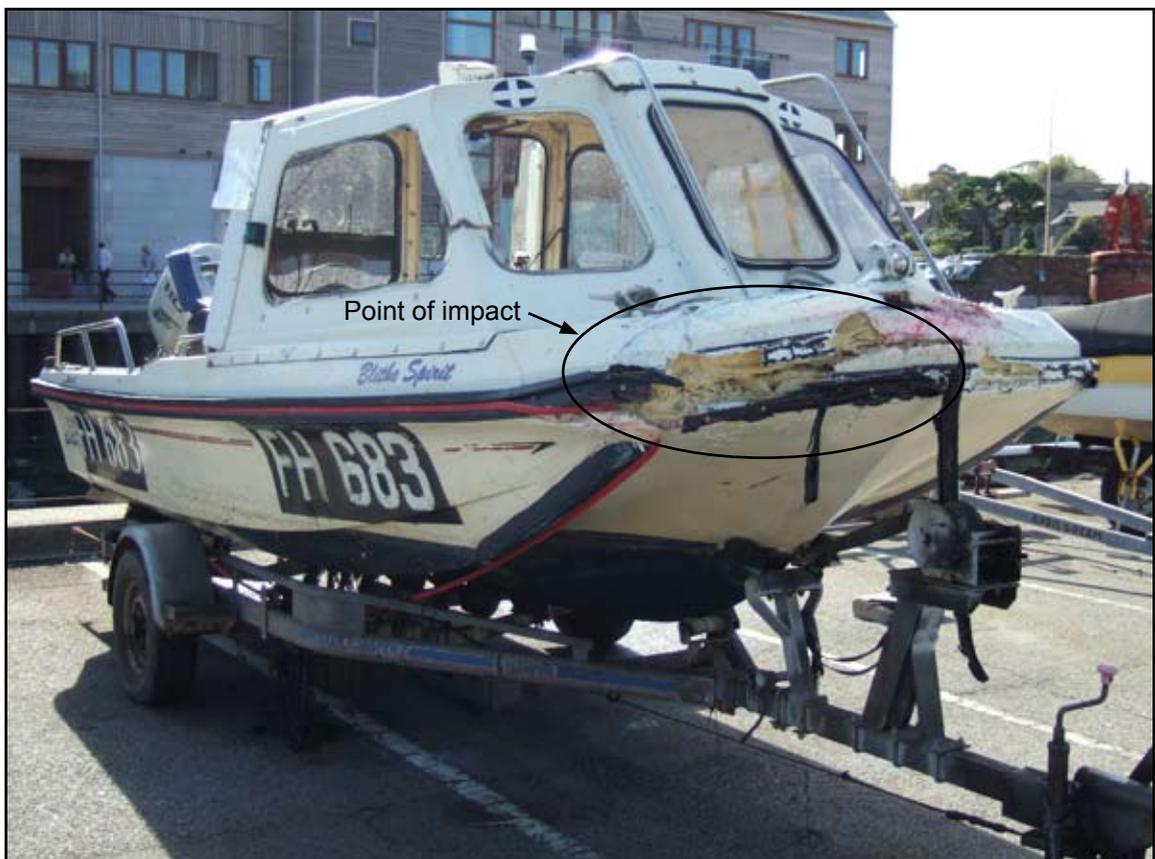
Figure 8

Damage to the bow of *Blithe Spirit*

The glass-reinforced plastic (GRP) of the starboard side of *Blithe Spirit's* blunt nosed bow was compressed and split across a length of approximately 1m (**Figure 8**). Traces of paint matching the paint used on the hull of *Lady Hamilton of Helford* were found on the damaged bow area and chines (**Figure 9**). The starboard side and starboard forward facing cabin windows had been knocked out and the stanchion between them was torn. Two Perspex windows of identical dimensions to the windows missing from *Blithe Spirit* were later found on the deck of *Lady Hamilton of Helford* after she was recovered.

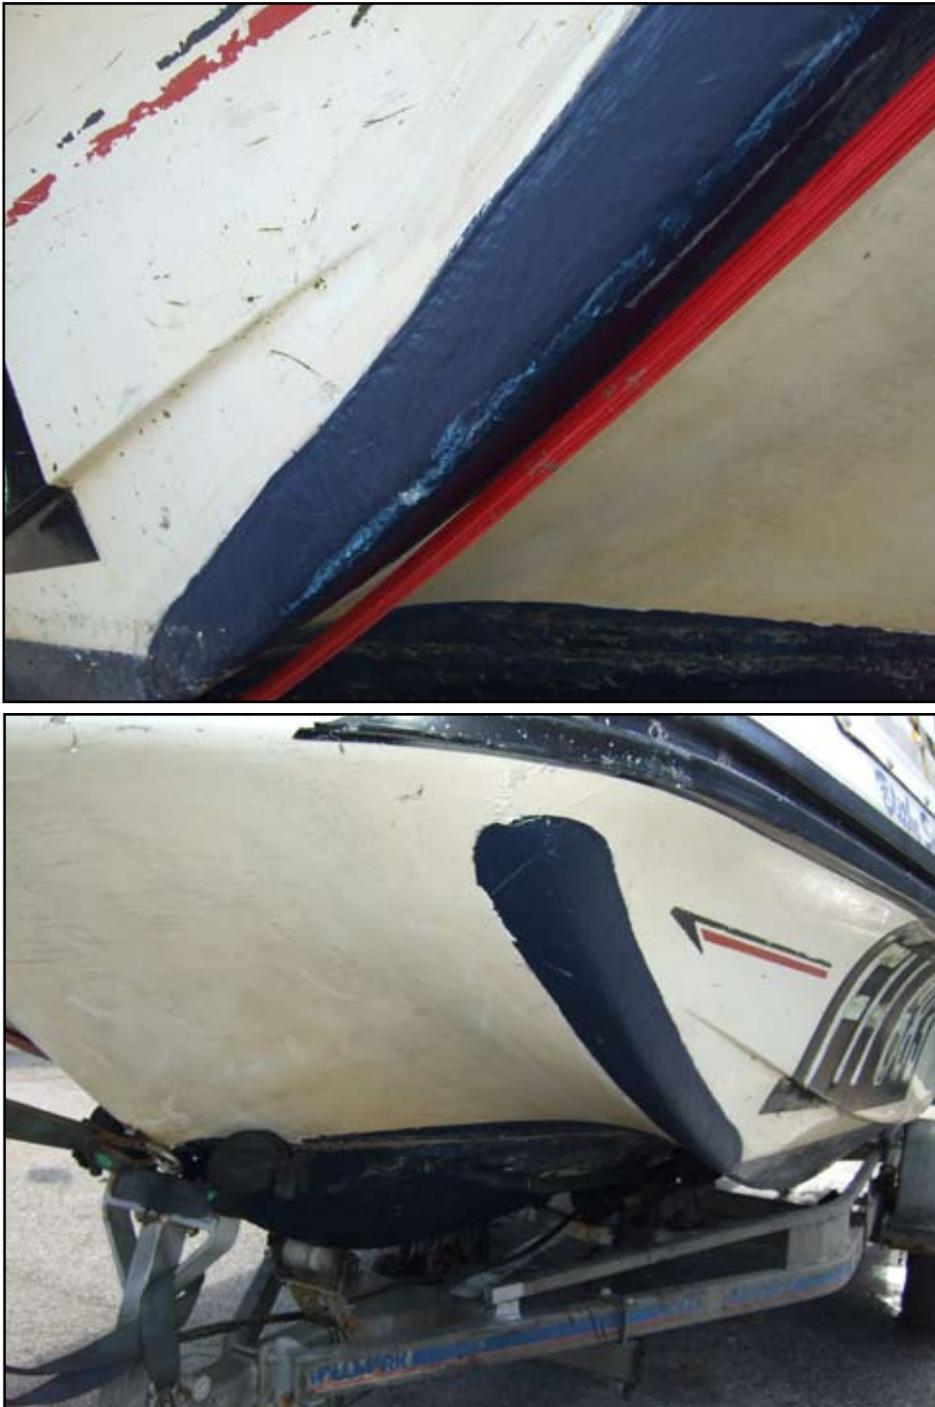
Figure 9

Paint marks on chines of *Blithe Spirit's* hull

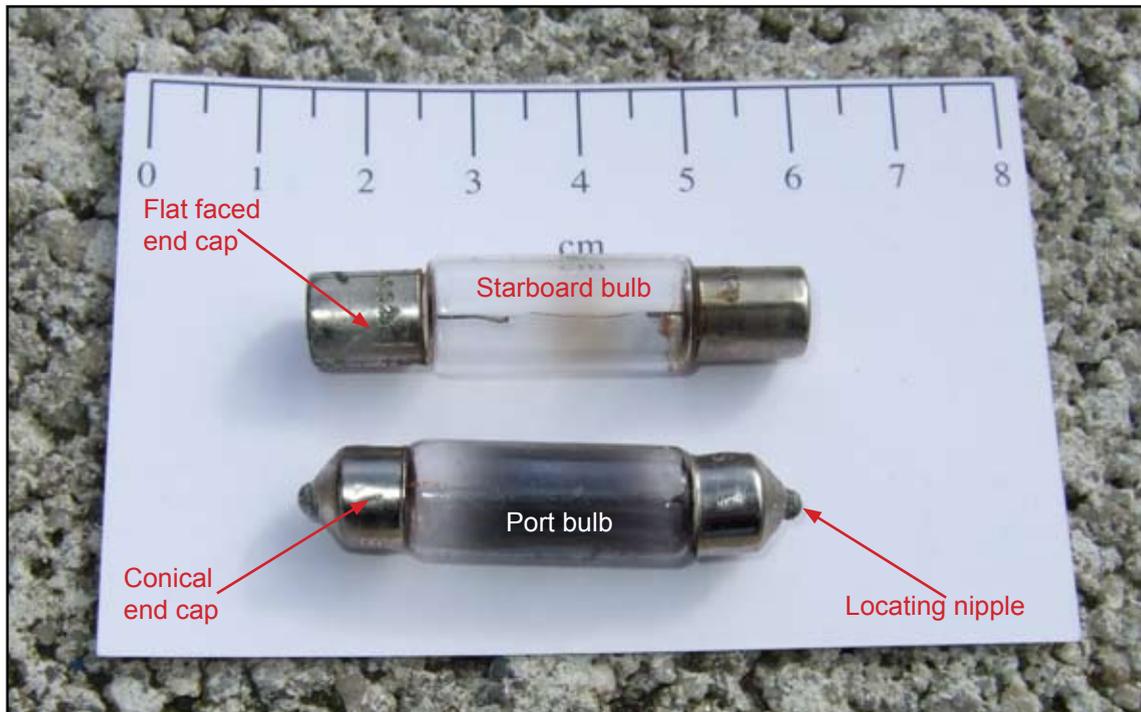
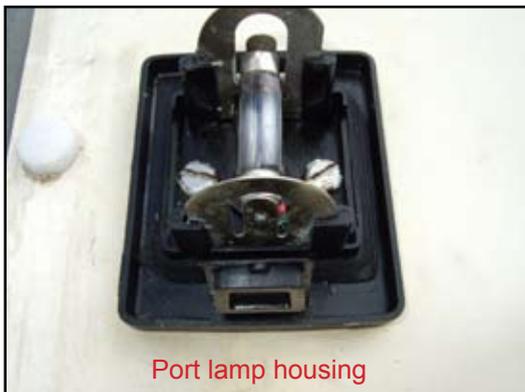
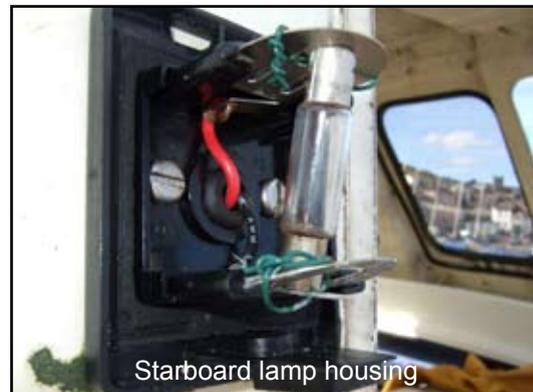
Figure 10

*Blithe Spirit's* sidelight lamps

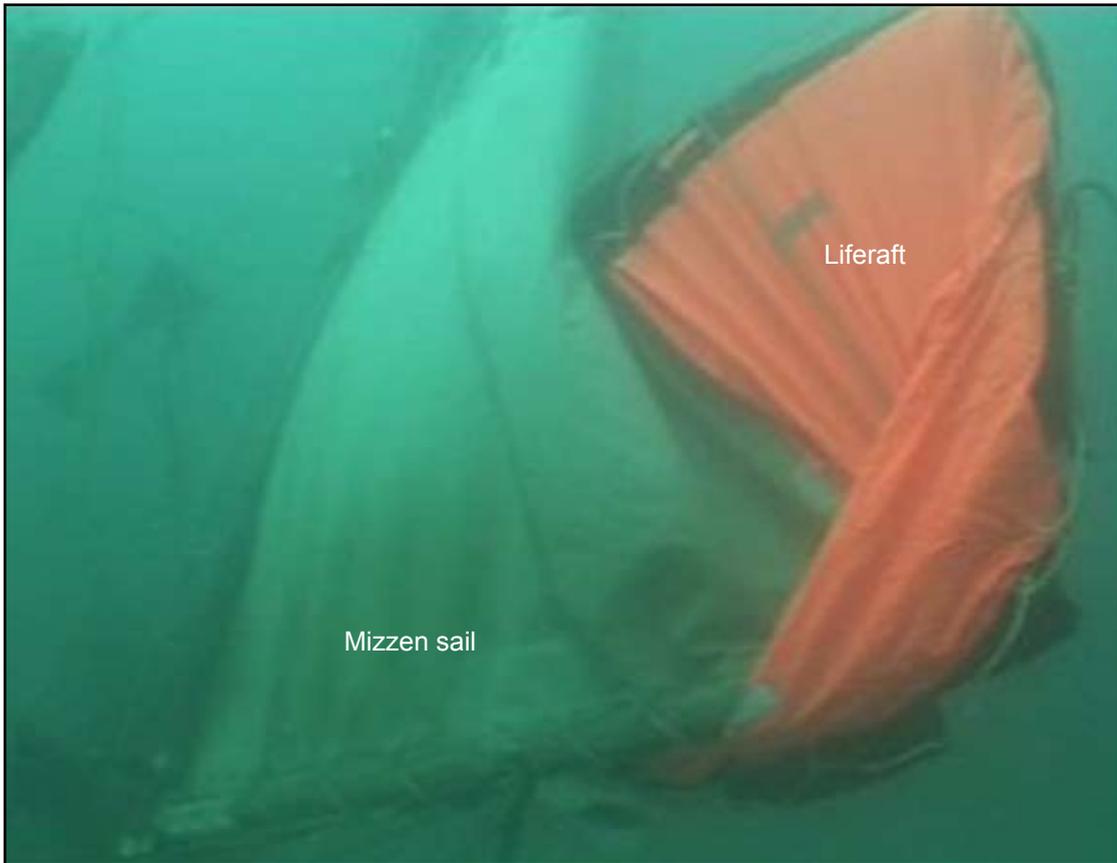
Figure 11

*Lady Hamilton of Helford's* liferaft (photograph taken during diver's survey)

The liferaft on board *Lady Hamilton of Helford* failed to fully inflate and was therefore unusable. It was fortunate that the pilot boat was sufficiently close to quickly assist her crew; otherwise the failure of her liferaft would potentially have led to more serious consequences.

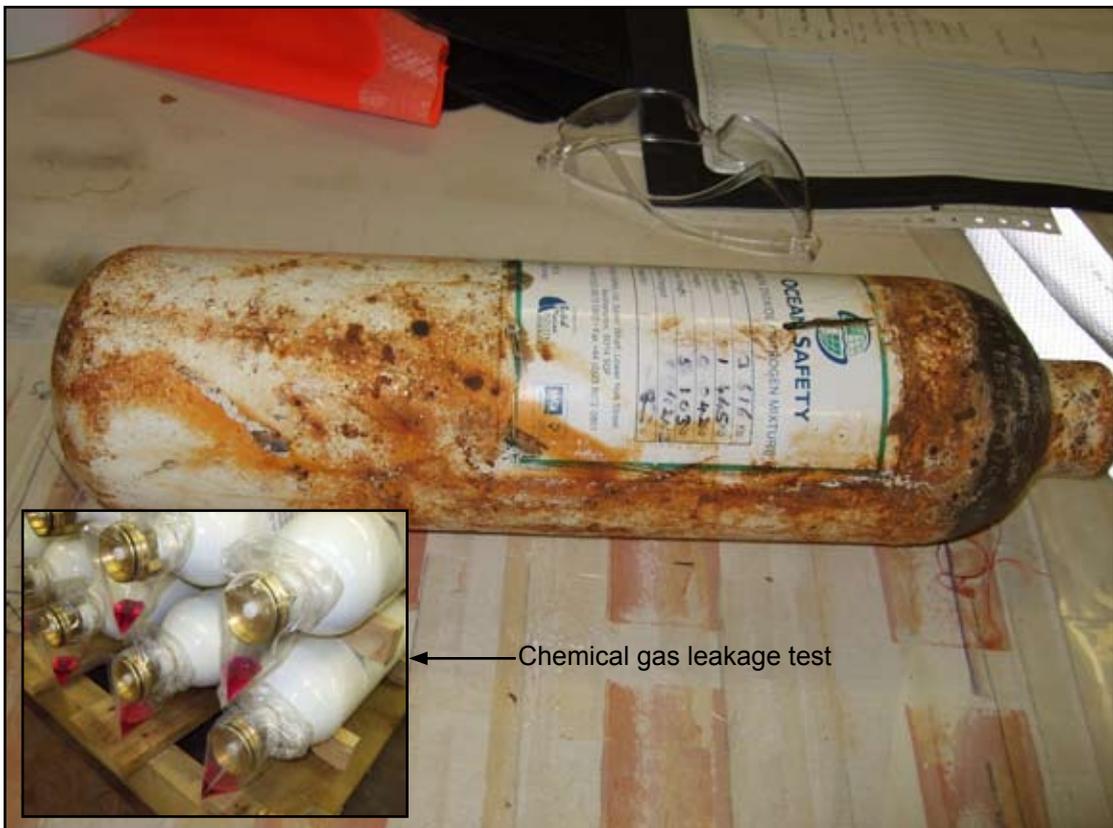
Figure 12

The carbon dioxide (CO<sub>2</sub>) gas cylinder and its operating head were also examined. The operating head appeared to function correctly but the steel cylinder had a significant amount of corrosion (**Figure 12**). The cylinder was charged with CO<sub>2</sub> and subjected to a chemical leakage test. The test indicated that at least 0.0022g of CO<sub>2</sub> had escaped over a 1-hour period. Attempts to locate the exact leakage point, by immersing the pressurised cylinder in water, failed. This indicated that the leak was extremely small. The manufacturer concluded that the gas leakage path was most probably through the threaded connection between the cylinder neck and its operating head. The test report is at **Annex A**.

Liferaft CO<sub>2</sub> gas cylinder

Tests on the liferaft (**Annex A**) indicate it did not fully inflate because there was insufficient CO<sub>2</sub> in its cylinder and gas had leaked from the cylinder via an extremely small leak in the screw connection to its operating head. However, it has not been possible to determine how long the leak had been present. The weight of the cylinder was not recorded on the liferaft's maintenance record sheet during its annual services (**Annex B**), and the cylinder had not been pressure tested in 2004, as required by the manufacturer. Although records indicate that the cylinder was re-filled in 2002, the reasons for this are not known.

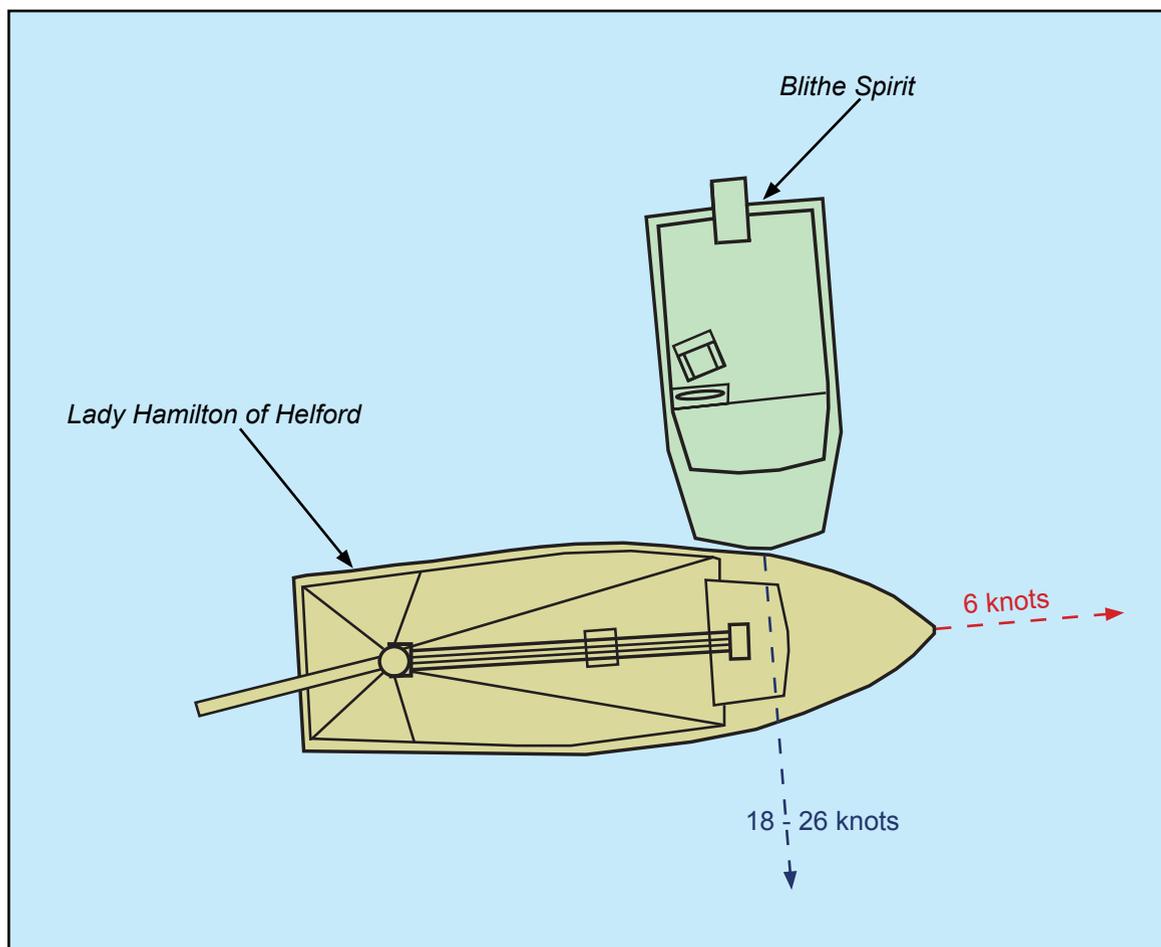
Figure 13

*Lady Hamilton of Helford* was struck on her port side forward and the damage to *Blithe Spirit* indicates she impacted with her starboard bow. The relative positions of the damage and the force of impact is consistent with the directions and the speeds of the vessels at the time (**Figure 13**). The geographical location of the collision is also consistent with intersection of the vessels' intended passages. The paint marks on the starboard and centre chines of *Blithe Spirit* (**Figure 9**) indicate that the dory rode up the side of *Lady Hamilton of Helford* before deflecting to port.

Estimated relative position of vessels on impact
