Report on the investigation of

Young Lady

Dragging anchor 5 miles east of Teesport and

Report No 3/2008
February 2008

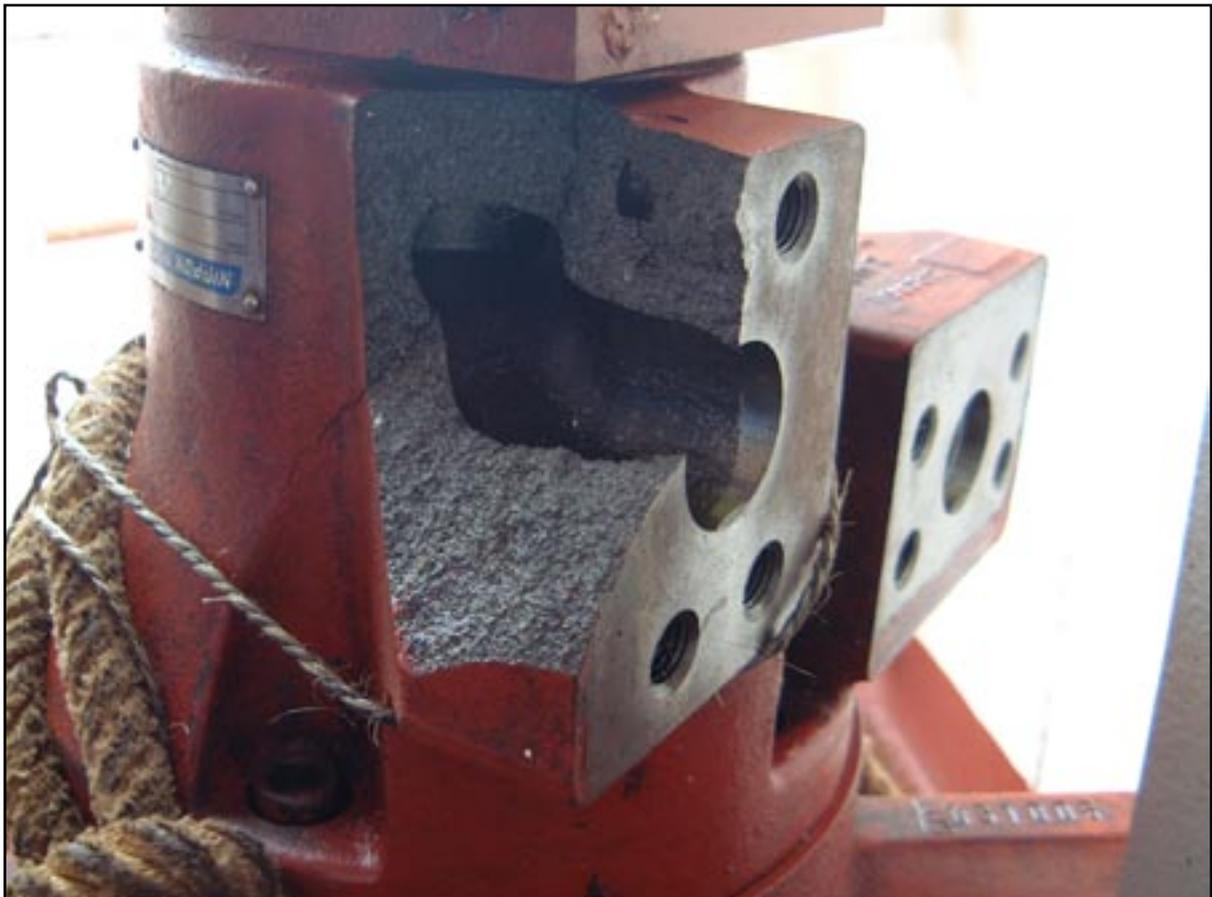
Figure 7

Damage to the port windlass hydraulic motor unit

It was not until 1330, when the crew had replaced the port windlass hydraulic motor, that it was possible to take the weight off the bitter end, remove the pin and finally slip the cable. *Young Lady* made ground to the north-east and awaited further instructions.

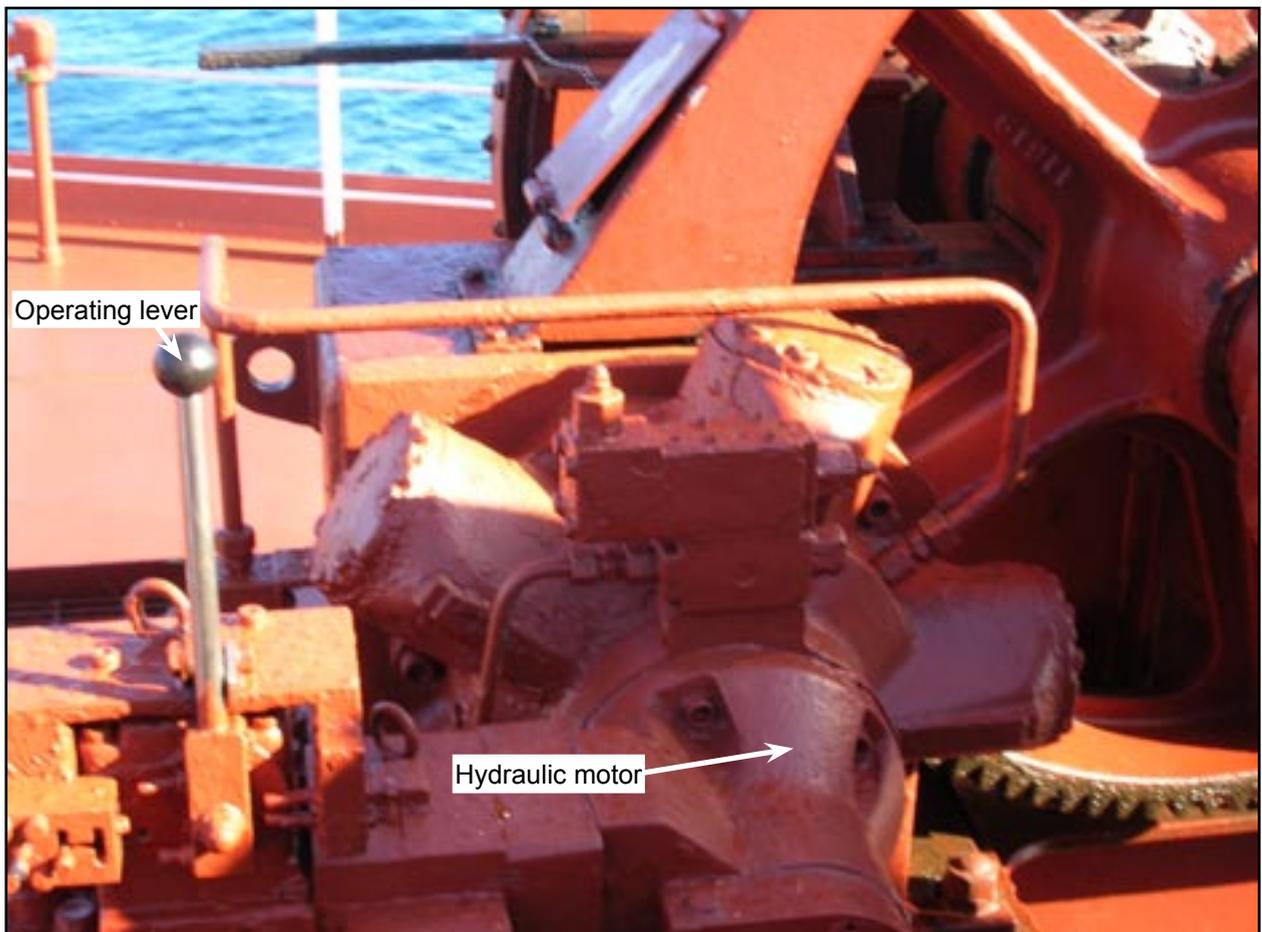
Figure 14

The hydraulic system was fitted with two in-line relief valves designed to operate when a hydraulic pressure of 240 Kgf was reached. One relief valve was fitted to guard against shock loads, and the other relief valve was fitted to guard against a gradual increase in hydraulic pressure encountered during the heaving operation. There was no relief valve fitted within the hydraulic motor itself.

Port Windlass Hydraulic motor

In April 2007, a defective hydraulic seal on the port windlass hydraulic motor led to a new motor being ordered and fitted. To facilitate the motor replacement, the crew designed and manufactured a tripod arrangement to hold the motor in position while replacement was carried out. The defective motor was later repaired on board by the crew, and became an unofficial spare. Fortunately, the availability of the spare motor and the tripod arrangement allowed the failed windlass motor to be replaced on the morning of 26 June 2007.

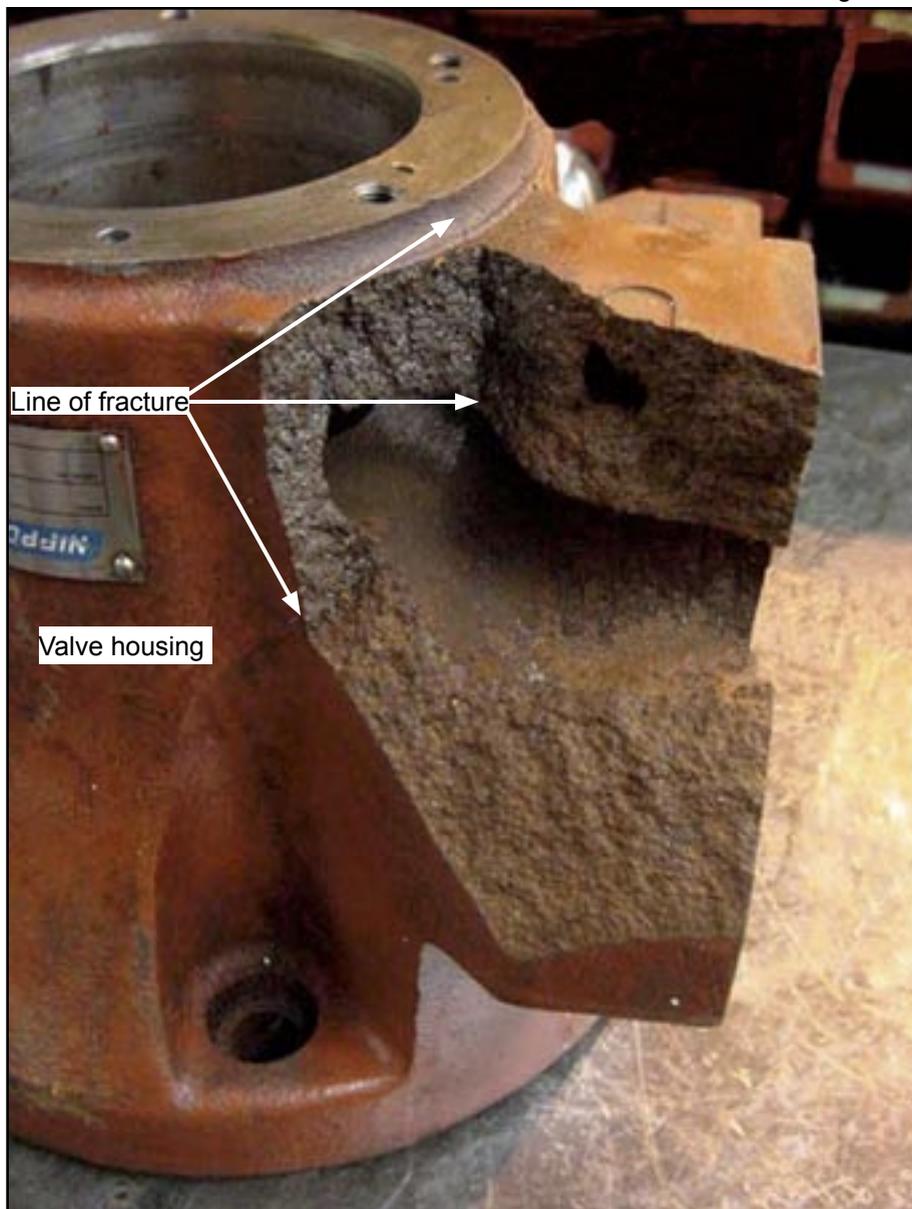
Figure 19

Comparison of the required and the actual capacities showed that there was little reserve power over and above the minimum required. When confronted with the weather conditions of 25 June, and when due consideration is given to the advice provided by the classification society, the potential risk of windlass failure was significantly greater than that faced under normal operating conditions.

Damage to motor casing

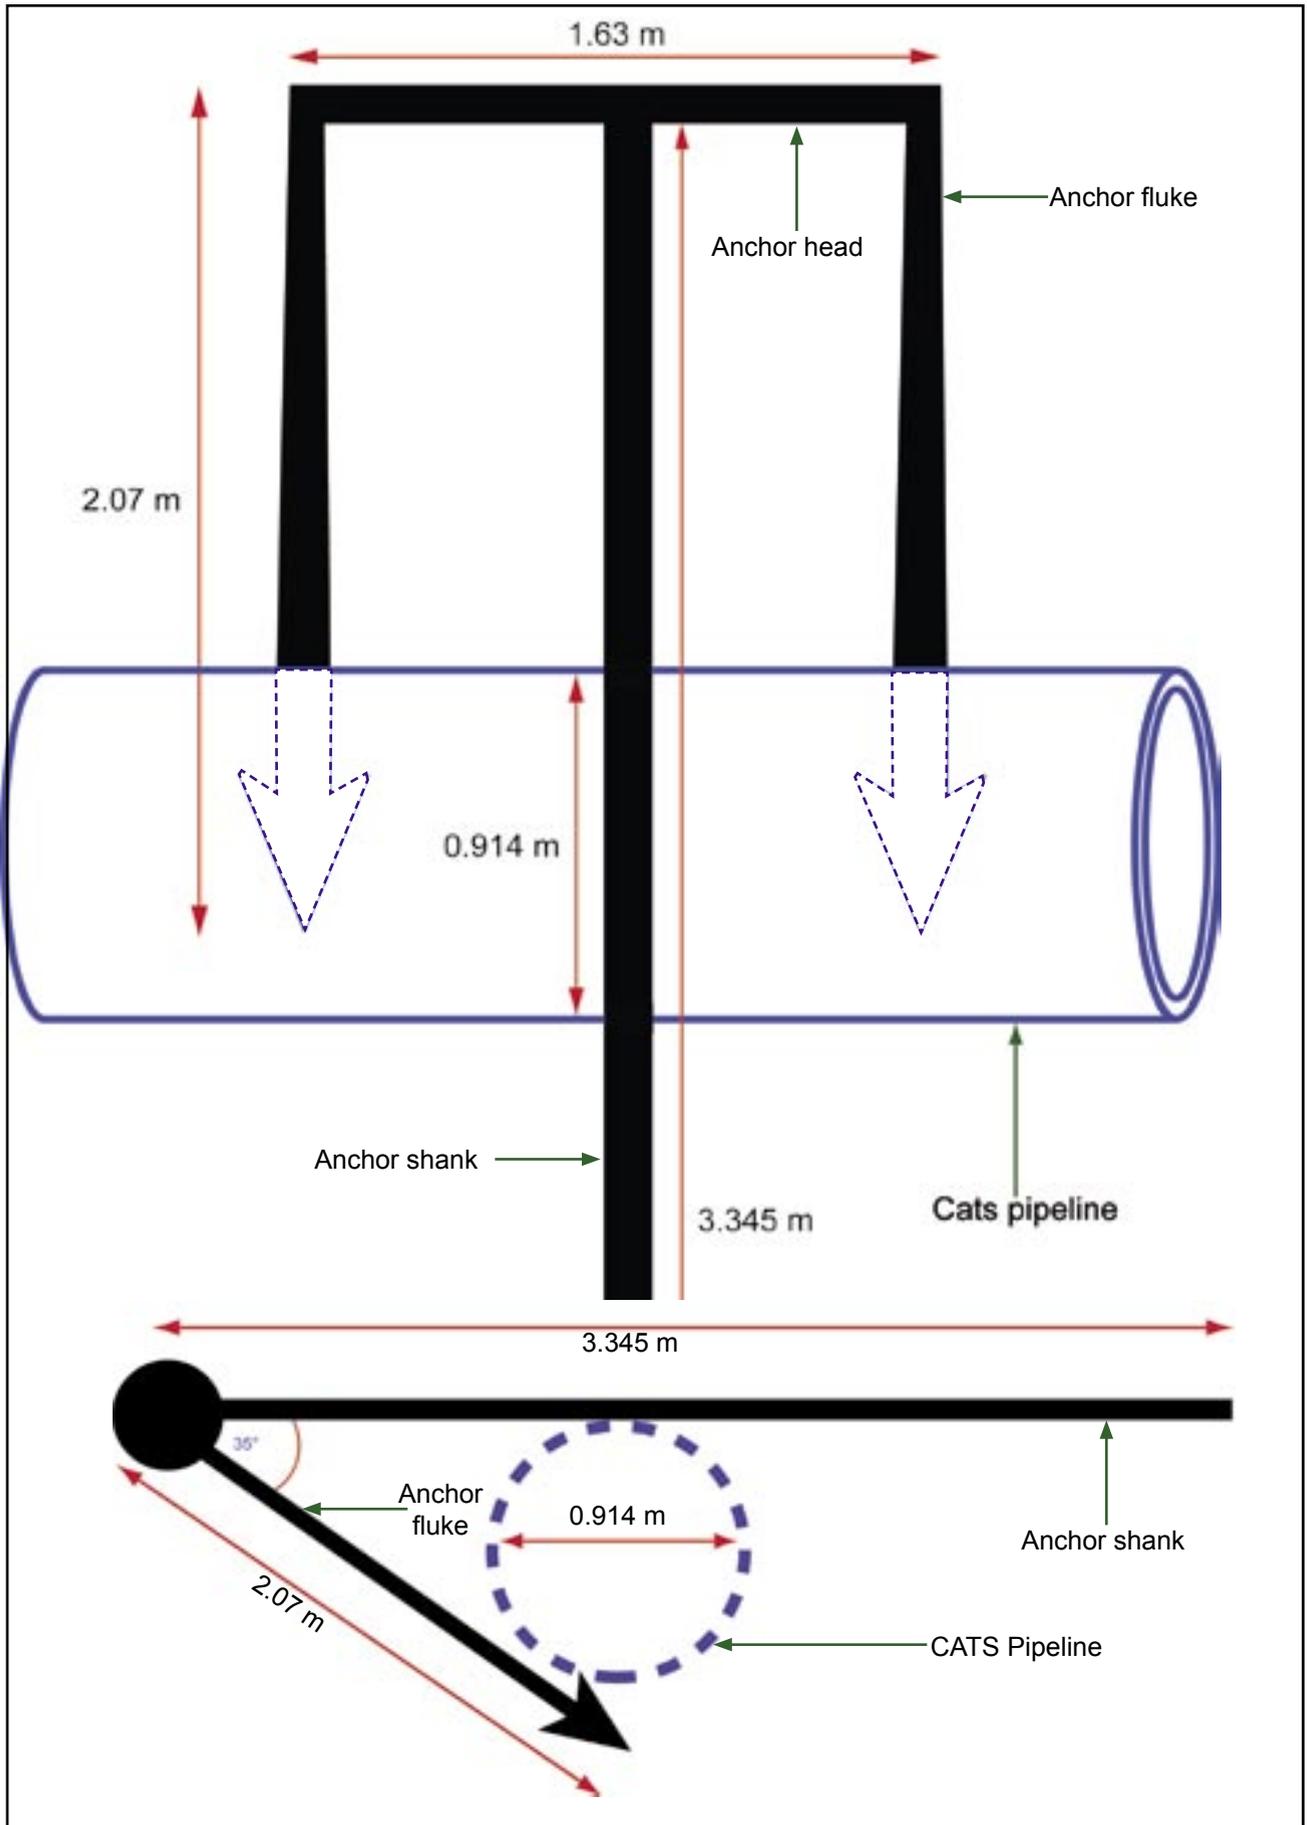
A subsequent survey of the pipeline showed that *Young Lady*'s anchor had lifted the pipeline out of its trench and dragged it about 6m laterally. The pipeline suffered damage to the concrete coating and impact damage to the steel surface.

Plan view and elevation diagrams representing *Young Lady's* anchor snagging the CATS pipeline

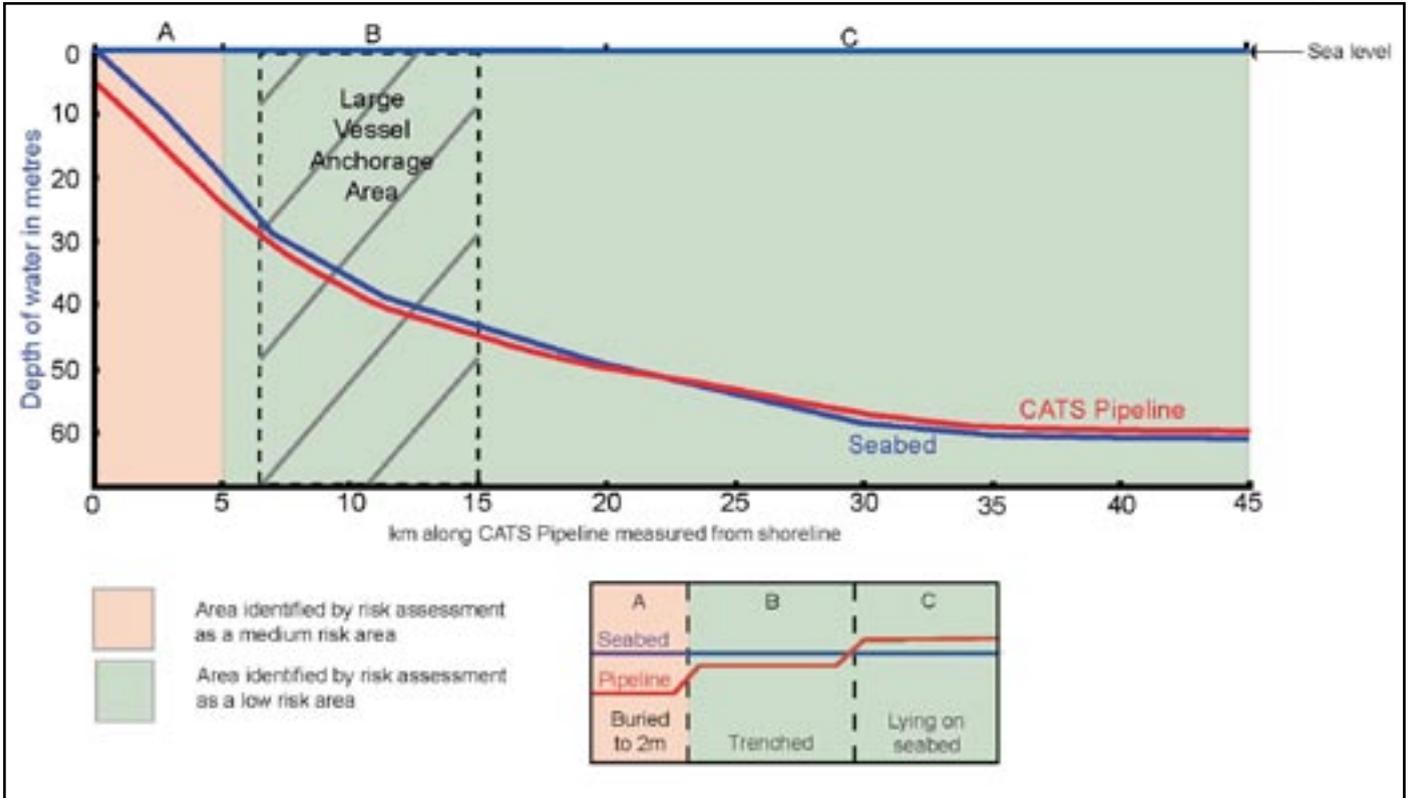
CATS Pipeline in relation to the seabed
