Report on the investigation of the collision between

***Audacity***

***Leonis***

**Report No 2/2008**  
**January 2008**

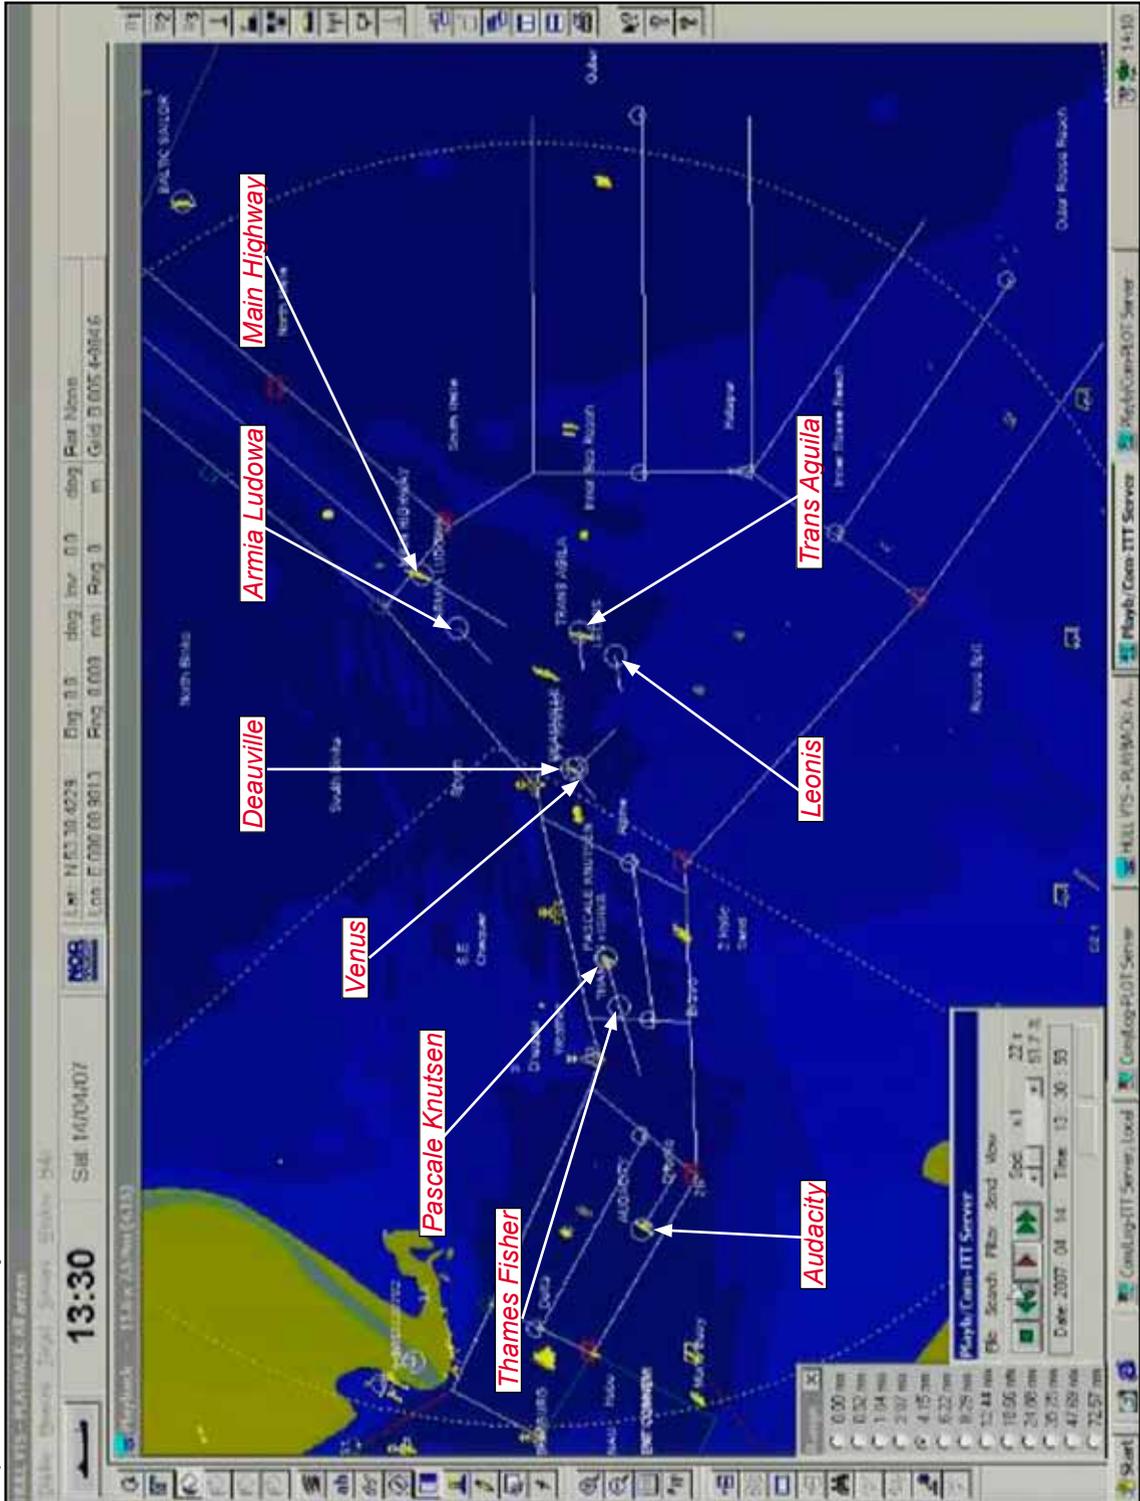
Figure 1

The positions of these vessels at 1330 are shown on a chartlet of the VTS area (**Figure 1**). The turn allocated to each vessel to embark a pilot was determined both by time of arrival and the vessel's final destination. As can be seen at **Figure 1**, at 1330 *Armia Ludowa* and *Trans Aquila* are further from the pilot boarding area than *Leonis*, however they were scheduled to embark a pilot before *Leonis* due to the latter's shorter river transit.

VTS Humber screen shot at 13:30

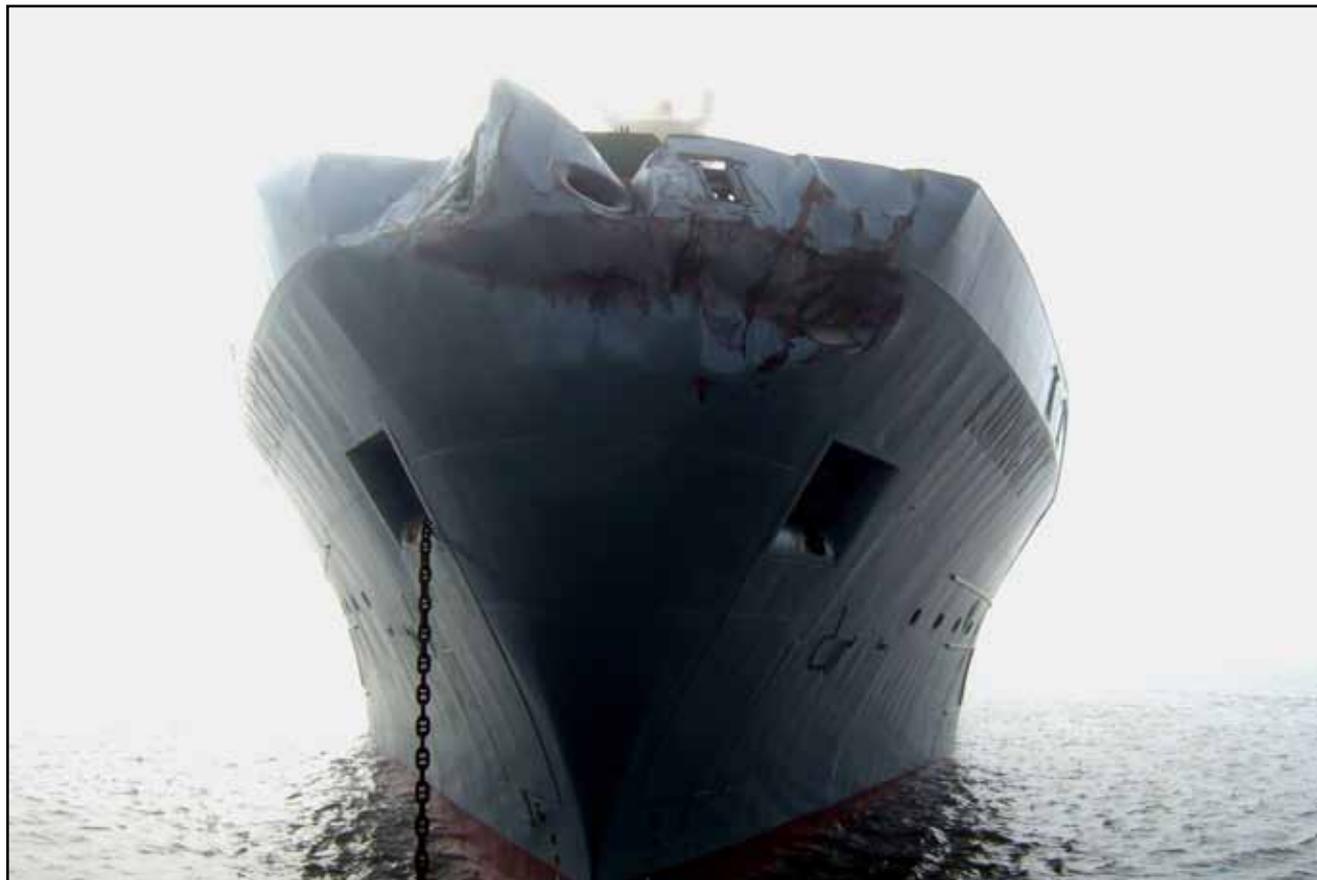
<b>Accident details</b>	
Time and date	: 1351 Local Time (UTC +1) on 14 April 2007
Location of incident	: Precautionary area approaching Spurn Point
Injuries/fatalities	: No injuries or fatalities
Damage	: Both vessels suffered significant bow damage.

Damage to the bow of *Audacity*

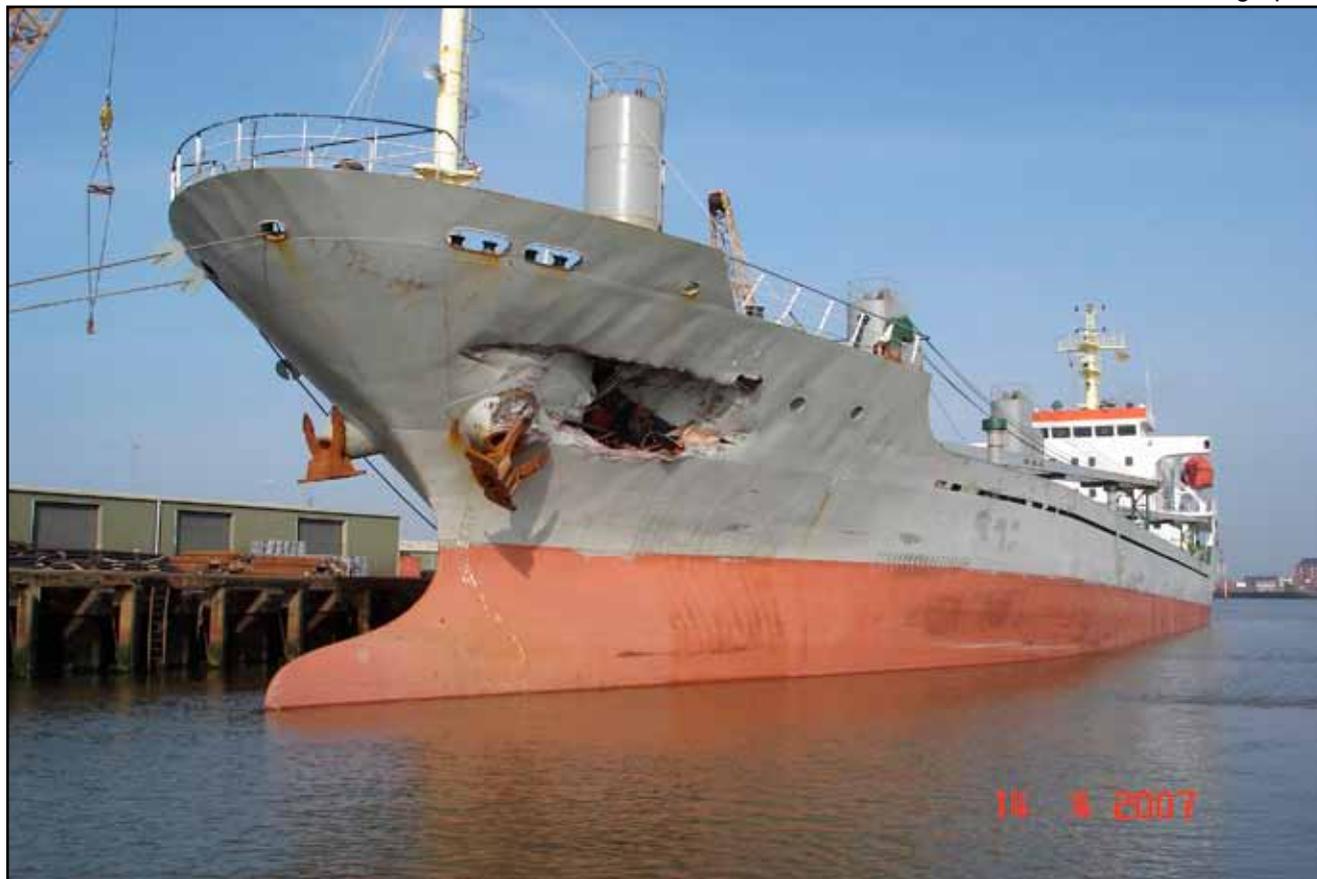
Damage to *Leonis*

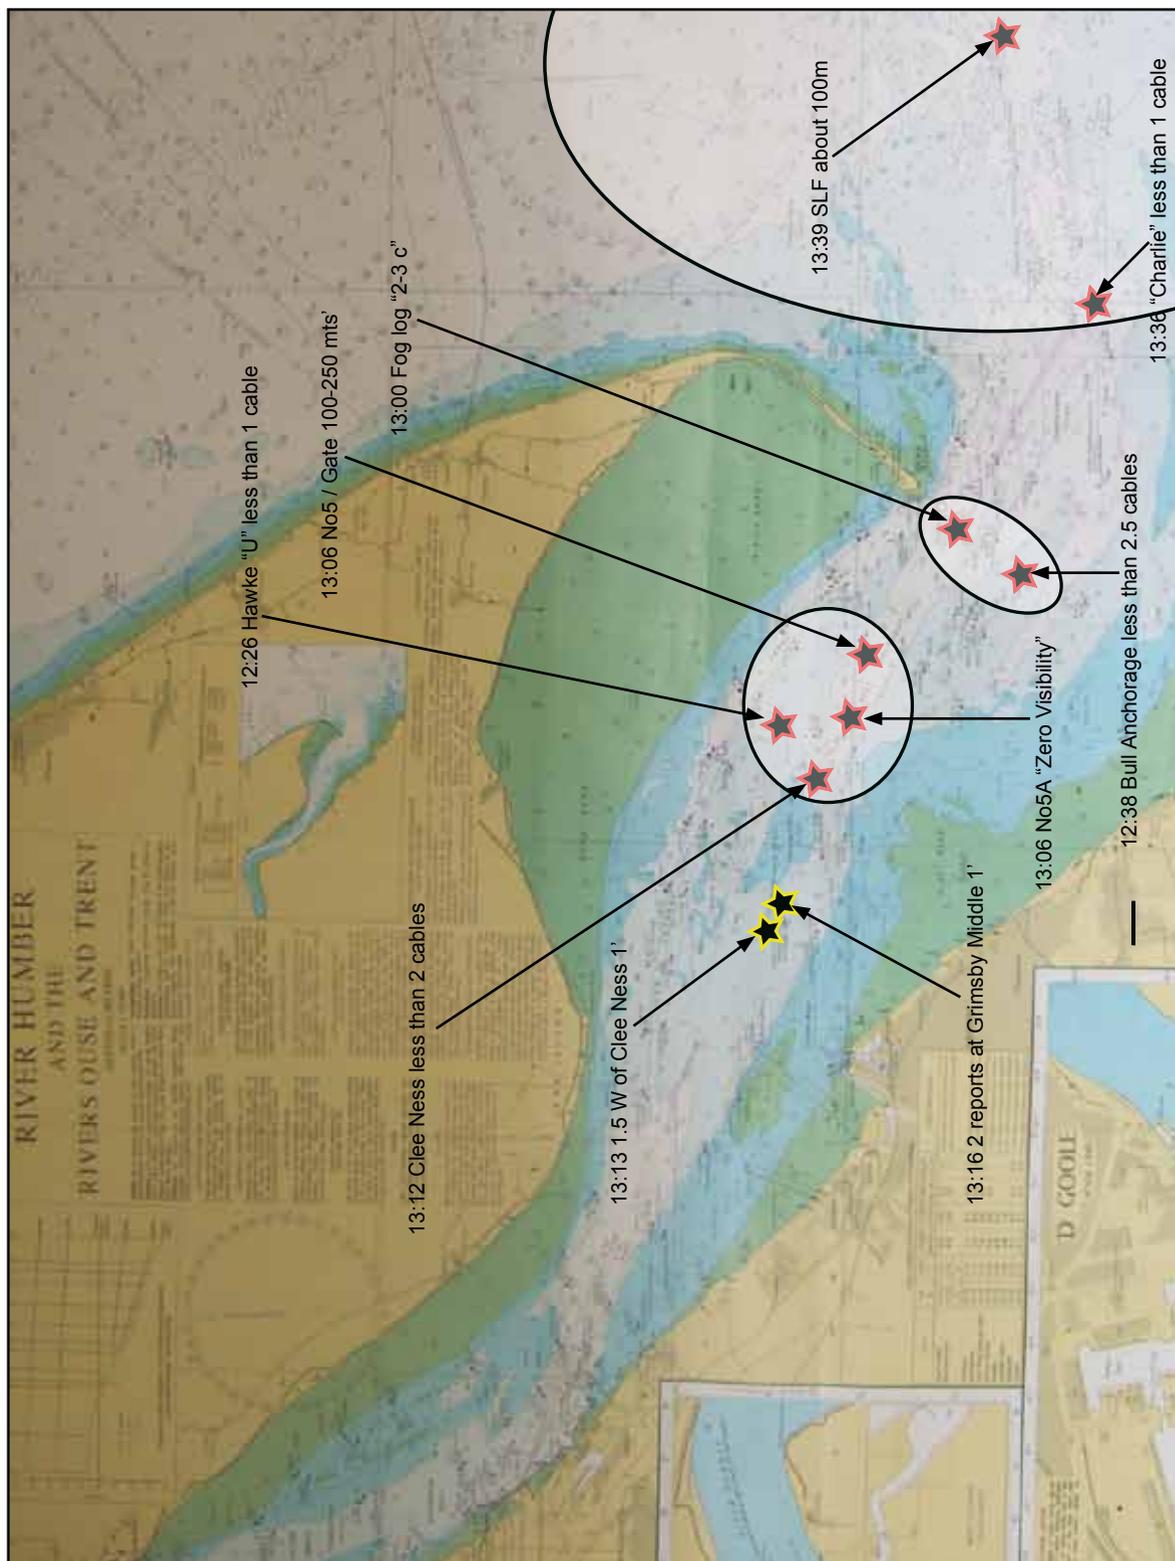
Figure 2

Estimated visibility within the Humber Estuary

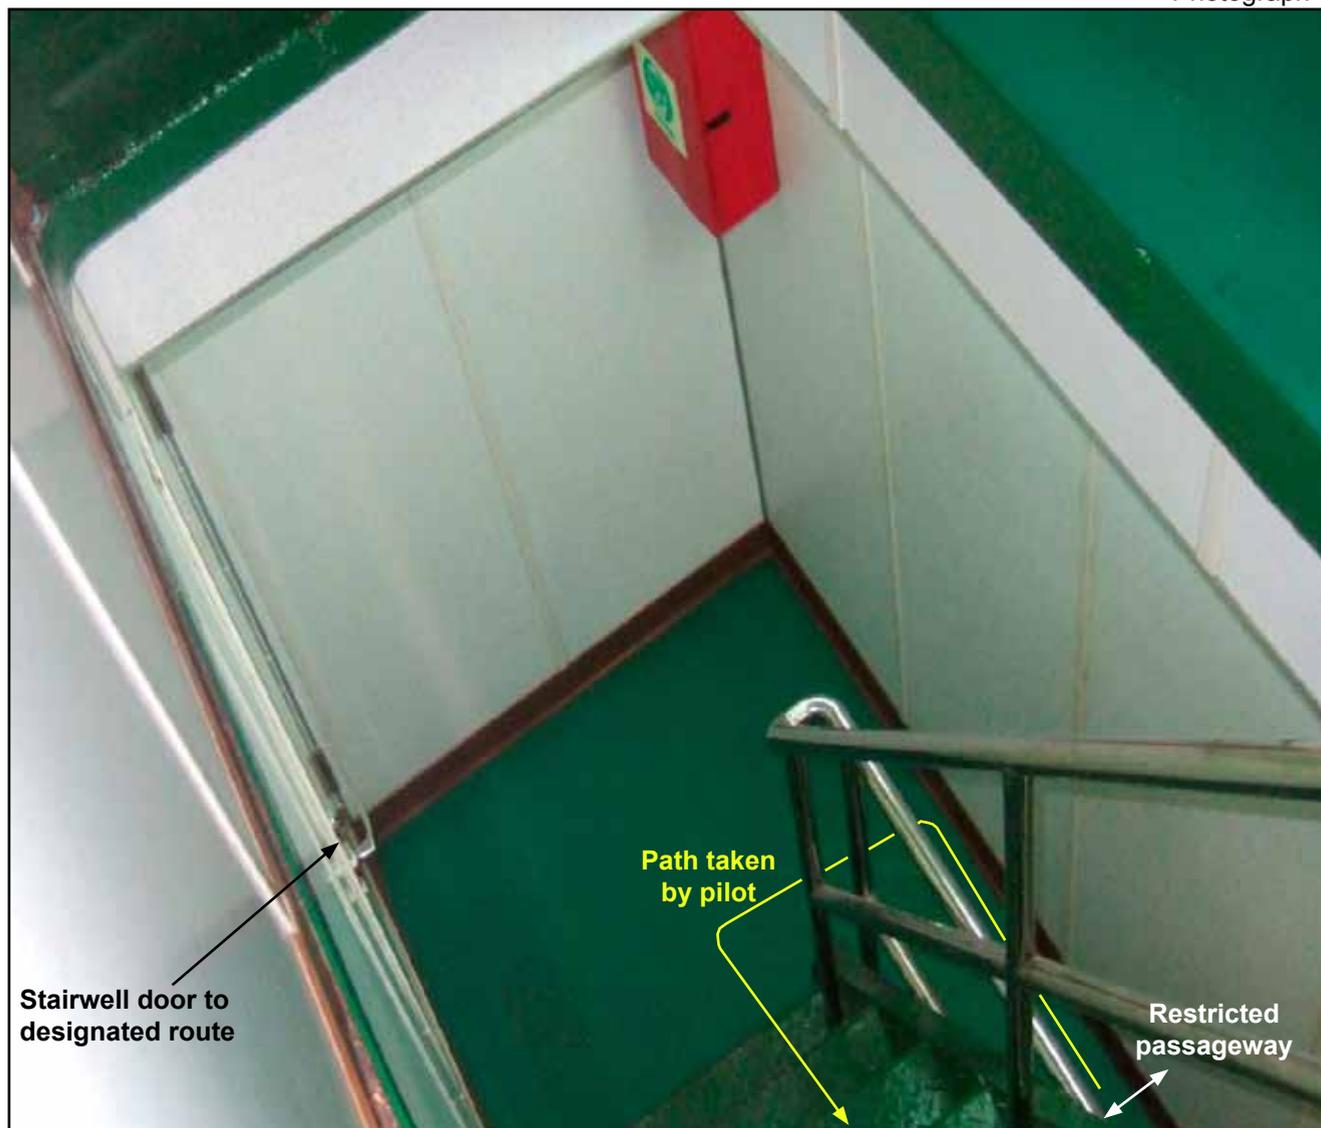
The pilot was taken from the main deck into the accommodation and up the stairs, via an enclosed stairwell, to the bridge. The pilot's progress was impeded because the design of the stairwell allowed just enough space for a slim and unencumbered person to pass between the stair railings and the bulkhead. In fact, this was not the most efficient way of using the stairs. There was a door at the head and foot of each flight of steps; and the correct way to use these should have been to enter the stairwell at the door at the base of the stairs, climb to the next deck, exit the stairwell into the adjacent alleyway, and re-enter at the foot of the next flight of stairs (**Photograph 6**).

Internal stairs within *Leonis*

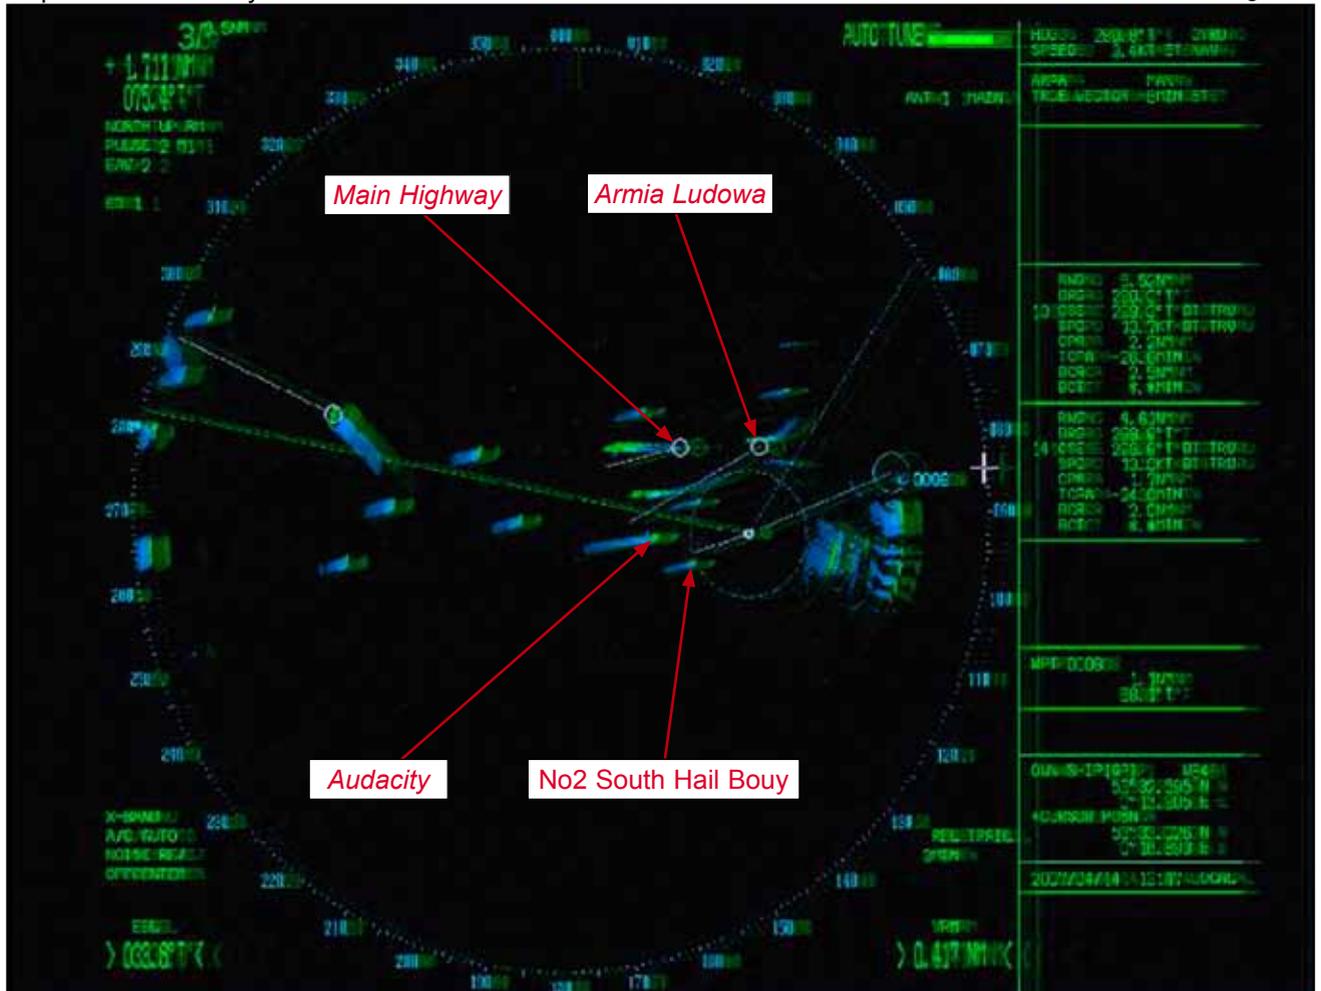
*Leonis*' radar at 13:47 - time the pilot reaches the bridge

There was no effective ARPA plot made of *Audacity*: when the radar target was acquired there was no time for a reliable vector to be calculated before the collision occurred.

Under these conditions, *Leonis* commenced an alteration of course without the bridge team clearly establishing if it was safe to do so.

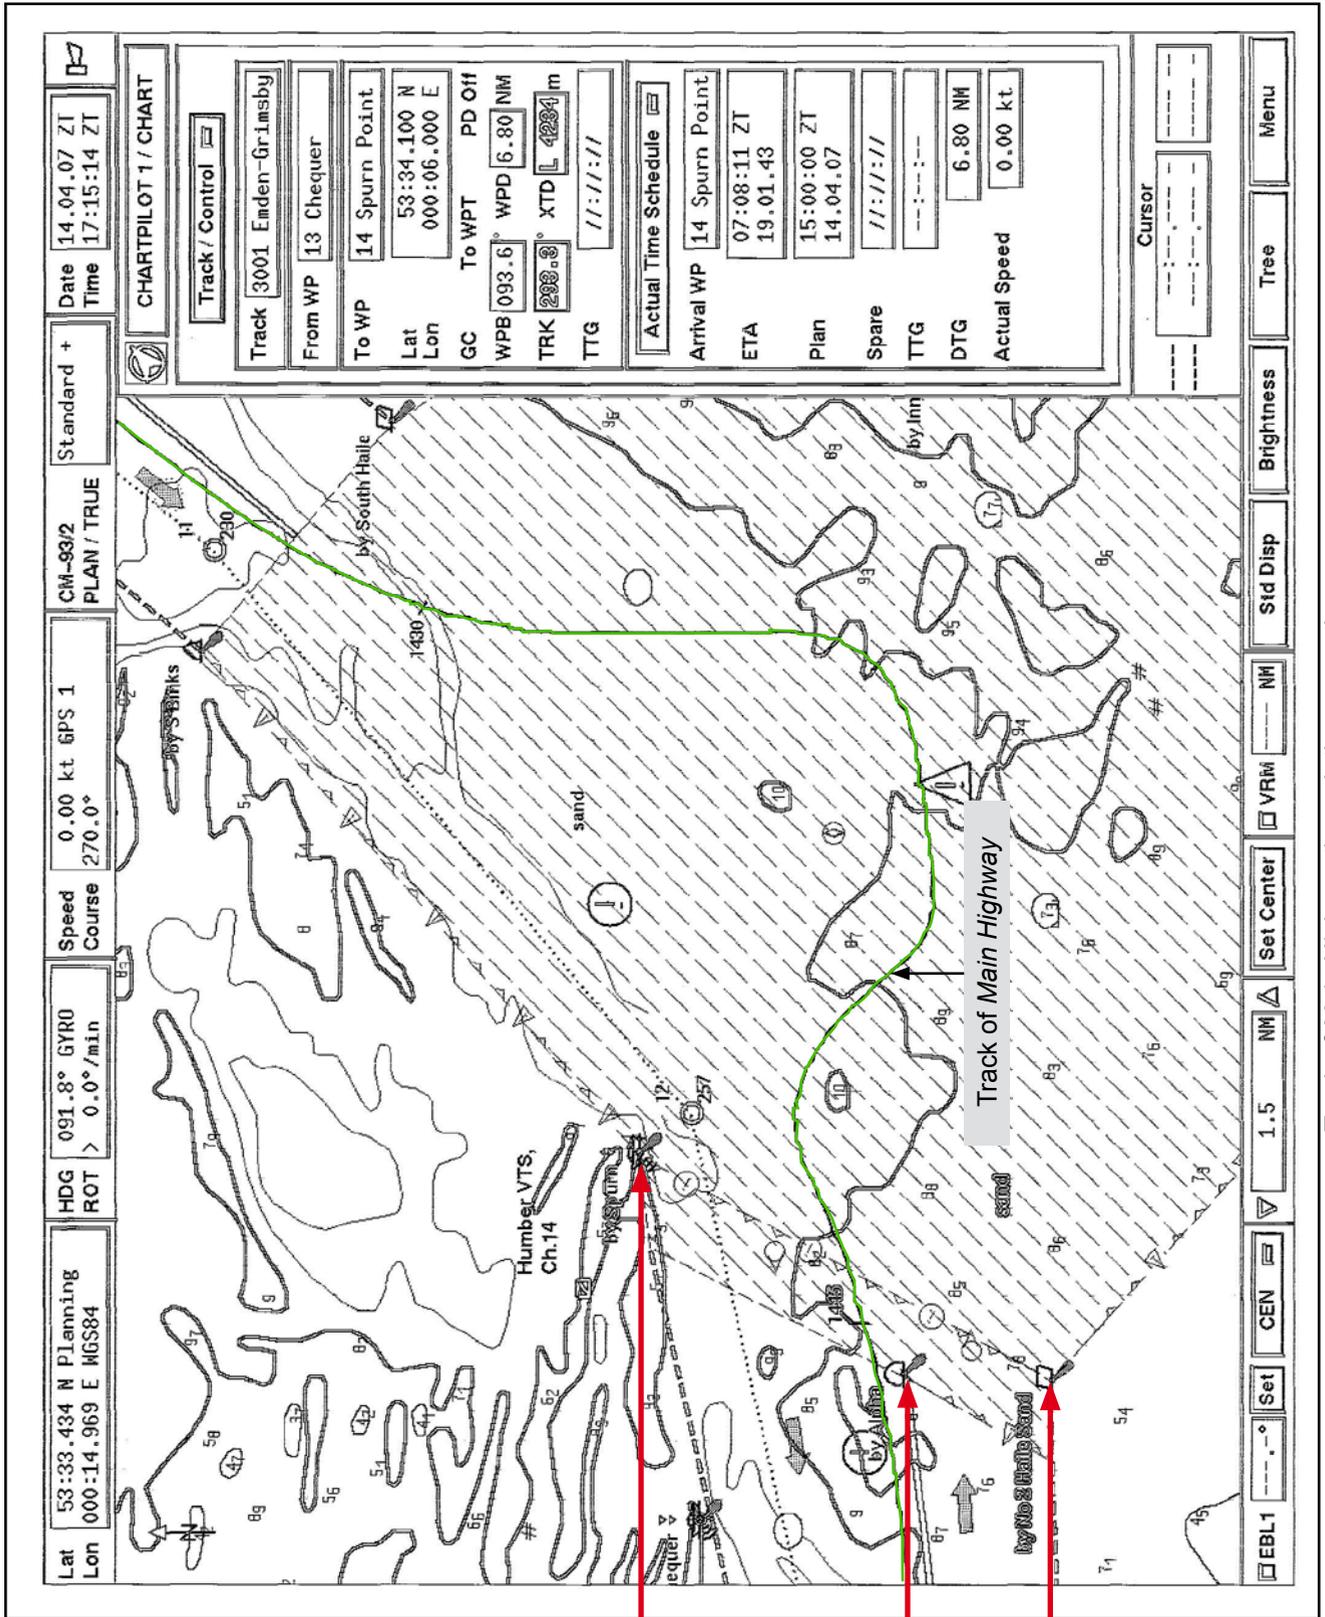
of his intention to pass to the north of *Leonis*. As a consequence, the master of *Leonis* placed the helm to port and, shortly afterwards, *Main Highway* passed to starboard at a distance of 2½ cables. This manoeuvre resulted in *Leonis* settling on a course of 245° with her engine stopped, which, combined with the effect of the tidal stream, caused her to move toward the exit of the outbound traffic lane.

Track of Main Highway through the precautionary area
