Report on the investigation of

the collision between

Sea Express 1

Alaska Rainbow

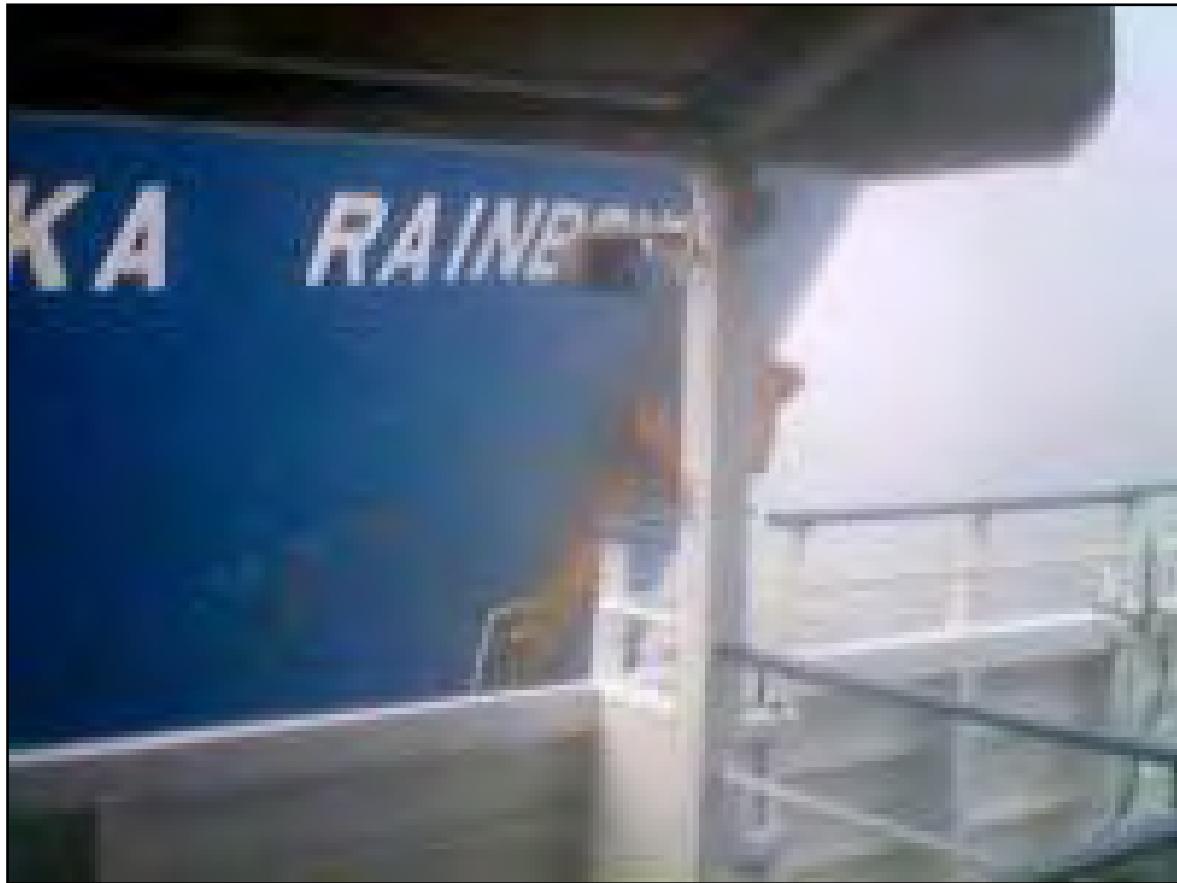
Figure 7

The aft part of the starboard hull of *Sea Express 1* and the bulbous bow of *Alaska Rainbow* collided, ripping a hole 2.5m by 6.5m in the engine room and jet pump room. This caused rapid flooding of the space, stopping the starboard engines and the two generators. The electrical load then transferred to the generator in the port engine room which overloaded and tripped out, leaving *Sea Express 1* temporarily on emergency electrical power only. The impact turned *Sea Express 1* to starboard, and a second impact was made with the hulls of the two ships parallel to each other (**Figures 7, 8 and 9**). *Sea Express 1* continued to slide down the starboard side of *Alaska Rainbow*, and the starboard bridge wing then made contact with *Alaska Rainbow*'s accommodation ladder stowed outboard of the ship's side railings near the accommodation. This impact ripped away *Sea Express 1*'s starboard bridge wing roof and windows, and damaged adjacent liferaft stowage arrangements.

Passenger photograph of the collision

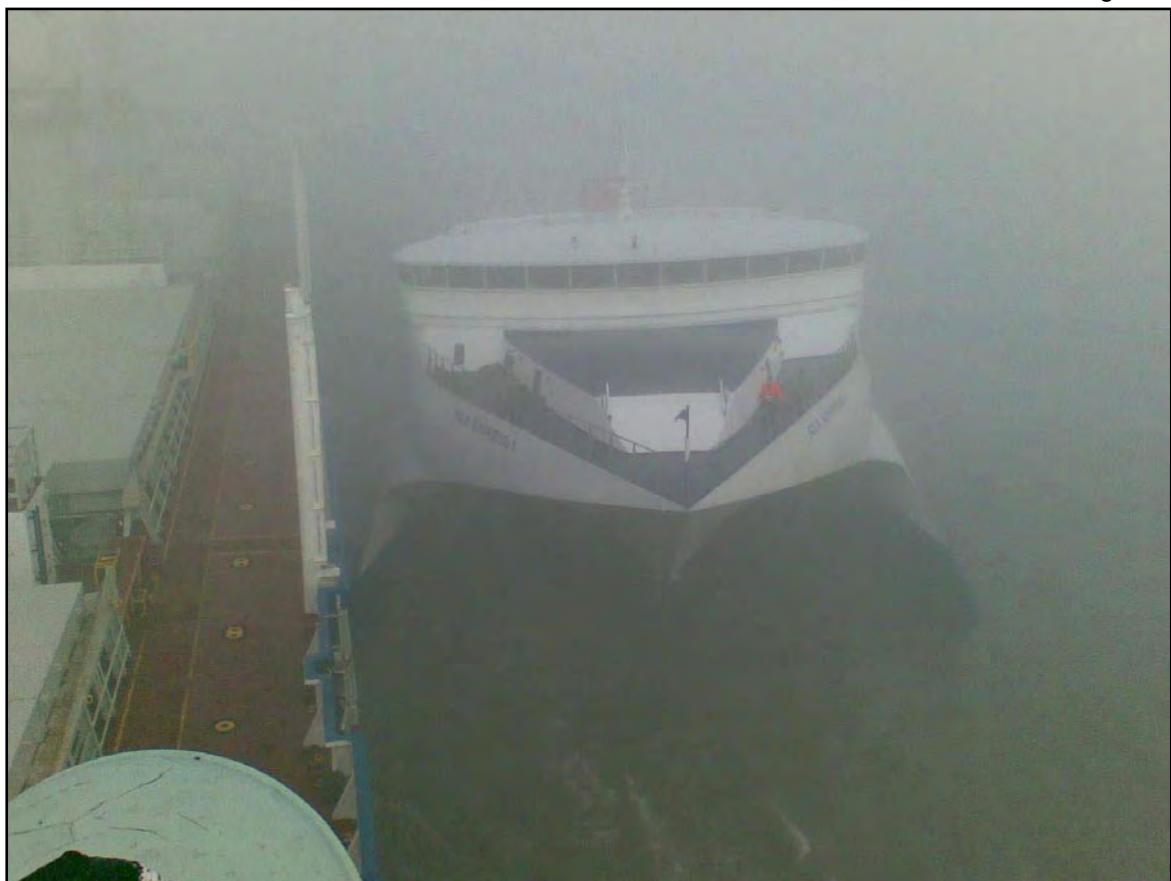
Figure 8

By now, *Sea Express 1* was listing to starboard and was trimmed by the stern (**Figure 8**). The trainee captain had sounded the emergency alarm shortly after the first impact, and the cabin crew were taking charge of the passengers, getting them to sit down and don lifejackets. With main electrical power restored but only the engines in the port hull available, the vessel was not manoeuvrable, and she drifted upstream with the tide. The small amount of thrust from the port engines, combined with the extra drag from the starboard hull, caused a slow turn to starboard.

Sea Express 1 parallel to Alaska Rainbow 20 seconds after the collision - note trim and list

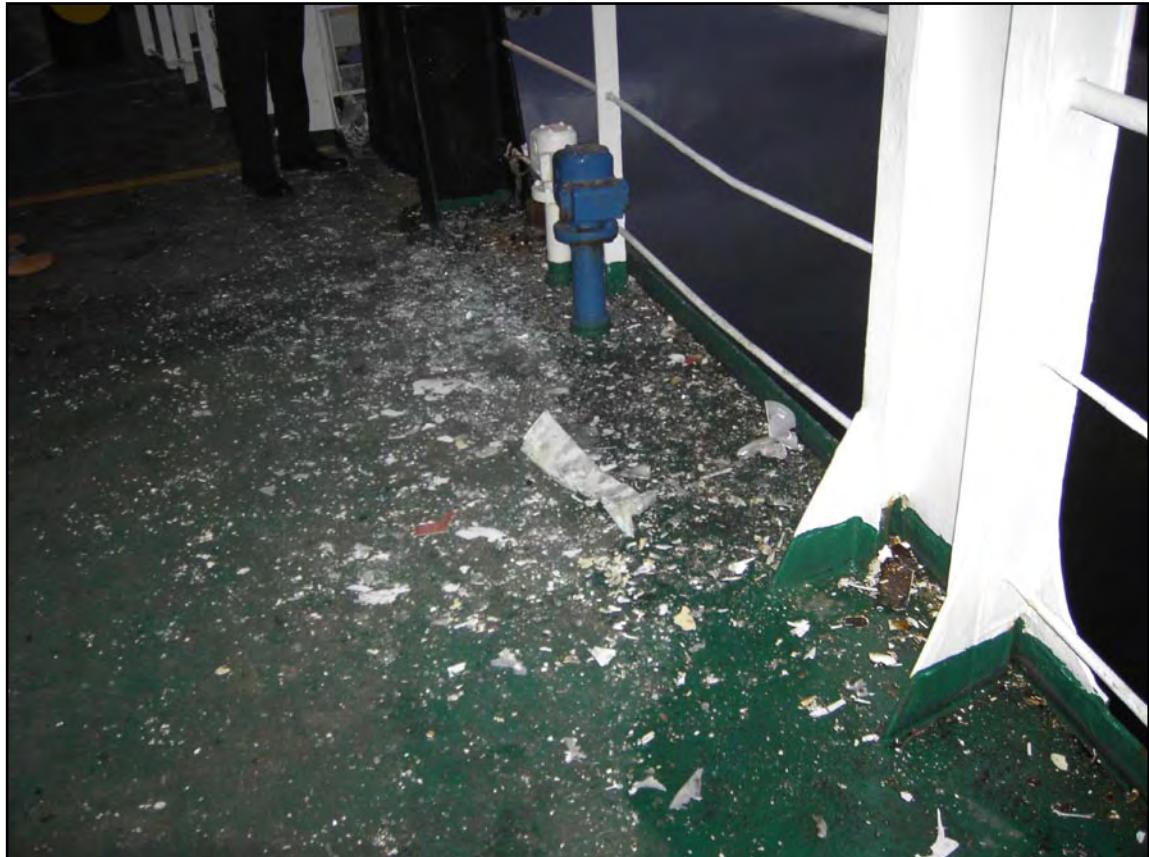
Debris from *Sea Express 1* on the deck of *Alaska Rainbow*

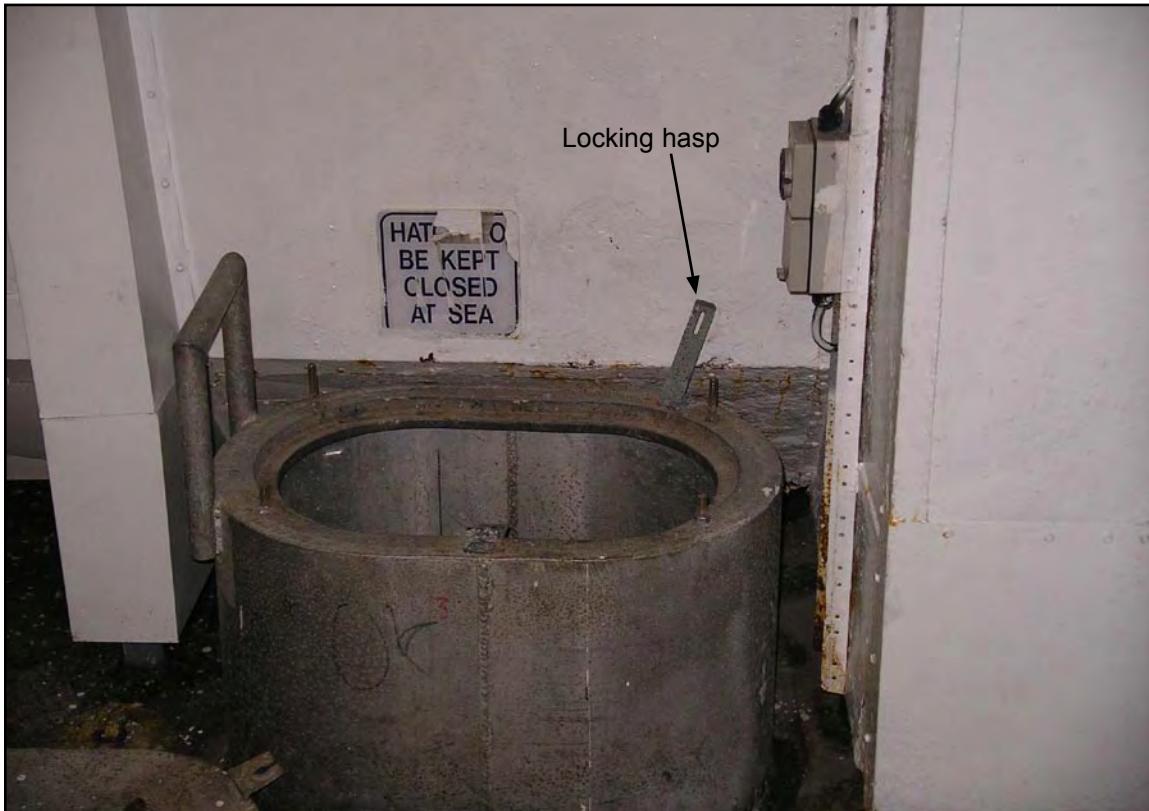
Sea Express 1 - access to void space

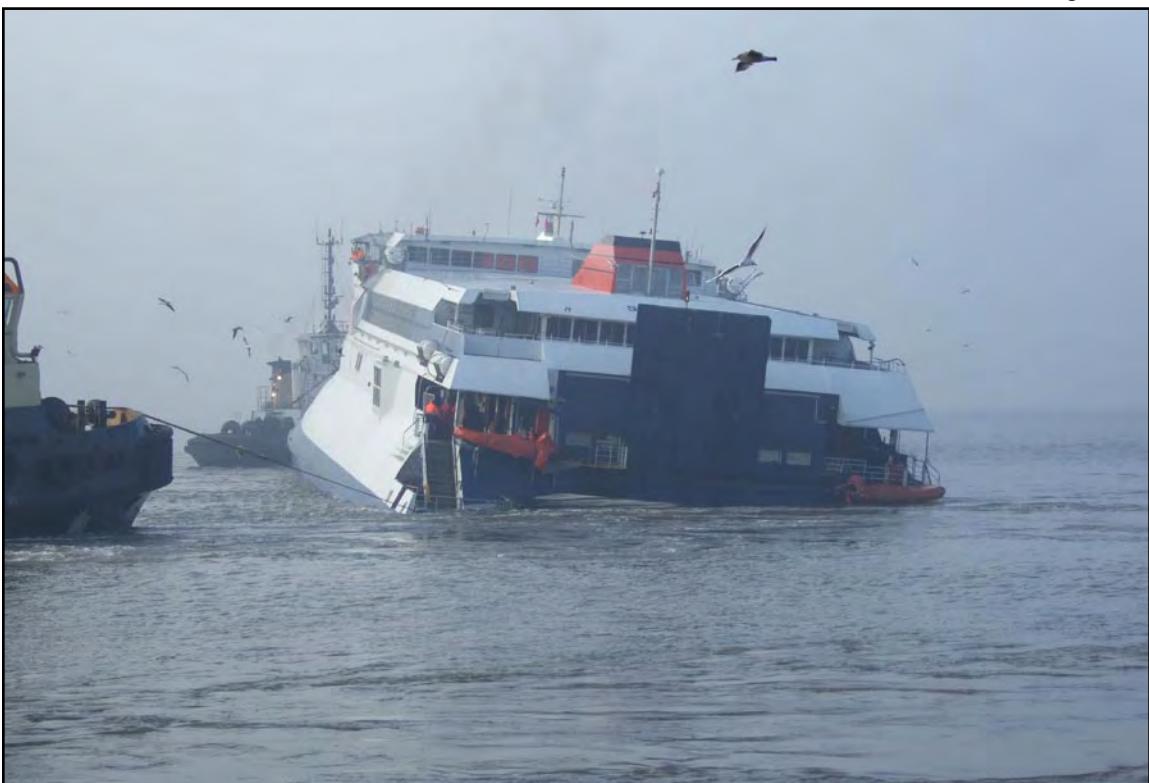
Sea Express 1 under tow

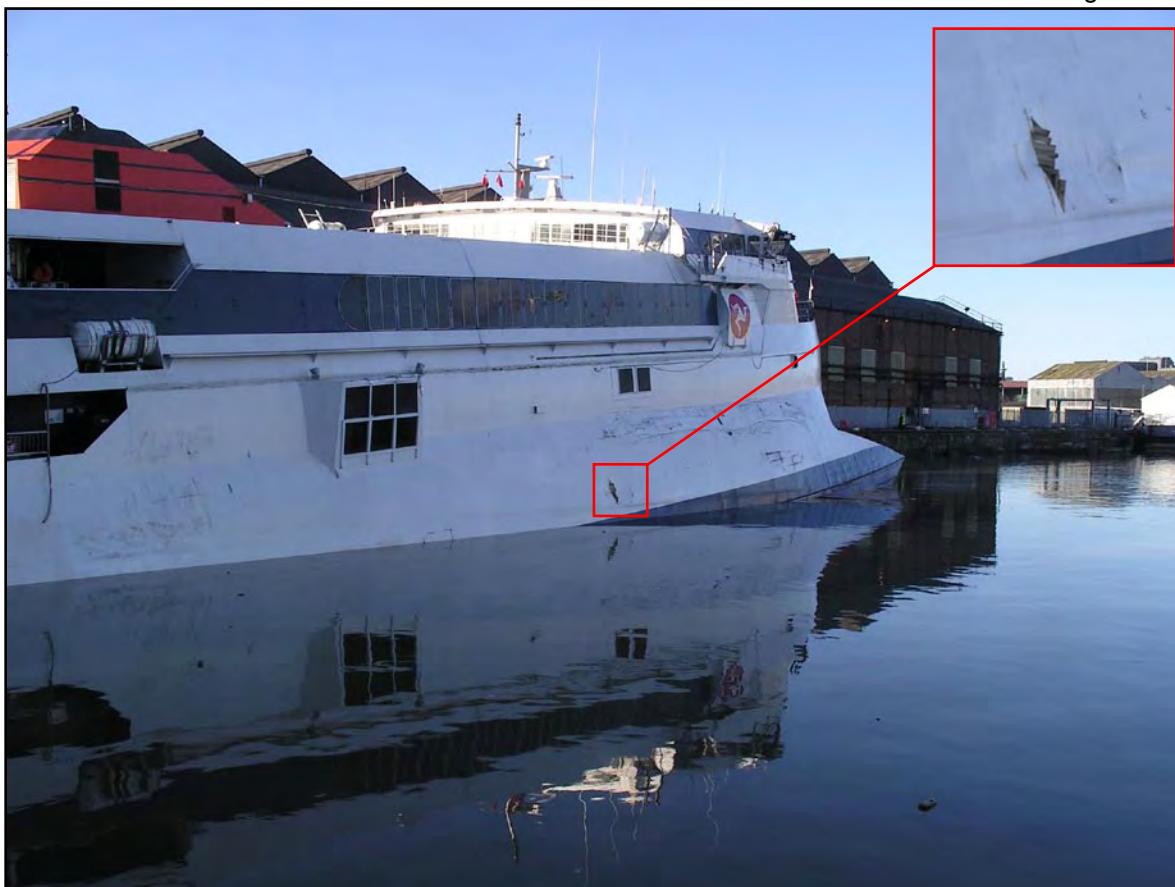
Figure 12b

Damage to Sea Express 1's starboard side

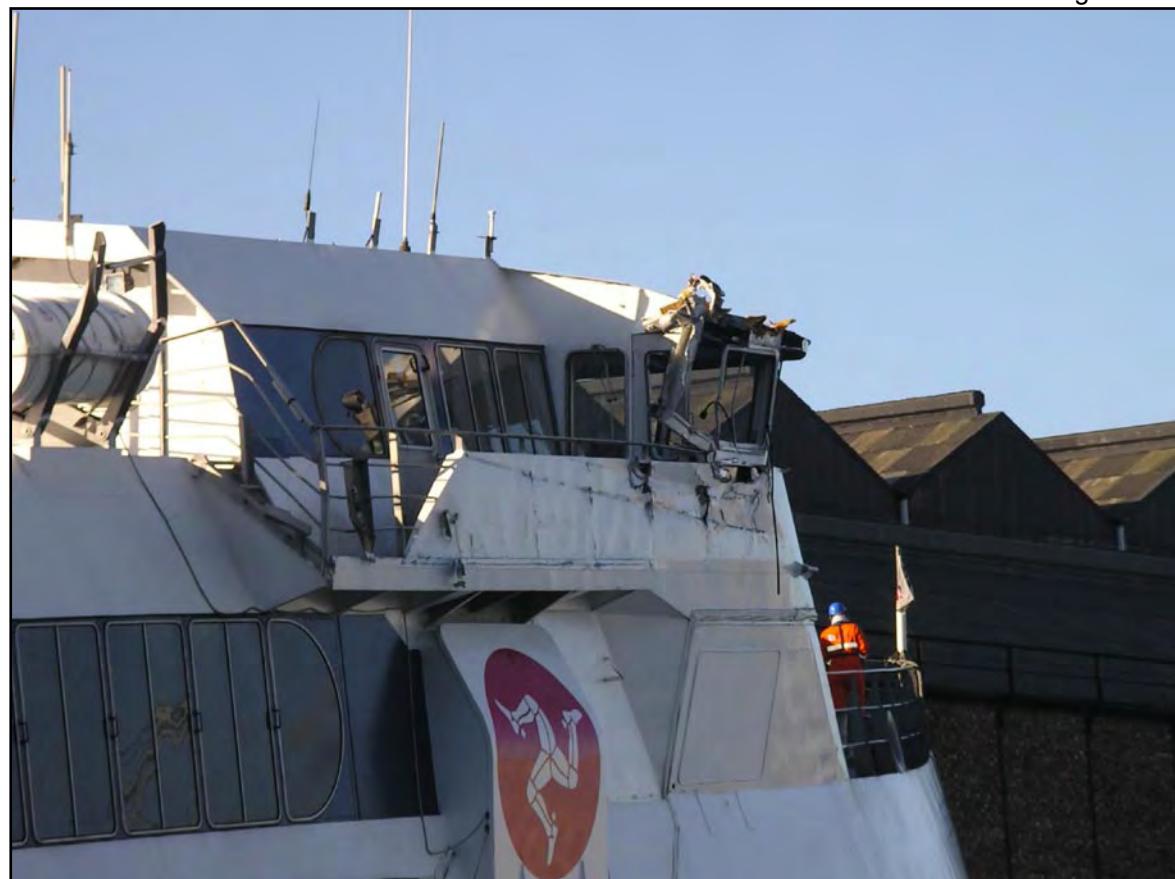
Figure 12c

Damage to Sea Express 1's starboard bridge wing

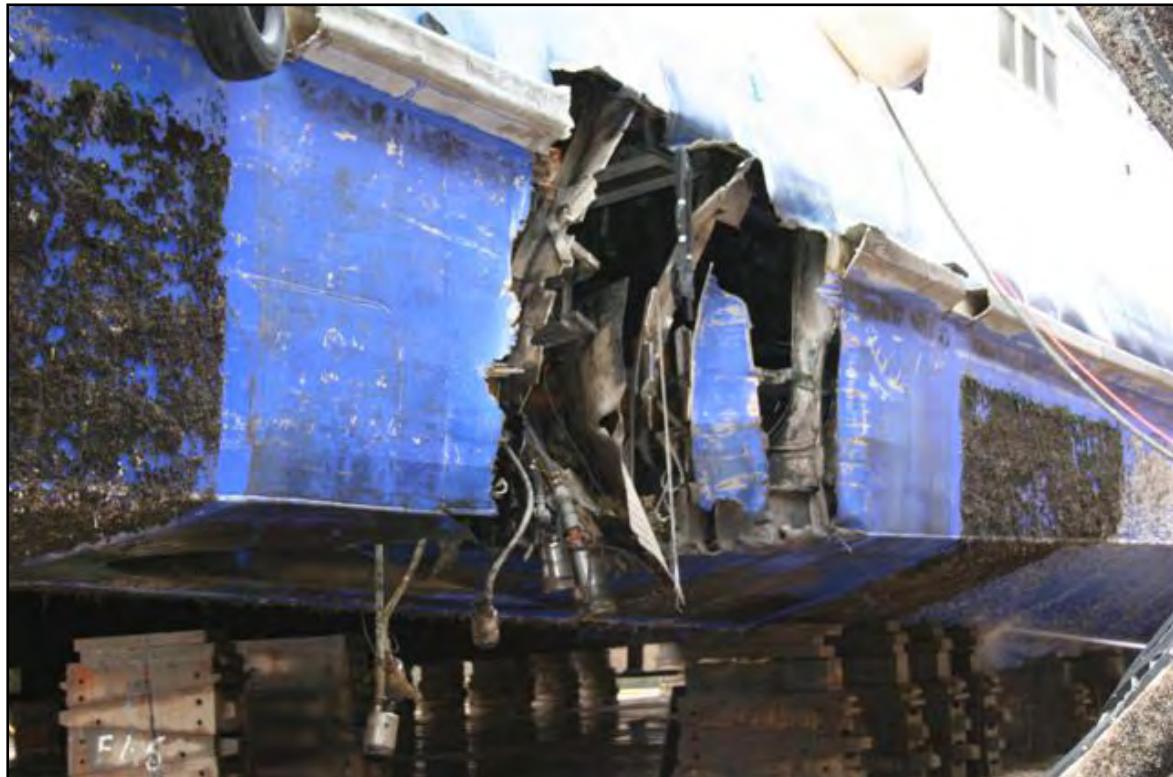
Figure 12d

Showing damage to starboard hull of *Sea express 1* once vessel dry-docked

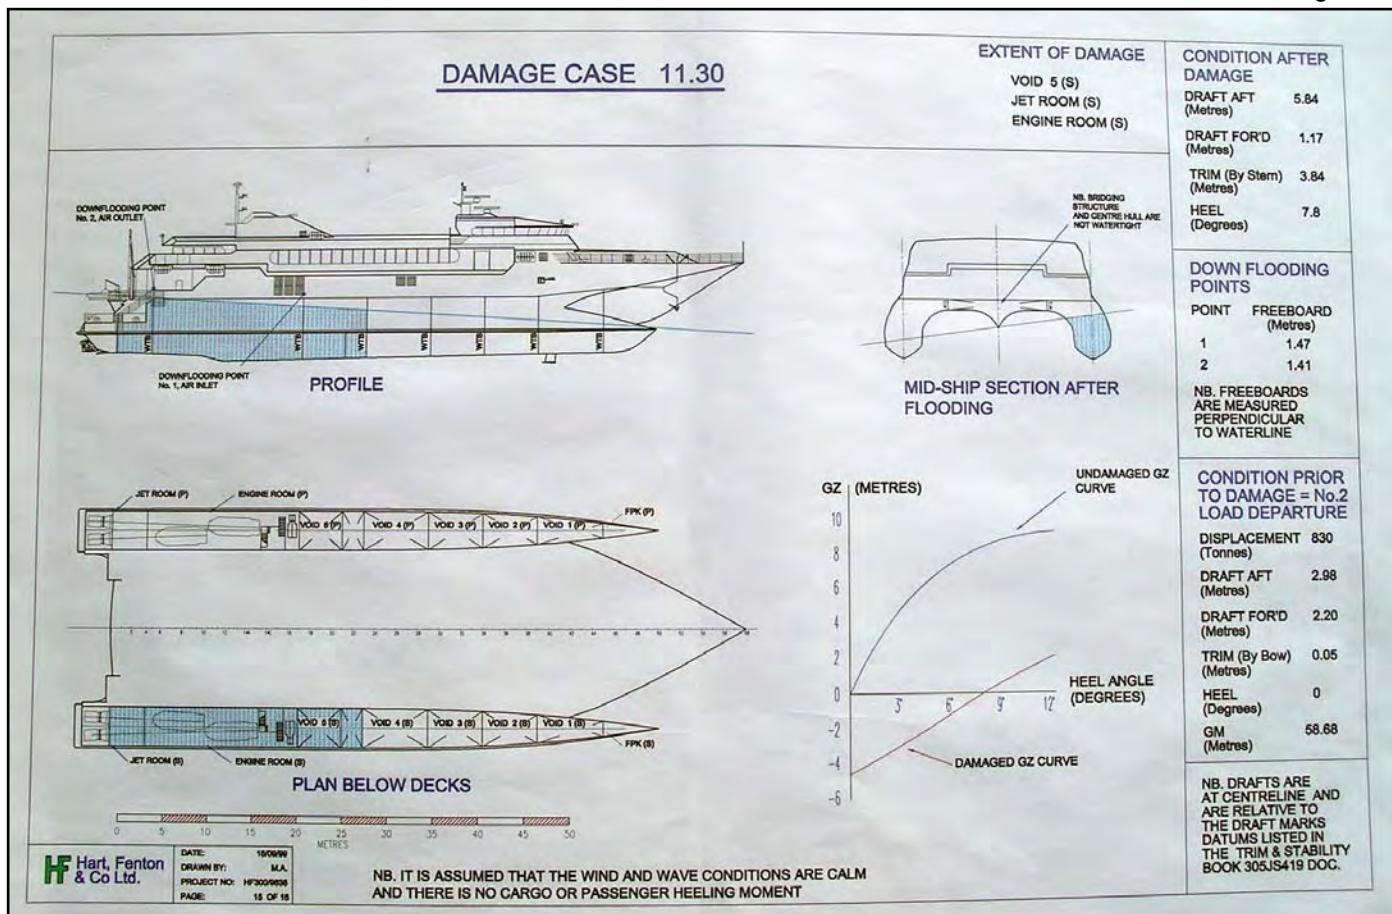
Figure 13

Damage case 11.30 (**see Figure 13**) of the decision support system referred to flooding in the starboard engine room, starboard jet room and void number 5 starboard. Since the jet room and engine room were separated by a non-watertight bulkhead, these two spaces were considered as one for the purposes of damage stability. Therefore, the vessel could have survived damage in the two aftermost watertight spaces.

The statement that the vessel could have survived flooding in the two aftermost spaces had been often repeated by the crew(s) of *Sea Express 1*, and, without referral to the damage control decision support system, had come to be accepted as meaning the jet pump room and engine room. Therefore, when the jet pump room and engine room flooded, great concern was raised that the vessel was at the limit of damage survivability, when in fact number 5 void could also have sustained damage.

Damage case 11.30

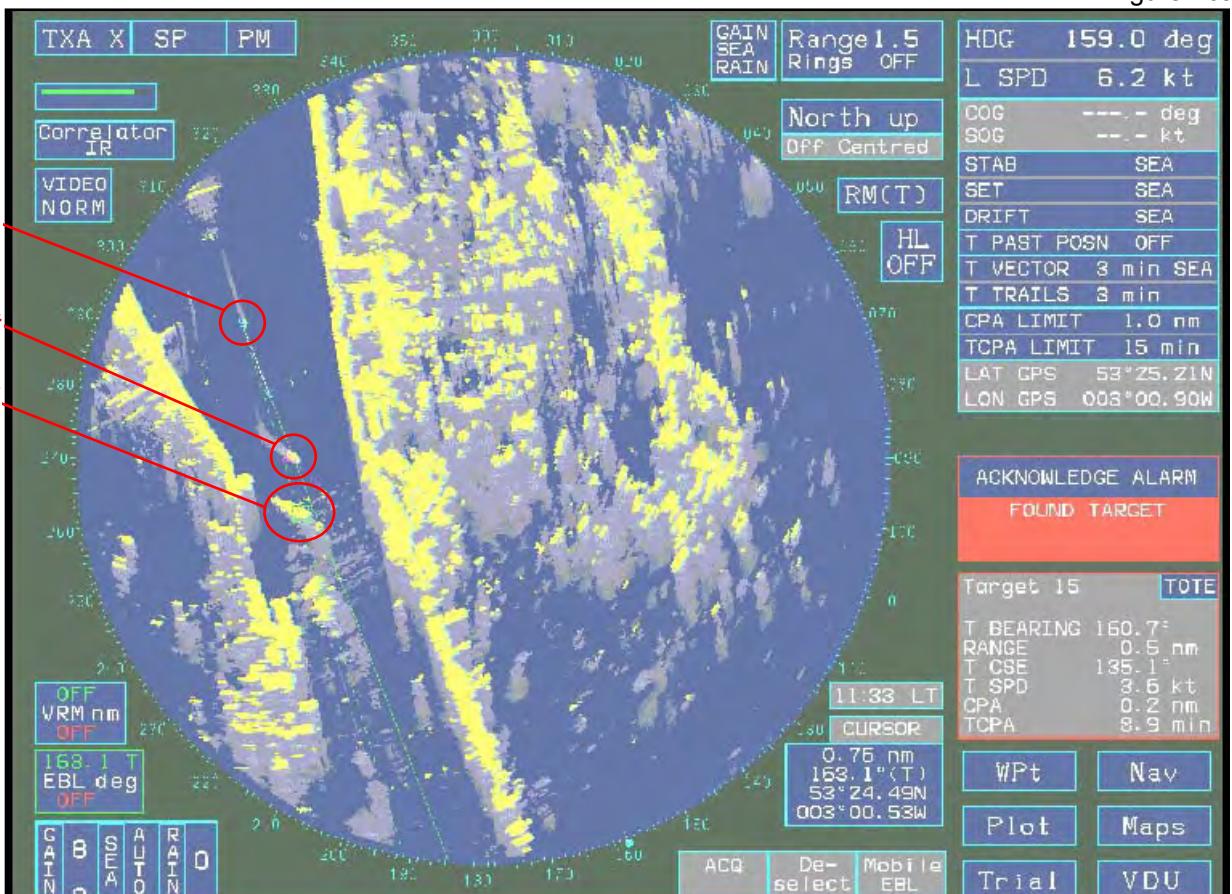
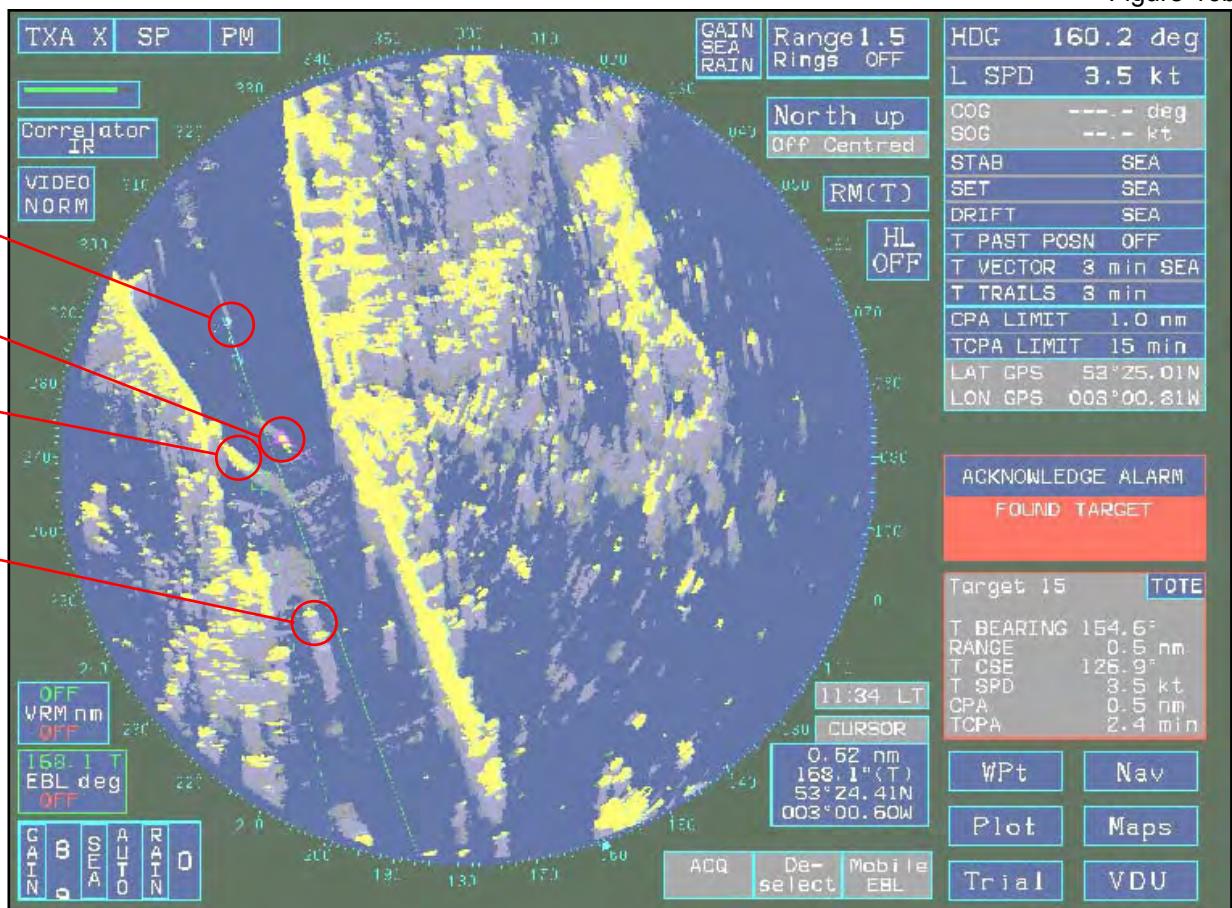
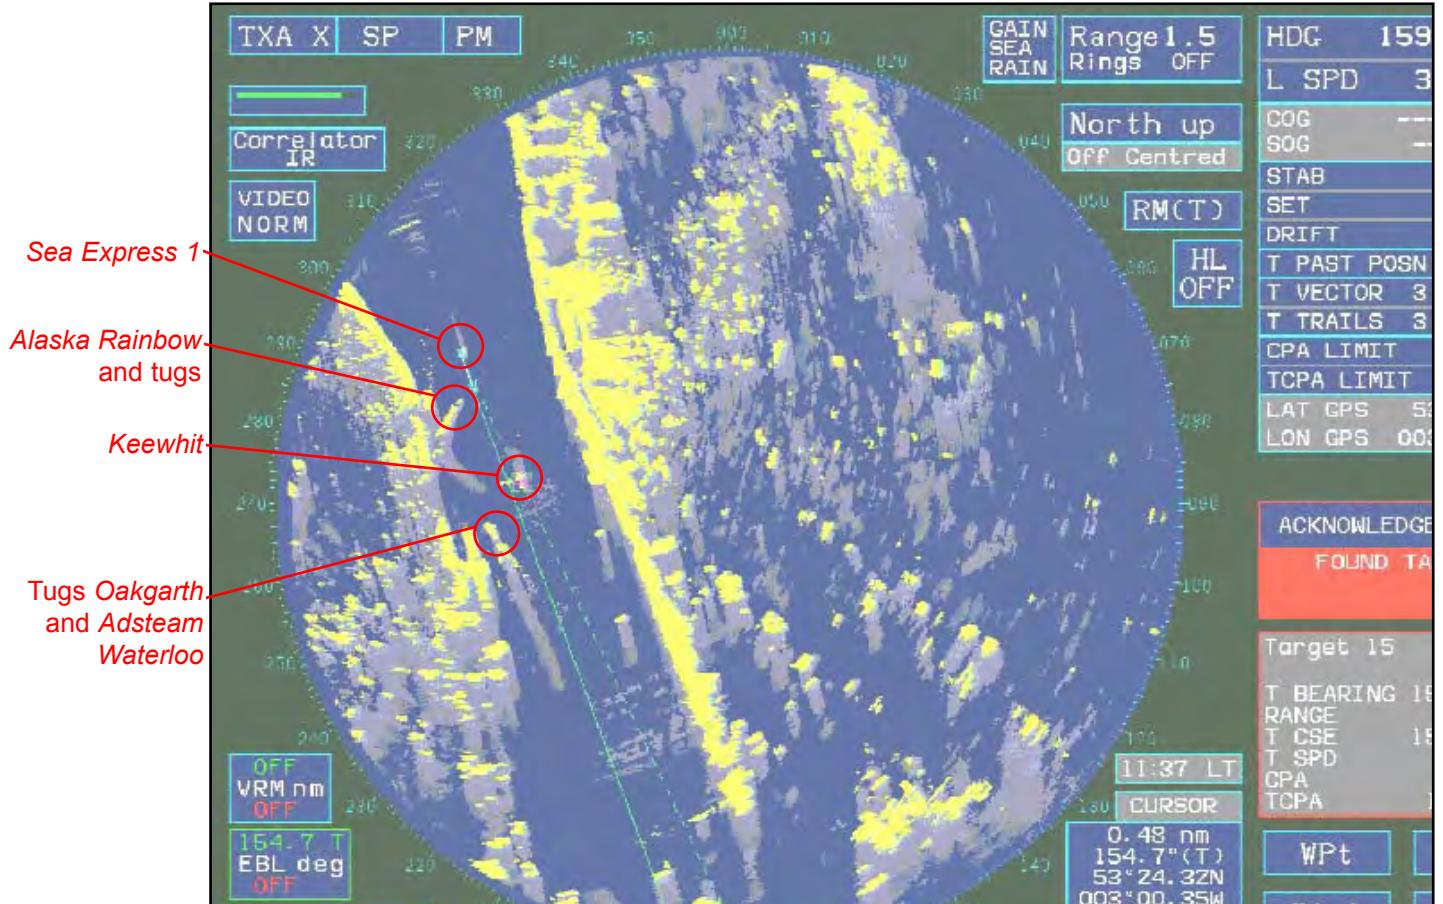
Radar display recorded on Sea Express 1's VDR at 11:33:25

Radar display recorded on Sea Express 1's VDR at 11:34:53

Radar display recorded on *Sea Express 1*'s VDR at 11:37:03

captain referring the trainee captain to methods for identifying the landing stage in fog. With the attention of the trainee captain now focussed on identifying the landing stage and preparing to be examined on berthing the vessel, and no other member of the bridge team allocated the task of collision avoidance support, other targets were not noticed or their movements tracked.

- 2007/185 Review its Safety Management System with particular respect to:
- using ground stabilised radar display in the confined waters of a river transit;
 - improving external communications in the event of an emergency in terms of urgency and detail.
- 2007/186 Ensure that the passenger safety instruction card illustrates the lifejacket to be found under the seat for which the card is provided.

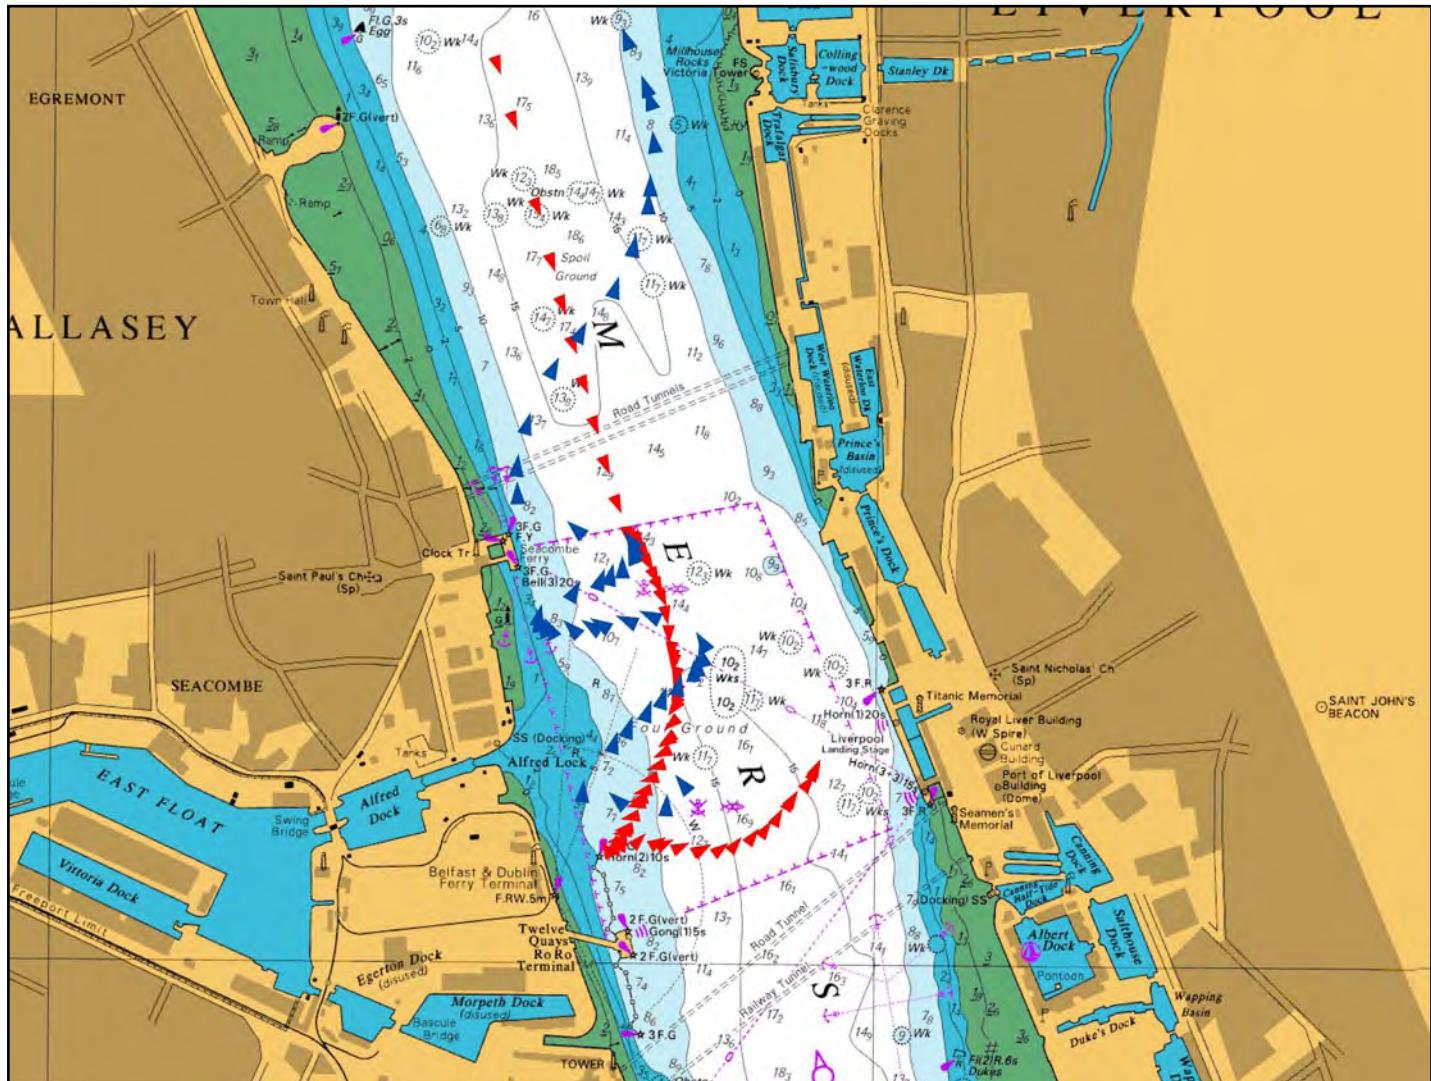
Figure 17

The movements of *Alaska Rainbow*, as recorded by VTS radar, the radar display of *Sea Express 1*'s VDR and AIS data (**Figure 17**), indicate that the pilot was not maintaining position and during a manoeuvre to the west, overshot the optimum position and entered the developing ebb stream. This caused the vessel to move north, requiring a large manoeuvre with both engines and steering, and the tugs to assist in avoiding Seacombe Stage, resulting in a significant move towards mid-river.

AIS data from *Sea Express 1* (red) and *Alaska Rainbow* (blue)
