Report on the investigation of
the fire on board the canal boat

Lindy Lou

at Lyme View Marina, Adlington

Report No 23/2007
October 2007

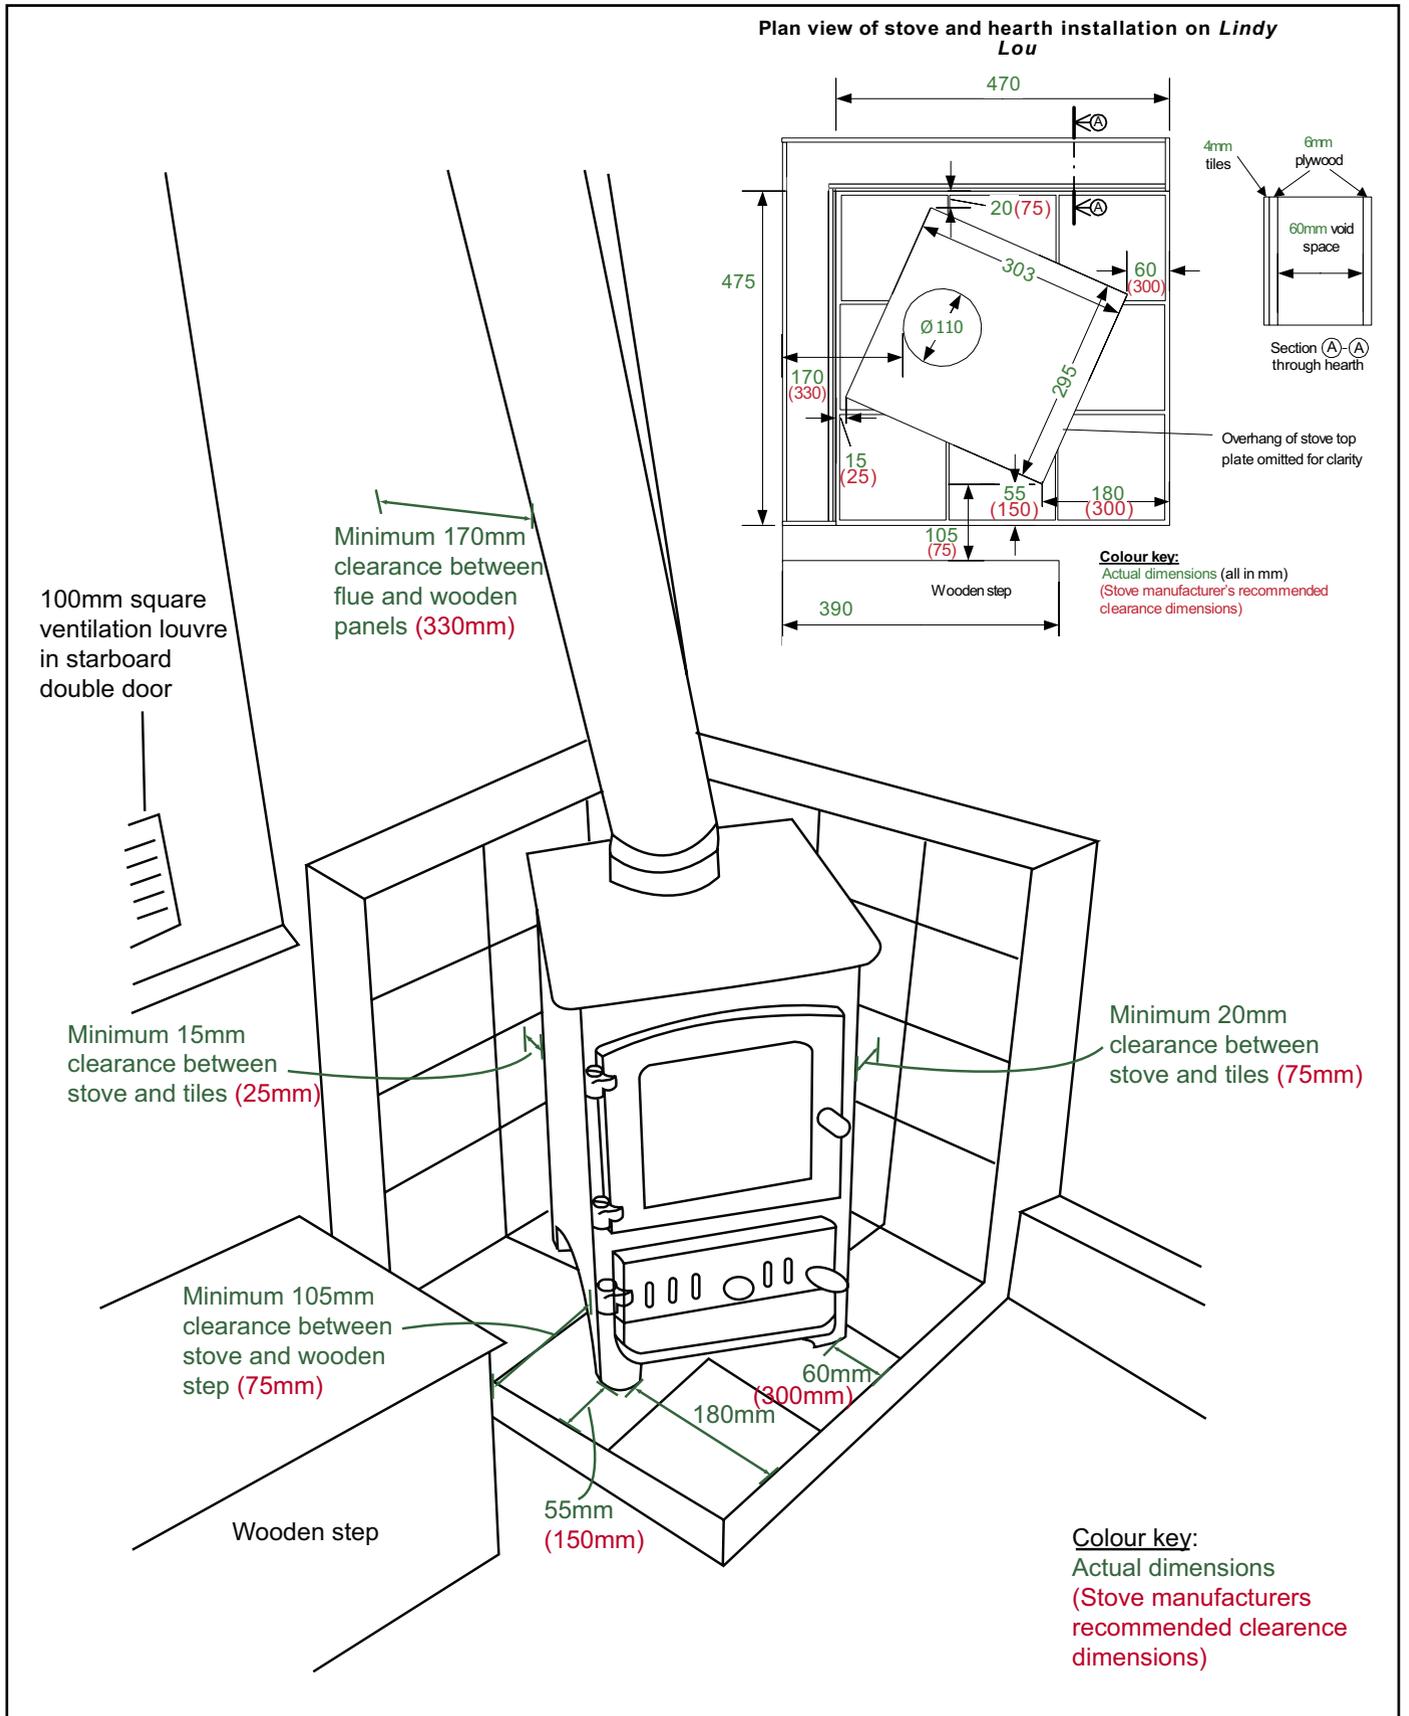
The stove was angled on the hearth to face towards the centre of the saloon. **Figure 6** depicts the dimensions of the hearth and the clearances around the stove, and also includes the comparative recommended clearances, based on the stove manufacturer's guidance, which are described in more detail at section 1.10.3 below. The minimum clearance between the stove and the tiles was 15mm at the rear of the hearth (forward bulkhead) and 20mm at the outboard edge. The minimum projection of the hearth in front of the stove was 60mm on the stove's right side. The inboard side of the hearth finished 50mm from the wooden step leading out to the forward deck, with the stove 105mm away from this step at its closest point.

Diagrammatic representation of stove and hearth installation on *Lindy Lou*

Figure 6 provides a comparison of the actual stove/hearth installation dimensions with those recommended by the stove manufacturer. The projection of the hearth in front of the stove was considerably less than the 300mm recommended by the manufacturers to provide a non-combustible zone to catch sparks while the door was open. The absence of such a buffer would have increased the possibility of an ember falling onto the carpet and smouldering when the fire was stoked up before the occupants went to bed.

The air gaps from the stove to the hearth tiles and the wooden step were also less than recommended, as was the gap between the flue and the wooden-faced sides of the boat. These gaps would have increased the likelihood of radiant heat transfer from the stove to these structures, and subsequent ignition. The owner's previous observation of discolouration of the wooden shelf on top of the hearth, appears to confirm that heat damage of the structure had been occurring.

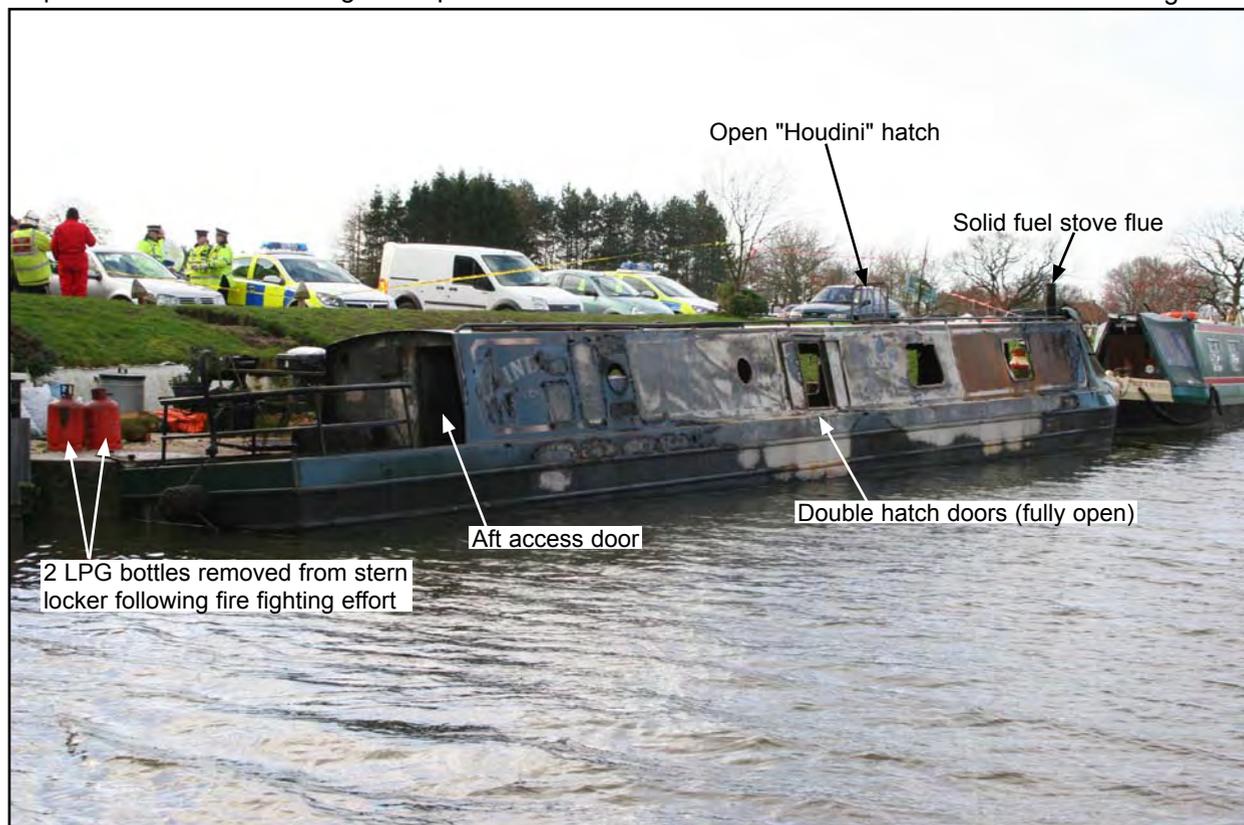
Figure 7a

Examination of the boat following the fire revealed that it had burnt with sufficient heat to cause permanent distortion to the cabin sides and roof, as shown at **Figures 7a** and **7b**. Glass in each rectangular window and circular porthole had shattered and temperatures had been sufficiently high to melt the aluminium alloy window frames in several places. Exterior paintwork was totally burnt away on the cabin structure and had been reduced to powder on the hull in the galley area. The aft section of a circular plastic television aerial, fitted externally above the saloon area, had partially melted.

External damage to starboard side of *Lindy Lou*

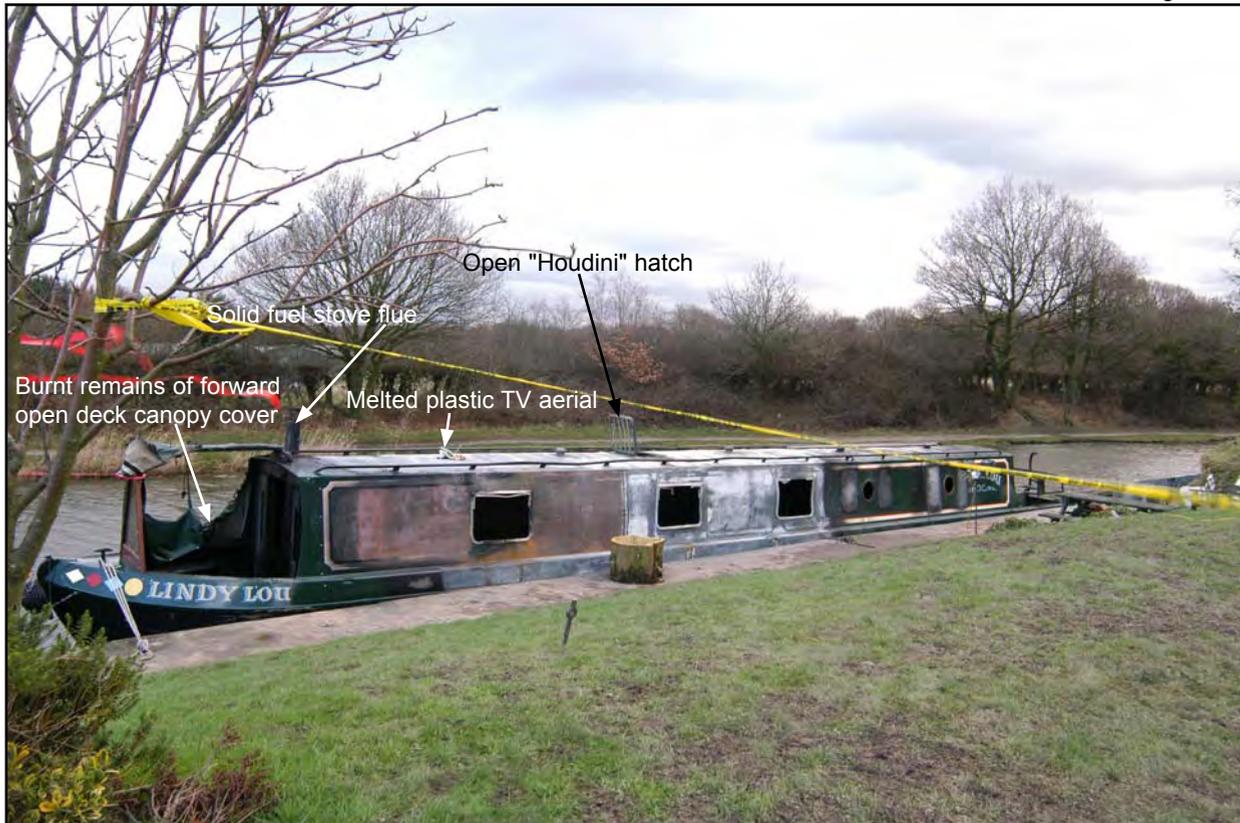
Figure 7b

The forward open deck cover had partially melted, as seen at **Figure 7b**, while marks on the exterior of the forward double doors provided evidence of hot gases escaping through the windows and vents in these doors (**Figure 8**). Other than the cover, no significantly burnt items were found on the forward open deck.

External damage to port side of *Lindy Lou*

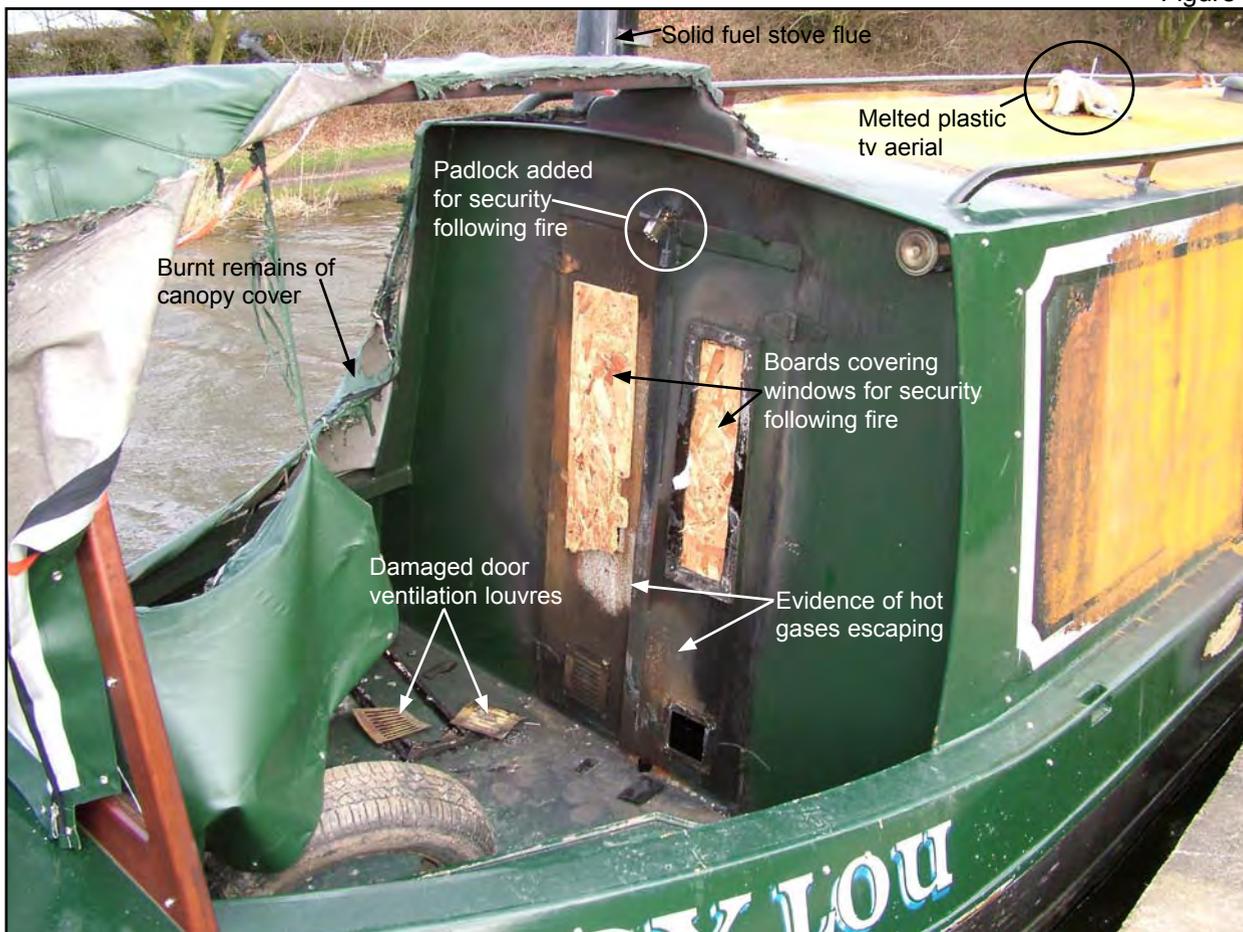
Figure 8

Forward open deck of *Lindy Lou*

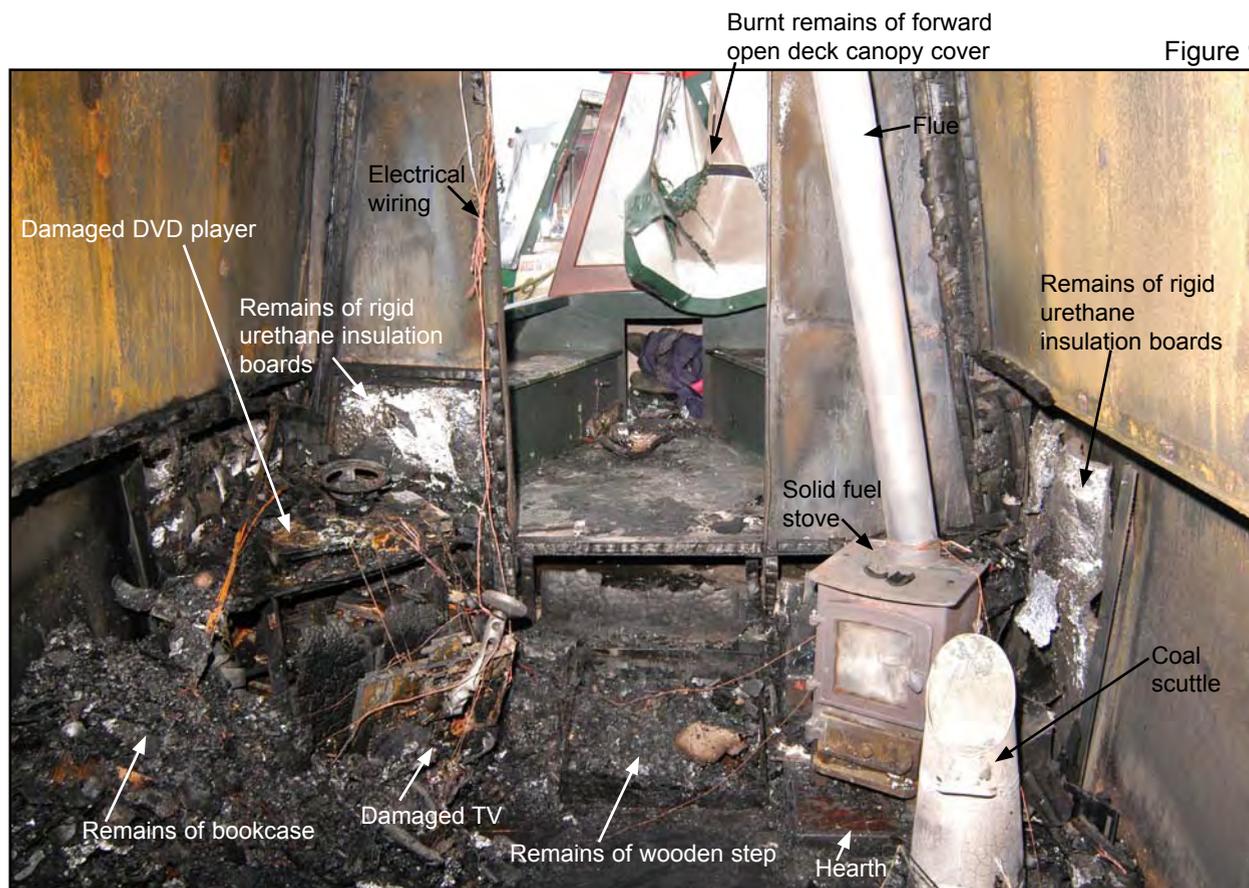
Wooden linings, insulation and partitions were mostly reduced to ash, other than in localised areas where materials were shielded from the fire. Furnishings in the saloon were burnt away, with only traces of metal springs and supports remaining. All the curtains had burnt, as had most of the nylon carpet, again except where it had been shielded by items standing on it. The television and DVD player were damaged, but the cupboard that they stood on was largely intact (**Figure 9**). The bookshelf further aft had been severely burnt, with only a few, heavily charred paperback books remaining.

Damage sustained to the forward area of the saloon

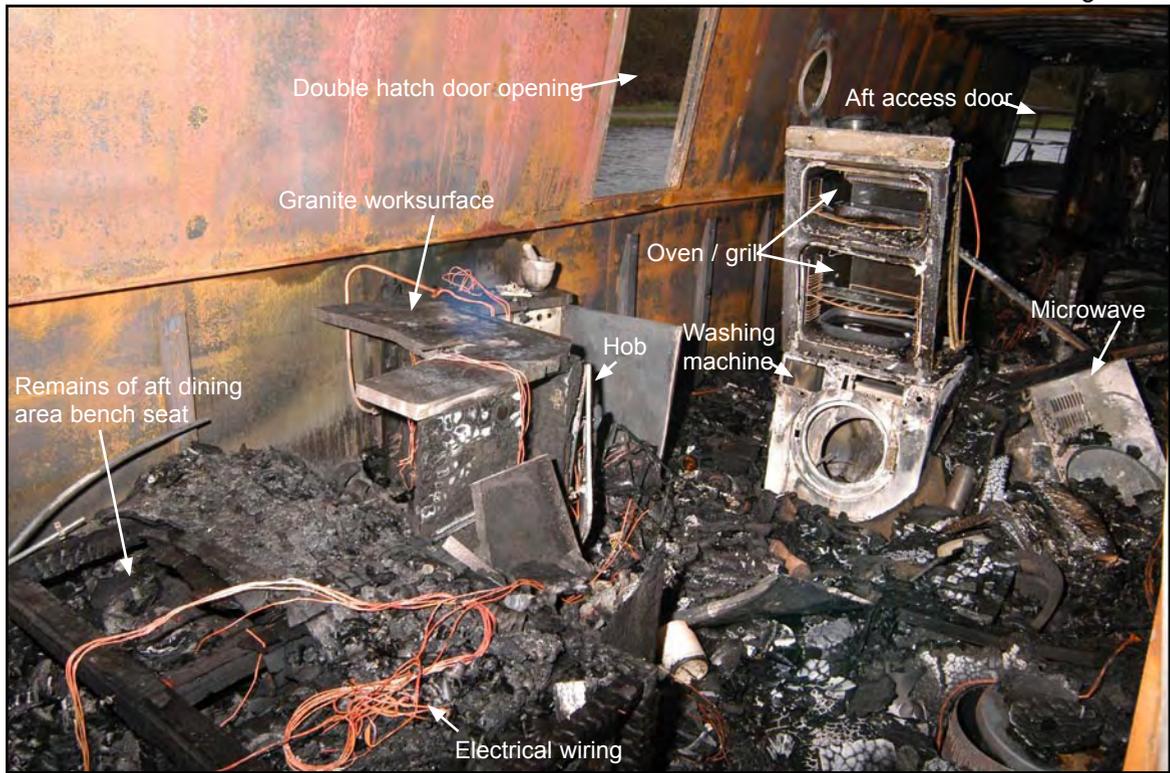
The dining area was less severely damaged, with the foam from one of the bench seats remaining, despite the pine structure being heavily charred or burnt. However, the galley work units were severely burnt (**Figure 10**). The plastic components of the appliances had burnt and there were small pools of solidified molten aluminium. The oven and hob controls were all found to be in the off position, and no food remains or cooking deposits were evident.

Remains of the galley area, looking aft

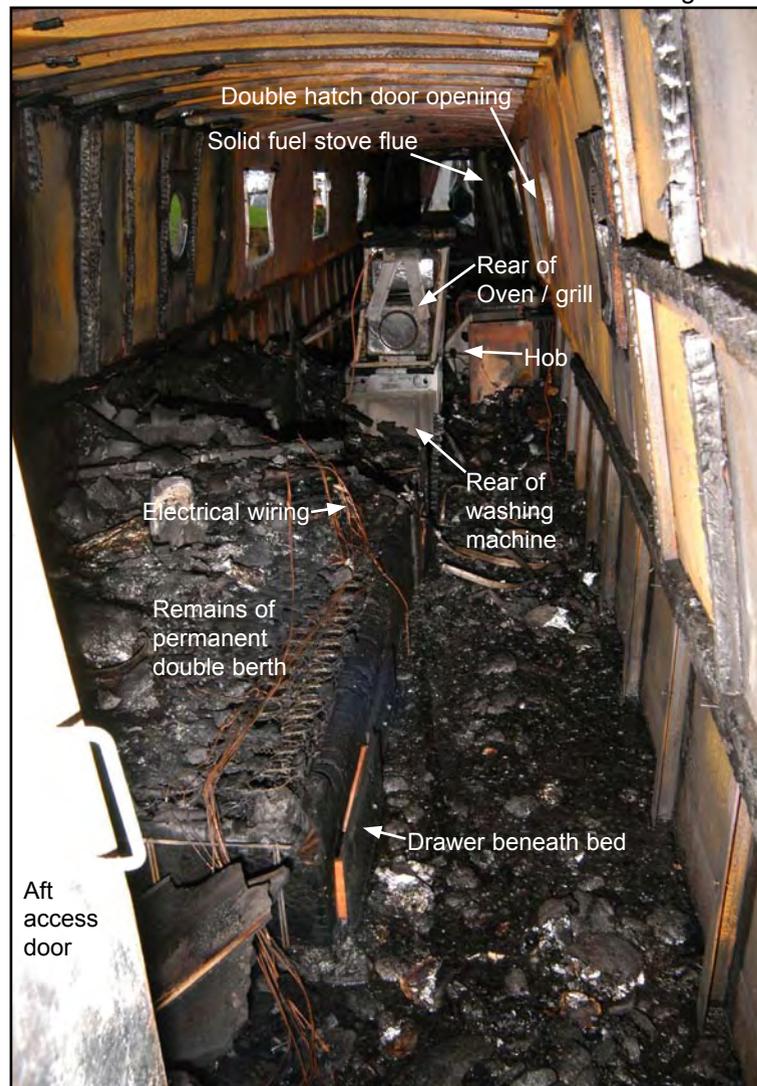
Figure 11

Looking forward from the aft access doorway

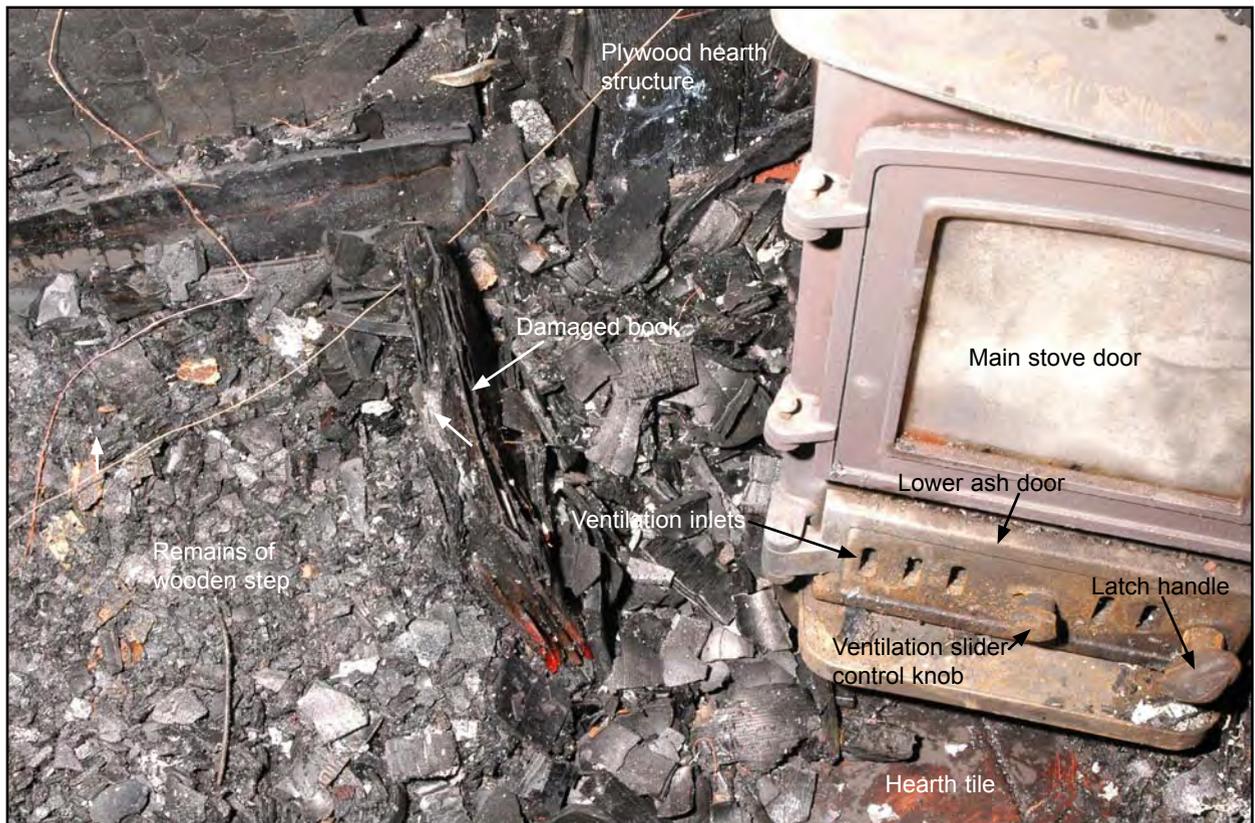
Figure 12a

A book had been left in the gap between the steps and hearth, and would have been approximately 100mm from the closest part of the stove. The book was partially burnt away with the remaining portion heavily charred, as shown at **Figures 12a** and **12b**.

Damaged book, adjacent to the left side of the stove

Combustible items near the stove and flue, such as the beanbag and chair, the book propped up next to the step, or the plastic-encased loudspeaker behind the flue, would have been susceptible to radiant heat transfer. The book was left particularly close to the stove, and was burnt from the top down, while little or nothing remained of the beanbag and chair. It is possible that one of these items could have ignited, forming the seat of the fire. A larger hearth would have discouraged the placing of objects too close to the stove.

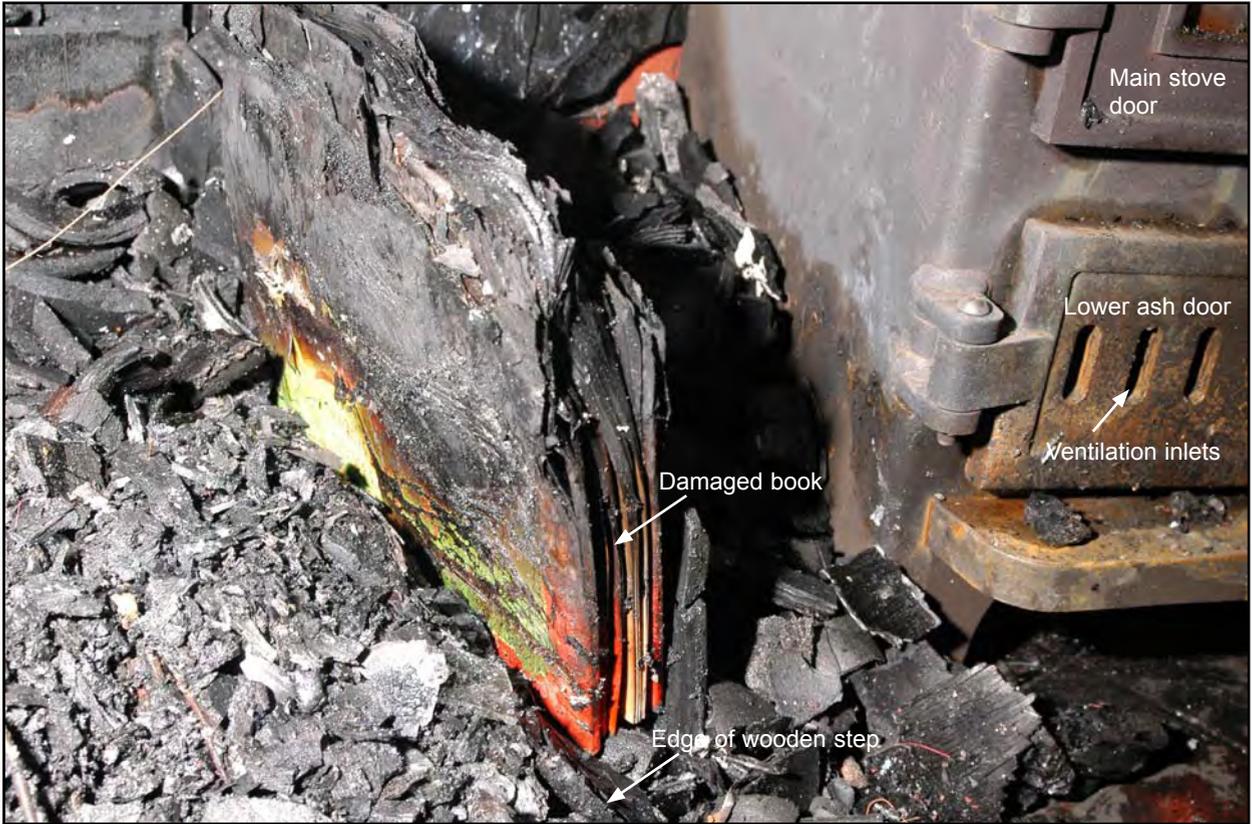
Figure 12b

Damaged book, adjacent to the left side of the stove

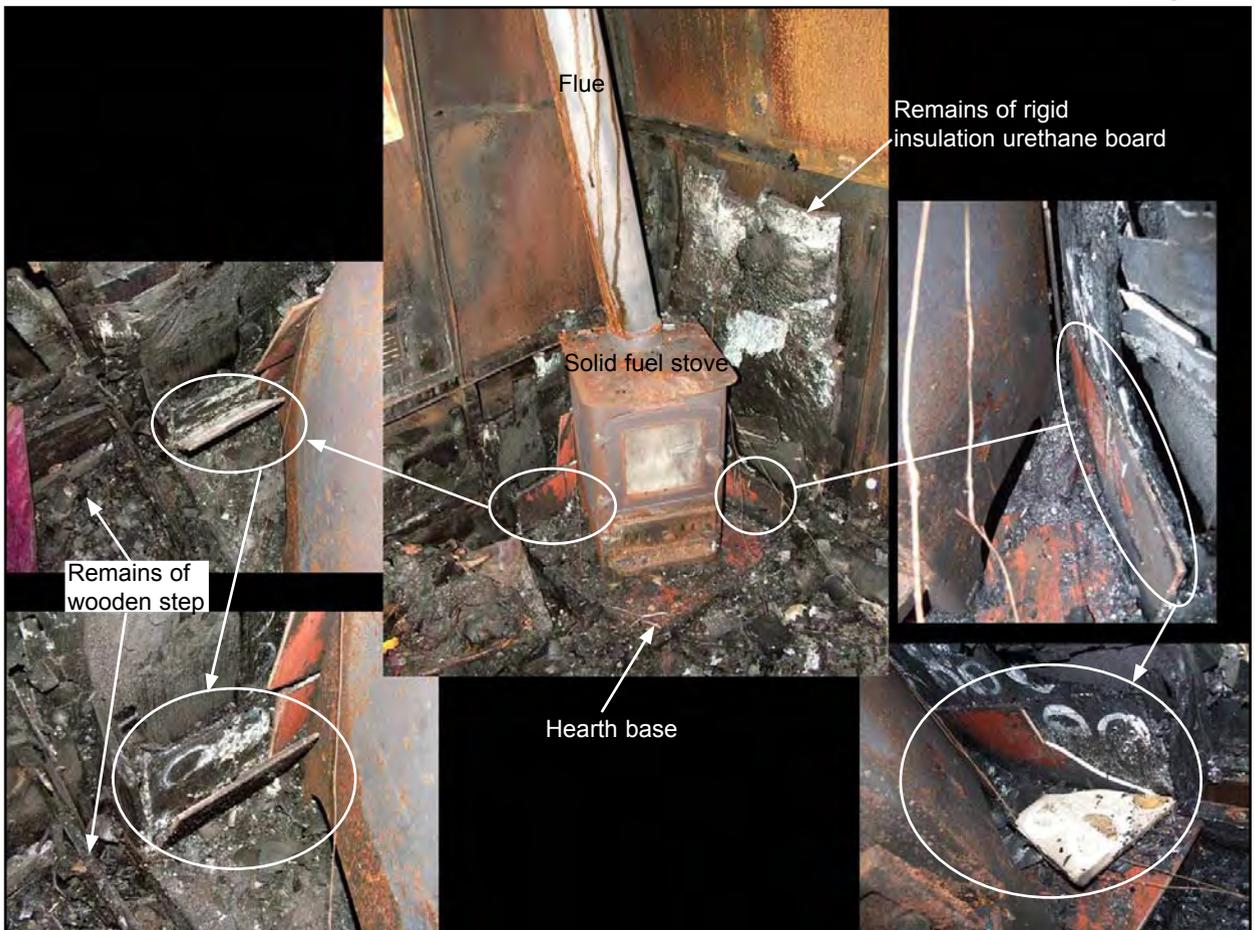
Figure 13

The base of the hearth was charred and the tiles were covered with soot, but otherwise undamaged. The vertical sides of the hearth around the stove had collapsed as the plywood had burnt away, although the bottom layer of vertical tiles was still attached to the remains of the sides. These tiles were removed, revealing the preserved layered structure of the plywood behind, although the wood was charred and had been reduced to charcoal. **Figure 13** depicts this charring.

Evidence of charring of the wooden hearth structure

Evidence also exists to suggest that pyrolysis⁸ had been occurring in the wooden structure behind the hearth tiles. The remaining lower sections of this 6mm plywood were charred, but with the layers of ply still clearly identifiable. *Kirk's Fire Investigation*⁹ confirms that although wood may not ignite at lower temperatures, prolonged exposure to lower temperatures in the absence of oxygen can cause wood to degrade to charcoal by distillation and pyrolysis, then ignite when a non-combustible barrier has suddenly failed.

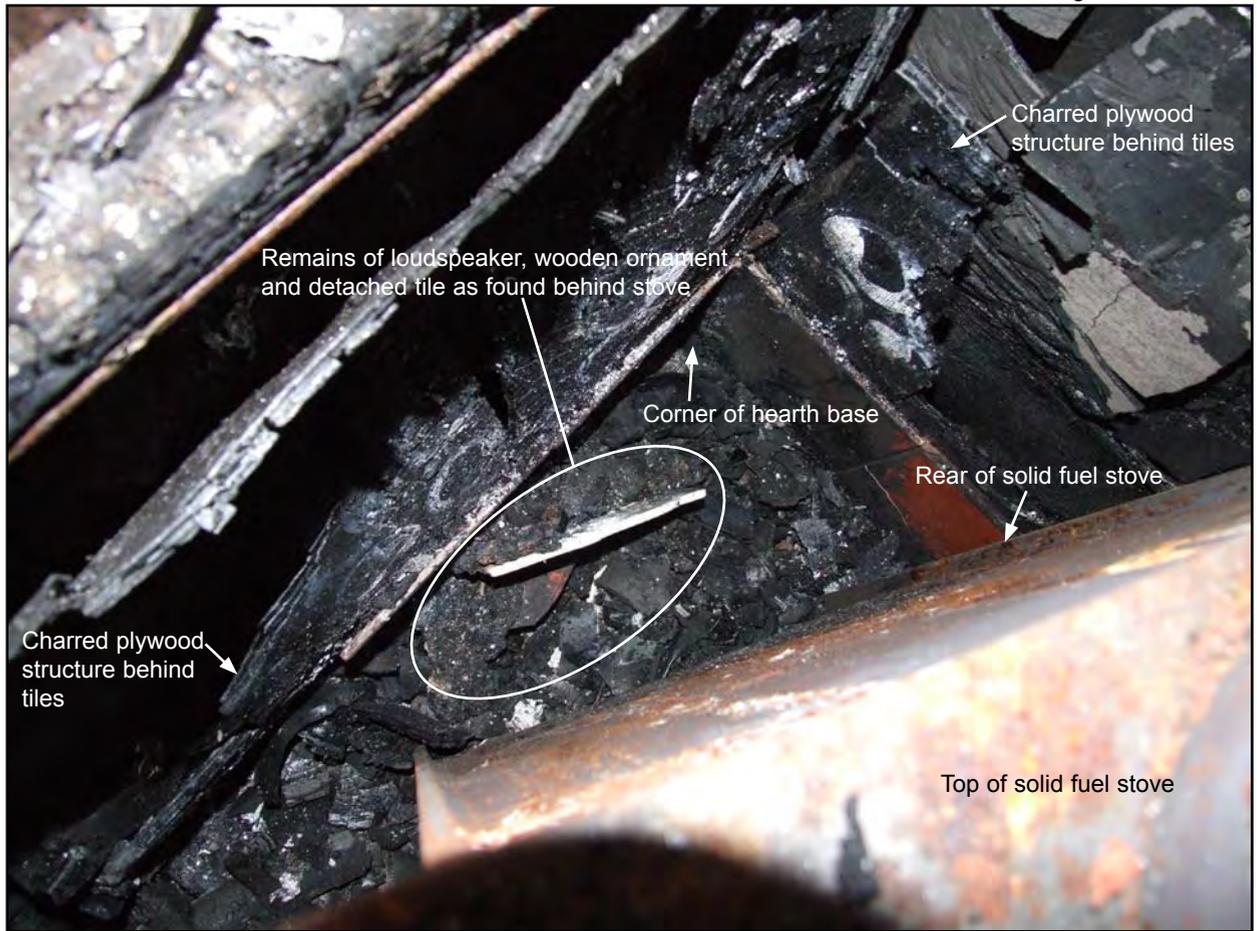
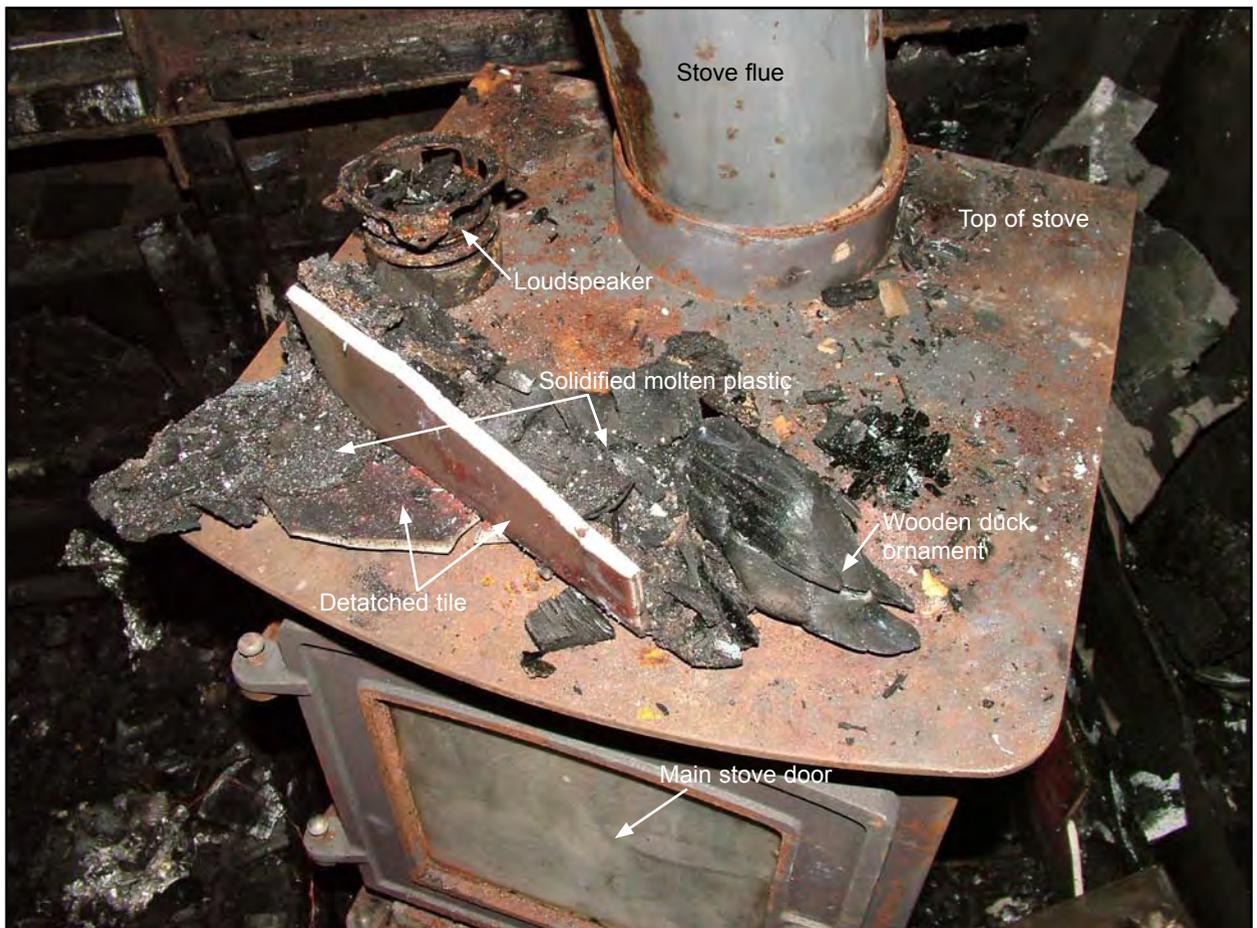
Figure 14a and b

Remains of loudspeaker, wooden ornament & detached tile in situ behind the stove (14a) and recovered to the stove top (14b)

The dislodged vertical hearth tile, and wooden ornament found embedded into the melted plastic remains of the loudspeaker behind the stove, confirm that the speaker had begun to drip molten plastic onto the hearth before the tile and duck fell. This molten plastic would have increased the risk of ignition of any combustible items that it dripped onto, such as the wooden shelf on top of the hearth. Given the gaps around the flue, the fitting of a plastic speaker in this area would have also increased the risk of it sustaining heat damage or ignition; the owner however reported no problems with the speaker in this location.

The dislodged tile was cleaner than the other soot-covered tiles in the area, suggesting that it possibly fell off the hearth at an early stage in the fire, or simply fell into a particularly well-protected location. The owner had not been aware of any loose or missing tiles, but these might not have been readily visible behind the stove. Once this and other tiles had become dislodged, the wooden structure behind would have quickly ignited.

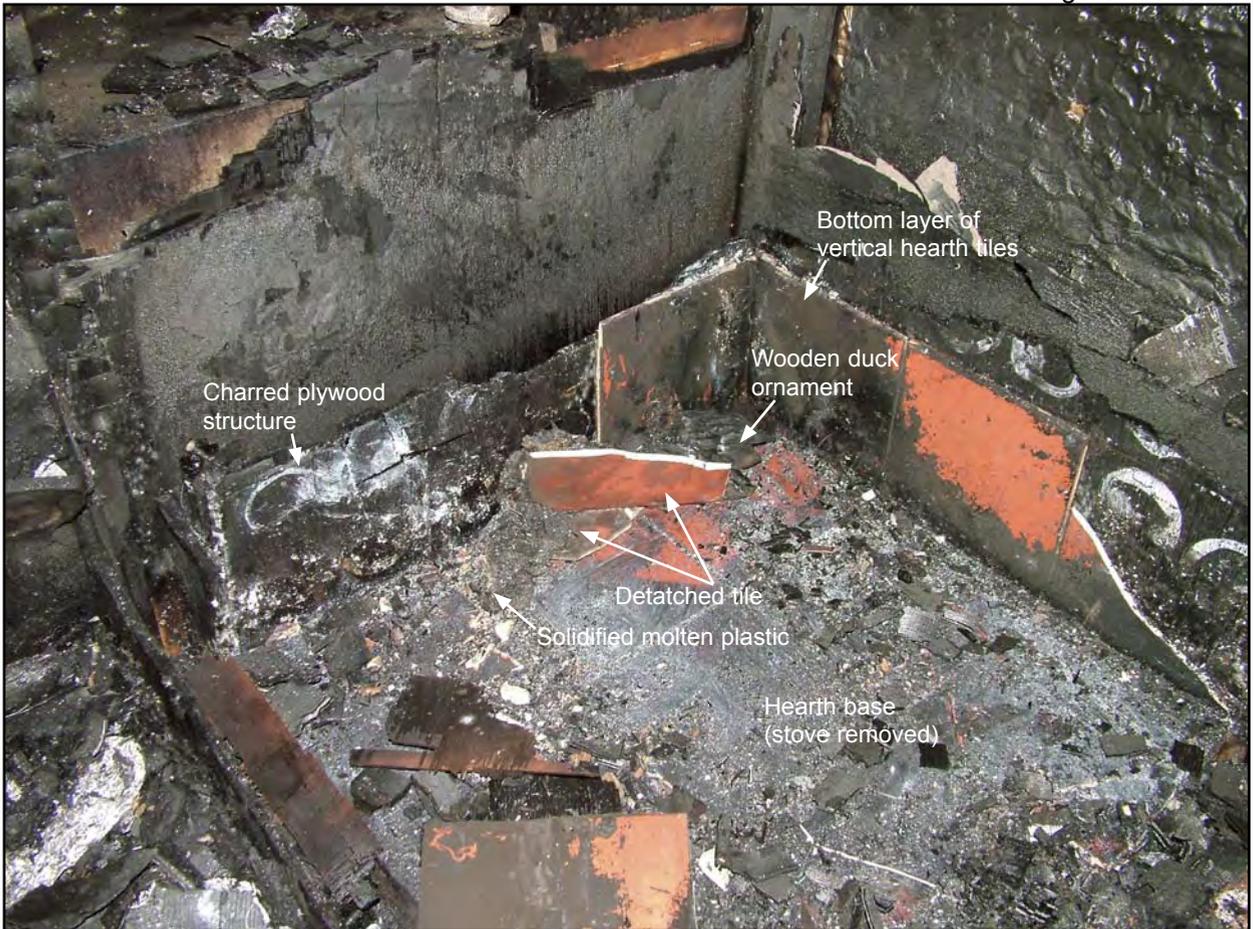
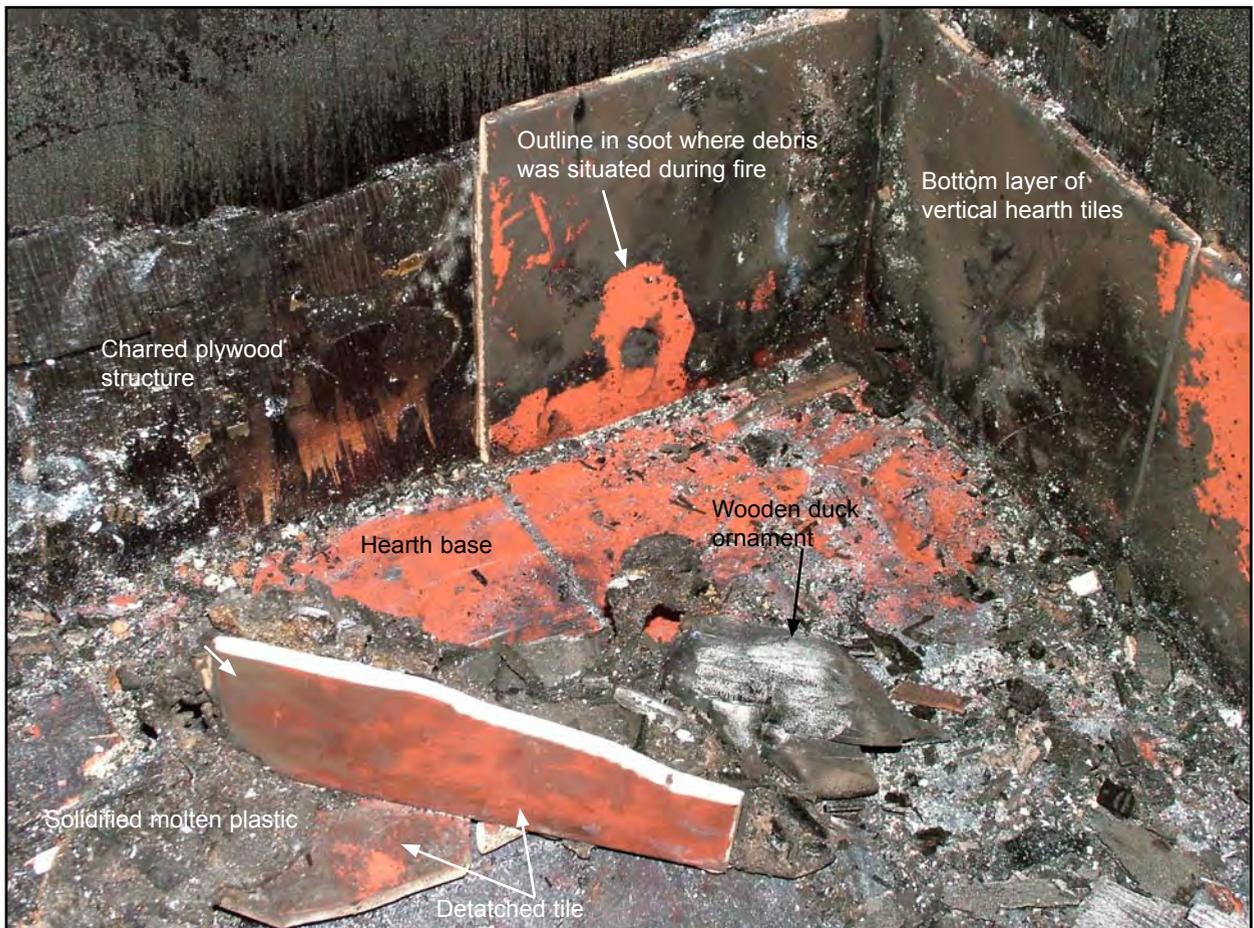
The debris behind and beneath the stove was systematically removed, being mostly ashes from the burnt insulation and lining materials. Underneath this debris behind the stove (**Figure 14a**) were the remains of a loudspeaker, a wooden duck ornament and a tile that had apparently become detached from a position higher up the hearth. These were all held together in a pool of solidified molten plastic that appeared to have dripped down from the loudspeaker, no trace of which remained on the bulkhead below the deckhead. **Figure 14b** shows this debris recovered to the top of the stove for inspection. The stove was lifted off the hearth and the area behind further inspected, revealing a clear outline of soot on the tiles behind, where the molten debris had been, as shown at **Figures 15a** and **15b**.

Remains of loudspeaker, wooden ornament & detached tile in situ on hearth (15a) and moved from in situ position on hearth (15b), following stove removal
