## CONTROL OF THE MAIN ENGINE

# **SUMMARY, RECOMMENDATIONS, OPINION AND CONCLUSIONS IN RESPECT OF TWENTY-ONE SAMPLES REMOVED FROM THE FORWARD HALF OF THE CONTAINER SHIP mv MSC NAPOLI**

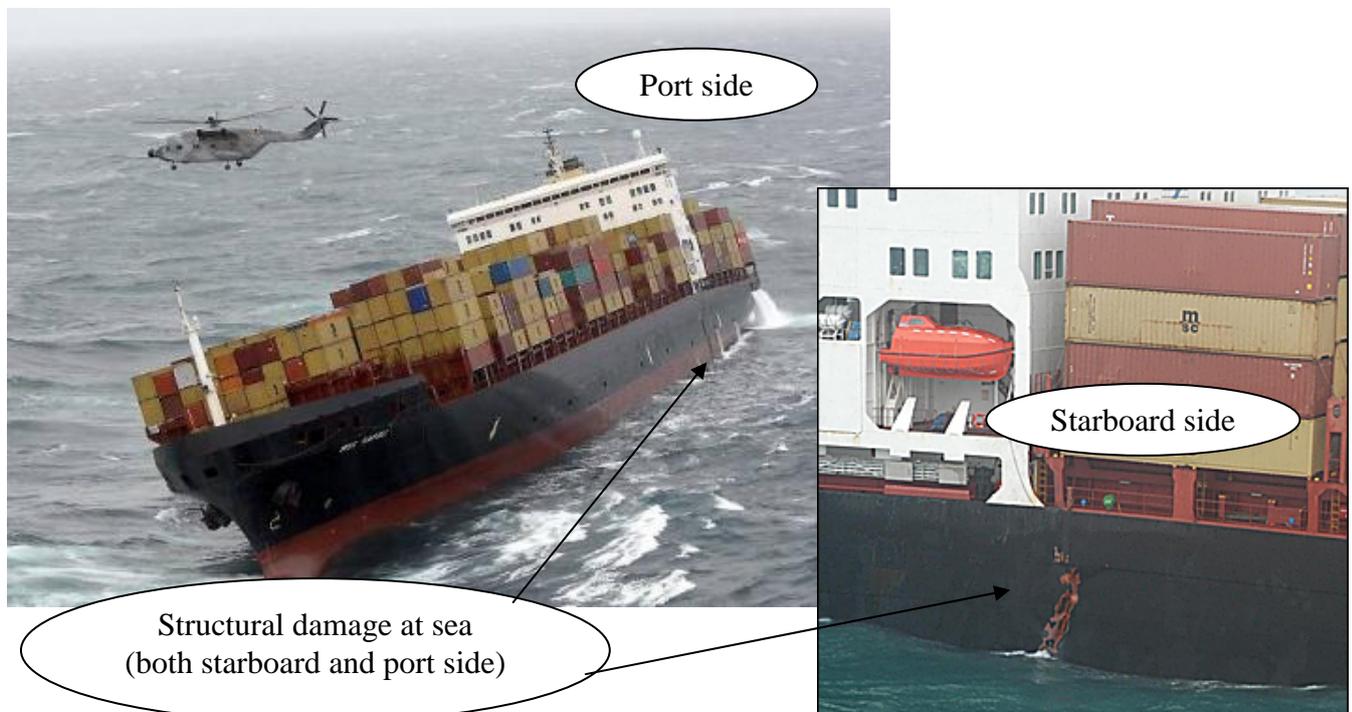
**Fig. 1.1 Structural damage in ship side. Pictures taken 18<sup>th</sup> of January 2007 after ship has been abandoned.** (with permission from Gargolaw)

From the pictures taken of the MSC Napoli at sea, Fig.1.1, it can be seen that the localized damage extends vertically at both starboard and port sides. Moreover, the change of the deck line slope at the engine room bulkhead, as marked up in Fig.1.2, implies that the bottom structure in this area must have shortened significantly in the longitudinal direction in order for this hull girder rotation (hinge) to develop. Such a bottom shortening is likely to be the result of buckling and collapse of longitudinally compressed elements in this region.

The main focus is on the hull sections in way of the engine room area, from around sea chest area (# 81) to engine room bulkhead (#88) since this area covers the collapsed hull plates with cracks, as seen and documented in Fig.1.1 above.

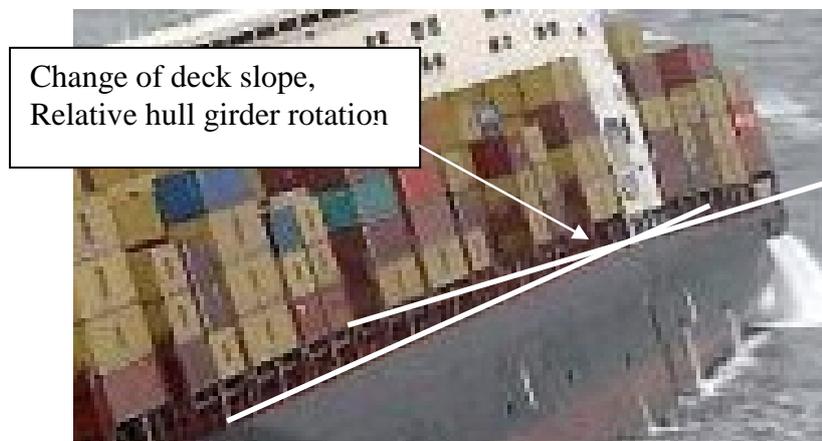
**Fig. 1.2 Structural damage in Ship side illustrating the change of deck slope at engine room bulkhead.** (with permission from Gargolaw)

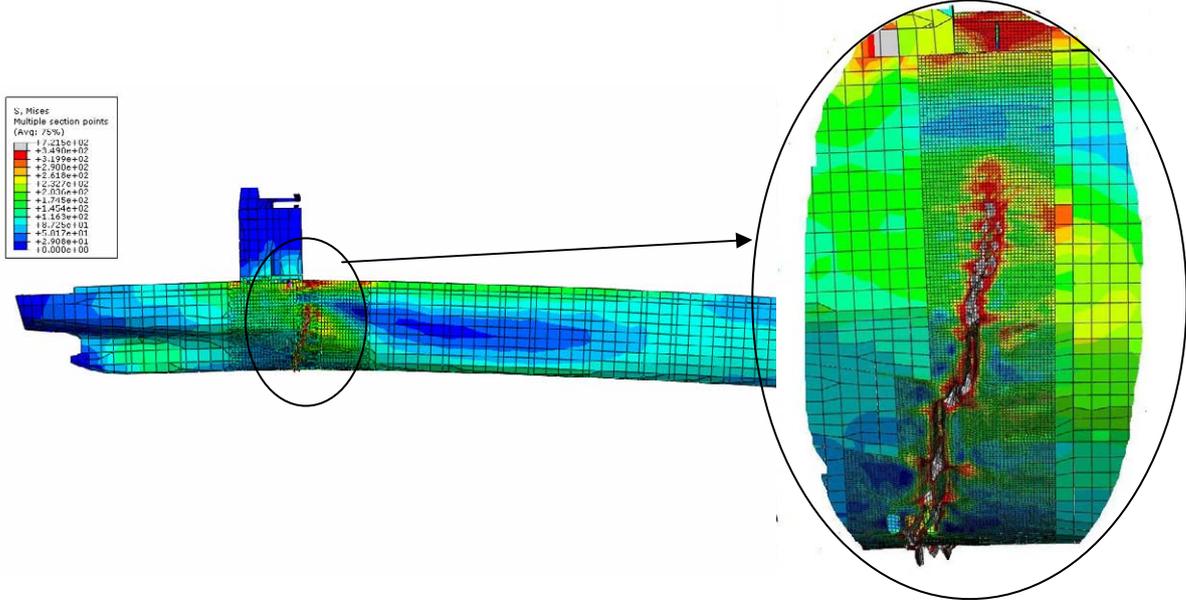
Associated with the total collapse of the hull girder is the development of a local progressive failure mechanism. The characteristics of this is that it starts with “elastic” buckling in the hull skin plating in the bilge area in way of # 81 to # 88. From here it gradually develops and progress into the bottom, double bottom and up into the ship side. It finally ends up as a localized collapse pattern across the whole hull section, from bottom to ship side, see Fig. 6.9.

**Fig. 6.9 Final failure mechanism as predicted by ABAQUS. Deflections scaled up 5 times for illustration purposes.**

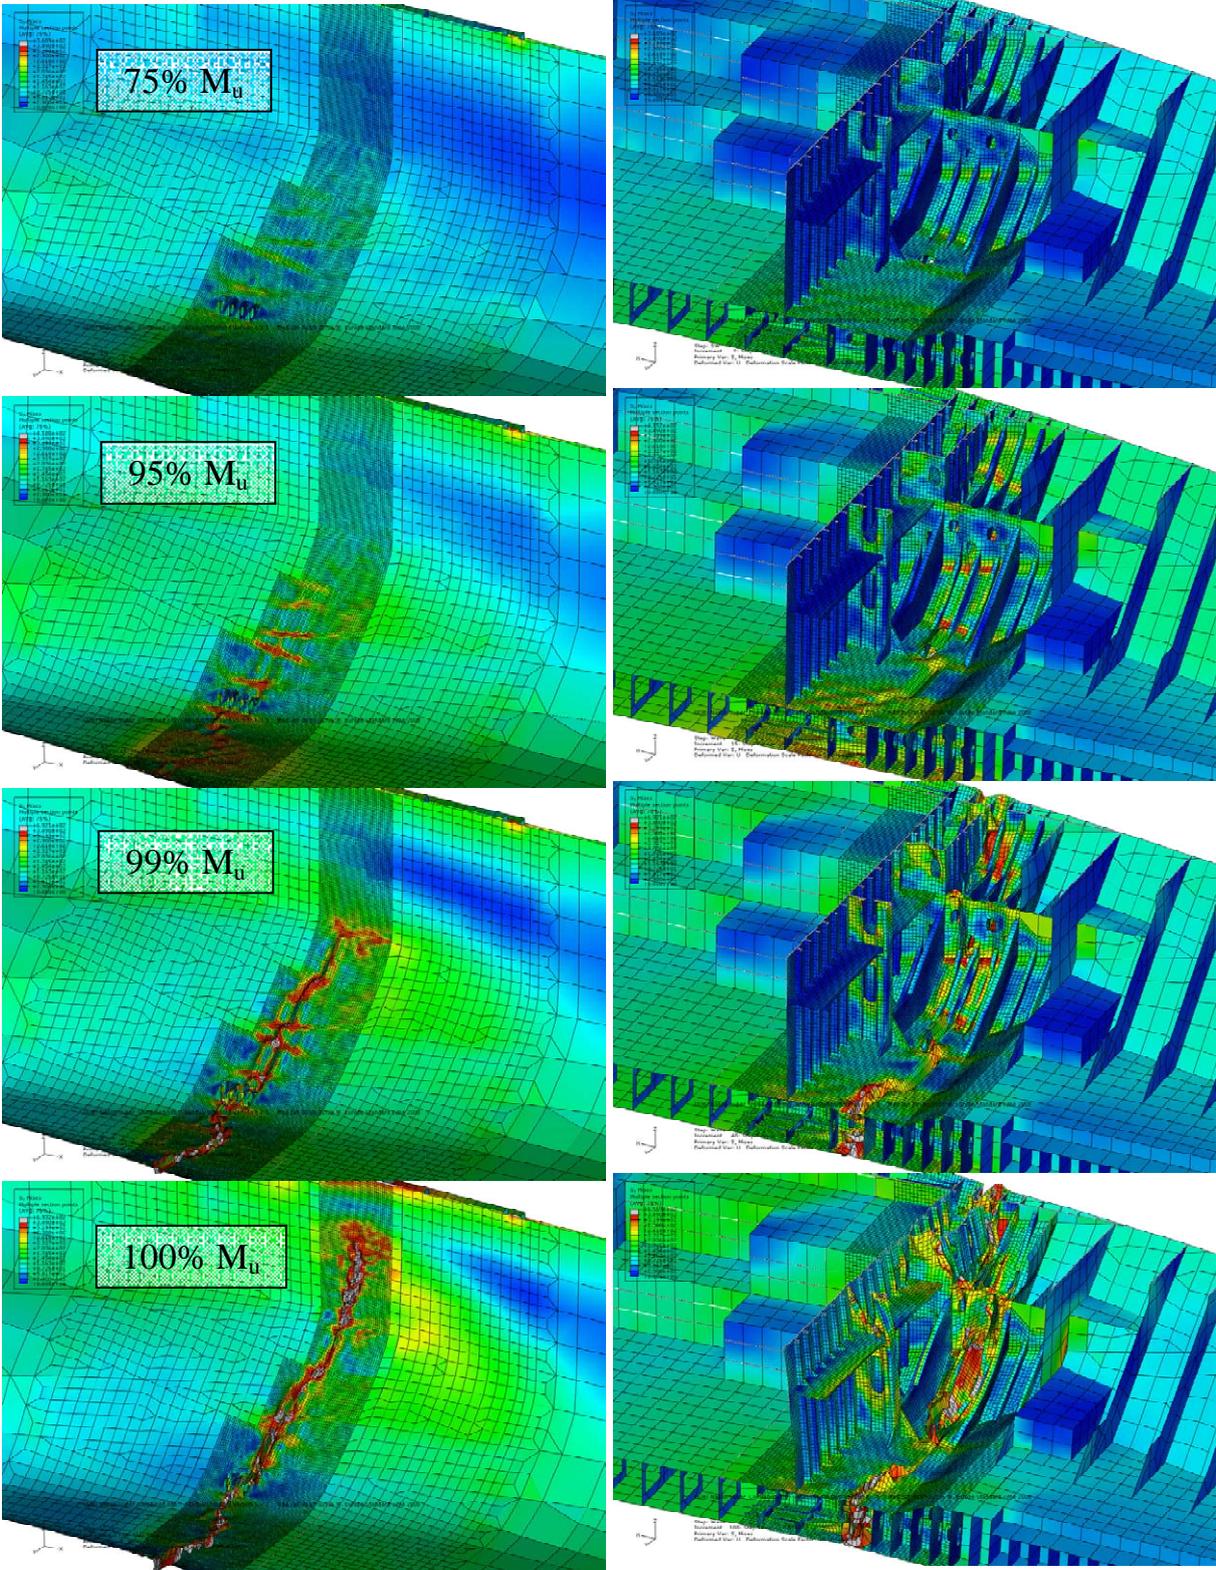
The progressive development of the failure mechanism is illustrated in more detail in Fig. 6.10, showing the stepwise development for four subsequent load levels; external and internal view.

**Fig. 6.10** Four stages of progressive collapse, outer (left) and inner structure (right)  
Deflections scaled up 5 times for illustration purposes.

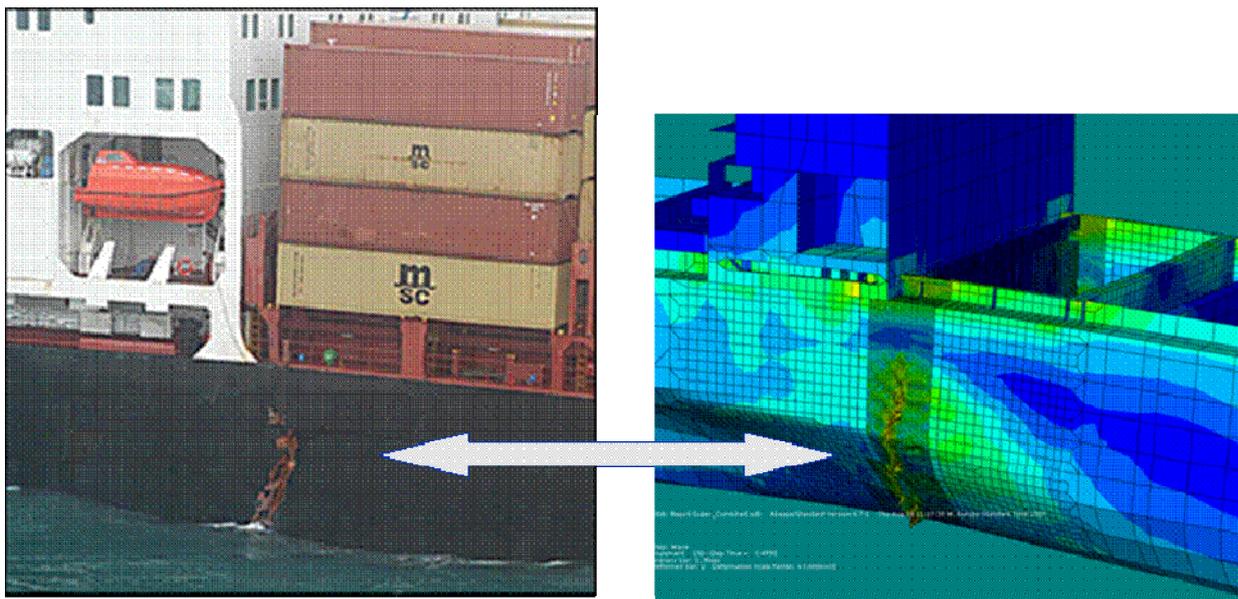
The computer analyses demonstrate that a very high vertical hull girder moment, close to or exceeding the corresponding capacity limit, may lead to a type of structural failure between #81 to #88, as is observed on MSC Napoli in open sea. This is evident from a comparison between a photo taken of the vessel's starboard side, before it is beached with the failure visible, and a computer simulation image of the same area, see Fig. 7.1. This is further supported by diving surveys while beached and also later from surveys of the forward part in dry dock.

**Fig. 7.1 Comparison of real life failure mode with computer simulations (ABAQUS FE model)**

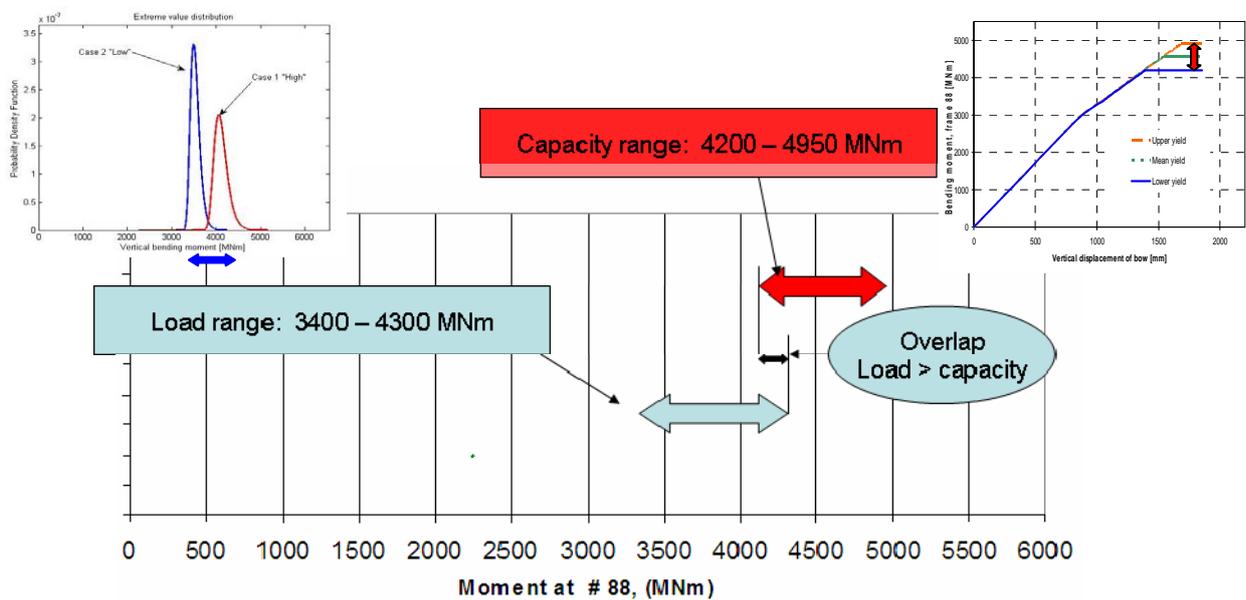
It is also documented that the overlap in load and capacity is very narrow indicating that such a failure scenario has a very low probability of occurrence for the assumed severe sea states.

By screening available wave statistic relevant for the English Channel during the last years it can be concluded that the assumed severe sea states are very rare. This reflects a very low probability for such events to take place in the future.

**Fig. 7.2 Calculated load and capacity ranges with overlap comparison (no whipping effects). Vertical bending moments (VBM) at engine room bulkhead #88**
