Report on the investigation of
the loss of control of product tanker

Prospero

and her subsequent heavy contact with a jetty at the
SemLogistics terminal, Milford Haven

**Report 24/2007
December 2007**

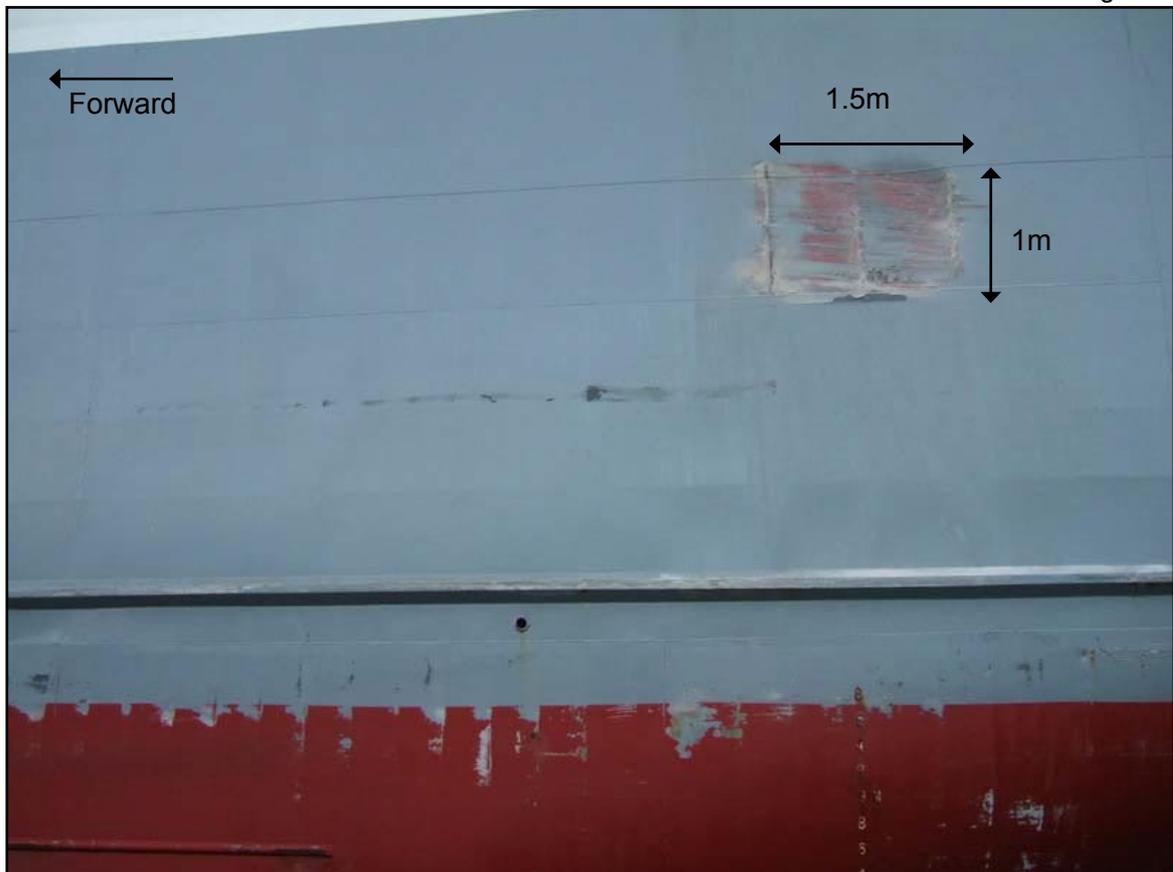
Figure 2

Damage to port quarter of *Prospero*, by jetty edge capping

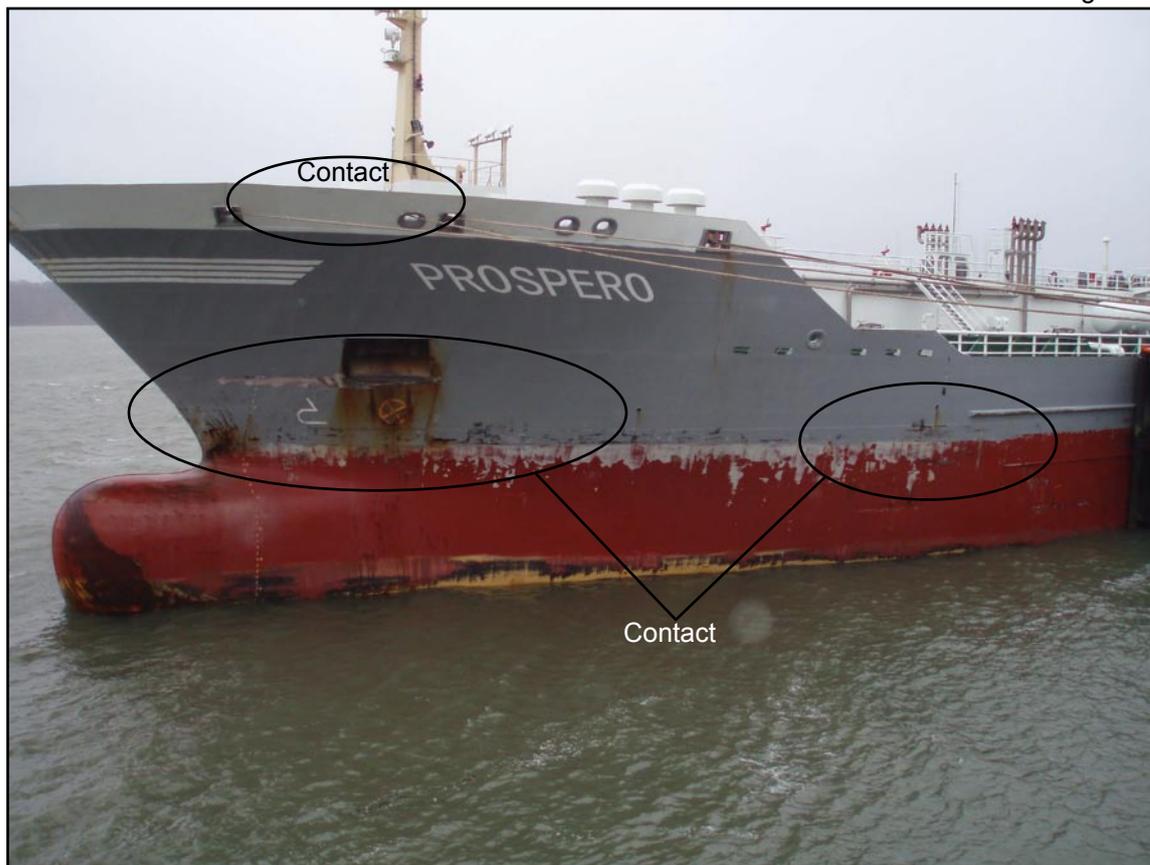
Figure 3

Bow of *Prospero*, showing damage by jetty and gantry

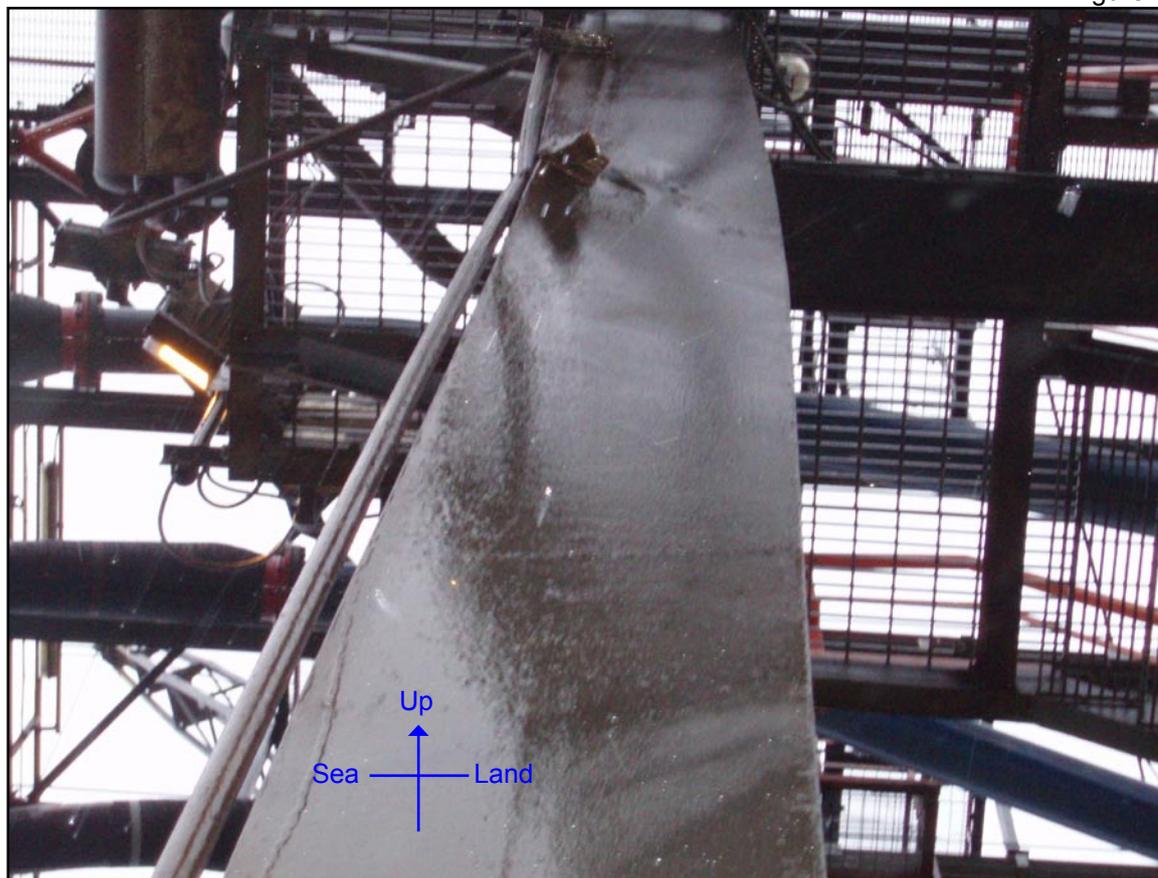
Figure 4

Damage to loading arm gantry, by bow of *Prospero*

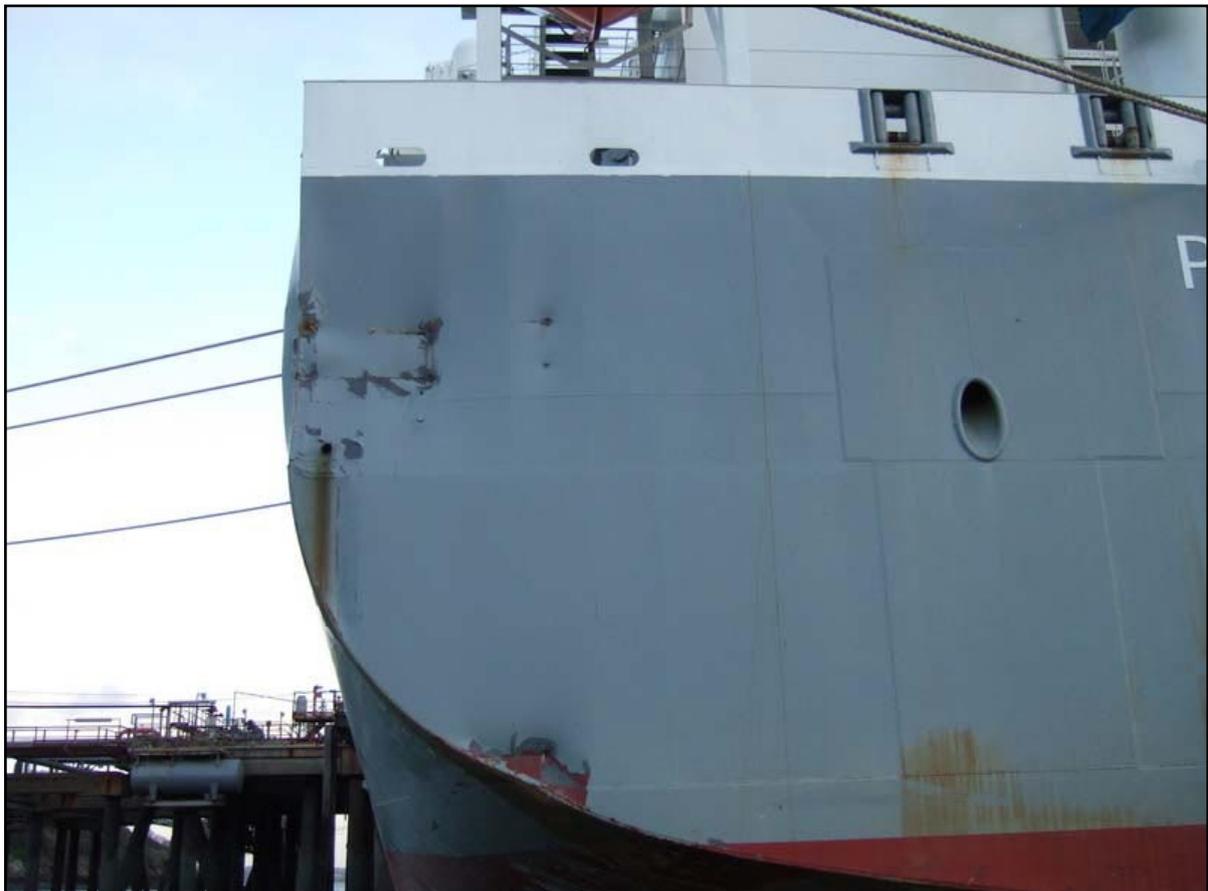
Figure 5a

Shortly after this second, undemanded, application of power, the vessel's port quarter made heavy contact with the first of the mooring dolphins to the west of the jetty. She then continued moving astern to also make contact with the second dolphin, resulting in significant damage being caused to both the vessel and the mooring dolphins (**Figures 5a, 5b and 6**).

Damage to stern of *Prospero* by jetty dolphins, from aft.

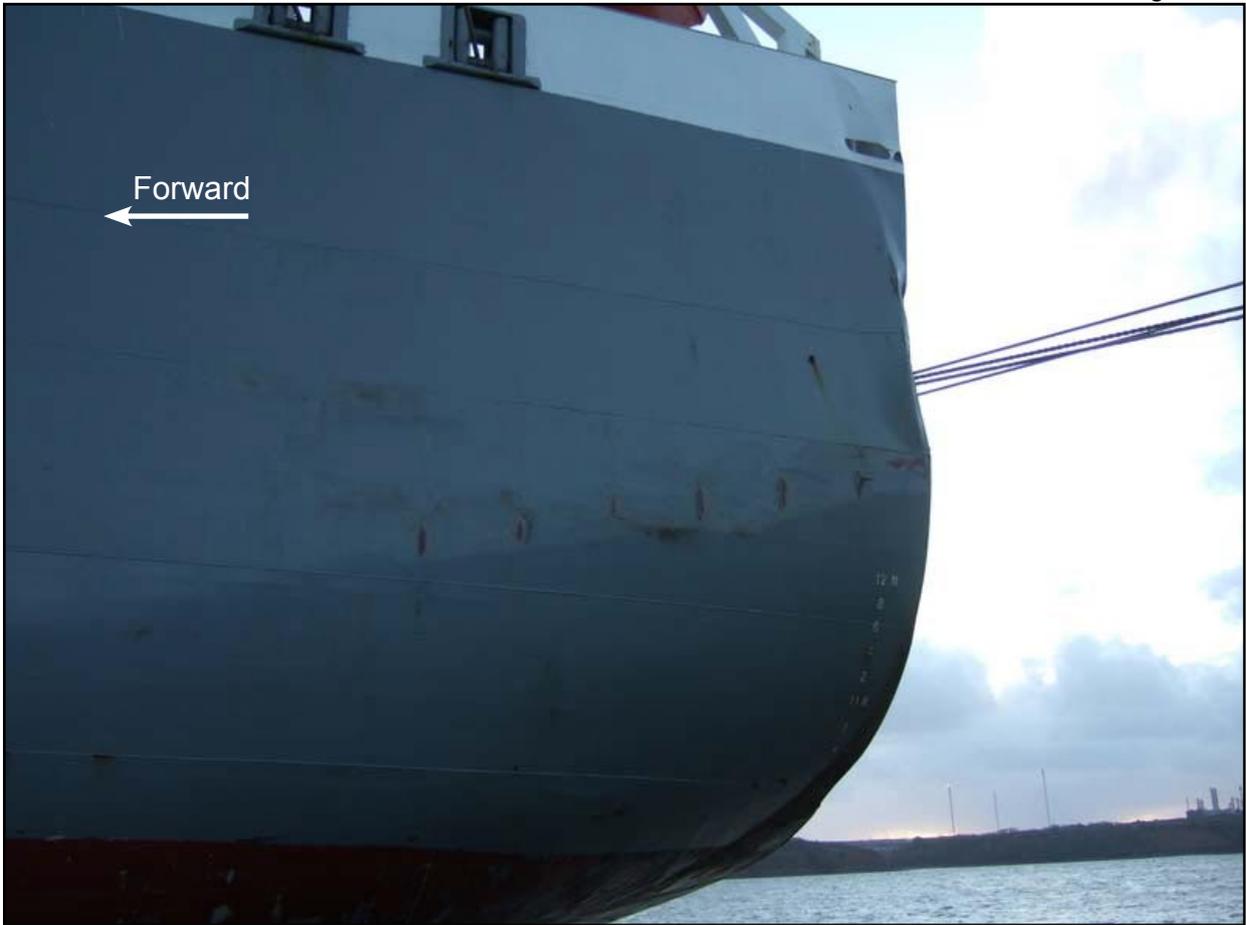
Figure 5b

Damage to stern of *Prospero* by jetty dolphins, from port side.

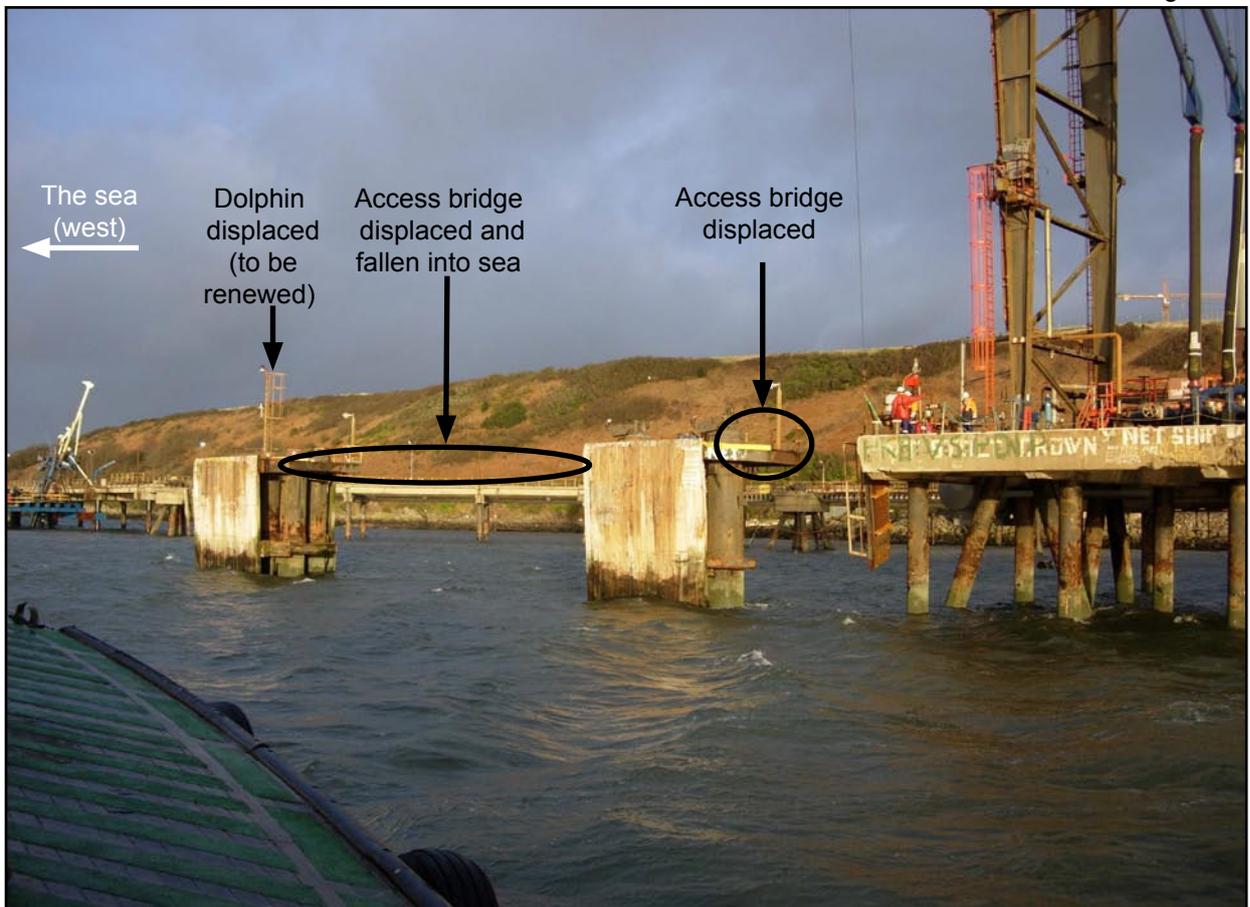
Figure 6

Damage to jetty dolphins, one displaced but attached, the other displaced and fallen into the sea.

The jetty was originally designed for vessels of up to 165,000 DWT, but due to the extent of the damage caused by the contact, it was necessary to impose a long-term restriction on this berth limiting the berth's capacity to 100,000DWT.

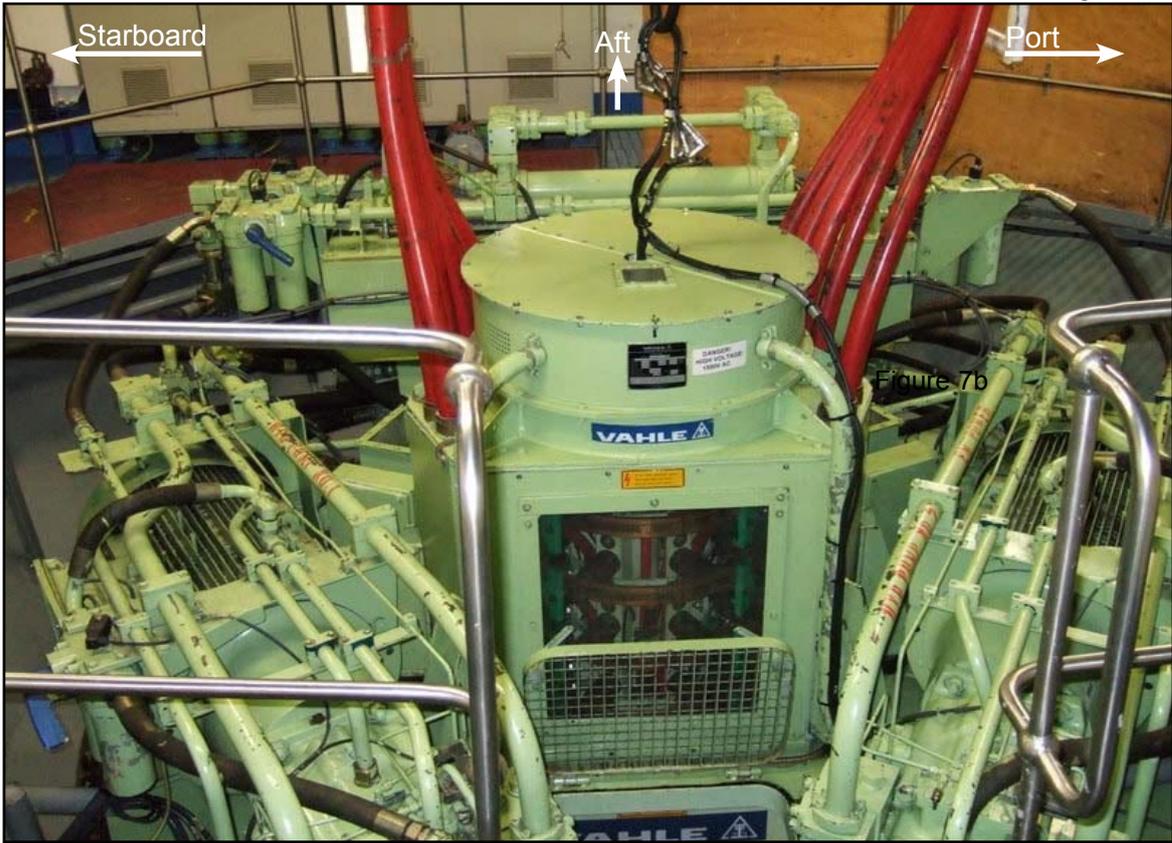
Figure 7a

The gauss signal transmitter had been ashore for repairs since September 2006. It was returned to *Prospero* during the repair period and refitted by the SSP engineer. However, the transmitter was still not functioning correctly, so was again taken ashore for further repairs and the temporary arrangement was reinstated (**Figures 7a and 7b**).

Pod room showing the temporary gauss transmitter arrangements.

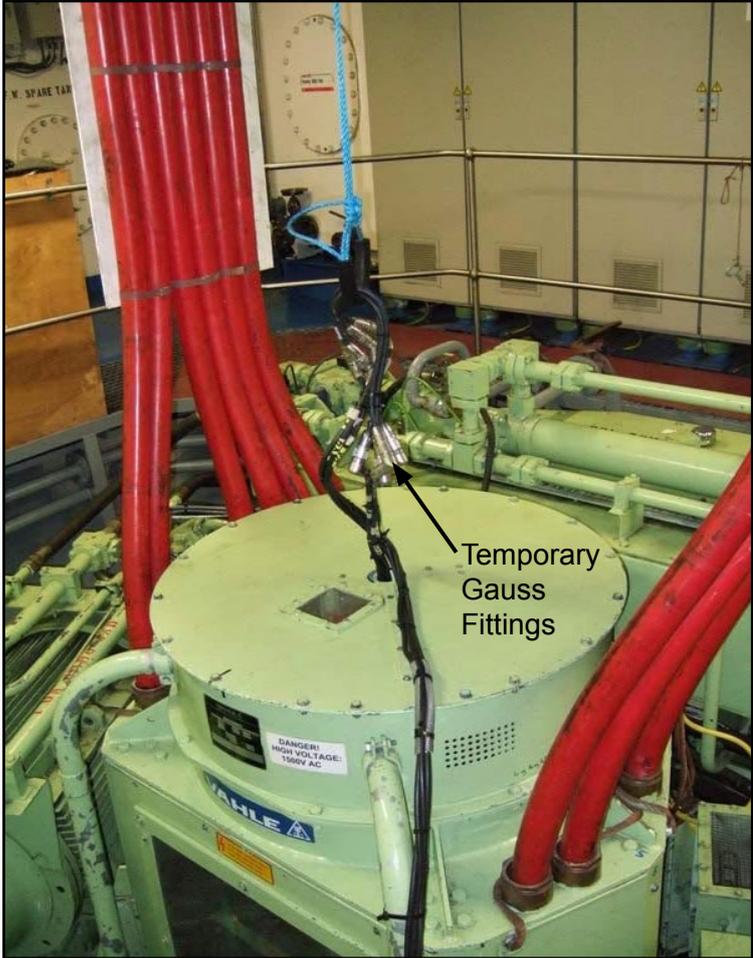
Figure 7b

Close-up showing the temporary gauss transmitter arrangements.

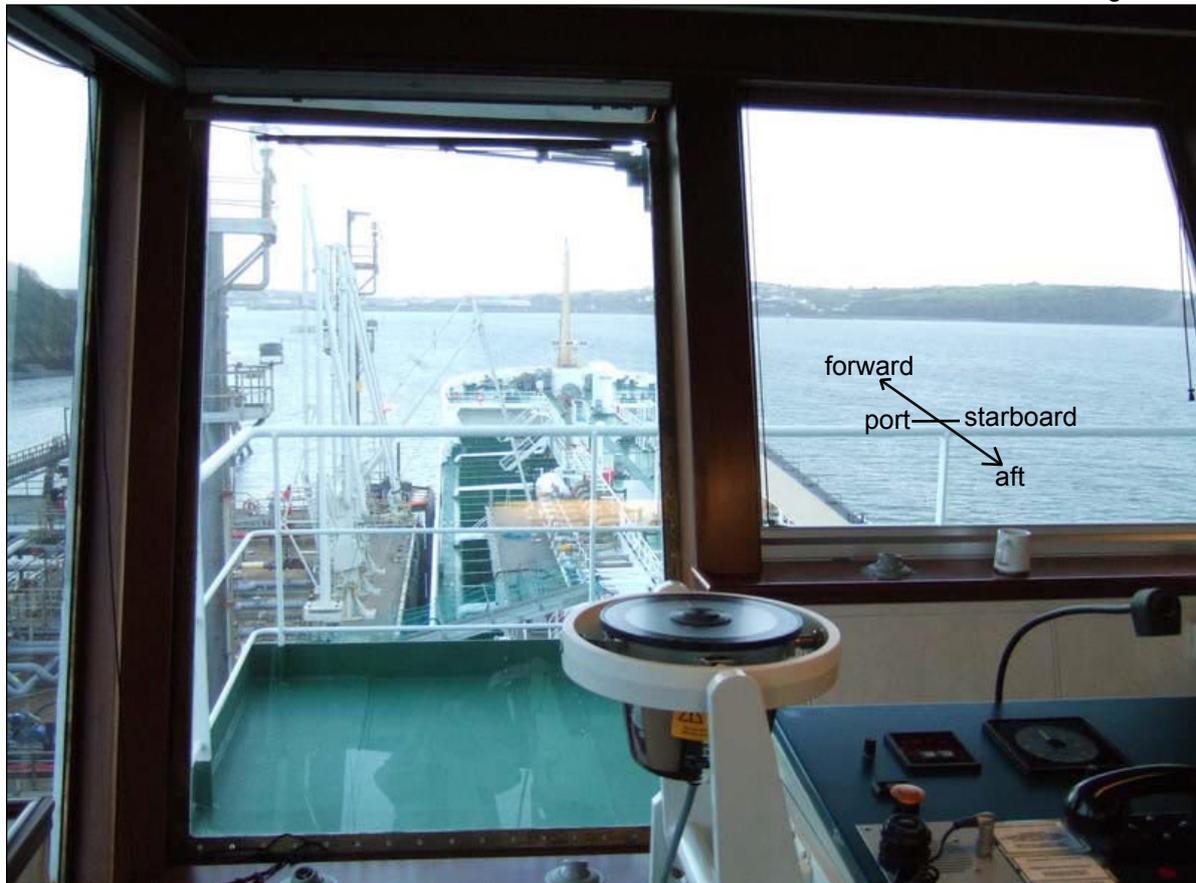
Figure 12

Visibility of the ship's side from the wheelhouse wing control consoles was restricted by the tops of the deckhouse below (**Figure 12**), and the person controlling the ship needed to move from the control console to the side windows in order to get a better view of the ship's side. This problem has been corrected on later vessels of the class.

Looking forward from wheelhouse port console, showing obstructed view.

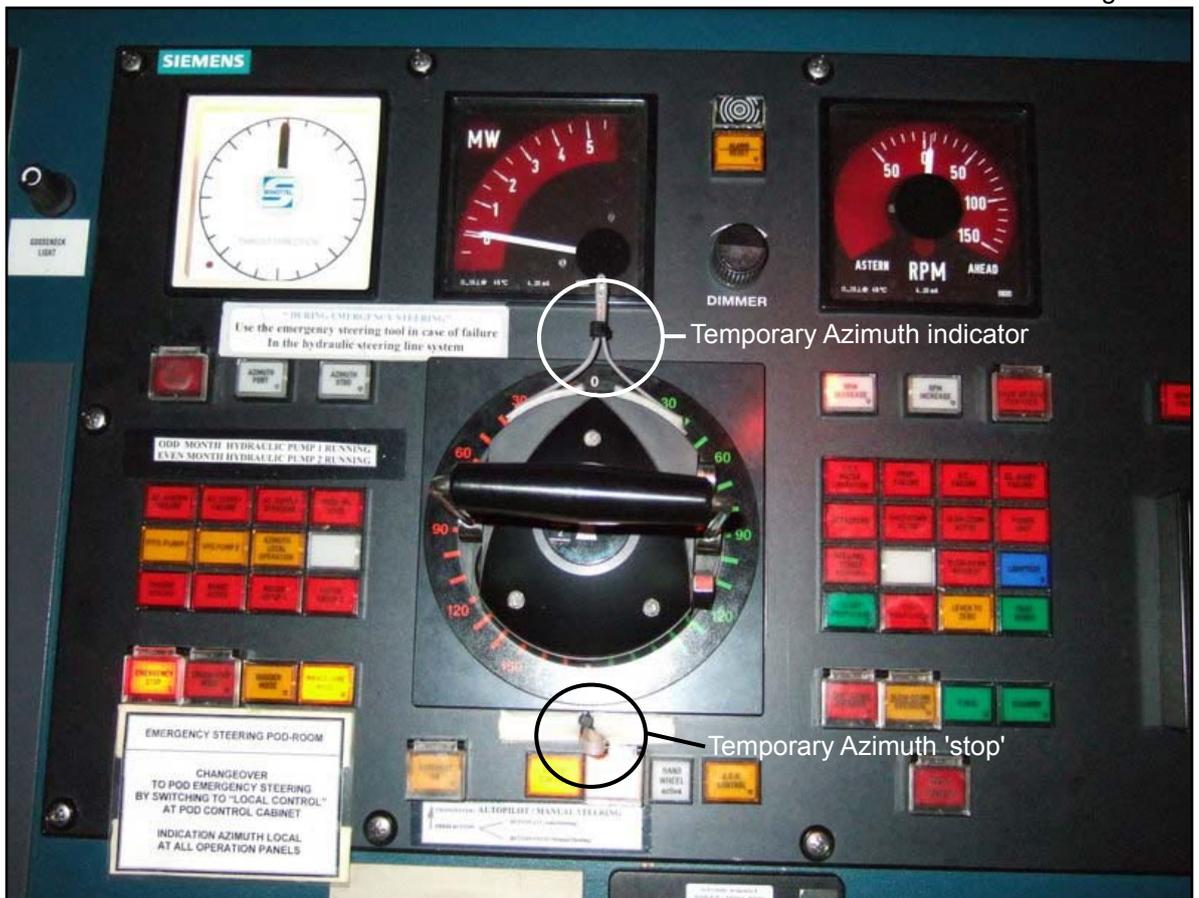
Figure 13

The pod controls at each console had an identical layout for ease of operation (**Figure 13**). This figure also shows the cable ties attached to the pod control levers as a result of the gauss transmitter failure on 19 September 2006. All the pod control levers were electrically driven to match the position of the 'in-command' control lever. Control levers which were not 'in-command' provided physical feedback to the operator through increased resistance to movement and automatically returning to the 'in-command' setting when released. There was, therefore, no need to set the lever to zero before transferring control which was instead achieved by pushing a button. Transfer of control of the pod between the wheelhouse and the ECR was also achieved by the push of a button.

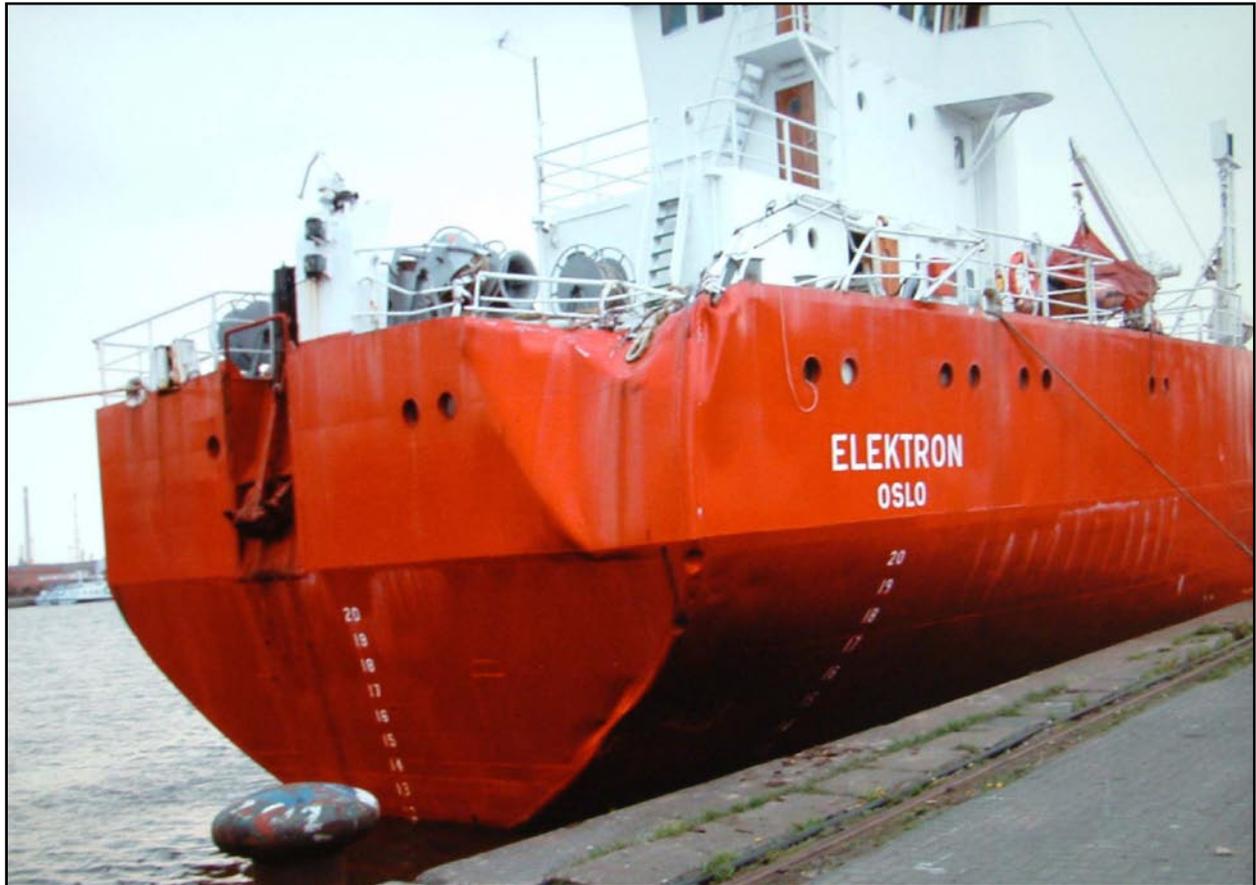
Figure 15

Damage to stern of *Elektron*, due to collision with bow of *Bro Sincero*

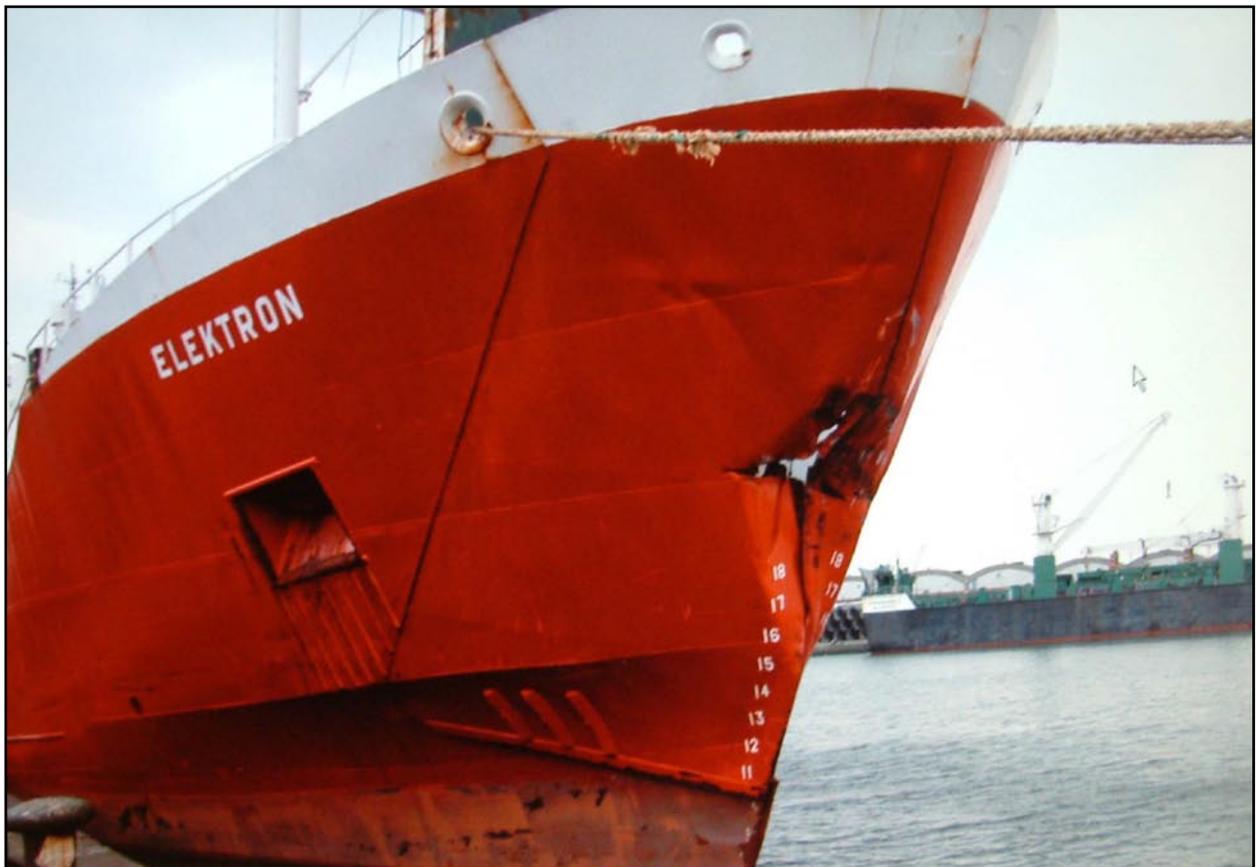
Figure 16

Damage to bow of *Elektron*, due to contact with lock gates.

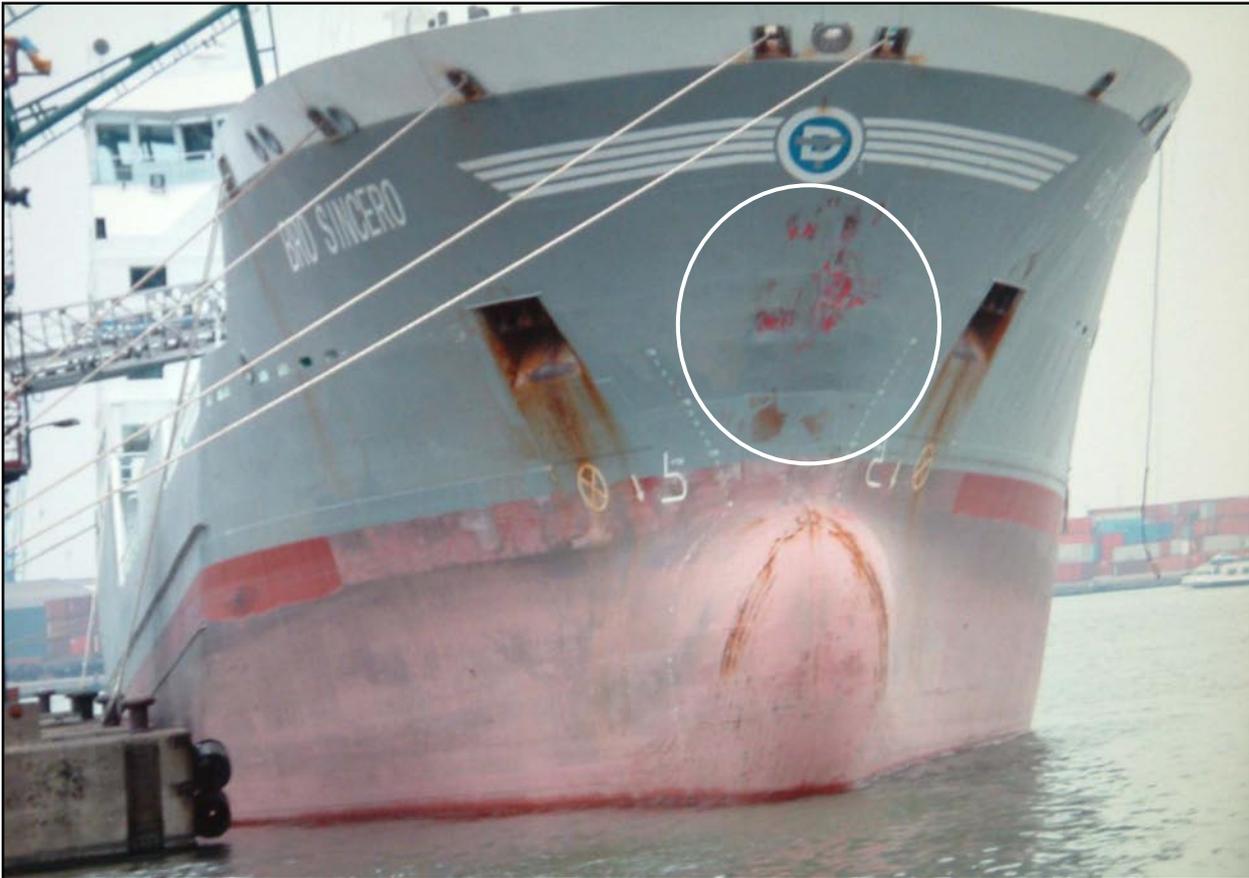
Damage to bow of *Bro Sincero*, due to collision with stern of *Elektron*.
