Report on the investigation of
the grounding of

mv Harvest Caroline

Tanera More, Summer Isles
north west coast of Scotland

**Report No 13/2007
June 2007**

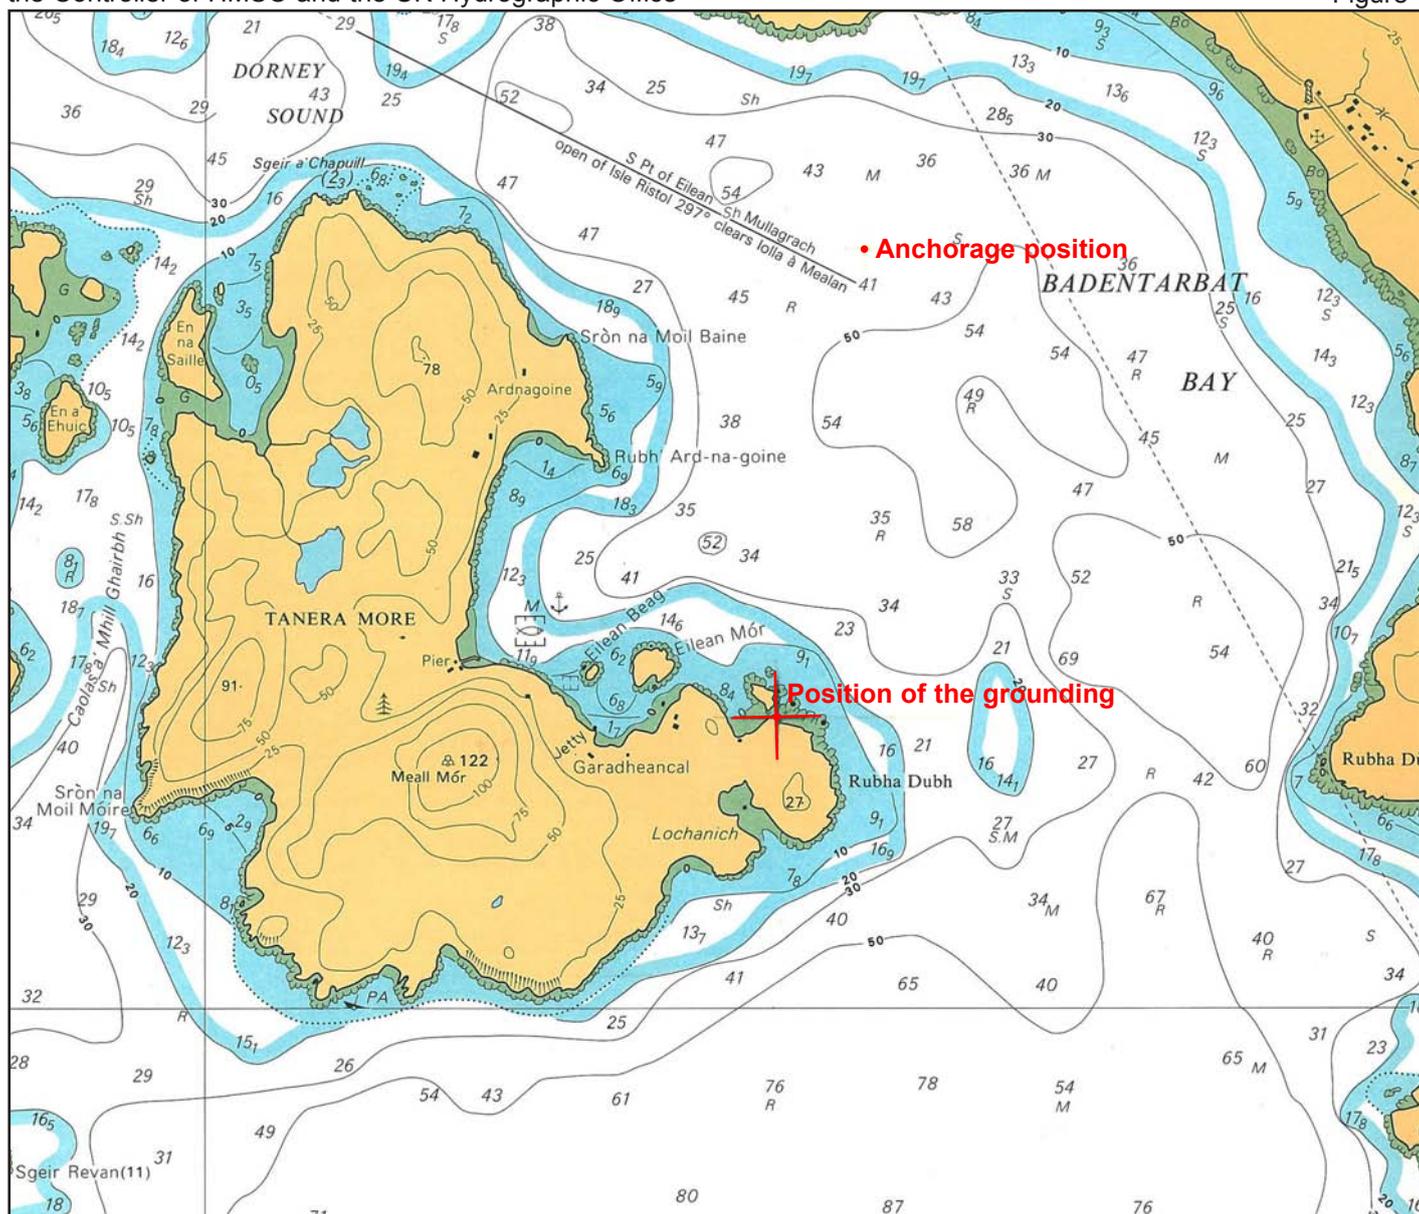
Extract of chart BA 2501

During the afternoon of 30 October 2006, *Harvest Caroline* was on passage to deliver fish food to a fish farm on the eastern side of Tanera More (**Figure 1**). As the ship passed the south east corner of the island at 1535, the master was advised by telephone that it was not possible to discharge the fish food that evening due to the limited daylight remaining.

The master decided to anchor overnight between Tanera More and Badentarbat Bay (**Figure 1**). The ship had anchored in this position on 23 September 2006 and the master considered that it would provide shelter from strong winds, which were predicted to veer from the south west to the north overnight.

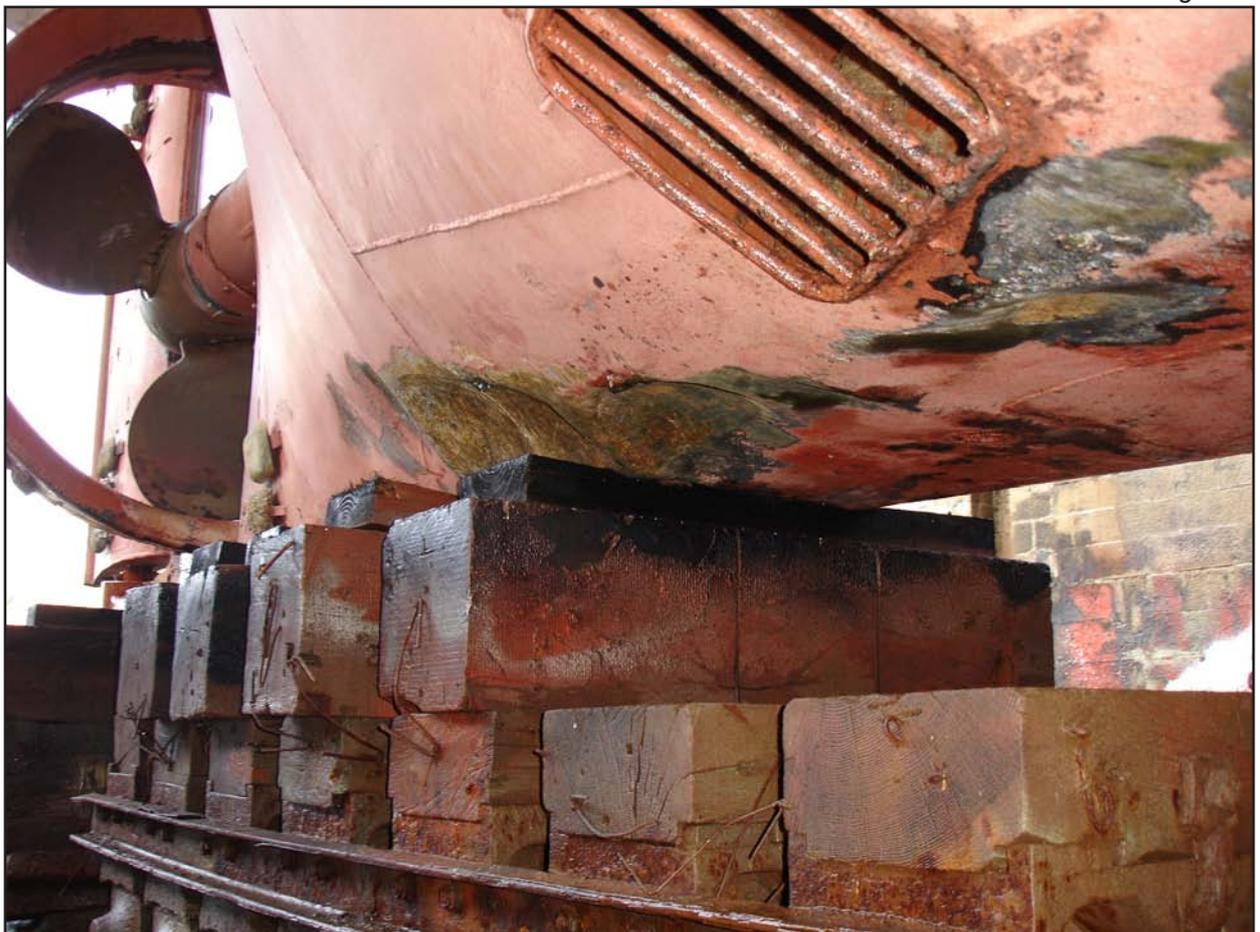
Figure 2

the ship to fall broadside onto the rocks. The starboard anchor was then let go underfoot. The chief engineer checked for damage in the engine room and found a small number of indentations in the underwater hull plating (**Figure 2**). A small ingress of water in the engine room bilge was also detected.

Photograph of damage to hull plating

On completion of an underwater survey and temporary repair to a small area of underwater hull plating, *Harvest Caroline* sailed from Ullapool on the evening of 1 November 2006. She arrived in Greenock the following day, where permanent repair was undertaken.

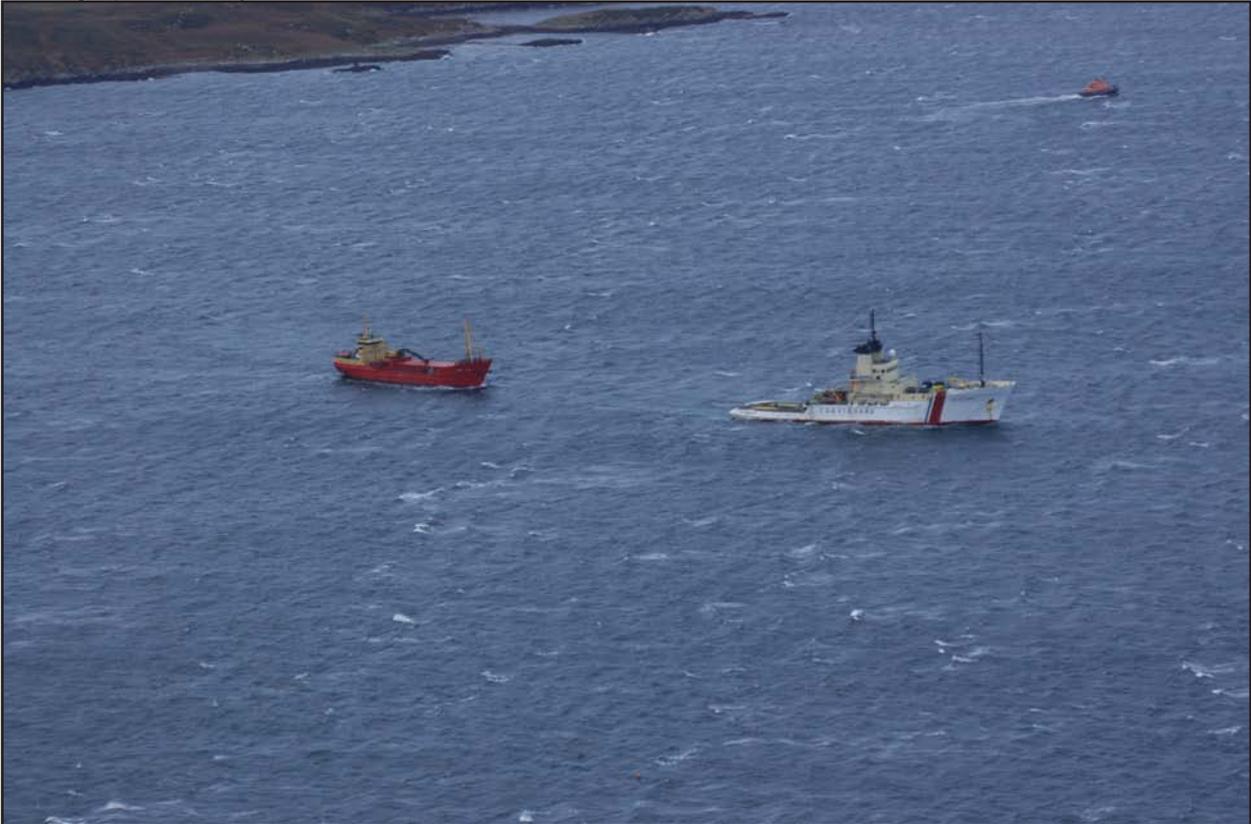
At 0727, the SAR helicopter winched a salvage pump onto, and the female passenger from, *Harvest Caroline*. When *Anglian Prince* arrived at the scene at 0940, *Harvest Caroline* had already started to re-float on the rising tide. She was taken in tow by the ETV (**Figure 3**), and was clear of the rocks by 1050. No pollution was detected by coastguard aircraft, either at the scene, or during the vessel's passage to Ullapool, where she arrived the same day.

Photograph of tow in progress

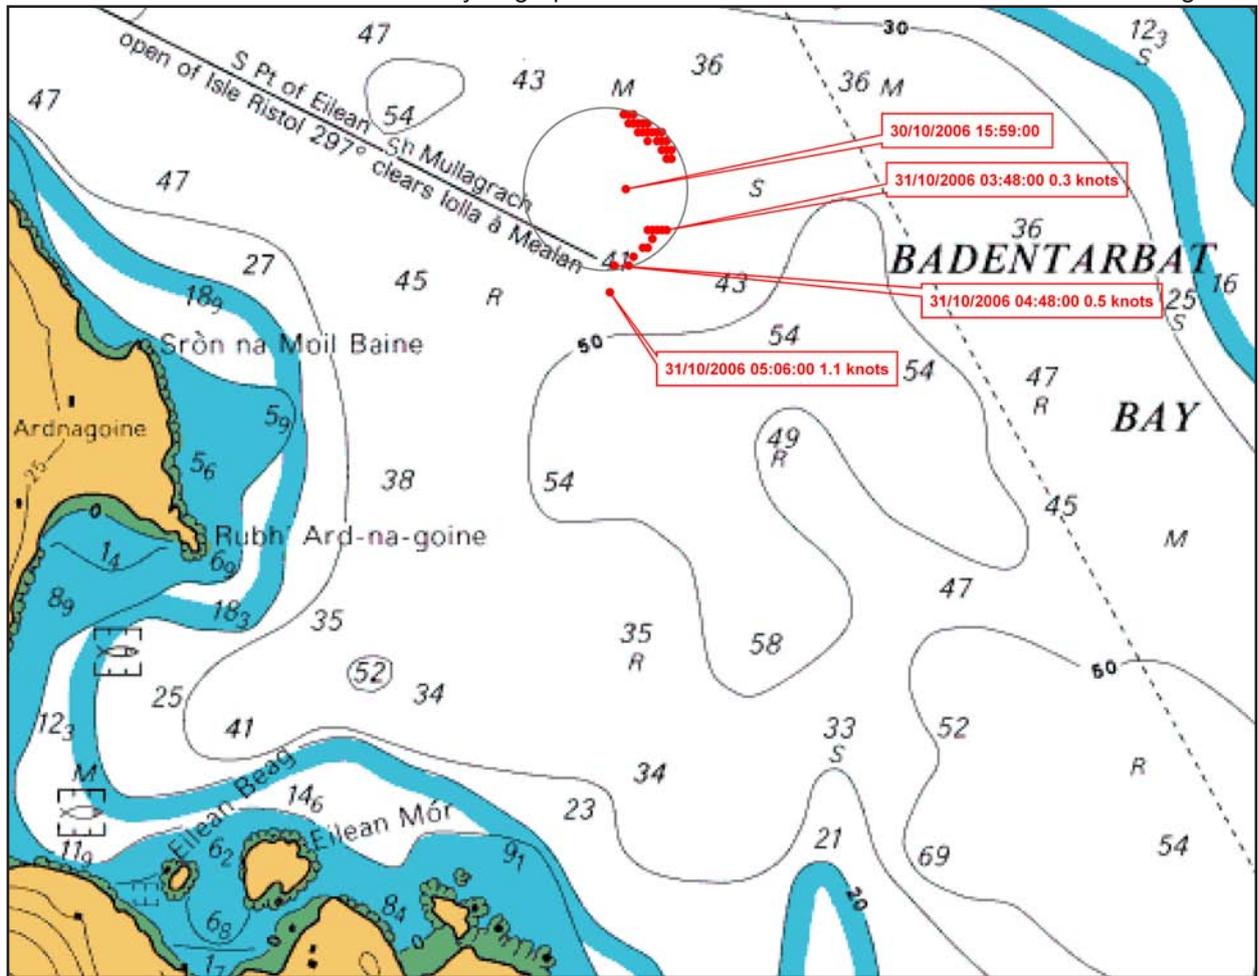
Positional data transmitted by the ship's AIS between 0300 and 0506 on 31 October 2006 is shown at **Figure 4**. No transmissions were received after 0506 until the ship grounded. The ground track from the ship's anchorage to the position of grounding, recovered from the ship's GPS receiver, is at **Figure 5**. No positional information was recorded on the ship's ECS.

AIS Positional Data

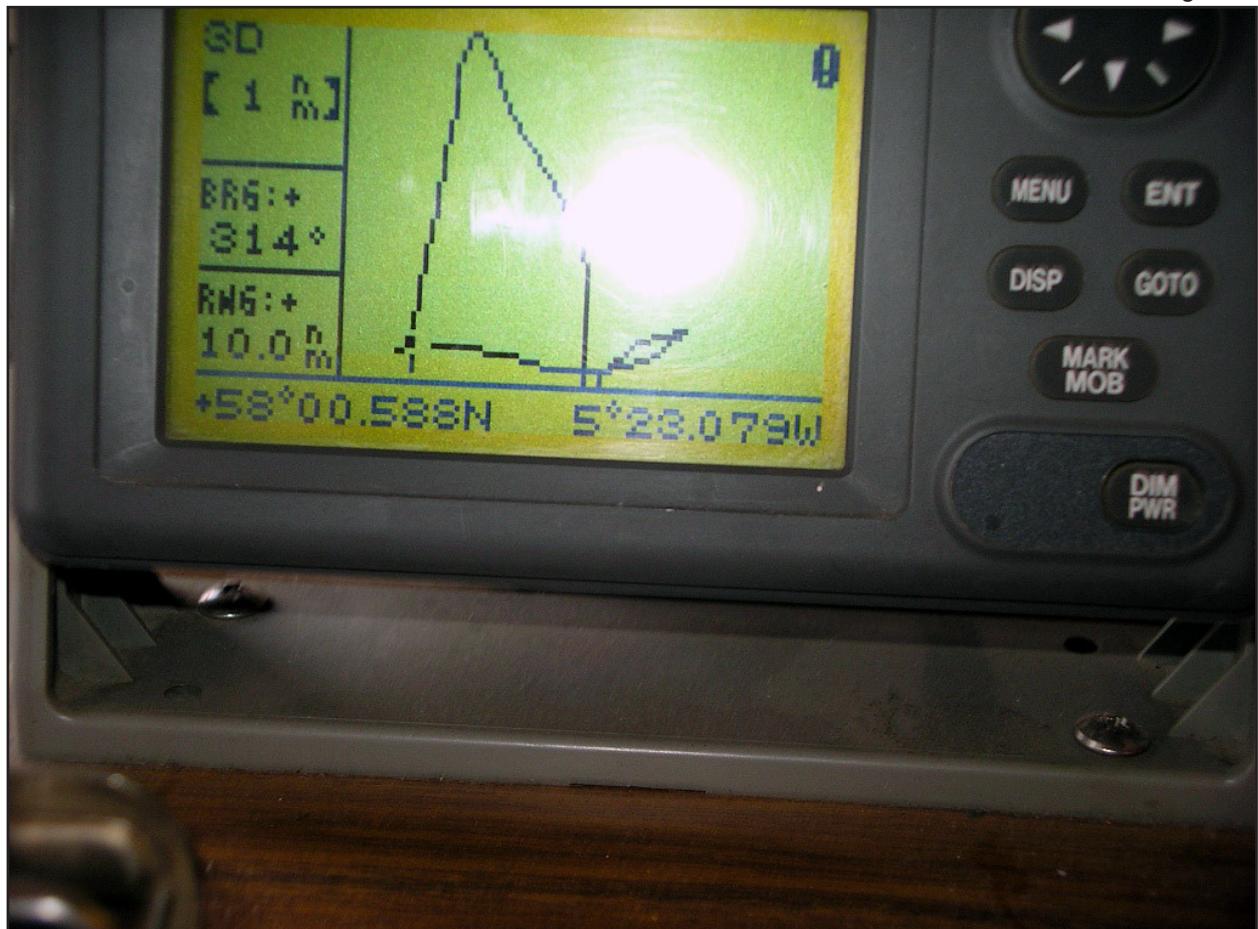
Figure 5

Photograph of GPS data
