Report on the investigation of
the close-quarters situation between the
ro-ro passenger ferry
Maersk Dover
the tanker
Apollonia
and the container vessel
Maersk Vancouver
in the Dover Strait
on 17 October 2006

Report No 9/2007
May 2007

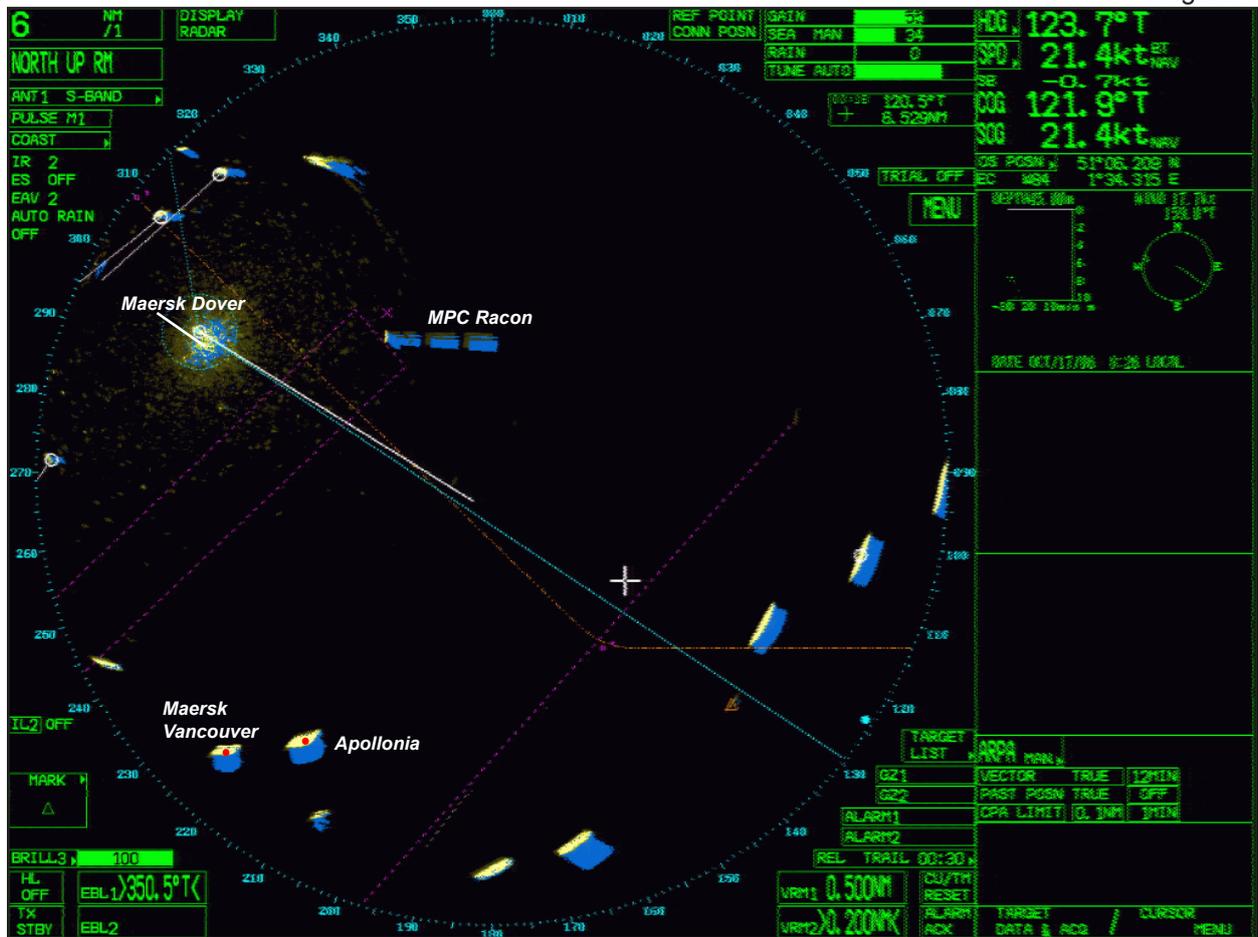
Figure 3

constrained by her draught and exhibiting a black cylinder in accordance with Rule 28 of the COLREGS. He also saw *Maersk Vancouver*, which was overtaking *Apollonia* on her port side. The VDR voice recording confirmed the 2/O's shock when he saw *Apollonia* for the first time.

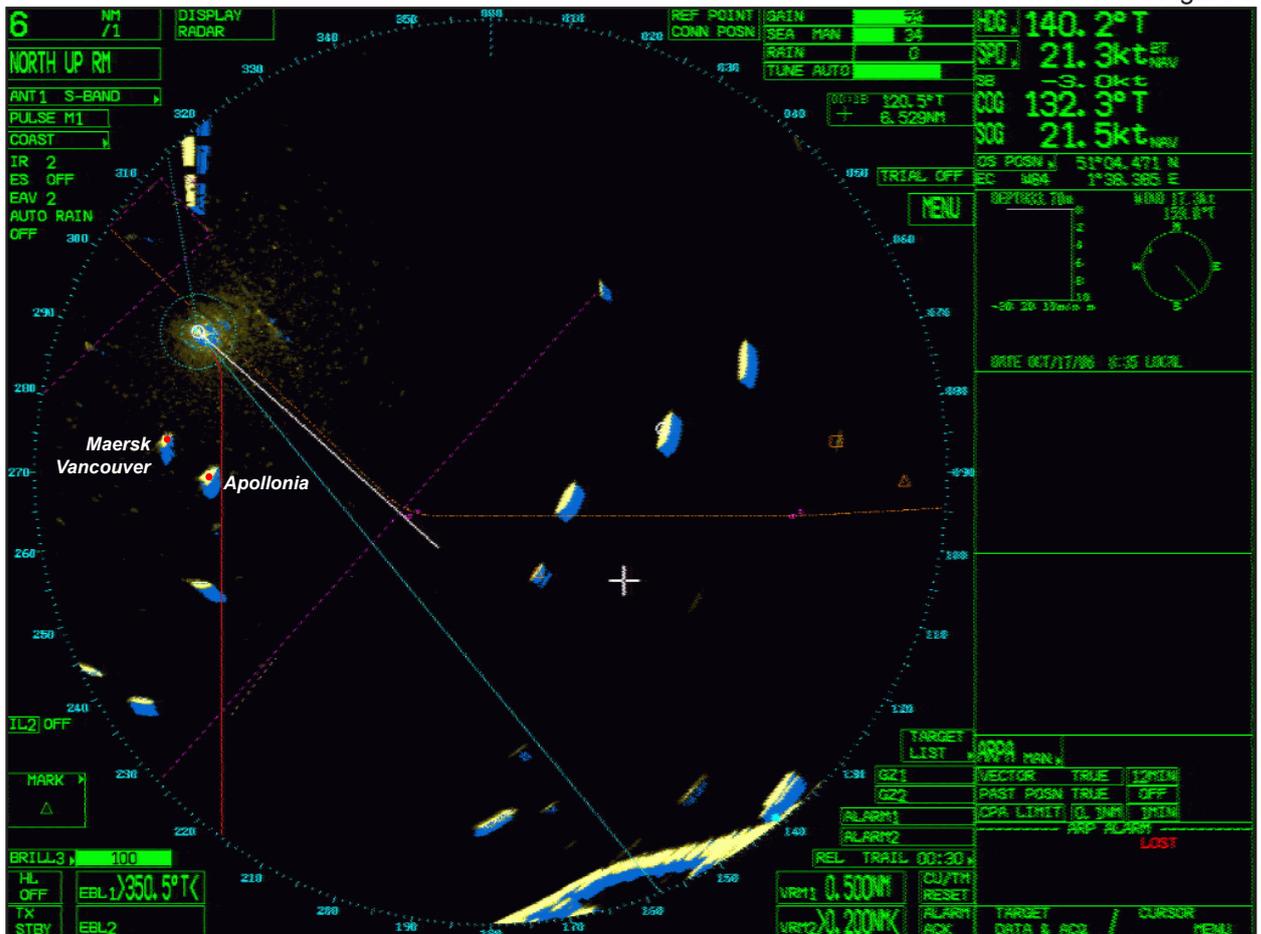
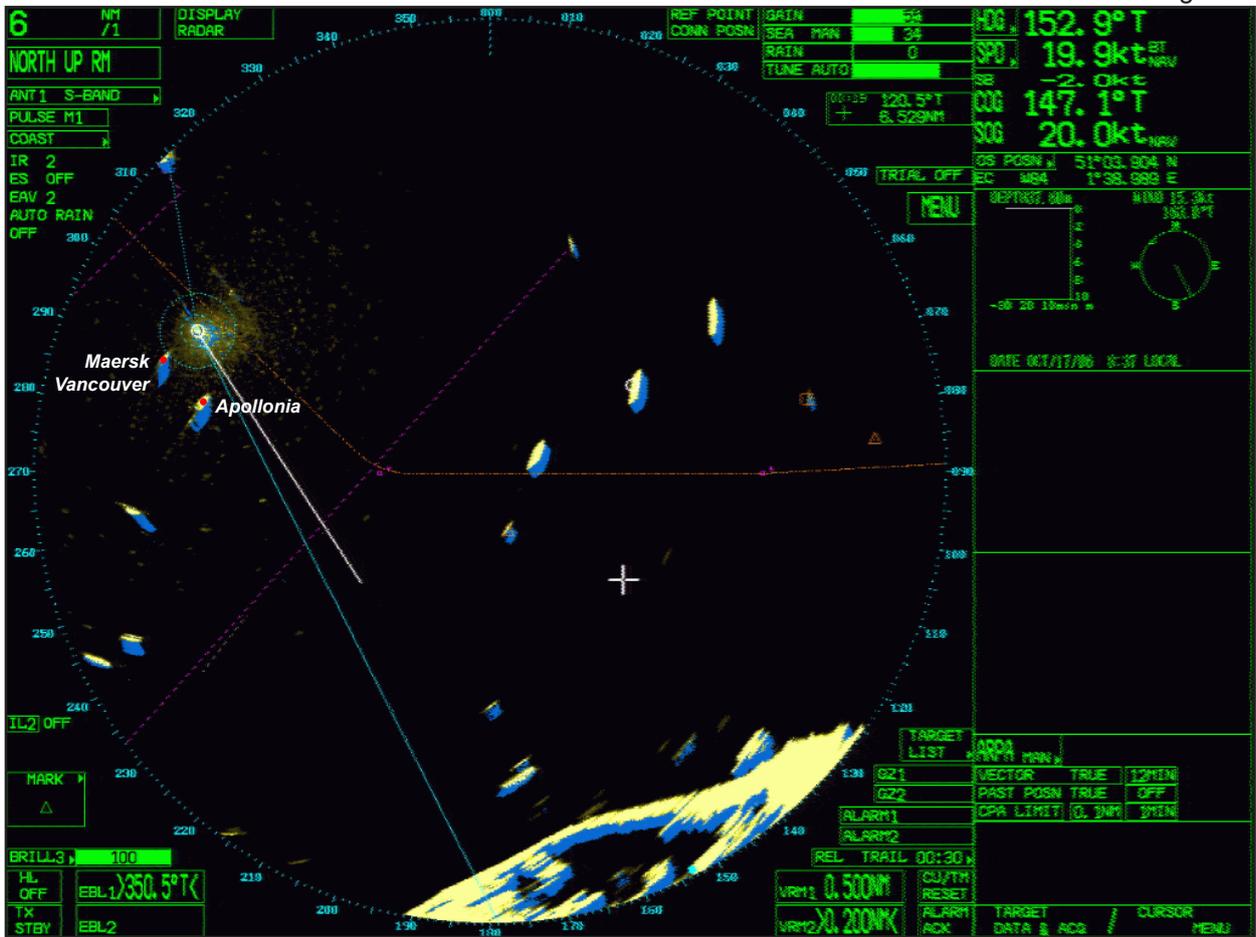
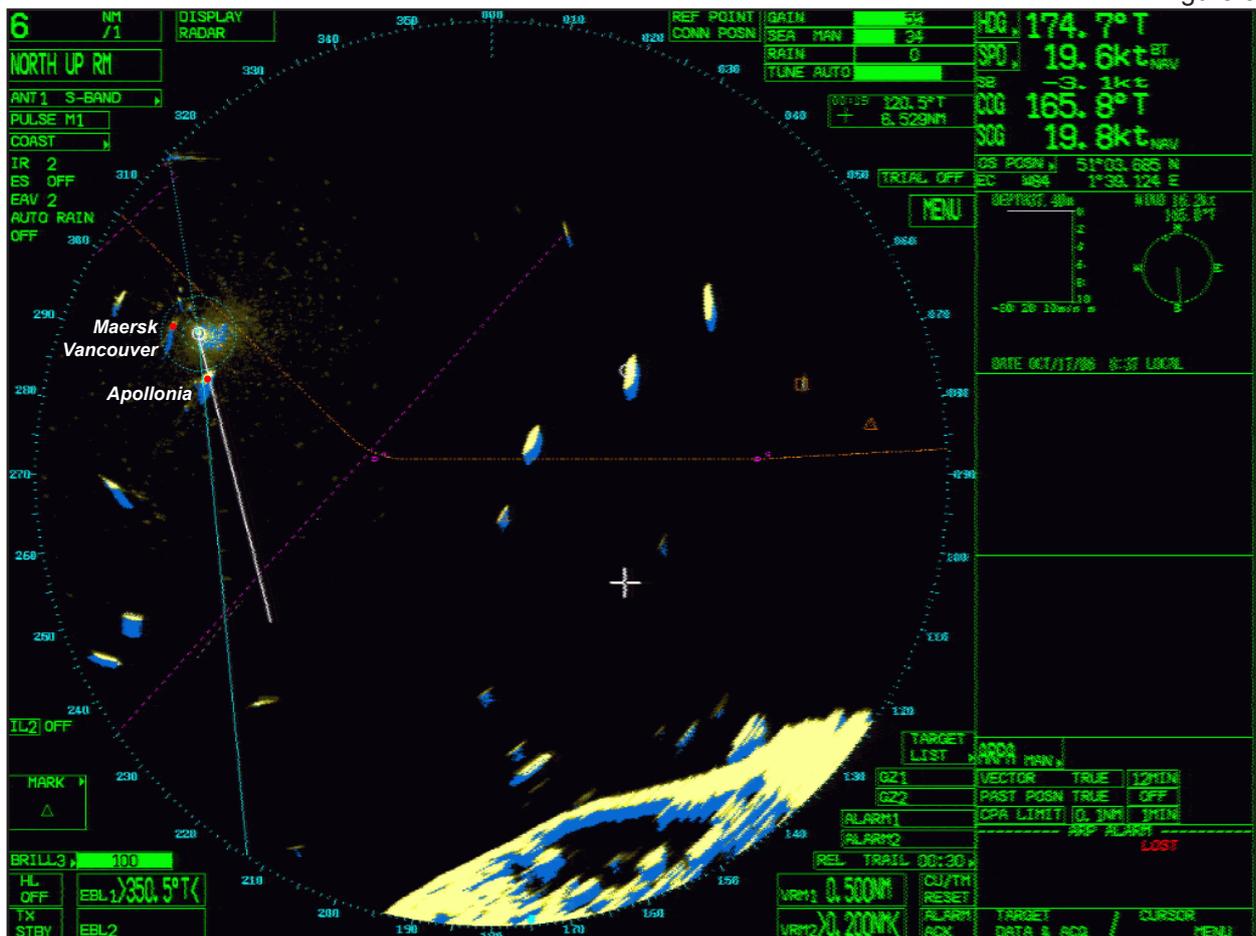
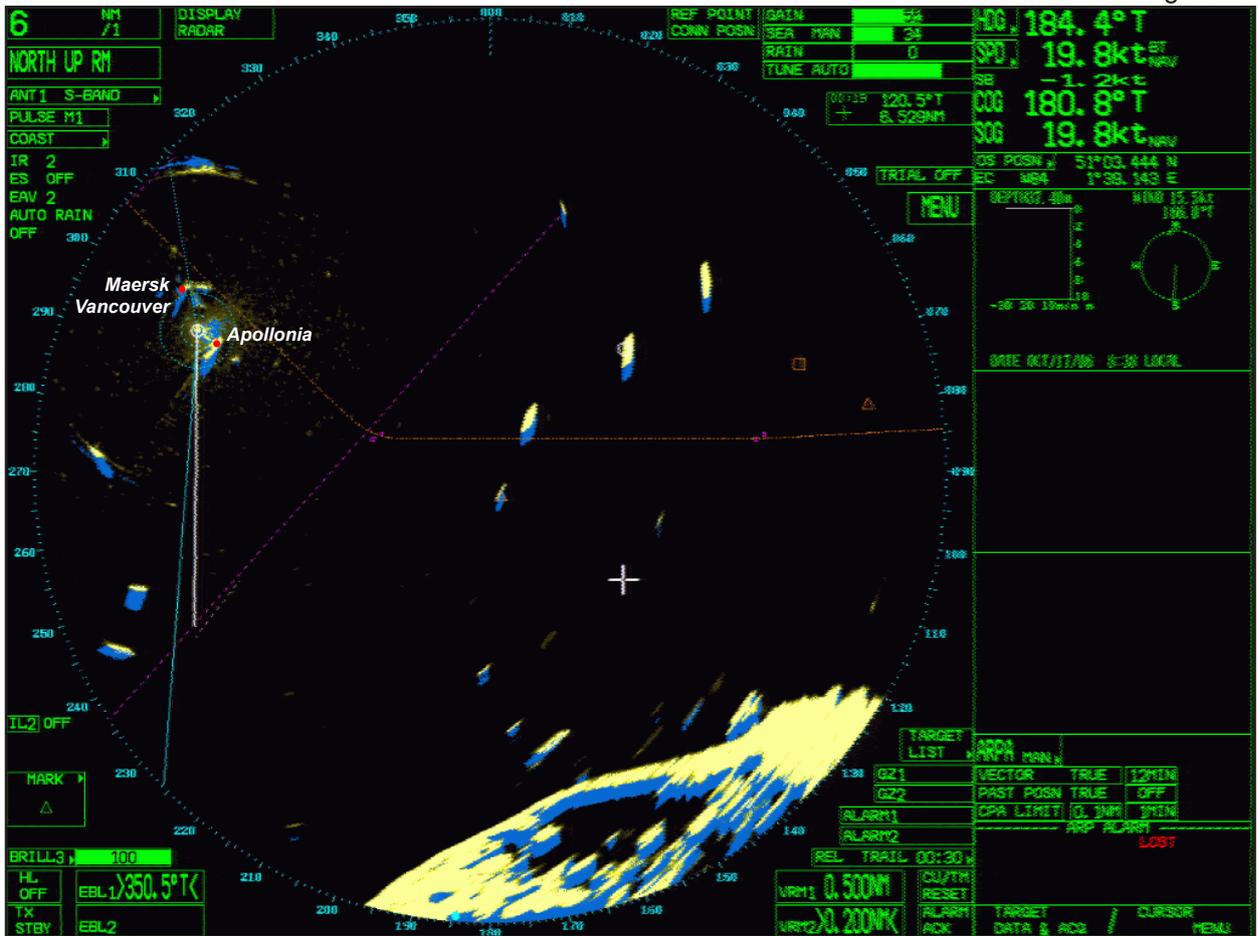
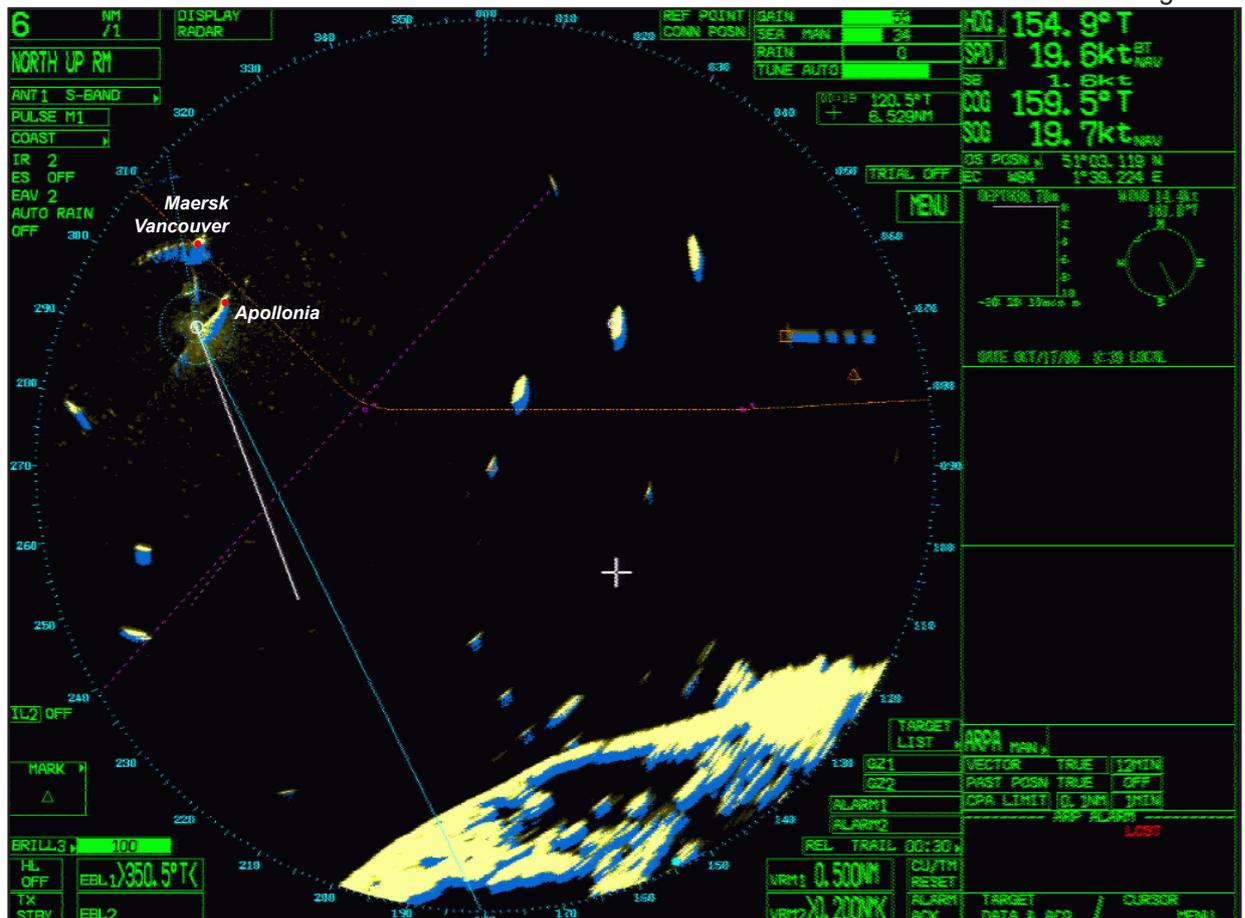
The VDR indicated that the bridge of *Maersk Dover* passed 5 cables ahead of *Maersk Vancouver*, resulting in a CPA of 3 cables on her starboard bow. This was followed, seconds later by closing *Apollonia* to 3 cables on the port bow, 2.5 cables on the port beam, and finally a CPA of 1 cable astern (Figures 7, 8, 9, 10, 11).

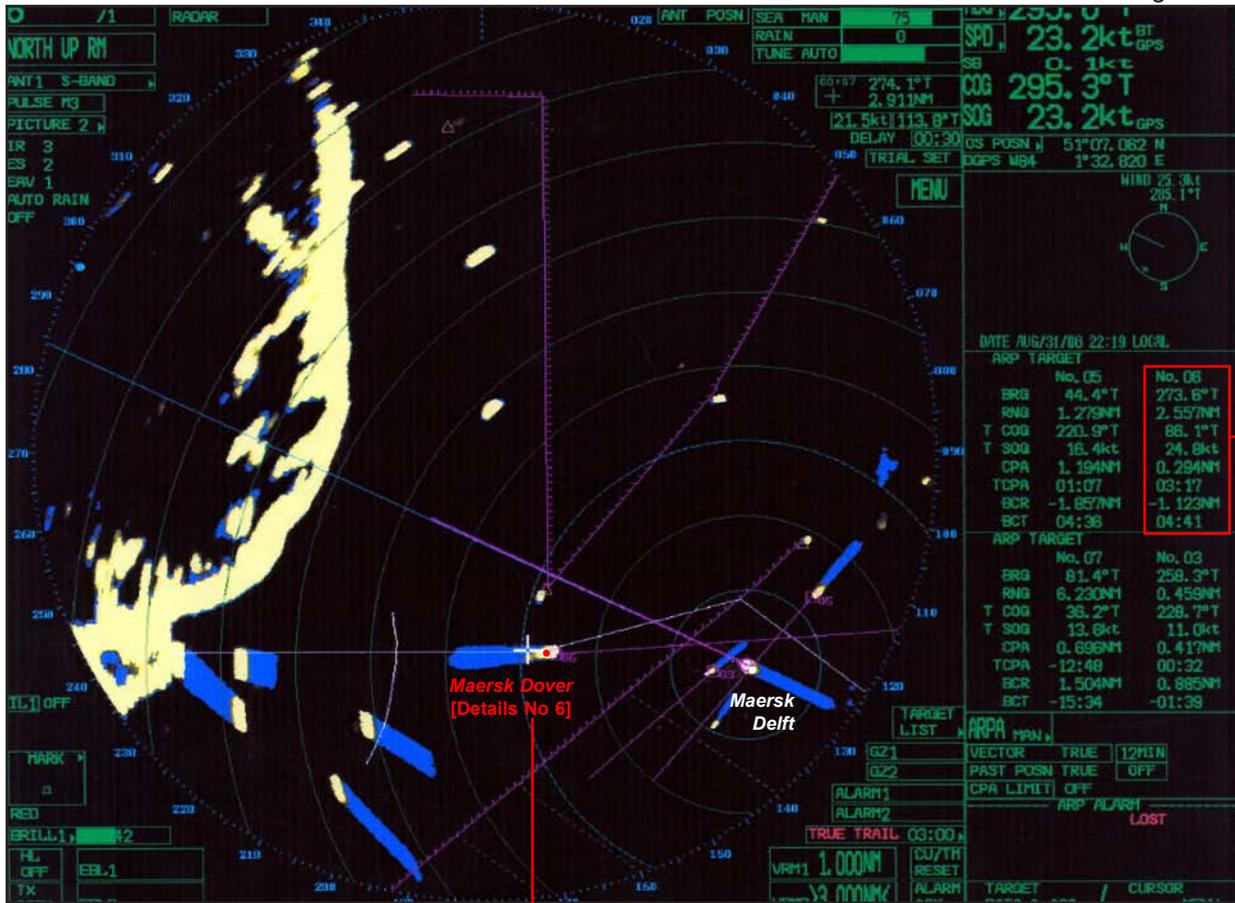
A close-quarters situation had been allowed to develop with *Maersk Dover* passing 1 cable or less, ahead of *Maersk Delft*.

Radar picture seen from *Maersk Delft*
