Report on the investigation of the grounding of the jack-up barge

***Octopus***

Stronsay Firth, Orkney Islands

**Report No 18/2007**  
**August 2007**

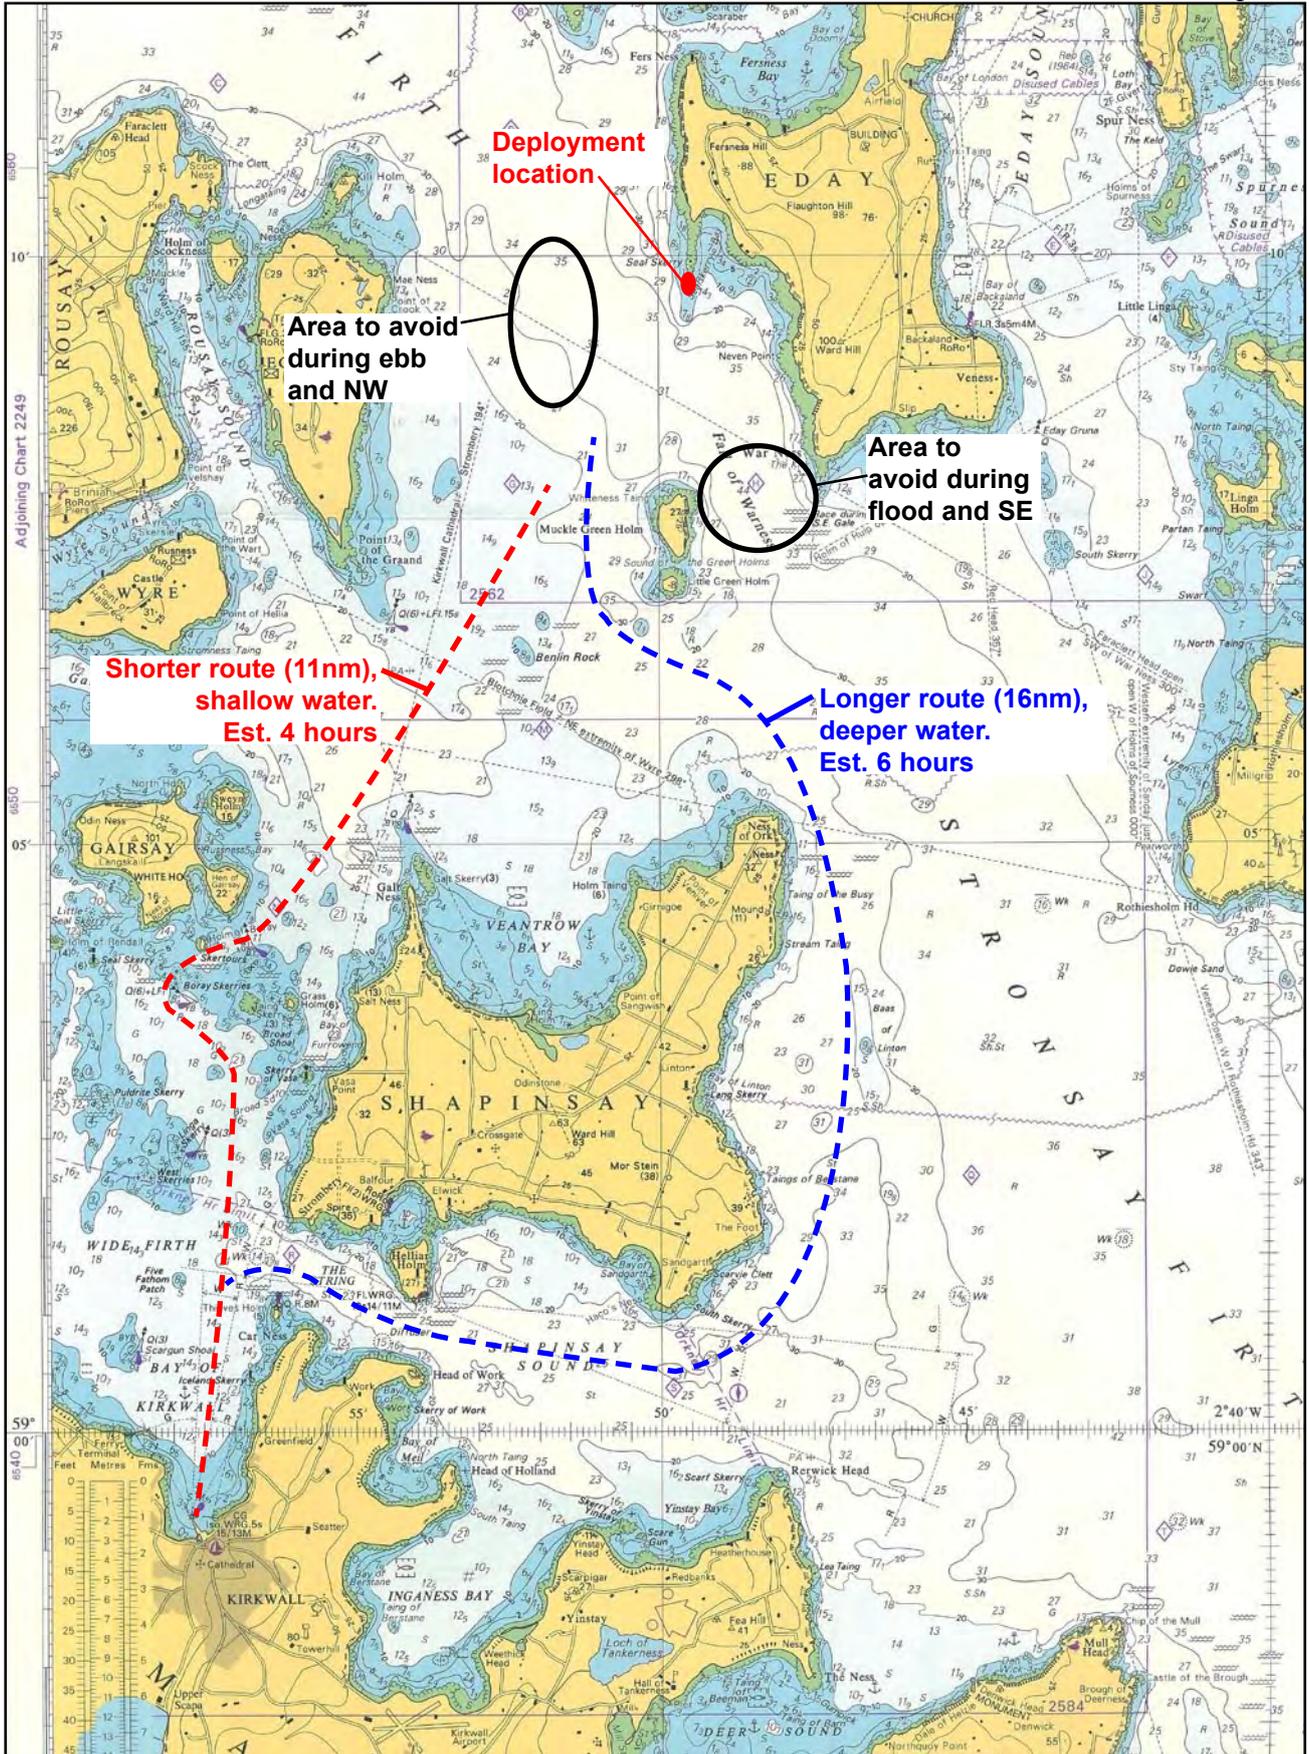
The tug and barge were initially planned to pass to the east of Shapinsay through the Falls of Warness, this route being considered preferable to the shorter shallower route west of Shapinsay. The east route also opened up the sub-options of passing either east or west of the Green Holm islands. During route planning meetings before the voyage, the preference was to pass east of the Green Holm islands although the agreed method statement route (**Figure 3**) indicated a passage to the west.

Route options considered during initial project planning

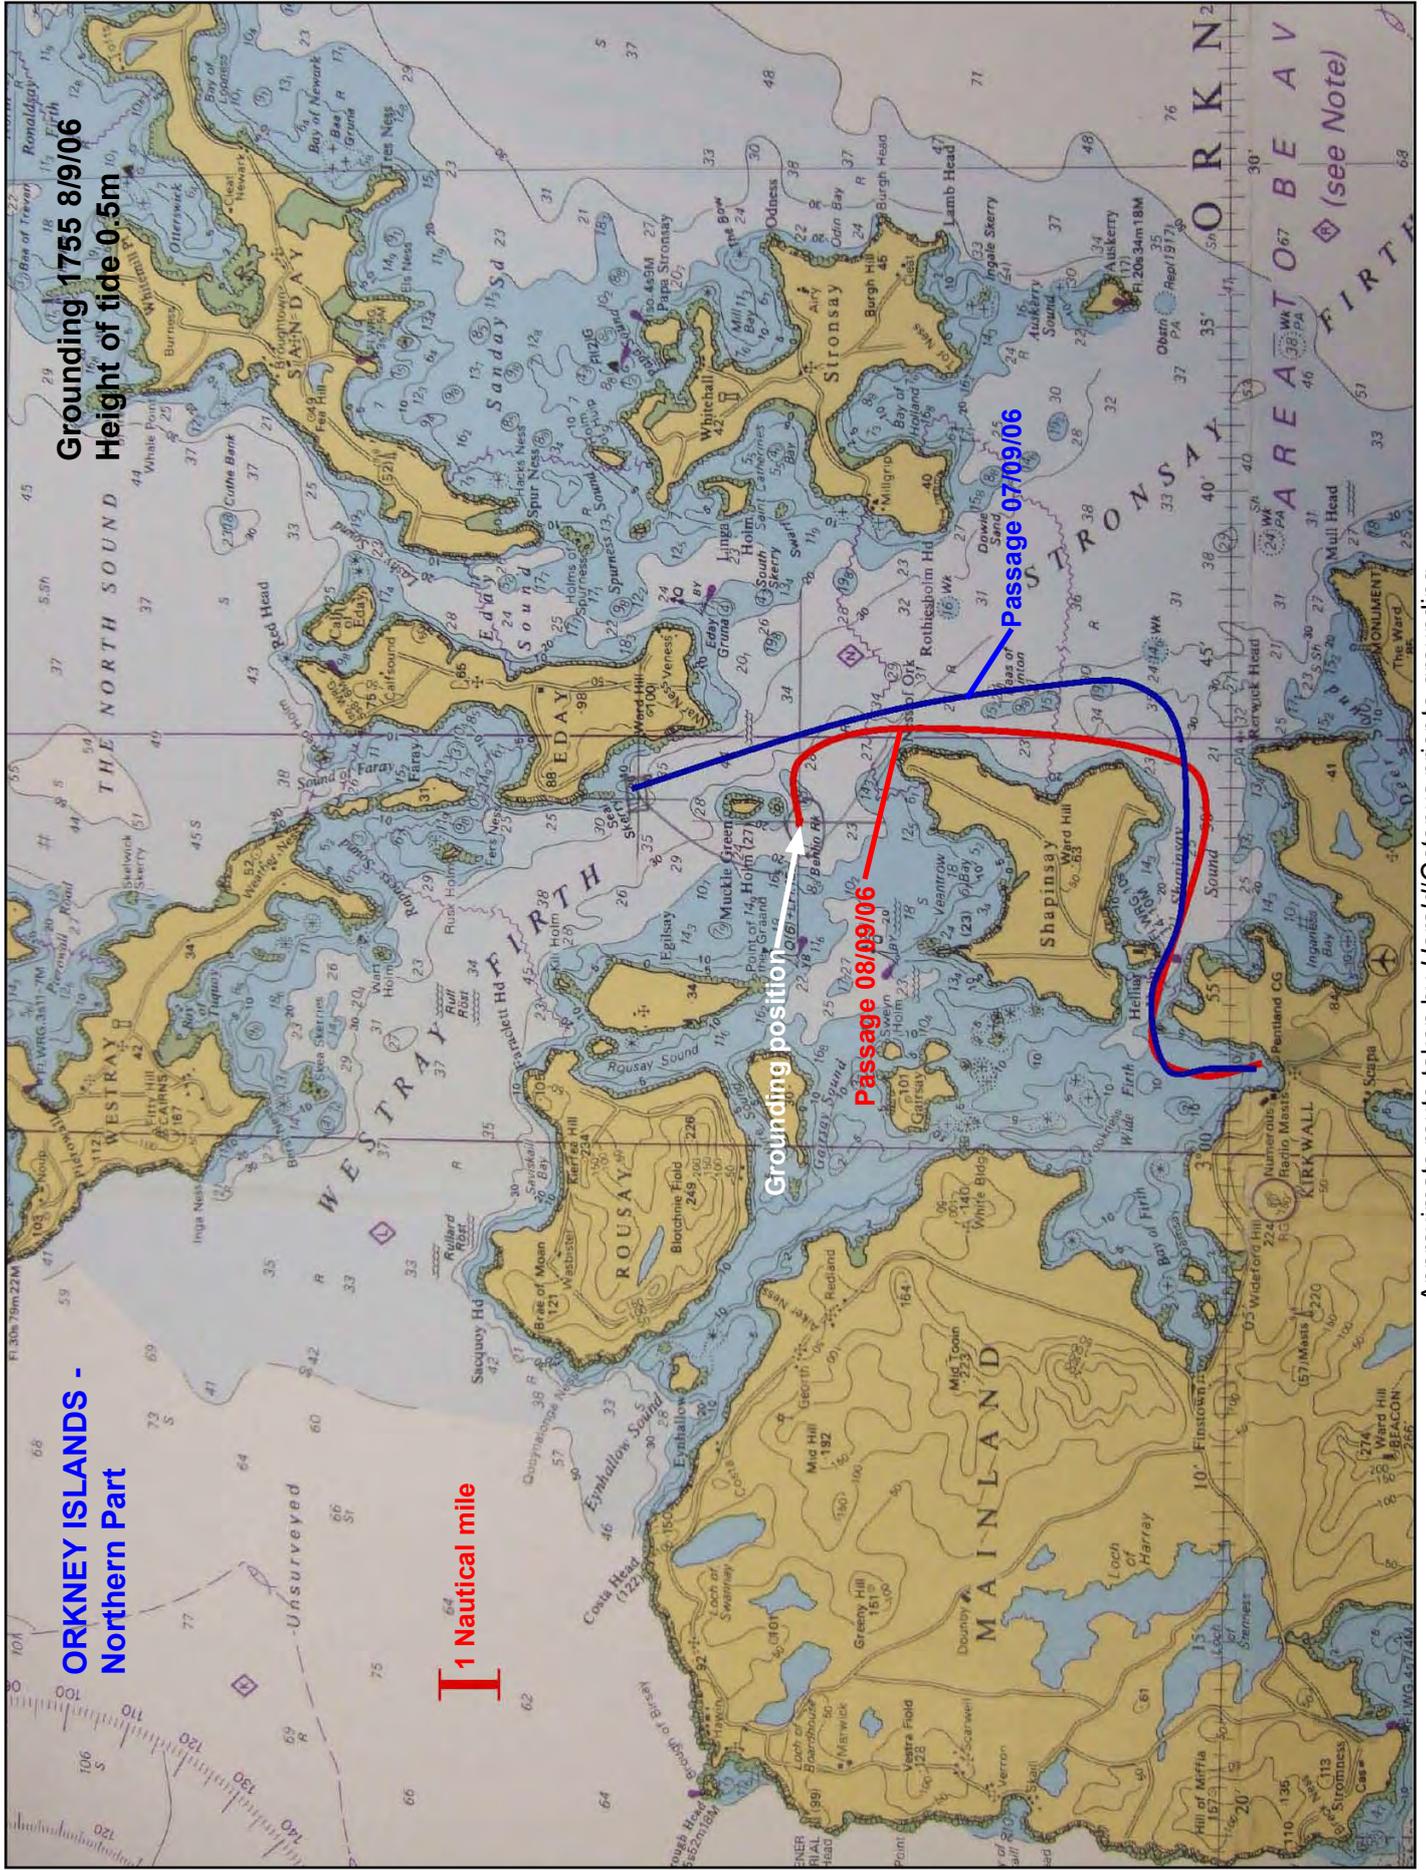
The tow's progress through the water was slightly reduced as the barge trimmed forward when the legs were extended. As the tug and tow approached the Falls of Warness at 1730, the following spring ebb tide, flowing at about 6 knots, set the tug and barge to the west. The tug skipper was aware that the westerly set continued through the Falls of Warness and would set them towards the Green Holm islands. He therefore discussed the situation with the tow master on the barge by VHF radio, and they agreed to pass to the west of Little Green Holm Island, a route *Harald's* skipper had used many times before. As the tug and tow altered course to the west-north-west to pass west of the Green Holm islands, their speed increased to 8 knots over the ground aided by the ebb tide (**Figure 4**).

Approximate route taken by Harald/Octopus prior to grounding

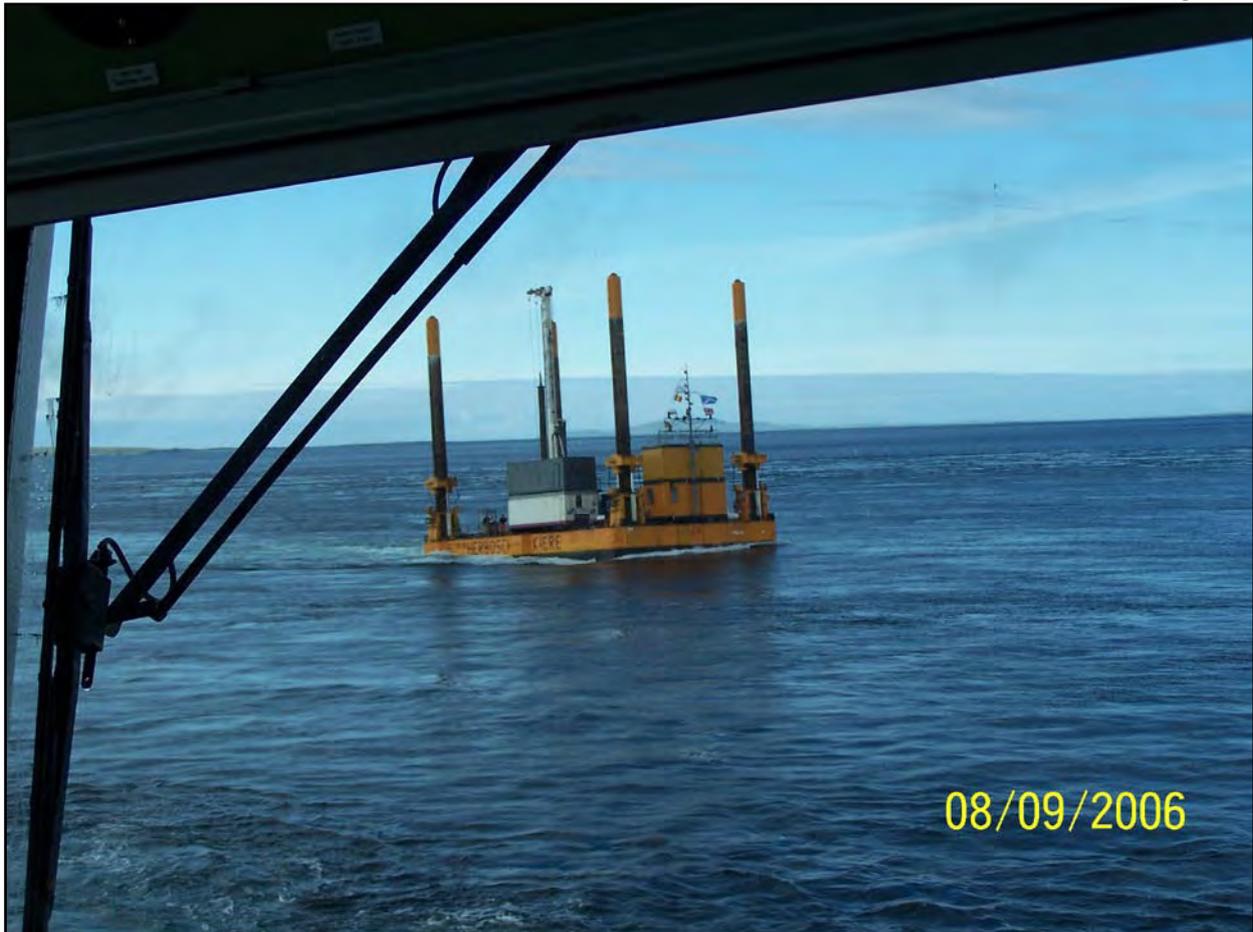
At 1755, half an hour after low water, *Octopus* grounded on her forward two legs, 3 cables south-south-west of Little Green Holm Island (**Figure 5**). The charted depth at the position of the grounding was assessed to be greater than 20m, the closest sounding indicating a depth of 26m. The force of the grounding caused some of the barge personnel to fall, however no one was injured and neither the tug nor the barge deck cargo was damaged.

*Octopus aground*

*Octopus* refloated 40 minutes after the grounding, and was returned to Hatston Pier in Kirkwall where all four legs were found to be damaged. The damage to the barge cost an estimated £1m to repair. The delay in returning *Octopus* to Seal Skerry Bay also resulted in extensive delays to the project when the seabed frame, constructed during the initial installation stage, collapsed in the strong tides.

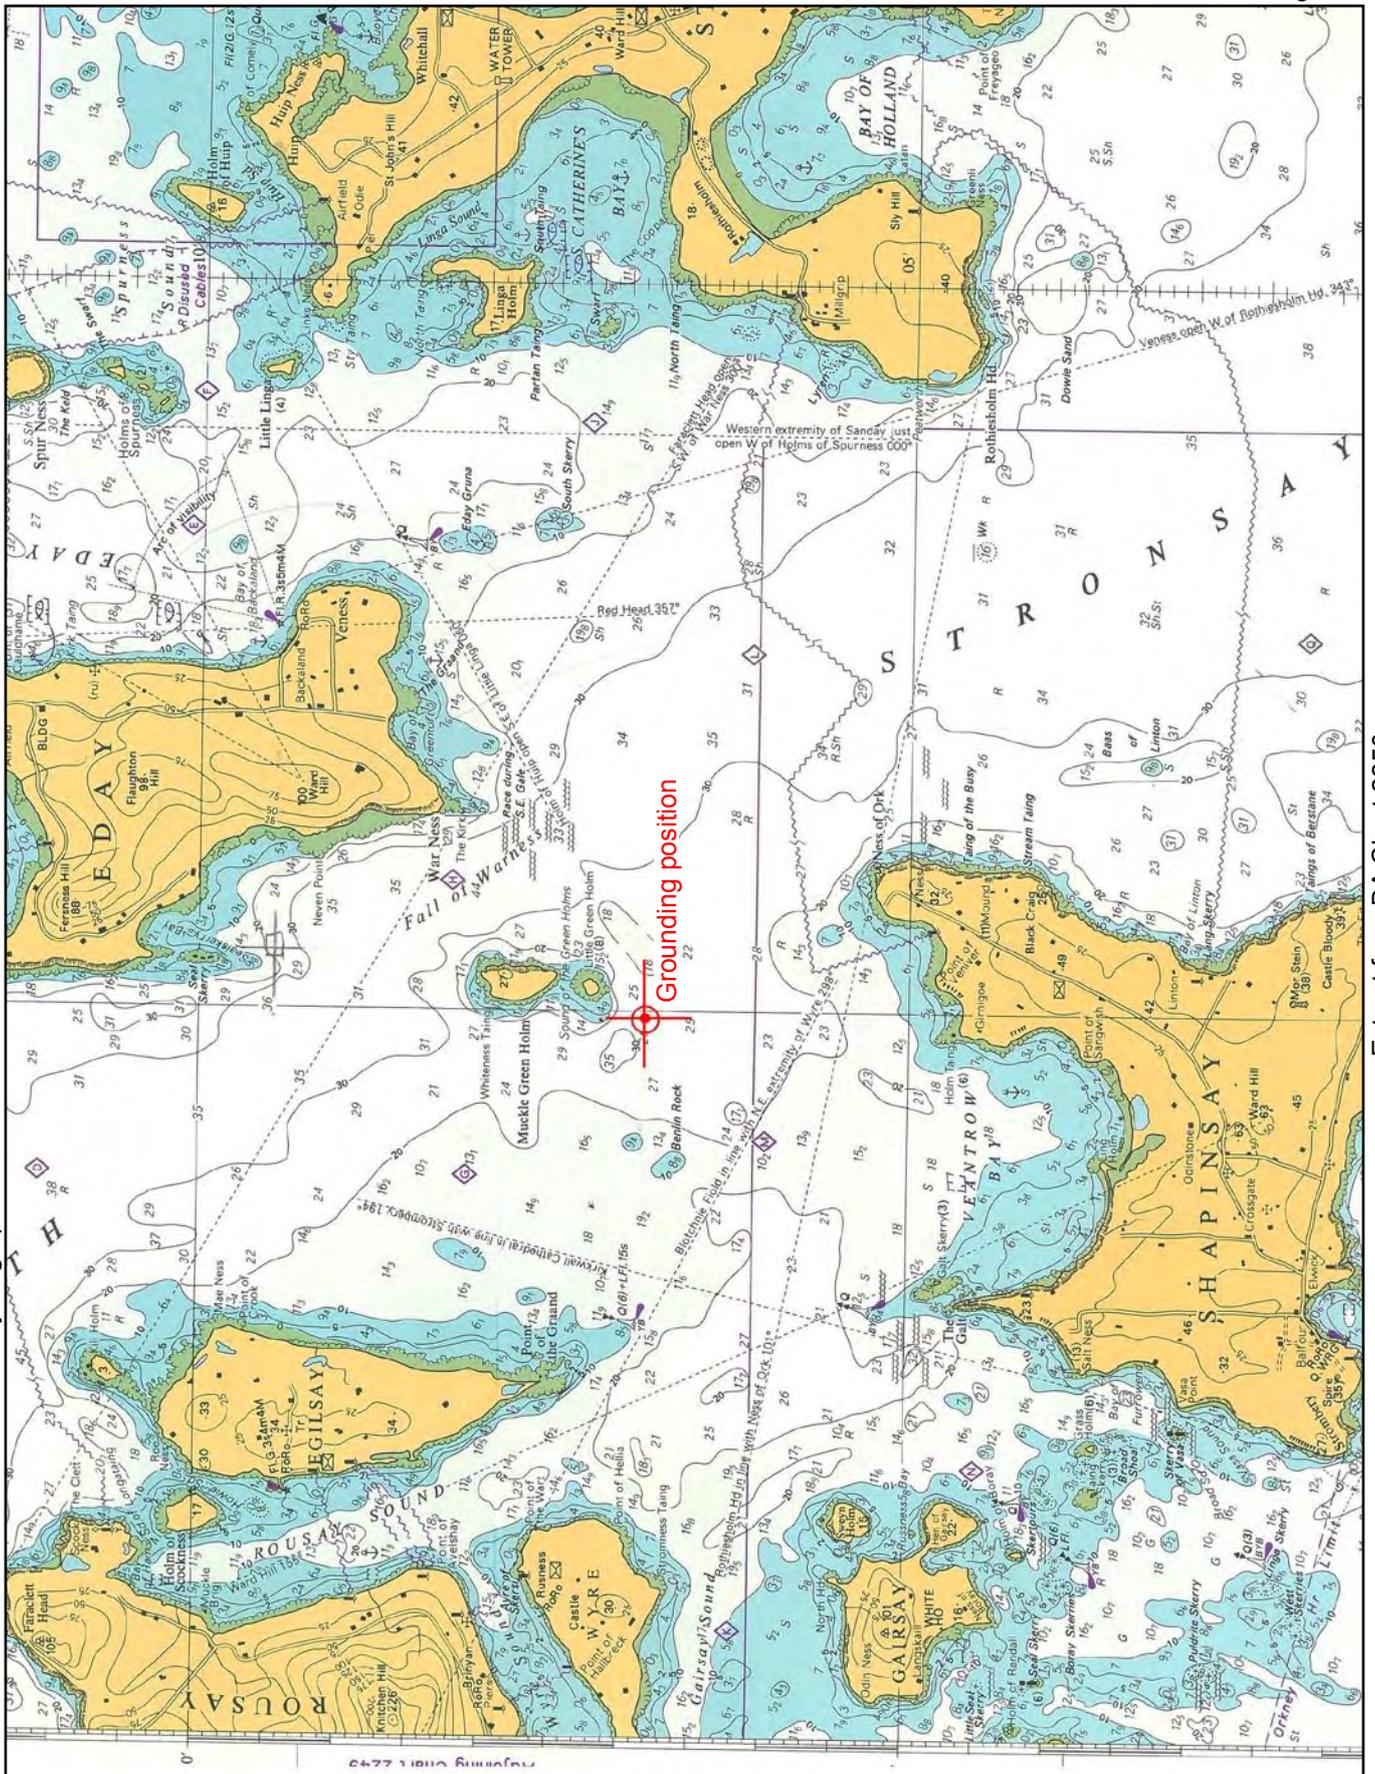
Figure 6

The MCA, UKHO and the Shetland Coastguard were advised of the survey's findings, and the area of the grounding was subsequently re-surveyed by the MCA's Emergency Towing Vessel (ETV) *Anglian Sovereign*. The more accurate survey data obtained during this survey was used to generate the chart correction data issued in Admiralty Notices to Mariners (NTM) Week 41, published on the UKHO Web site on 5 October 2006 and in paper format on 12 October 2006. The revised charted depth in the location of the grounding was shown in the NTM as 7.1m (**Figure 6**).

Extract from BA Chart 2250

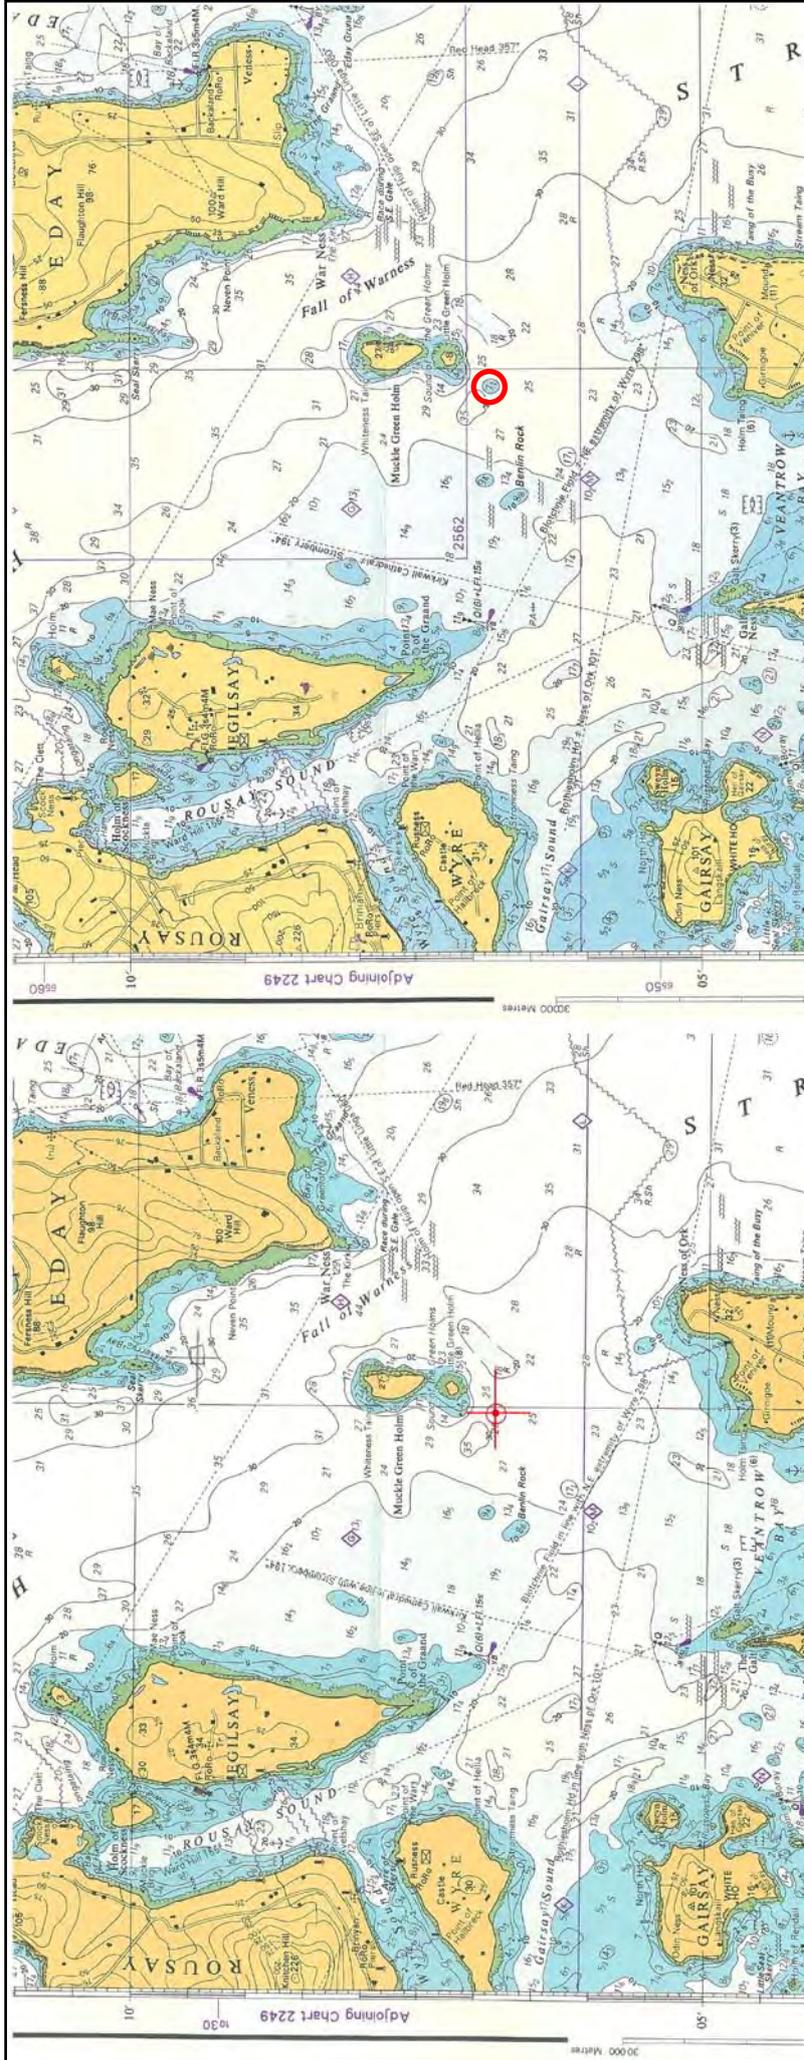
The UKHO British Admiralty (BA) Chart 2250, Edition Number 3 dated 28 July 2005, Orkney Islands, Eastern Sheet, is the largest scale chart of the area of the grounding with a scale of 1:75000. The detail of the area where the grounding occurred is shown before and after the discovery of the shoal in **Figure 7**.

Admiralty Chart 2250 before and after the grounding

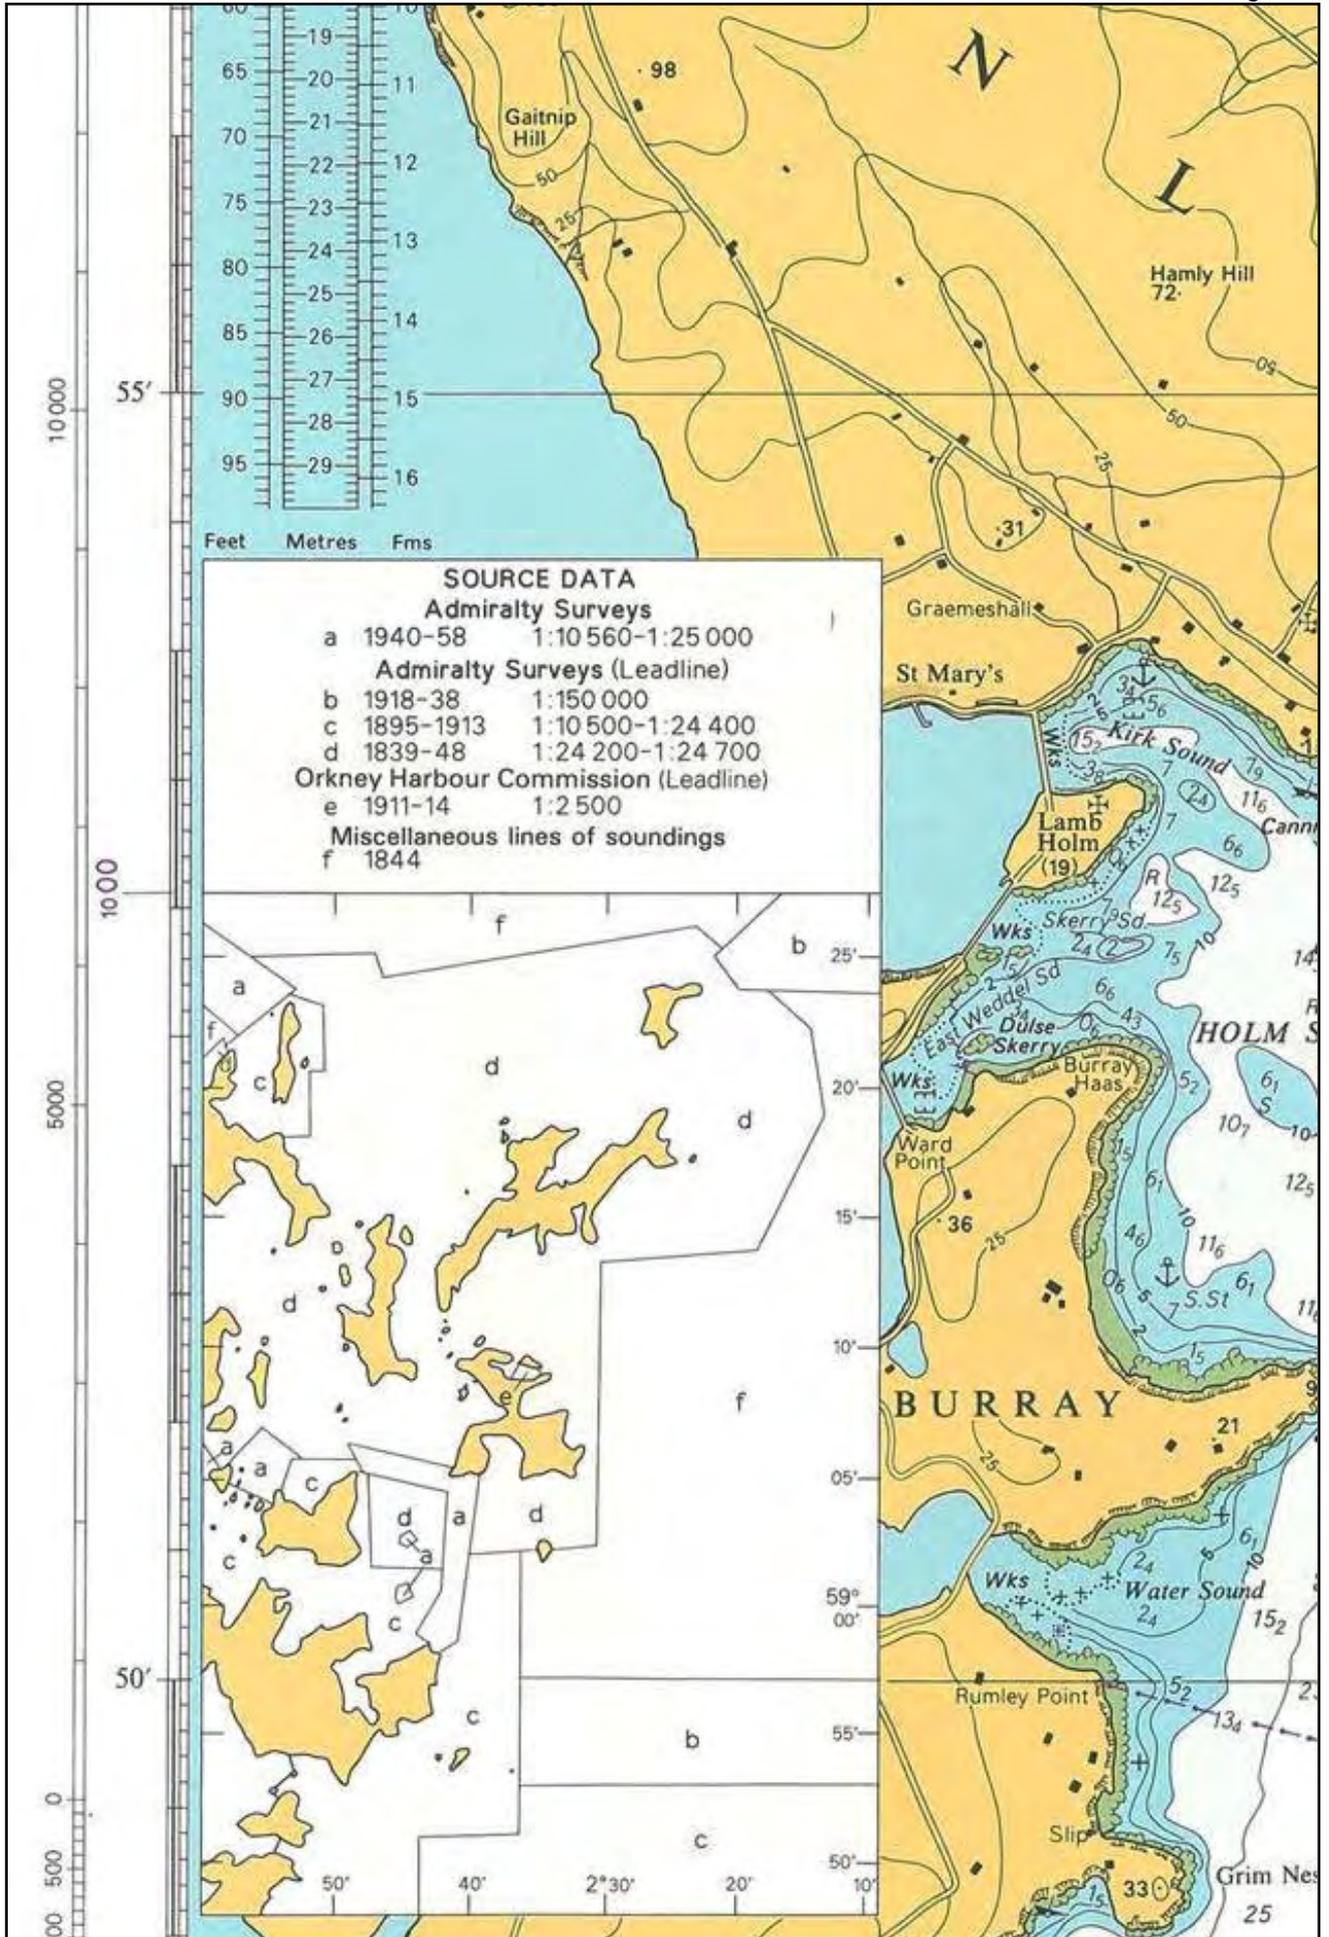
The source diagram for BA Chart 2250 (**Figure 8**) shows the area to have been surveyed during *British Government Survey (leadline) 1839-1848*. Lieutenant Commander George Thomas, master commanding, was on board HMS *Mastiff* when the survey of the grounding area was carried out in 1843 and 1844. The original survey record fair sheet (**Figure 9**) showed that the survey results were correctly transferred to the chart, and that the 7.1m bank was missed due to the sampling nature of the leadline survey undertaken.

BA Chart 2250 Source data

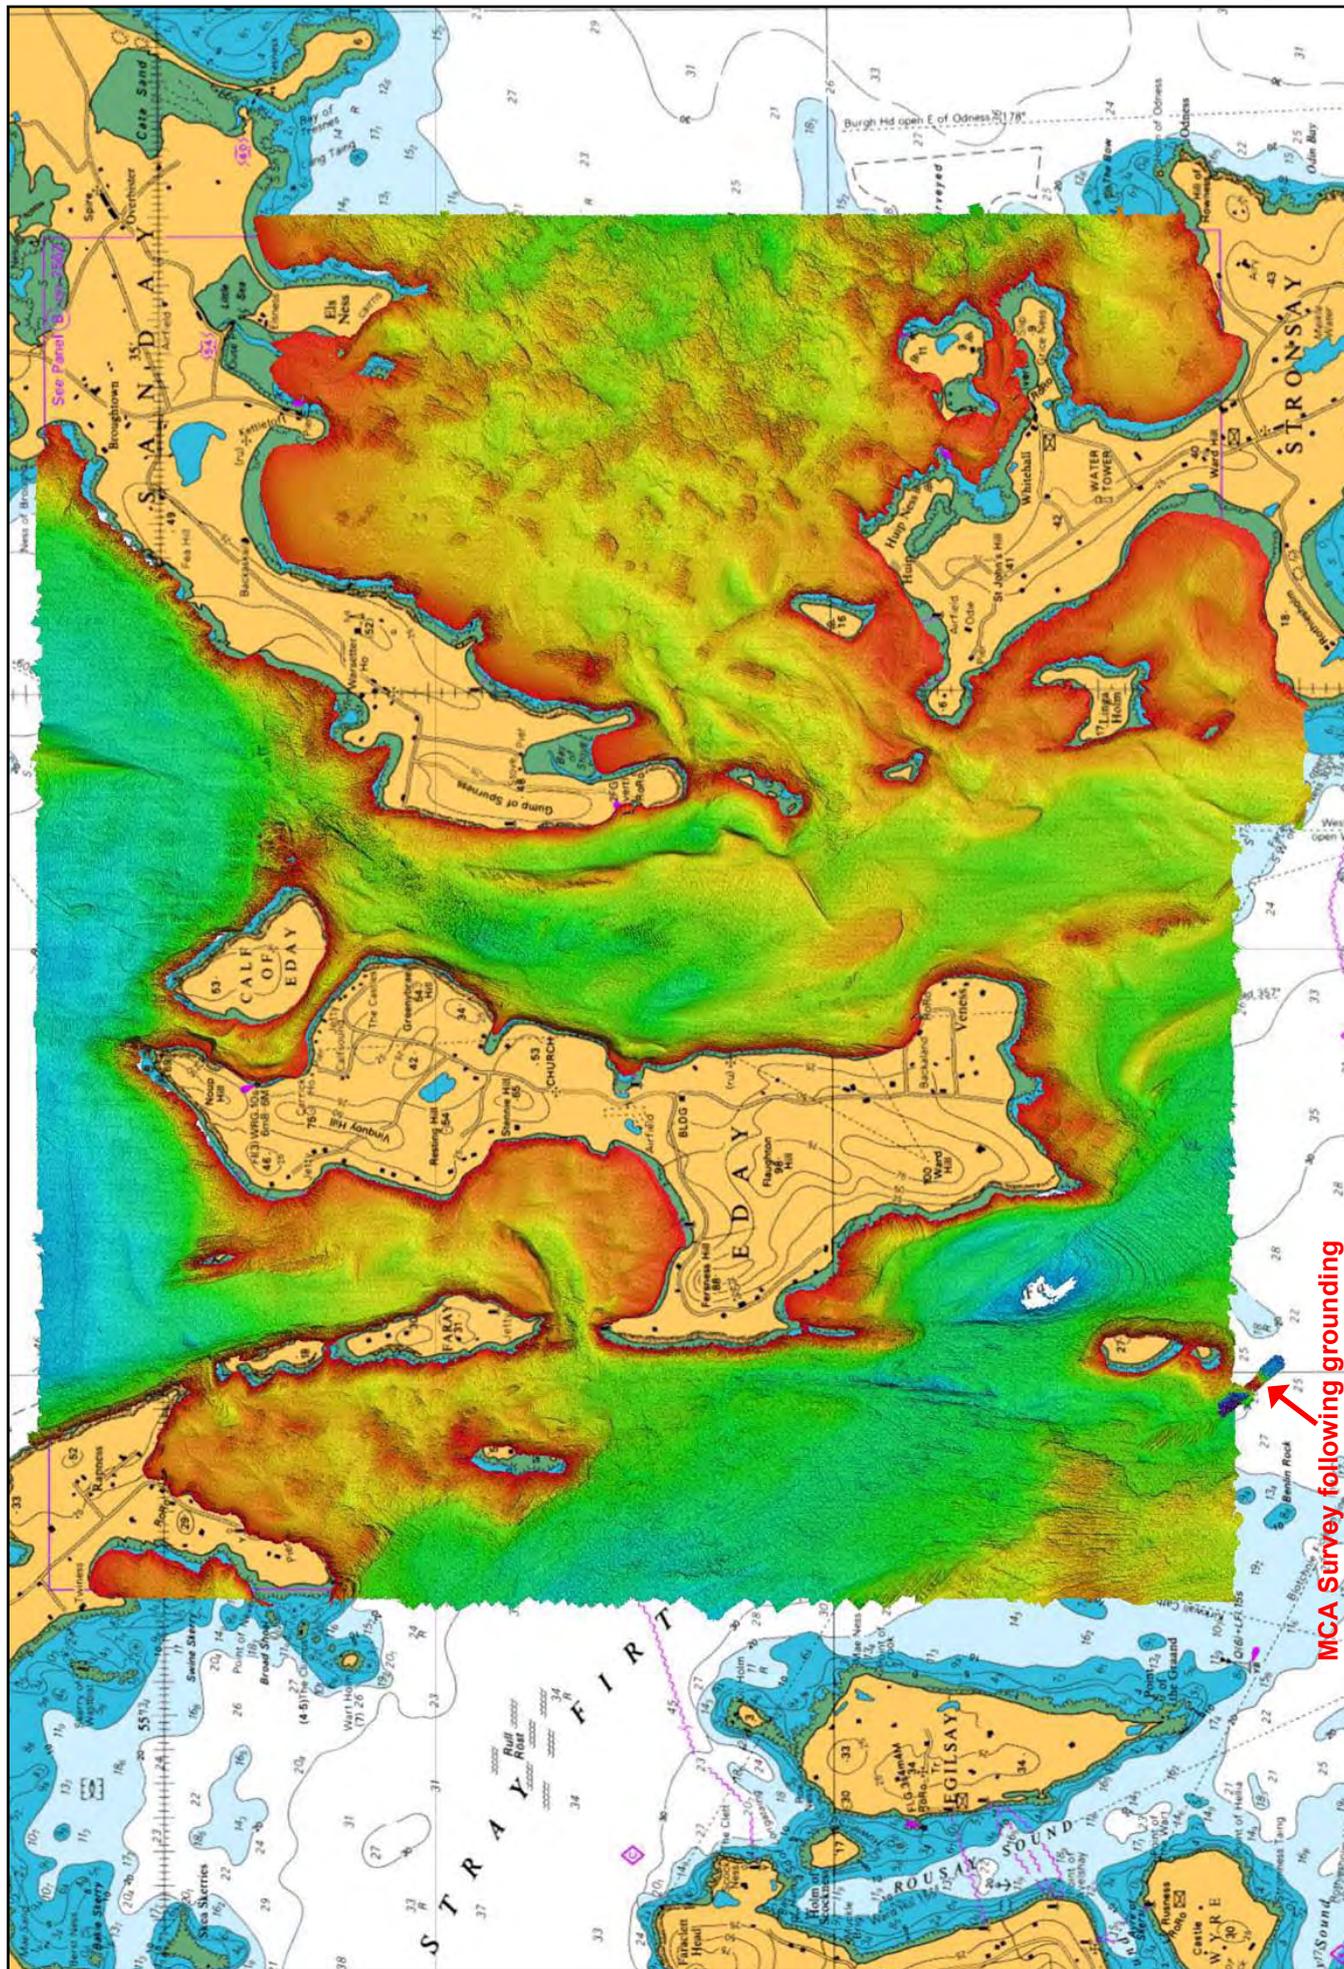
Figure 10

2006 MCA survey results - with additional MCA survey following the grounding

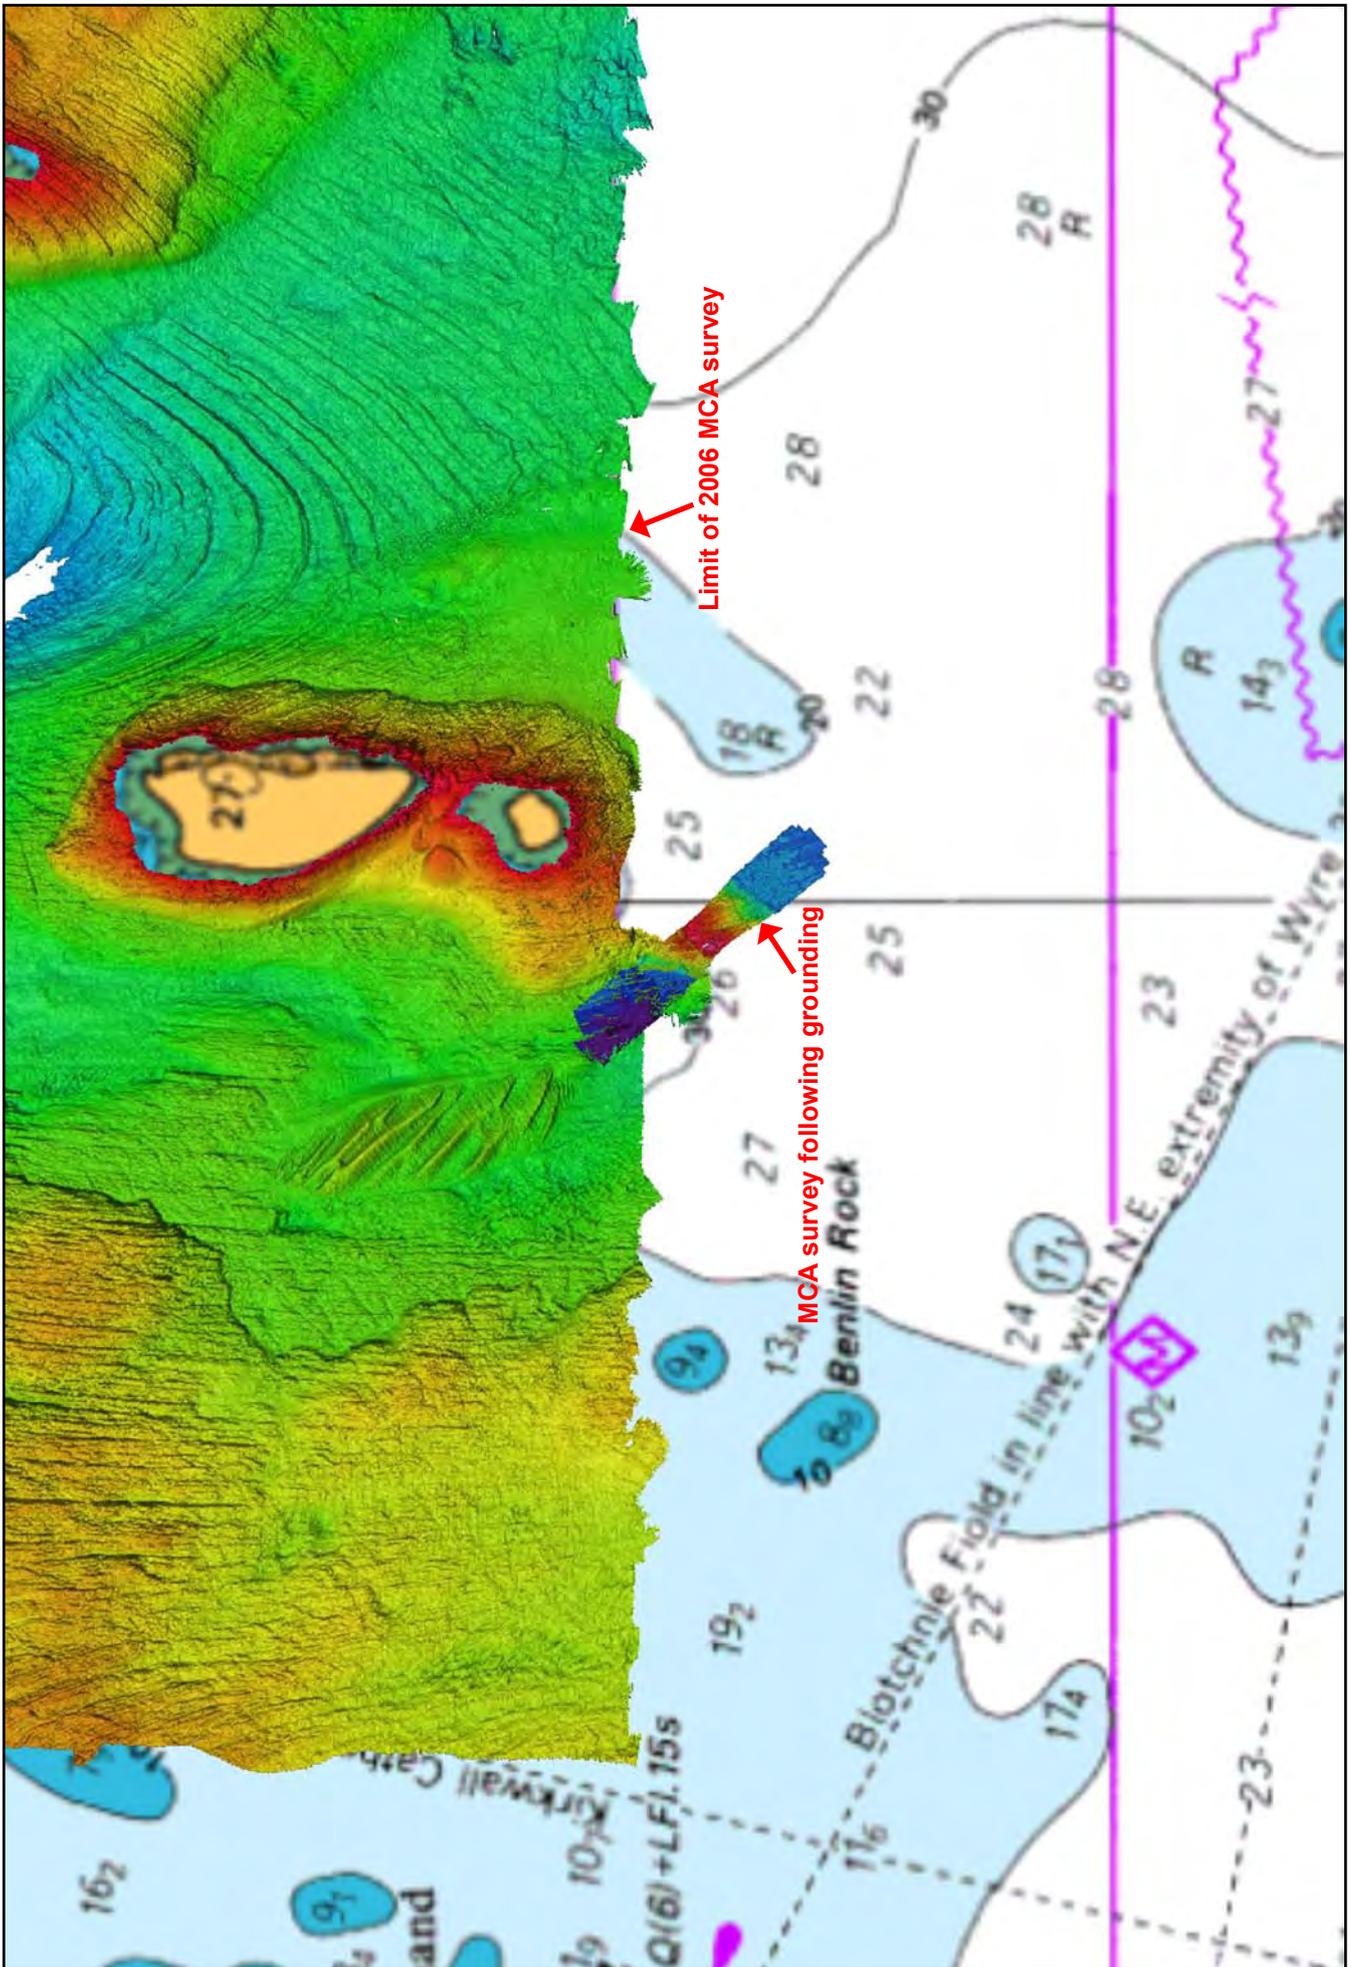
When the commercial survey vessel *Ping* surveyed the area north of the grounding position in early 2006, the survey resulted in 69 NTM warning of changes to charted depth, although none were of the exceptional nature of the shoal where *Octopus's* grounding occurred (**Figure 10**). The southern limit of the 2006 survey of the area around the Island of Eday was less than 200m north of the 7.1m shoal patch (**Figure 11**).

2006 MCA survey results - with additional MCA survey following the grounding
