Report on the investigation of
the major injuries sustained by a deckhand on board

fv *Danielle* BM478

on 6 June 2006

**Report No 5/2007
March 2007**

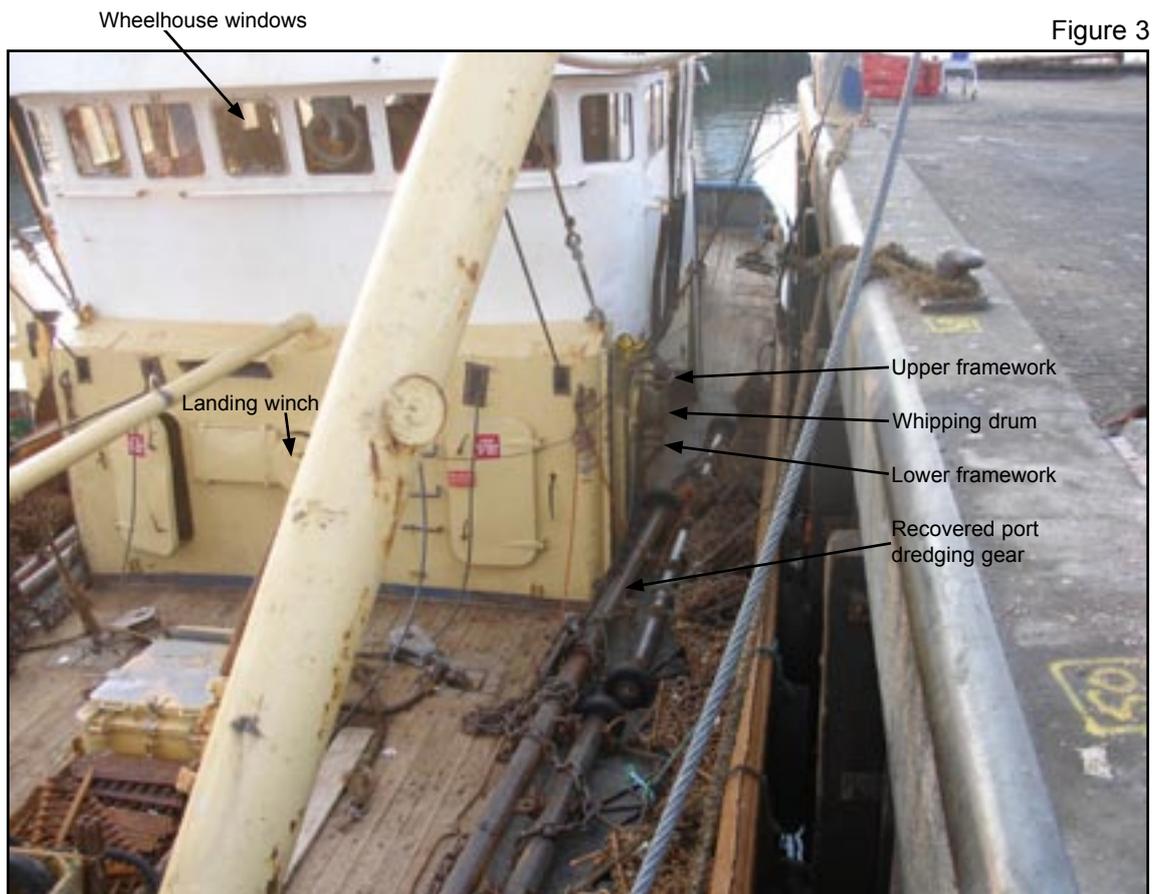
General port side main deck view, looking aft

The substantial poles and dredges need to rest in the side passageways, as shown in **Figure 3**, and represent significant slip and trip hazards, especially given that the poles are round and wet.

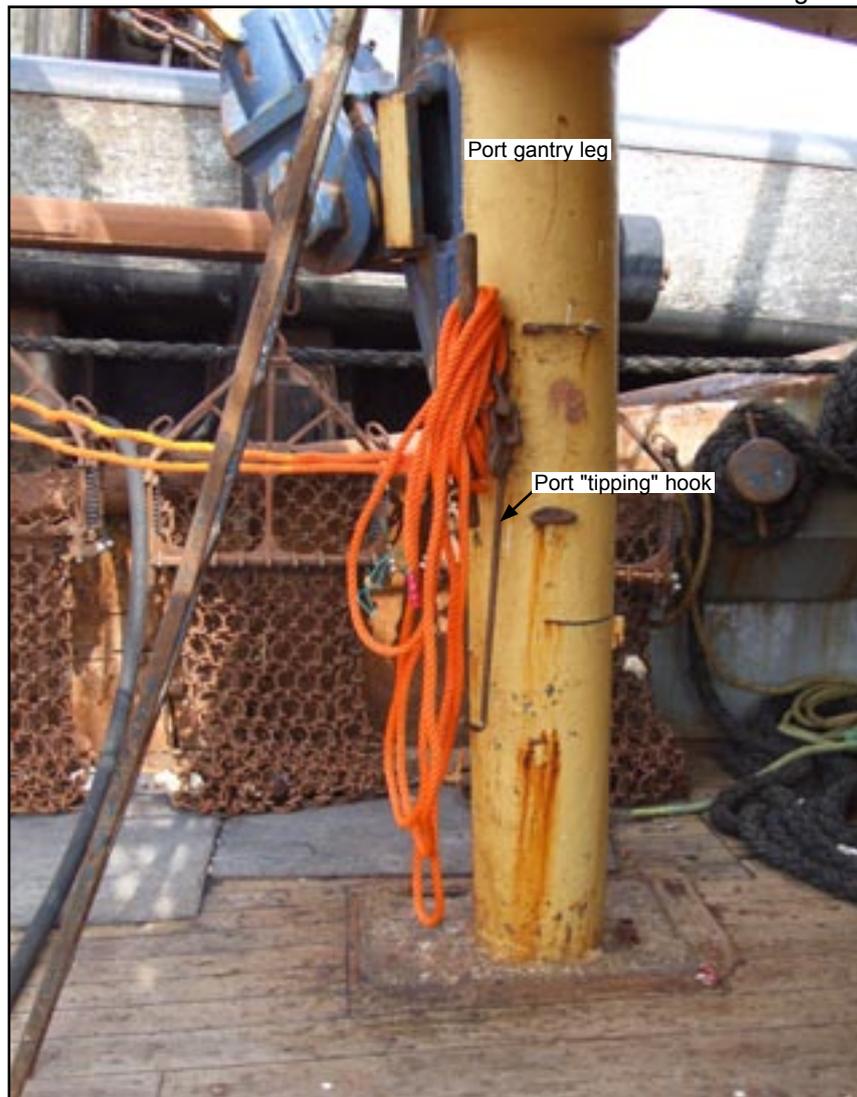
Figure 7

Port gantry leg and stowed port "tipping" hook

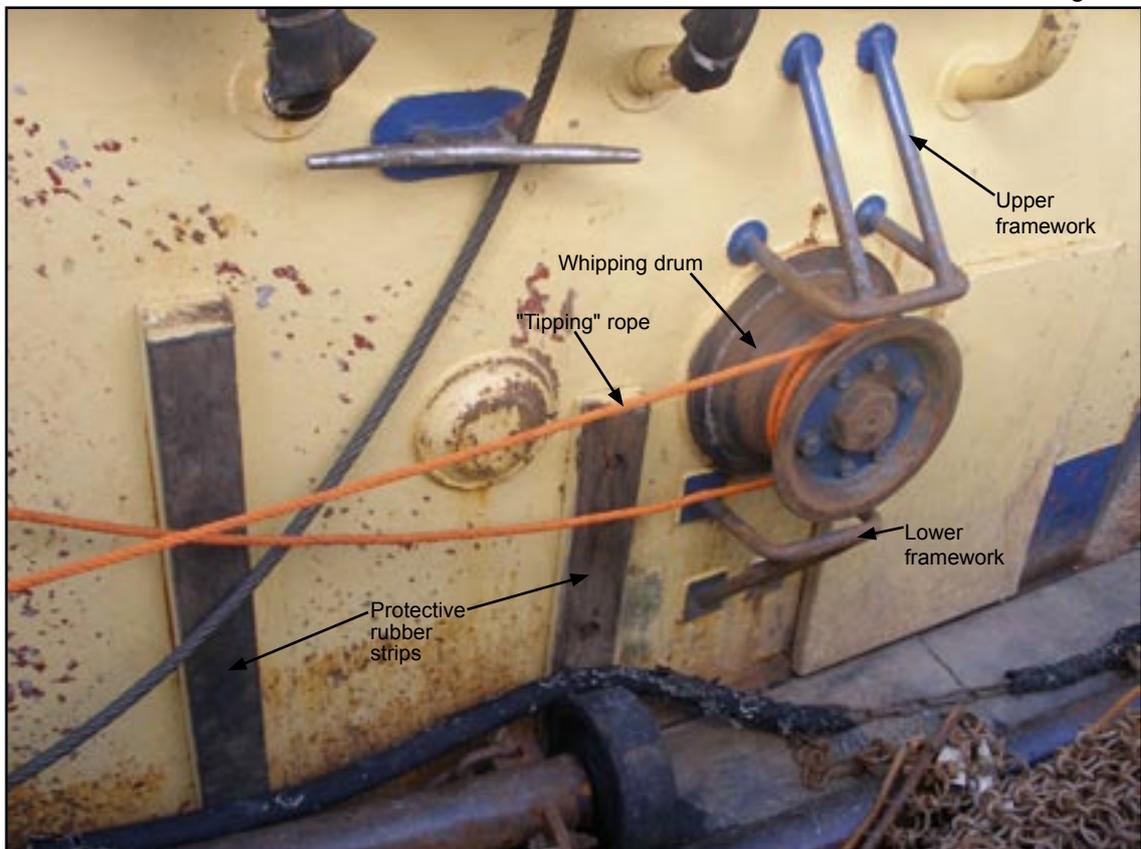
Figure 9

Port whipping drum, with turns of "tipping" rope

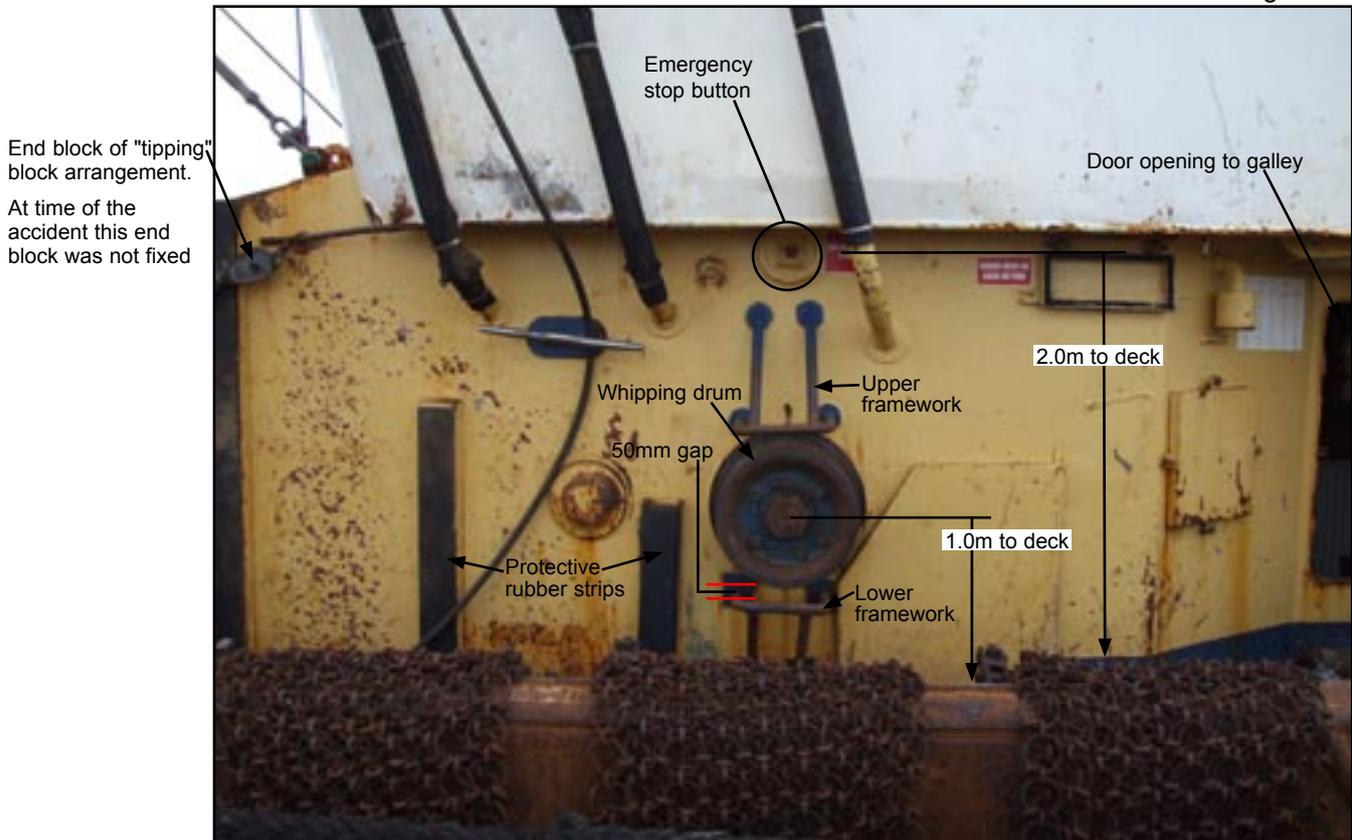
Port whipping drum and emergency stop button position

The framework, combined with the bars added to protect the wheelhouse sides from the gear, also meant that the original emergency stop button positions were no longer easily accessible, and were rendered inadequate.

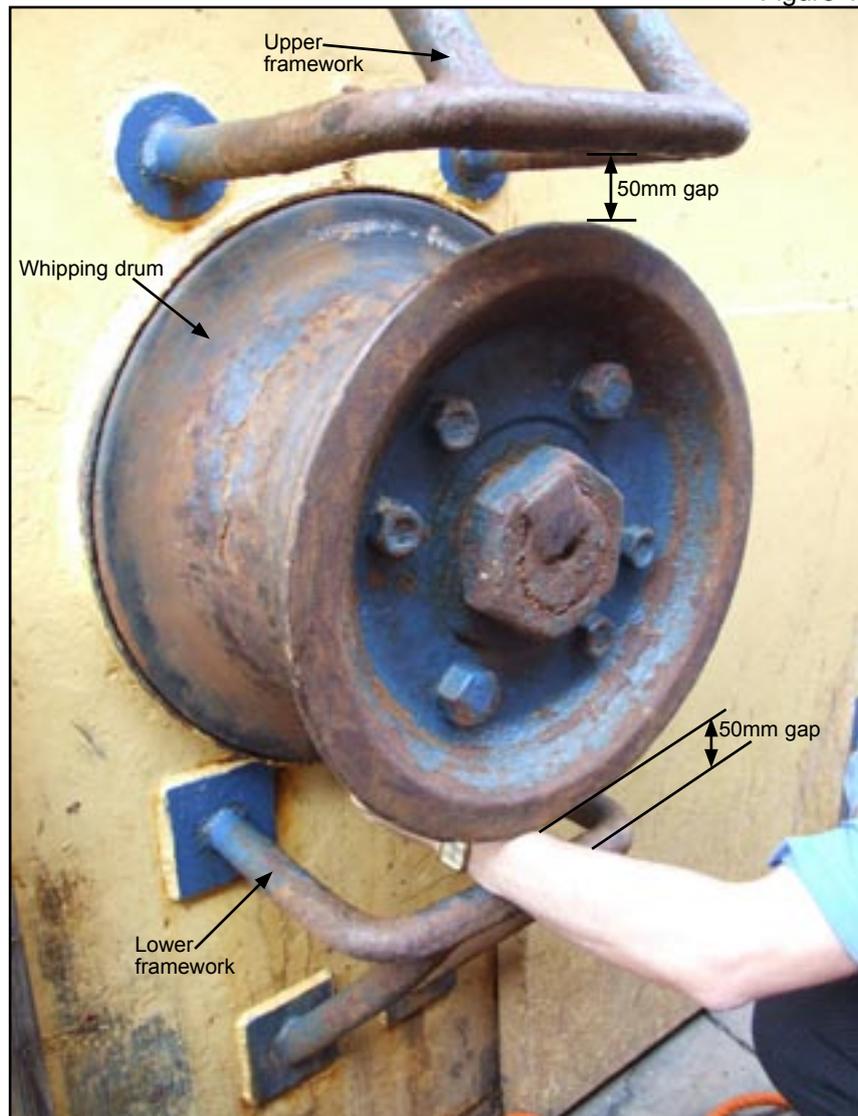
Port whipping drum with demonstration of an arm in the gap between winch head and lower framework

As his hand and arm were dragged into the gap between the lower framework and the anti-clockwise turning winch head, he did two backward somersaults, as he was dragged right round the winch. Following the second circuit, he landed heavily on his heels, and again could not reach the recessed stop button above the winch head. Having already sustained horrific injuries, he realised that if he went round a third time, he might not survive, and therefore managed to stand up and stretch to hit the stop button, following which the winch took about half a revolution to stop. He had remained conscious throughout, and ended up pulled in tight against the framework above the winch, with his ribs against the rim of the whipping drum, and his face against the bulkhead. He immediately started to shout and bang the bulkhead to try to raise the alarm.

More significantly, substantial guard frameworks were fitted above and below the whipping drums. Their purpose is not considered to have been to protect individuals from the winch, but to guard it from being struck or snagged during deployment and hauling of the dredging gear. The presence of these frameworks created additional hazards. In fact, the horrific injuries sustained by the deckhand were largely caused by this framework, as he twice was dragged around and over it, with his arm trapped in the narrow gap between the winch head and the framework.

Alternative configurations of guard framework exist on other vessels that would be less likely to pose a hazard to crew. The current arrangement on *Danielle* needs to be reviewed.

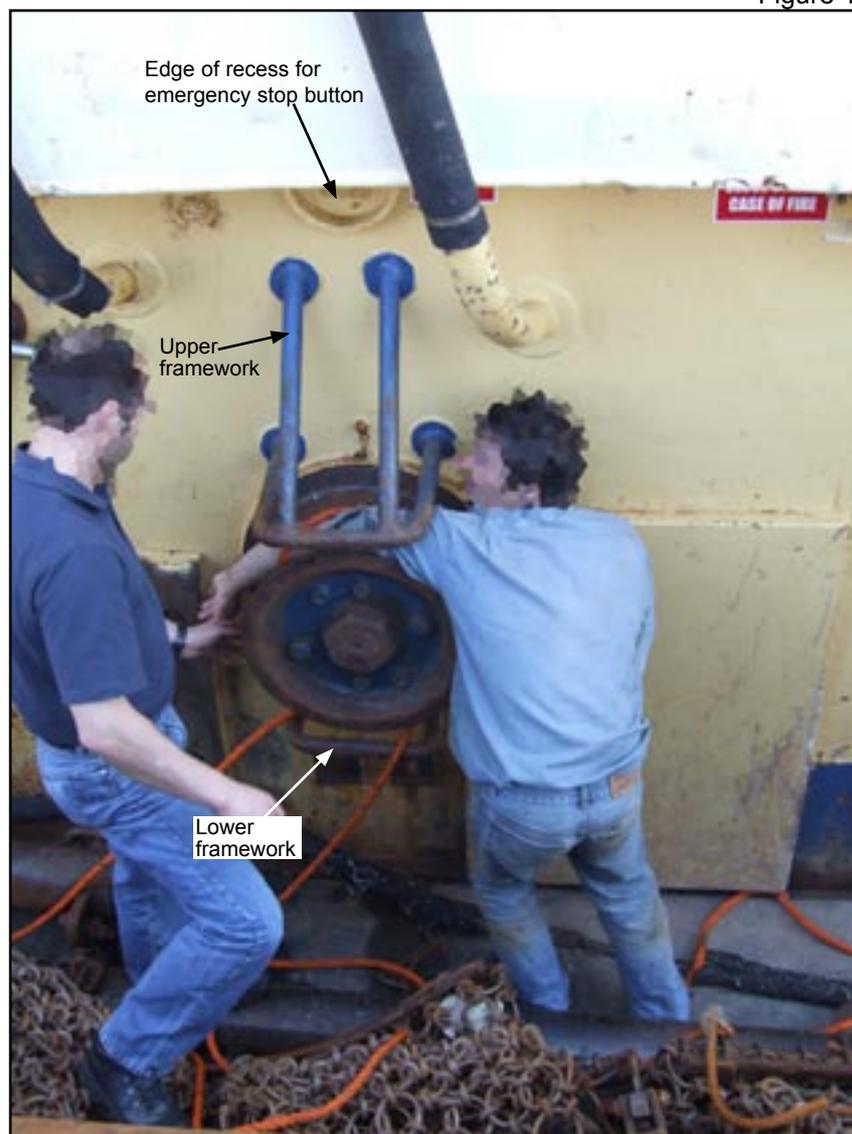
Figure 12

Demonstration of “as-found” position of deckhand, trapped in whipping drum

By the time the skipper had arrived at the whipping drum, the Latvian had already removed the turn of rope over the deckhand’s upper arm. Both estimated that there were about 6 or 7 turns round the winch and the deckhand when they found him. The skipper then supported the deckhand, and began to unravel the turns of rope running over his hand on the winch head. In the process of doing this, the deckhand was able to pull away slightly from the winch and release his hand from the left glove, which remained trapped in the rope. This revealed that the flesh had been stripped off his left little finger and ring finger.

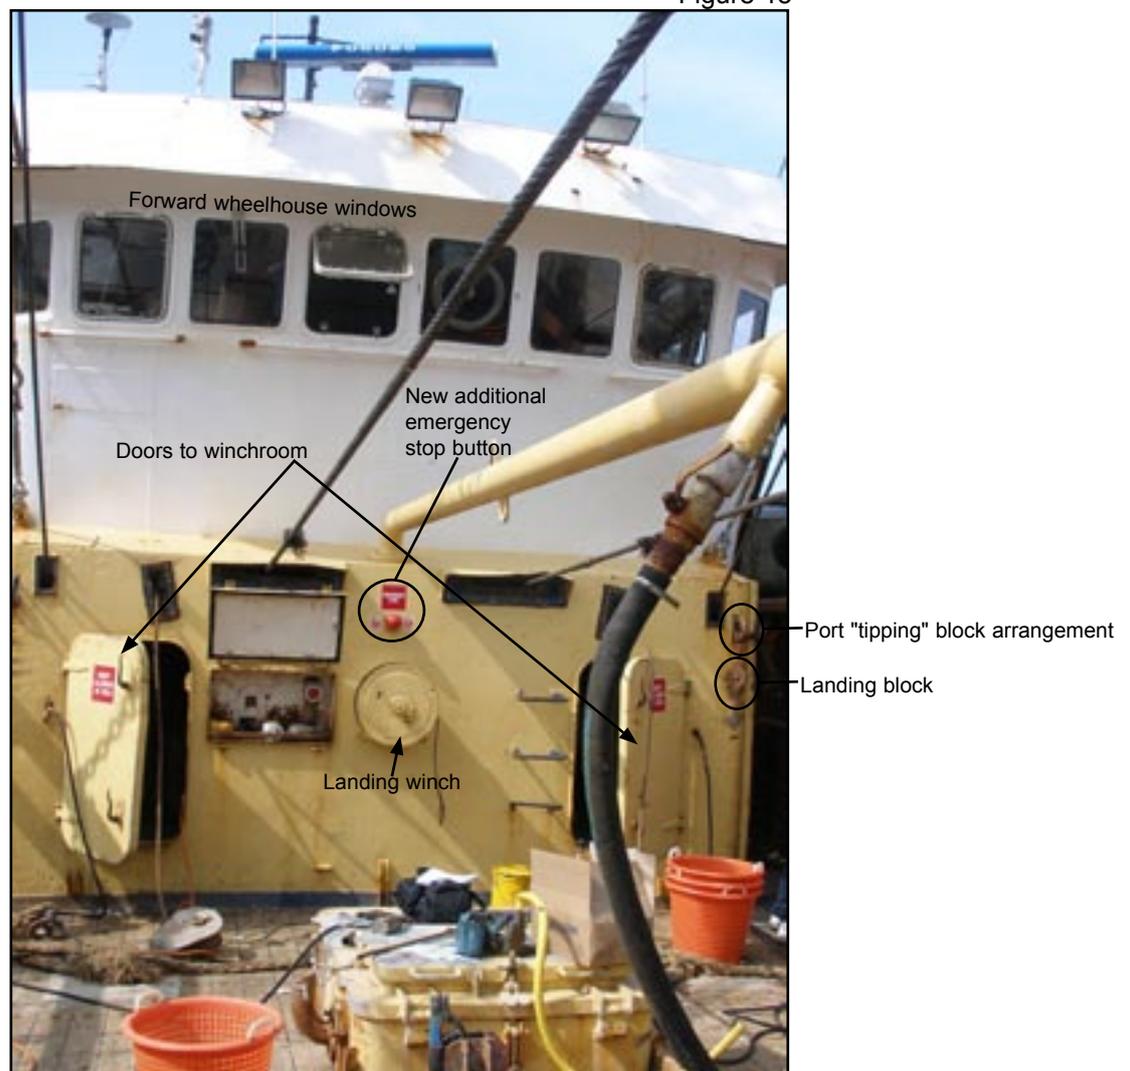
Figure 15

Forward end of wheelhouse showing new emergency stop button

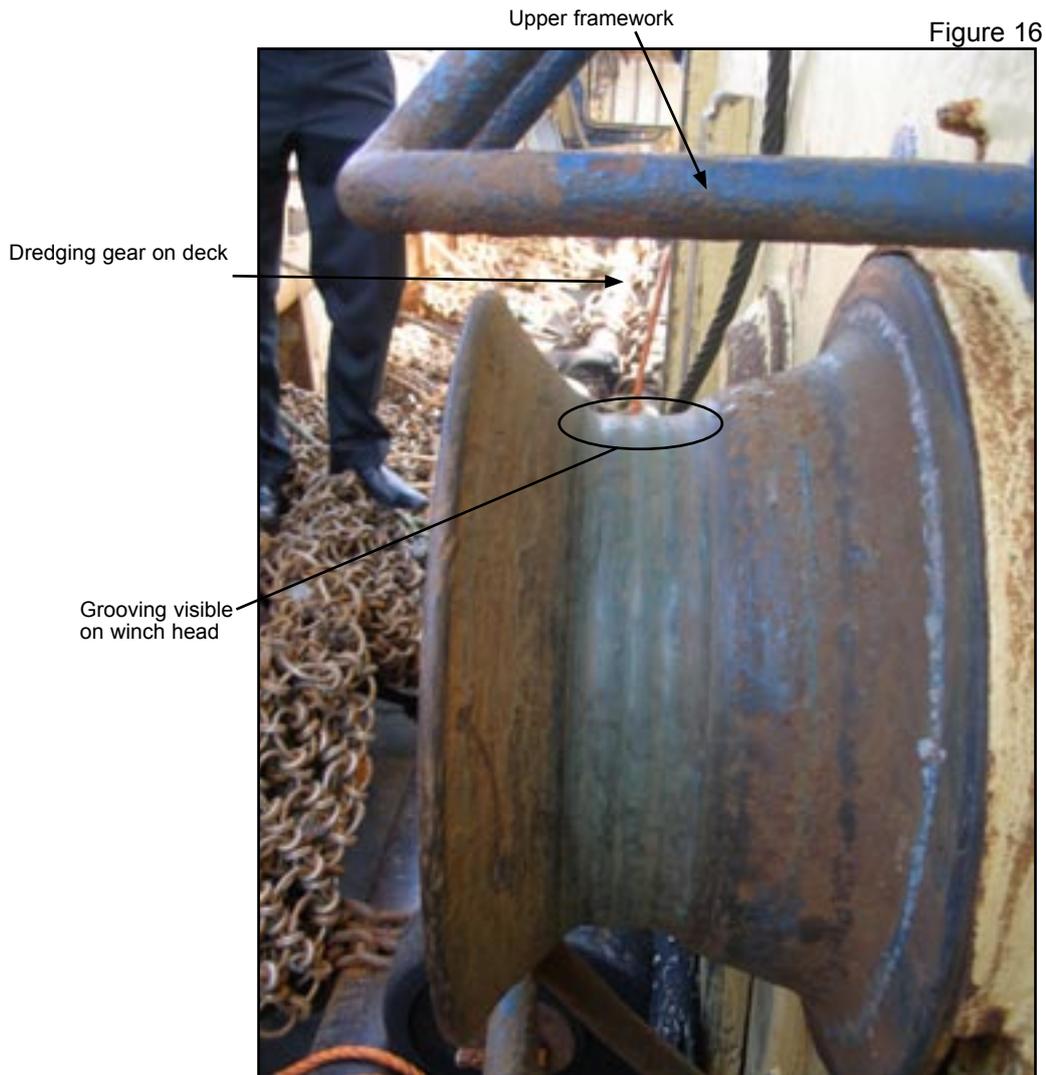
The owner reported that the whipping drums eventually become worn with use, and are then removed and machined smooth. **Figure 16**, taken two days after the accident, illustrates some grooving of the winch head, which the owner did not consider to be excessive.

Close-up view of grooving on port whipping drum

Figure 16 indicates that the condition of the port side whipping drum was in question, with visible grooving. Again, it is not known whether this contributed to the particular riding turn, but such grooving will affect the performance of a whipping drum, and should be regularly attended to.

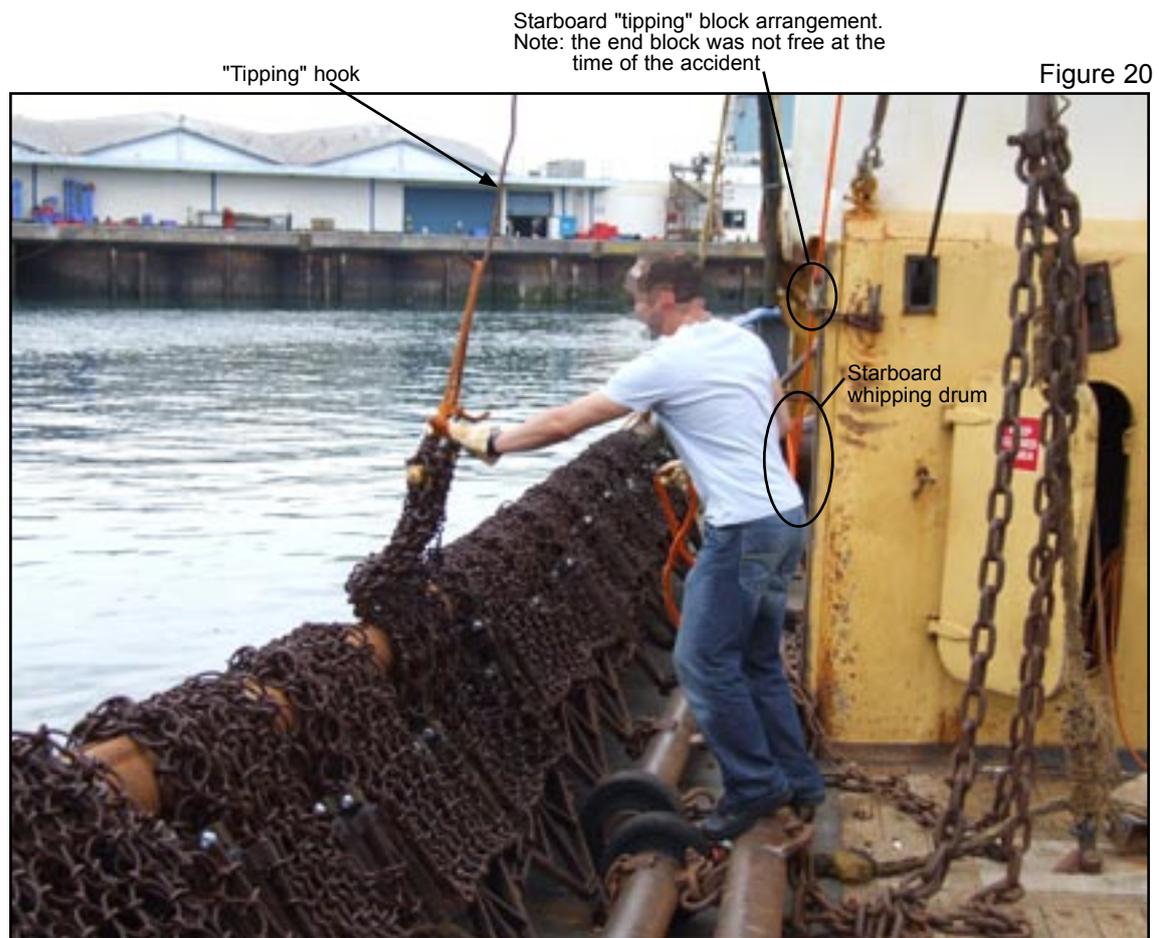
Figure 20 shows a view of the “tipping” demonstration provided by the crew on 26 July 2006 on the vessel’s starboard side.

“Tipping” demonstration on board *Danielle* on 26 July 2006

However, it is during the process of "tipping" the dredge contents onto deck that the risks and hazards of single-handed working intensify. This had already been identified by the operators, as it was customary for the skipper or mate to leave the wheelhouse unattended and assist the less experienced deckhand "tip" the dredges on his side. Unless the spare hand is on duty, this leaves the more experienced man to empty the other dredges alone, the scenario during this particular accident.
