Report on the investigation of  
the grounding of  
**fv *Brothers***  
with the loss of two lives  
off Eilean Trodday  
on  
1 June 2006

Marine Accident Investigation Branch  
Carlton House  
Carlton Place  
Southampton  
United Kingdom  
SO15 2DZ

**Report No 1/2007  
January 2007**

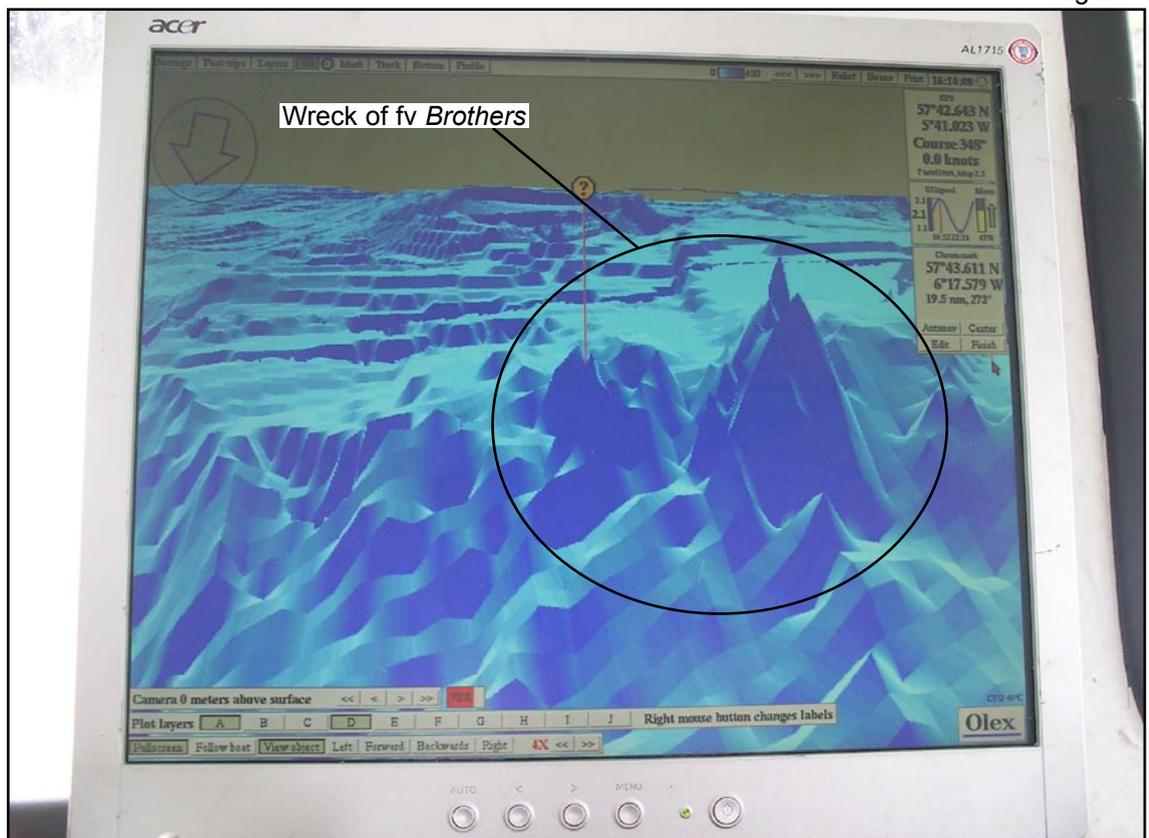
Figure 4

A little after midday, one of the fishing boats which was searching off the north-east coast of Eilean Trodday, reported that fuel could be seen coming up from the seabed and that an oil slick had formed on the surface. Upon closer investigation, they reported seeing an unusual trace on their fish finder and what appeared to be a mast under the water in the area where the oil was coming to the surface (**Figure 4**).

Fishfinder trace of sunken vessel

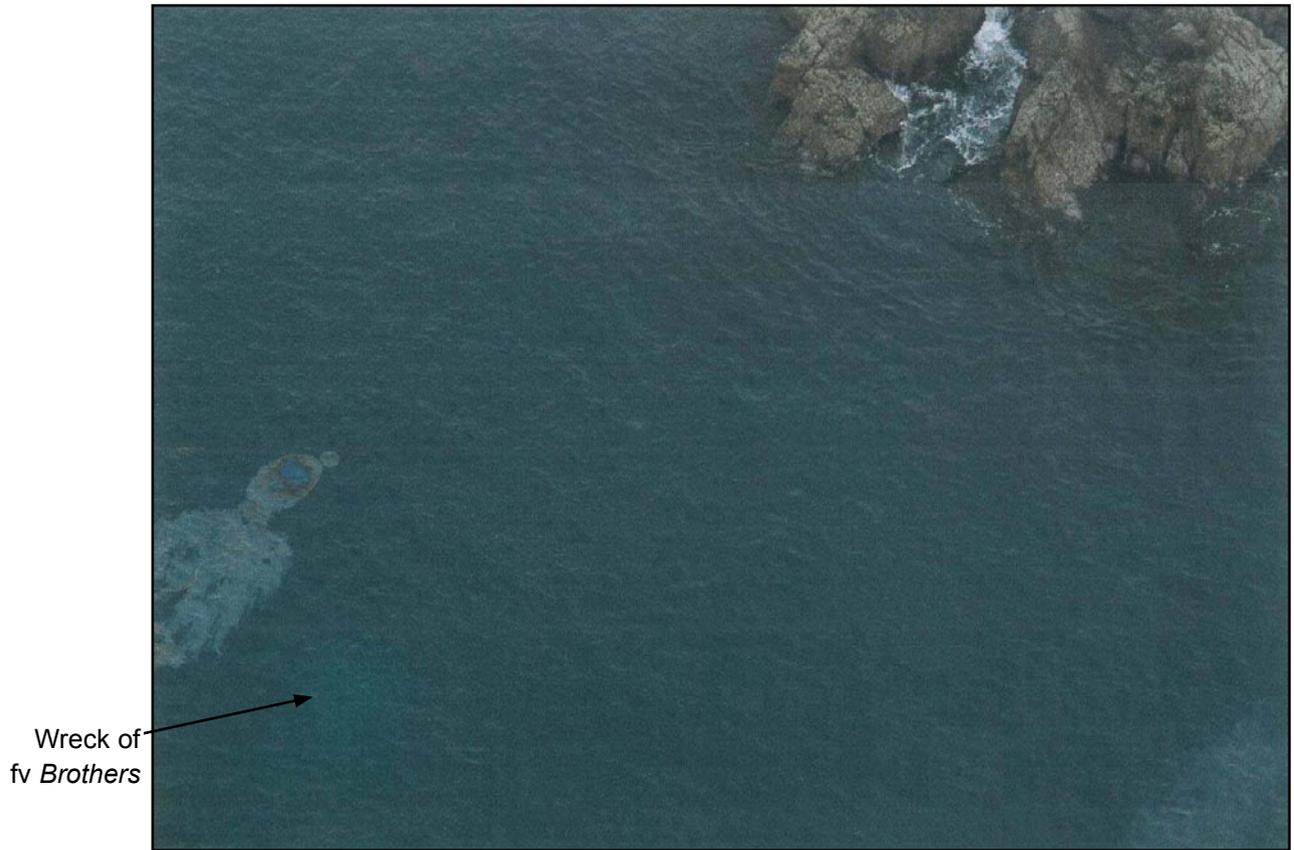
Figure 5

Wreck of  
fv *Brothers*

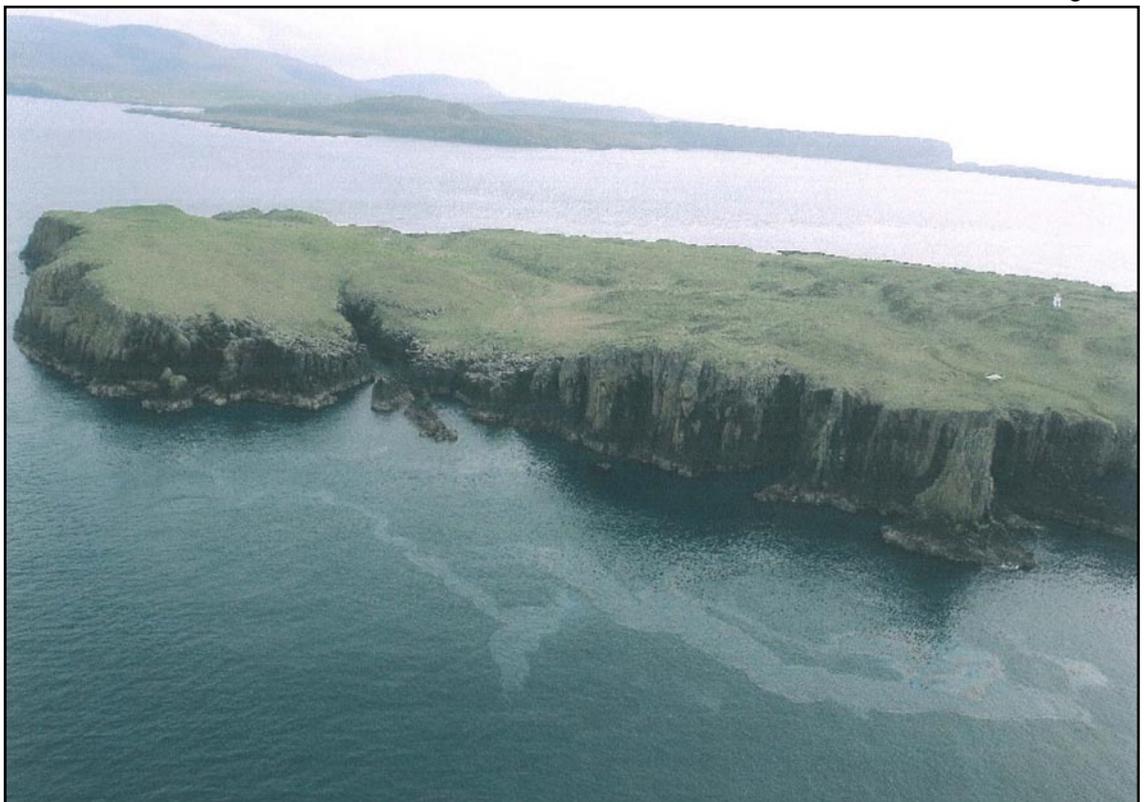
Figure 6

Oil on surface off Eilean Trodday

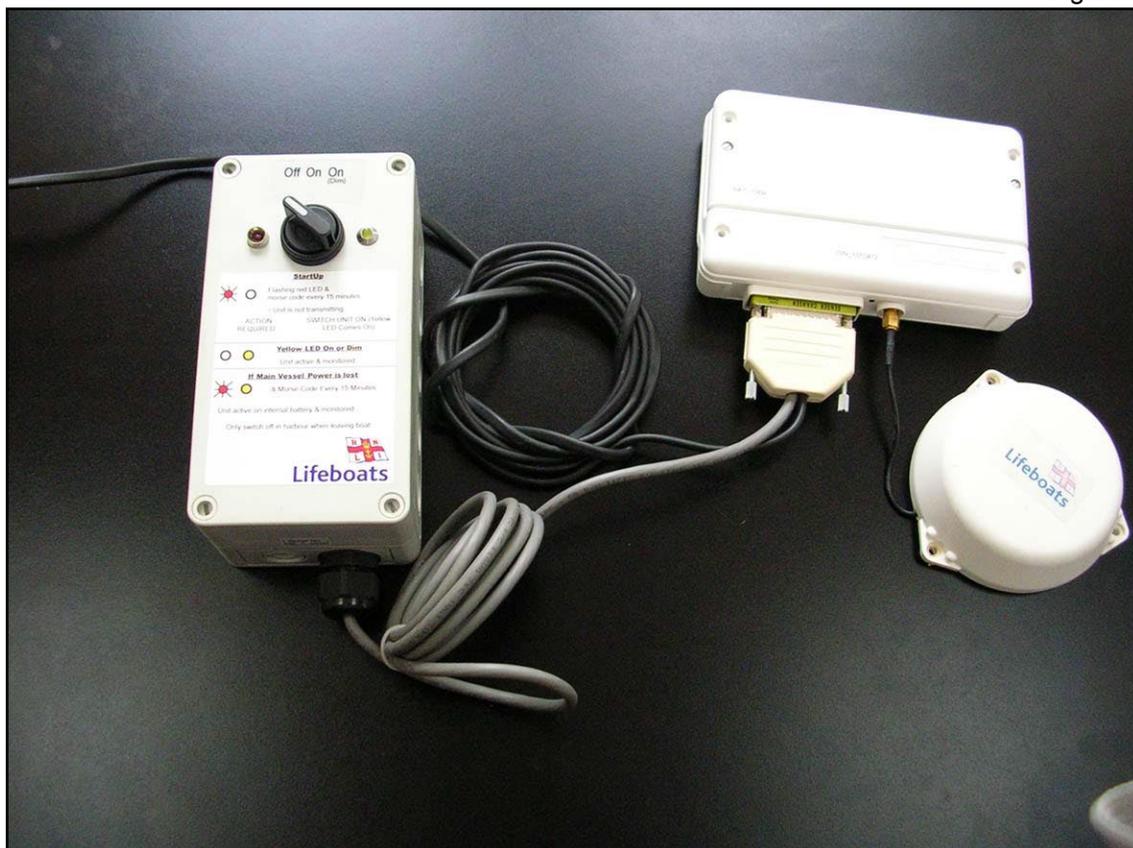
CPRS vessel equipment

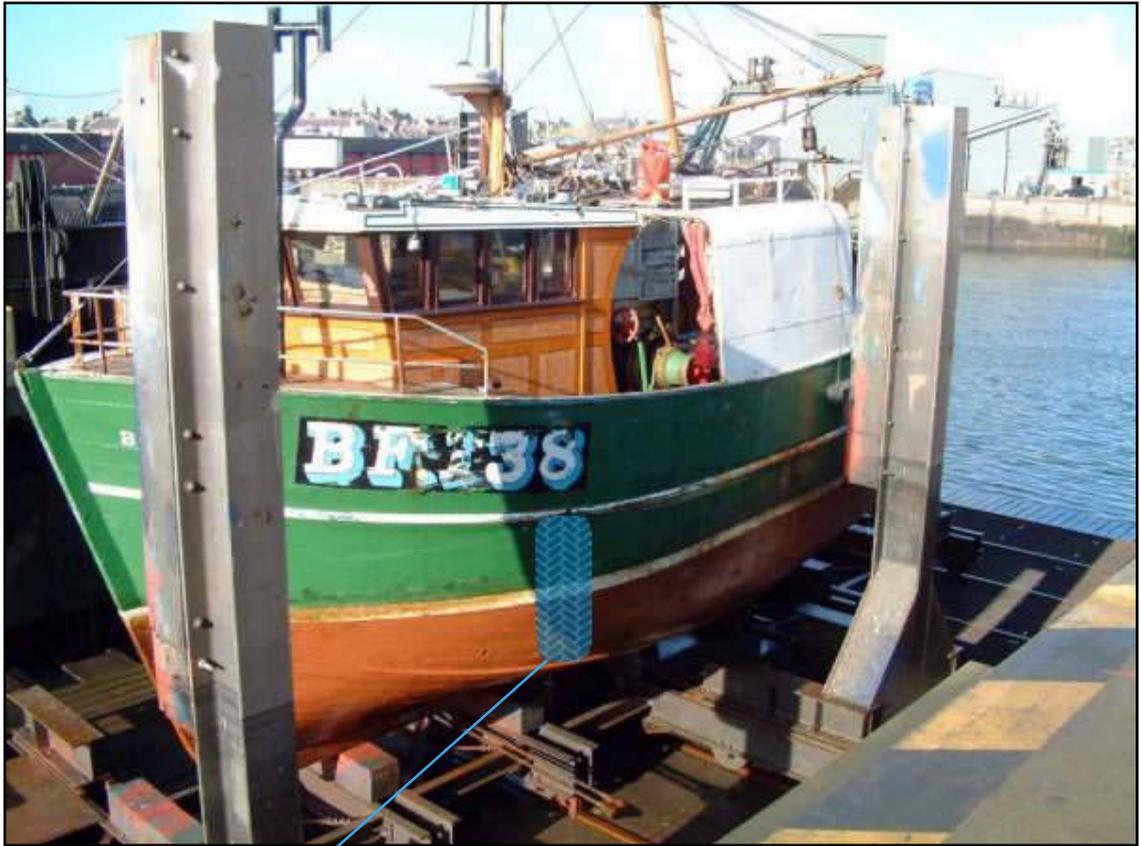
Figure 9

Area of damage to vessel

Although a number of possible scenarios that might have led to the foundering of *Brothers*, and the consequent loss of her two crew, have been considered, the evidence strongly indicates that the vessel ran aground at speed on Eilean Trodday, causing catastrophic damage to her port bow. It appears that one of the crew members was able to put the engines astern and pull the vessel clear of the rocks before she rapidly sank at about 0520 and in the position in which she was later discovered 40 metres from the shore. The fact that the escape hatch from the cabin was found open by the police divers might indicate that at least one crew member was asleep in the cabin at the time, and that he escaped from the sinking vessel by that means. However, the escape hatch could also have been blown open by the water rushing into the space when the vessel foundered.

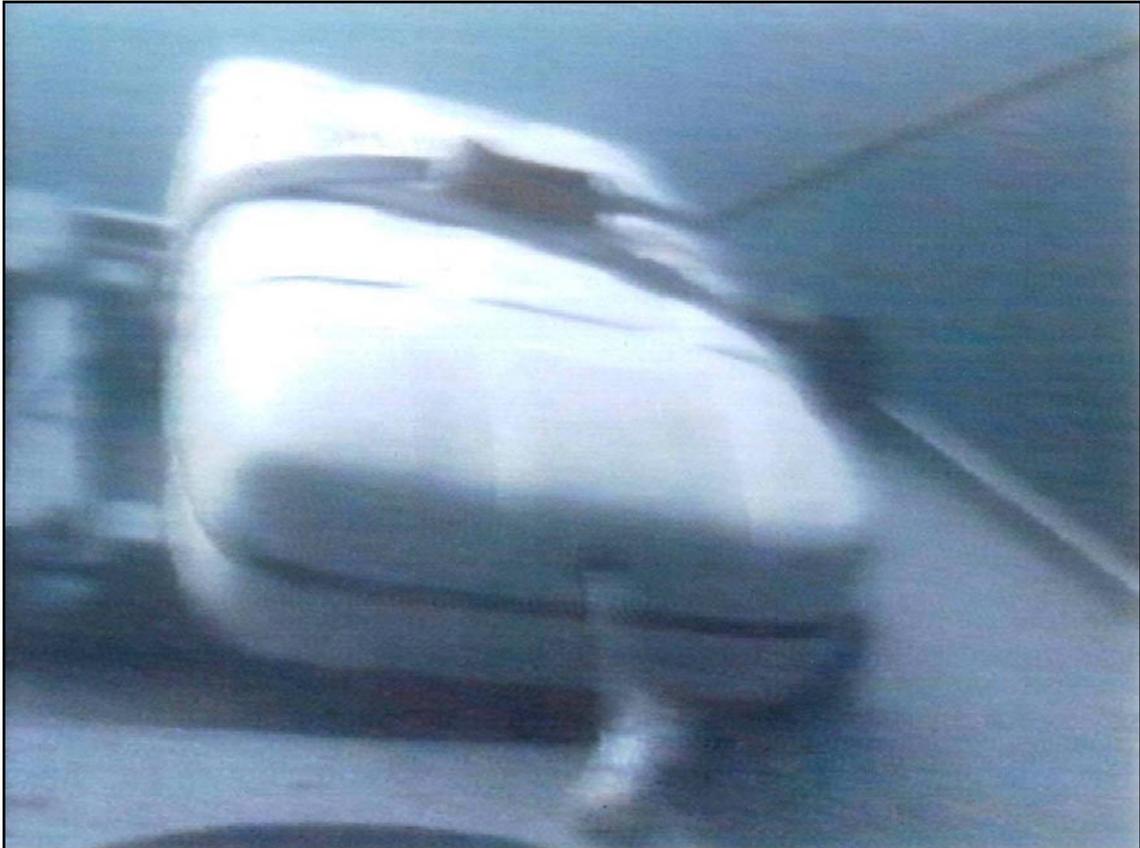
Figure 11

*Brothers* had a fully serviced 4-man Lifeguard Oceanic liferaft on board, even though there was no requirement to carry one. The raft was lashed by rope to a purpose-built cradle on top of the wheelhouse, and the painter was left unsecured (**Figures 11 and 12**). If the vessel's liferaft had been fitted with a hydrostatic release unit, it would have been released from its cradle, allowing it to float to the surface soon after the vessel foundered. A liferaft would have provided protection for the two fishermen for several hours, or longer, as well as making a potential search more likely to succeed. The RNLI fishing safety team developed a Hydrostatic Release Unit (HRU) Installation Guide during 2004, which has been widely distributed to the fishing industry (**Annex 3**).

Liferaft lashed to cradle on wheelhouse top

6. If the vessel's liferaft had been fitted with a hydrostatic release, allowing it to float free when the vessel sank, it would have been of great benefit to the two fishermen in the water. [2.3]

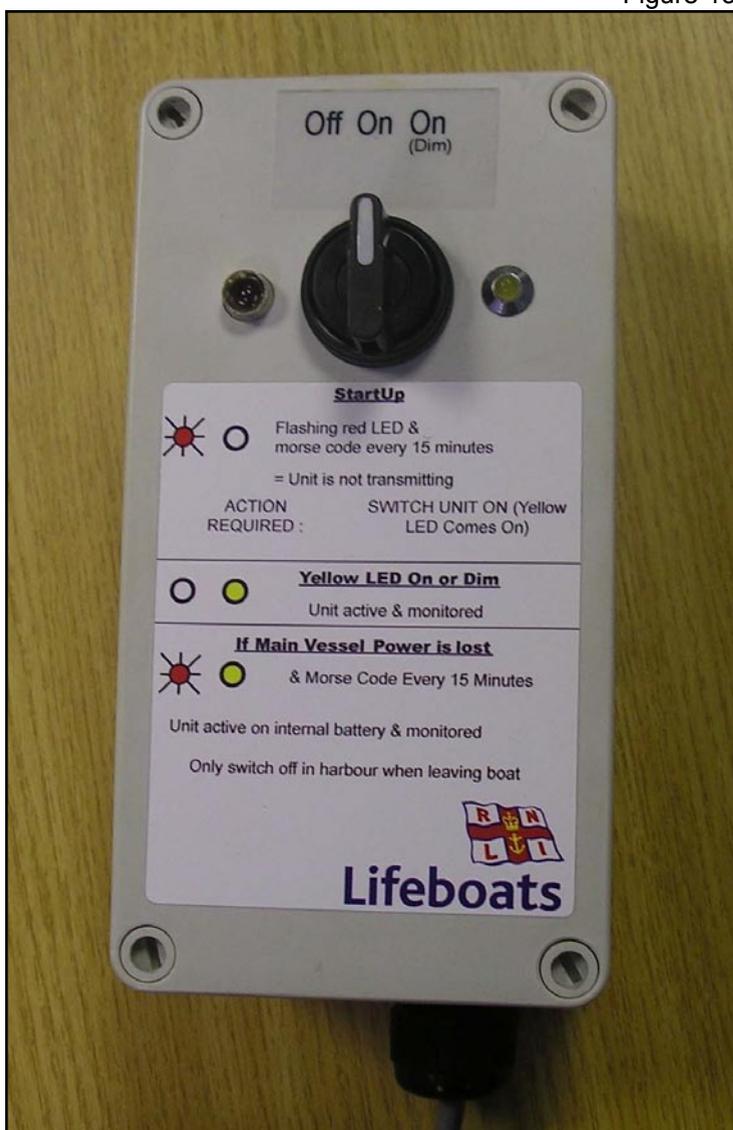
Figure 13

CPRS control unit switched ON  
(Sample unit)

The skipper was known to have switched the unit on each time he left port, and to switch it off on return. Further evidence that this was the case is highlighted by the unit being found switched ON or in the “seagoing position” after it was recovered from the wreck (**Figure 13**).

As stated above, the precise message passed to the skipper in October 2005 is not known. However it is unlikely that he was told the unit had completely failed because there is strong evidence to suggest that he continued to switch the unit “on” and “off” for the next 8 months, presumably in the belief that it was working or, at least, might work in an emergency. It is improbable that he would have continued to have done so had he been told that it had completely failed.
