MAIB SAFETY BULLETIN 2/2006

Gybing on yachts - two separate accidents resulting
in life threatening injuries to crew members

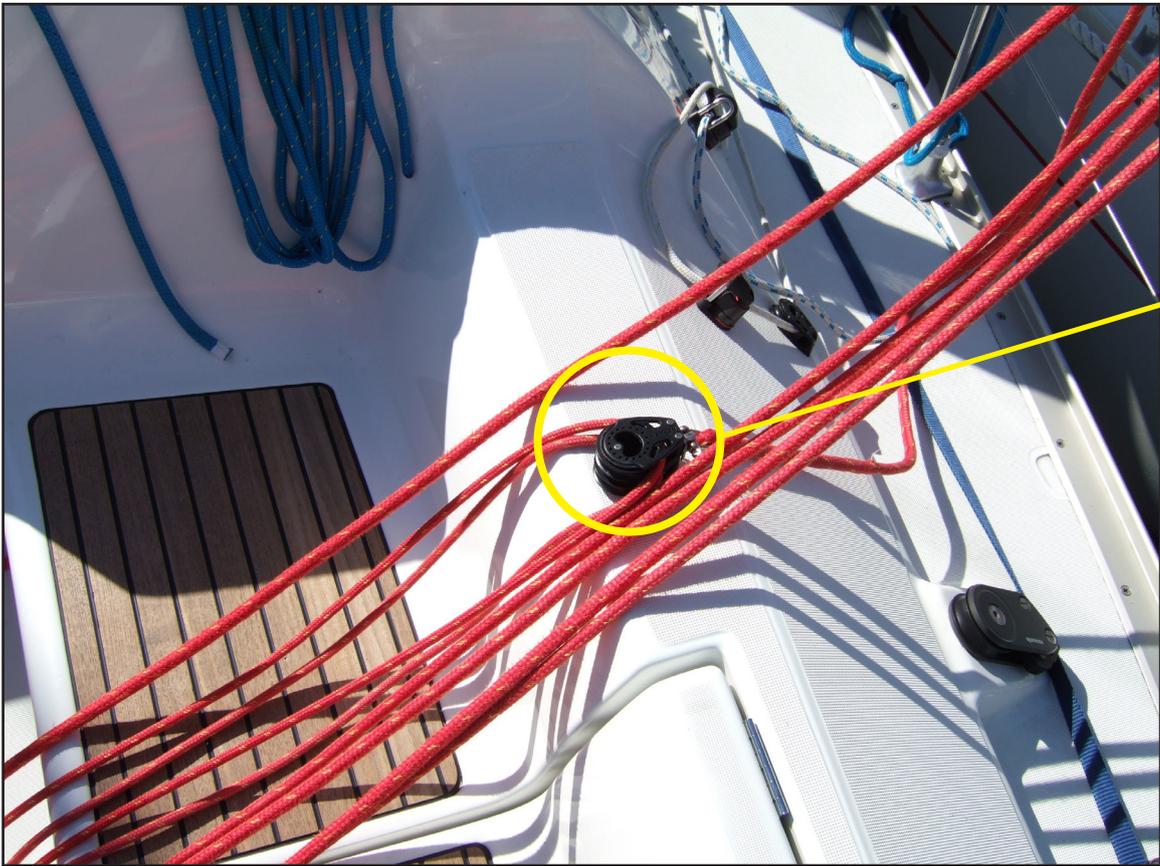
Figure 1

The yachts, which were identical Jeanneau 'Sunfast 37', Bermudan rig 10.75m vessels, were sailing under reefed mainsails only; one with a single reef and one with 2 reefs, in winds of about 30 knots. In both accidents the injuries occurred when the crew members were struck by the fine tuning block, which forms part of the main sheet arrangements on these boats, (see Figures 1 and 2) as the boom passed across the cockpit during the gybe. One of the crewmembers was also thrown across the cockpit by the impact and sustained further injuries as a consequence.

Fine tuning block

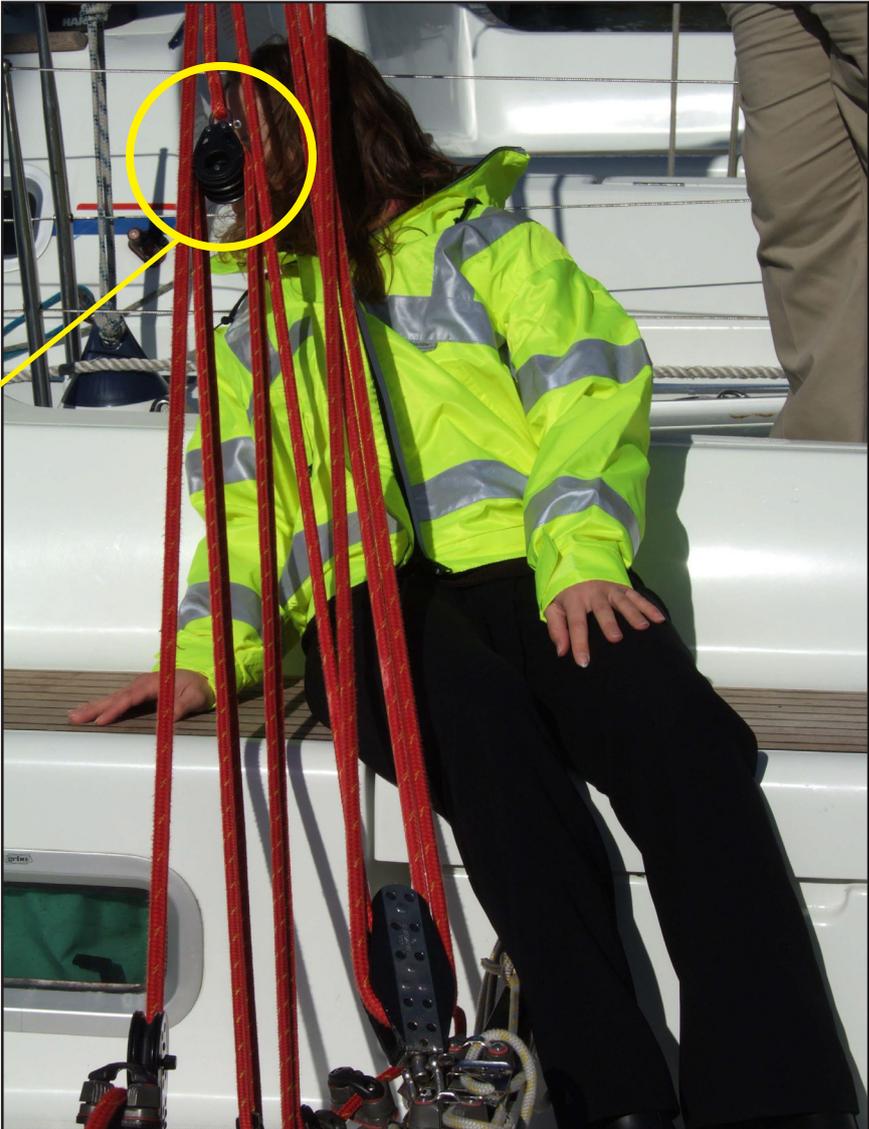
Figure 2

The fine tuning block is at head height when sailing - crew should keep clear of this, particularly during a gybe

- 1. Skippers should ensure that when giving a brief before sailing, they take into account the crew's experience on similar boats and their familiarity with the rig, fittings and associated hazards on the boat.**
- 2. The main hazard associated with a gybe is generally perceived to be the movement of the boom. This accident demonstrates the need to ensure that all crew members are also made aware of the dangers of being struck by the sheets and associated gear as the boom passes overhead during the gybe.**
- 3. Charter companies should ensure that the briefing given to crews on handover should stress any specific hazards on the boat which members of the crew may not have previously encountered.**
