Report on the investigation of
the engine room fire on board
the passenger cruise vessel

The Calypso

6 May 2006

Report No 8/2007
April 2007

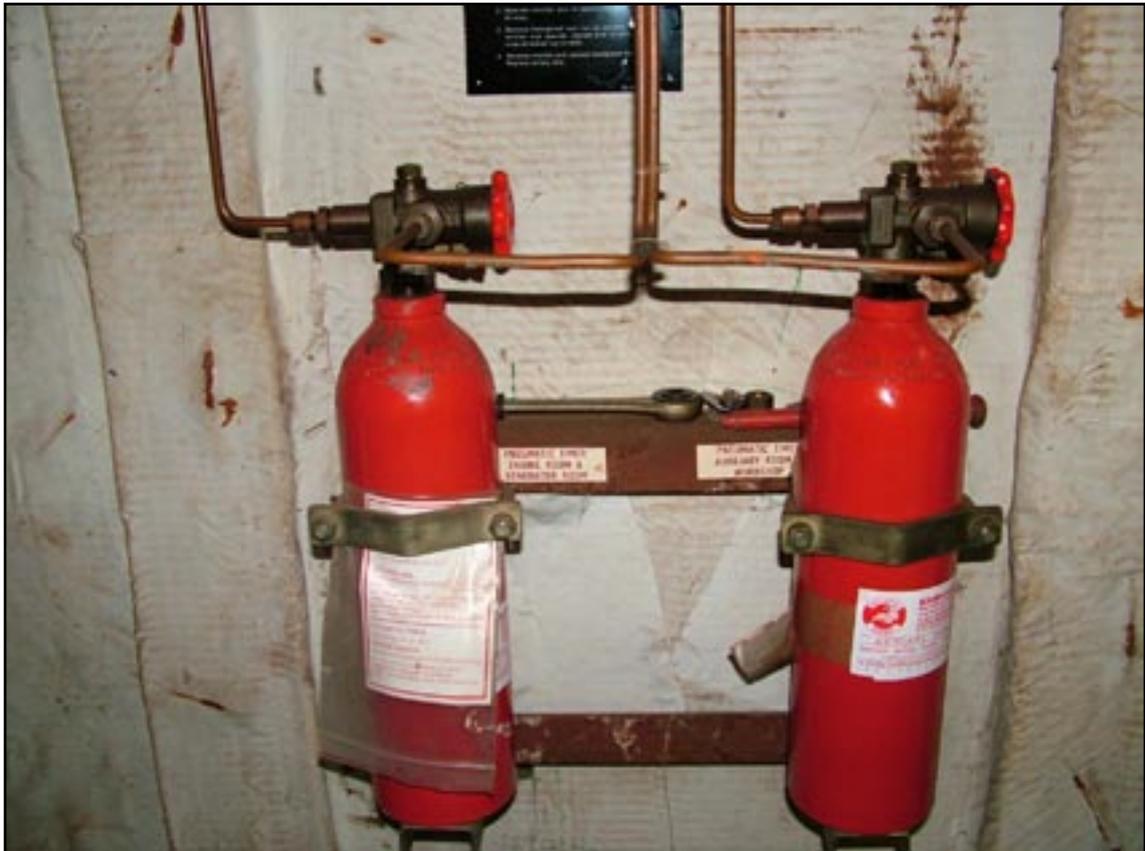
Figure 4

The chief electrician opened the valves on two small bottles on the aft bulkhead, which he believed were the pilot cylinders (**Figure 4**). He then operated the control levers for the engine and boiler room gas supply lines (**Figure 5**), as directed by the posted instructions, and manually opened the distribution valves to the engine room and boiler room (**Figure 6a/6b**). He left the CO₂ room within a few minutes and informed the chief engineer that the CO₂ system had been operated. At 0350, the safety officer contacted the bridge and confirmed that the CO₂ had been released. At about this time, an electrical blackout occurred and the emergency diesel generator started.

Timer cylinders

Below the control levers were two red pneumatic timer bottles linked to the control switches through small bore copper pipes. Timer devices are used to delay the opening of main or distributing valves until a short period after the CO₂ alarm has sounded. This is a common method of meeting the SOLAS requirement to provide a delay between the CO₂ release alarm and the release of the extinguishing medium (**Figure 4**).

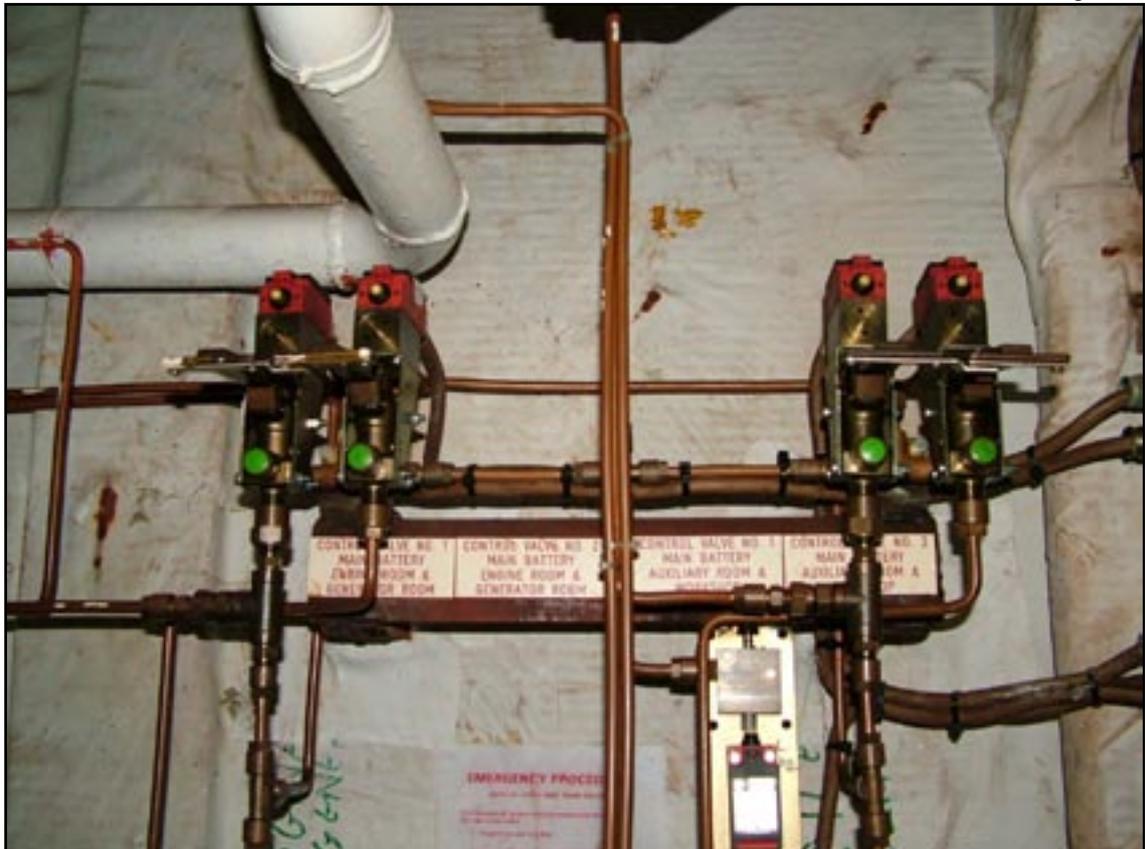
Figure 5

Control levers - in released condition

On the aft bulkhead of the CO₂ room were the manual/pneumatically operated levers for the release of the CO₂ from the bank cylinders into the manifold and for the operation of the relevant distribution valve. In manual mode, these levers (two per protected space) were pulled down to allow the pilot CO₂ from the manually operated pilot cylinders, to pass through internal orifices in the switch body and external small bore copper pipework to charge the system. The pilot gas also operated electrical switches for the CO₂ alarms and for ventilation shutdown of the protected space. In pneumatic mode, the pull down levers were automatically pushed open by small pistons behind each switch, pressurised by CO₂ gas from the remote pilot cylinders. Labels identified the levers (**Figure 5**).

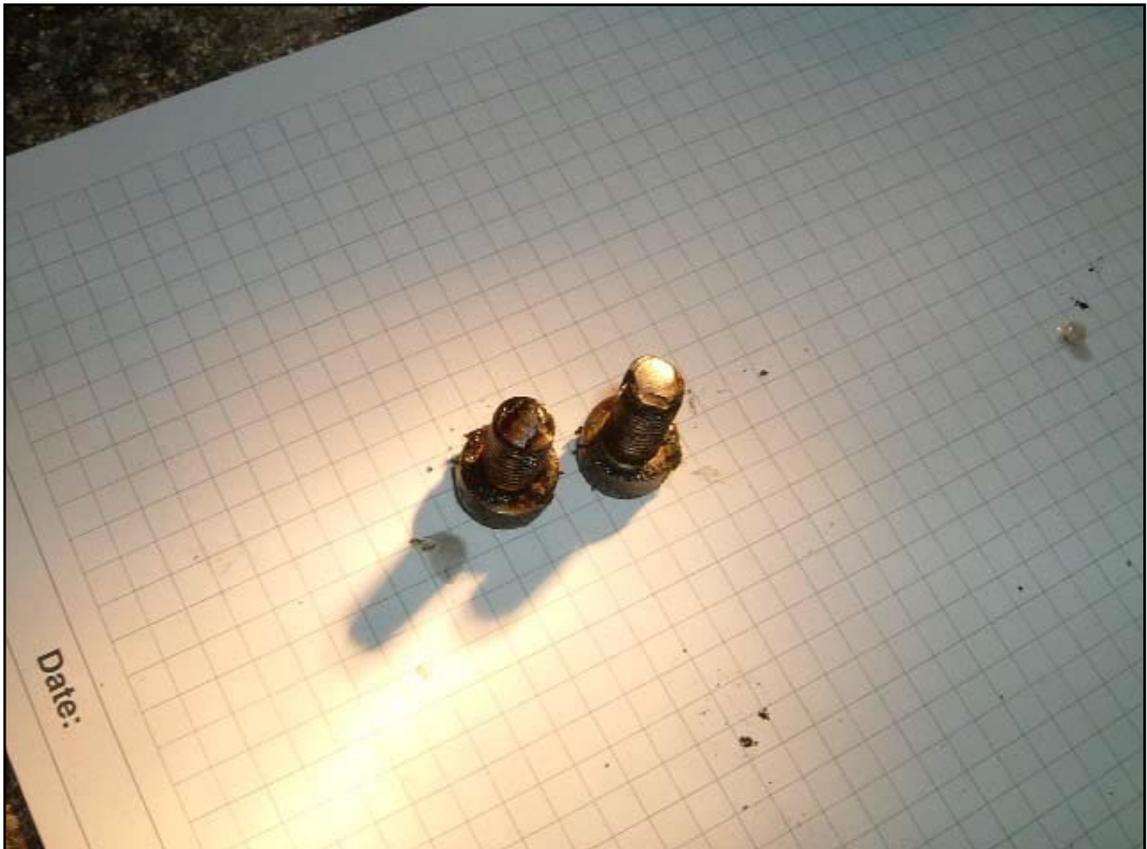
Figure 22

The flanges had separated because the two, 10mm, socket headed flange bolts had failed. Their failure allowed the flanges to separate slightly, thus causing the "O" ring seal to become dislodged and fuel, at a pressure of up to 10 bar, to spray through the gap in the flanges (**Figures 22, 23a/23b**).

Fatigue is a long term metallurgical process which results in the development of a crack under oscillating loads, although the ultimate failure is likely to be sudden. The precise initiation of the fatigue failure was not identified during the analysis but can arise from a number of potential origins, such as localised material defects, manufacturing defects, localised areas of damage, normal engine vibration or pressure pulses from the fuel injection pumps.

Failed bolts

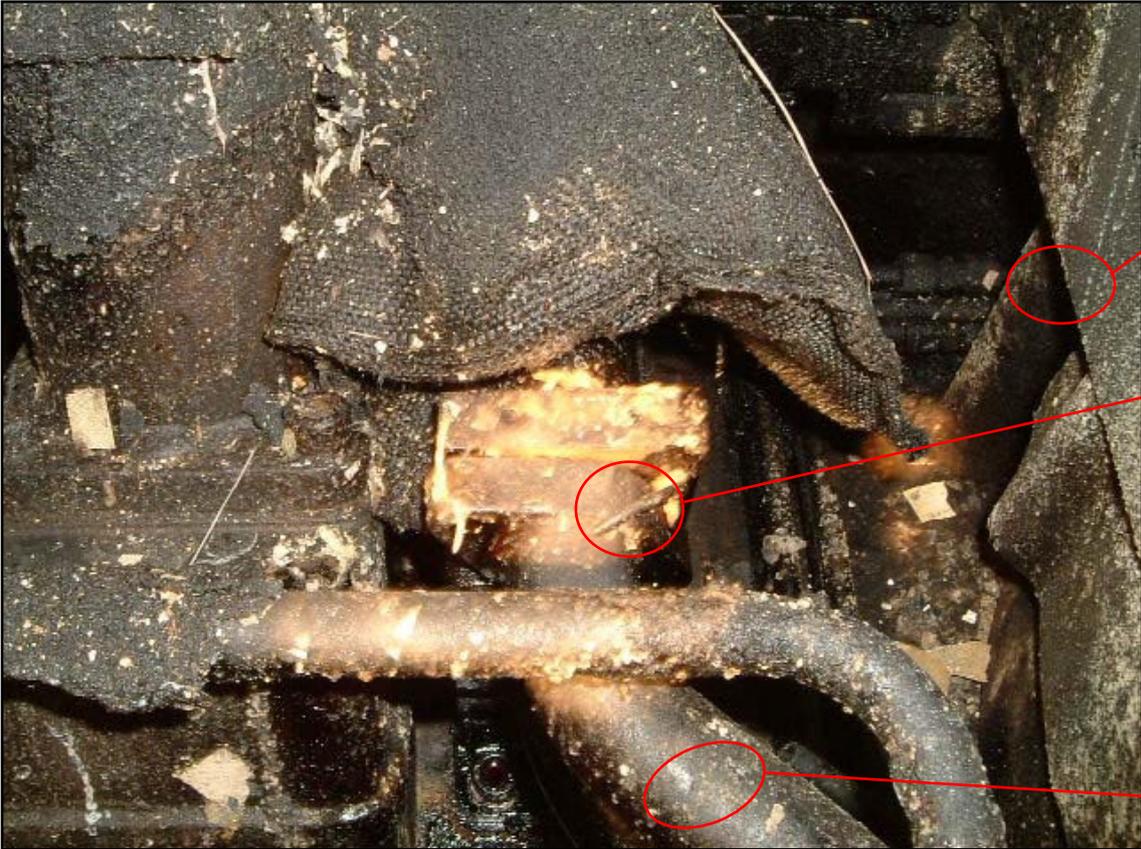
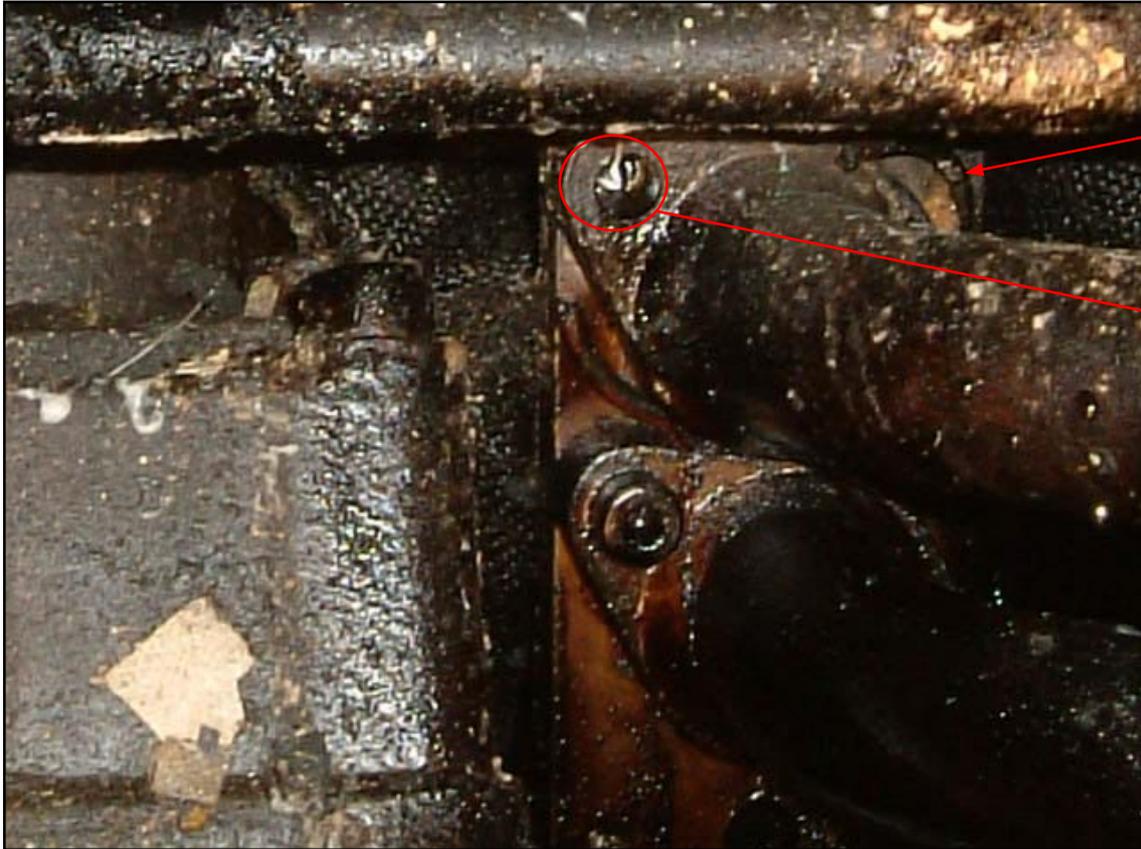
Figure 23a and b

Fuel pipe flange and "O" ring seal

The Wartsila technical bulletins 3217T011Gb and 3217T044GB(01) (see Sections 1.10 and 2.8 and **Annex 4**) provided relevant comprehensive advice including the replacement of two bolt flanges with four bolt flanges and other modifications aimed at dampening pressure pulses and vibrations in the fuel supply system. The recommended modifications had not been carried on *The Calypso*.

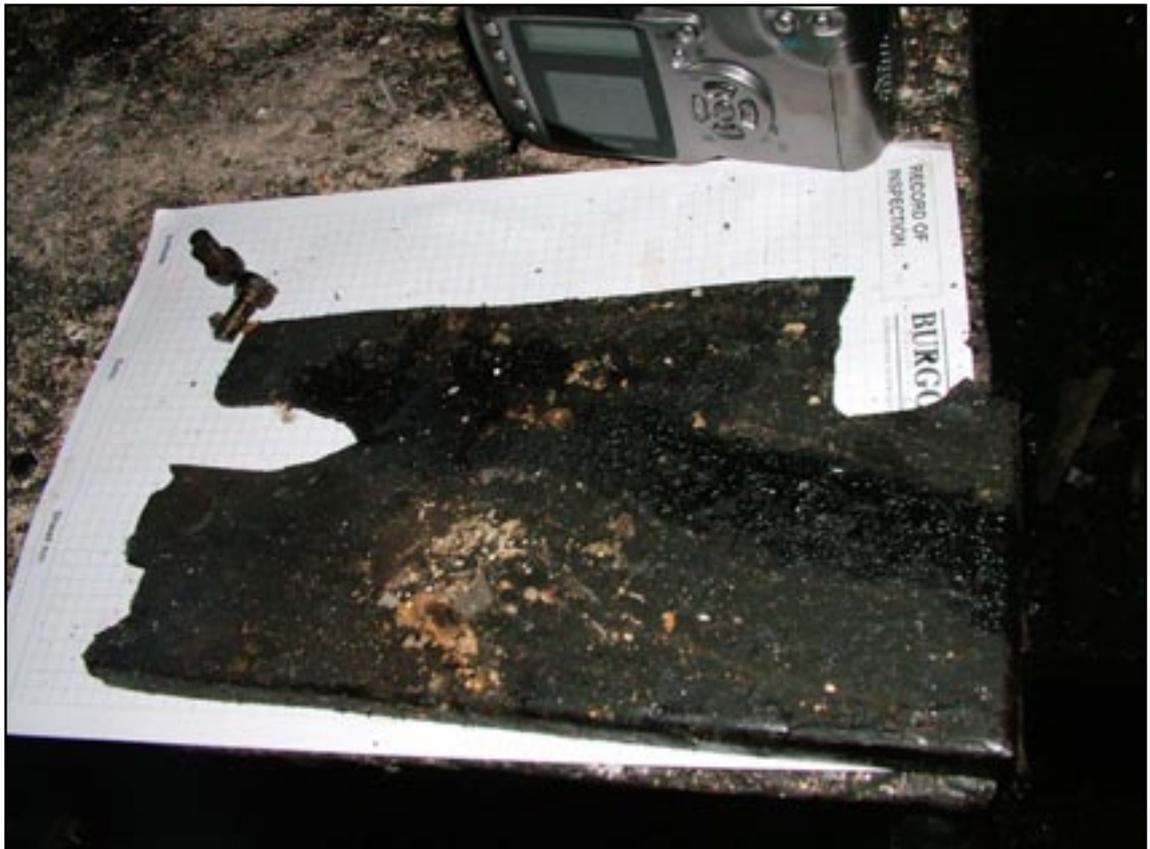
Figure 24

It is concluded that a combination of factors, primarily the fatigue failure of the securing bolts on an LP fuel pipe flange and including a poorly fitting or loose sprayguard and the close proximity of hot spots to cause ignition, caused the fire. If the advice contained within the Wartsila technical bulletins had been followed, it is likely that this fire would have been avoided.

Spray guard

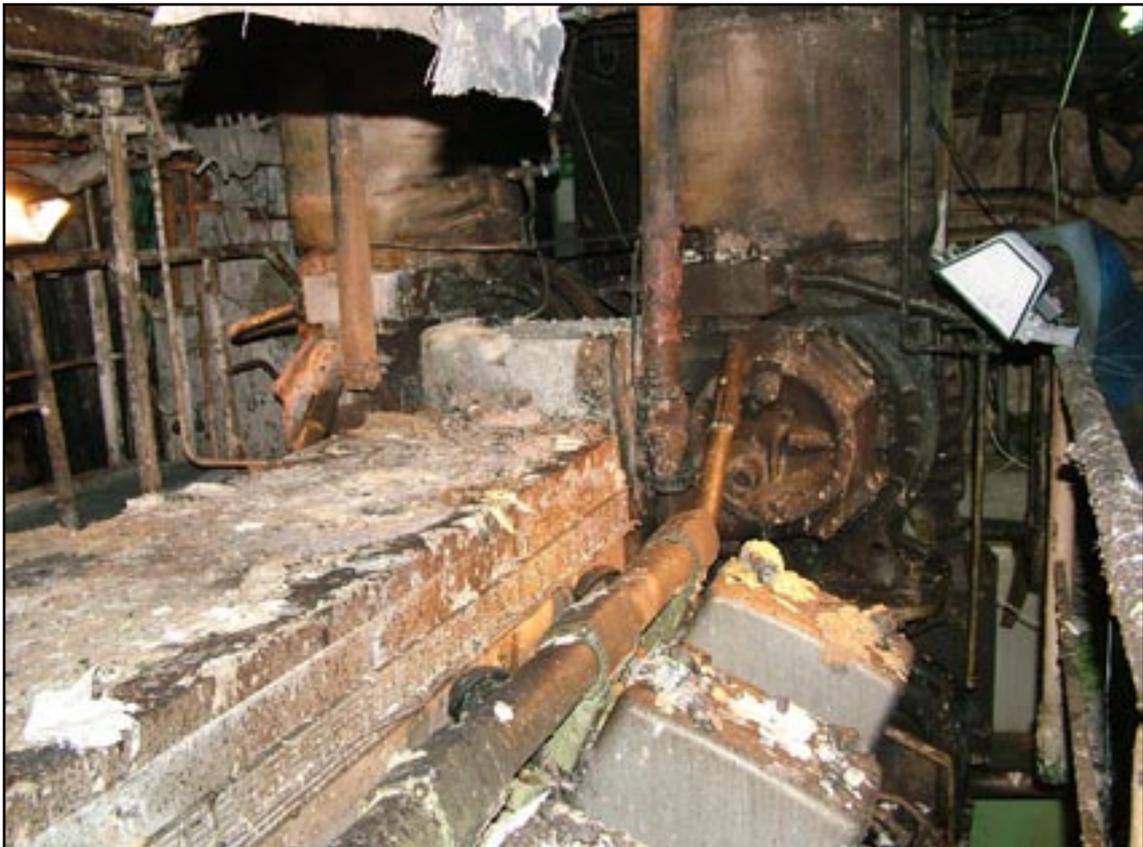
Figure 25

Fire damaged turbo chargers

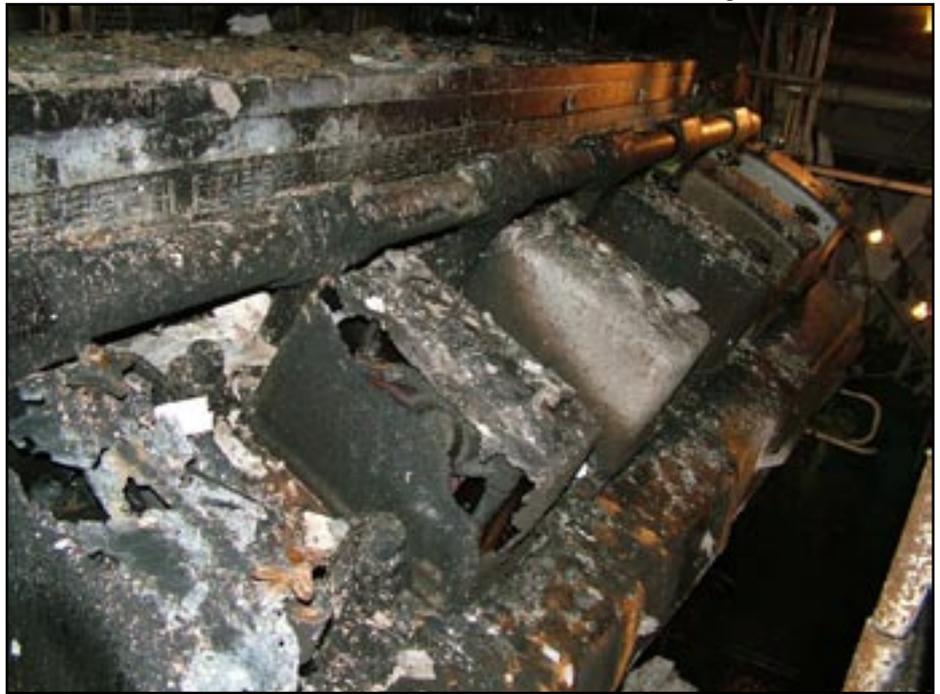
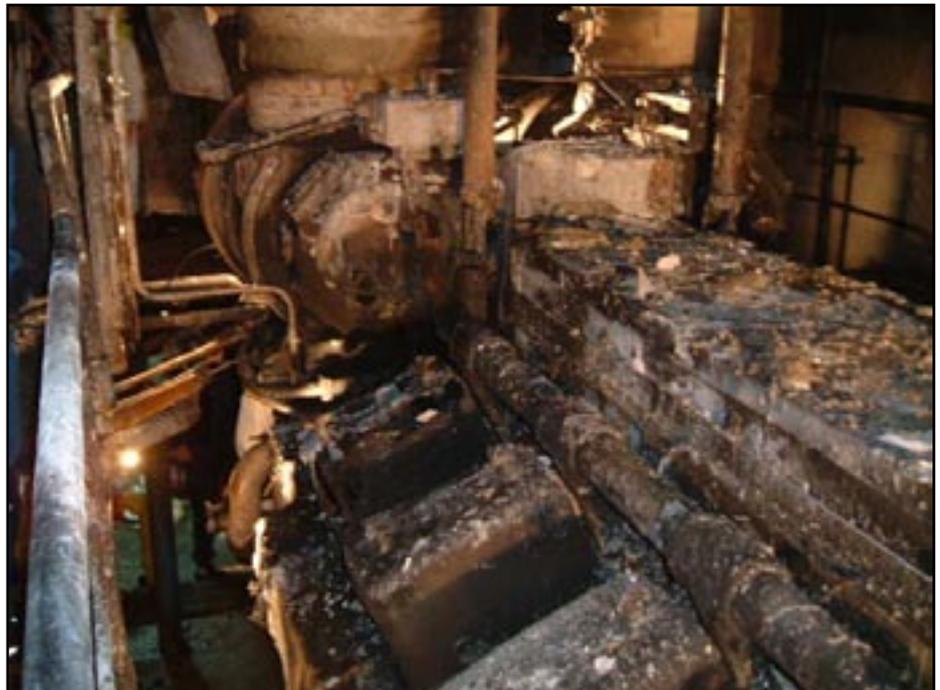
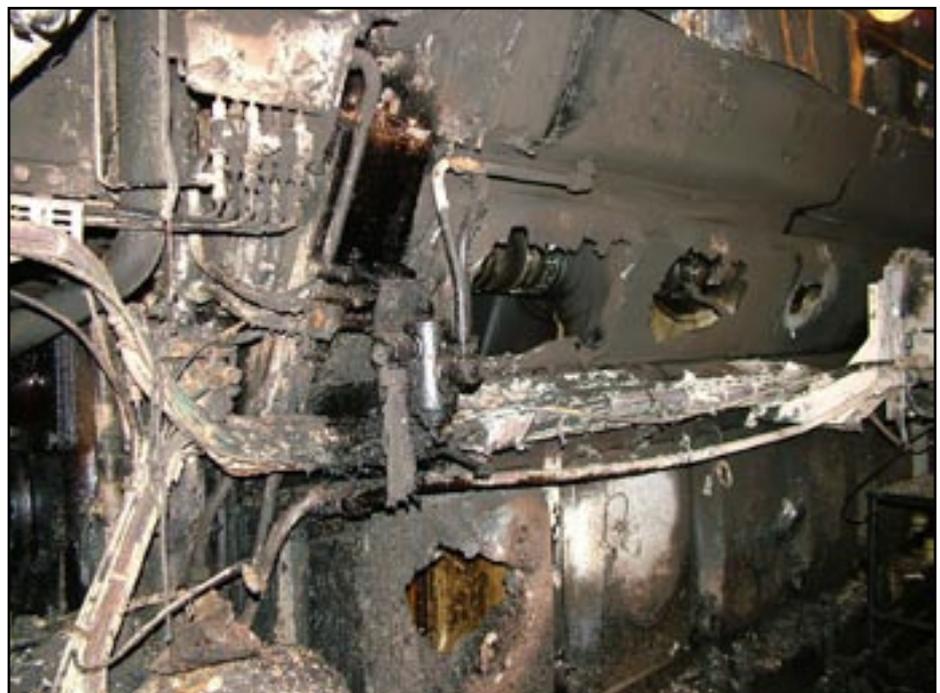
Damaged rocker covers, camshaft and crankcase doors

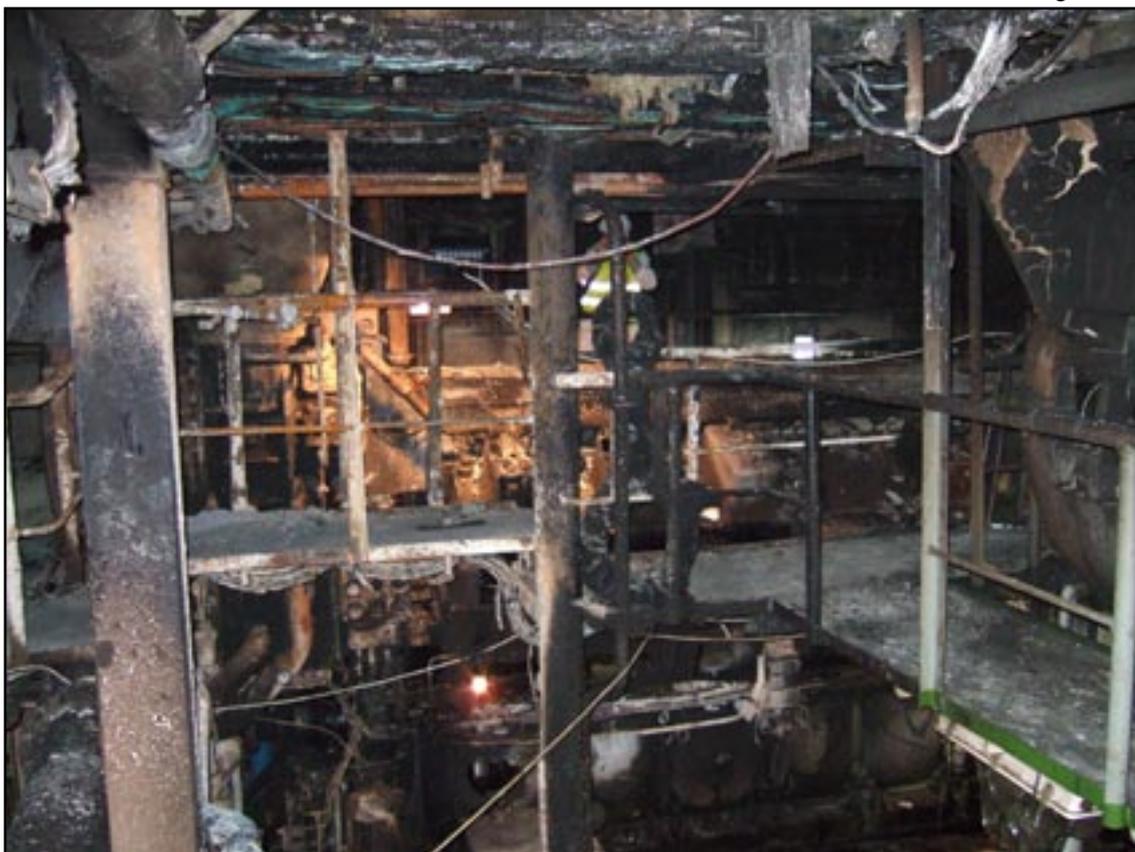
Damaged upper areas
