Report on the investigation of the  
fatal accident due to collapse of a portable bulkhead onboard

***mv Neermoor***

at Teignmouth, UK

**Report No 31/2006**  
**December 2006**

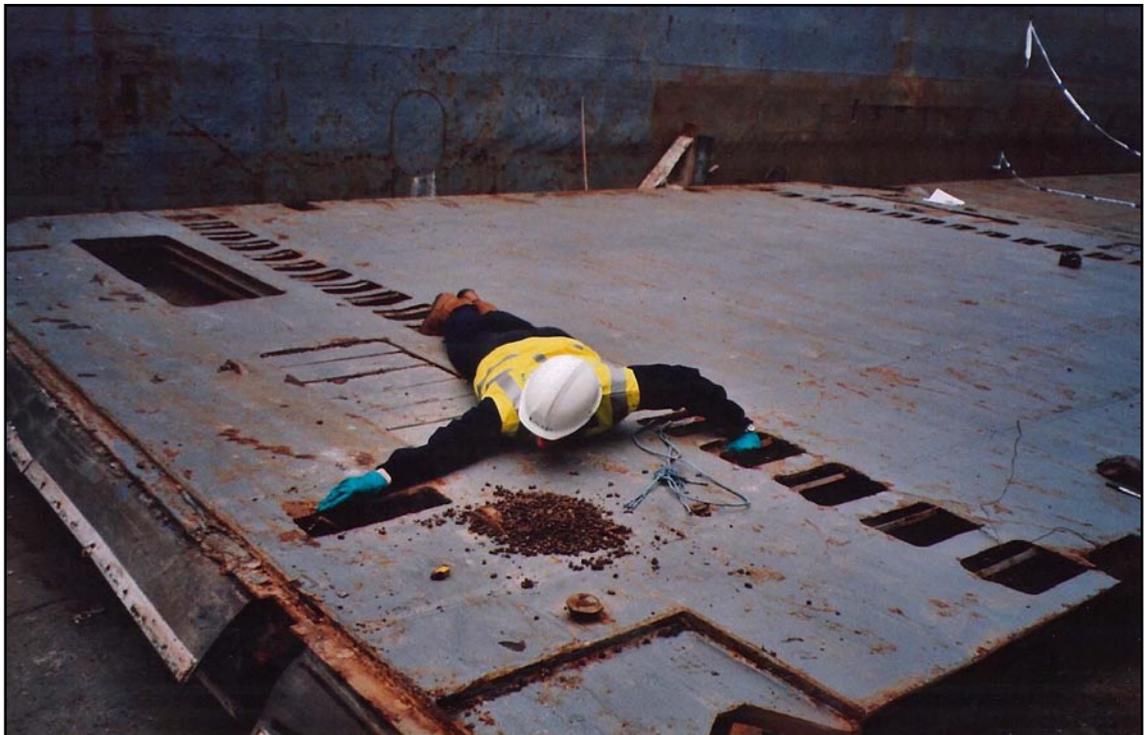
Figure 3

The operating controls for the pins were recessed into the forward face of the bulkhead. Gaining access to the two upper pins on the bulkheads was both difficult and potentially dangerous. In order to operate the upper pins it was necessary to climb up the ladder recessed into the face of the bulkhead to gain access to them, some 4m above the bottom of the hold. Once the operator was at this height, the easing handles of the pins were at a full stretch (**Figure 3**).

General arrangement of pin operating position, aft bulkhead shown lying on the bottom of the hold.

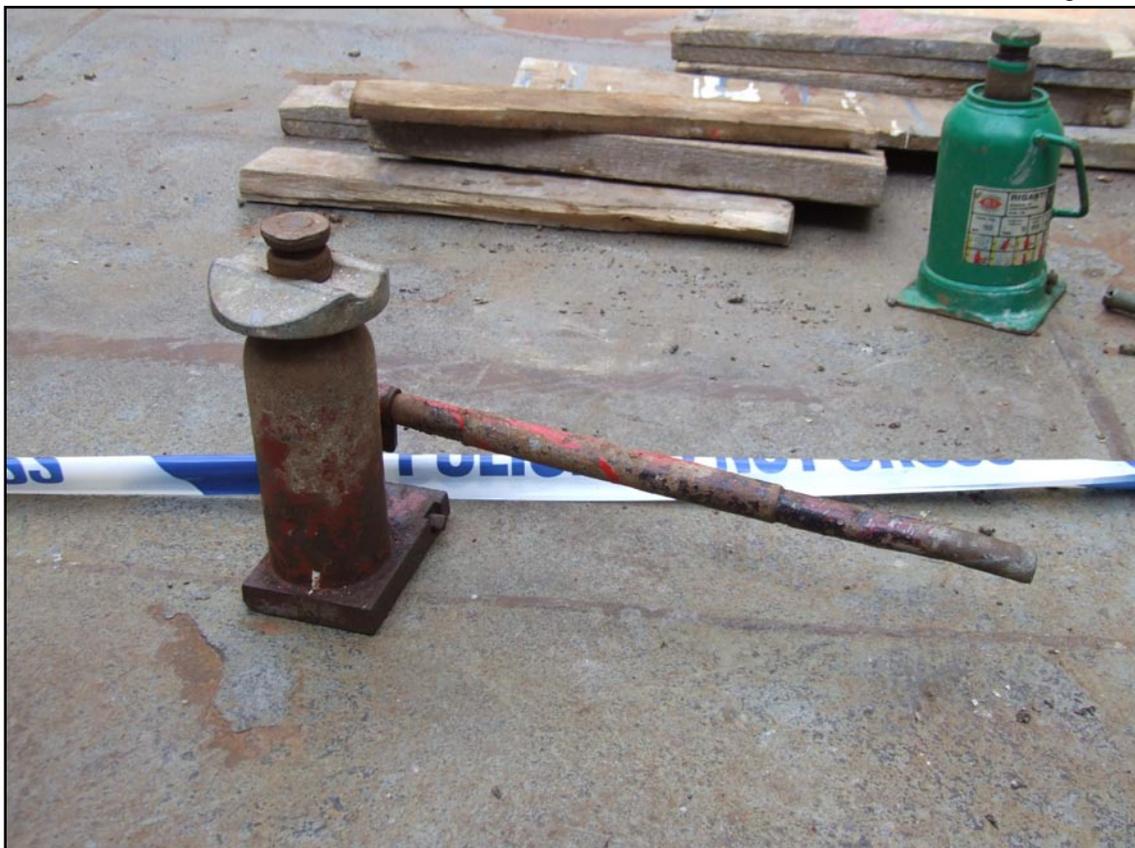
Figure 5

Bulkhead lifting jacks as found on board

In this accident, it is likely that the asymmetric jacking of the bulkhead by using separate dissimilar jacks caused the securing pins to retract. However, poorly maintained jacks could as easily have led to hydraulic failure resulting in a dropped or jammed bulkhead. As a crucially important piece of equipment that formed an integral part of a lifting system, the jacking system should have been treated with greater respect and perhaps been subject to routine survey.

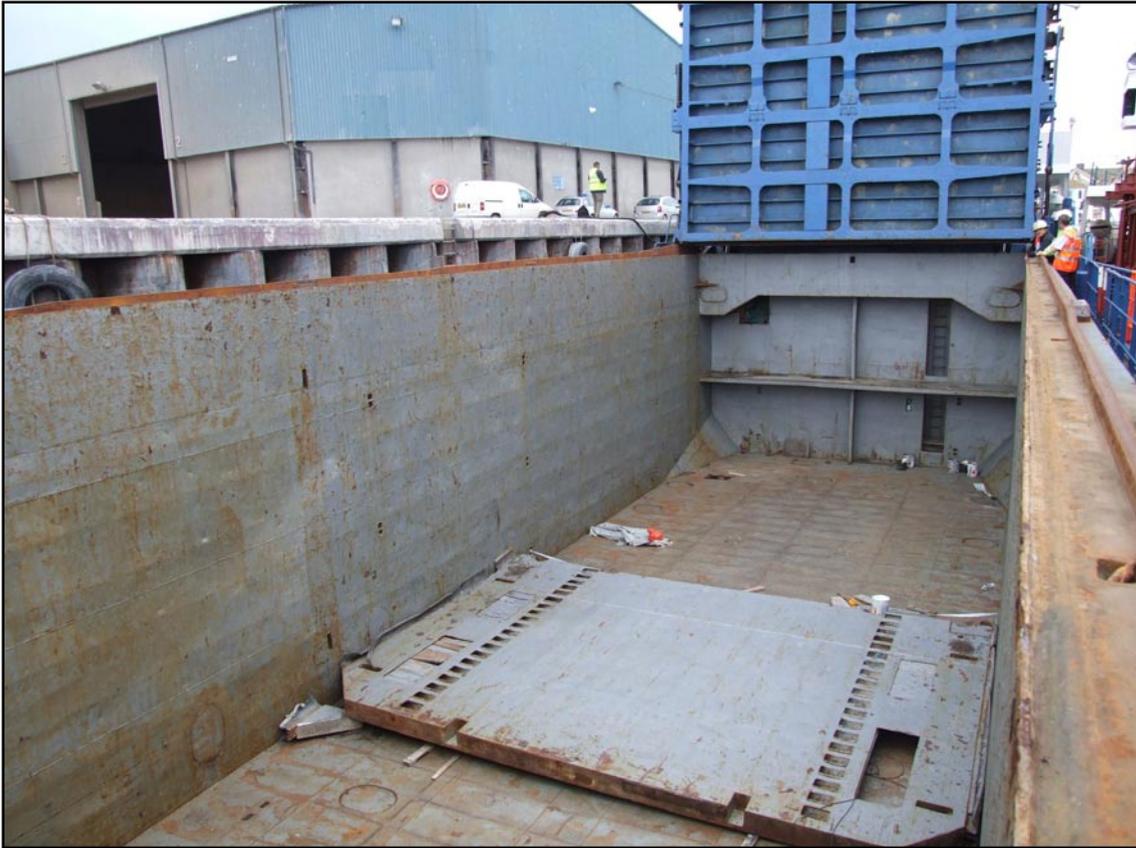
Figure 6

The accident site, looking aft

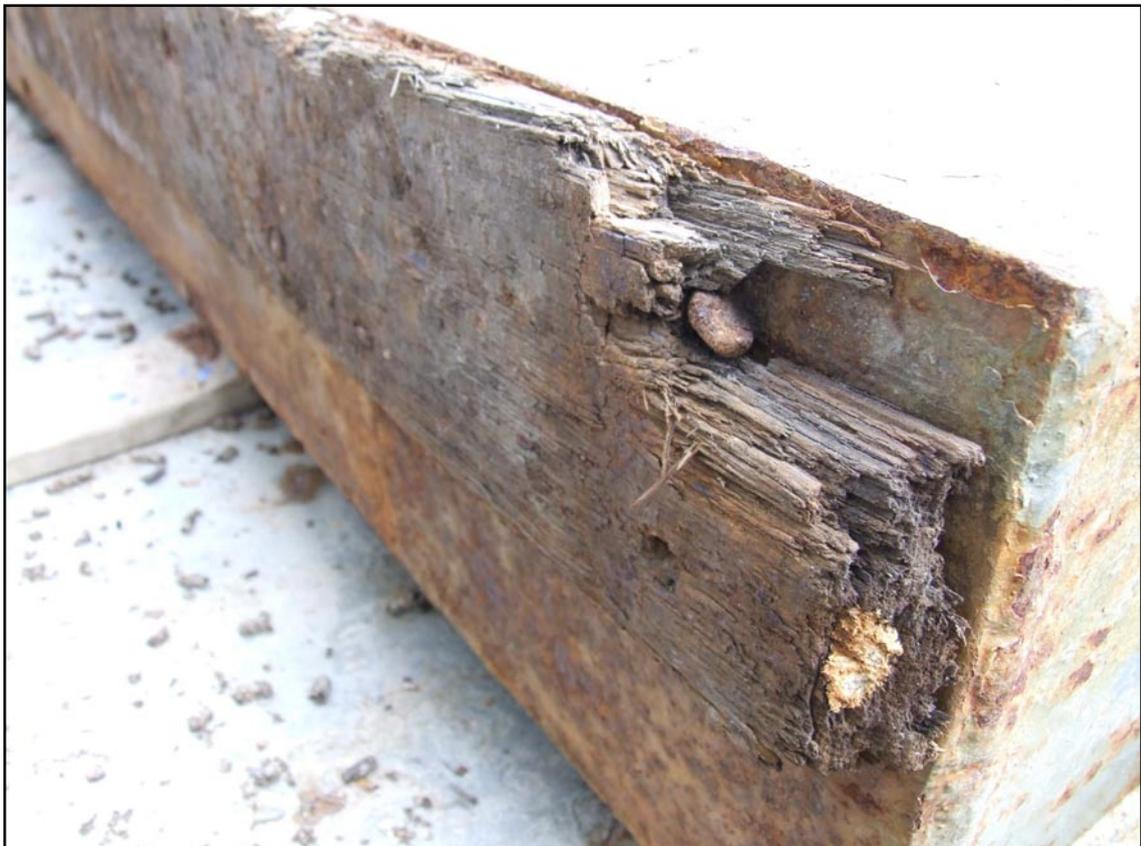
Figure 7

Lower edge of fallen bulkhead

The undisturbed corrosion seen around the upper parts of the pockets, and witness marks on both the pins and the sloping pocket faces, indicate that the bulkhead pins had been engaging into the lower, tapering section of the pockets. For this to have occurred, the bulkhead must have been sitting lower than its designed position, in relation to the position of the pockets. The only explanation for this is that the wood facing on the lower edge of the bulkhead was too thin. Some sections of the wood facing were noted to be damaged and missing, but it is also possible that the incorrect thickness of wood facing was fitted at some earlier point (**Figures 7, 12, 13, 14 and 15**).

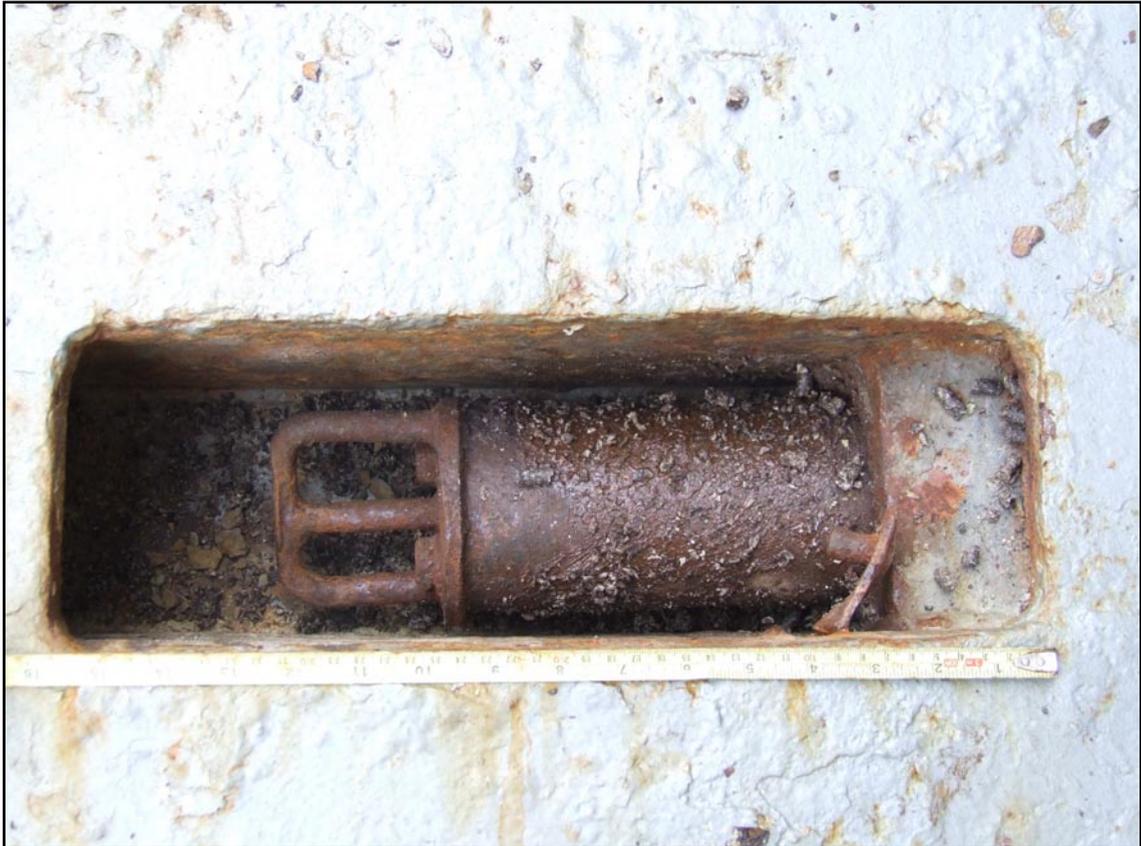
Figure 8

Port lower pin: Found retracted. Latching arrangements incomplete - missing the locking plate and the inboard side of the pivot cheek plate (**Figure 8**).

Securing pin port lower aft

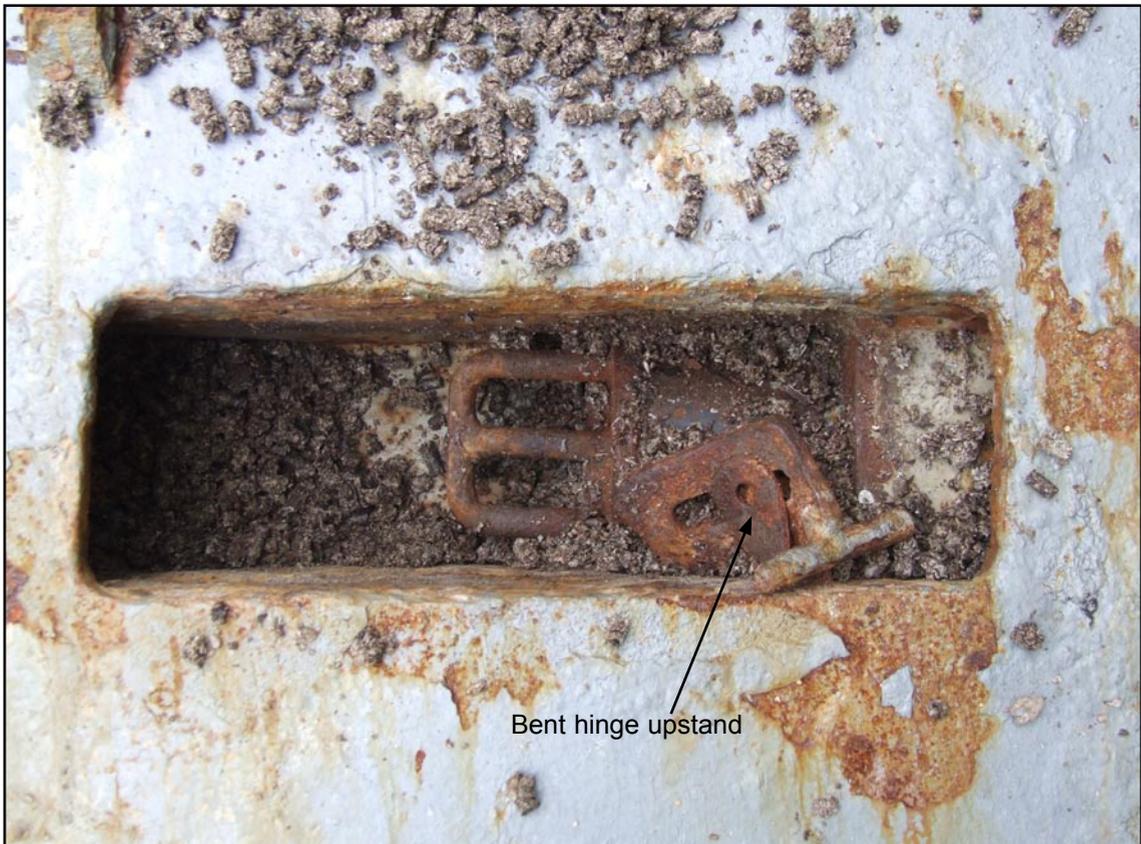
Figure 9

Port upper pin: Found half deployed. The outermost end was touching the hold side plating. Locking plate bent and a small bright spot was seen on the rim forming the edge of the locking pin (**Figure 9**).

Bent hinge upstand

Securing pin port upper aft

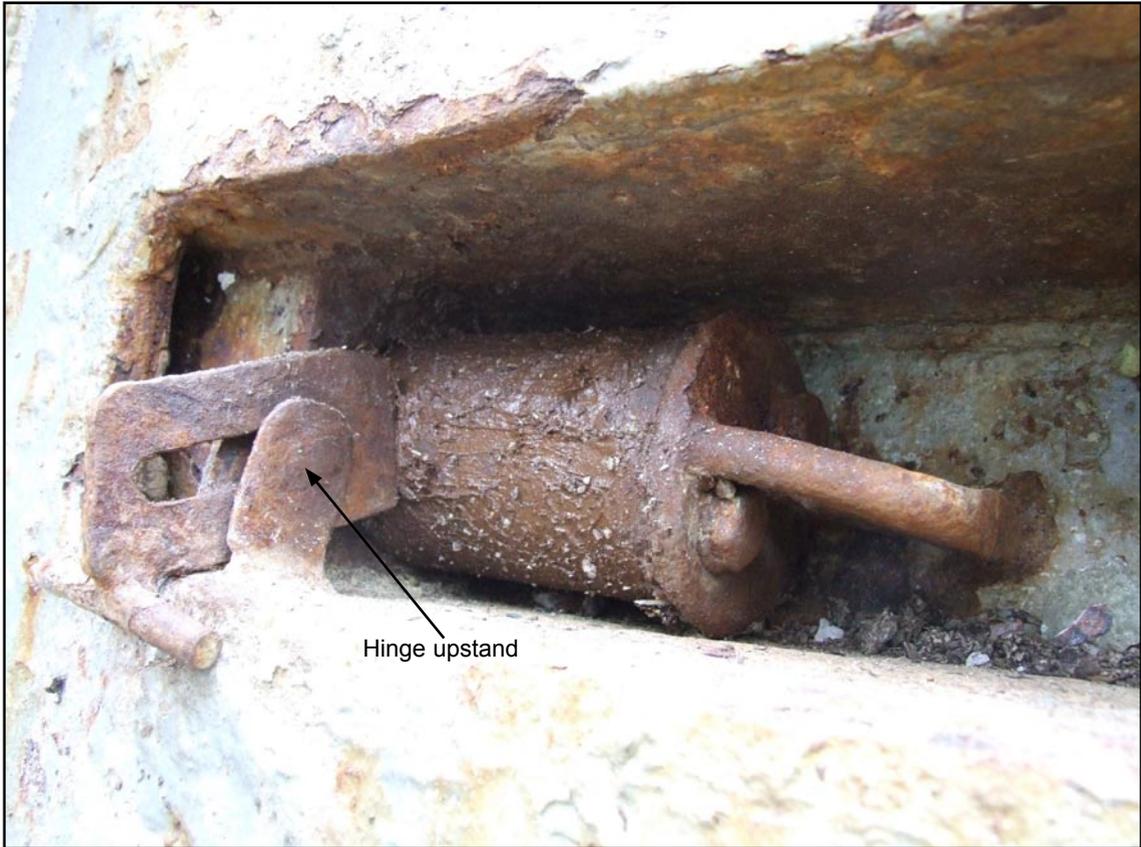
Figure 10

Starboard lower pin: Found half deployed. Latching arrangement not damaged (**Figure 10**).

Securing pin starboard lower aft

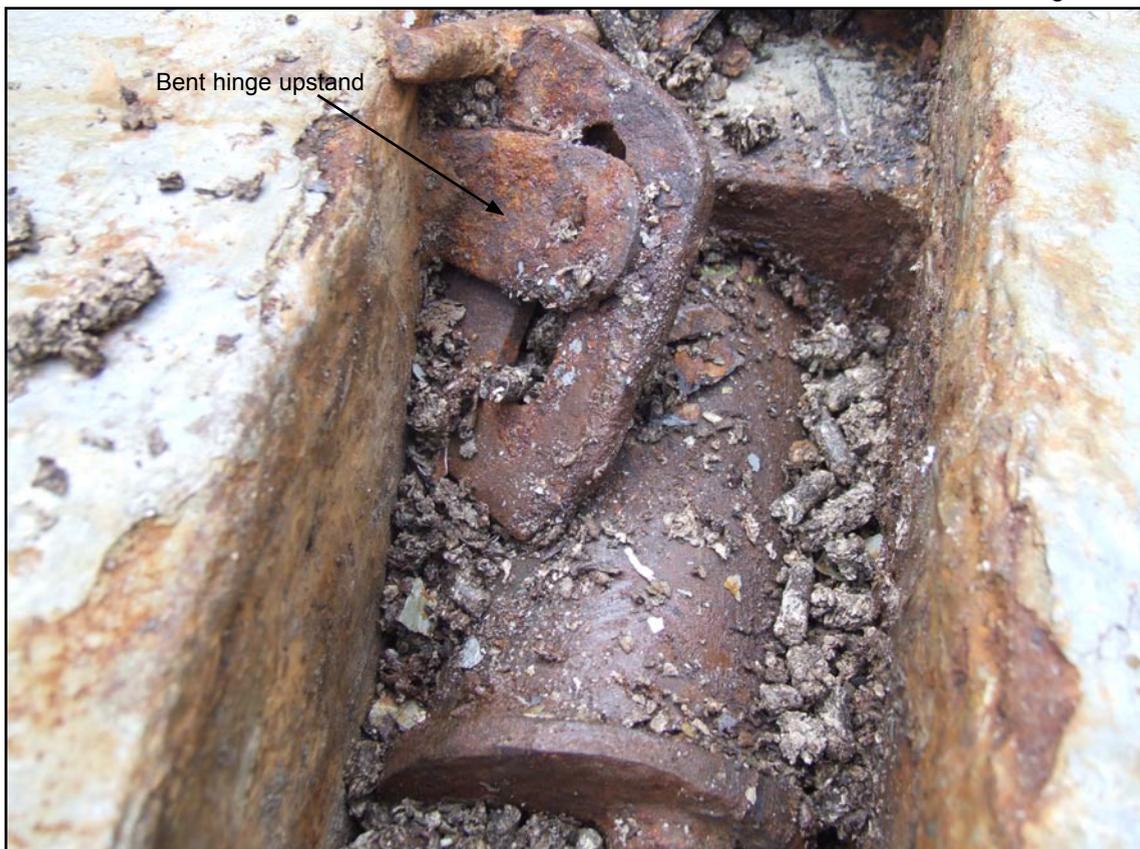
Figure 11

Starboard upper pin: Found half deployed. Locking plate bent inboard in a similar fashion to that seen at the port upper (**Figure 11**).

Securing pin starboard upper aft

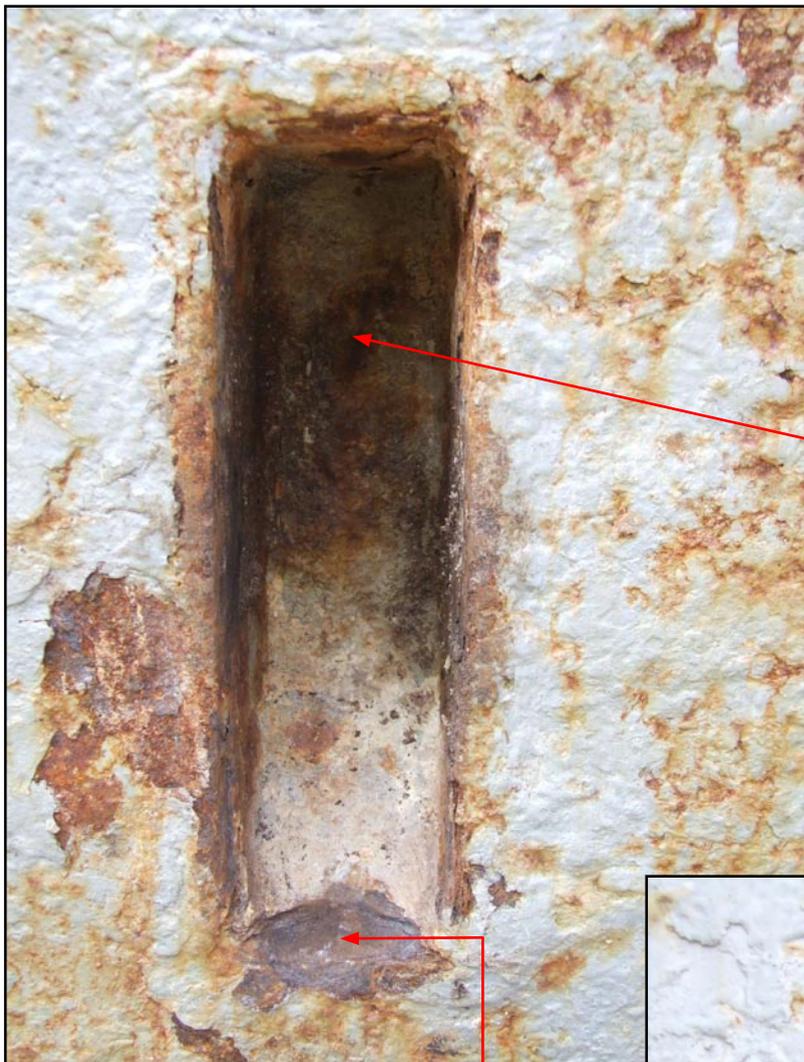
Figure 12

All pin pockets were seen to be moderately scaled due to rusting. Rust scale was generally intact in the upper parts of each pocket. No evidence was seen of there having been recent metal-to-metal contact, pocket against pin, in the “slotted” portion of the upper part of each pocket.

Securing pin pocket, port lower aft

Pin witness marks

Undisturbed rust scaling

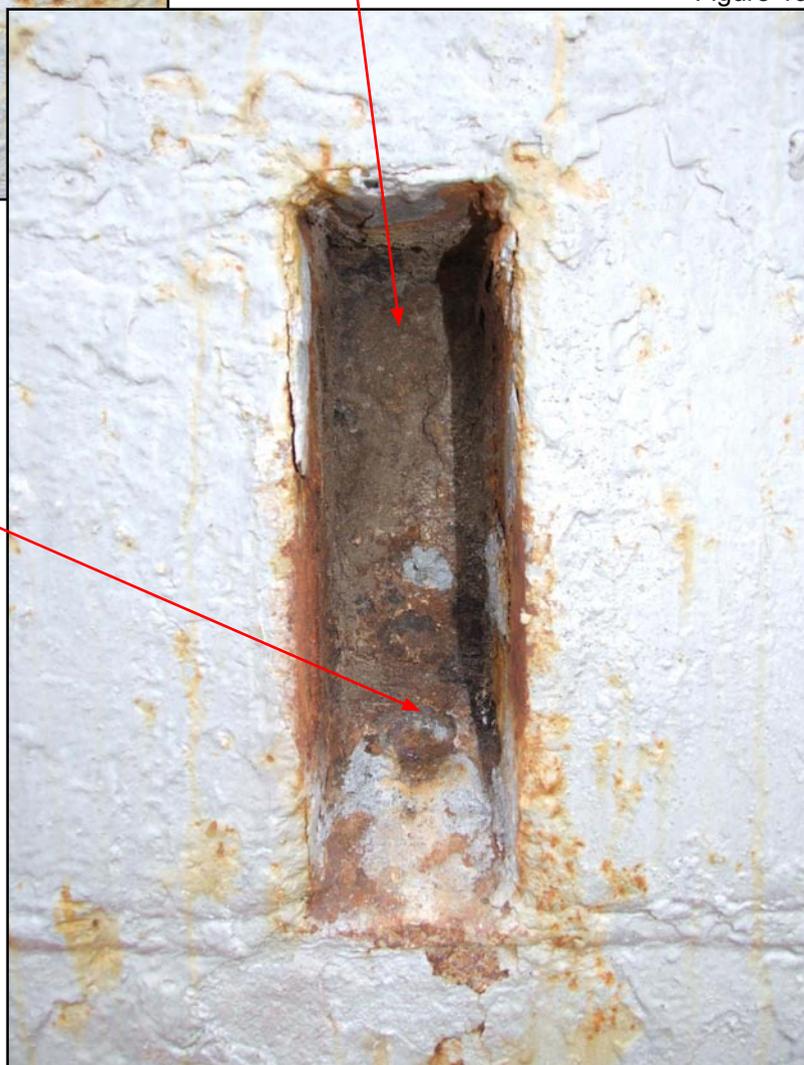
Figure 13

Securing pin pocket, port upper aft

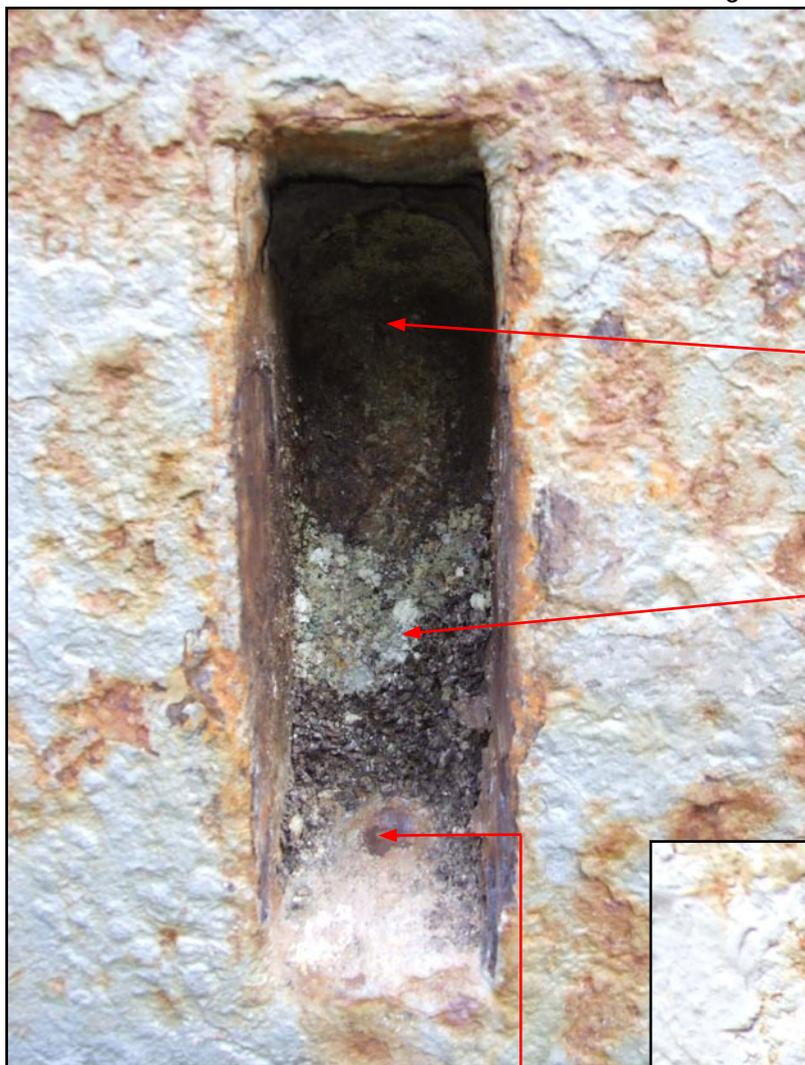
Figure 14

Securing pin pocket, starboard lower aft showing cargo residue in pocket

Pin witness marks

Undisturbed rust scaling

Cargo residue

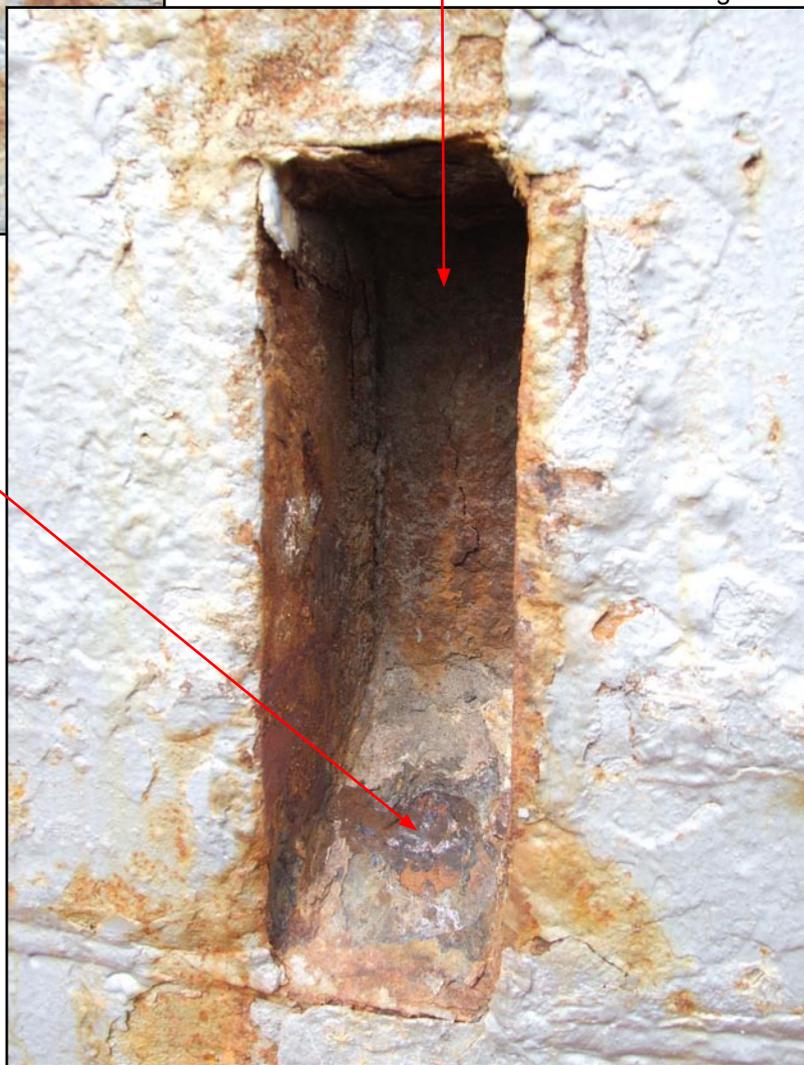
Figure 15

Securing pin pocket, starboard upper aft

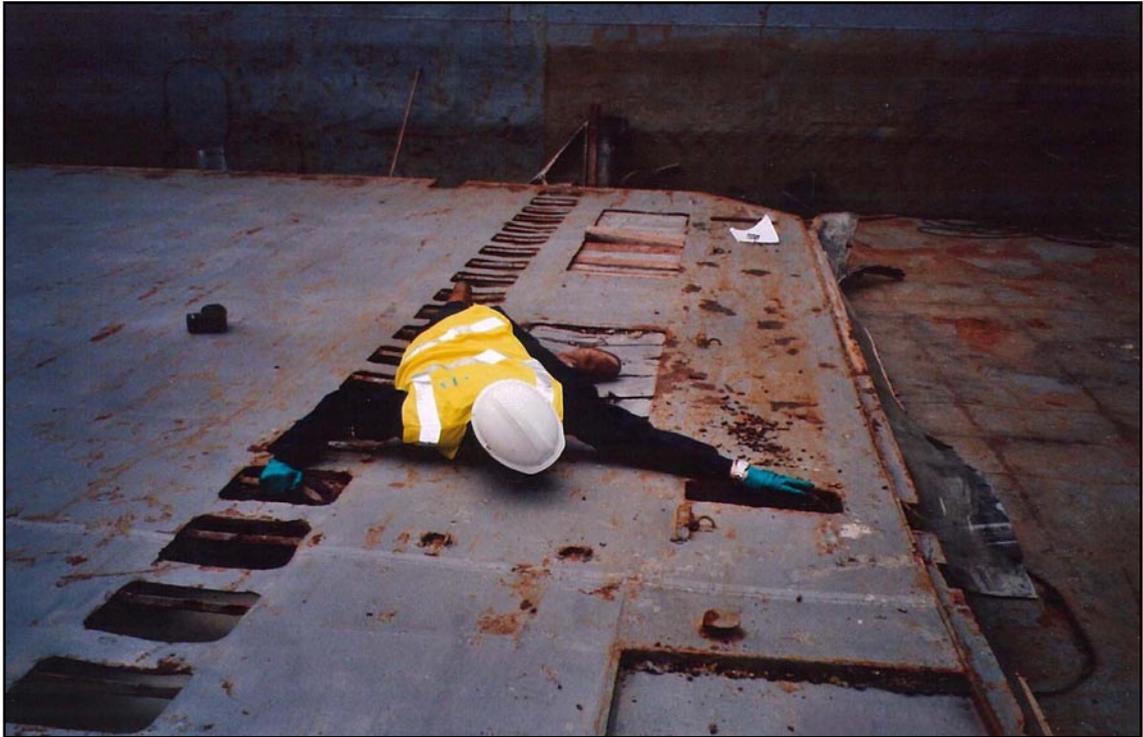
Figure 16

recesses might have hindered any but a close visual inspection of the bulkhead securing pins. Another means of indicating that the pins were positively engaged and locked should have been provided (**Figures 3 and 16**).

General arrangement of pin operating position, aft bulkhead lying on the bottom of the hold

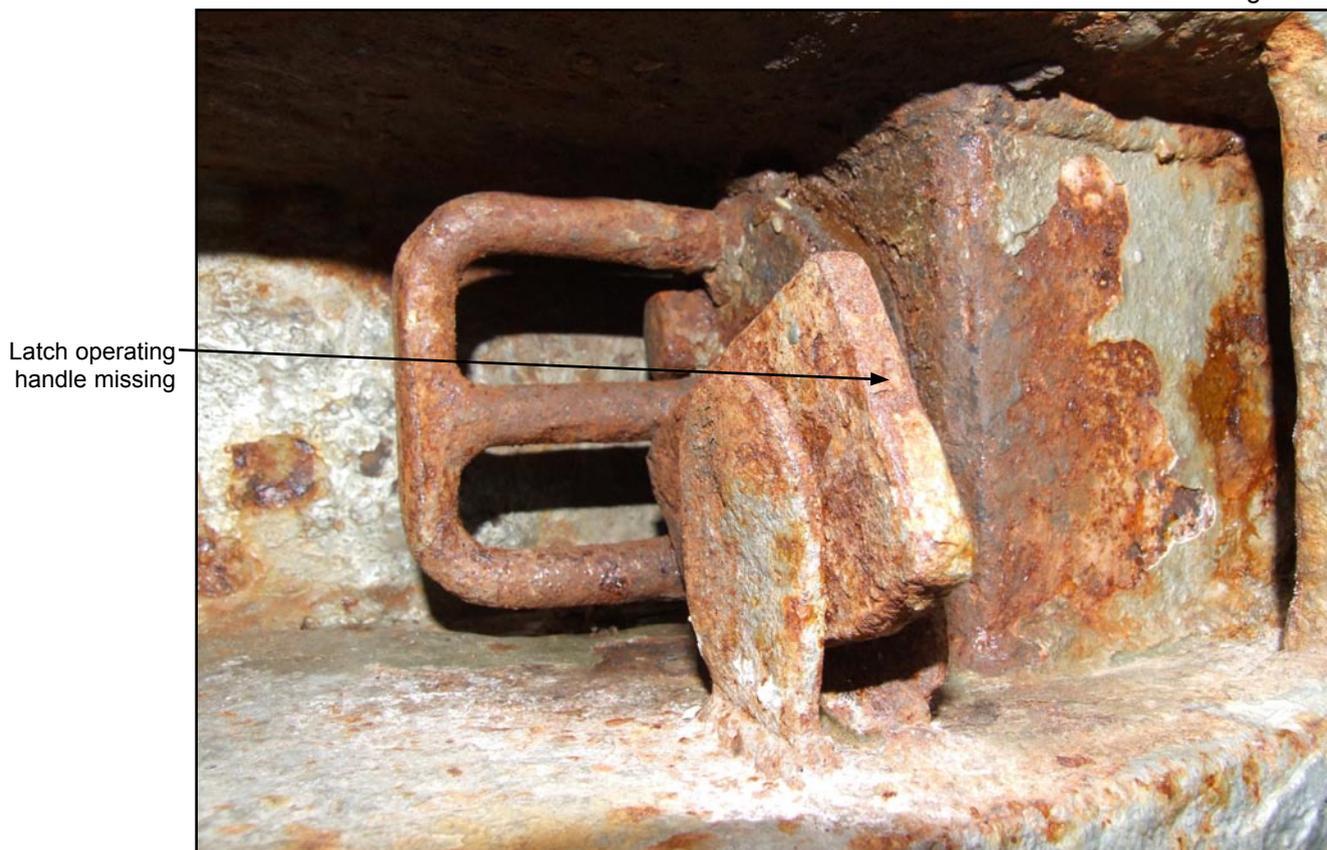
Figure 17

The easily-observed lower securing pins and their associated latches showed obvious defects, on both the forward and aft bulkheads. On the aft bulkhead, the port lower latch had parts missing, and both the securing pins had retracted; the port lower pin completely (**Figure 8**). On the forward bulkhead the securing latches on the port side were wasted by corrosion, the pivot cheek plates were deformed, and one latch operating handle was missing (**Figure 17**). On the starboard side, the lower latch mechanism was apparently sound. However, the end of the latch plate had almost entirely corroded away, so it covered the end of the pin by no more than 10mm (**Figure 18**).

Forward bulkhead, port lower securing pin

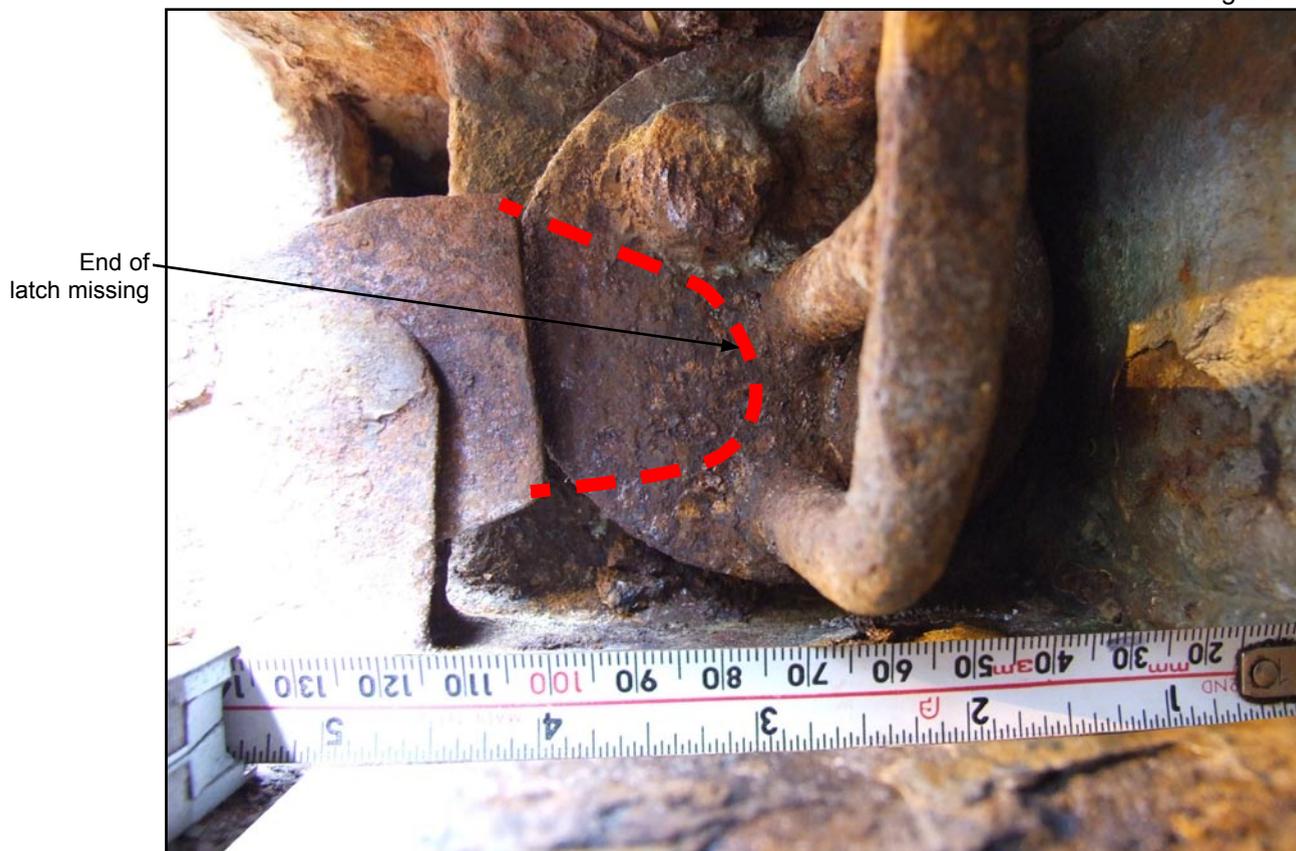
Figure 18

Forward bulkhead, starboard lower securing pin
