Report on the investigation of  
the loss of one man overboard  
from the sailing yacht

***Pastime***

17 March 2006

**Report No 25/2006**  
**September 2006**

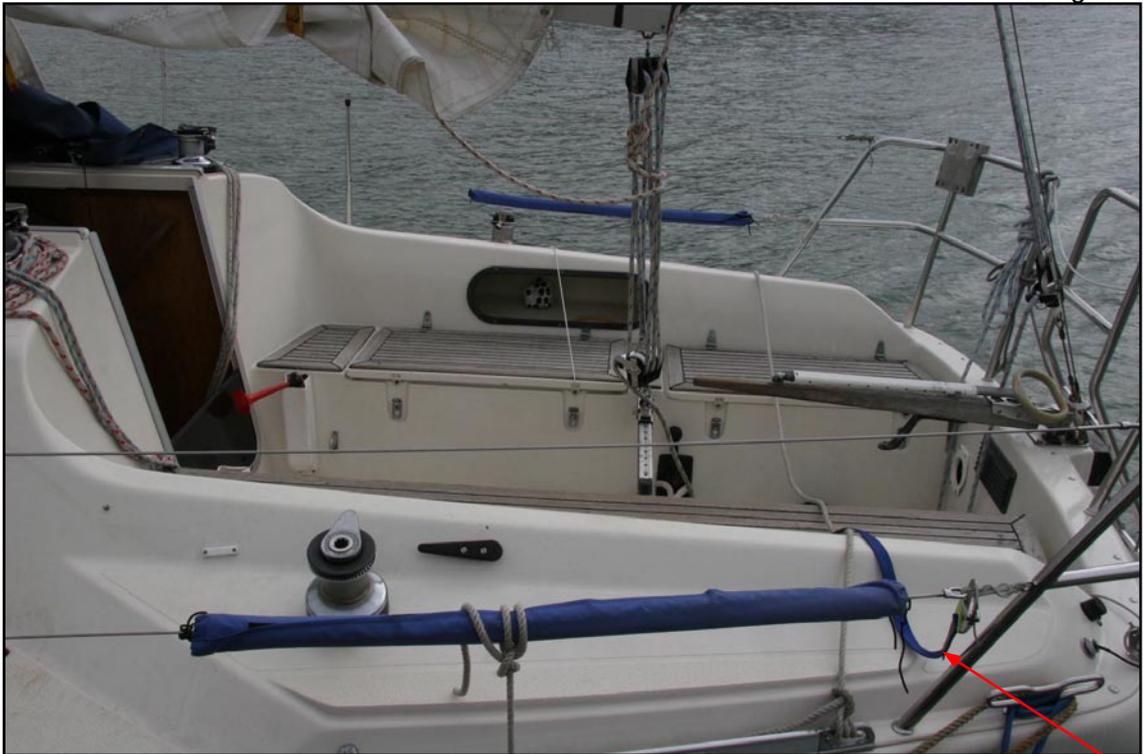
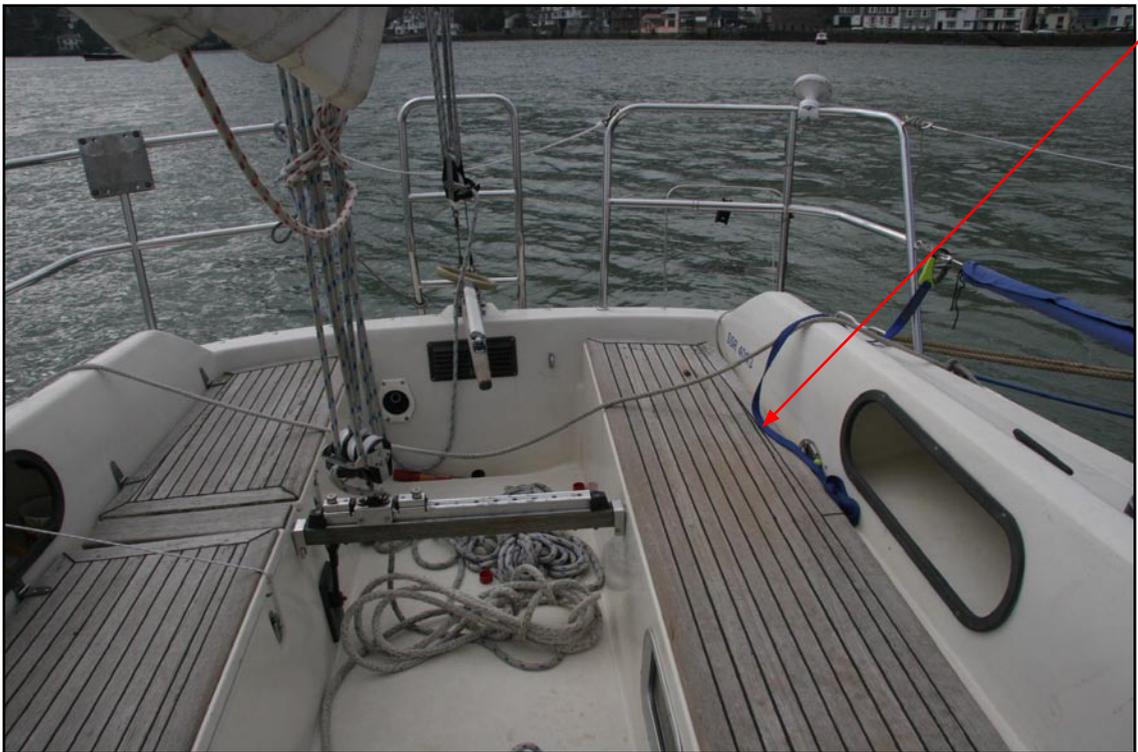
Figure 2

Owner's  
lifeline

The cockpit

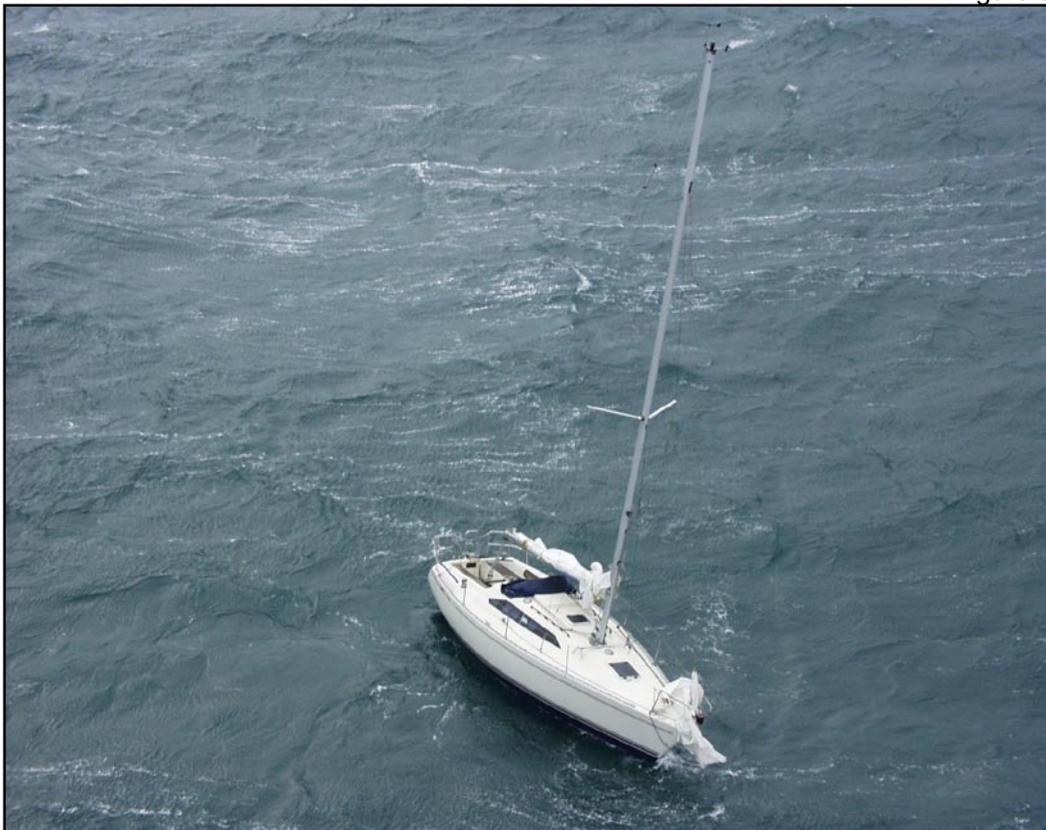
Figure 3

*Pastime* was eventually taken under tow by the tug *Kingston* and taken to Dartmouth. The yacht was discovered to be afloat, intact and upright with the foresail wrapped around the pulpit (**see Figure 3**).

Yacht *Pastime* the following morning

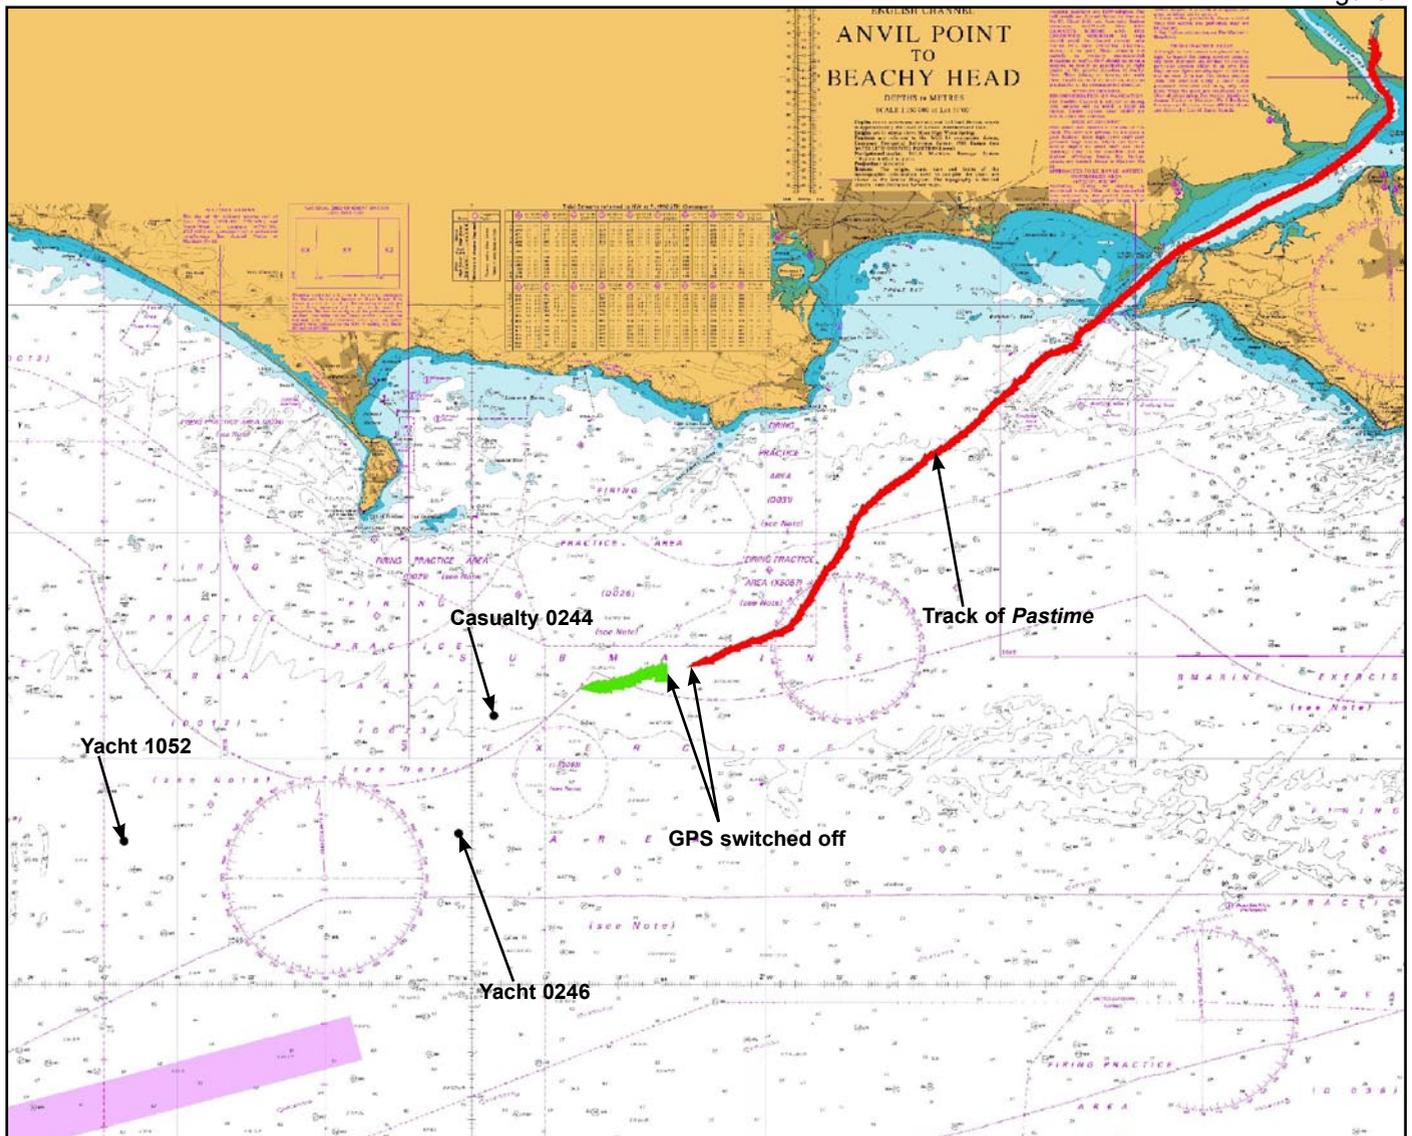
Figure 4

**Figure 4** shows the tracks downloaded from the GPS receiver on *Pastime*. The red and green tracks are two separate files found in the memory of the receiver during the MAIB investigation. They indicate that power to the unit was interrupted, as the record of positions is not continuous. It is unfortunate that the time recorded with the positions by the unit is the time interval between the recorded positions, and not UTC. It is not possible to determine the exact time at which the power went off and when it was restored, nor the time it finally failed. The estimated times extrapolated from this information support the witness's recollection of events, and support the timescales for electrical power reduction given in **Diagram 1** (see Section 2.8, page 30).

Download from GPS showing track of *Pastime*

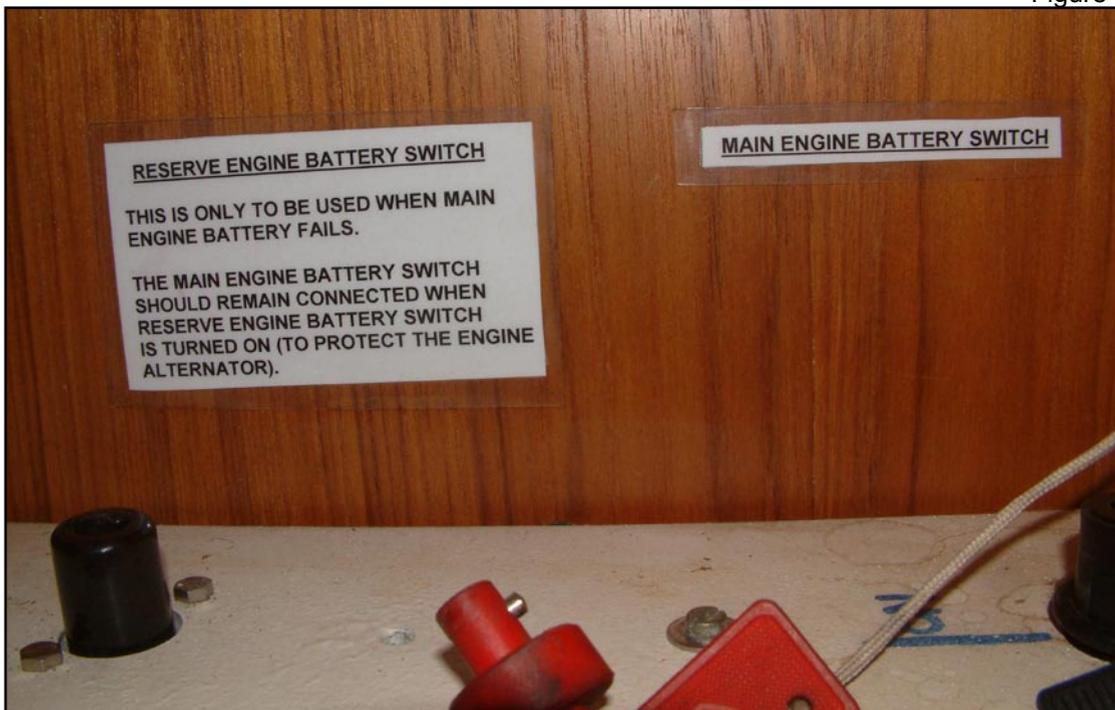
Figure 7

Battery changeover labelling

The independent report into the loss of electrical power identified that the battery cross-connection switch was defective, and that the two batteries were permanently connected in parallel. Because of this, any reduction in domestic battery power would have resulted in the engine starting battery power also being reduced.

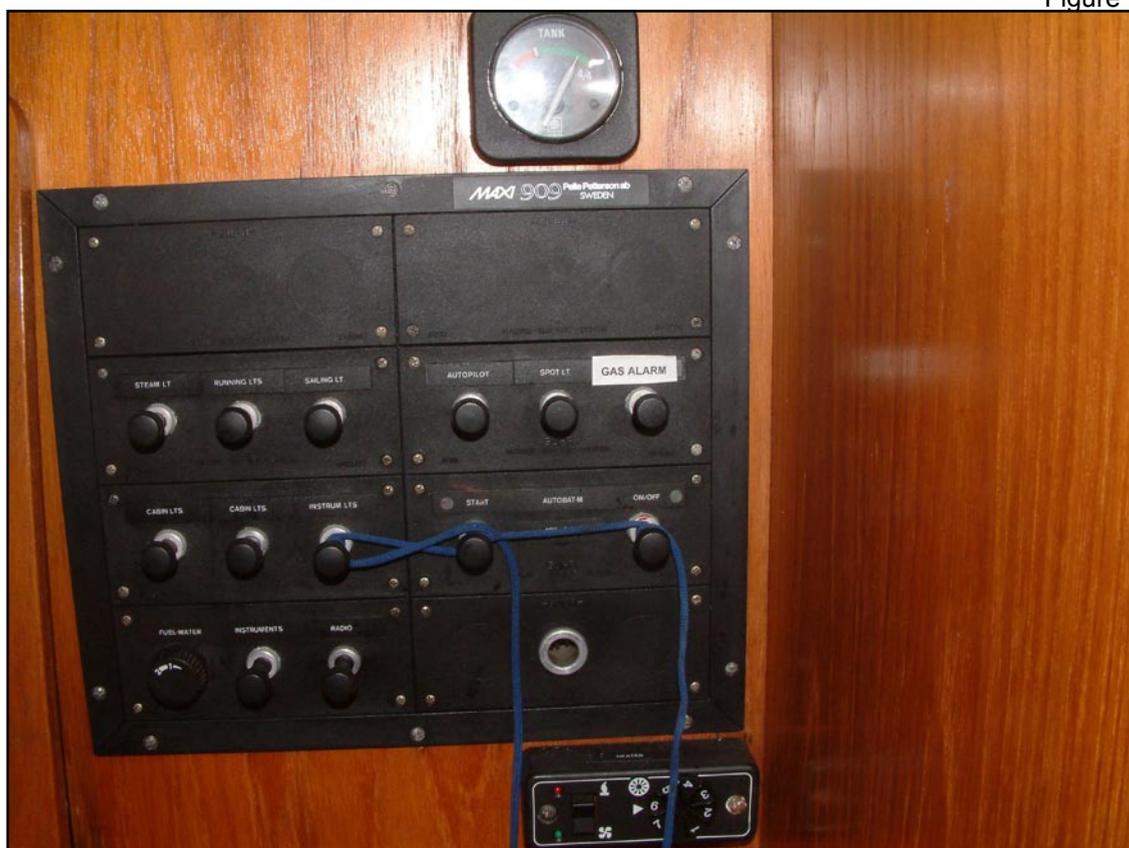
Figure 9

unit. During the initial examination of the distribution panel at Dartmouth, a spectacle cord, belonging to the delivery skipper, was found to have been wound around the ON/OFF, START and INSTRUMENT LIGHT push button switches (see Figure 9). The significance of this is discussed in Section 2.8.

Distribution panel showing spectacle cord overriding switches

Section 1.7.4 notes that the delivery skipper's spectacle cord was wound around the START switch. This would have artificially held the low voltage protection switch in the ON position to prevent it from operating, and thus keeping the onboard services live until they progressively failed as the voltage diminished. Luckily, there was just sufficient battery power left for the owner to alert the coastguard of the emergency situation once the skipper had been lost overboard.

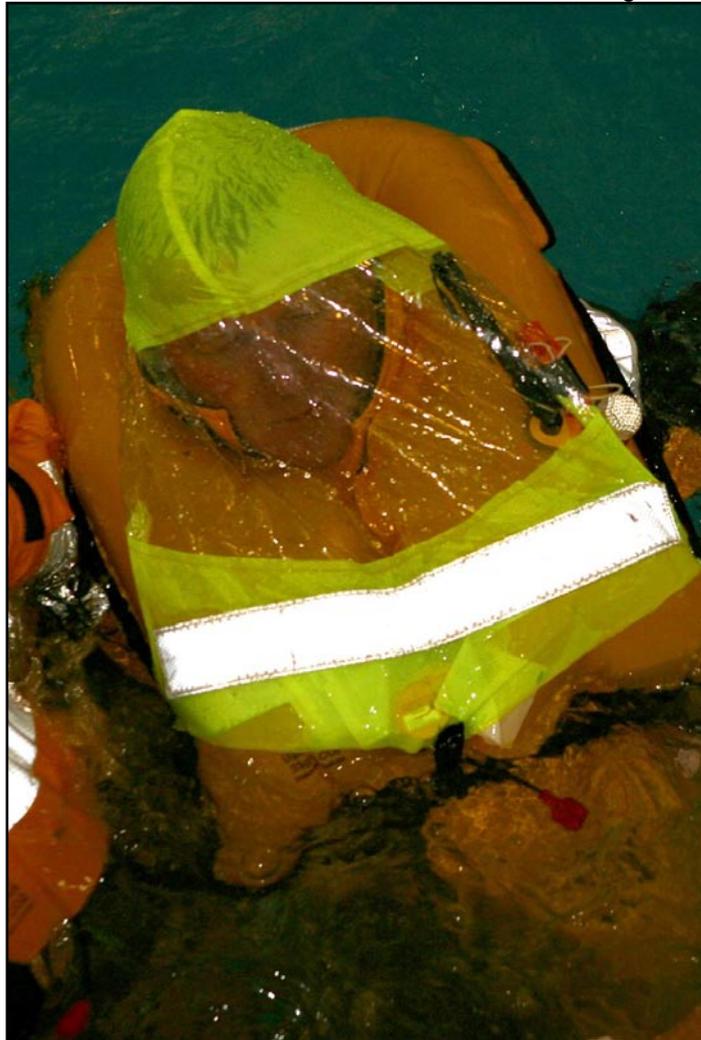
Figure 10

Also in this book, they discuss the use of lifejackets. Lifejacket buoyancy is mainly distributed over the front of the upper torso, to facilitate self-righting. The legs then act as a sea anchor, turning the body so that within one or two waves, an unconscious person will float facing the on-coming waves. In larger breaking waves, the narrow wave crest may, periodically, wash entirely over the wearer’s face. This phenomenon is known as “wave splash”. Repetitive wave splash will interfere with normal breathing. A conscious person can synchronise breathing with wave splash, but this becomes uncomfortable. A conscious person will soon learn to put their back to the waves. To maintain this position requires small swimming movements, and thus increases the rate of heat loss. An unconscious individual is more likely to drown due to wave splash than to succumb to hypothermia. The use of a spray guard, or hood fitted to the lifejacket, avoids the problem of having to synchronise breathing with wave splash (**see Figure 10**).

Typical spray hood - under evaluation by RNLI

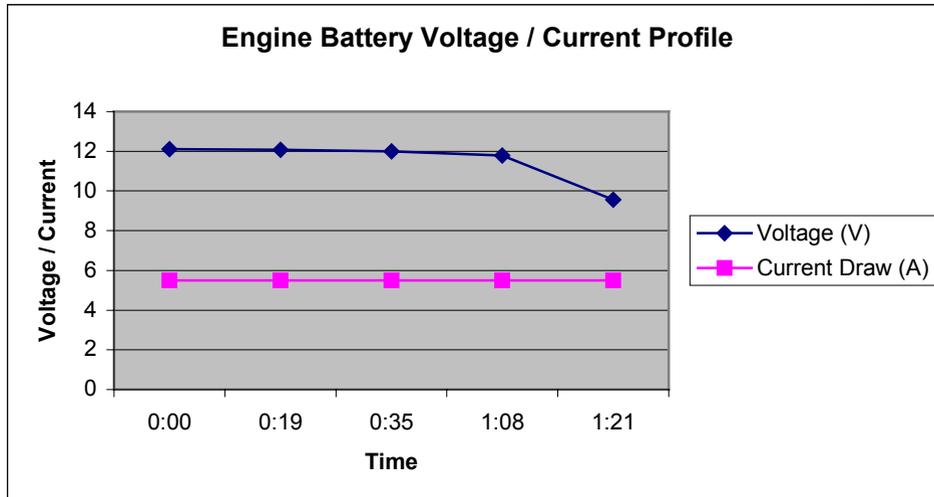
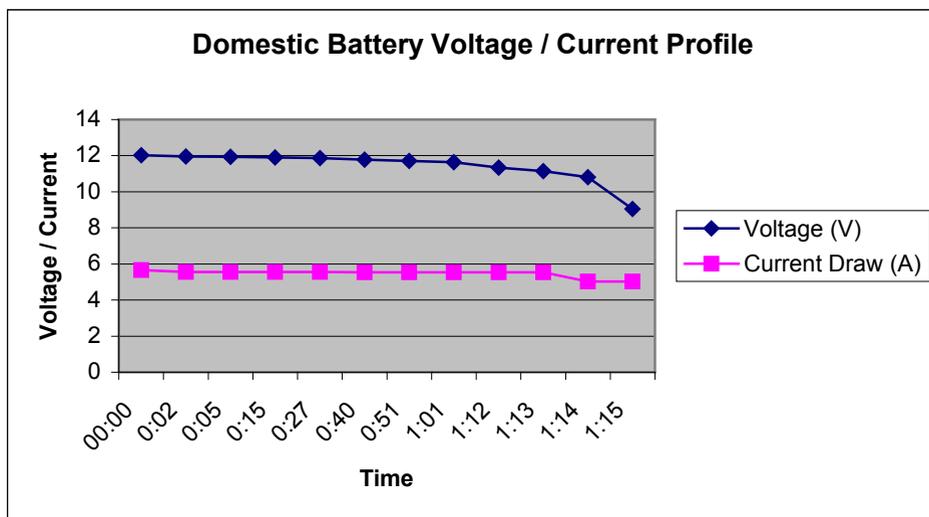
Diagram 1

It was also found that the domestic battery plate condition was very poor and had suffered from sulphation, rendering it incapable of maintaining its charge, and this was the cause of the power failure. Trials proved that the combined battery output would have lasted for only about 2 1/2 hours, based on the electrical equipment in use at the time. The battery voltage would have rapidly dropped off after that time, making it impossible to start the engine. The domestic and engine battery time/current/voltage trial profiles are shown at **Diagram 1**.
