Report on the investigation of the serious  
injury to a member of the crew of the LASH vessel

***Spruce***

at Victoria Docks, Hartlepool

**Report No 27/2006  
October 2006**

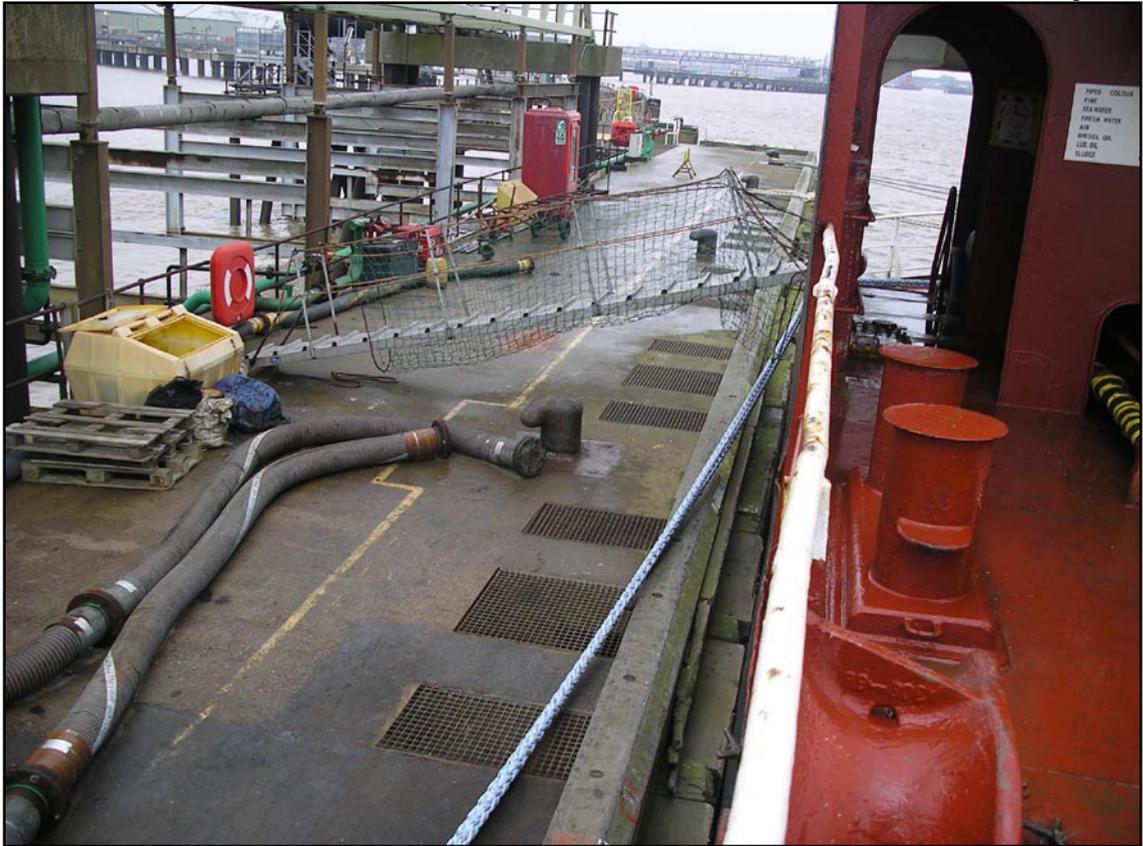
The pilot arrived at 1705, and the crew were called to prepare for departure at 1712. Five crew members, two seamen, two motormen and the steward, started to manhandle the gangway on board. The gangway was portable, about 100kg in weight and 6.0m long (**Figure 3**).

*Spruce* gangway rigged aft

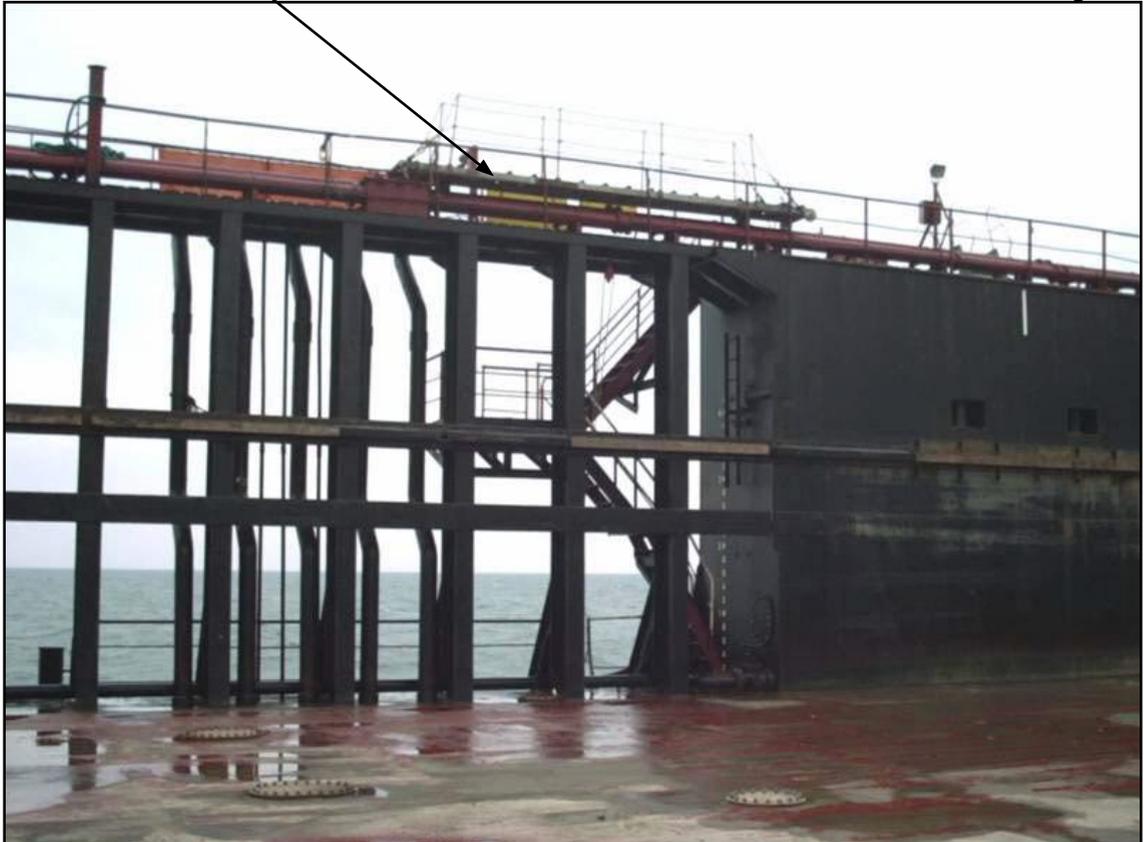
Figure 5

Access to the cargo hold and the tank top could be gained from the main deck using integral ladders built into the hull sides (**Figure 5**).

Photograph showing the ladder which is recessed into the hull

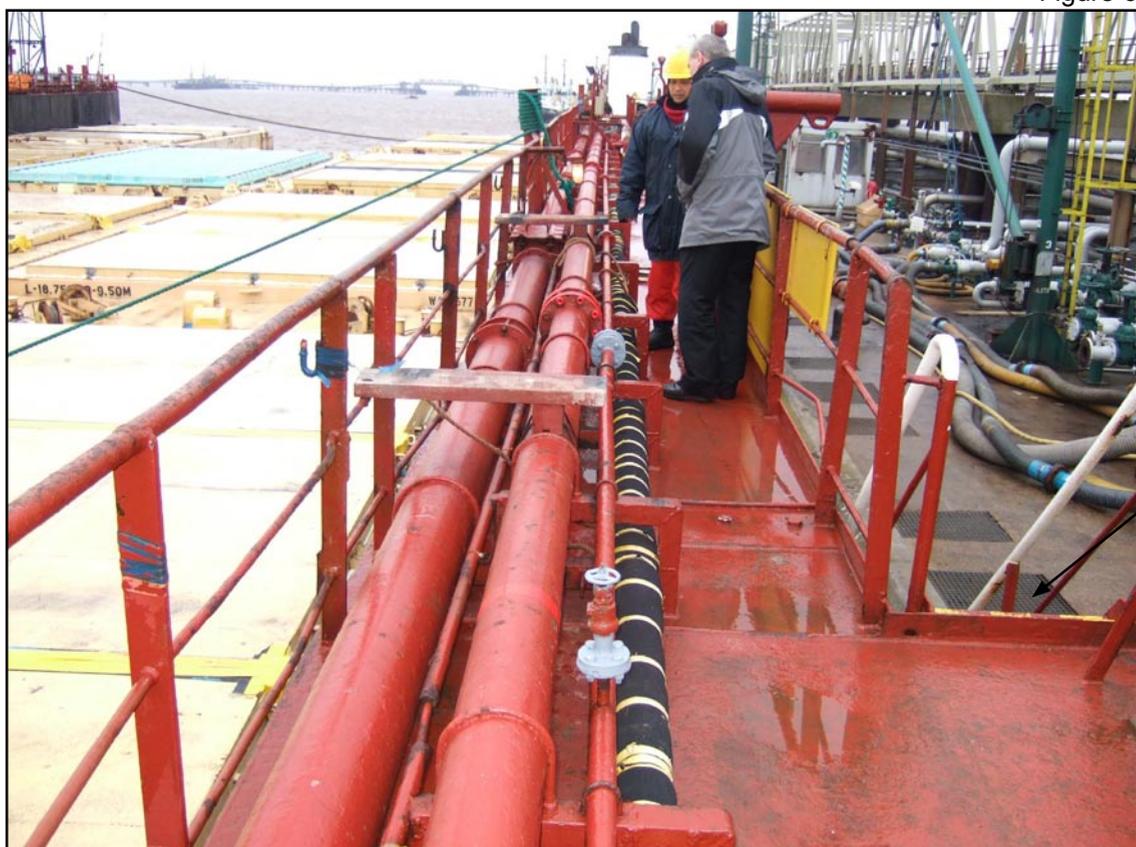
Figure 6

Ladder

Gangway stowage area

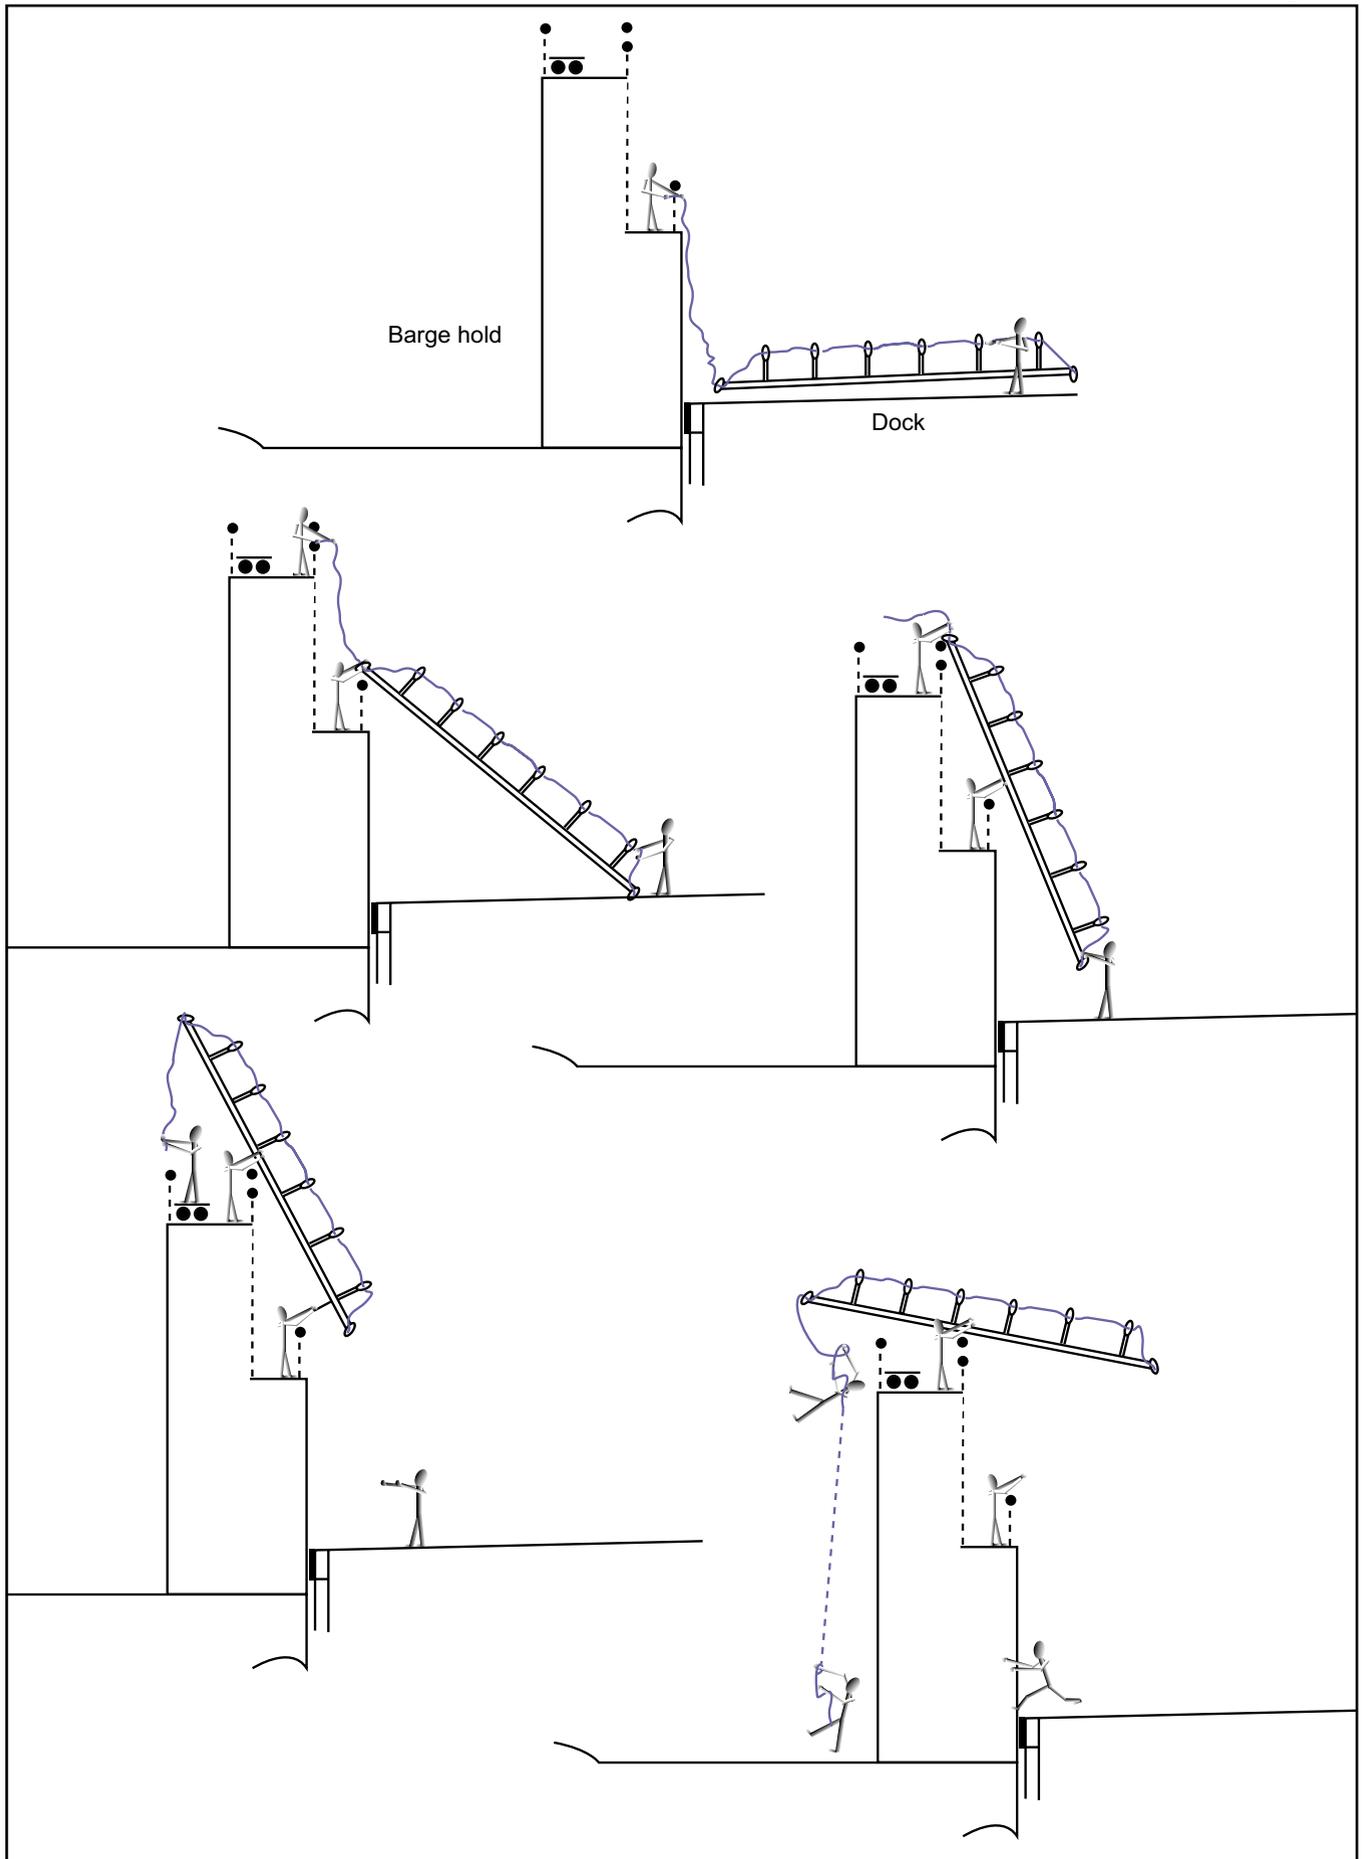
Without being asked, the cook took hold of the steadying line at the end of the gangway, wrapping it around his hands, and then proceeded to pull down to help turn the gangway in and onto the deck near its stowage position. Due to the restricted amount of space, the retrieval of the gangway was hampered. As the gangway came further inboard, the cook found he needed to move further towards the inner side of the deck space, and he stepped onto some pipes to get better leverage. Finding that this was not sufficient to bring the end of the gangway down, he then straddled the inner ship's rail.

Diagram showing sequence of events (not to scale)

The crew continued to heave and push as the gangway came further over the outer ship's rails. The cook was still heaving on the line but, by now, he was leaning out and over the empty cargo space.

The gangway pivoted over the top rail and tipped towards the cook very suddenly, and he found himself with nothing to pull against and consequently lost his balance.

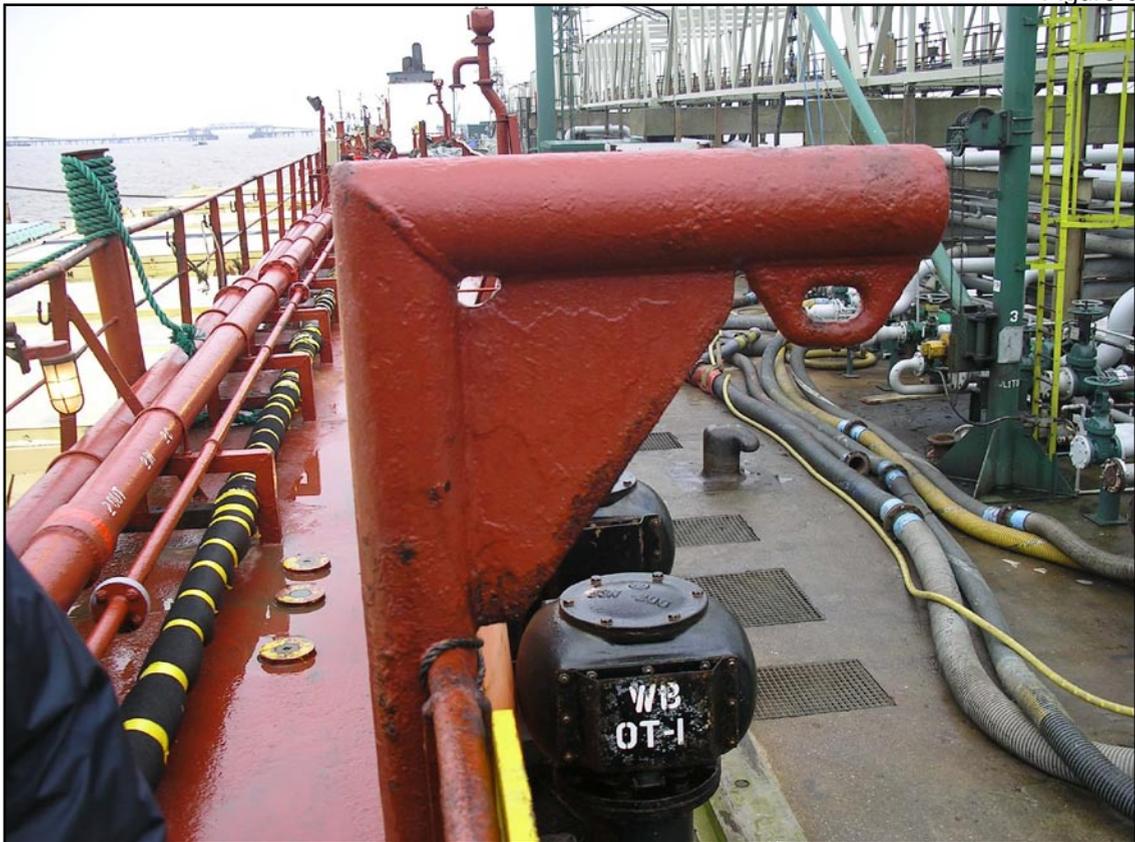
A system to help in handling a fixed gangway had been fitted during an earlier period of the ship's life (**Figure 9**). This had been removed some time before the accident, and had not been replaced. The date of its removal, and the reason, was not documented and is not known.

Remains of removed lifting arrangement

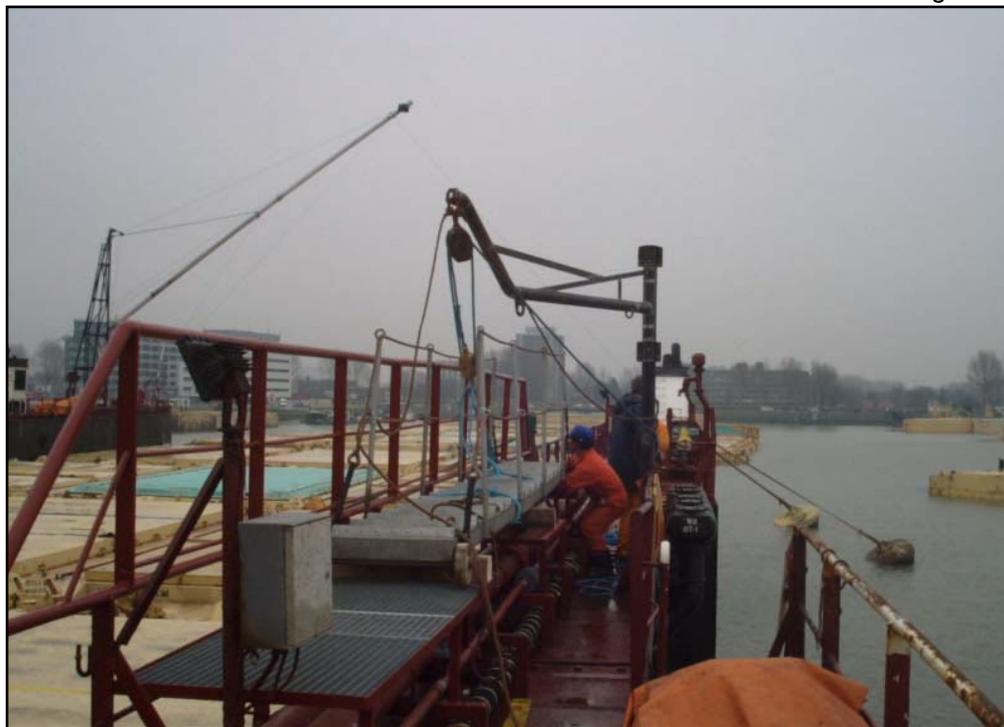
Figure 11

Modified lifting arrangements and extended safety rail

- 1) LMS Shipmanagement Inc has arranged for fixed gangway lifting arrangements to be designed, supplied and fitted to *Spruce*. Additional railings have been fitted on the inboard side adjacent to the gangway stowage position (**Figure 11**).
