Report on the investigation of
the grounding and subsequent foundering of
fv Greenhill
off Ardglass, Northern Ireland
19 January 2006

Marine Accident Investigation Branch
Carlton House
Carlton Place
Southampton
United Kingdom
SO15 2DZ

Report No 19/2006
August 2006

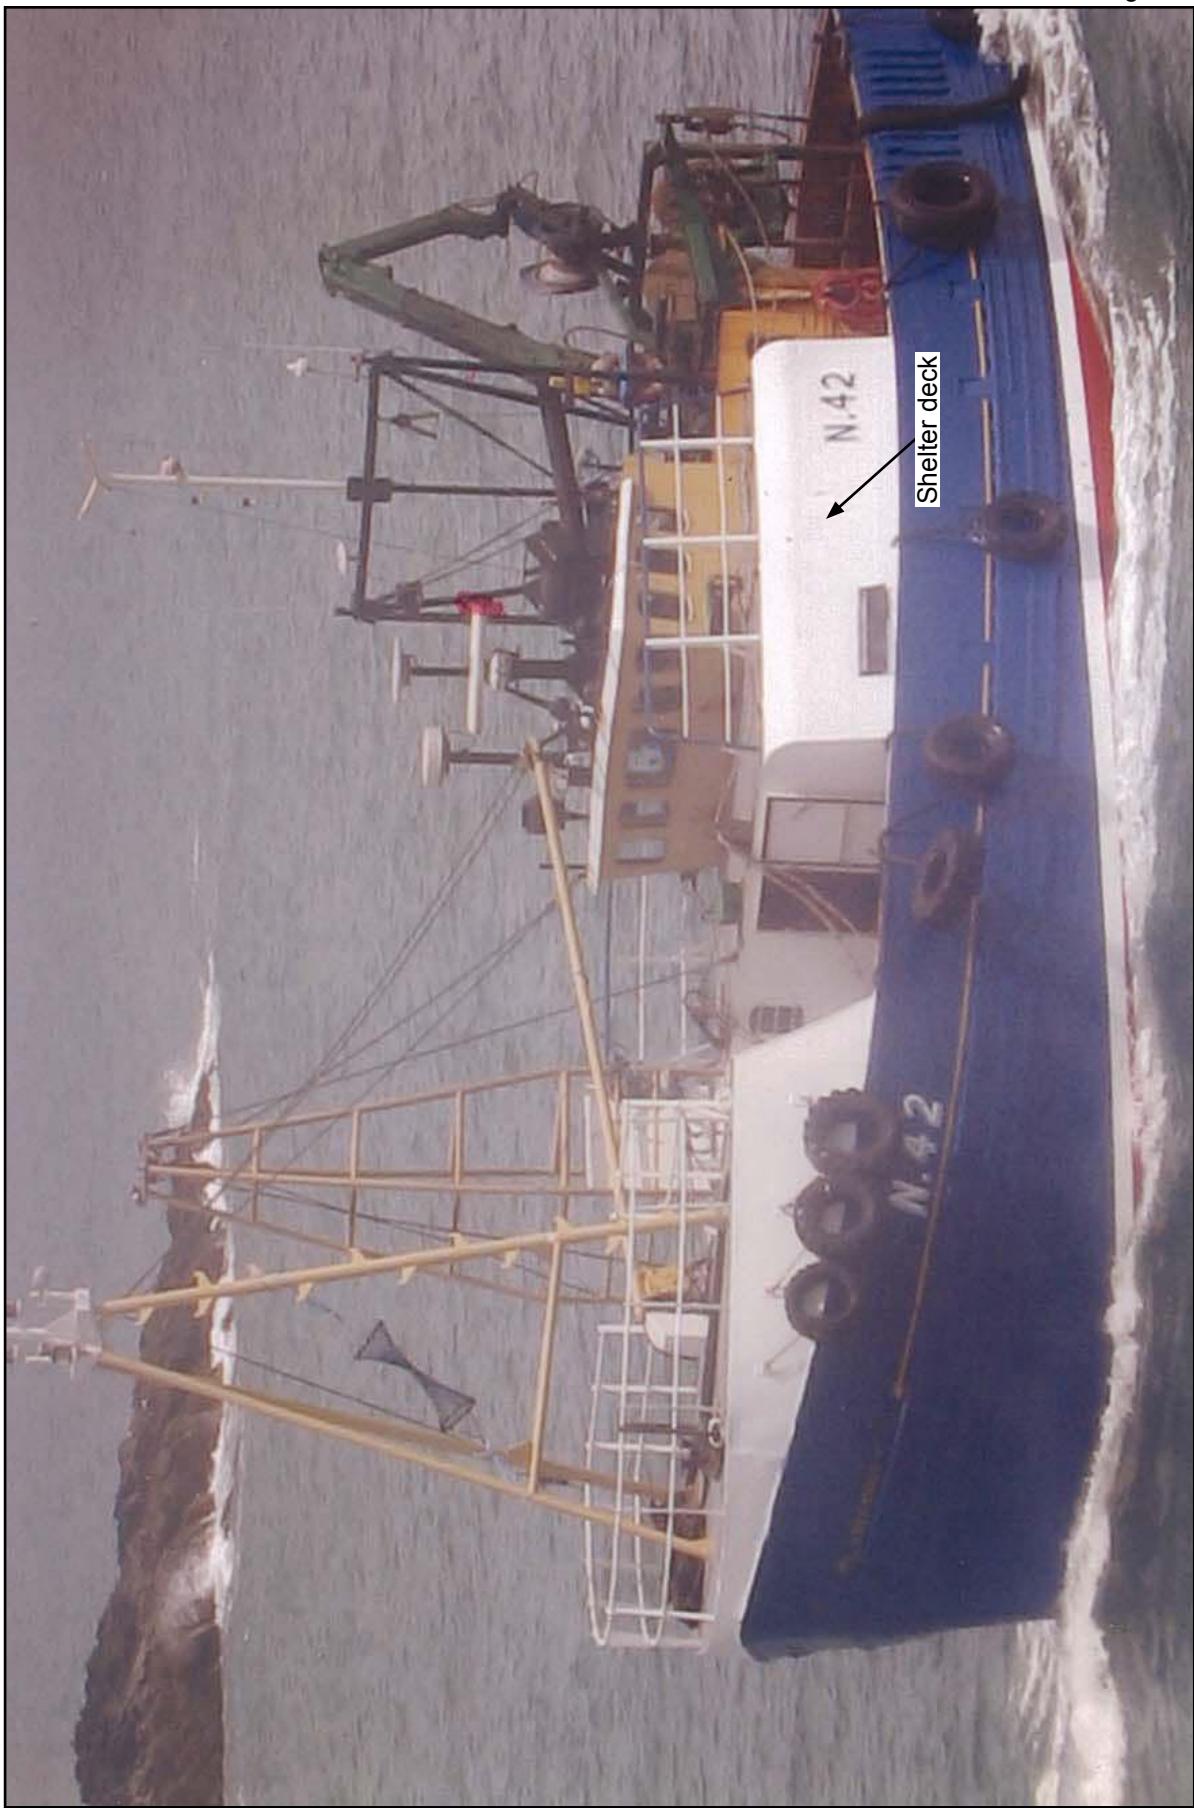
Figure 1

Photograph of Greenhill's port side

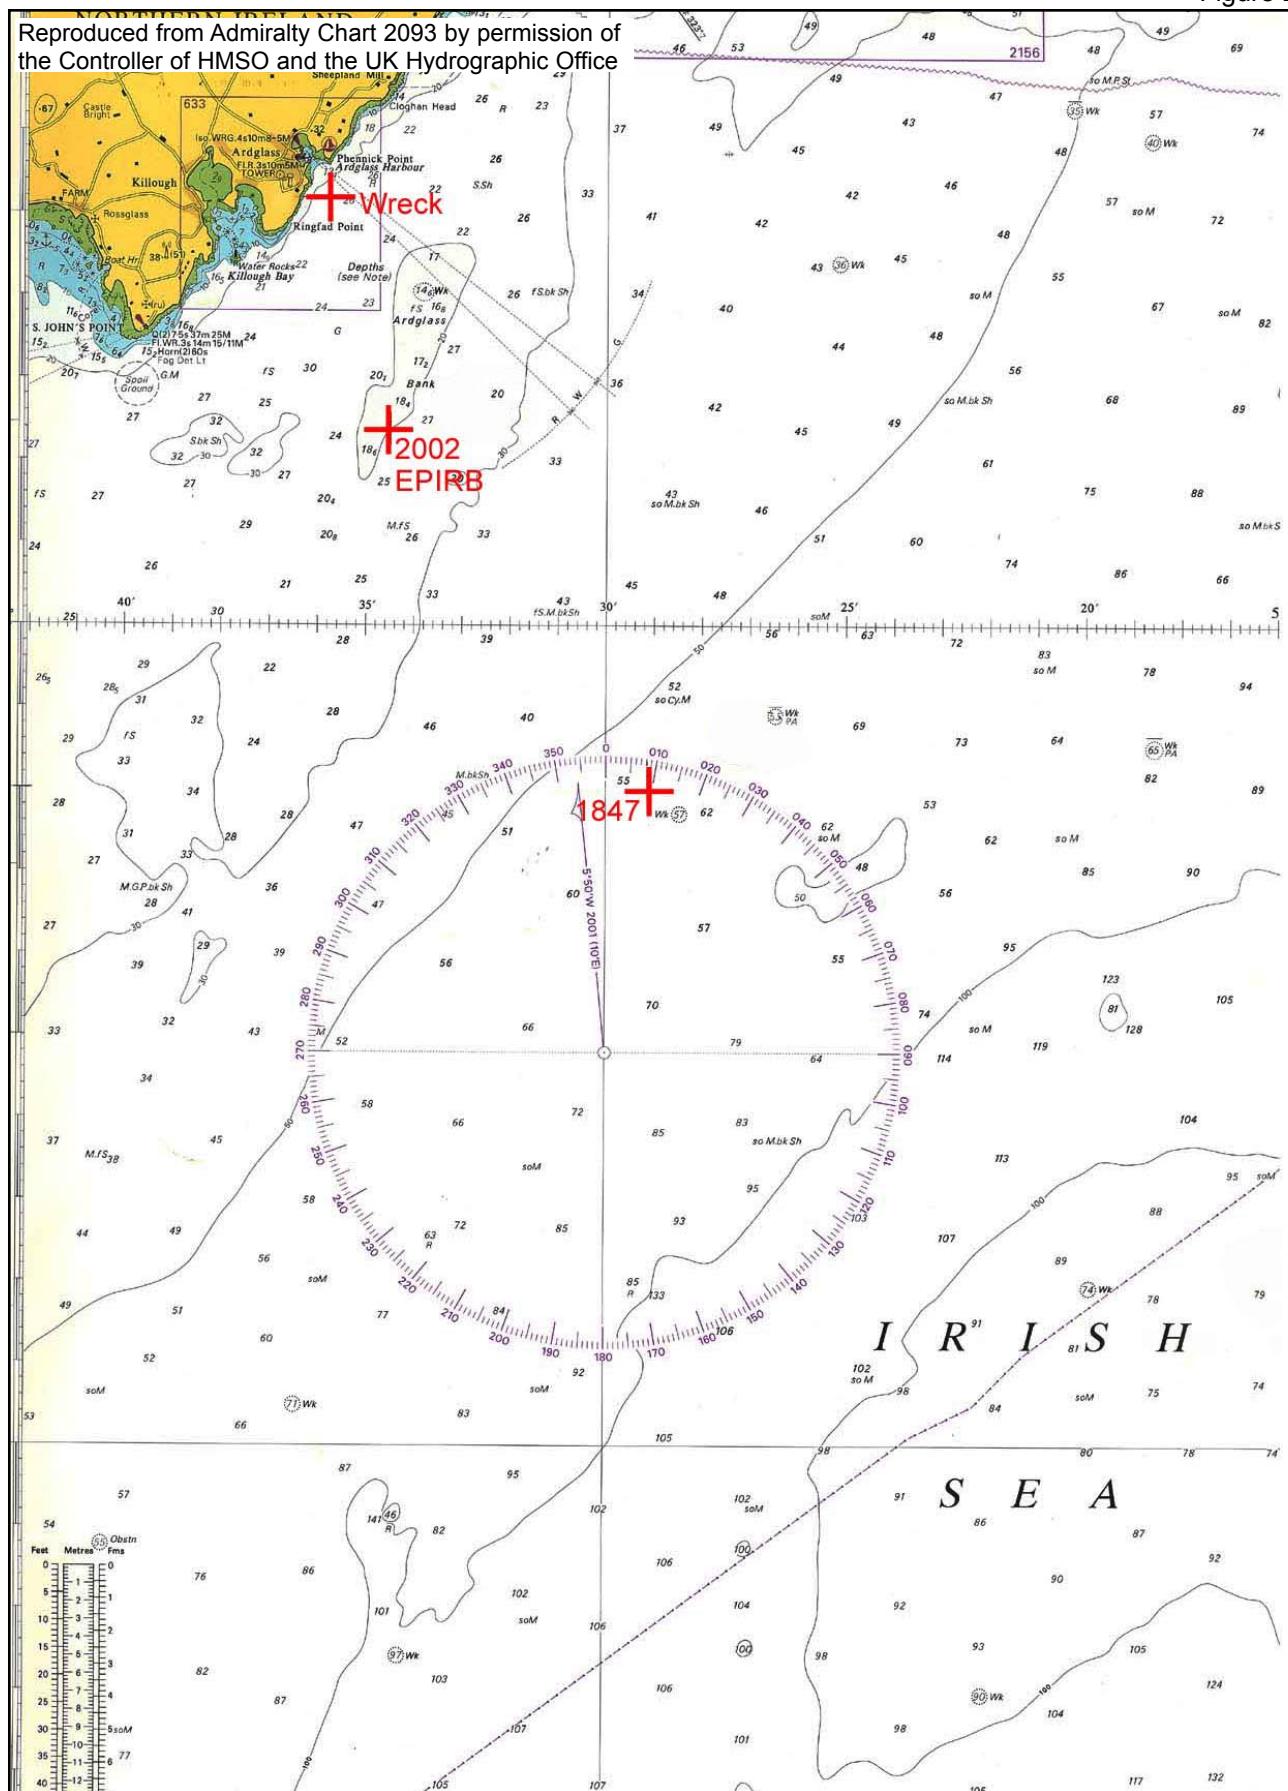
Figure 2

On completion of hauling at about 1730 on 19 January 2006, the skipper of *Greenhill* set a course of 335° on the autopilot to return to Ardglass, which was about 18 miles to the north-west. Speed over the ground was between 6.5 and 7 knots. The skipper then joined the vessel's two deckhands in the shelter deck (**Figures 1 and 4**). During the passage, the skipper and deckhands prepared the catch of prawns for market, using a table on the port side of the shelter deck. The skipper returned to the wheelhouse about every 5 minutes to check on the vessel's position and to adjust the course set on the autopilot. He also reset the watch alarm during these visits. The vessel's position at 1847, which was transmitted automatically to the MFA, is shown at **Figure 2**.

At about 1945, the skipper made a routine visit to the wheelhouse. The red sector of the light in Ardglass (**Figures 2 and 3**) was visible, and he estimated by eye that the ship was about 1 mile from the shore. Neither radar, nor GPS were used to verify *Greenhill*'s position. The skipper then returned to the shelter deck to complete the preparation of the prawns, which he estimated would take about 5 minutes.

Extract of Chart BA 2093

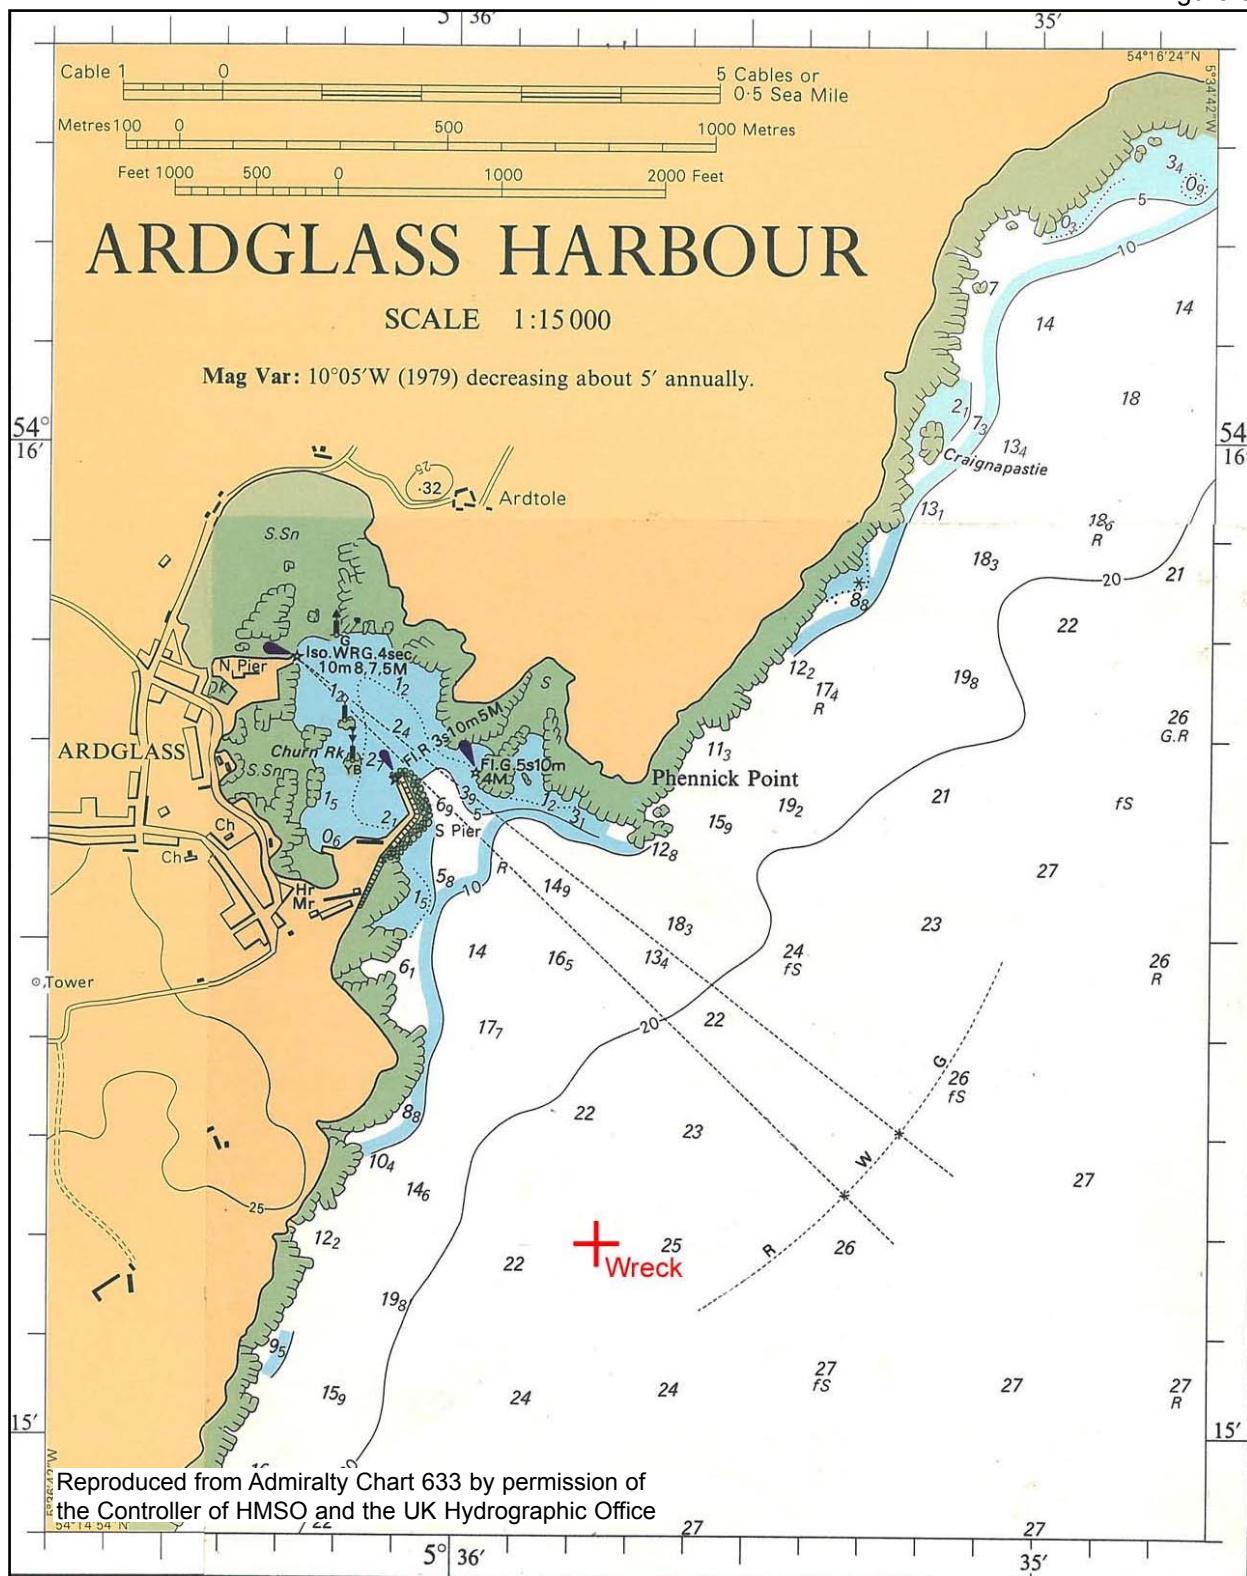
Figure 3

Extract of Chart BA 633

The wreck of *Greenhill* was located 600m from Ardglass harbour (**Figure 3**) on 20 January 2006. The vessel was searched by divers from the Police Service of Northern Ireland (PSNI) and the Army. Reports from these and subsequent dives by local volunteers, indicate that the vessel was embedded in the seabed of hard sand and mud up to the normal waterline, with a slight list of about 5° to starboard. The wheelhouse engine control was set in the ‘ahead’ position. Damage included: a hole through the bottom half of the vessel’s bow; sprung planks; the shelter deck dislodged to port; and the forward part of the whaleback lying down, and over, the port rail.

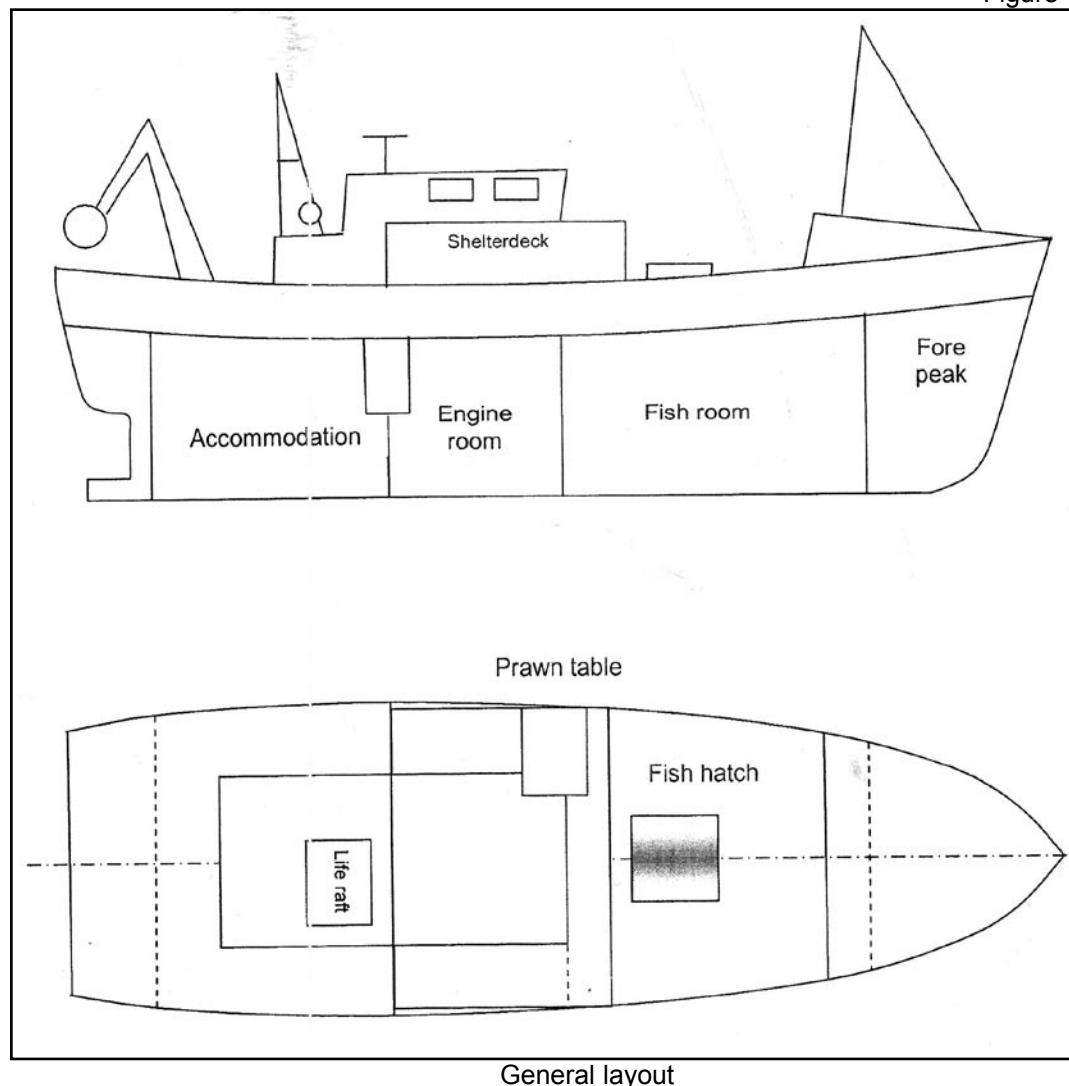
Figure 4

A general layout of *Greenhill* is shown at **Figure 4**. The vessel was one of the largest of about 20 boats based in Ardglass harbour. Built as a herring trawler in 1975, the vessel was made of larch on oak in carvel construction. *Greenhill* had a whaleback at her bow and had, in 2004, an aluminium shelter deck fitted forward of the wheelhouse and galley (**Figures 1 and 5**). The vessel was roll tested on 18 November 2004 to confirm her stability after the shelter deck was fitted. The test results indicated that the vessel's calculated metacentric height (GM) was 0.90m, which was in excess of the 0.69m minimum required for the vessel's dimensions.

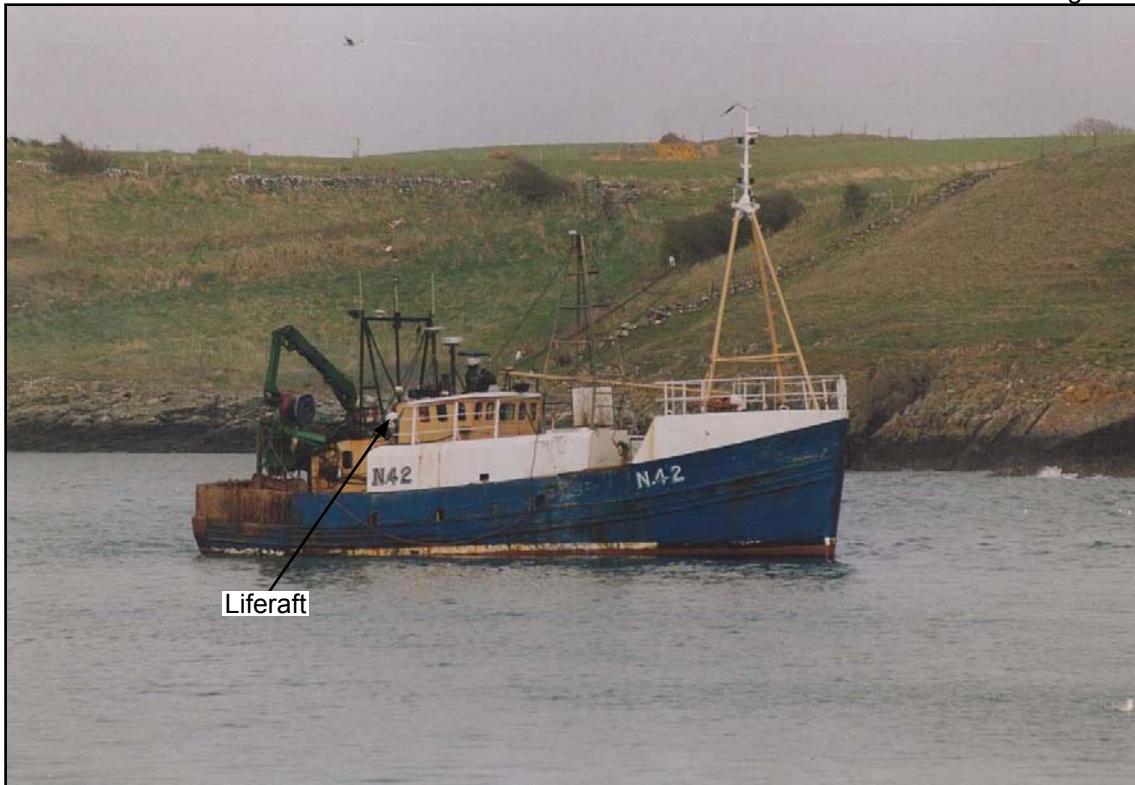
Figure 5

Photograph of *Greenhill's* starboard side
