Report on the investigation of
the grounding of

Berit

Trindelen Bank, near Gedser

Report No 17/2006
July 2006

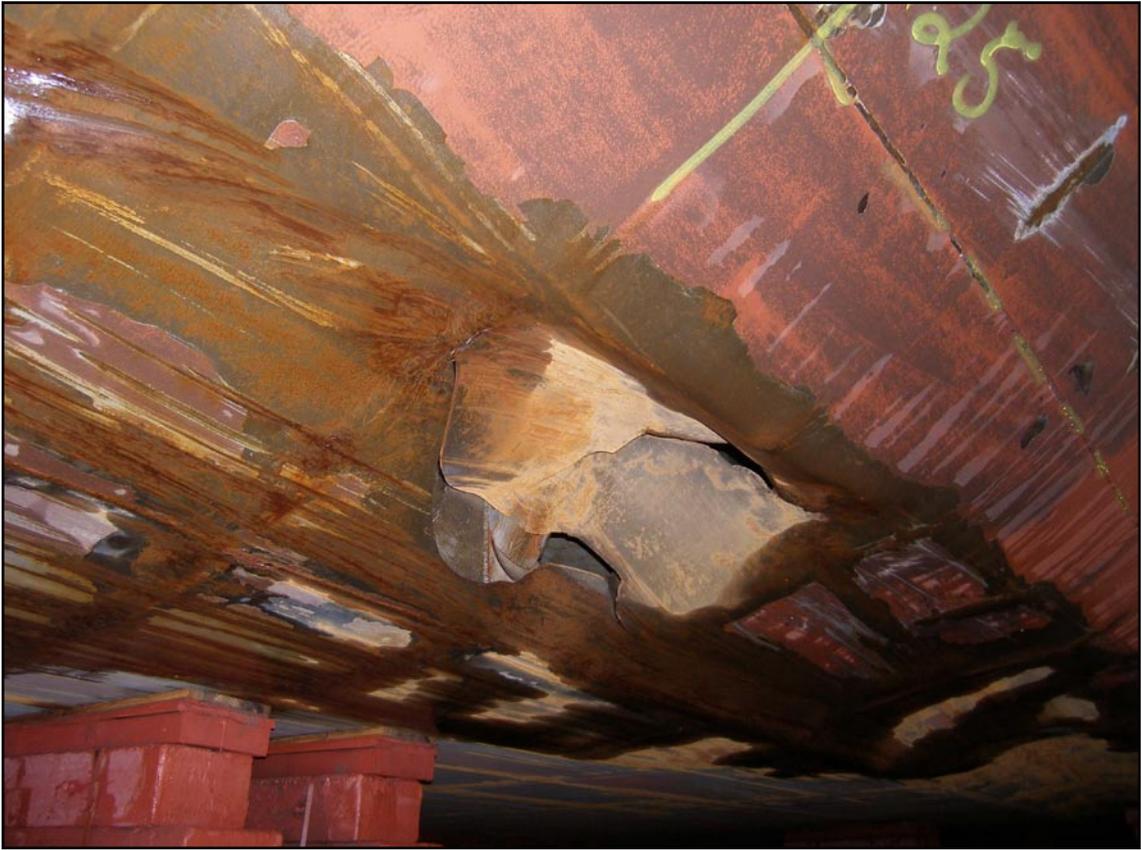
Figure 2

Damage to port side no. 3 water ballast outer tank

Due to deteriorating weather, a diver survey of the hull while at anchor was not possible. After negotiations, and with a tug standing by, *Berit* proceeded to the port of Rostock, Germany, under her own power, to facilitate the diver survey of her hull. There, it was confirmed the hull had been breached in two places. The tank sounding system had not indicated any damage as the spaces affected had been full with sea water ballast before the grounding.

The ship's classification society, Germanischer Lloyd, permitted *Berit* to sail to Rotterdam at reduced speed to unload and conduct repairs. **Figures 2 and 3** show the damage that was sustained to the hull during the grounding. **Figure 4** shows the damage inflicted on the tips of the CPP blades. Temporary repairs were made in Rotterdam before *Berit* sailed in ballast to Gdansk for full repairs.

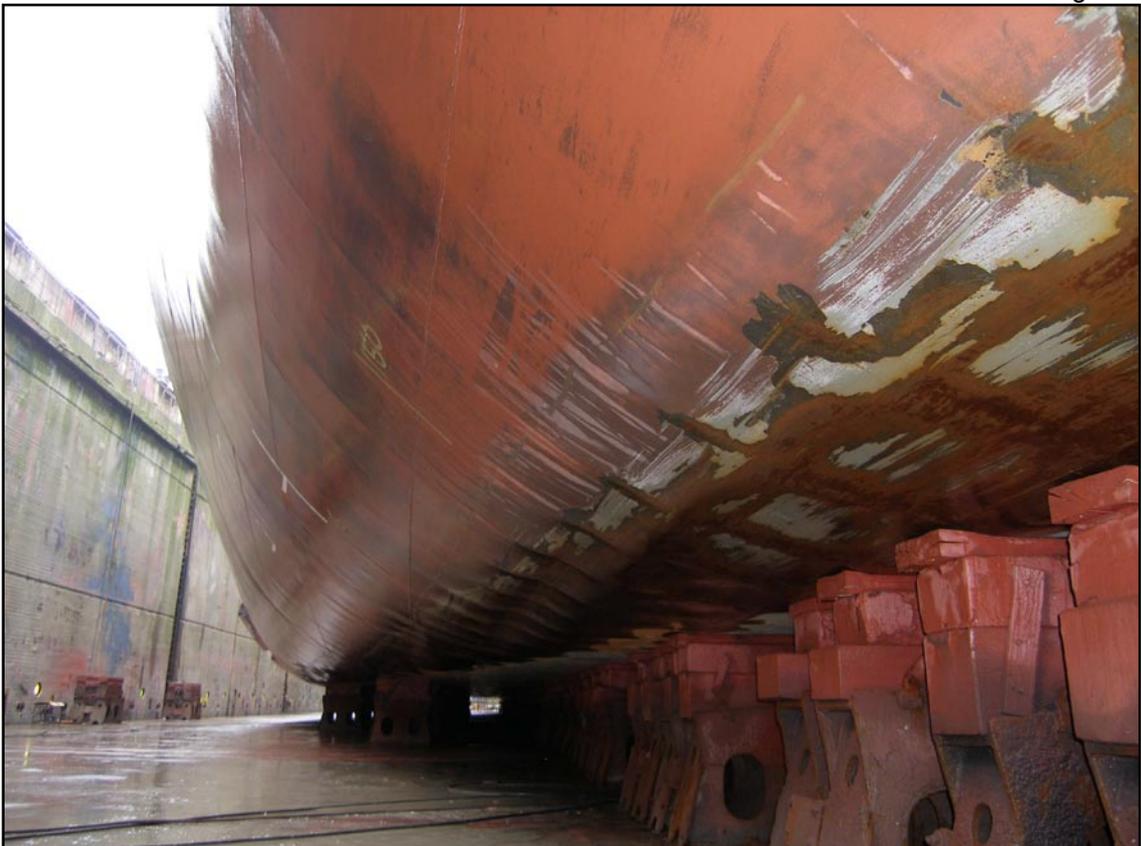
Figure 3

Damage to starboard side turn of bilge

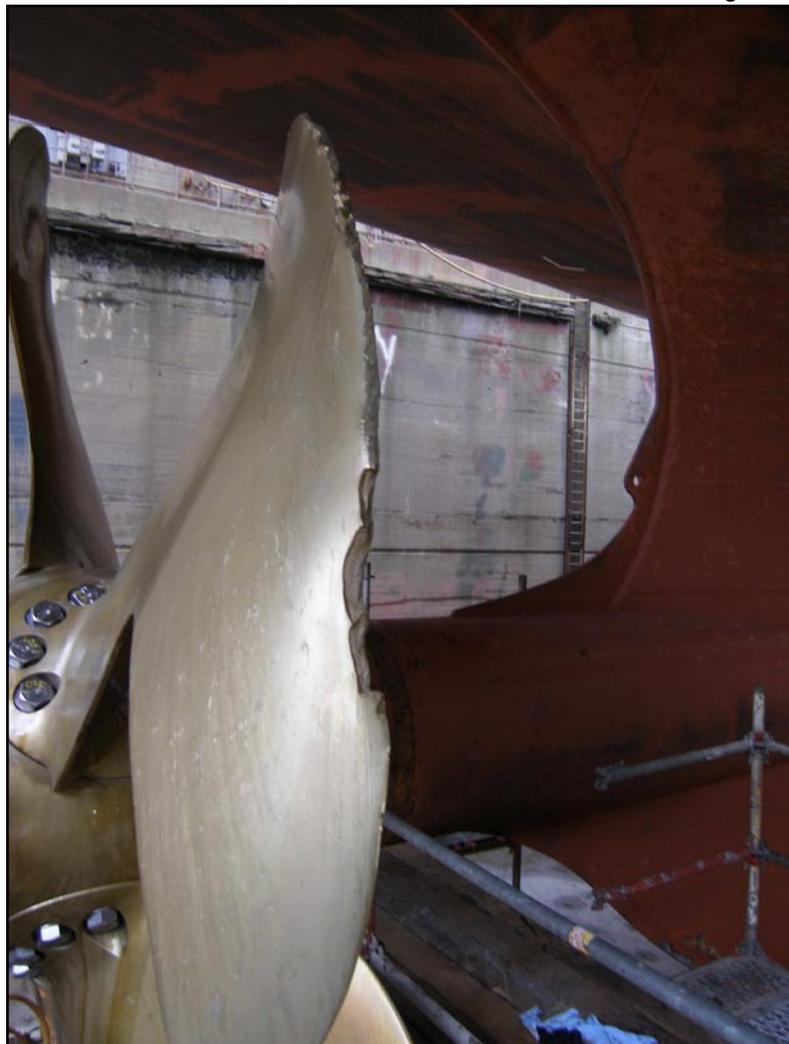
Figure 4

Propeller damage

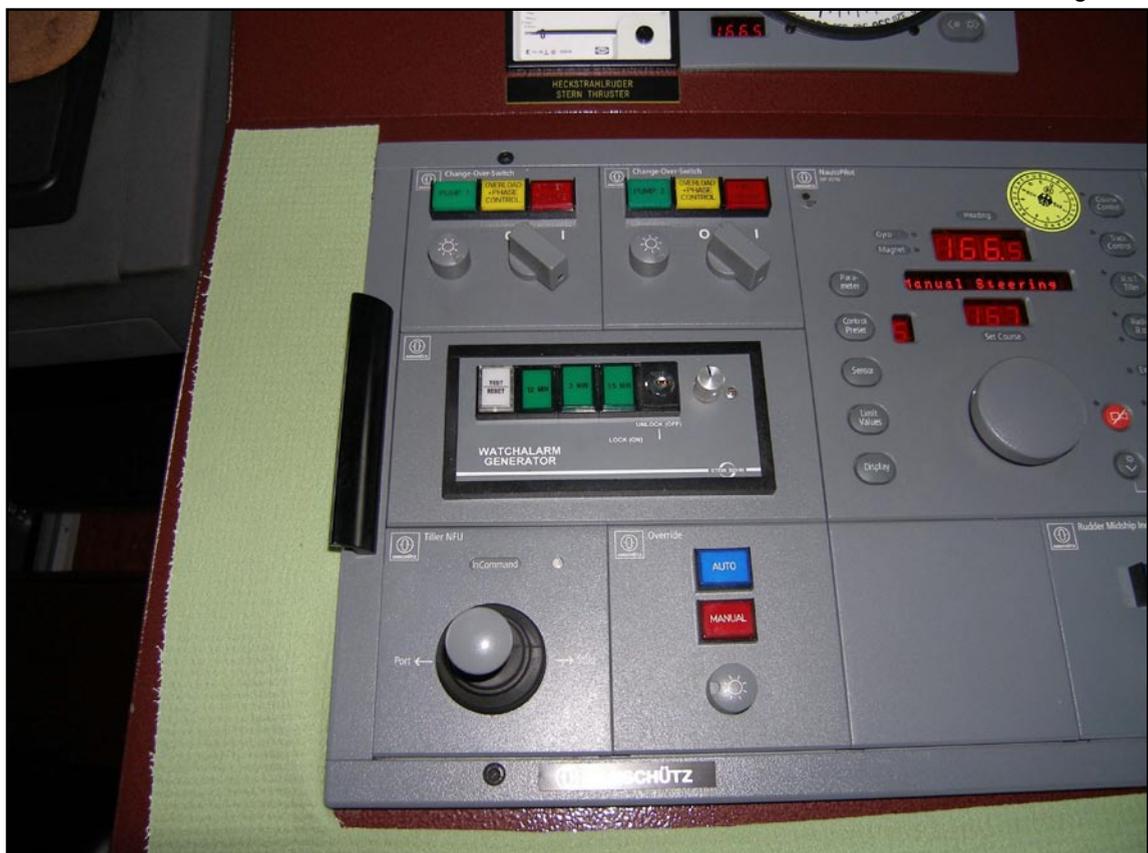
Figure 7

Steps had been taken on *Berit* to ensure an OOW stayed alert by the provision of a watch alarm. However, there is some evidence that the key to activate the system was not always removed, therefore permitting those on the bridge to disengage it.

A watch alarm is an alarm system that is designed to alert the watchkeeper at pre-determined intervals. On *Berit*, the watch alarm was incorporated in the ship's autopilot (**Figure 7**). It was activated by turning a key, which could be removed, ensuring the watch alarm remained on whenever the autopilot was engaged. The initial alerting period was 12 minutes, after which a visual alarm activated. This was followed, after a short period of time, by an audible alarm on the bridge. A short time later, if one of the reset buttons in the bridge had not been pressed, an alarm would sound in the officers' cabins. If the watch alarm had still not been reset after sounding in the cabins, the general alarm would sound.

The watch alarm could be reset before 12 minutes had passed, and the cycle would start again. Resetting the alarm could be achieved at one of 7 reset positions around the bridge: on the bridge wings, either side of the centre console, in the chart area, in the communications area and at the watch alarm control. The watch alarm was not generally used during the day, but was engaged from when the master left the bridge at night until his return in the morning. The key for the watch alarm was usually kept by the master.

Watch alarm control
