Report on the investigation of the  
capsize of the fishing vessel

***Noordster Z122***

13 December 2005

**Report No 30/2006  
November 2006**

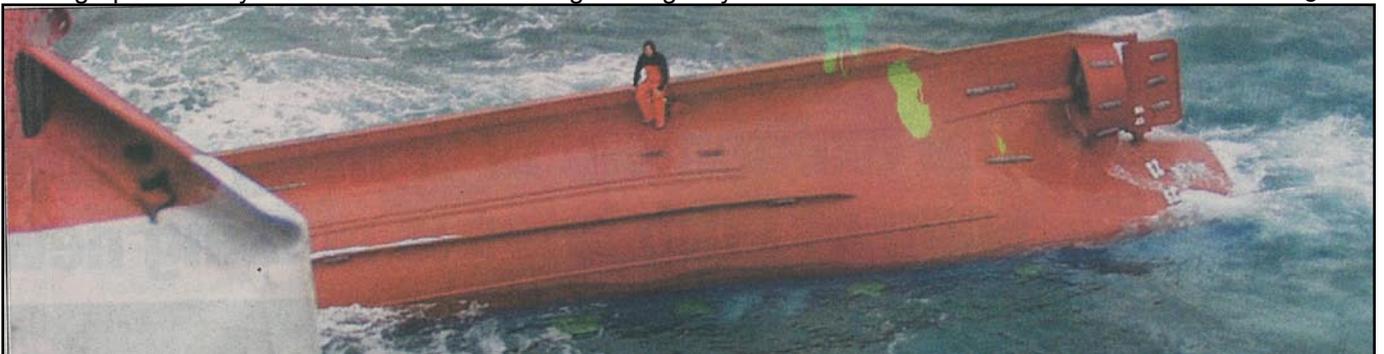
Figure 3

Survivor on upturned hull

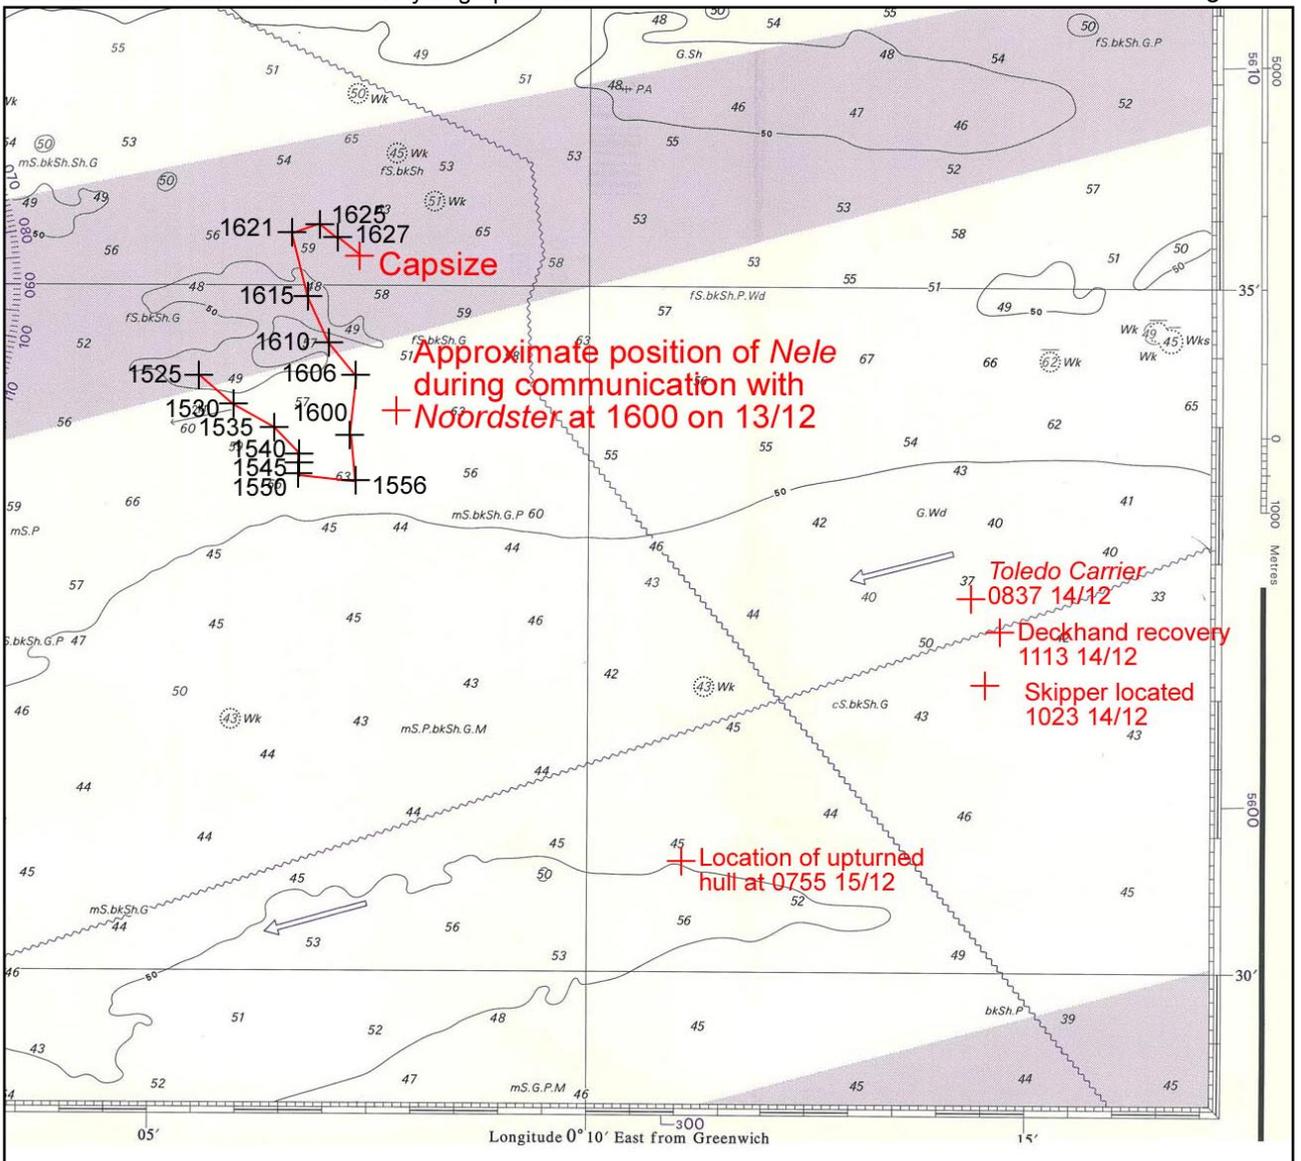
Figure 15

The analysis of *Noordster's* track (**Figure 15**) and speed indicates clearly that her port gear probably came fast at about 1630. The fact that the vessel's radar target disappeared from the screens at 1658 might be indicative of the time of capsizing. However, the elapsed time of 28 minutes does not accord with the survivor's evidence that everything happened very rapidly. Furthermore, the speed with which the gear could have been hauled, bearing in mind the amount of warp out and the speed and power of the winch, would indicate a likelihood that actual capsizing happened earlier. It is possible that the upturned vessel offered a larger radar target initially which reduced as spaces began to flood and she settled further in the water.

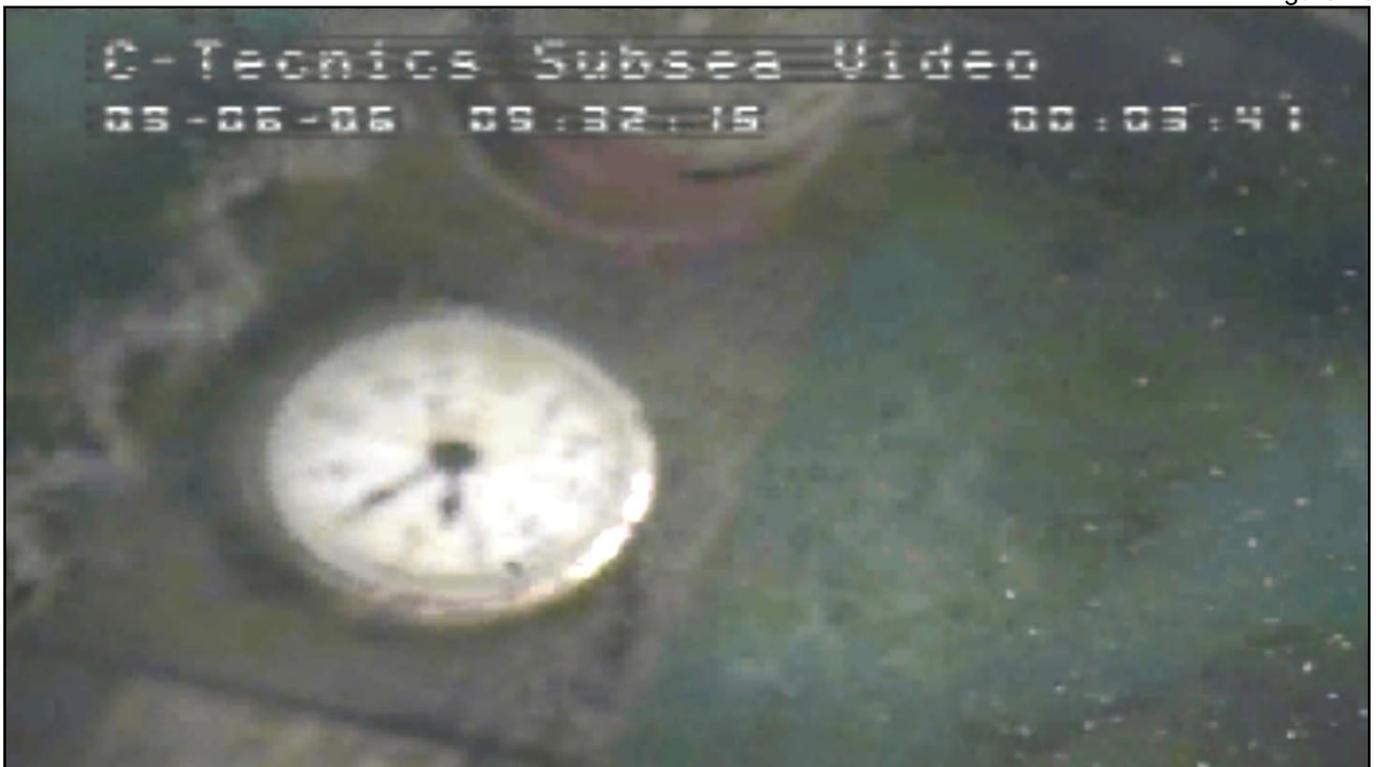
Figure 16

During the underwater survey of the vessel's wheelhouse, it was determined that the wheelhouse clock had stopped at 1735. The clock would have been showing the local time on board (ie the time in Belgium), equivalent to 1635 UTC. Although there is no information available on the accuracy of the clock, its time of failure is too coincidental with the time at which *Noordster* appears to have come fast, for it to be ignored as an indicator of the time of capsizing, although the time span of 5 minutes between coming fast and capsizing, seems too short.

It is therefore concluded that the actual time of capsizing cannot be determined with certainty, but it is believed to have happened between 1635 and 1658.

Wheelhouse clock indicating 1735 (or 0535)

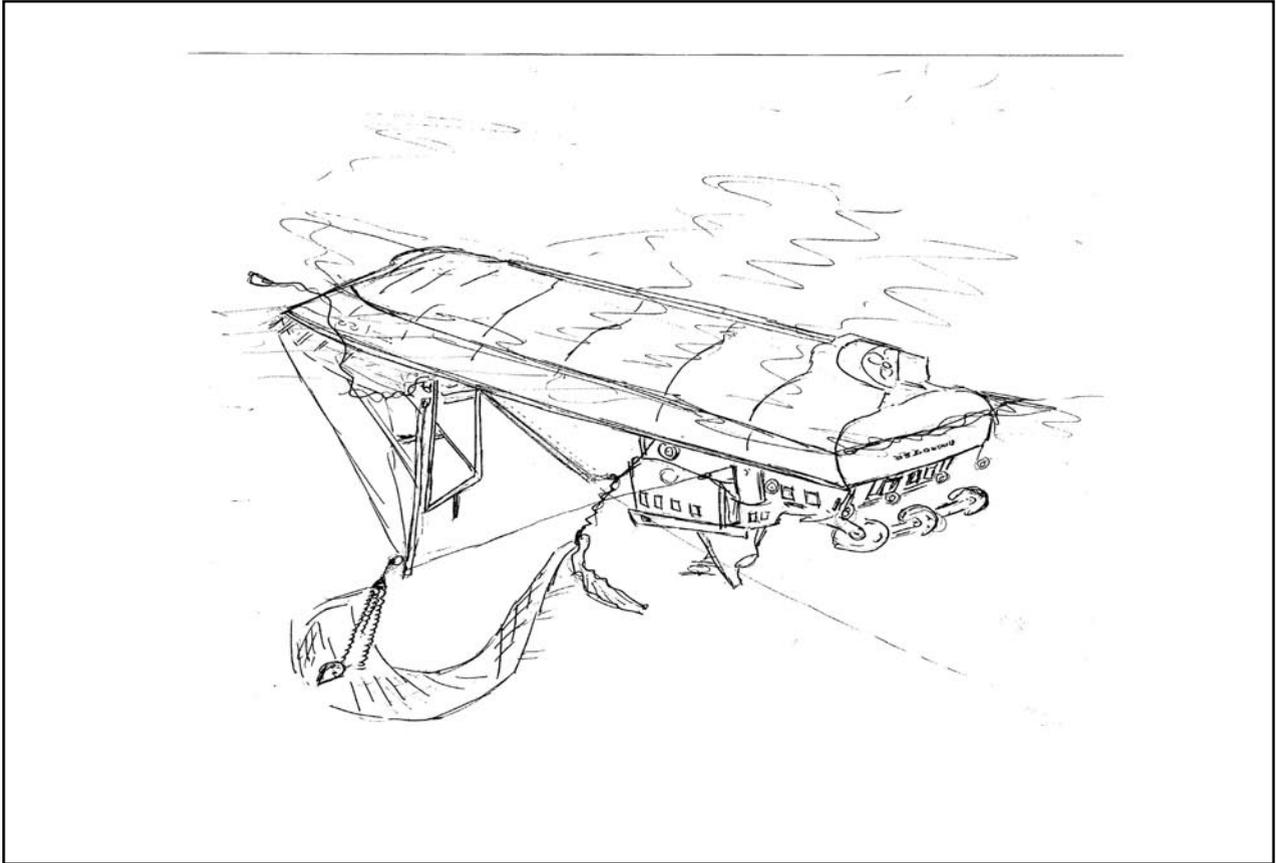
They noted the fishing gear suspended from the starboard derrick. They could see the beam and the opening of the net. The rest of the net appeared to be hanging and moving with a slow steady motion, which indicated to them that no weight was in the net. The 'lazy deckie' was found secured on a cleat on the forward starboard side of the wheelhouse.

Drawing produced by *Multisalvor* diver while vessel was afloat and inverted

Other damage noted during the ROV survey included a bent cleat on the starboard side of the winch room. In their drawing, *Multirasalvor's* divers noted that the 'lazy deckie' line had been attached to the cleat at that time. The damage to the cleat also probably occurred as the vessel sank. The movement of the starboard derrick could easily have caused excessive tension on the 'lazy deckie' which, in turn, could have caused the cleat to bend and the line to be released.

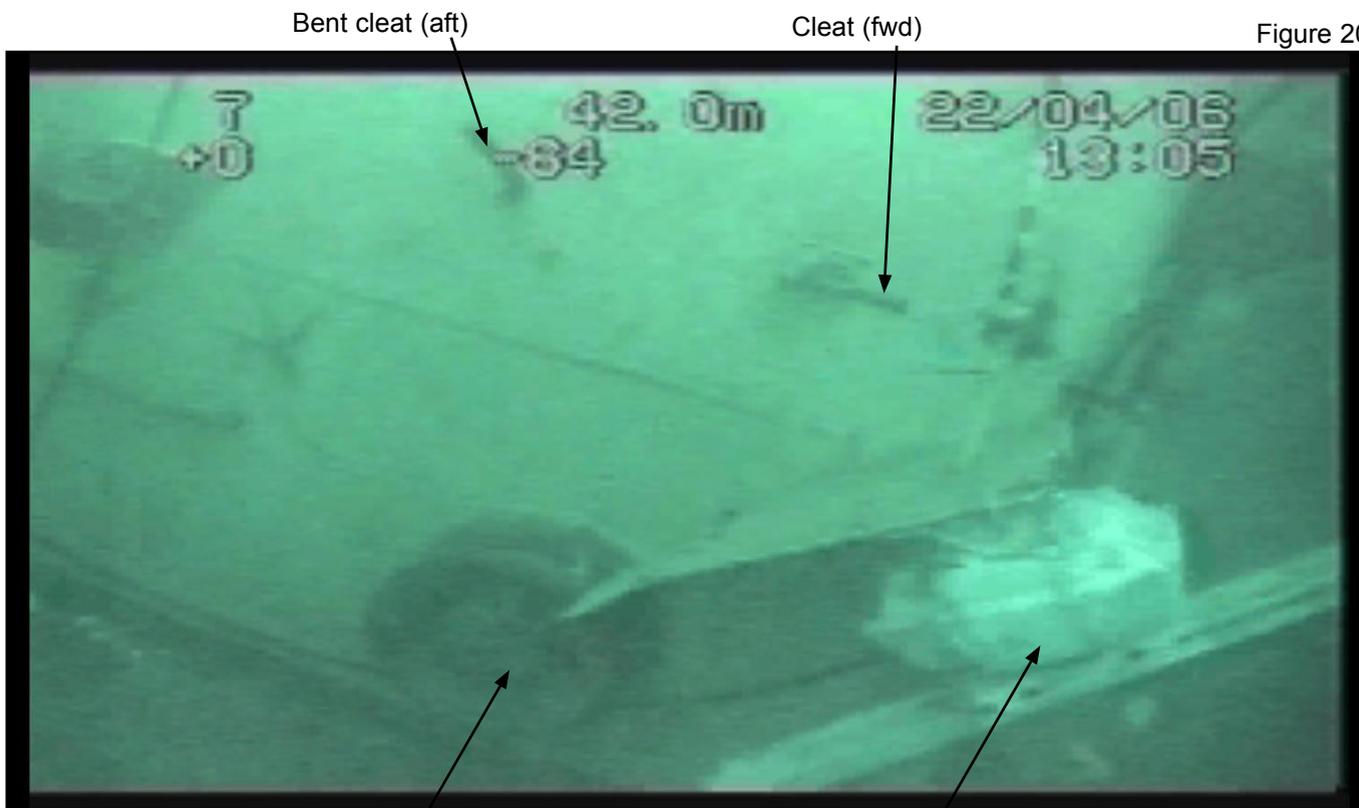
Figure 20

Bent cleat (aft)

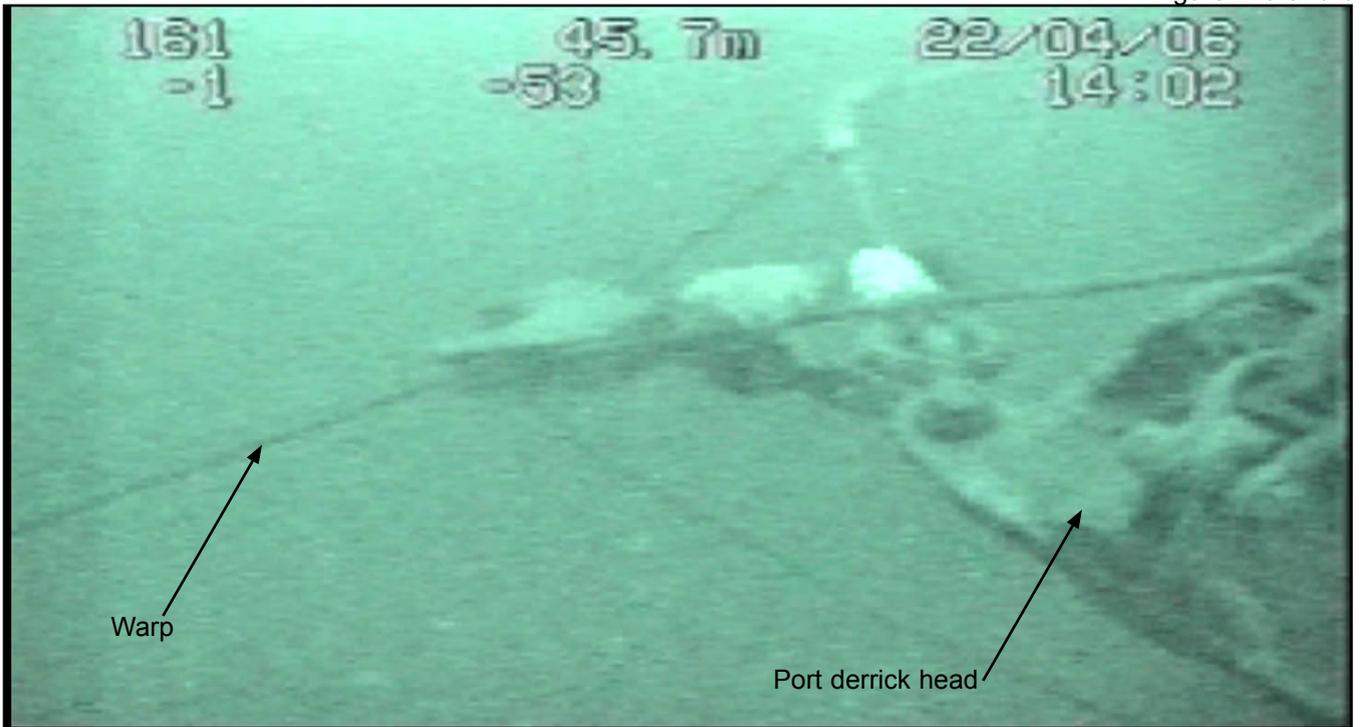
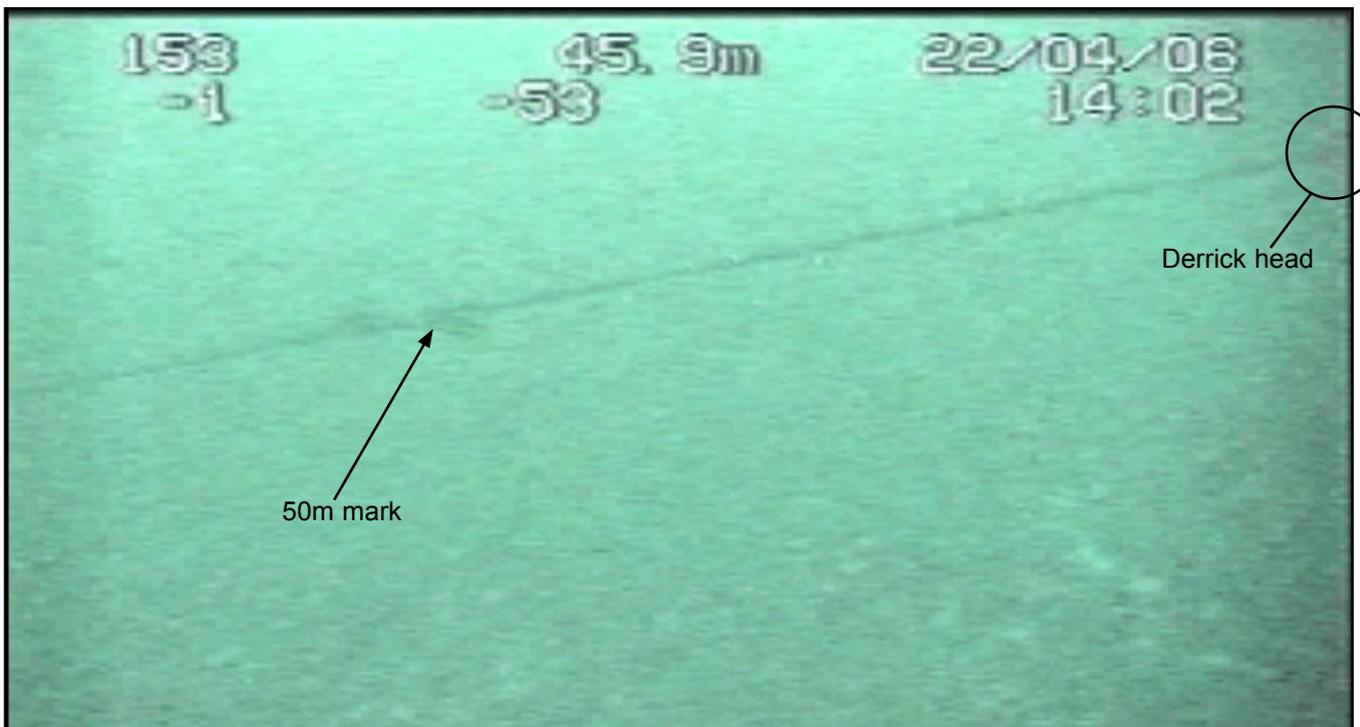
Figure 21a and b

Port derrick head and warp with 50m mark

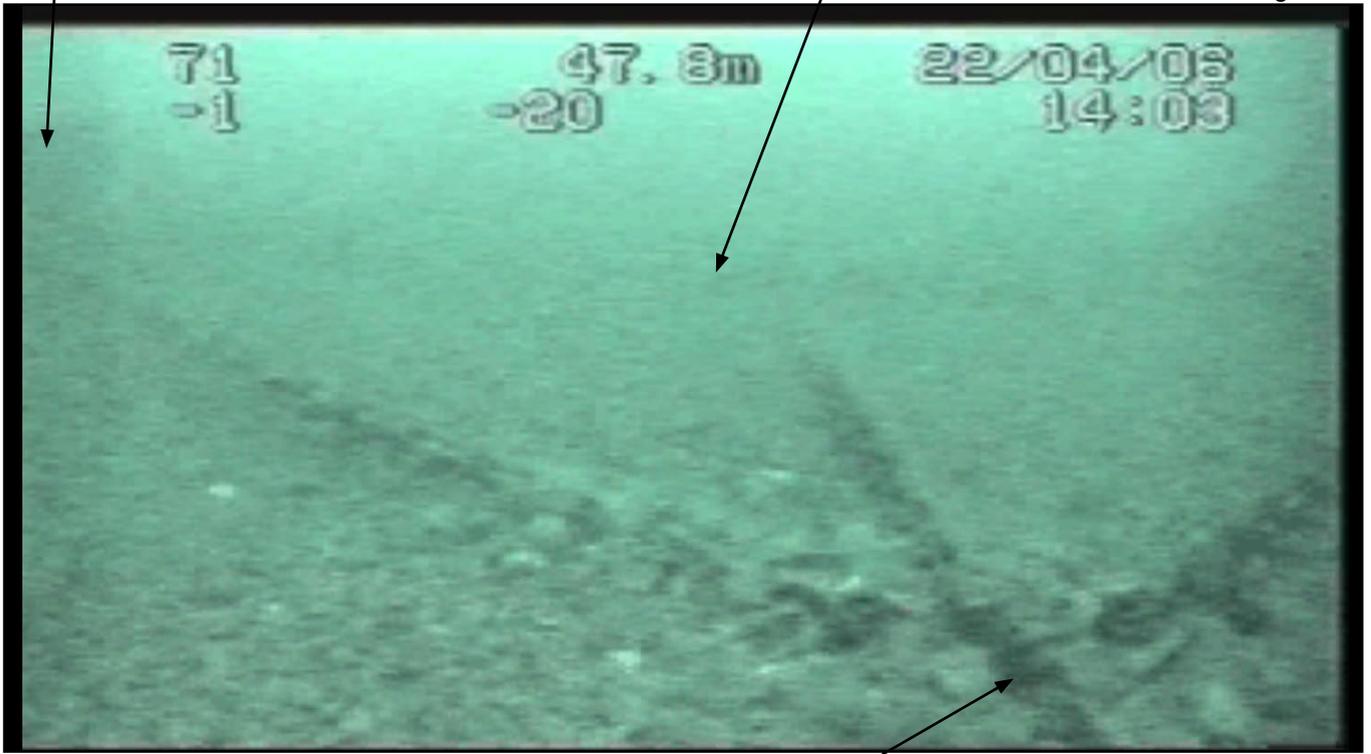
Figure 22

Port bridle

Port gear on seabed

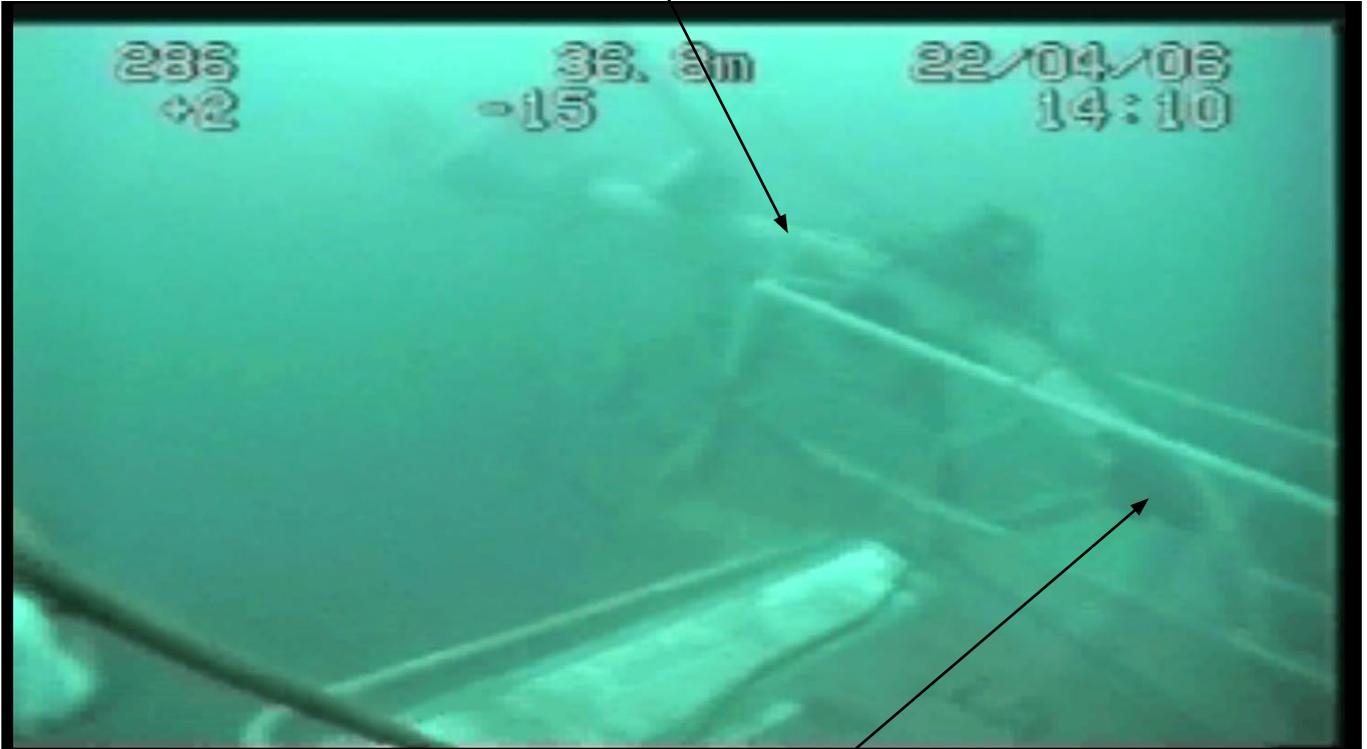
Figure 24

The light mast at the top of the forward gantry had been bent over to starboard, and the lower section of the mast steelwork had fractured. A mooring rope had become entangled around the mast. The forward stay for the starboard derrick was taut.

Mast fracture

Forward gantry looking aft at lightmast bent to starboard

No damage to *Noordster's* hull was recorded during the ROV or diver surveys. Some damage to the mast on top of the forward gantry was noted, and some fittings were noted to be hanging off (a light fitting and the radar scanner). It is concluded that this damage occurred when the vessel sank.

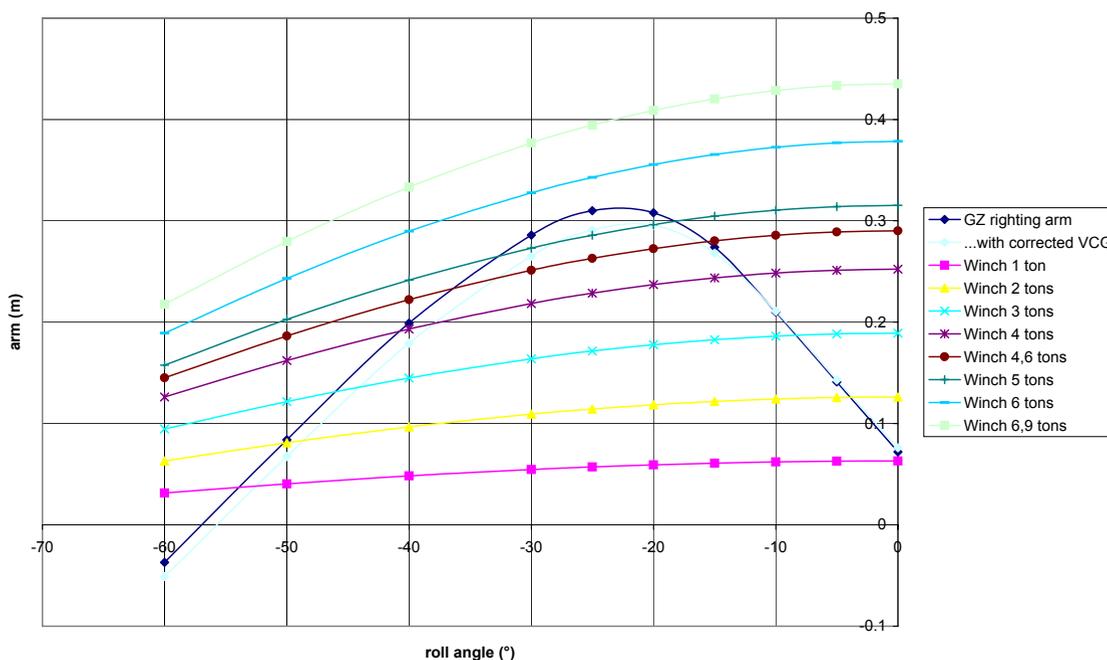
**Figure 29**  
Stability curve of the fishing vessel with destabilising curves of winch force

- When the winch was operating at its maximum force (4.6 tons for 50m of warp out), the angle of heel of the vessel would be 16.4° with very little dynamic reserve left, making her position extremely vulnerable;
- With the winch operating at its stall force (6.9 tons), the vessel would capsize.

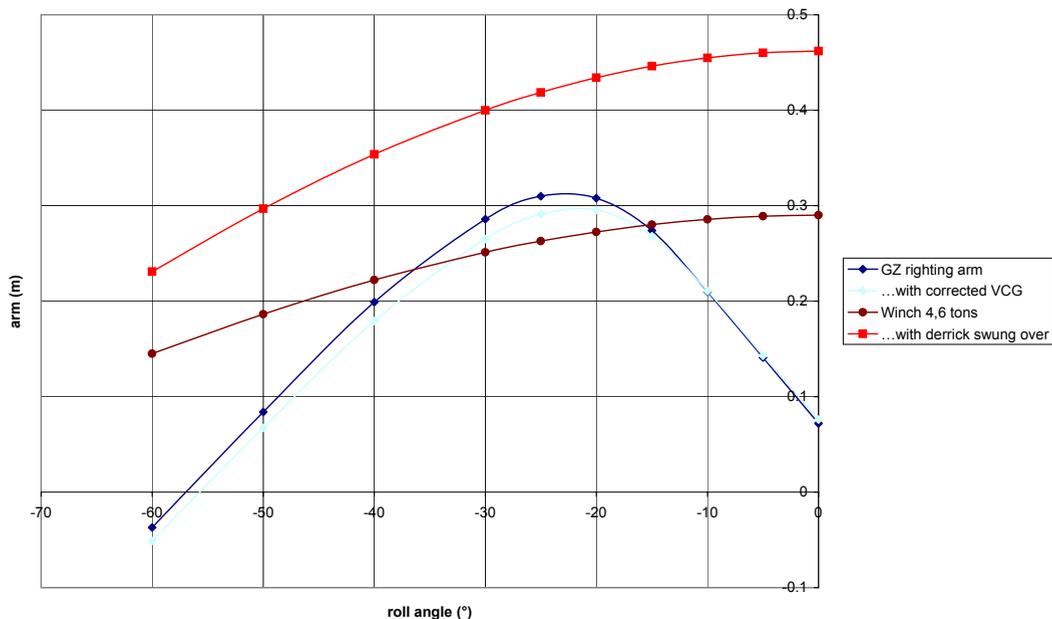
Furthermore, if the winch was operating at its maximum force of 4.6 tons, causing the vessel to heel 16.4° to port, the starboard derrick (in its position of 60° - 70° plus 16.4°) would swing around through any external dynamic force (wave, sudden tug on the fastener), and the vessel would capsize.

**Figure 30**  
**Stability curve of the fishing vessel with destabilising curves of winch force and the starboard derrick swinging over from the 60° position to the 120° position**
