Report on the investigation into the grounding of  
ro-ro passenger ferry

***Dieppe***

on the approaches to Newhaven

**Report No 18/2006**  
**July 2006**

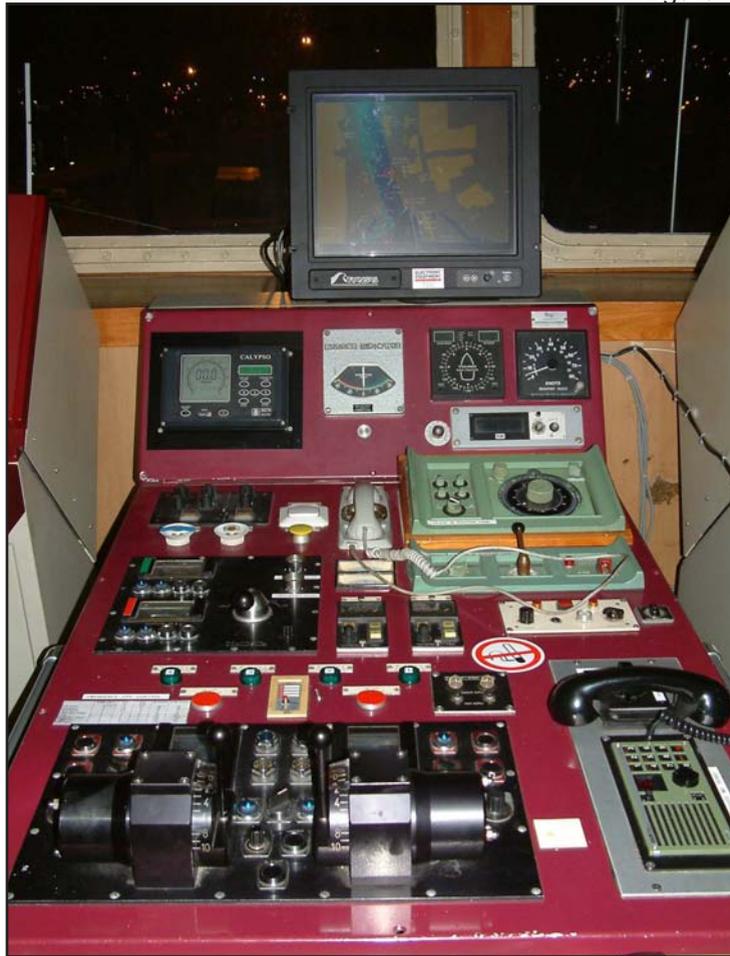
Figure 1

The vessel was navigating using a Transas ECS (**Figures 1 & 2**) and had BA chart 2154 (Newhaven Harbour) available for reference. The ECS was interfaced to a local DGPS system financed by the ship management company as a result of a previous grounding in 2002. It contained a passage plan with courses inserted for entry into Newhaven, but there was no evidence of passage planning on BA chart 2154.

Transas ECS positioned on the centreline

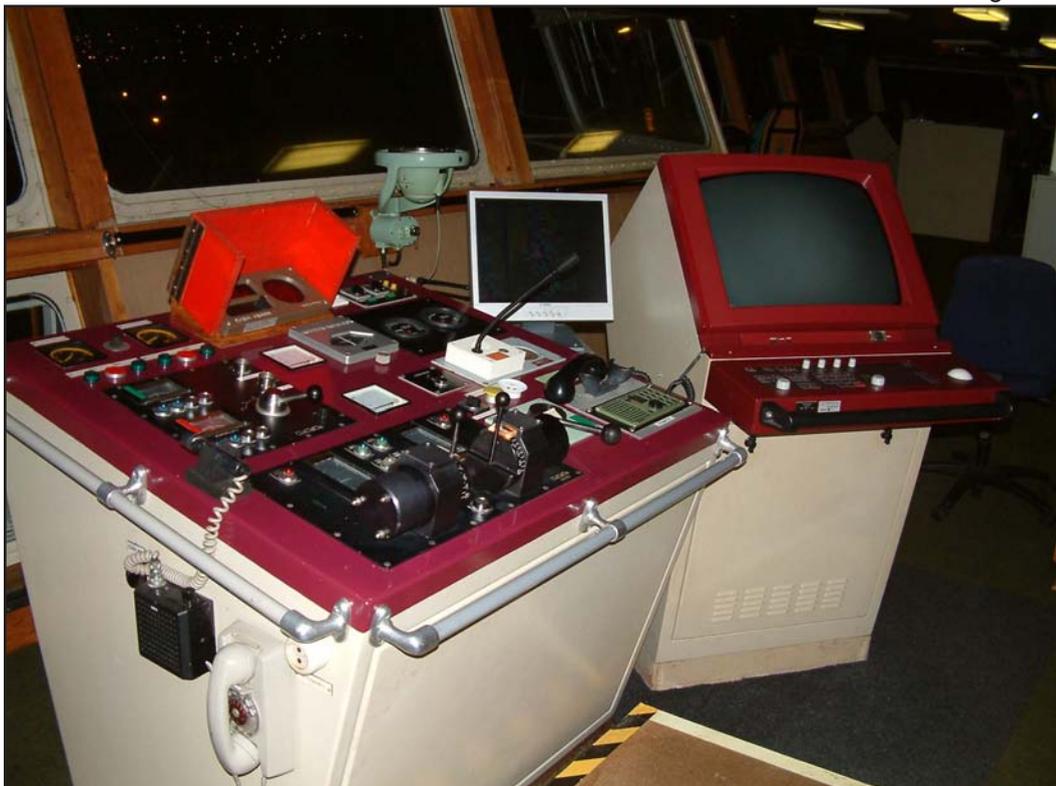
Figure 2

Transas ECS bridge wing repeat

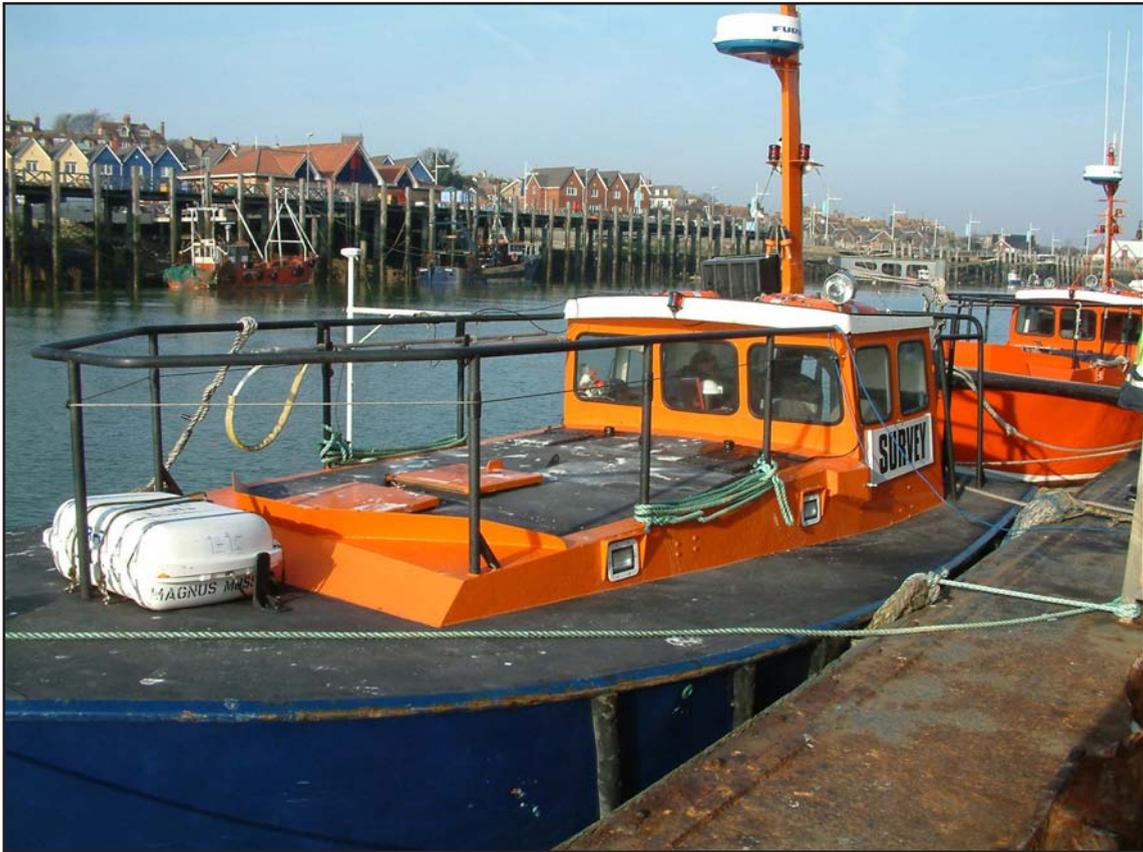
Figure 4

A dedicated survey launch fitted with portable survey equipment was available to the harbourmaster, and at the time of the accident, both the launch and the survey equipment were fully operational (**Figures 4 & 5**).

Refurbished survey launch

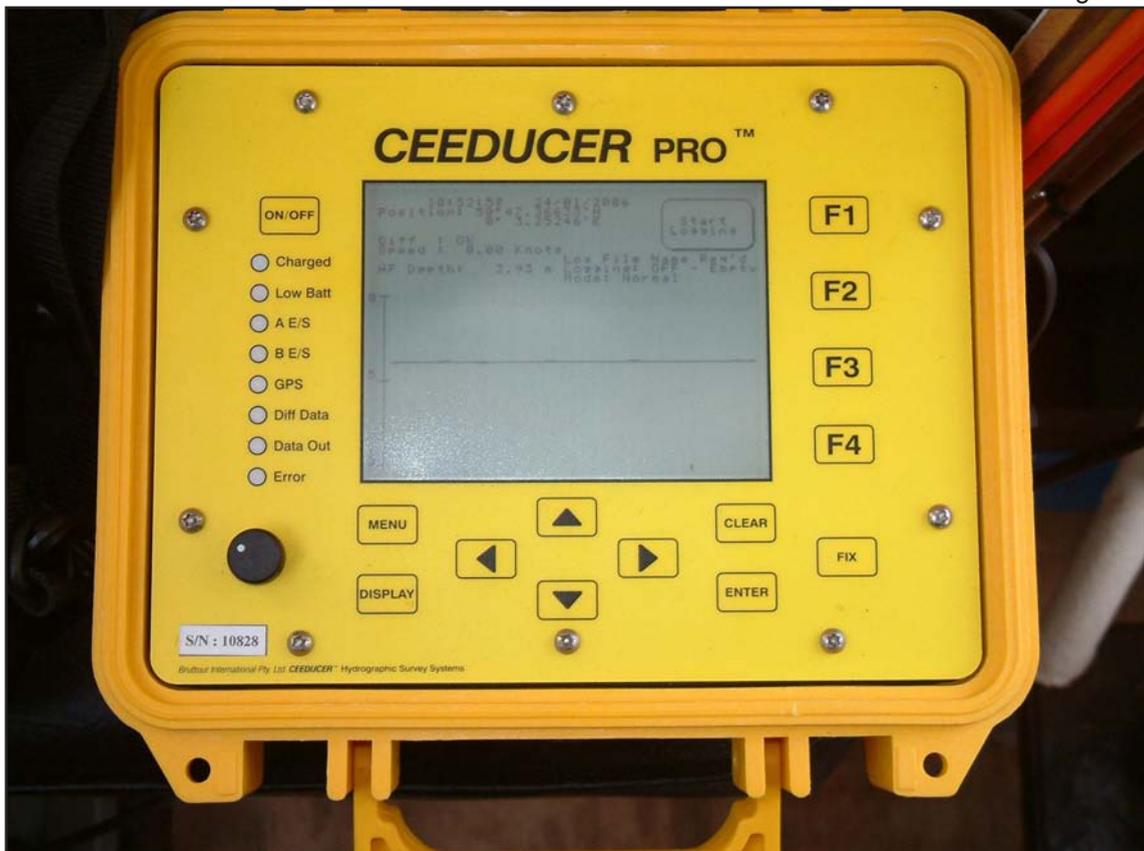
Figure 5

Portable surveying equipment

- f. Hydrographic surveying is the principal method of identifying reduction in depth, and the reliability and availability of the port's surveying equipment is key to maintaining this risk monitoring capability. No duplicate set of equipment exists, and NPP has no contract in place to either repair defective equipment or bring in alternative equipment.

- NPP has decided to arrange for the provision of a rapid response repair service for its Hydrographic survey equipment.
- To satisfy the MCA that the new measures would be enforced, the managing director of NPP provided them with written confirmation that the harbourmaster:

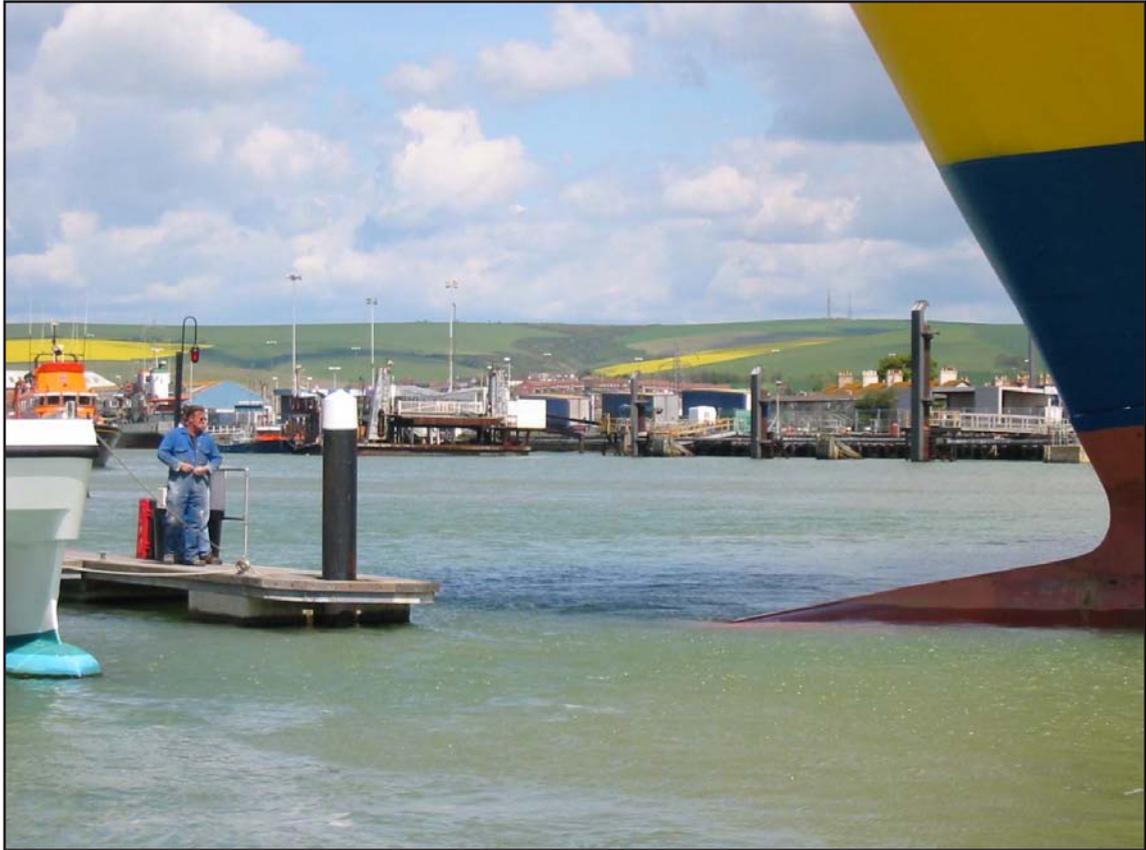
Enlargement of the turning basin remains an outstanding issue, restricting *Dieppe* from turning prior to departure (**Figure 6**).

*Dieppe turning trail. Closest point of approach*

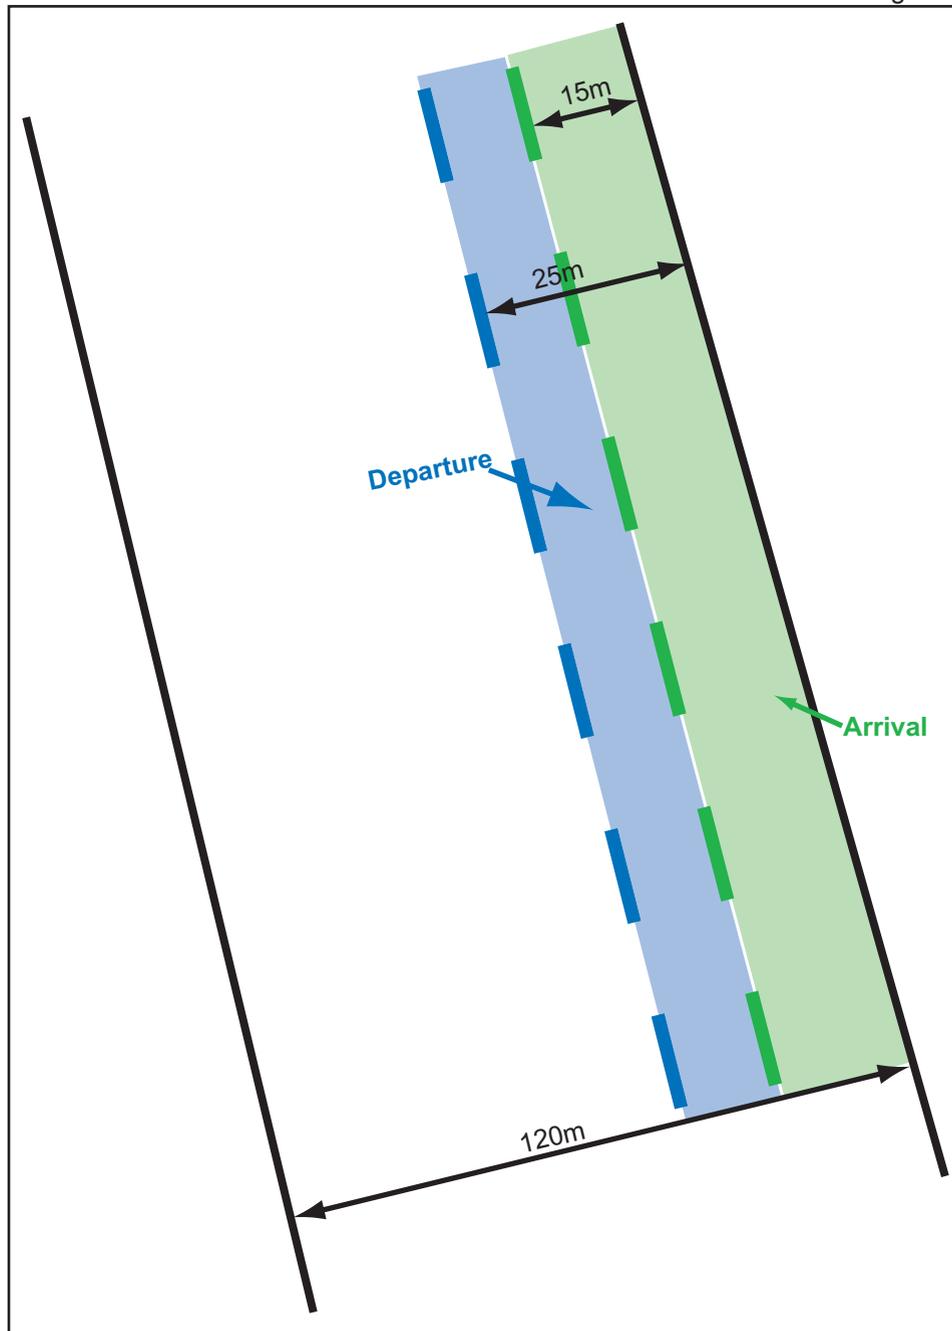
Figure 7

Newhaven approach channel - minimum permissible depth diagram
