Report on the investigation of  
the collision between **Arctic Ocean** and **Maritime Lady**,  
capsize of **Maritime Lady** and contact with wreck of  
**Maritime Lady** by **Sunny Blossom**, and its subsequent grounding  
in the Elbe River  
5 December 2005

**Report No 2/2007**  
**February 2007**

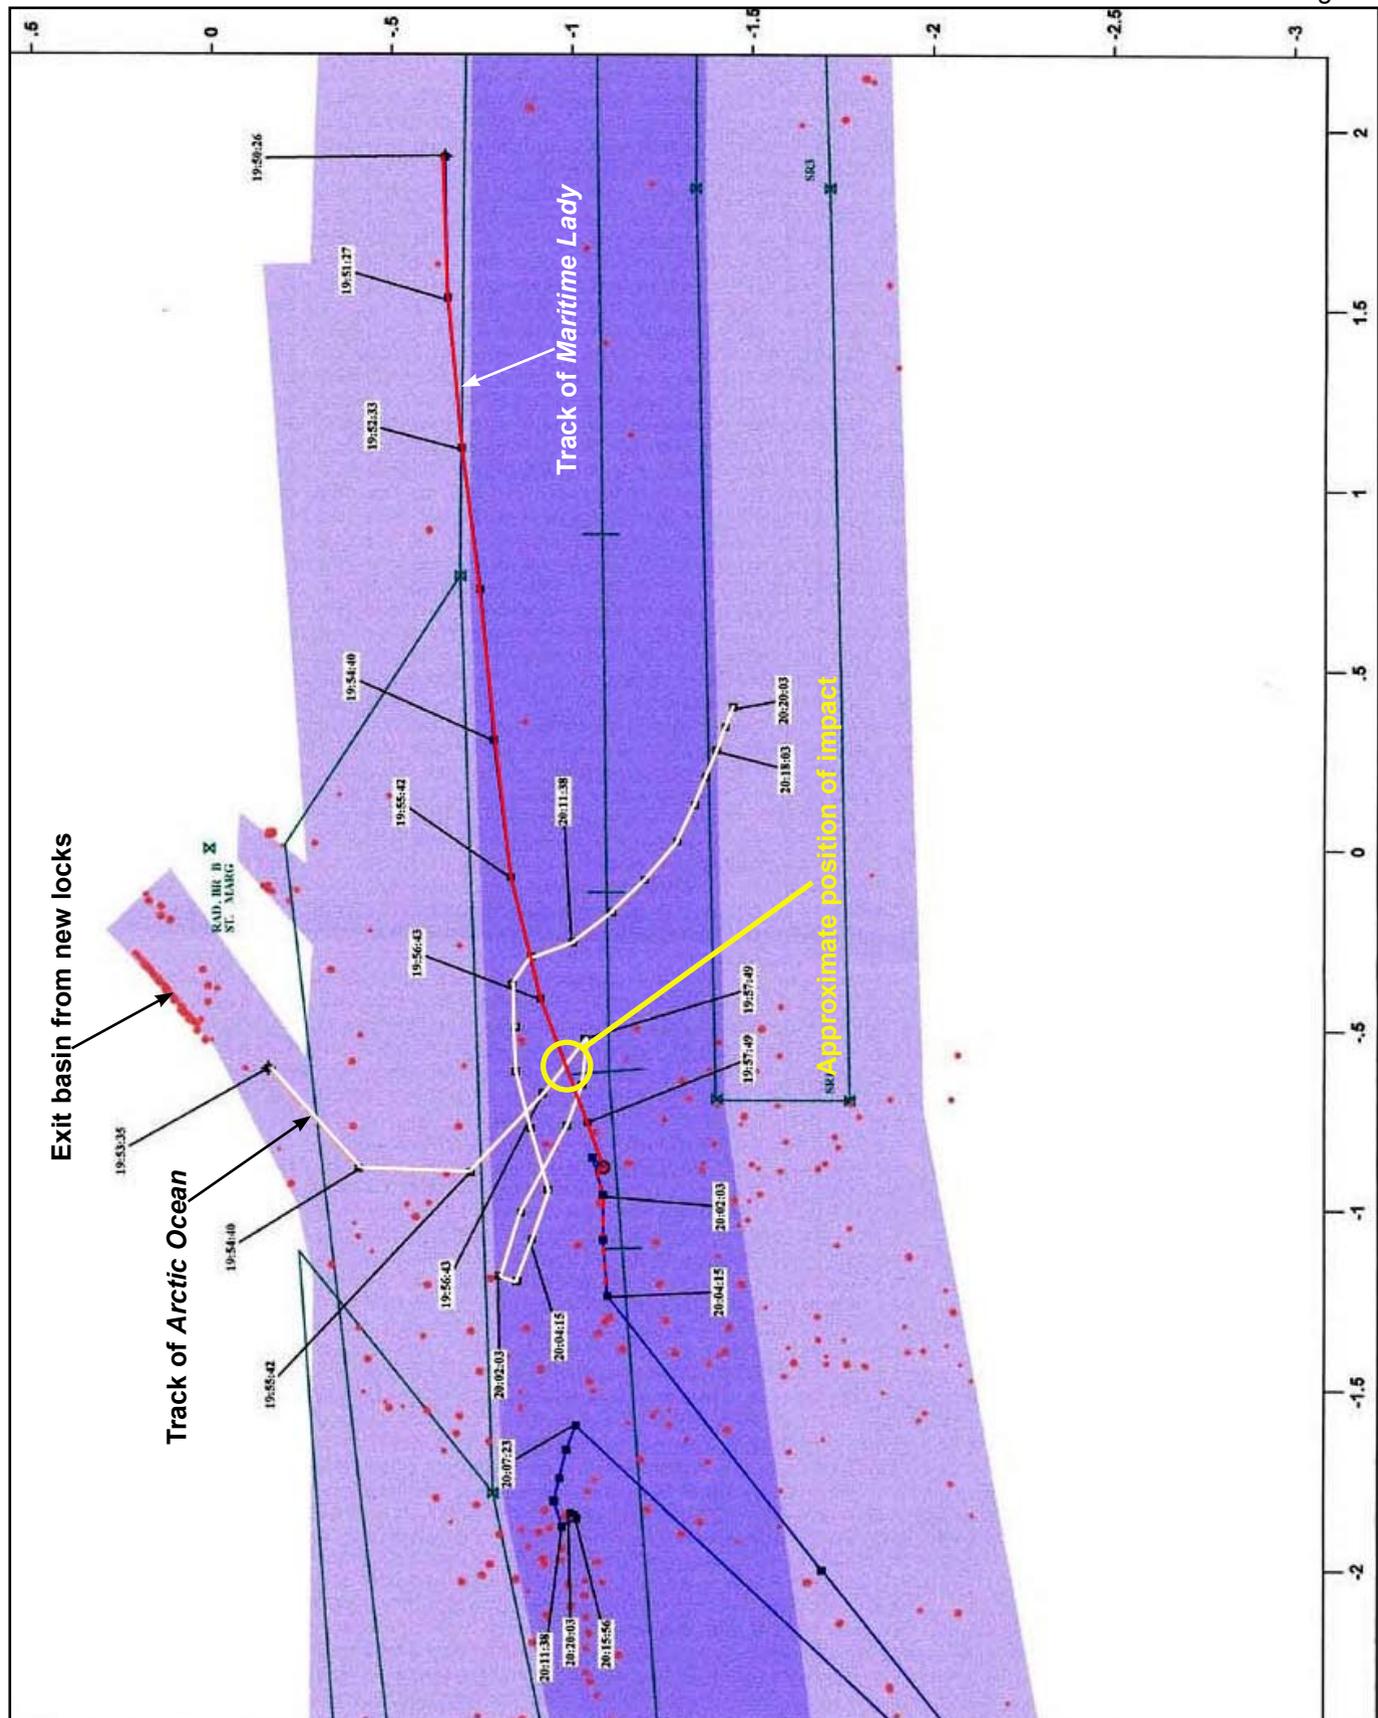
Figure 5

The two vessels collided at about 1957, some 90 seconds after their first exchange on VHF (**Figure 5**).

Radar records - collision Arctic Ocean and Maritime Lady

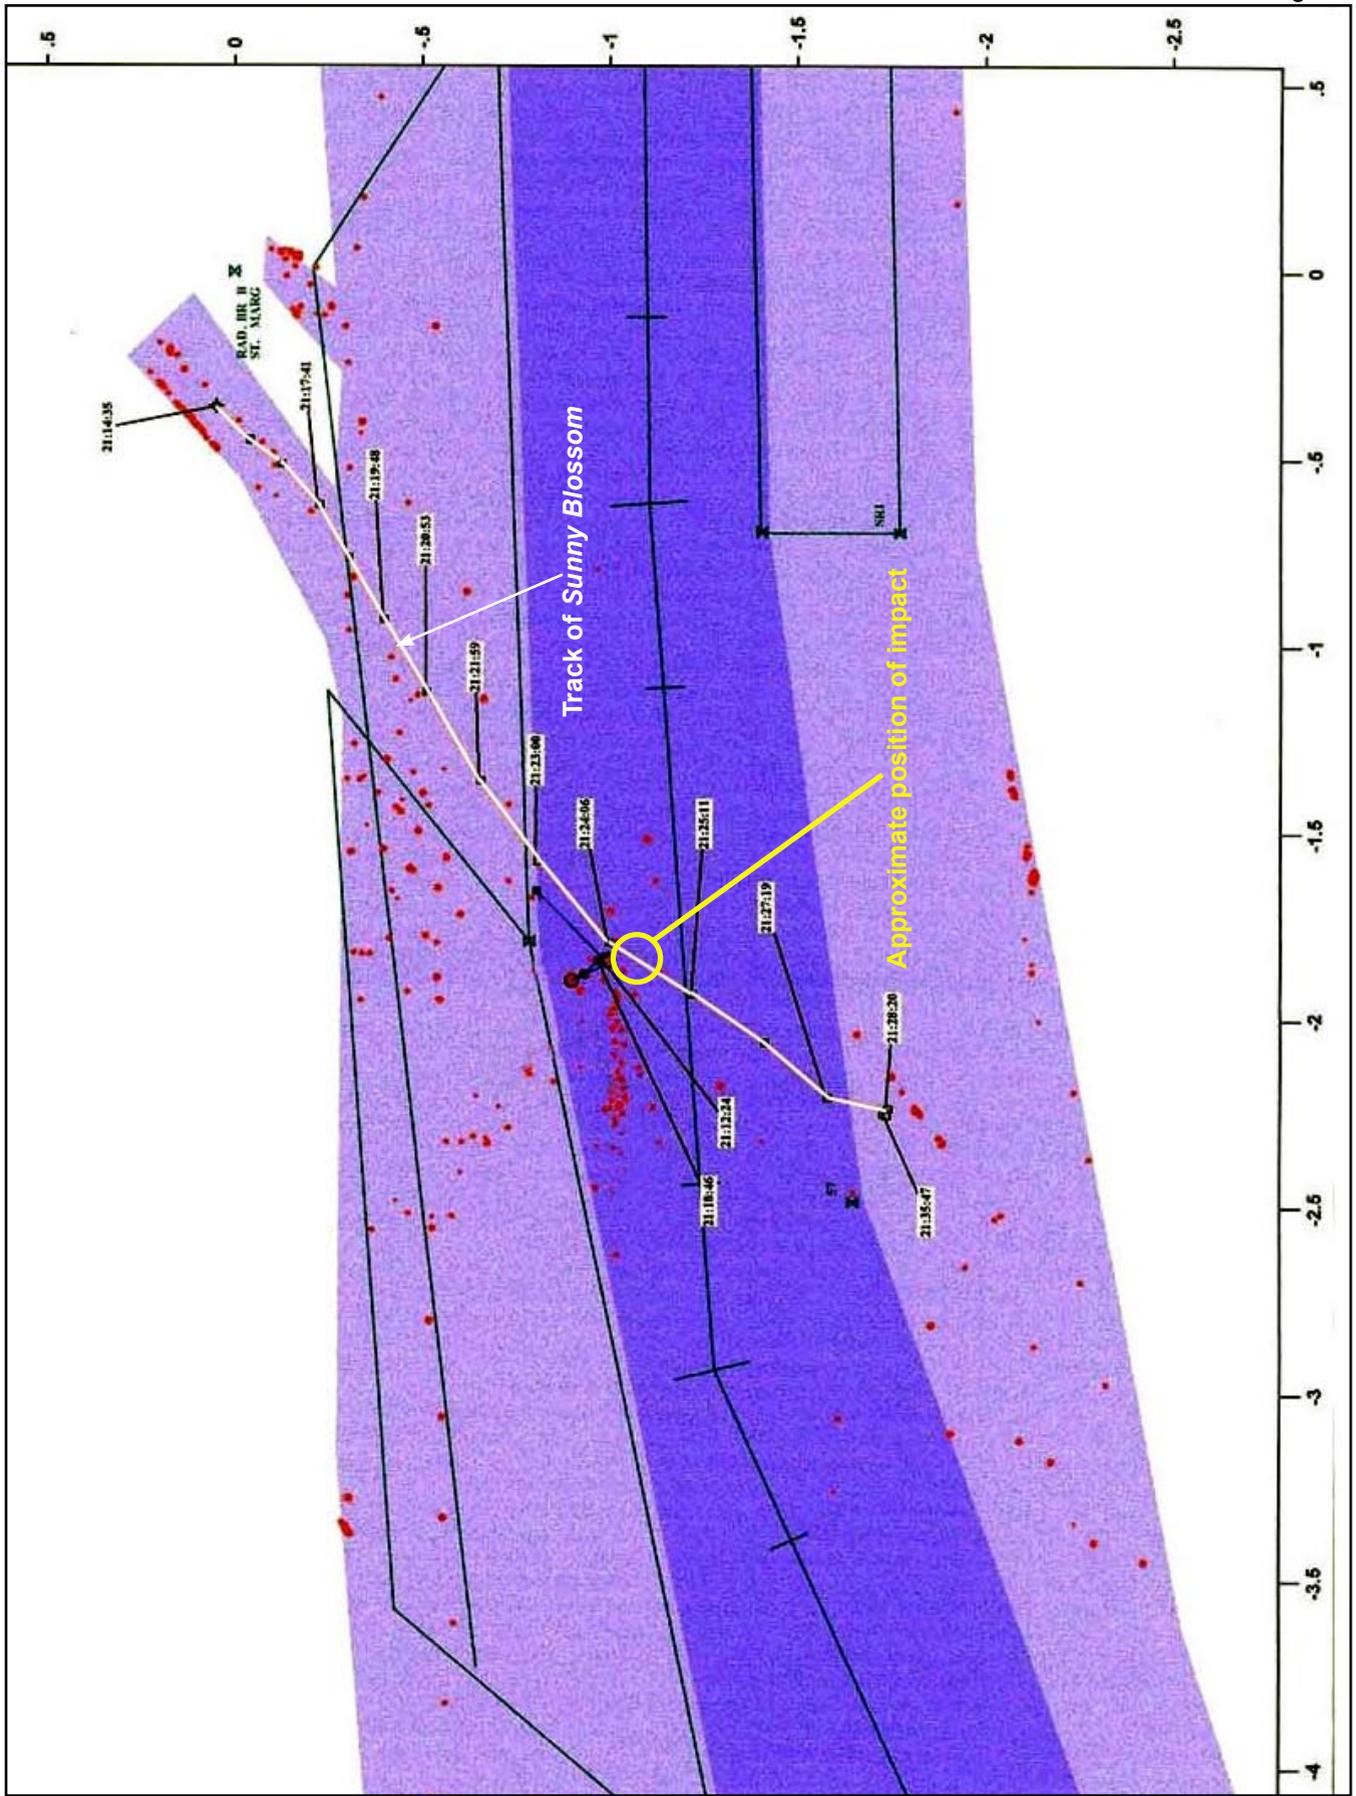
Figure 8

Radar records - grounding of Sunny Blossom

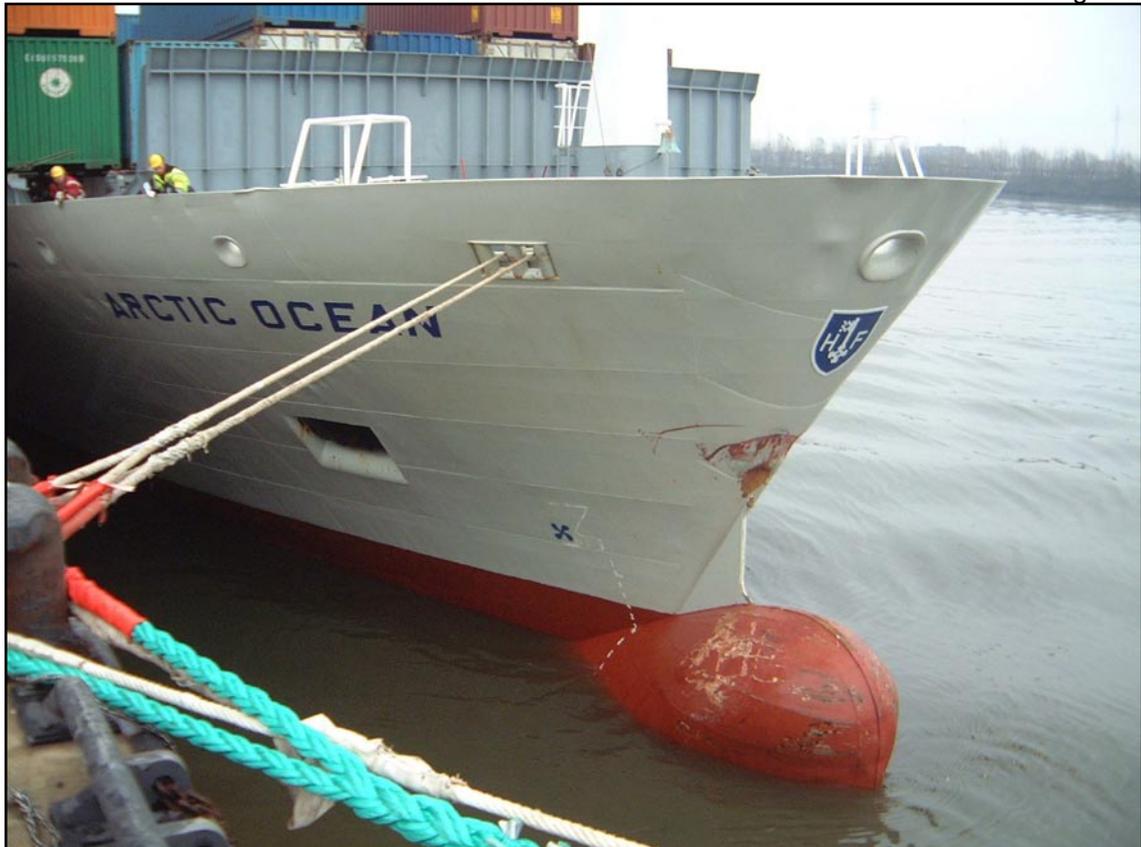
Figure 9

Damage to *Arctic Ocean*, as a result of the collision, was confined to her bulbous bow and stem. The bulbous bow suffered minor paintwork damage but no obvious indentation of the plating. The stem, several metres above the bulb, was slightly indented (**Figure 9**).

Damage to bows of *Arctic Ocean*

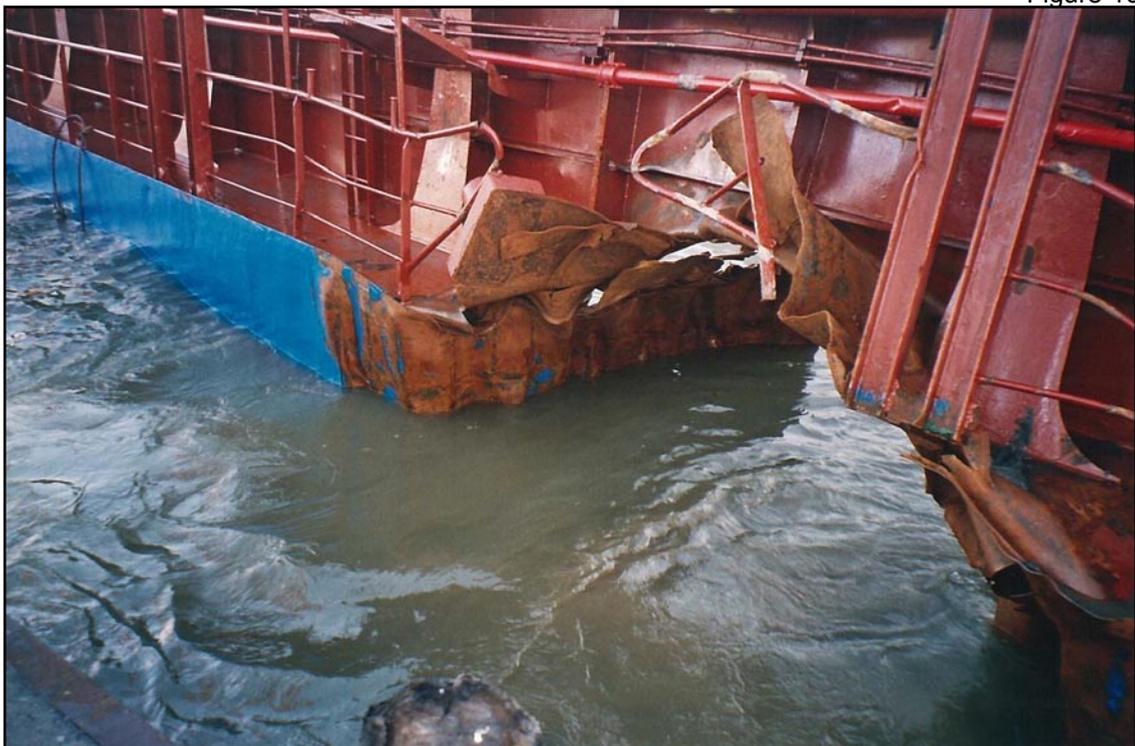
Figure 10

Damage to starboard side of *Maritime Lady*

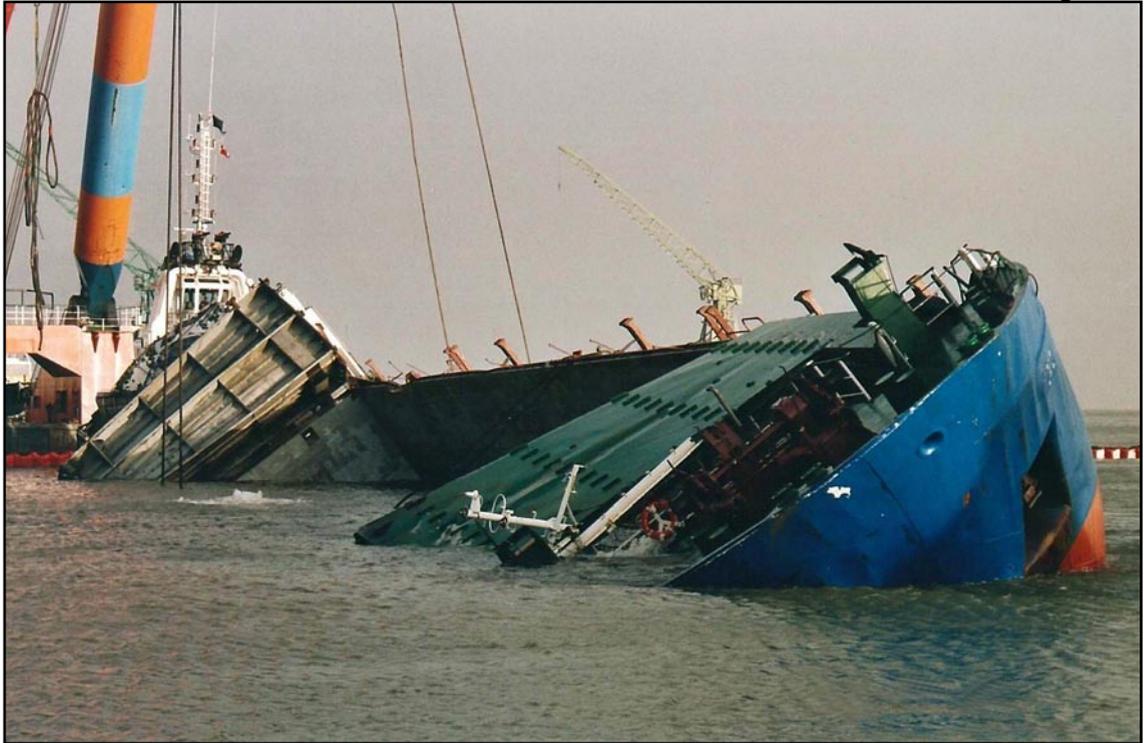
Substantial further damage occurred as a consequence of the vessel's capsize, drift in the river, contact by *Sunny Blossom* and salvage. This included: loss of all hatch covers except two sections, crushing of the wheelhouse; displacement of most equipment in the wheelhouse; loss of funnel; loss of masts; destruction of the starboard lifeboat davit; accommodation linings torn free; total loss of cargo, aft peak tank holed and rudder and stock deflected (**Figure 11**).

*Maritime Lady* during recovery

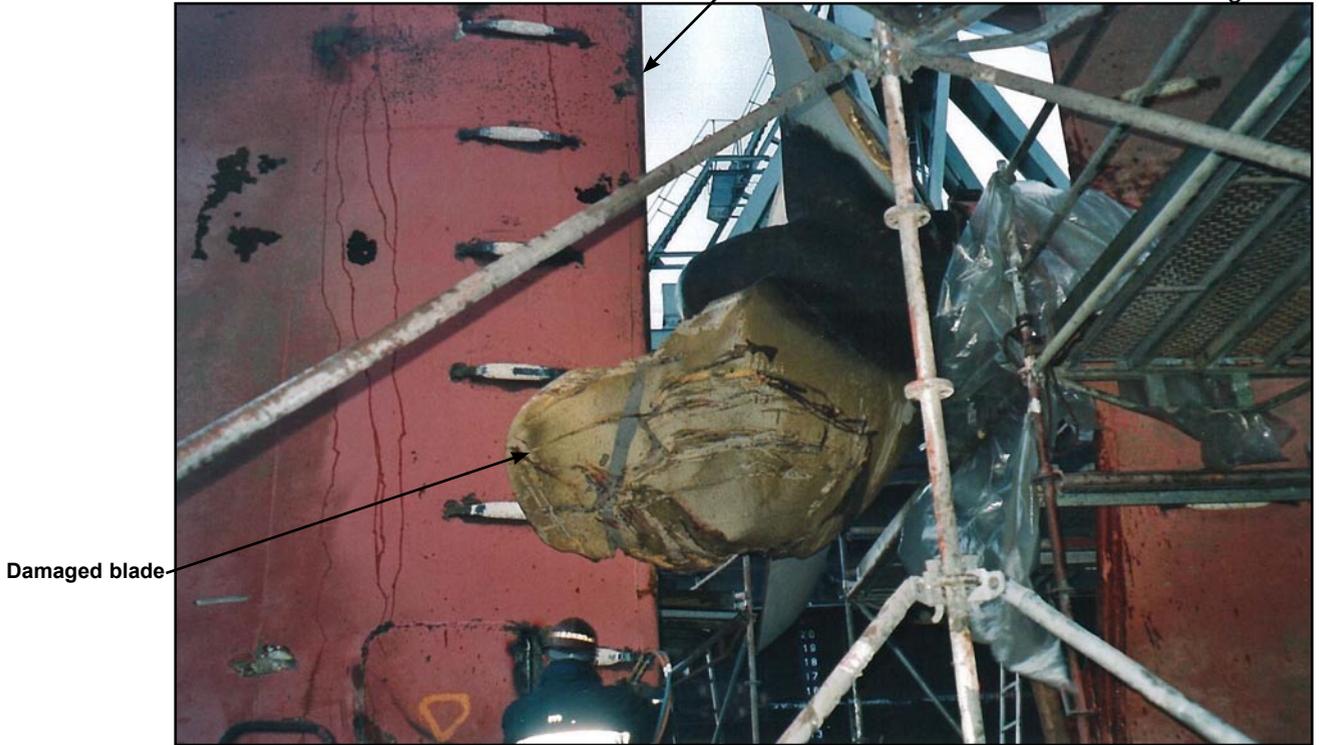
Figure 12

Following her collision with the wreck of *Maritime Lady*, the following damage to *Sunny Blossom* was found: a slight fore and aft crease in the starboard quarter of her hull plating, in way of the engine room; damage to the rudder stock and bearing; one blade of her propeller was deflected aft; and the tail and intermediate shafting were damaged.

Although the damaged propeller blade did not make contact with the rudder, the degree of deflection was such that the blade extended aft of the leading edge of the rudder (**Figure 12**). While recording this damage, it was noted that two further blades had previously been cropped (**Figure 13**).

Damaged blade

Damage to propeller blade of *Sunny Blossom*

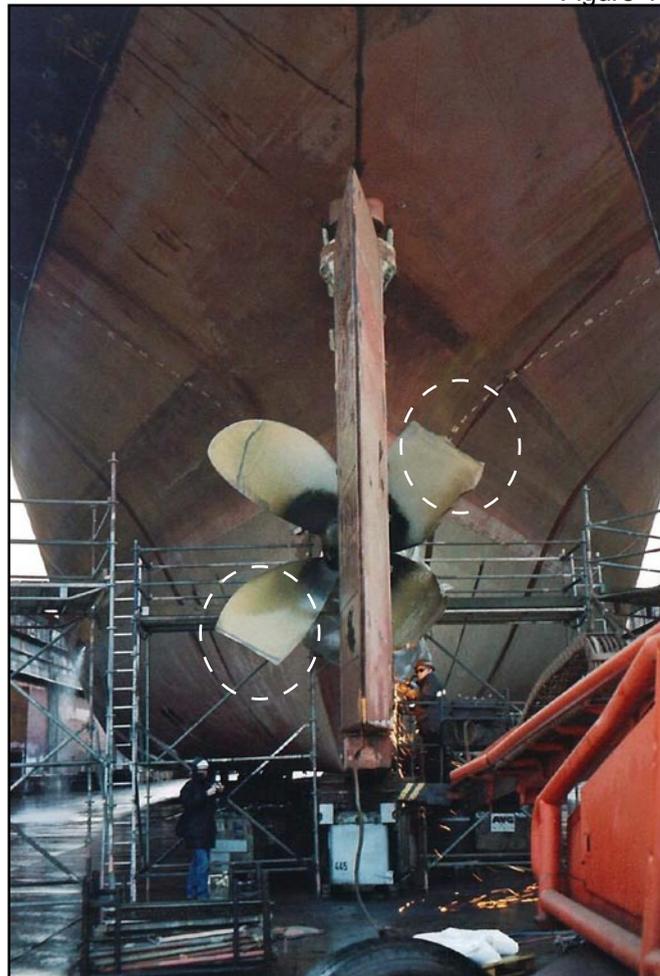
Figure 13

Propeller of *Sunny Blossom* - showing two cropped blades

During survey by the vessel's classification society, Det Norske Veritas (DNV) between 7 and 17 June 2005, the tip of one propeller blade was recorded as damaged over a length of approximately 600mm. The same amount of material was removed from the opposite blade, and the blade edges rounded off and faired in.

Following this survey, a classification society condition was imposed requiring permanent repairs be made to the propeller by 31 March 2006. Ship's staff were advised to adjust engine speed in such a way as to avoid possible excessive vibration. Any abnormality in service was to be reported to DNV.

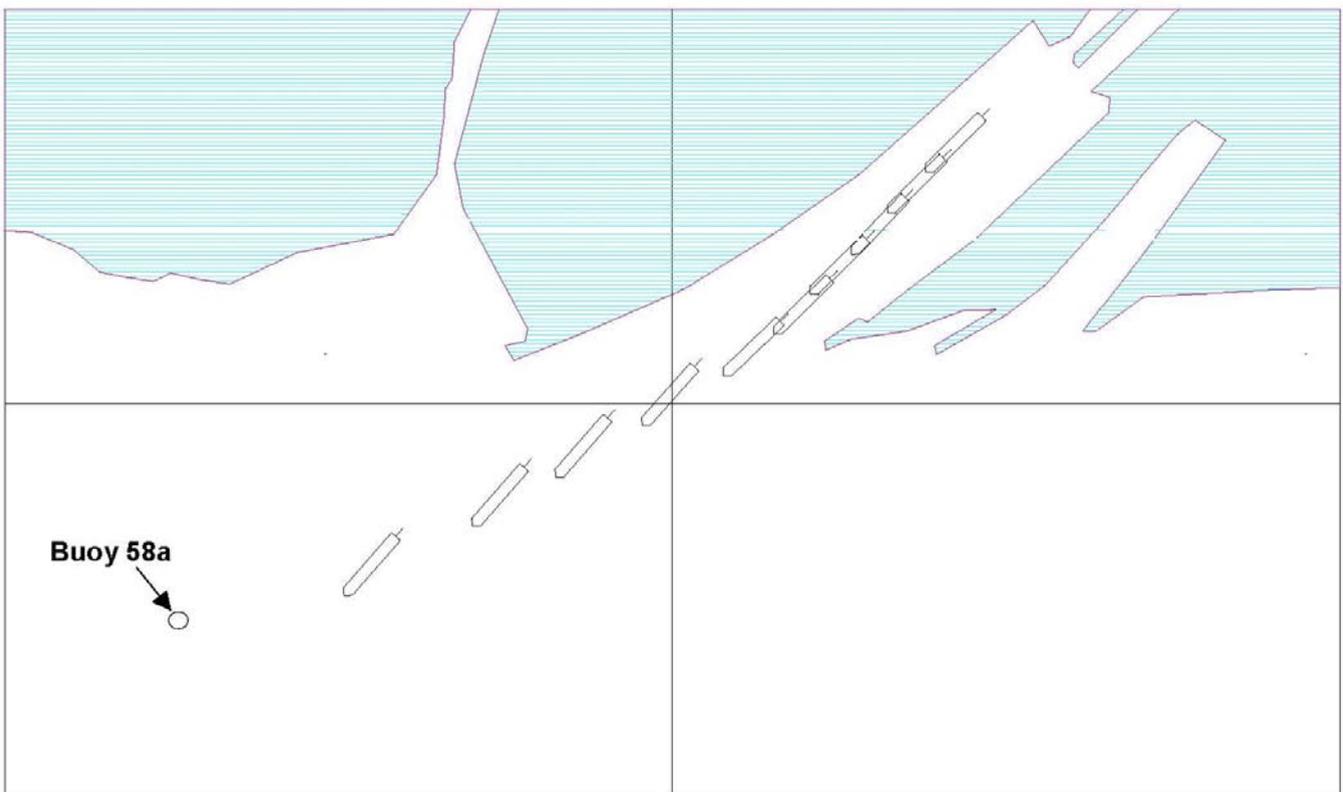
Figure 18

*Sunny Blossom*, therefore, moved at a rather slow speed when she passed through the current shear zone at the exit from the basin, and appears not to have picked up much speed through the water before hitting the wreck of *Maritime Lady*. Because of her slow acceleration, a more easterly heading, before she left the lock basin, would have been necessary to allow full port helm to counter the tidal shear due to the ebb (see **Figure 18**).

*Sunny Blossom* track reconstructed from AIS information
