Report on the investigation of
the capsize and foundering of the
fv Harvest Hope PD120
40 miles north-east of Peterhead
on 28 August 2005

Report No 21/2006
August 2006

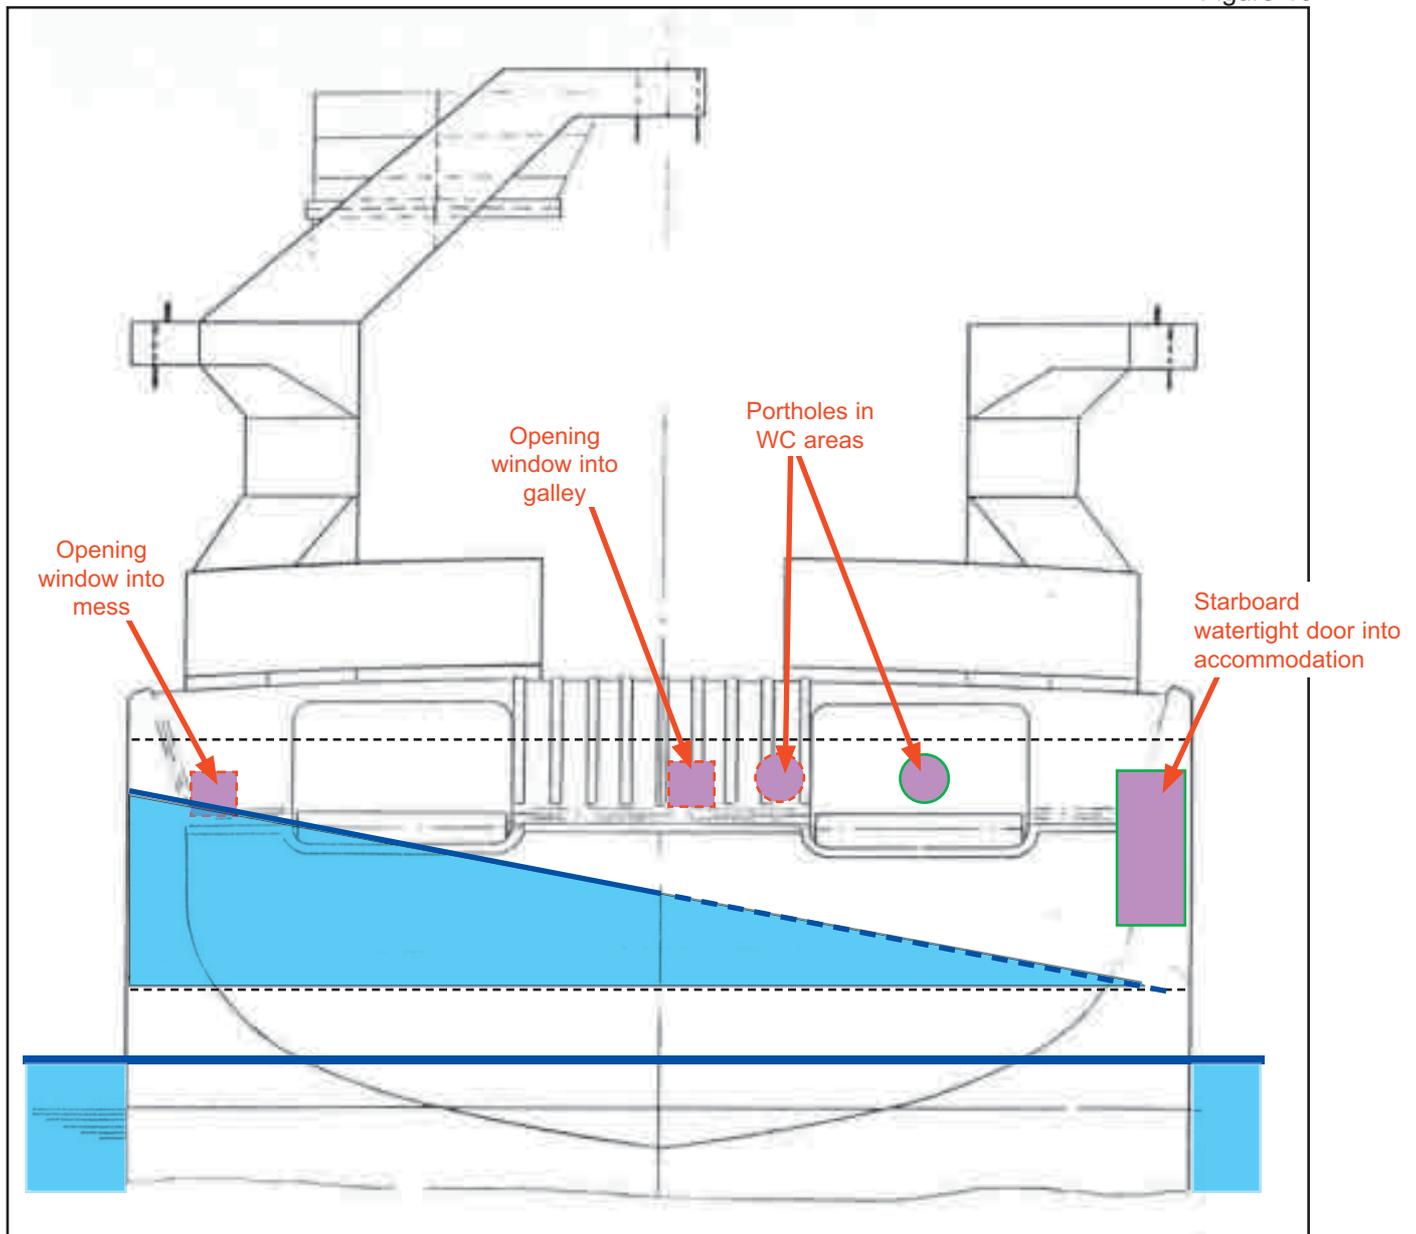
Figure 10

By this stage, the vessel had started to adopt an increasingly large port list, and the relief engineer noted that the water had reached shoulder height (about 5') at the ship's side and was still about 3' deep, adjacent to the hydraulic control position at the centre of the net space. Based on these observations, the waterline at this stage has been depicted at **Figure 10**.

View on stern looking forward
(on forward bulkhead in net drum space)

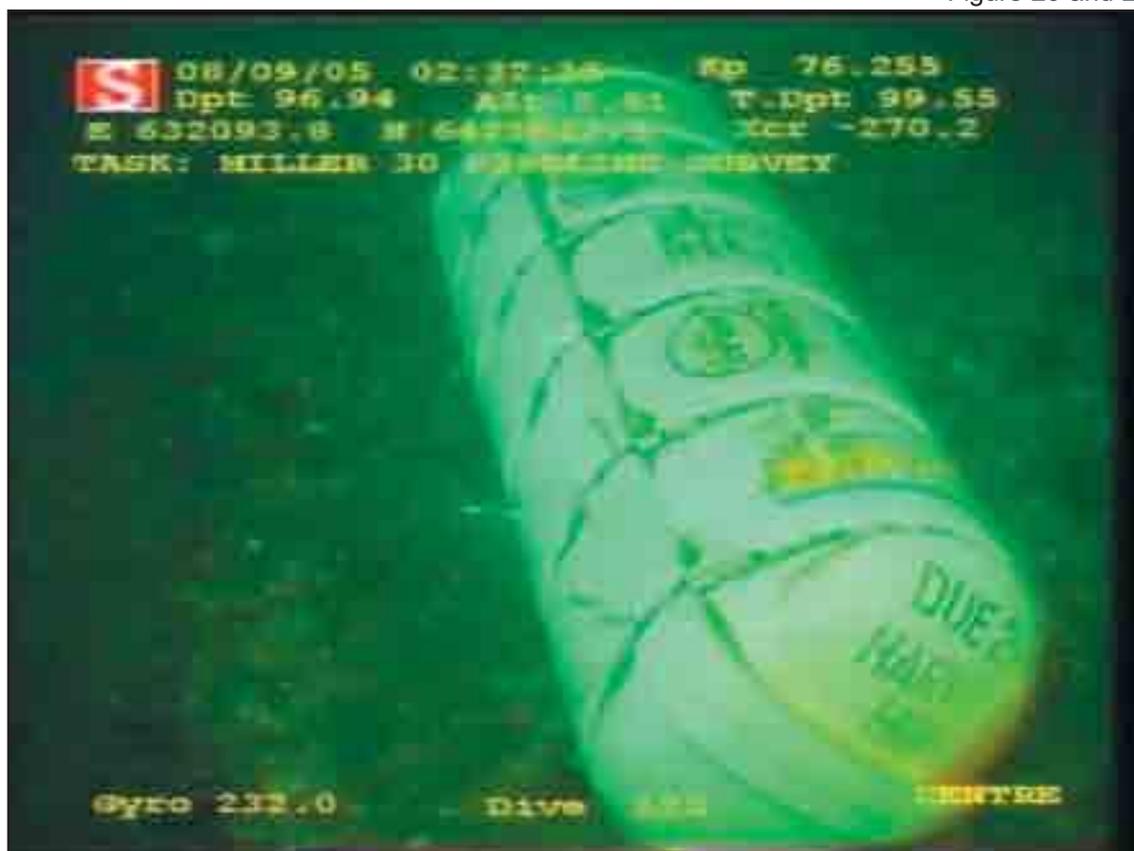
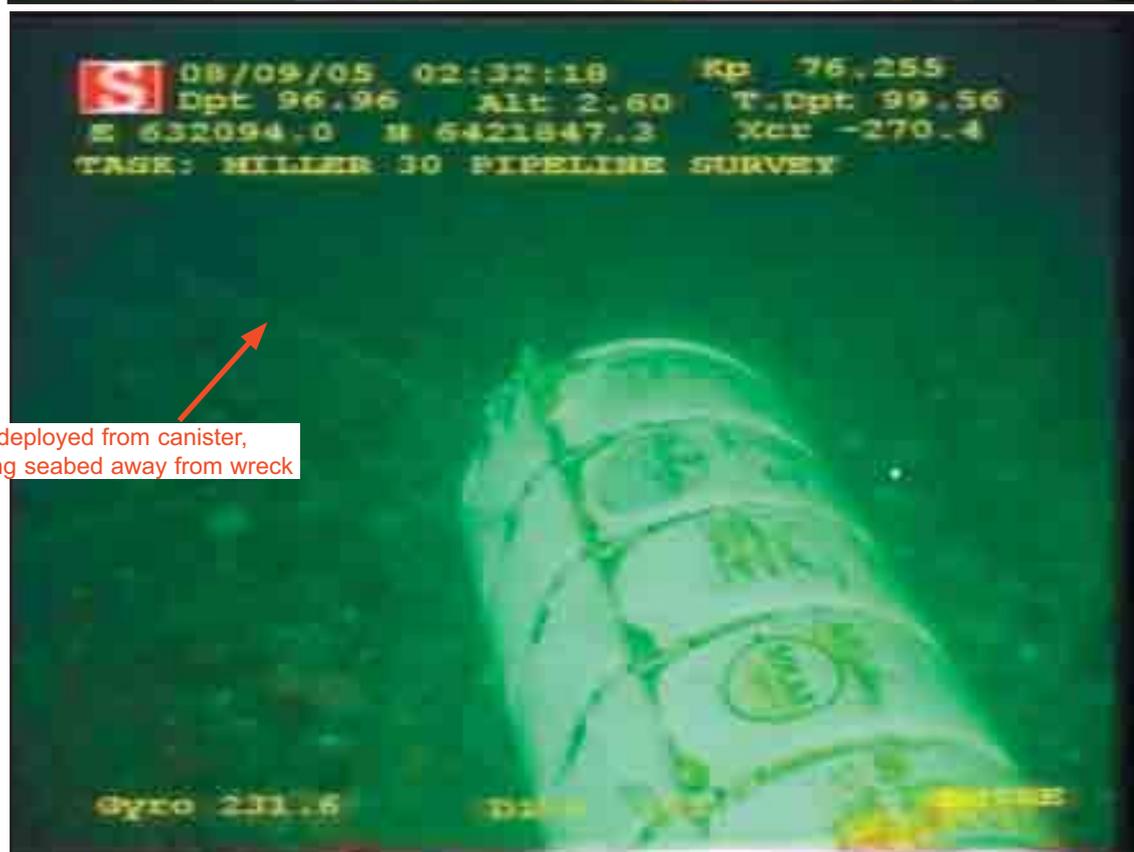
Painter partially deployed from canister,
running taut along seabed away from wreck

Harvest Hope's port liferaft canister on seabed

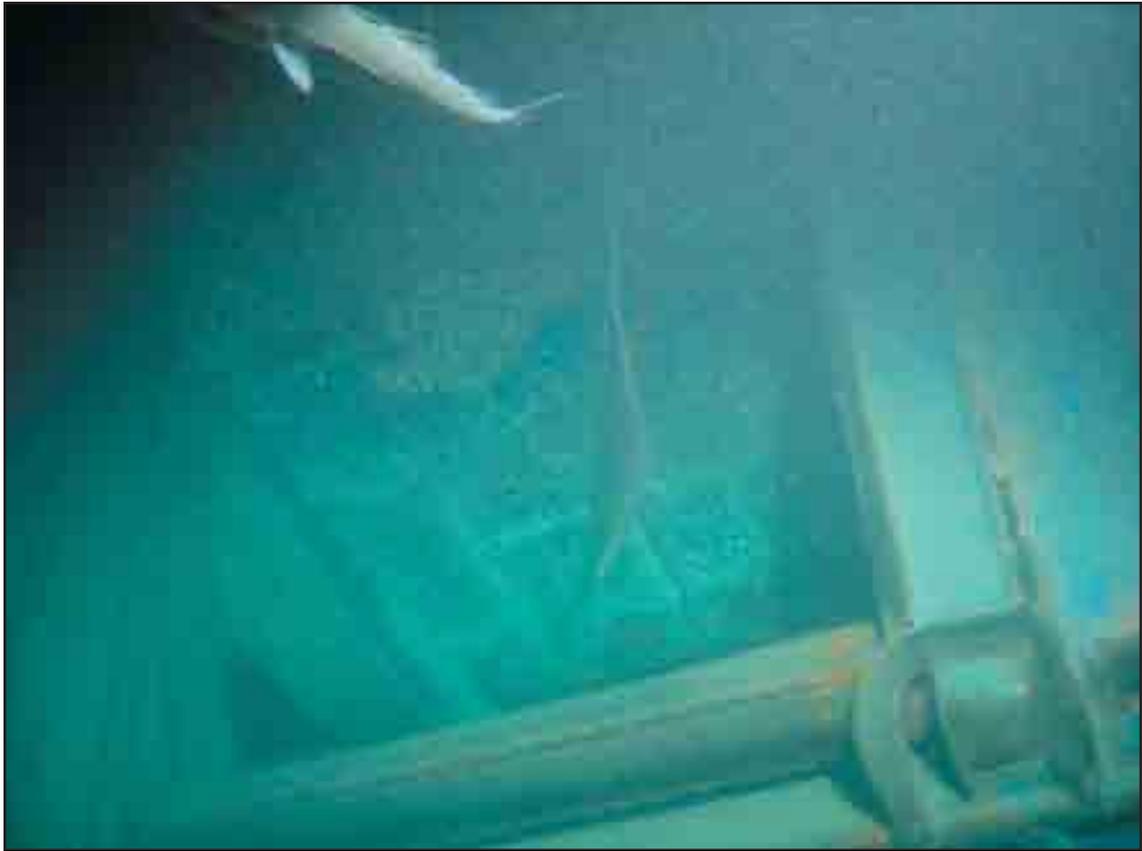
Figure 22

About 27 minutes of ROV footage was captured of the wreck of *Harvest Hope* itself. Again, only certain areas of the wreck were inspected, with no images obtained to confirm the integrity of the tonnage valve openings. The port transom door was again observed to be open (**see Figure 22**), and some slight damage was observed near the bow of the hull.

Port transom door on *Harvest Hope* open

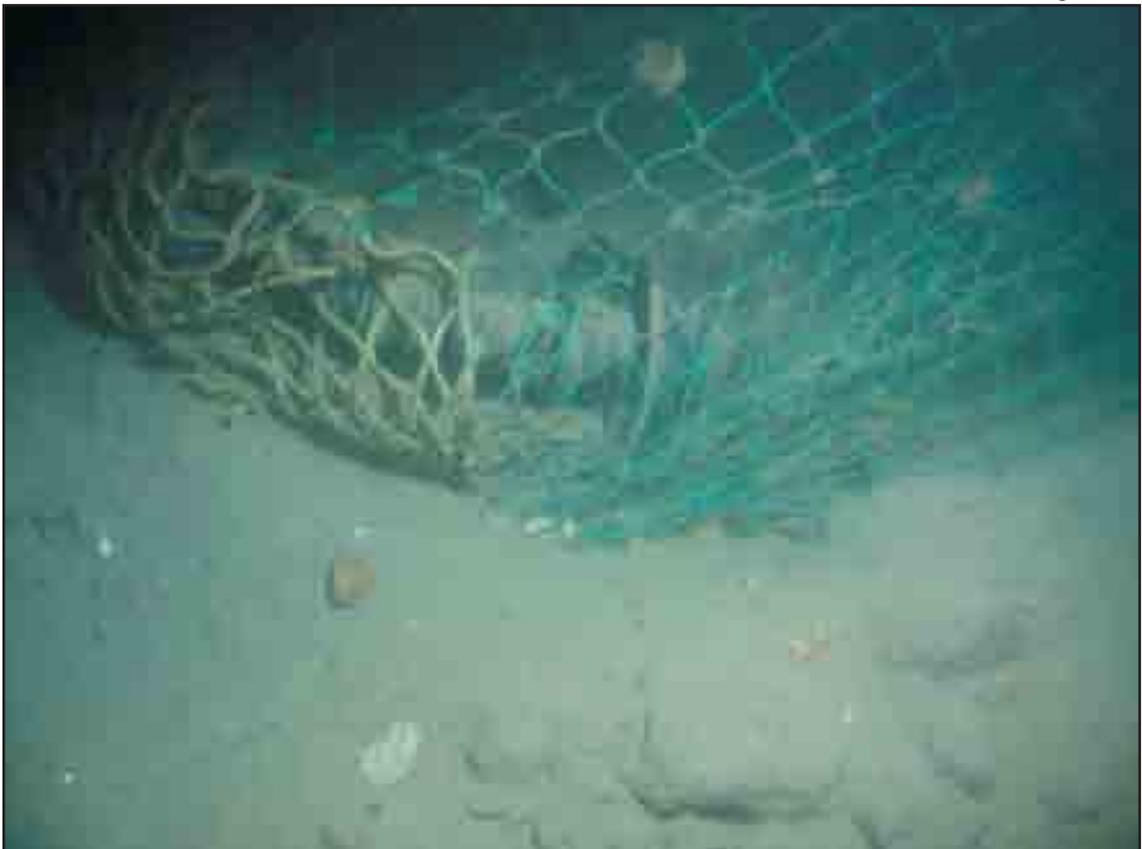
Figure 23

Underwater footage of the snagging area was subsequently viewed during a meeting in December 2005 between Shell, Boreas and the vessel's owners. The latter felt that the footage confirmed that the tickler chain at the forward end of the trawl net had become fast in large mounds of boulder clay by the edge

Harvest Hope's trawl gear embedded into large mounds of boulder clay

of the 4-inch MEG line trench. The owners also noted that their “auto-trawl” system had paid out slowly following the snagging, which is typically indicative of coming fast in mud, rather than a hard obstruction, such as a rock. They also confirmed that they had successfully trawled the area many times previously in both directions.

The Boreas report made various recommendations to Shell regarding the removal from the seabed of the trawl gear, which was considered to pose a significant hazard to other deep sea users, and the promulgation of the lessons learnt regarding trenching procedures.

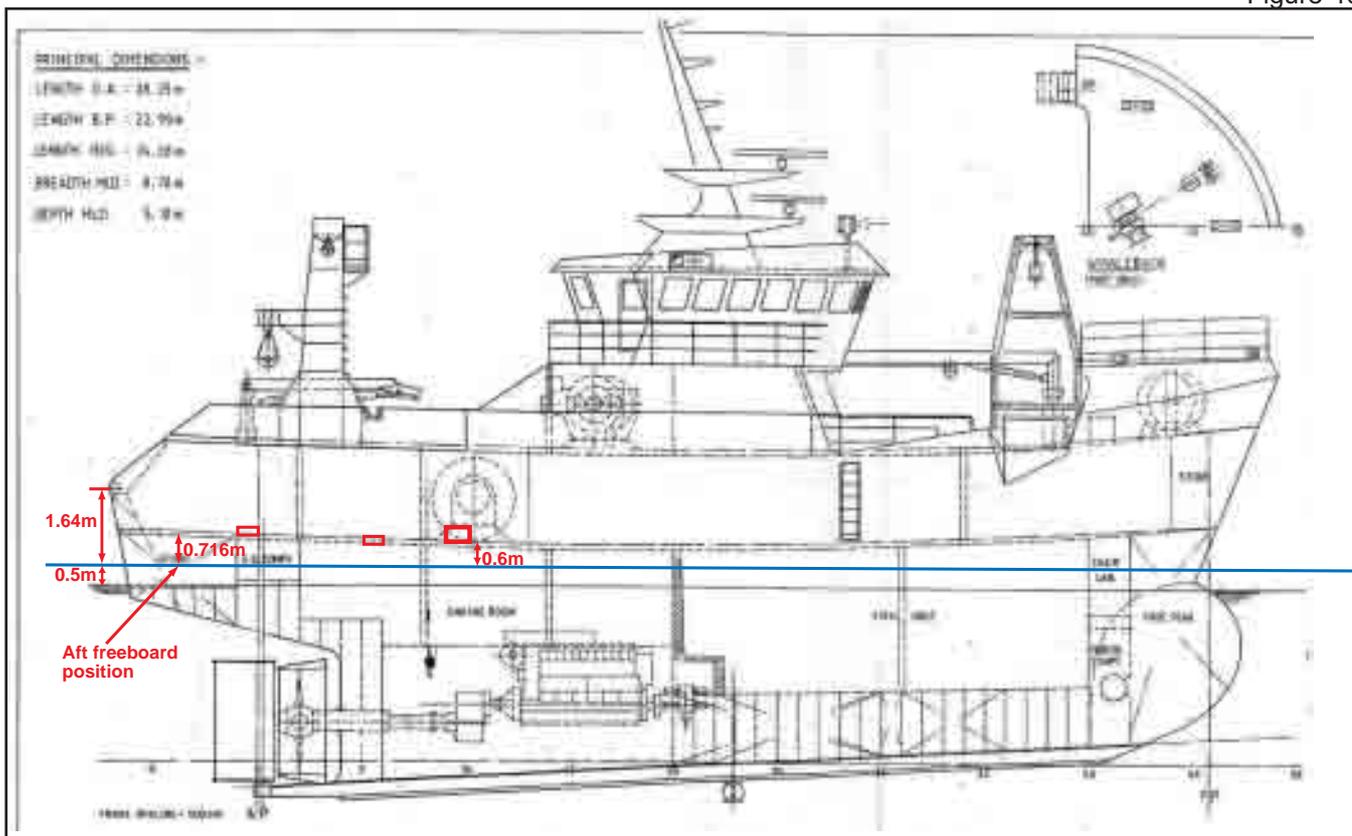
Figure 40

It can be seen that this operational waterline exceeds what is presumably the vessel's intended design draught by about 0.5m and that the aft "rule" freeboard was 0.716m, which is less than the required value of 0.818m, stipulated in the stability booklet at **Annex J**. The freeboard in way of the forward tonnage valve in the net drum space would have been even less, due to main deck sheer.

Profile depicting estimated waterline during final voyage

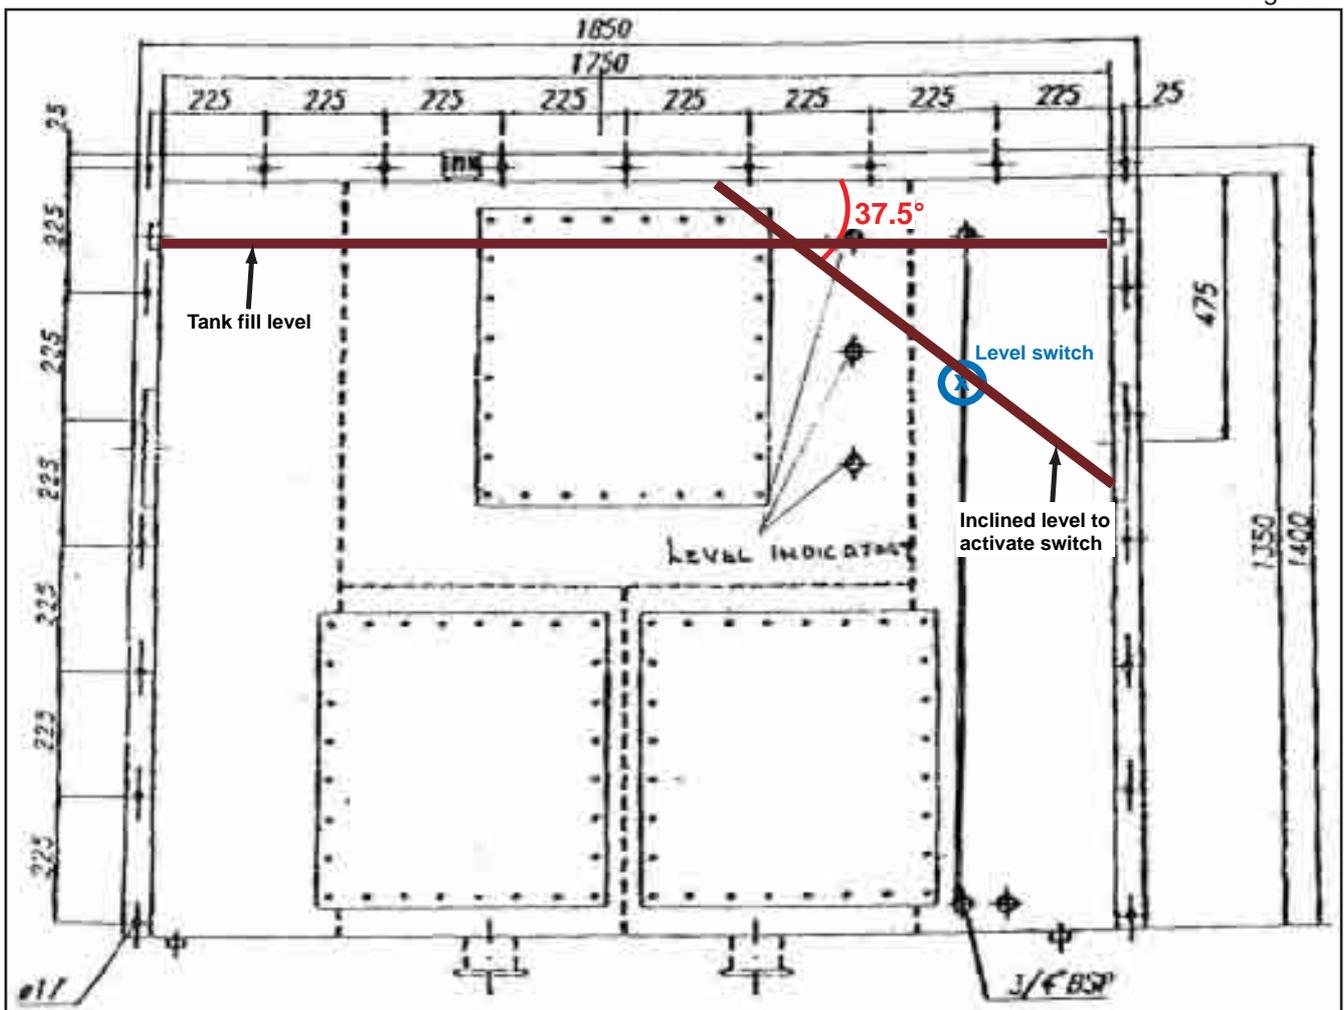
Figure 42

Based on the descriptions of the crew, the hydraulic oil level during the voyage and the position of the “Murphy switch” have been marked on a diagram of the tank, at **Figure 42**. Although baffles were understood to be fitted in this tank to dampen the fluid motion, the level in the tank would tend to settle at angles approximating to the vessel’s angle of heel. Therefore, assuming no loss of oil during the incident, it can be seen that a heel of about 35° would have been required to activate the alarm, and shut down the main hydraulic pumps. However, the possibility of hydraulic oil system loss, perhaps when the hydraulic ram became detached from the port transom door, can also not be discounted. What is evident from **Figure 42** is that if the “Murphy switch” had been positioned more centrally in the tank, it would have been less prone to activation while the vessel was rolling or listing to port.

Drawing of hydraulic oil tank on *Harvest Hope* showing level of oil
